ARCHAEOLOGICAL MONITORING

**NEW YORK CITY DEPARTMENT OF
DESIGN AND CONSTRUCTION/15DOT010R
CAPITAL PROJECT HWR1132B:
SOUTH BEACH RECONSTRUCTION AND
DRAINAGE IMPROVEMENTS
STATEN ISLAND, NEW YORK**

2020

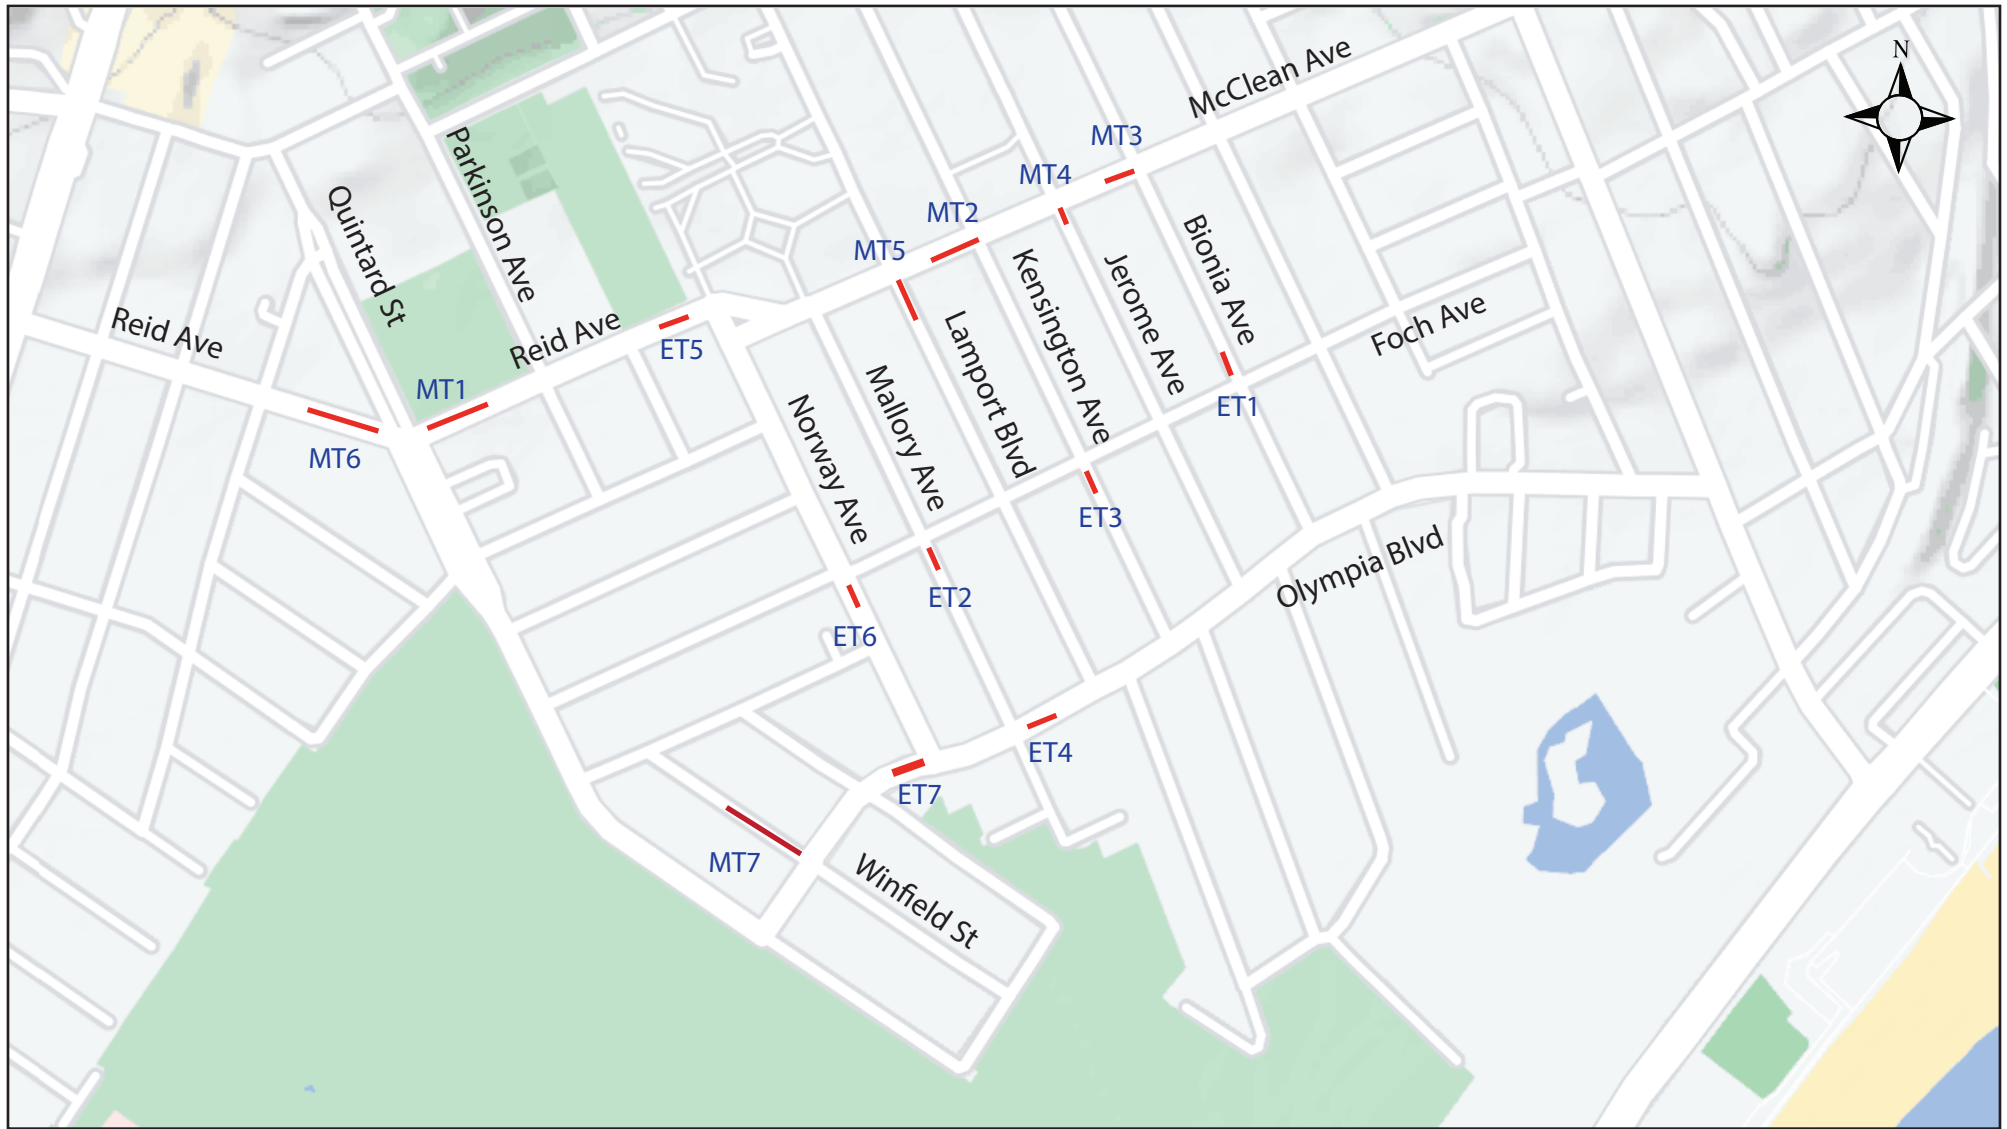
- Figure 3. Location of Excavation and Monitoring Trenches within the Project APE.
- Figure 4. Location of Excavation Trenches 1 and 2.
- Figure 5. Location of Excavation Trenches 3 and 4 (base map: Pillori Associates 2005).

Excavation Trench 1 was a roughly north-south trench, 22 ft (6.7m) by 12 ft (3.6m), that was located on Bionia Avenue north of the intersection with Foch Avenue (Figures 3 and 4). Excavation exposed an abandoned gas main and its surrounding installation trench below the asphalt on the east side of Excavation Trench 1. The utility trench contained several pieces of asphalt and a handful of glass bottle fragments. Testing found that to install the gas line in the streetbed, the utility trench had been excavated well into the subsoil. On the western side, a more typical strata were observed below the asphalt (Photograph 1). Four strata were noted below the asphalt and is this stratigraphic sequence is presented in Table 1 below.

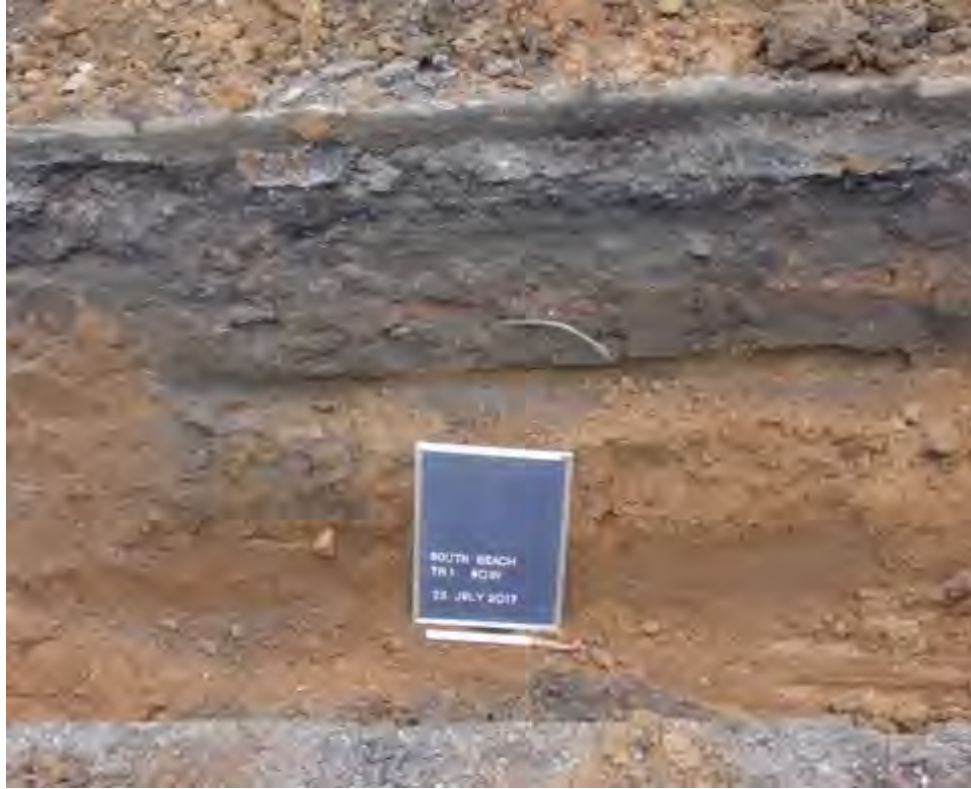
Photograph 1. West Wall Profile of Excavation Trench 1.

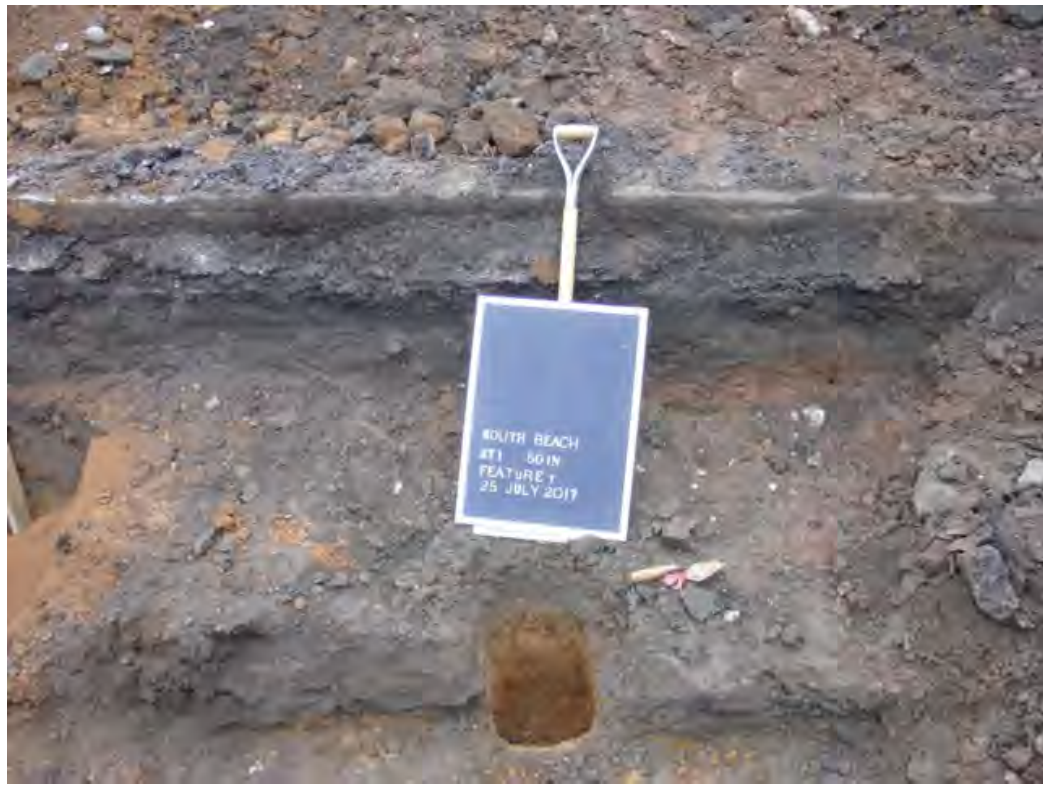
The soils down to 2.3 ft (70cm) were mechanically removed, and what appeared to be the top of the B horizon was shovel shaved in an attempt to expose any potential features. A circular soil stain, about 1.8 ft (0.5m) in diameter

and 0.16 ft (0.04m) thick, was noted within the trench at a depth of 2.3 ft (70 cm). The archaeologists excavated a ST1 in that location and found a limited number of modern artifacts including nails, a fragment of a metal funnel, an iron rod fragment, clam shell fragments, a brick fragment, and a ceramic fuse (Photograph 2). It is likely that this was a modern intrusion, likely from the same time period as the nearby utility trench on the east side of the trench.

Photograph 2. Soil Stain and Completed ST 1 in Excavation Trench 1.

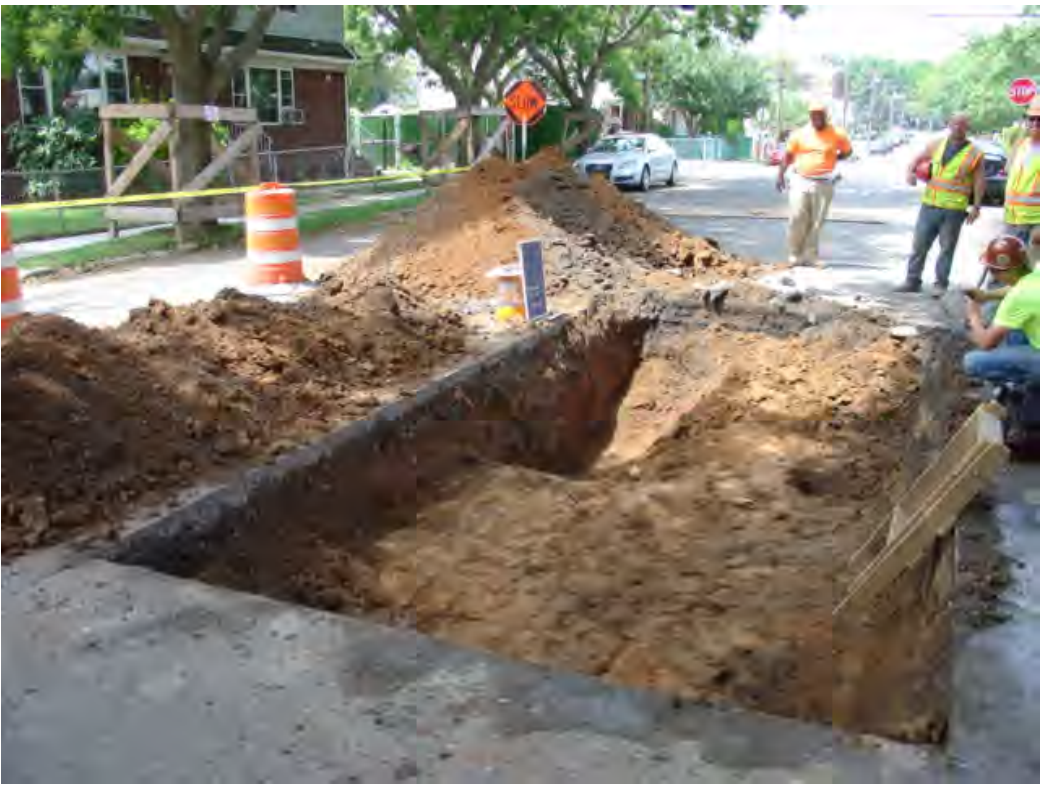
Excavation Trench 2 was located in Mallory Avenue, just south of Foch Avenue (Figures 3 and 4; Photograph 3). The trench measured 19 ft (5.75m) north-south by 9 ft (2.7m).

The eastern third of the trench, an area 2.8 ft (85cm) wide, was comprised of disturbed mixed fill. Several fragments of macadam and a few unidentified metal fragments were observed in the fill. Similar to Excavation Trench 1, this disturbance was likely the result of buried utilities in the streetbed, although no pipe was exposed. The trench was excavated to a depth of 5 ft (1.5m).

Photograph 3. View looking northwest at Excavation Trench 2 in Mallory Avenue south of Foch Avenue.

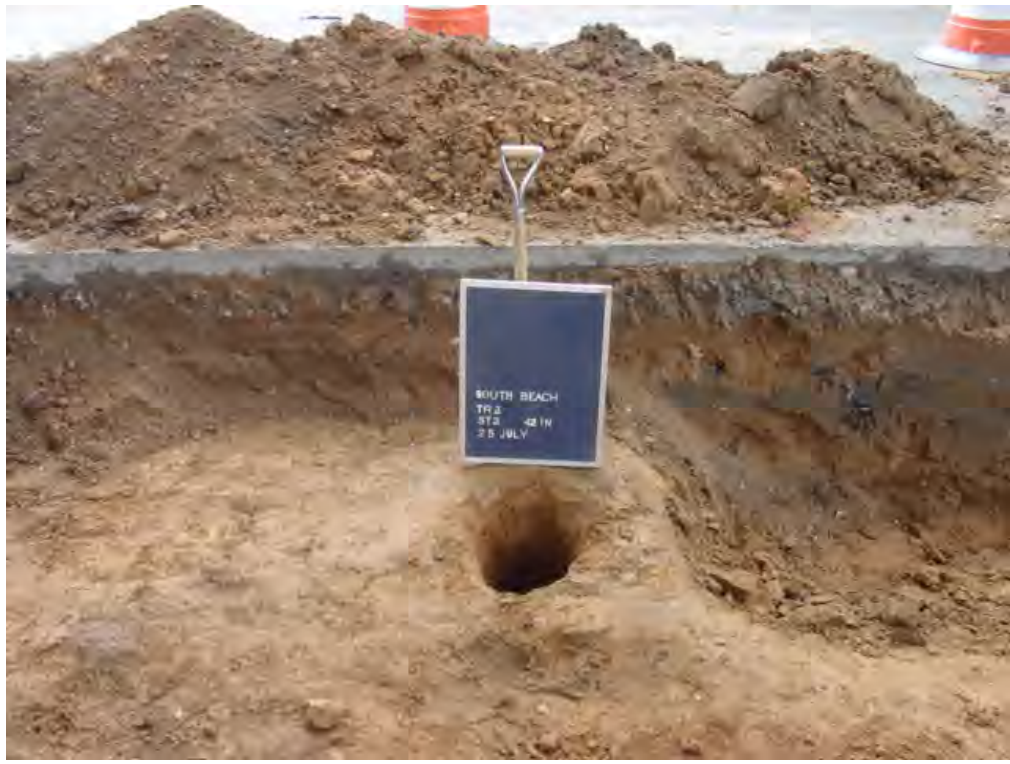
The western side of the trench appeared to be primarily undisturbed beneath the asphalt and upper surface stratum. ST2 was investigated beneath the upper strata and confirmed that Levels 3 and 4 on the west side of the trench were natural strata (Photograph 4). No cultural material or features were noted in Excavation Trench 2. Table 2 presents the profile of the western wall of the trench.

Photograph 4. West Wall Profile and Completed ST2 in Excavation Trench 2.

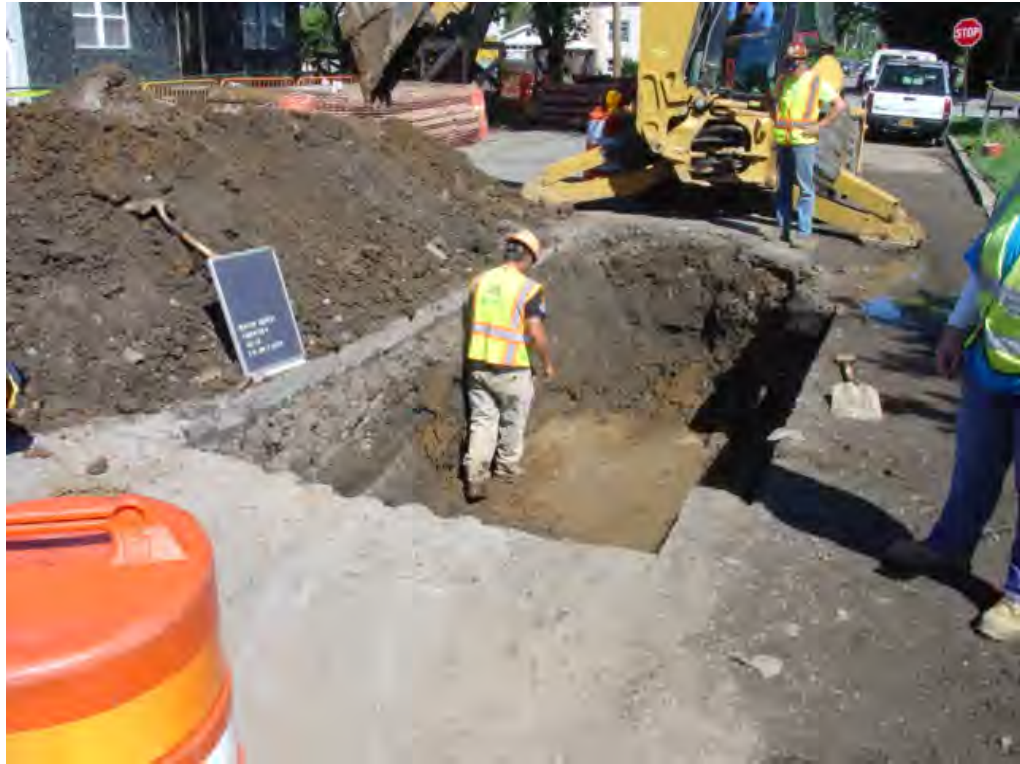
Excavation Trench 3 was excavated in Kensington Avenue just south of Foch Avenue (Figures 3 and 5, Photograph 5). This trench was 18 ft (5.5m) north-south by 7 ft (2.1m) in size. A decommissioned gas pipe was exposed on the east side of the trench at a depth of 3.5 ft (1.1m) below surface. The majority of Excavation Trench 3 appears to have been disturbed by the installation of the gas pipe. Several pieces of asphalt were observed in the disturbed fill.

Photograph 5. View looking northwest Excavation Trench 3 in Kensington Avenue, south of Foch Avenue.

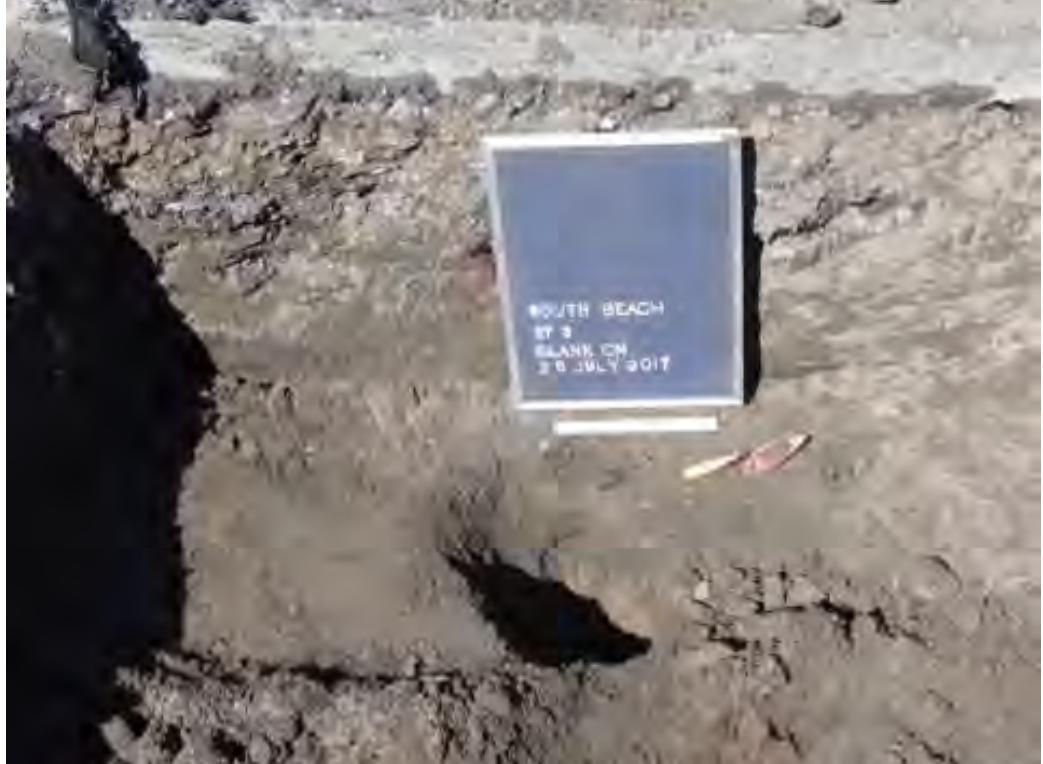
Following the removal of the upper strata, ST3 was investigated in the southwest part of the trench, in order to examine the strata (Photograph 6). The shovel test confirmed that the strata were disturbed by the utility installation trench. The trench was excavated to a depth of 5 ft (1.5m) and no cultural material or features were noted.

Photograph 6. West profile with ST3 in Excavation Trench 3.

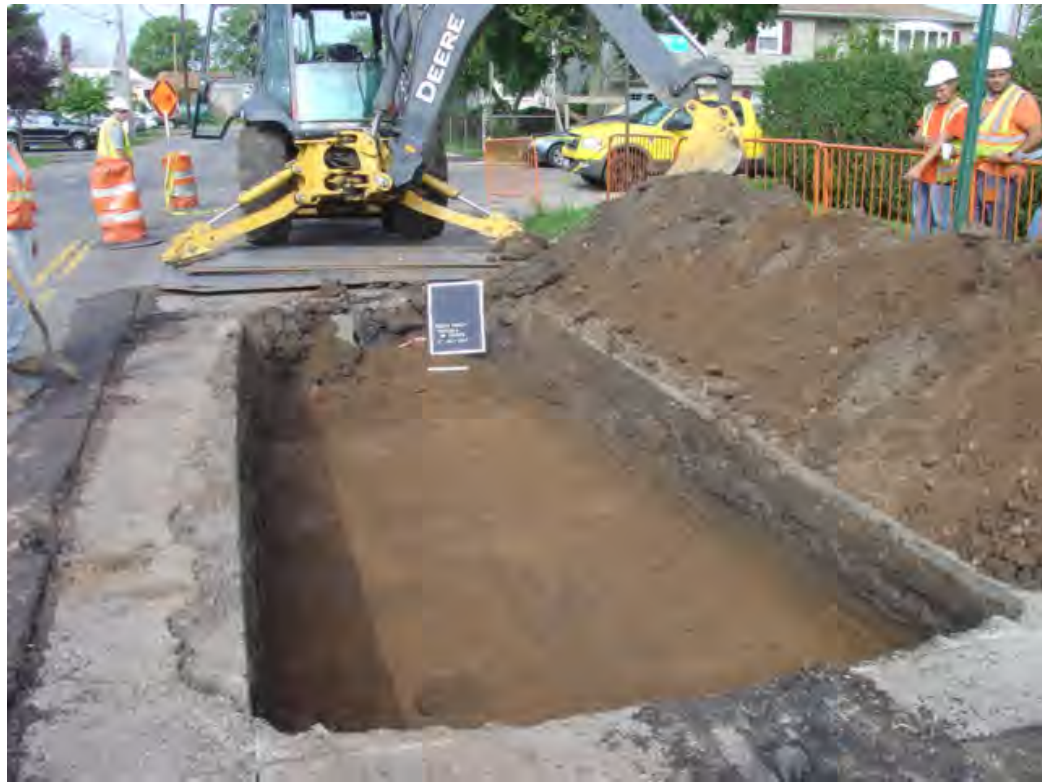
Excavation Trench 4 was located in the south end of the project APE, on Olympia Boulevard between Mallory Avenue and Lamport Boulevard (Figures 3 and 5; Photograph 7). The trench measured 20 ft (6.1m) east-west by 7.5 ft (2.3m). Beneath the asphalt road surface, five strata were noted (Table 4; Photograph 8). ST4 was placed in the southeast end of the trench, near the base of Level 3, at a depth of 1.4 ft (0.4m). ST4 was investigated in order to confirm the presence of undisturbed strata. At the top of the shovel test, a few small fragments of brick were noted in what appeared to be the A-horizon. No cultural material was found in the remainder of ST4, which terminated at a depth of 3.4 ft (103cm).

Photograph 7. View looking west Excavation Trench 4, located in Olympia Boulevard east of Mallory Avenue.

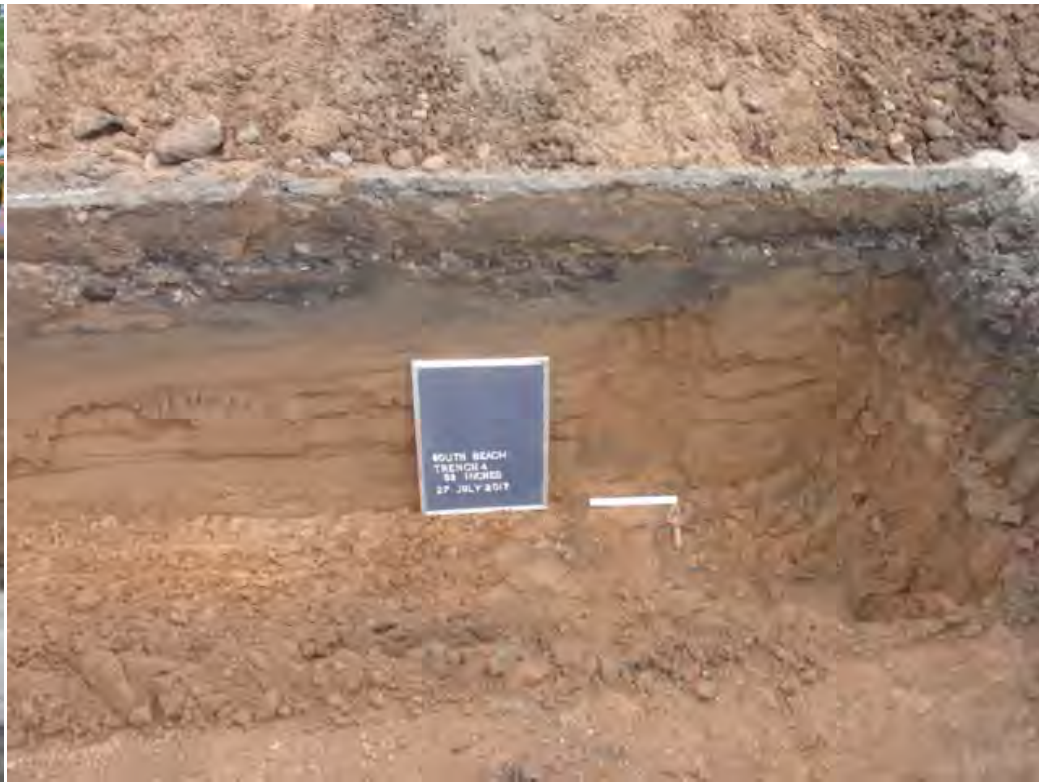
Photograph 8. North Profile of Excavation Trench 4

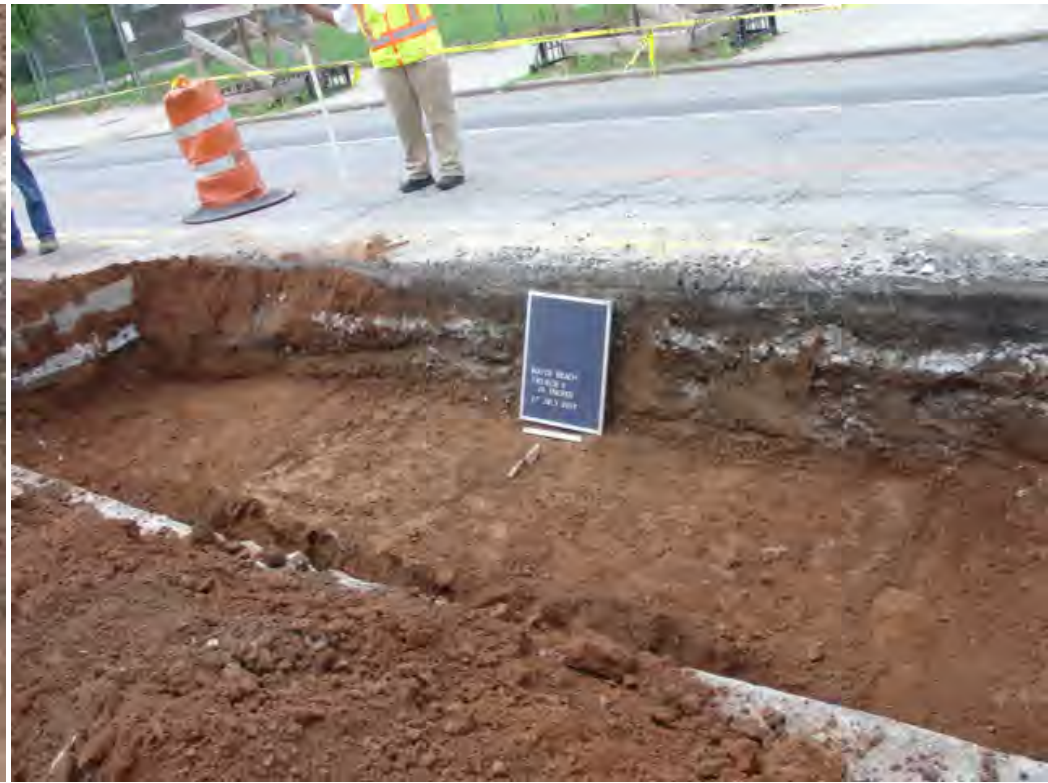
Excavation Trench 5 was located in the north end of the project APE, on Reid Avenue just east of Oberlin Street (Figures 3 and 6; Photograph 9). The trench measured 19 ft (5.75m) east-west by 7 ft (2.1m). Beneath the asphalt the strata encountered appeared to be disturbed. To confirm, ST5 was placed near the southeast corner of the trench. The hand excavation of ST5 commenced at a depth of 2 ft (60cm) and confirmed that the soils in this location were disturbed (Photograph 10). The only cultural materials noted were fragments of anthracite coal and ST5 terminated at a depth of 3.7 ft (113cm). The remainder of the trench was mechanically excavated and no features were exposed. Subsoil was reached at a depth of 2.6 ft (79cm).

Photograph 9. Overview of Excavation Trench 5, facing north.

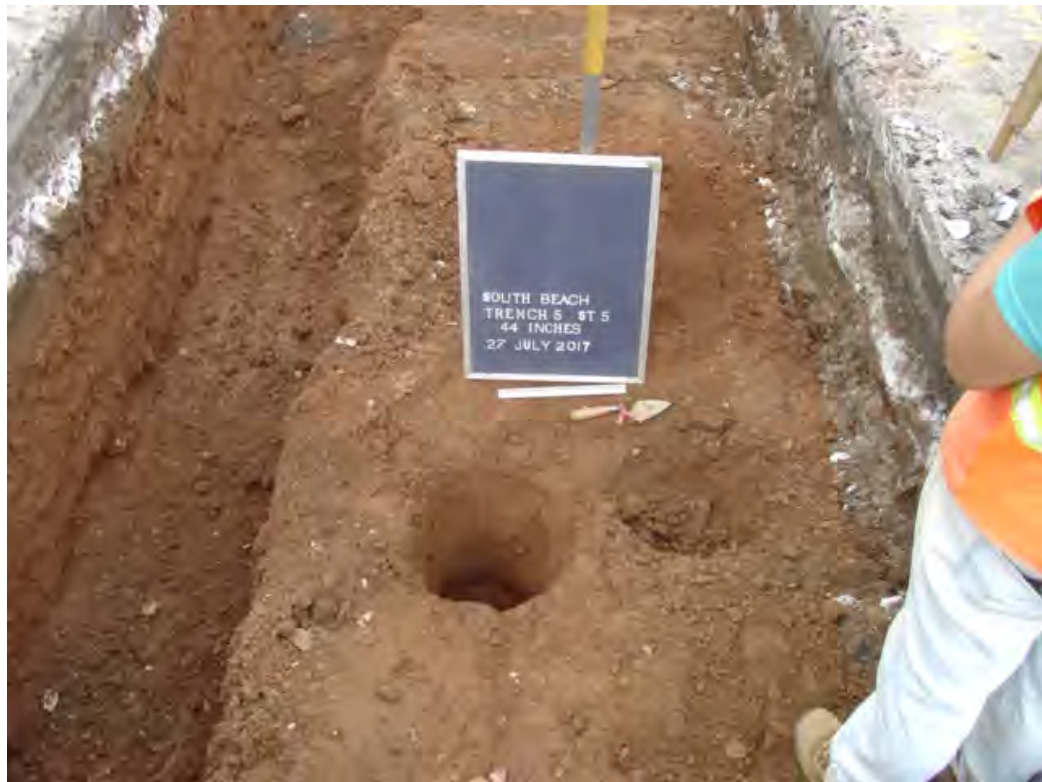
Photograph 10. West profile of ST5 in Excavation Trench 5, located in Reid Avenue east of Oberlin Street.

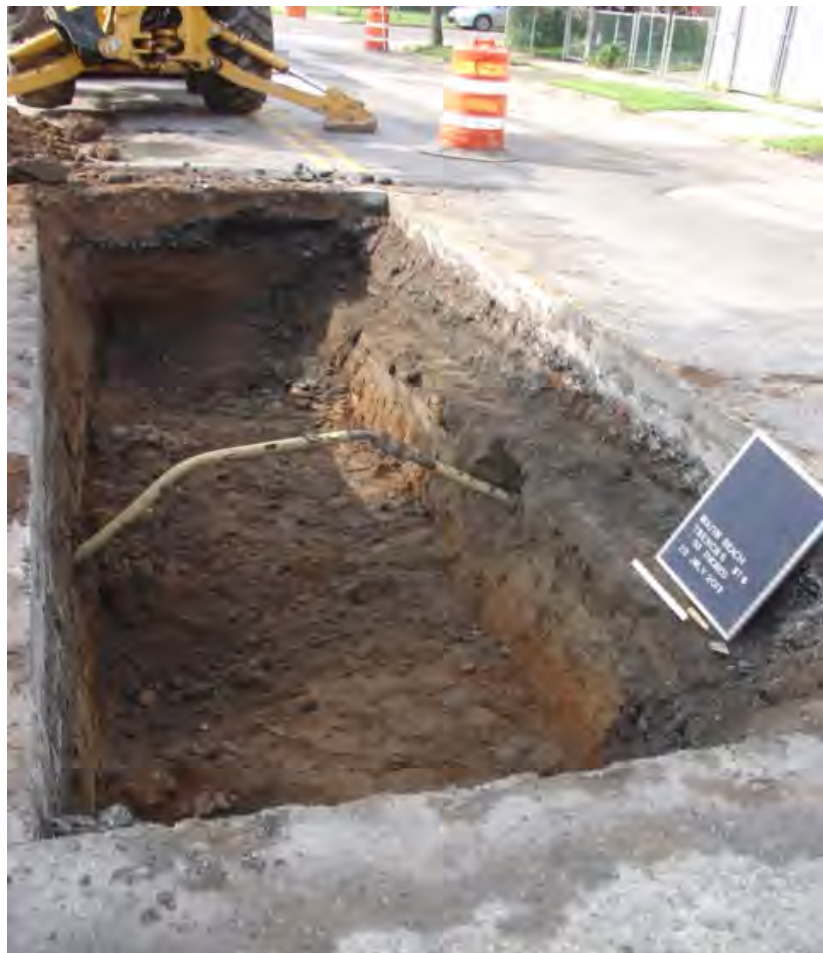
Excavation Trench 6 was near the center of the project area, on Norway Avenue between Nugent Avenue and Appleby Avenue (Figures 3 and 6; Photograph 11). The trench measured 22 ft (3.6m) north-south by 12 ft (3.6m). Beneath the concrete road surface, and older layer of macadam was exposed. The majority of Trench 6 was disturbed by previous utility installation, including a deeply buried sanitary sewer.

Photograph 11. View looking southwest at Excavation Trench 6 in Norway Avenue, south of Foch Avenue.

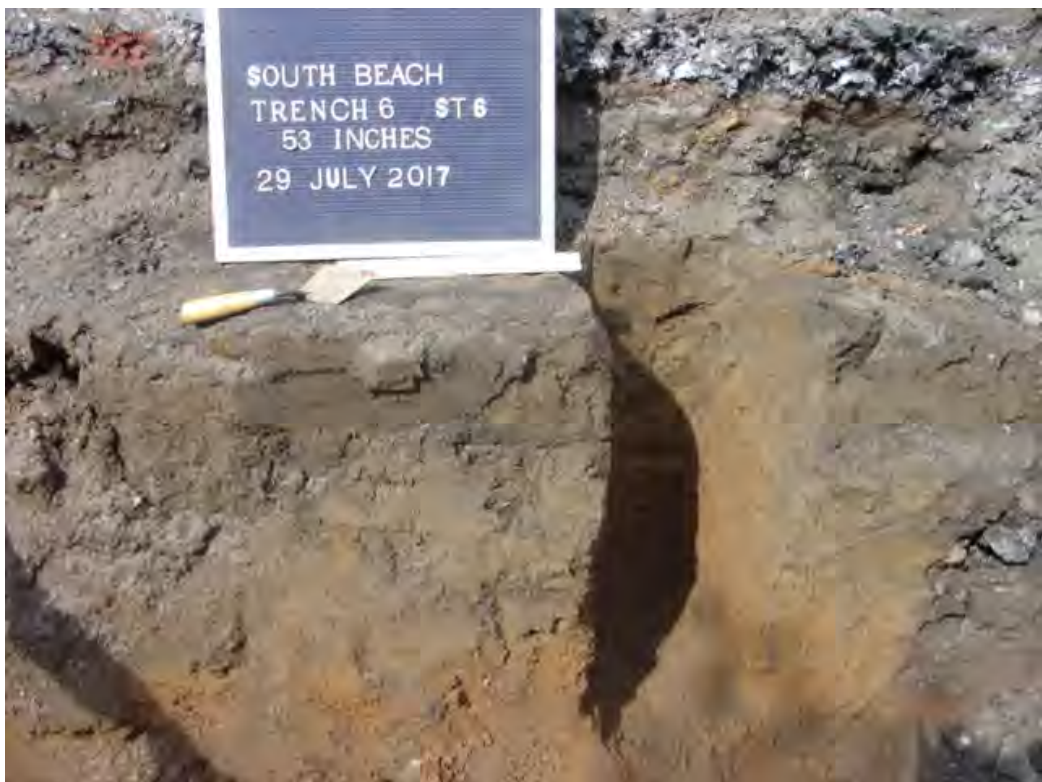
Only a narrow strip of soil on the western edge of the trench (0.9 ft/0.3m) was more or less intact. To identify the integrity of the soil strata, ST6 was located in the north end of this strip (Photograph 12). Three modern whiteware fragments, two brick spalls, and a small piece of red glass were recovered from the surface fill layer. Following the completion of ST6, the intact strip was mechanically excavated to the top of the subsoil and shoveled and troweled to expose any potential features. No features were found and excavation halted at a depth of 4.5 ft (1.4m). Three distinct soil layers were identified beneath the concrete and macadam road surfaces (Table 6).

Photograph 12. West profile of ST6 in Excavation Trench 6.

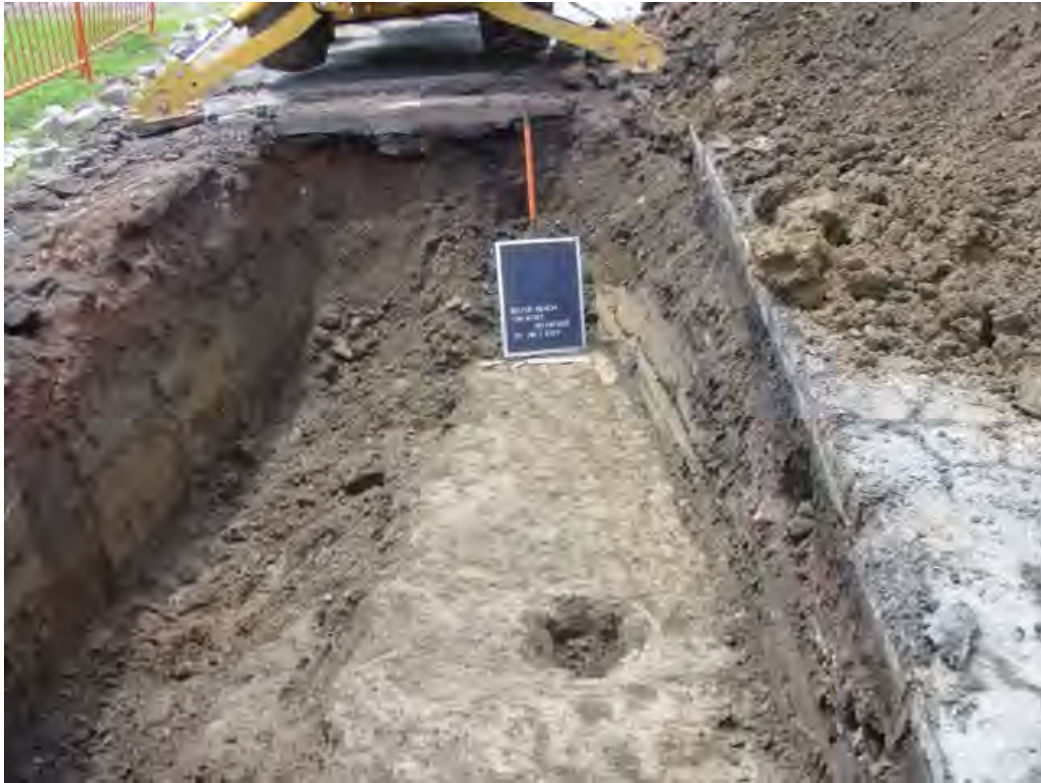
Excavation Trench 7 was located on the south side of Olympia Boulevard, west of Norway Avenue (Figures 3 and 7; Photograph 13). The trench measured 18 ft (5.5m) east-west by 9 ft (2.7m). ST7 was located near the northeast corner of the trench to confirm the stratigraphic sequence (Photograph 14). A few small fragments of clam shell were noted along with fragments of a ceramic drainpipe. Once the depth of subsoil was noted, excavation within the ST7 ended.

Photograph 13. View looking west at the top of the B horizon in Excavation Trench 7. ST7 is shown partially backfilled in the foreground.

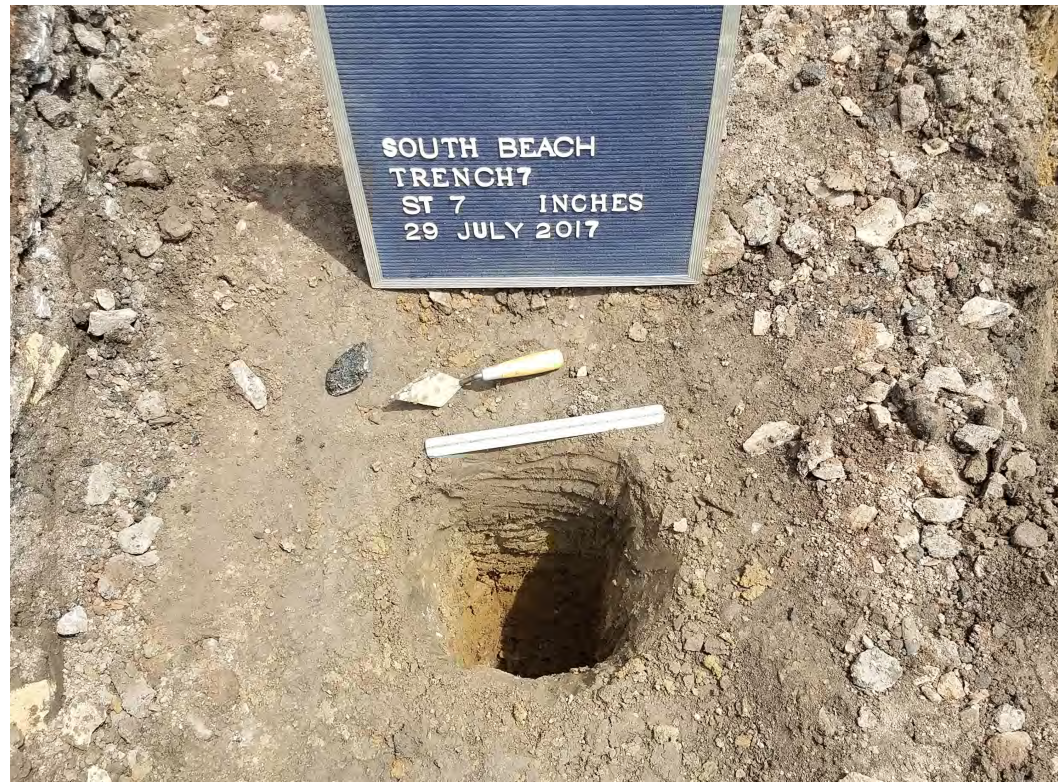
Photograph 14. East profile of ST7 in Excavation Trench 7.

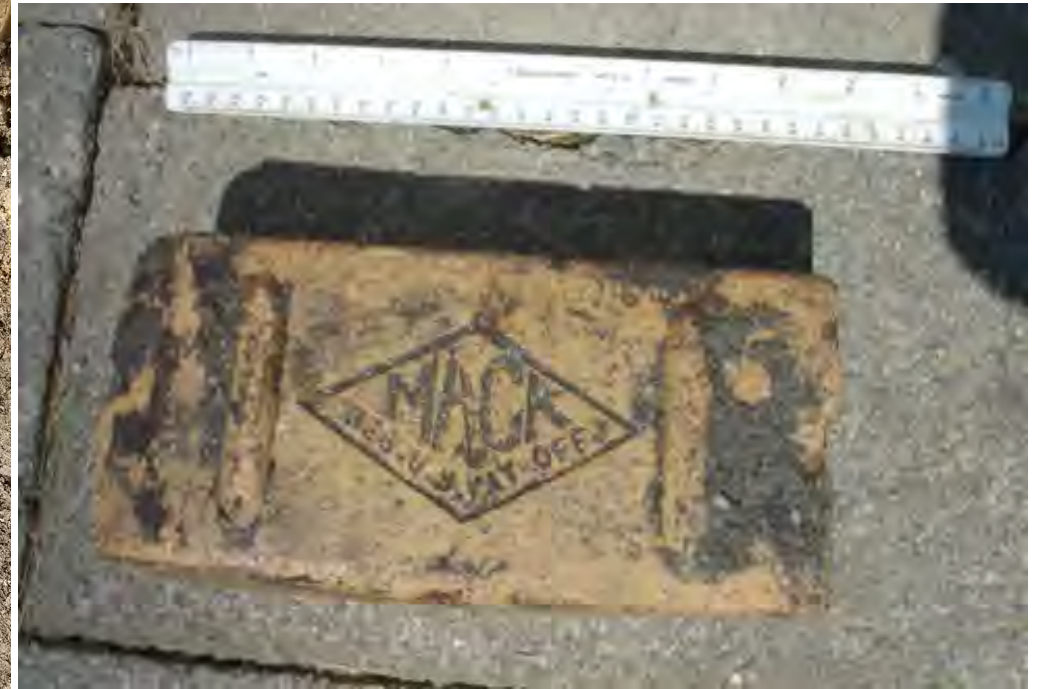
Following the completion of ST7, the trench was mechanically excavated and the exposed surface shovel shaved in an attempt to determine if any features were present. During the mechanical removal of the fill, one complete and several pieces of “Mack” firebricks (twentieth century), unidentified iron, and small traces of clam shell were noted (Photograph 15). No features were found. Beneath the asphalt surface, four soil strata were encountered and are presented in Table 7. Excavation halted at a depth of 4.1 ft (1.2m).

Photograph 15. MACK Firebrick from fill in Excavation Trench 7.

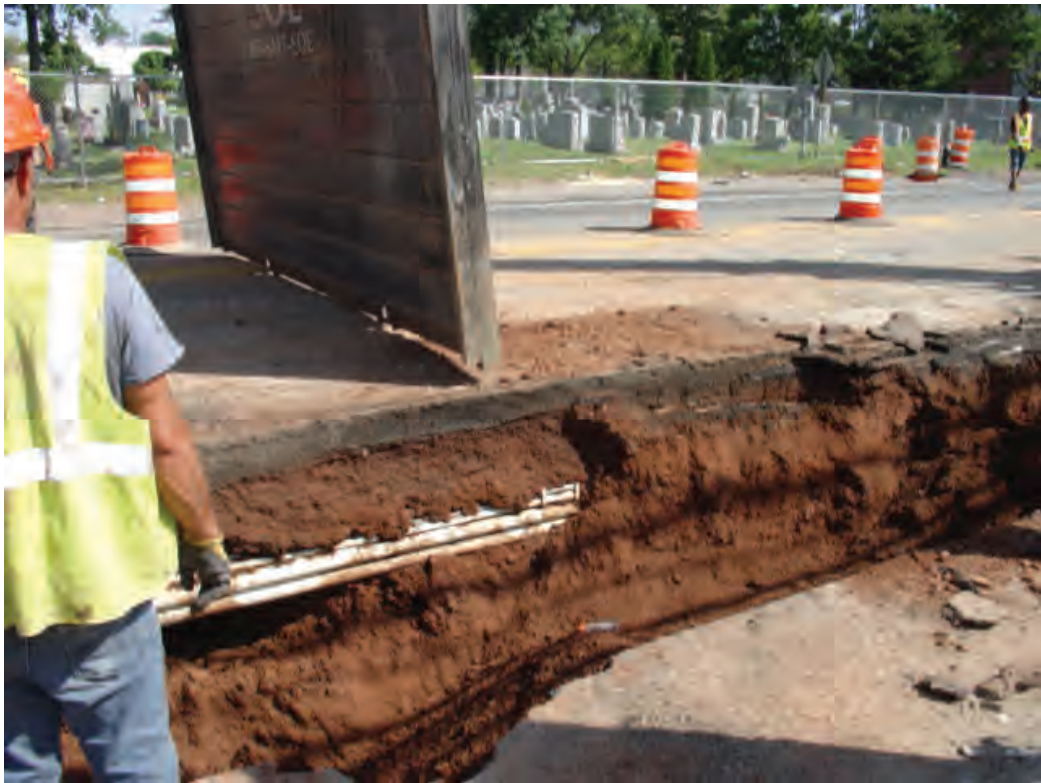
Monitoring Trench 1 (MT1) was located on Reid Street to the south of Quintard Street and was excavated for the sanitary sewer replacement in this location (Figures 3 and 8; Photograph 16). The approximately 200 ft (60.1) by 10 ft (3m) trench was initially excavated to a depth of 4.5 ft (1.4m) where several older utilities were observed. The trench contained mixed, disturbed fill that was impacted by the introduction of these utilities, including the former sanitary sewer line and phone/cable lines. Excavation halted at a depth of 12 ft (3.7m). The stratigraphy noted within MT1 is presented in Table 8. No features were noted within MT1.

Photograph 16. Monitoring Trench 1, facing northeast.

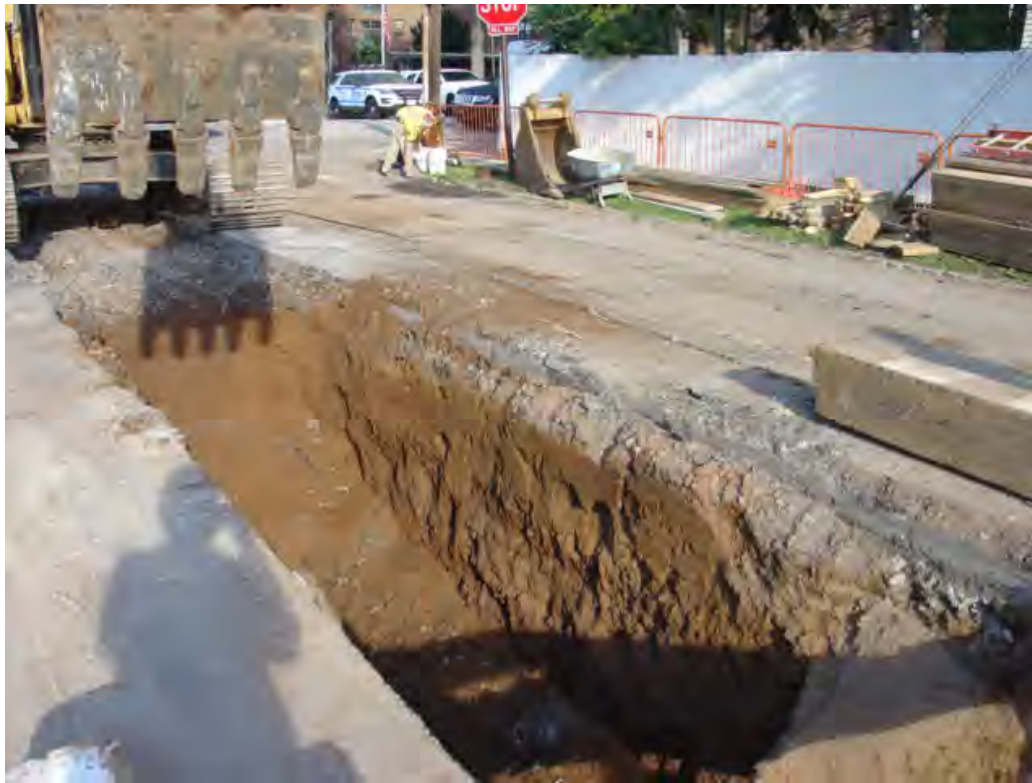
Monitoring Trench 2 (MT2) was located on McClean Avenue to the west of Kensington Avenue and was excavated for the sanitary sewer replacement in this location (Figures 3 and 8; Photograph 17). The approximately 80 ft (9.1m) by 10 ft (3m) trench was initially excavated to a depth of 4 ft (1.4m) when a shoring box was installed for safety. Similar to MT1, this trench also contained mixed, disturbed fill. Excavation halted at a depth of 7.6 ft (2.3m). The stratigraphy noted within MT2 is presented in Table 9. No features were observed during monitoring.

Photograph 17. Monitoring Trench 2, facing southeast.

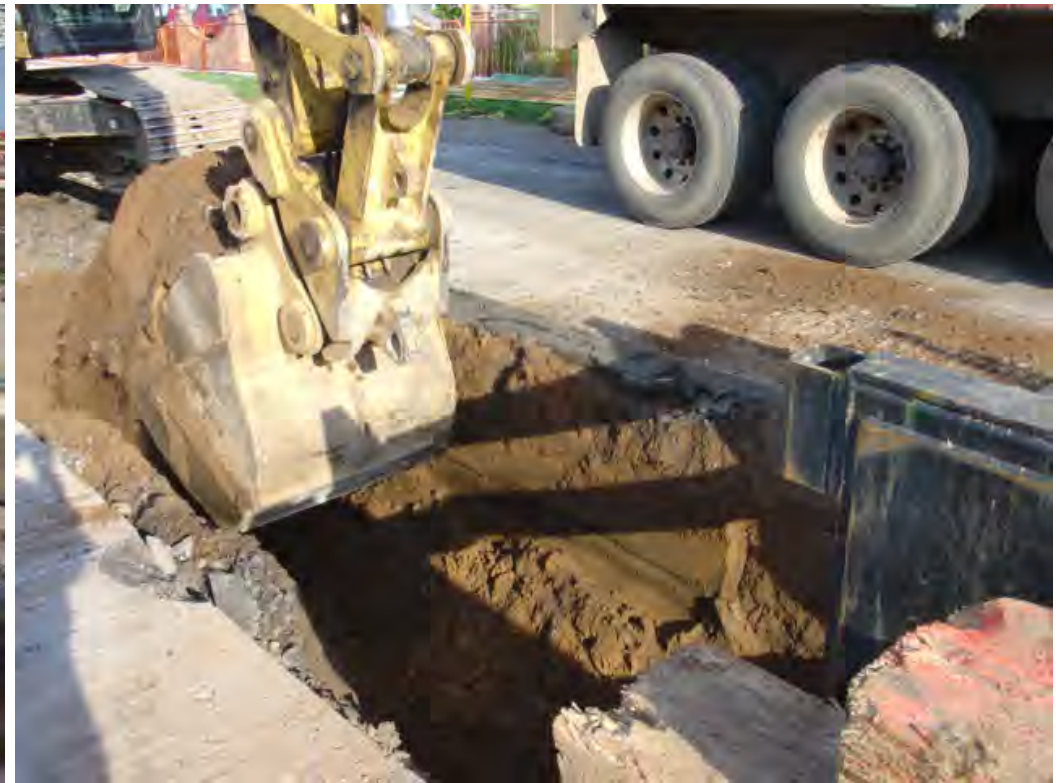
Monitoring Trench 4 (MT4) was located at the northeast corner of Jerome and McClean Avenues (Figures 3 and 9; Photograph 18). The approximately 20 ft (6.1m) by 10 ft (3m) trench was initially excavated to a depth of 4 ft (1.4m) when a shoring box was installed for safety. Similar to MT1, this trench also contained mixed, disturbed fill. Excavation halted at a depth of 10 ft (3.04m). The stratigraphy noted within MT4 is presented in Table 11. No features were observed during the monitoring of MT4.

Photograph 18. Monitoring Trench 4, during excavation.

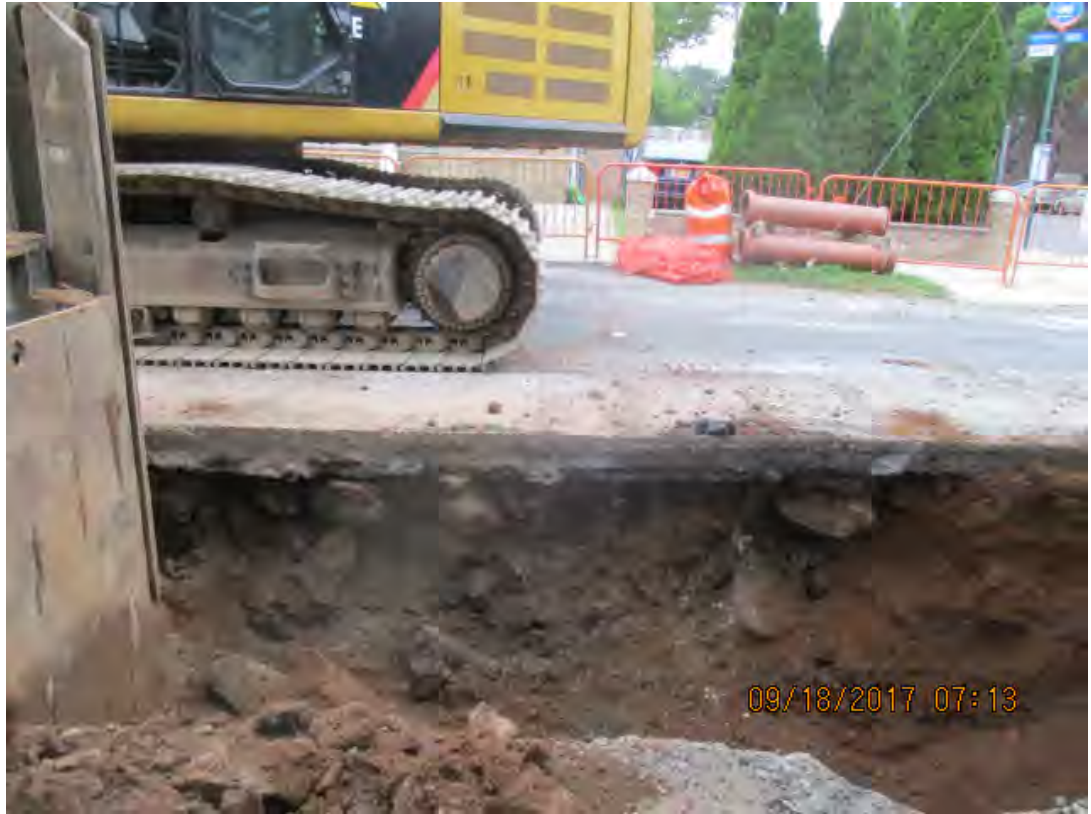
The southernmost section revealed a stratum of mixed fill and architectural demolition debris (e.g., bricks, concrete, utility pipe fragments) beneath the asphalt. The second section encountered the extreme edge of partially demolished stone foundation in the trench wall, likely the easternmost extension of the former residence noted on Figure 11 (Photograph 19). This small portion of the foundation appears to have been partially destroyed during demolition and there were numerous brick and pipe fragments in the surrounding fill. Several brick fragments with a partial unidentified mark “EBO” were noted. MT5 continued northward to the east of the foundation for the third and final section. This section also contained demolition debris in the fill and a handful of artifacts (e.g., brick fragments, unidentified metal, modern whiteware). The stratigraphy noted within MT5 is presented in Table 12. Although MT5 extended to a depth of 10 ft, only the upper 4.5 ft was visible for profiling due to the presence of the shoring box. No additional features were observed during the monitoring of MT5.

Photograph 19. Section of partially demolished foundation exposed in west wall of Monitoring Trench 5 during excavation.

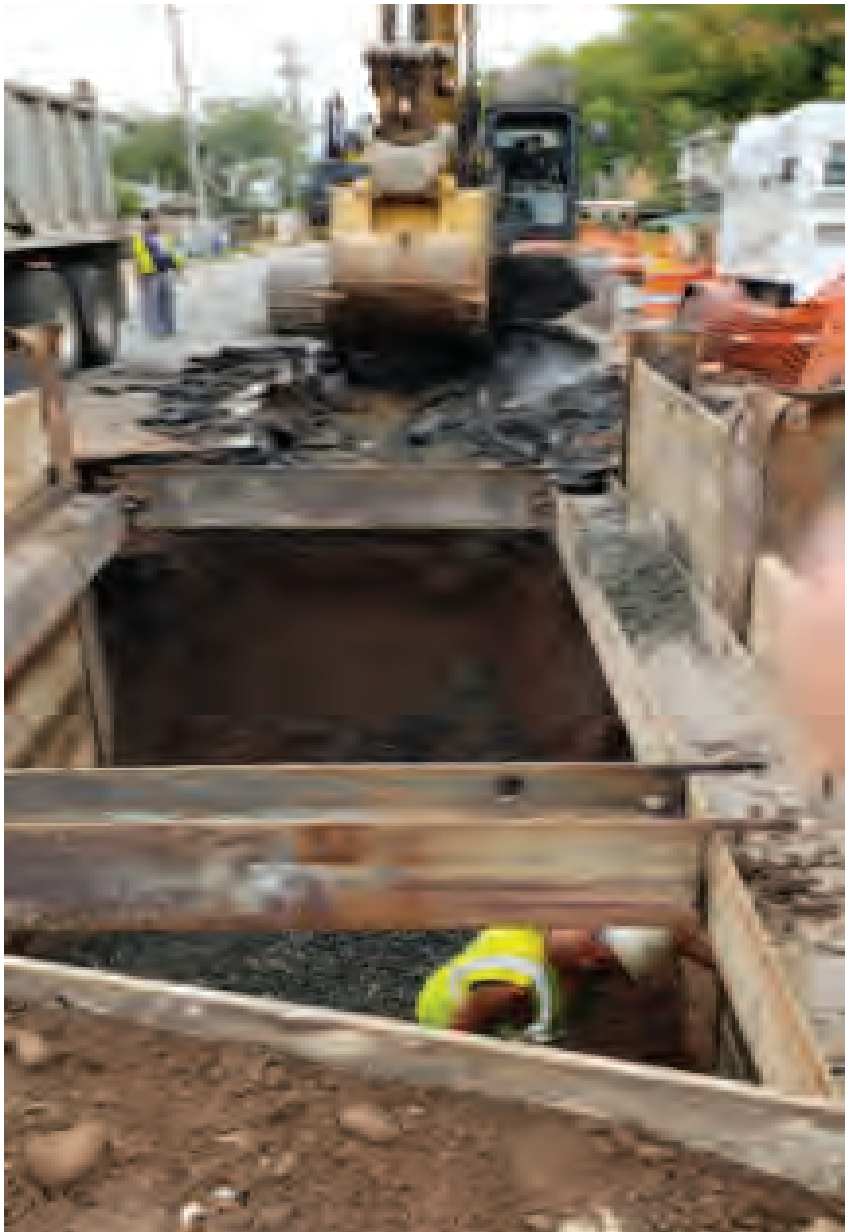
Photograph 20. .Shoring Box in Monitoring Trench 6, during excavation.

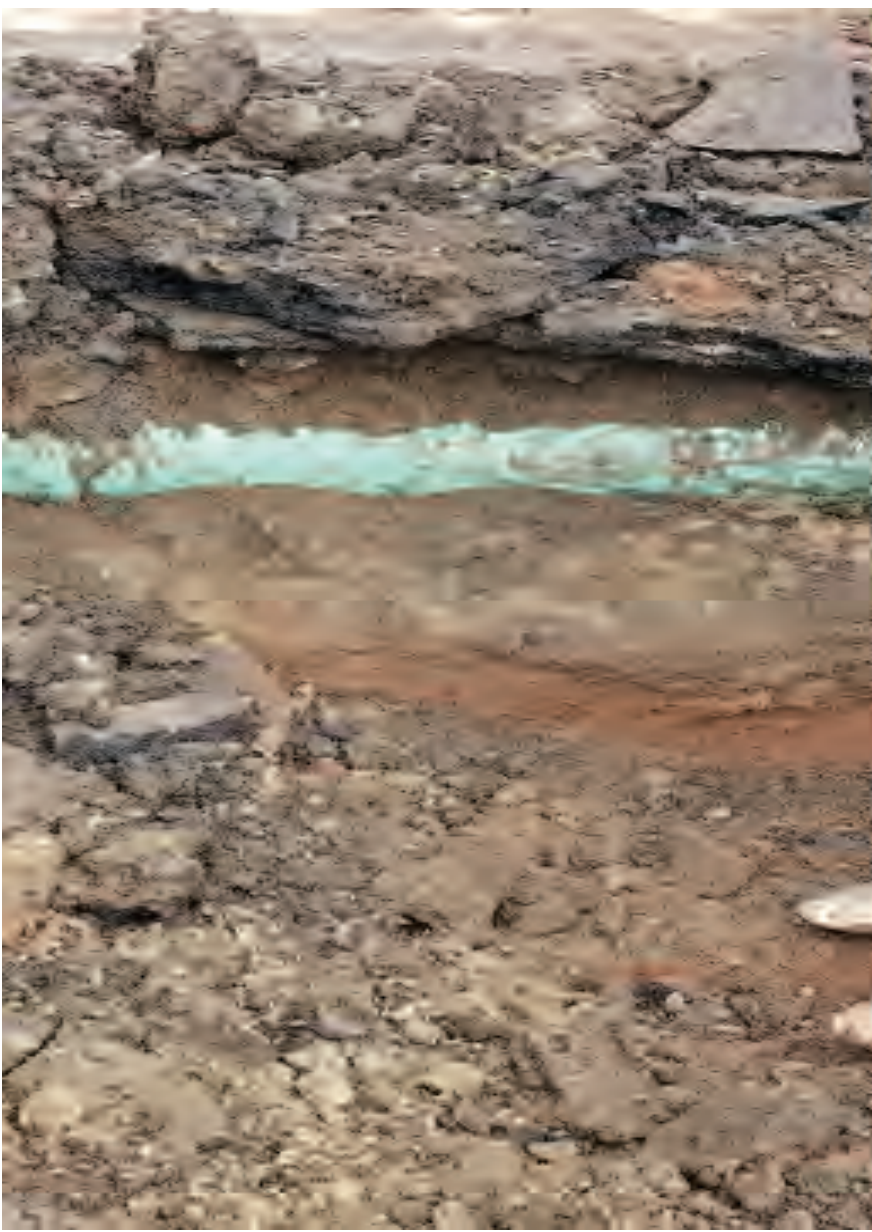
Excavation halted at a depth of 10 ft (3.04m), although only the uppermost 8.2 feet could be documented for the profile. The stratigraphy noted within MT6 is presented in Table 13. Although three defunct utility pipes were noted during the excavation, no features or artifact concentrations were observed during the monitoring of MT6 (Photograph 21).

Photograph 21. Exposed Pipe and profile of East Wall in Monitoring Trench 6, during excavation.
