ARCHAEOLOGICAL MONITORING

**NEW YORK CITY DEPARTMENT OF
DESIGN AND CONSTRUCTION/15DOT010R
CAPITAL PROJECT HWR1132B:
SOUTH BEACH RECONSTRUCTION AND
DRAINAGE IMPROVEMENTS
STATEN ISLAND, NEW YORK**

2020

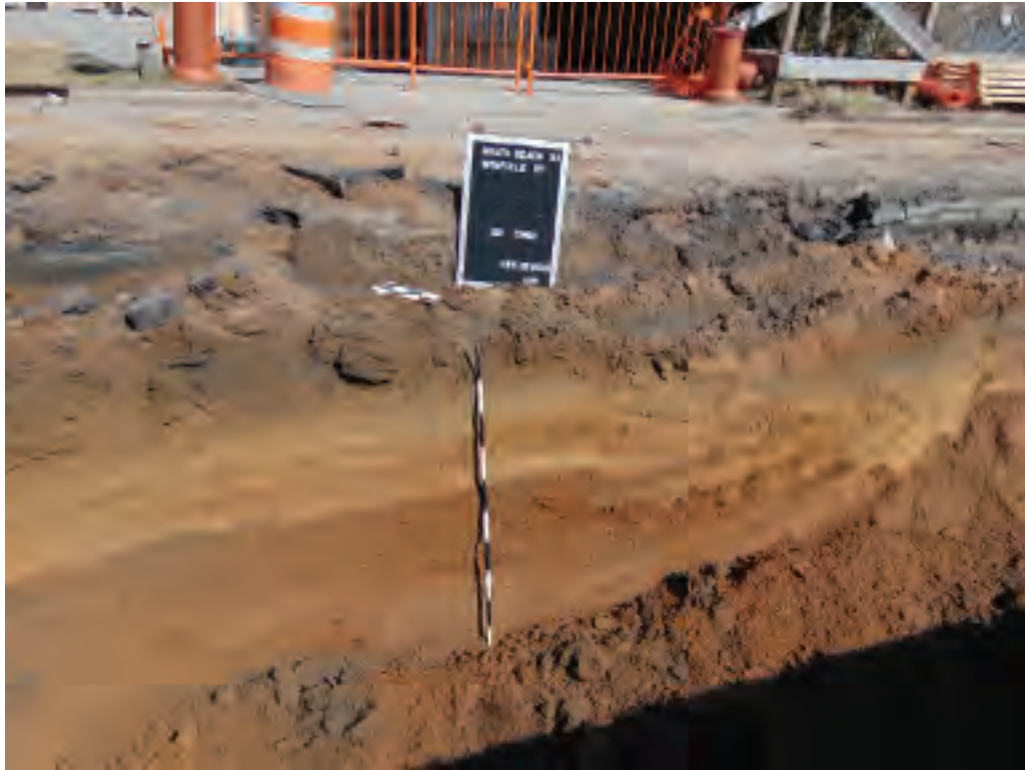
Excavation halted at an approximate depth of 10 ft (3.04m) and stratigraphy noted within MT7 is presented in Tables 14 and 15, as the strata were slightly different at the north and south ends of MT 7 (Photographs 22 and 23).

Photograph 22. Profile of north wall in northeast half of Monitoring Trench 7.
