ARCHAEOLOGICAL TESTING REPORT
THE DUPONT STREET SENIOR HOUSING PROJECT
GREENPOINT, BROOKLYN
KINGS COUNTY, NEW YORK
68-78 Dupont Street
CEQR# 91-149K

Prepared by:
William I. Roberts IV
Greenhouse Consultants Inc.
54 Stone Street, 7th Floor
New York, New York 10004

December 1991

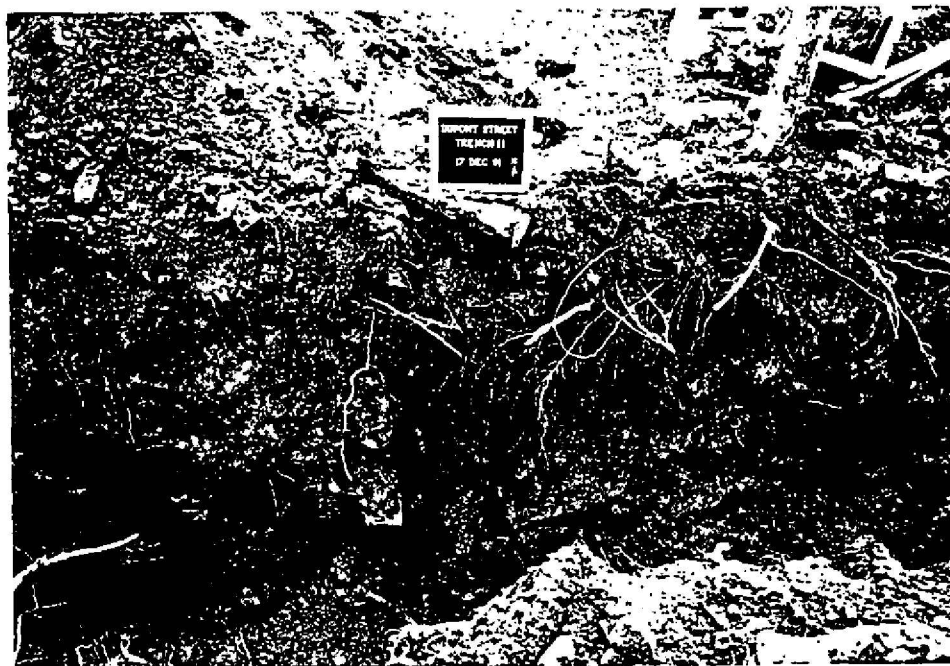
2 in most of Backhoe Trench 2 was layer 3. This deposit of yellowish brown sandy silt was devoid of cultural material. It was found between 1.6 and 5.5 feet below grade. Below this was layer 4, a pale brown silty sand also devoid of cultural material. Layer 4 extended from 5.5 feet below grade past the limit of the excavation which was at six feet. Layers 3 and 4 in Backhoe Trench 2 were interpreted as subsoil. Along the north side of the trench from 11 to 16 feet from the western end was the fifth deposit. This deposit was found underneath layer 2 and cut into layers 3 and 4. It had a stone and soft mortar lining or foundation. The fill of this feature contained building destruction rubble including relatively undecayed wooden planks, as well as red bricks, stone, mortar and metal pipes. It was interpreted as a probable cellar entryway for the building formerly at 68 Dupont Street. See Plate 2 for a view of Backhoe Trench 2 and Plate 3 for a detail of the cellar entryway feature.

Detail of probable cellar entryway in Backhoe Trench 2 looking north.

General Notes : (Note if cult. material retained, and if soil samples are taken.) Stopped @ 6.0'.
cellar entryway in western lot begins under layer 2 and cuts into 4
Starts at 11' ~~East~~ East of fence and continues to 16'. feature contained
relatively undecayed wooden planks.

It is our conclusion that no potentially significant cultural resources were found within the two mechanically excavated trenches. Based on this subsurface testing, we further conclude that it is highly unlikely that any significant archaeological resources will be impacted by the proposed construction of the Dupont Street Senior Housing project. We recommend that no additional archaeological testing or mitigation is necessary at this location within Block 2495 in Greenpoint, Brooklyn, New York.
