# **Reconstruction of the Tide Gate Bridge Over Flushing Creek and Reconstruction of Tide Gates and Sluice Gates**

## **Block 2018, Lot 1**

**FLUSHING MEADOWS CORONA PARK, FLUSHING, QUEENS COUNTY, NEW  
YORK**

### **Phase 1A Archaeological Documentary Study**

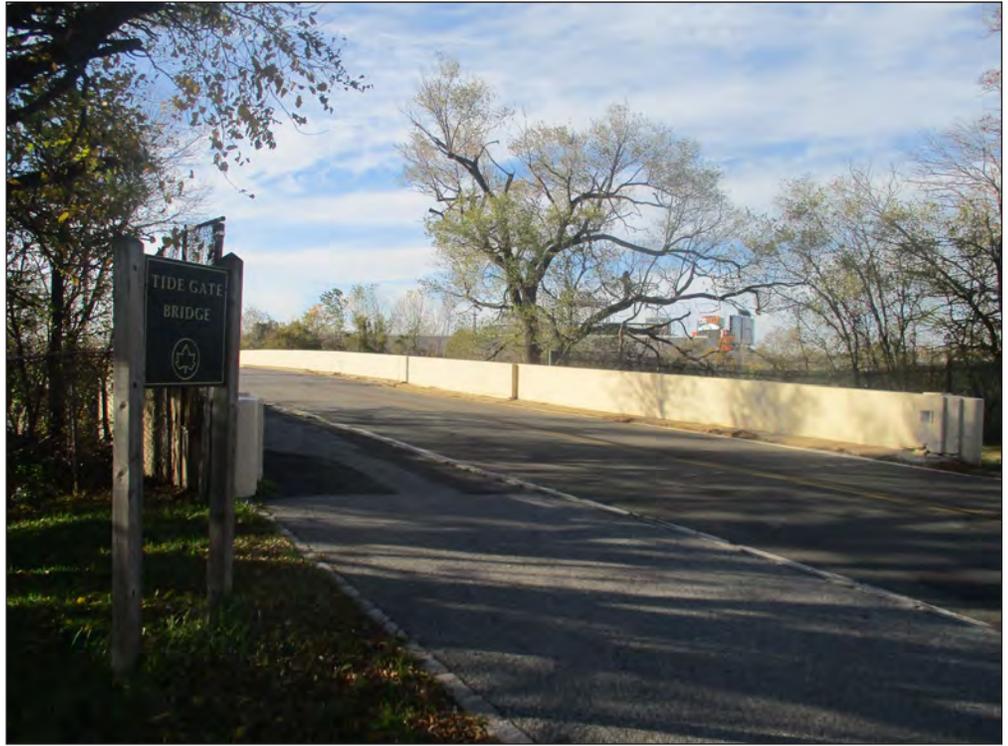
South side of Meridian Road looking west over the Tide Gate Bridge 1

As described previously, the project site surrounds the existing Tide Gate Bridge, which carries Meridian Road over the Flushing Creek and is situated on top of a substantial foundation and supported by piles (see **Figures 3A through 3D**). Areas within the project site adjacent to the road contain paved pathways or flat landscaped lawns with trees. A foundation remnant is located to the northwest of the bridge, outside the limits of the project area, that would be left in place and not impacted by the project. Manholes, utility cover plates, catch basins, and light poles are visible within and adjacent to the streetbed of Meridian Road, confirming the presence of utilities beneath the road surface and in adjacent grassy areas. A sewer line runs through the grassy area parallel to and north of Meridian Road and other utilities including telecommunications and water lines are located along the southern side of the project site and below the bridge foundation. A switch pad on a concrete slab is located in the northwest corner of the project site. With the proposed project, some of these existing electrical infrastructure in the grassy lawn to the northwest of the bridge will be removed and replaced with new infrastructure elsewhere within that same area.

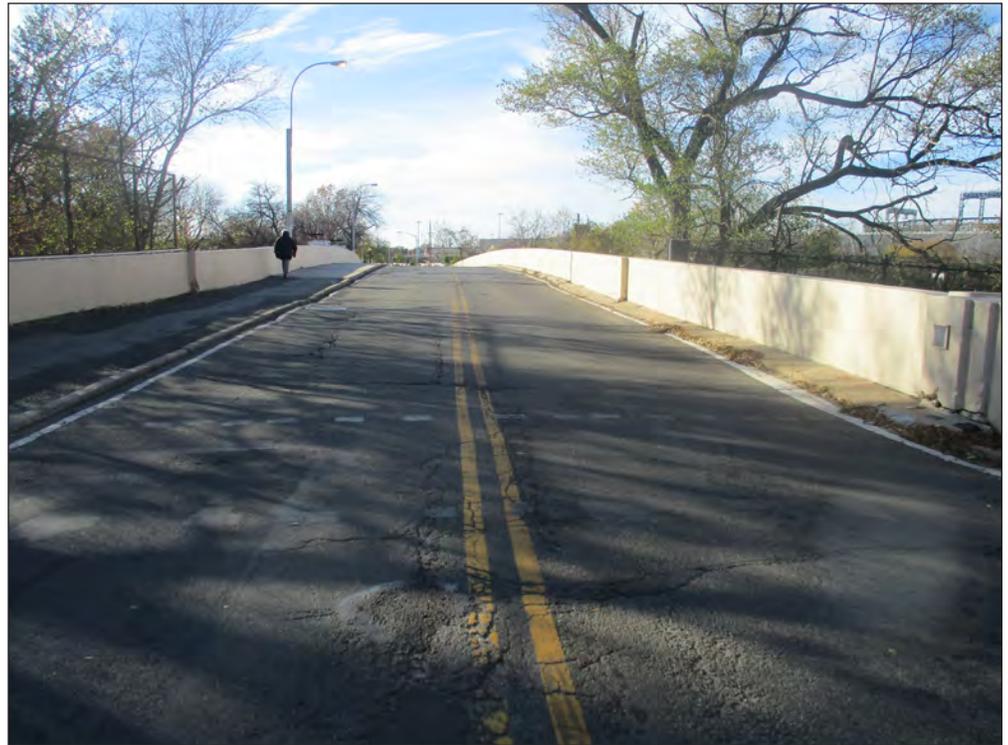
Meridian Road looking west over Tide Gate Bridge 2

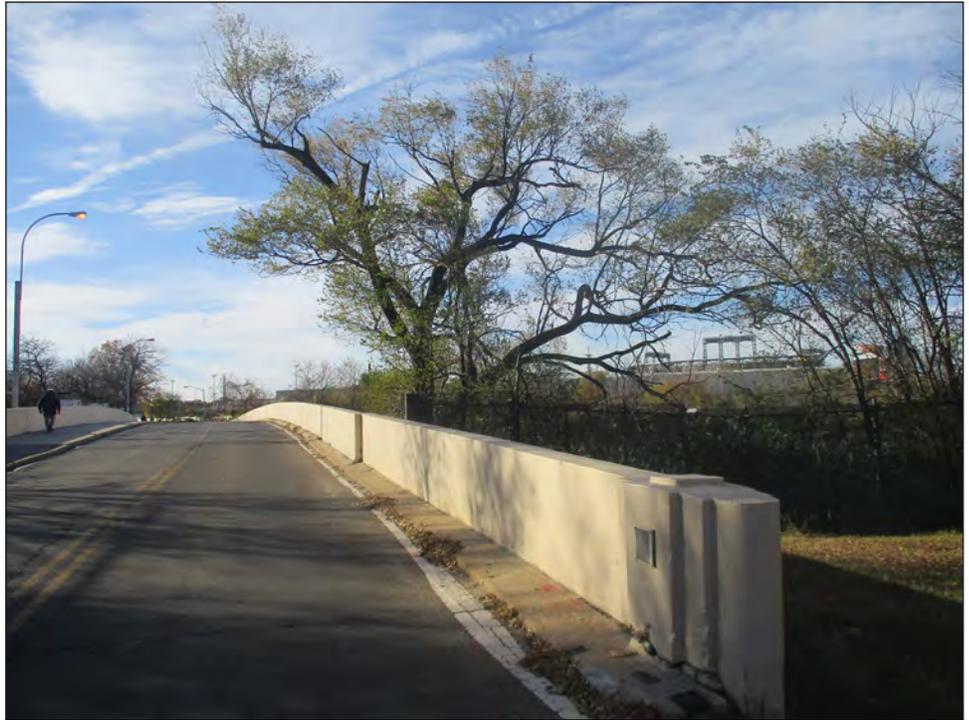
North side Meridian Road looking west over the Tide Gate Bridge 3

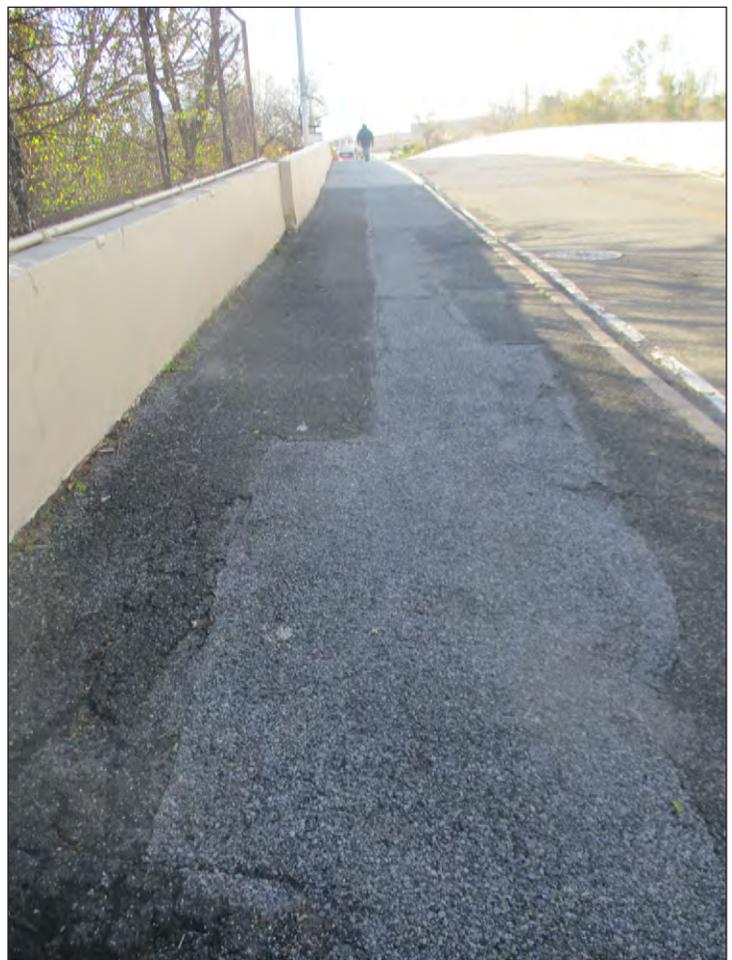
East side of Tide Gate Bridge looking west 4

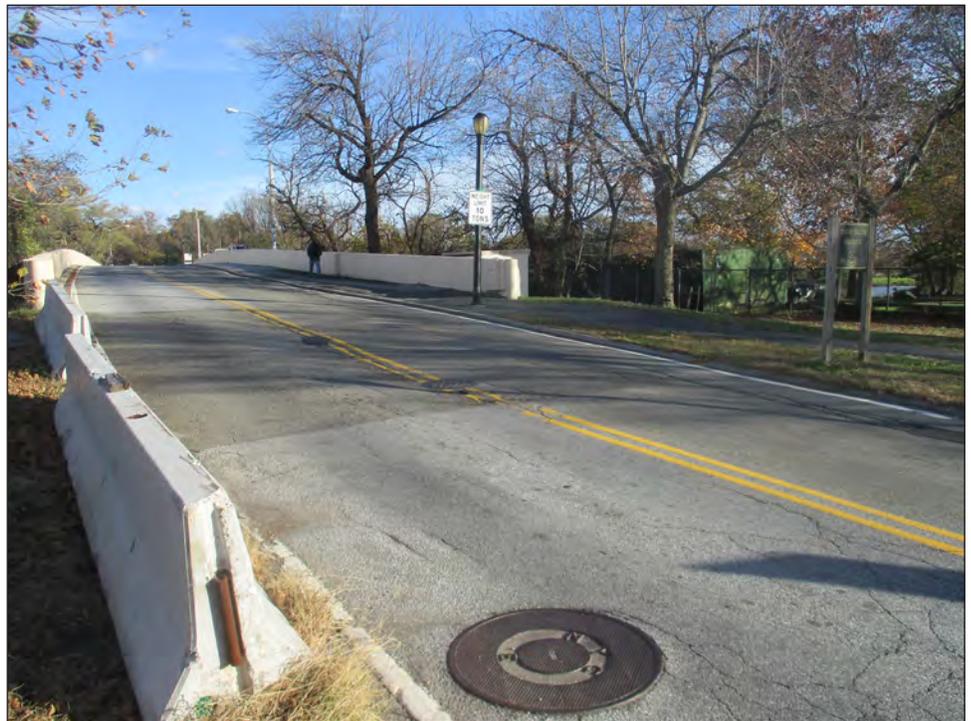
West side of Tide Gate Bridge looking east 6

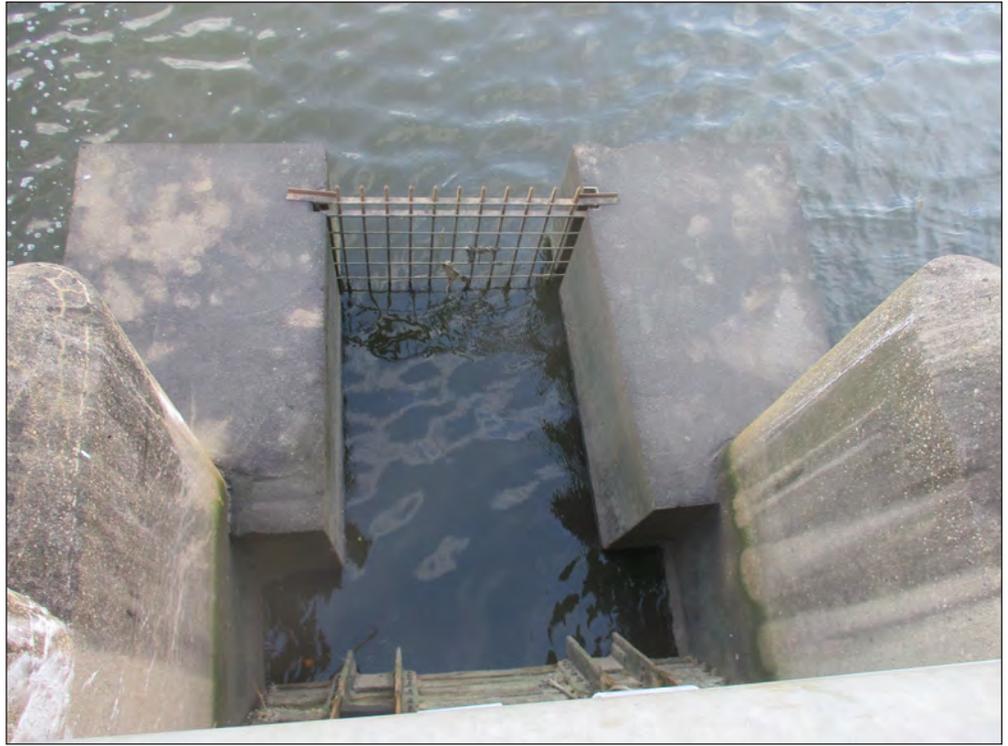
North side of Tide Gate Bridge 7
