ARCHAEOLOGICAL TESTING REPORT FOR  
457, 461 AND 465 WAVERLY AVENUE  
BROWN MEMORIAL CHURCH DEVELOPMENT PROJECT  
BROOKLYN, NEW YORK  
CEQR# 91-075K

Prepared by:  
William I. Roberts IV  
Greenhouse Consultants Inc.  
54 Stone Street, 7th Floor  
New York, New York 10004

March 1991

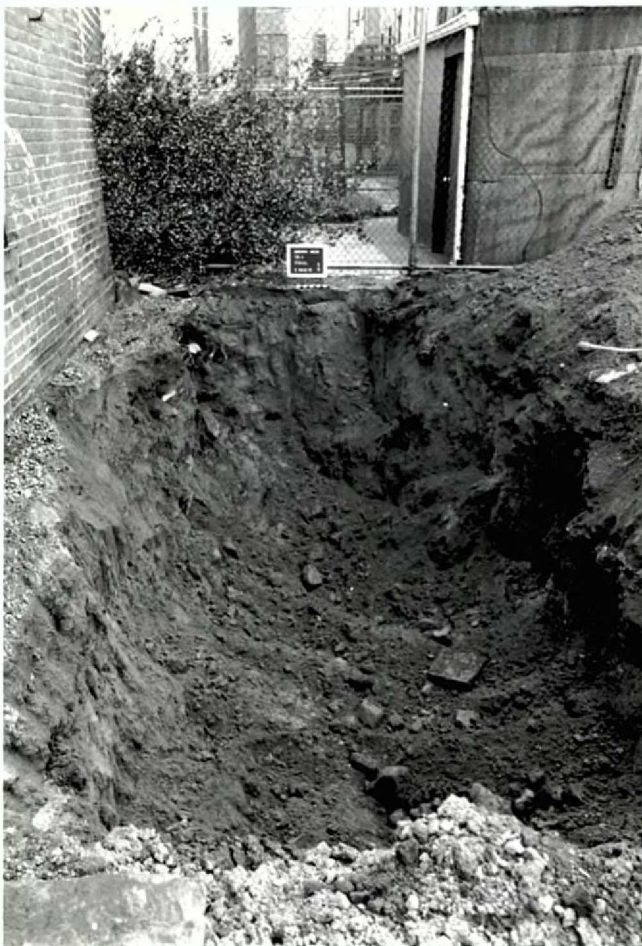
Plate 4: View of Trench 3 looking south. Scale in tenths of feet.

The strata exposed in two of the three backhoe trenches excavated at Brown Memorial Baptist Church were consistent while those seen the remaining trench exhibited some variation. Three strata were seen in Trenches 1 and 3. The top stratum consisted of grey gravel in a matrix of light grey sand. It was approximately 0.6 feet in thickness and was interpreted as the parking lot surface. Below this was a stratum consisting of silty to sandy loam medium to dark brown in color. A few flagstones were found set into the top of this layer which was about 0.6 feet in thickness. This second stratum was interpreted as topsoil from the former backyards. The bottom of the three strata identified consisted of a matrix which was predominately sand but had packets of clay, patches of silt and sandy silt, and stone inclusions ranging from pebbles through cobbles to small boulders. This layer continued below the bottom of the excavations, so it was over four feet thick. It was interpreted as fill based on the mixed grain sizes and documentary evidence regarding the grades on Block 1978 and the adjacent streets (Roberts 1991:10). See Plates 1 and 4 for illustrations of this stratigraphy.
