**Phase IB Archaeological Field Investigation**  
**DOCK STREET REZONING, DUMBO**

**54-62 Water Street, Block 36, Lots 1, 3, 14, 49, 52, and 53**  
**Brooklyn, New York**  
**NYCLPC # 01DCP004K**  
**CEQR #09DCP025K**

August 2013

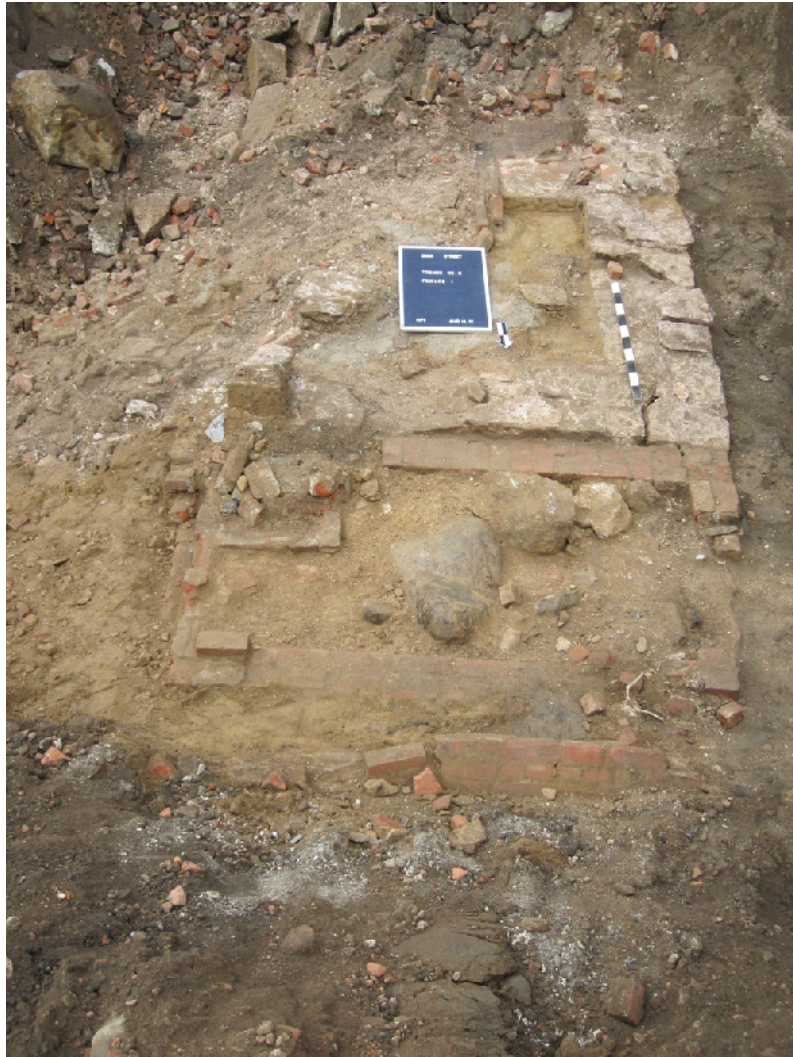
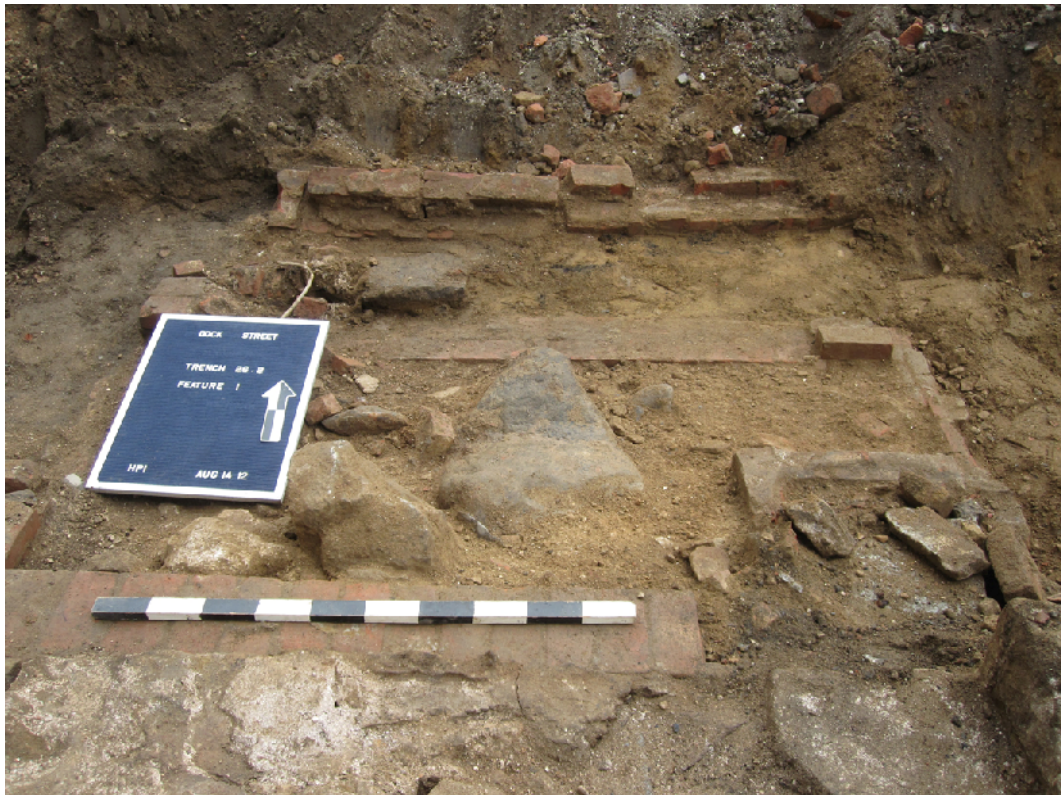
Immediately north of the wall – to the rear of the former building – the team uncovered a rectangular brick foundation for a small addition to the building that was designated Feature 1B (Photographs 1 and 2). The excavation team bisected the feature revealing a pocket of ash with

Photograph 1. Trench 26-2, Stone Foundation and Feature 1, looking south.

Photograph 2. Trench 26-2, Feature 1, looking north. Drain is located at left.

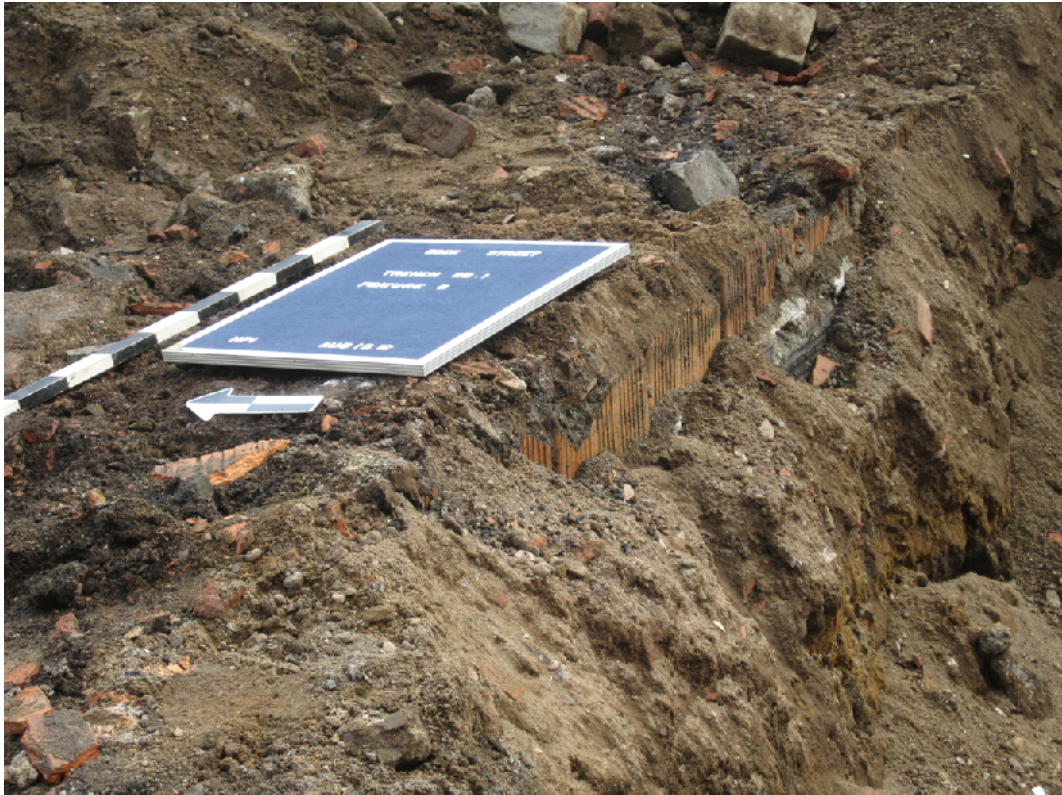
The backhoe exposed a partial remnant of the 20<sup>th</sup> century garage floor (Feature 2) at a depth of approximately 4 m (13 ft), constructed of brick and concrete (Photograph 4; Figure 4). Once cleared, the team examined the fill beneath Feature 2, which was found to contain early to mid 20<sup>th</sup> century refuse including several fragments of *Mission Beverages* bottles. The bottle fragments date to the 1940s, the time period just prior to the construction of the parking garage.

Photograph 4. Trench 26-1, Feature 2, looking northeast.

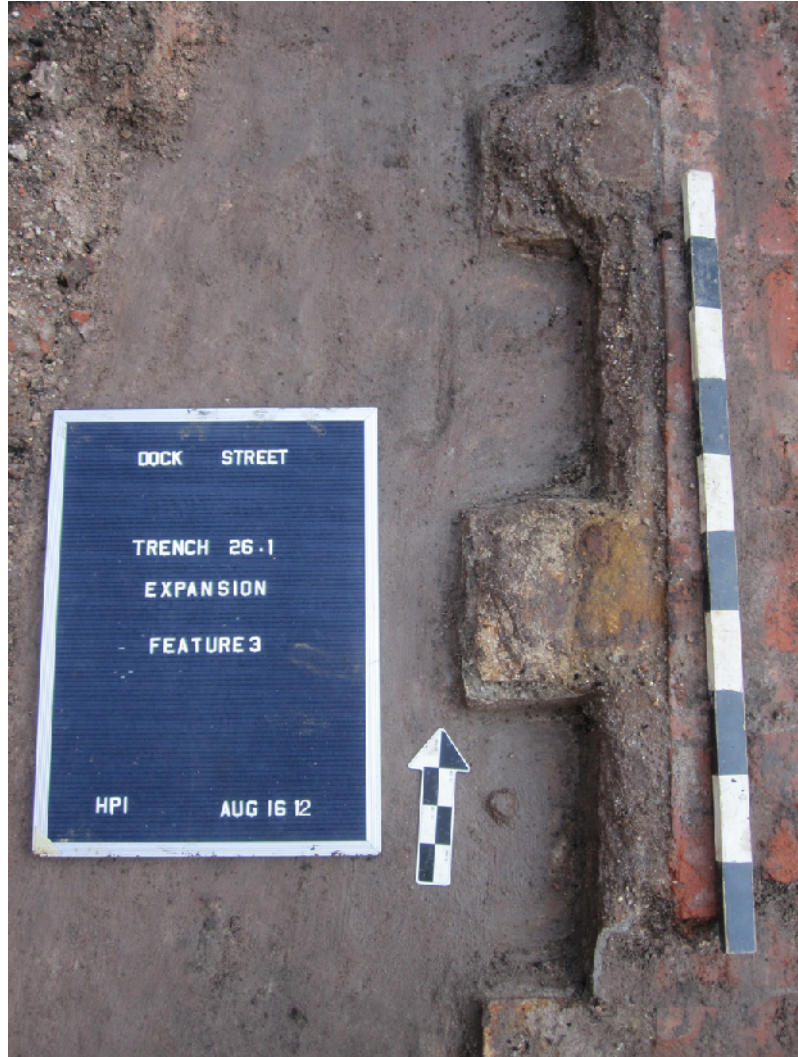
Photograph 7. Trench 26-1 expansion, showing the edge of the concrete and brick floor (Feature 3). Several indentations were noted where support columns once stood.

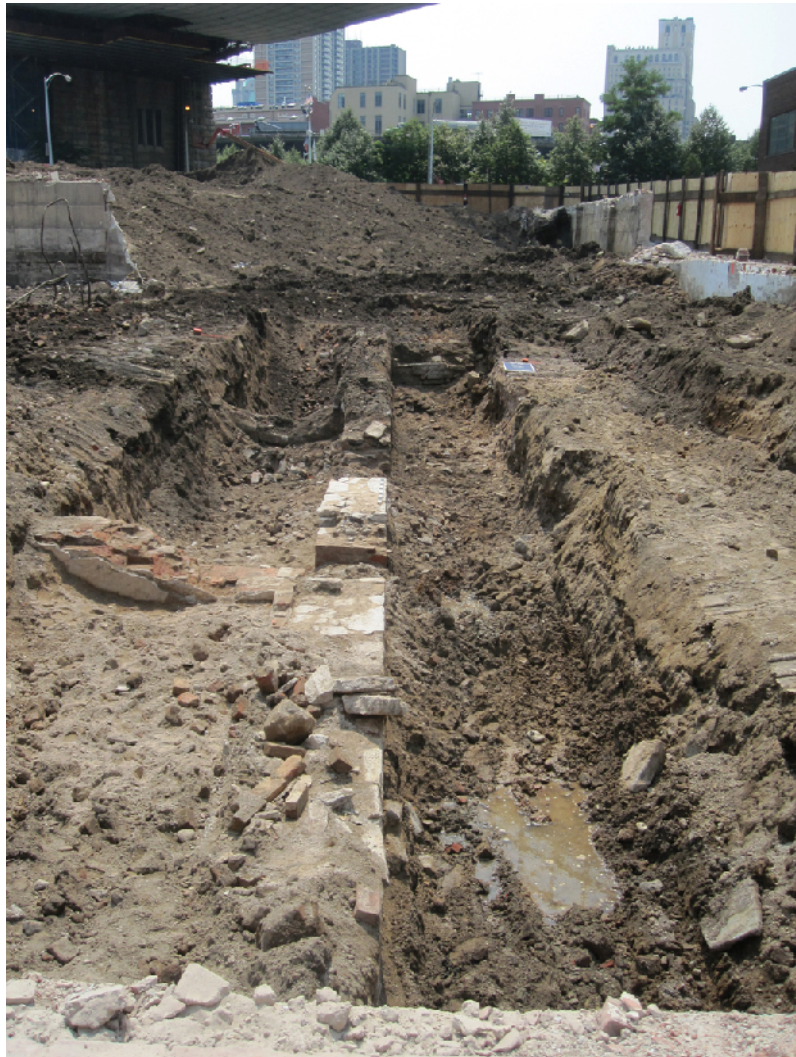
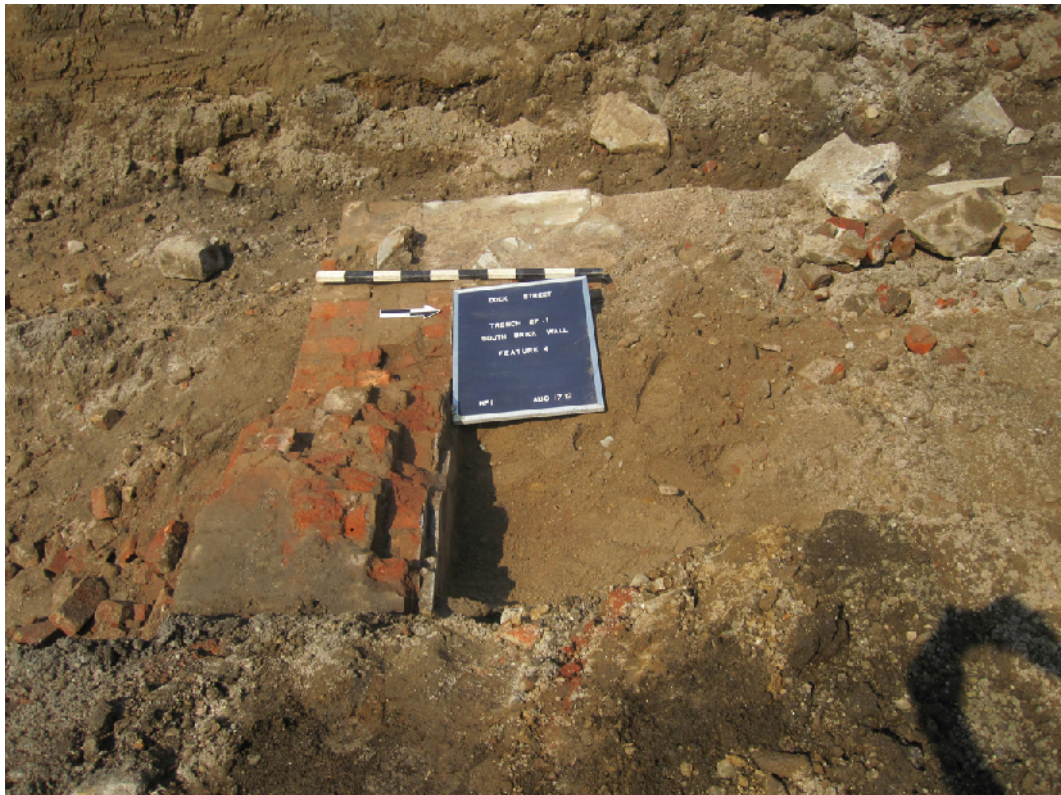
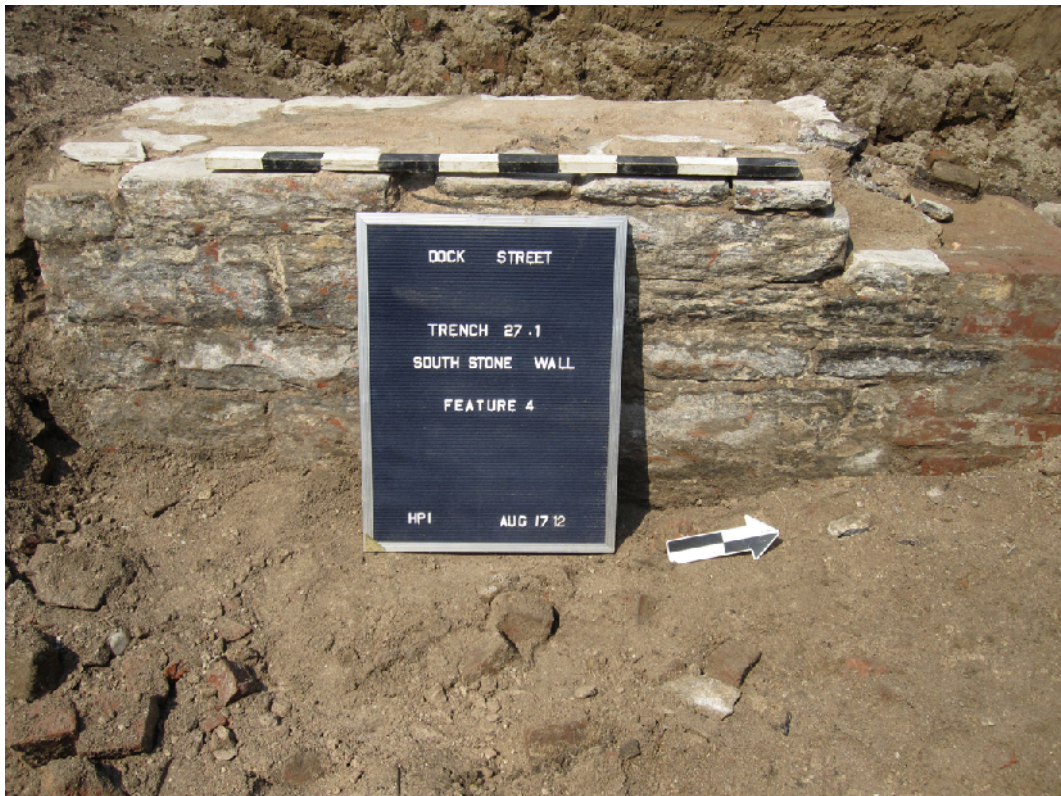
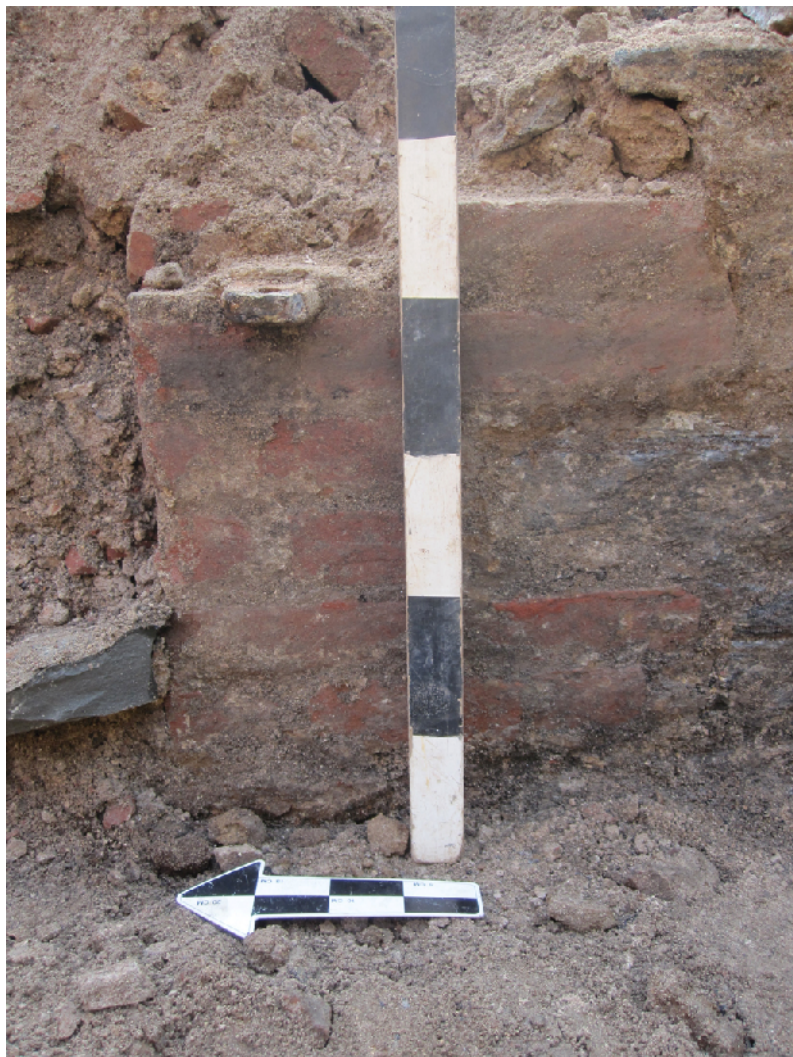
Remains of the c.1837 sugar refinery foundation, floors and walls were encountered within Trench 27-1 (Figure 4). The refinery-related structural remains were designated as Feature 4 (Figures 4 and 6; Photographs 9-12). The remains included a north-south mortared stonewall that corresponded with the location of an internal dividing wall depicted on the 1887 Sanborn Atlas (Photograph 9). The wall was comprised of cut fieldstone and shell mortar (Photograph 11). Modern intrusions, including a large cast-iron sewer pipe that bisected the main north-south wall, were noted within the trench and were typically surrounded by brick infilling (Photographs 10 and 12). For recording purposes, the trench was divided into areas – Areas A and B were on the east side of the Feature and Area E was on the west side.

Photograph 9. Trench 27-1, Feature 4, looking south.

Photograph 10. Trench 27-1, Feature 4, looking west.

Photograph 11. Trench 27-1, Feature 4, stone wall, looking west.

Photograph 12. Trench 27-1, Feature 4, looking east.

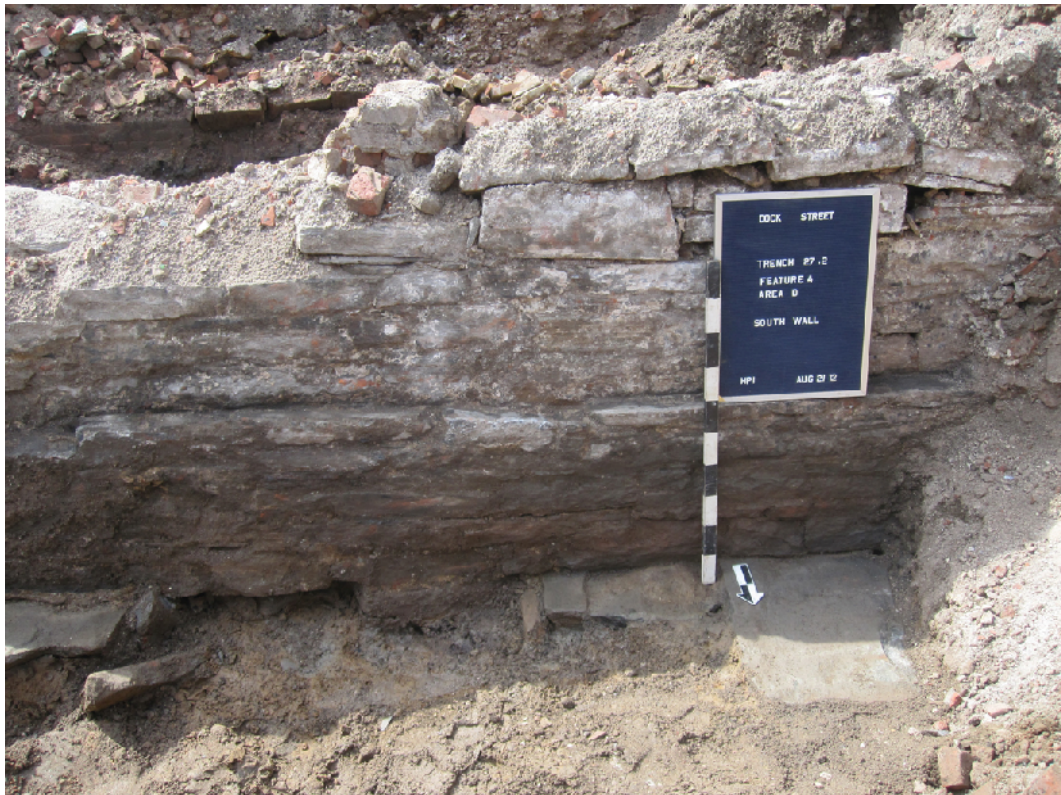
At the south end of the north-south wall, the remains of the sugary refinery interior walls, including an east-west interior wall and two brick machine pads (bases) were noted (Figure 4 and Figure 6; Photograph 13). The machine pads were revealed to the west of the central north-south wall. One of the machine pads was in a cross shape and the second was rectangular. No

Photograph 13. Trench 27-2, Feature 4, south wall, Area D, looking south.

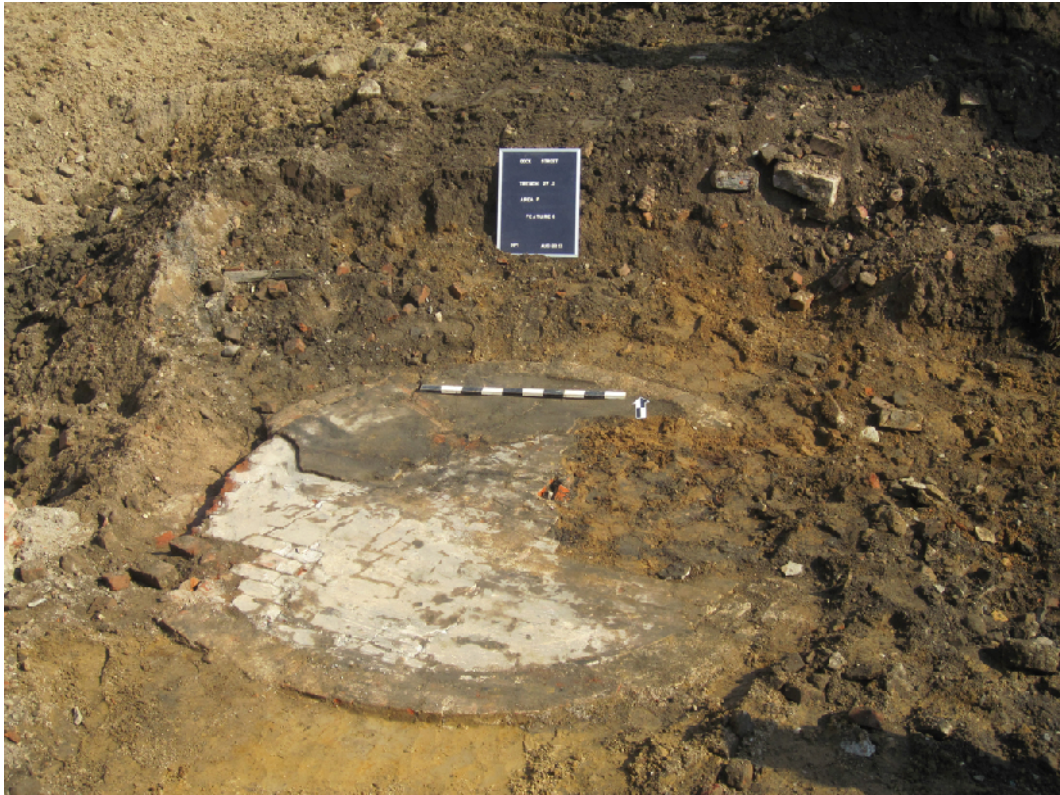
Excavation continued on the east side of Trench 27-2. Approximately 1 m (3.5 ft) to the east of the Feature 4 foundation wall, another large concrete and brick machine pad was revealed (Figures 4 and 6; Photograph 15) and identified as Feature 6. This feature was roughly circular (2.8 m diameter) and had a 90 cm (3 ft) concrete base. Beneath the feature was a layer of fill with large stones under which, a grayish brown (10YR 5/2) fine sandy subsoil was recorded.

Photograph 15. Trench 27-2, Feature 6, Circular Brick and Concrete Machine Pad, looking north.

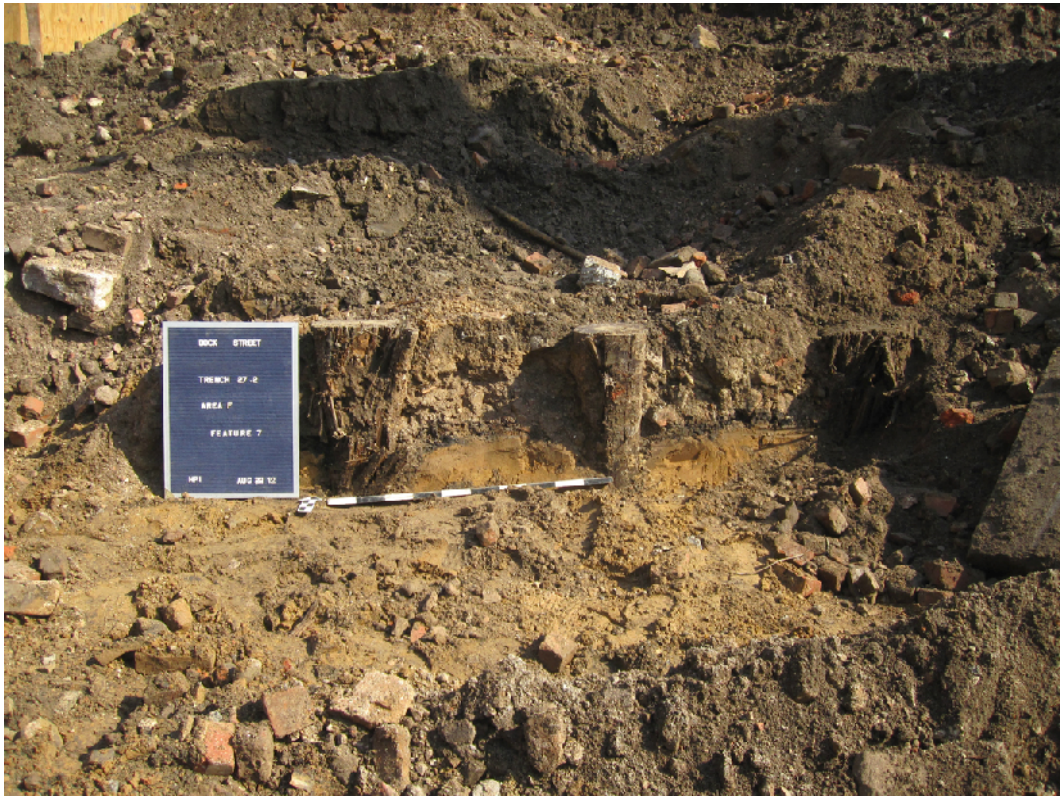
On the north side of the east end of Trench 27-2, three timber piles, identified as Feature 7, were observed driven into the fill (Figure 6; Photograph 16). Above them was a poured concrete pile cap with brick and stone inclusions. Likely the piles and cap date to the period of site use by the refinery, but the installation date of this feature is unknown. Two poured concrete footings were also noted (Figure 6).

Photograph 16. Trench 27-2, Feature 7, Area F, looking north.

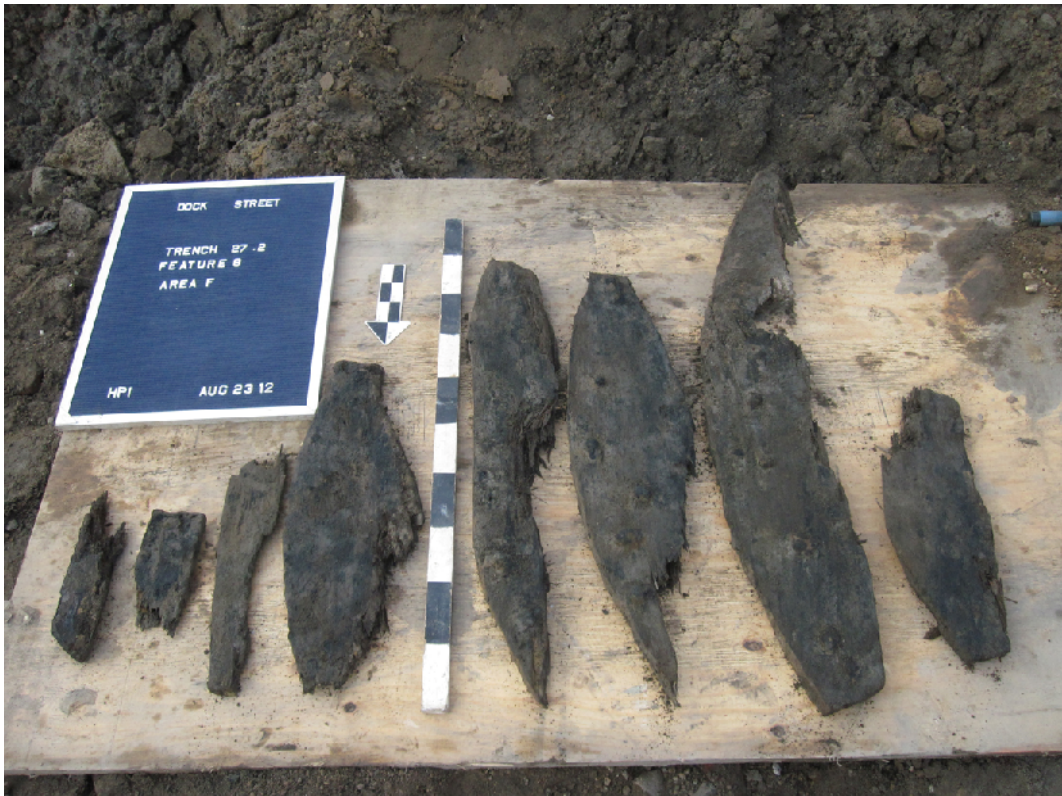
Fragments of a thick circular wood cover were found in the surrounding fill (Photograph 21). These fragments might have been part of a wooden cap for the privy. This feature appears to

Photograph 21. Trench 27-2, Feature 8, planks from possible privy cover.

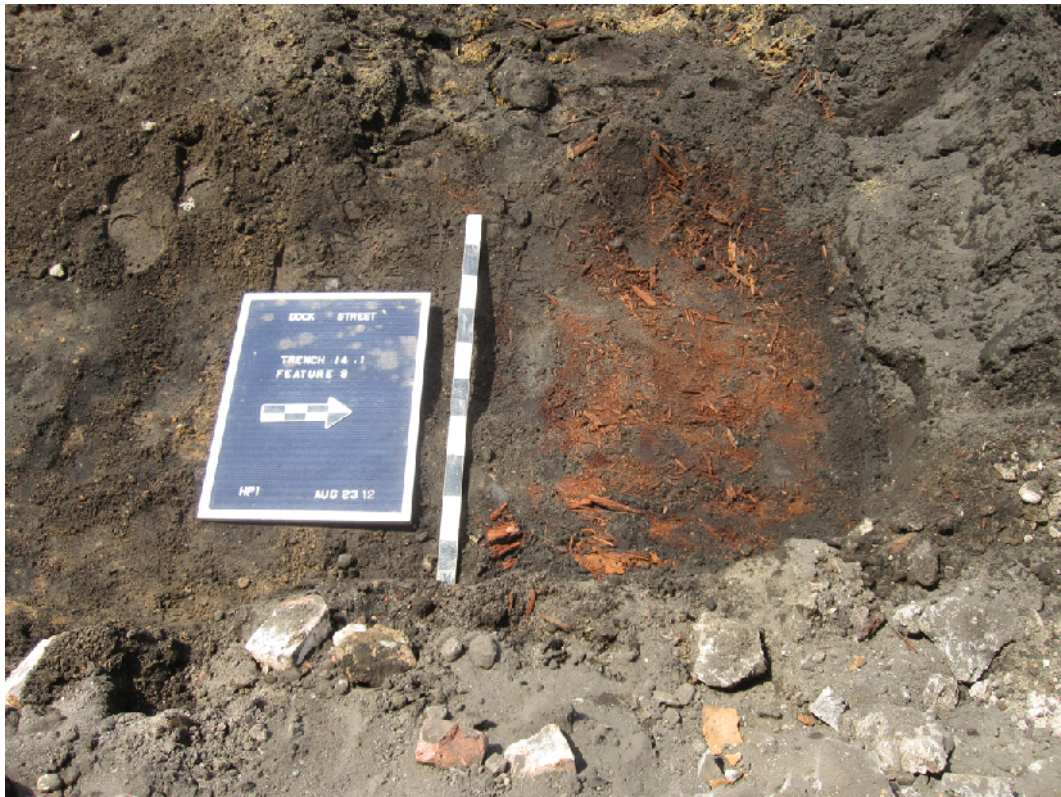
Building files record the last known building foundation within this lot was a concrete slab with no cellar. The archaeology team encountered a concrete floor and had the backhoe remove it in the location of the test trench. Beneath the floor, a dark black demolition stratum was revealed. Once cleared, the team identified two decomposing wood floor supports at the eastern end of the trench (Figures 3 and 8; Photograph 22). Several brick foundry walls at various depths were also

Photograph 22. Trench 14-1, Feature 9, wood floor supports, looking west.

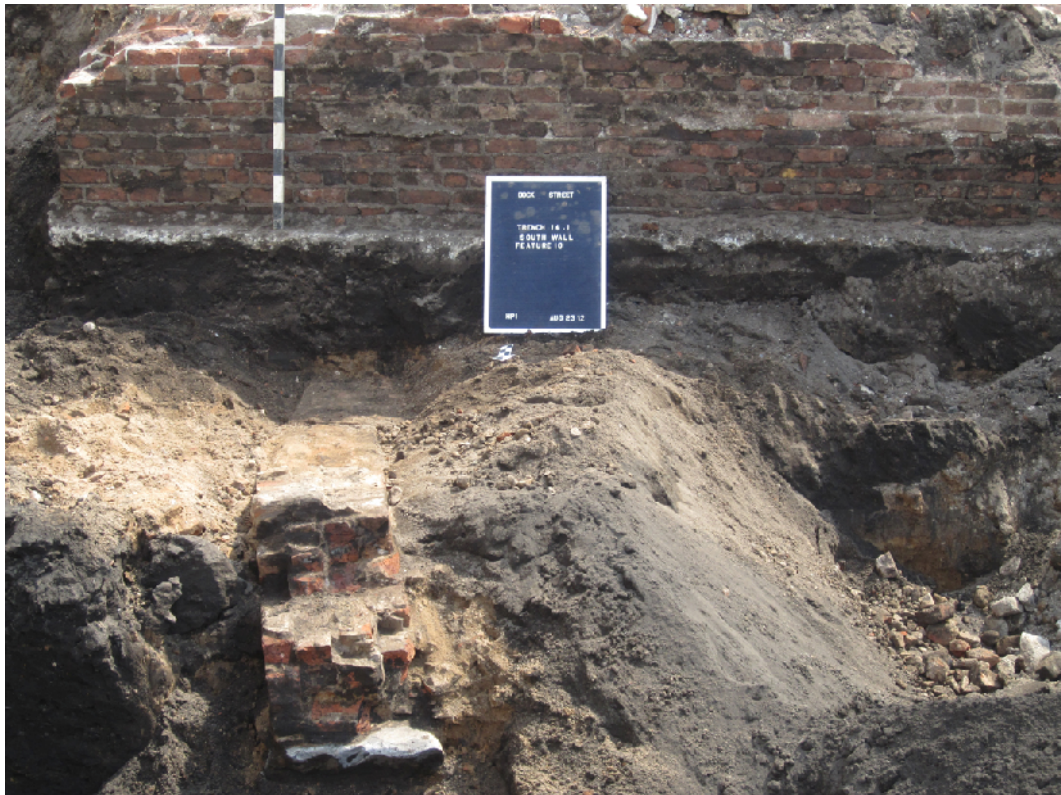
Further clearing at the back of the lot identified a series of platforms or pads used for industrial machinery (Photographs 23 and 24). The surrounding fill contained architectural demolition debris, and slag. In addition, numerous metal rings, were noted and a broken stone crucible was collected (Photographs 25 and 26). Black fill constituted the matrix in the northern half of the trench, while demolition debris and clean sandy fill were noted in the southern and western areas. Excavations continued beneath the clean fill until a level believed to be original river bed was encountered (Table 7). No historical features were found beneath the foundry remains.

Photograph 23. Trench 14-1, Feature 10, Area A, looking south.

Photograph 24. Trench 14-1, Feature 10, south wall, looking south.

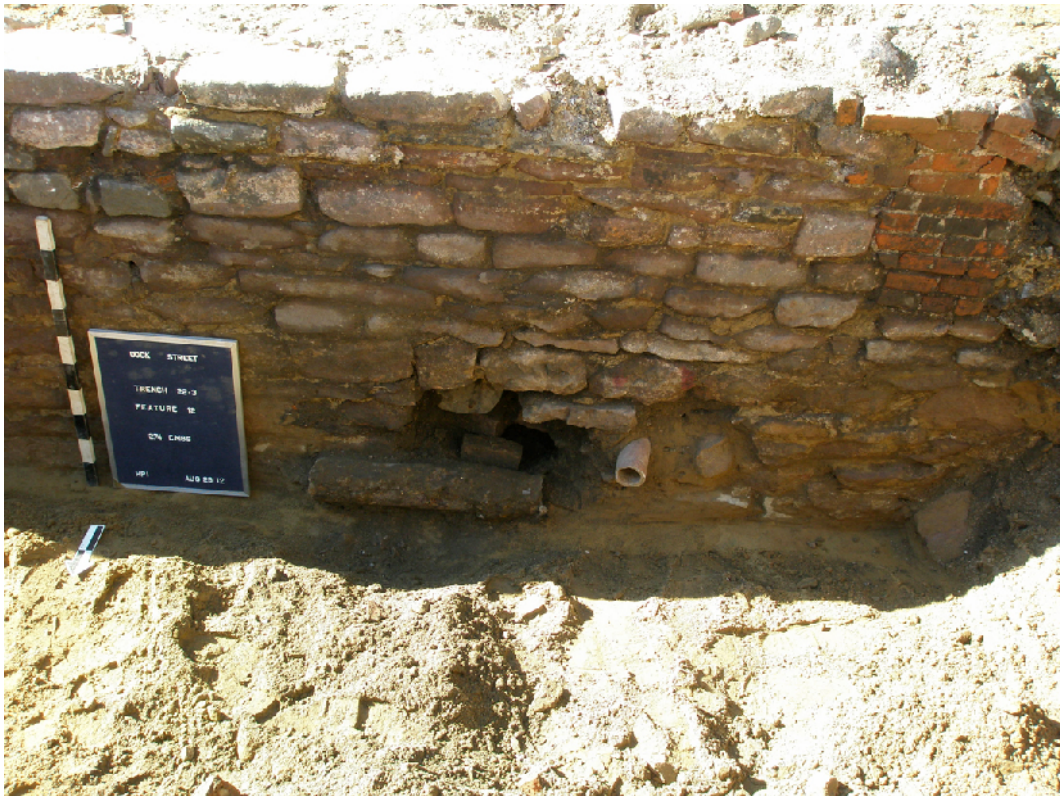
The fill within the open foundation dates from the 20<sup>th</sup> century when the house was demolished to establish the parking lot (Appendix 1). The top of the truncated foundation wall was found approximately 1.3 m (4.2) feet below the surface. The wall was recorded and a section was removed for preservation (Photograph 38). No builder's trench was identified along the interior or exterior of the remaining foundation. A utility pipe trench was found along the exterior that likely destroyed any potential builder's trench in that location (Figure 12; Photograph 35).

Photograph 35. Trench 22-3, Feature 12, looking south.

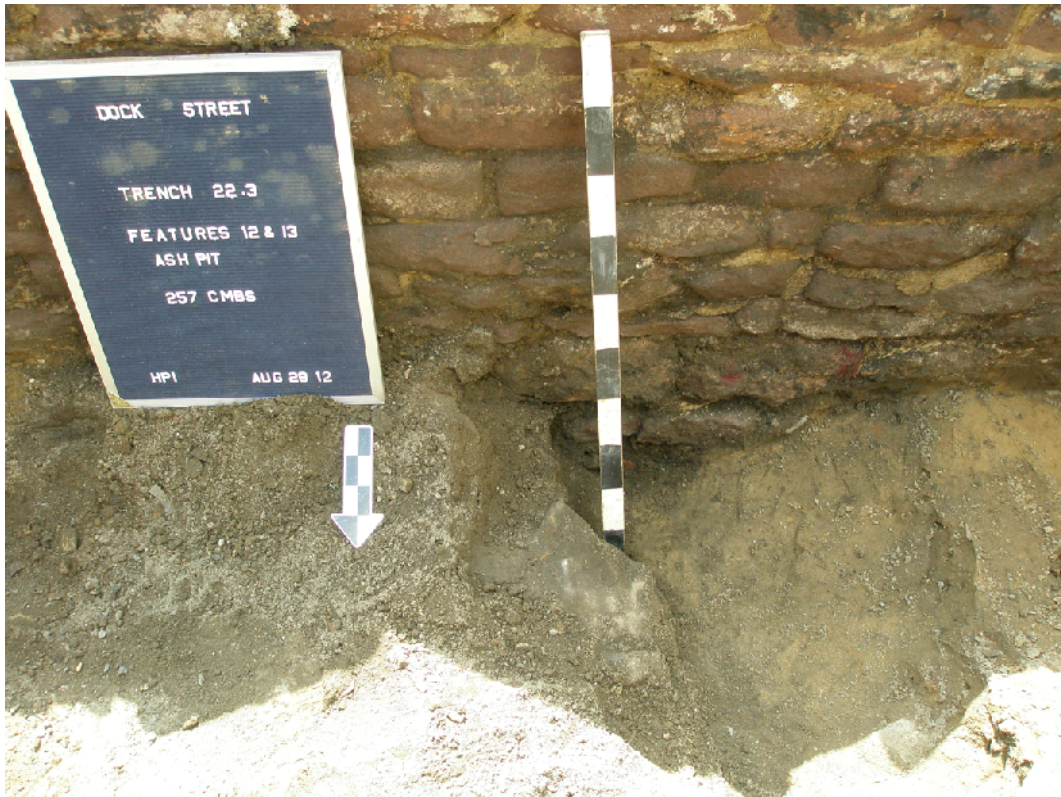
A small ash pit that also contained domestic refuse was noted to the north of the foundation wall (Feature 13). This feature was also bisected and sampled by the field team. The feature was irregularly shaped and extended from 2.1 to 2.4 m (6.9 ft – 7.8 ft) below the surface. A small assemblage of 19<sup>th</sup> century domestic material was collected from the feature (Appendix 1).

Photograph 36. Trench 22-3, Features 12 (Sands House foundation wall) and 13 (ash pit), looking south.
