Historical Research, Laser Scanning
and Archaeological Investigations
Blockhouse No. 1
Central Park, New York

Prepared for:

Central Park Conservancy

October 2019

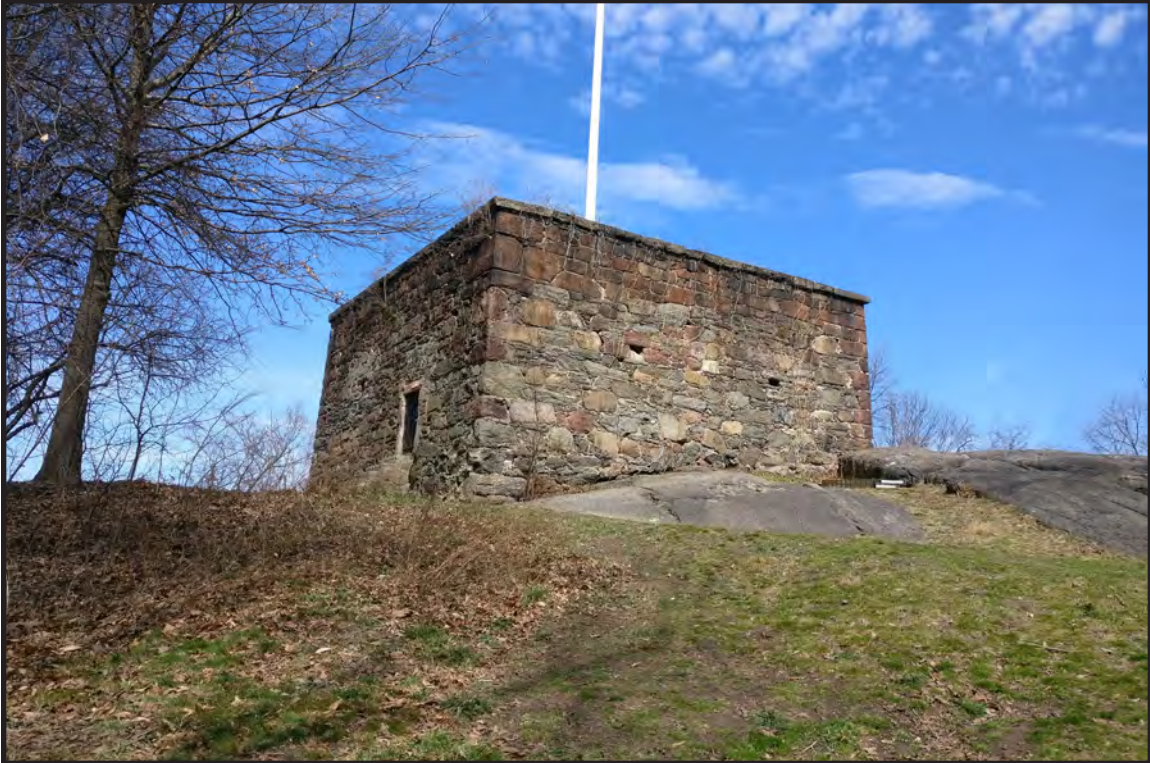
Photograph 1.1. Recent view of Blockhouse No. 1 looking northeast (Photographer: James Lee, March 2017 [HRI Neg.#17013/D1:014]).

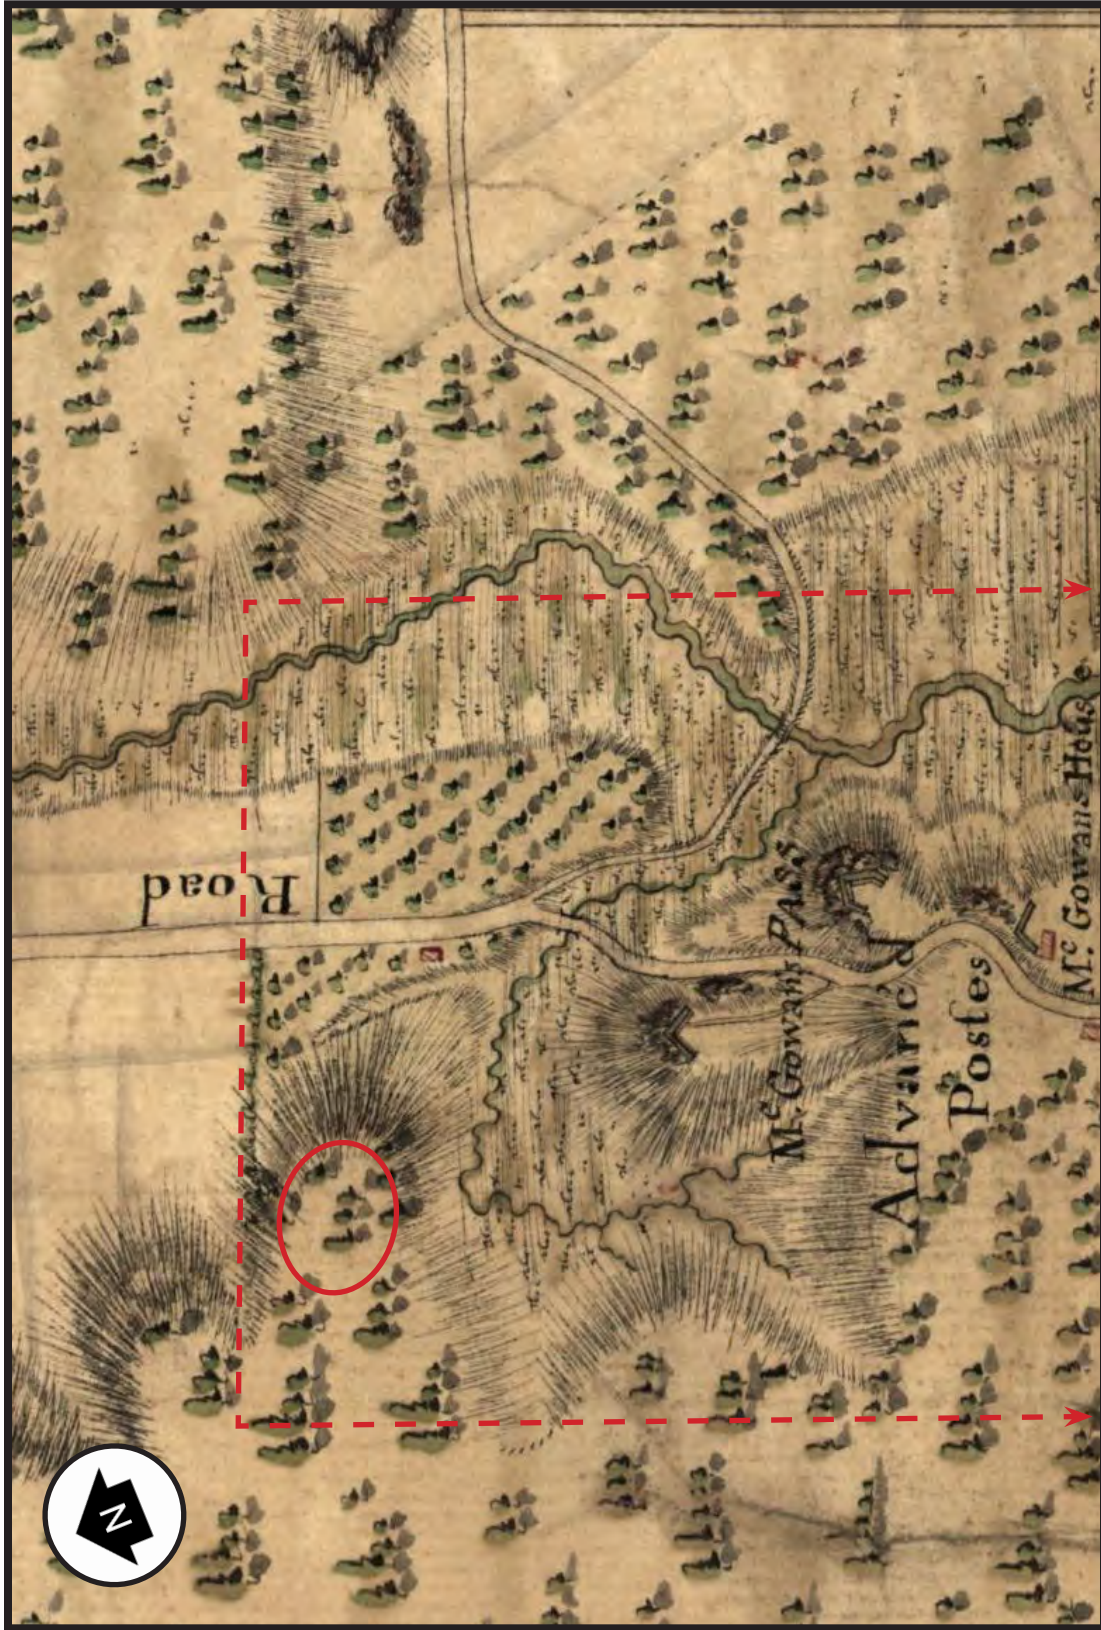
Figure 2.2. Sauthier, Claude J. Detail of "A Map of Part of New-York Island" 1776. Scale 1 inch = 600 feet (approximately). Approximate limits of Central Park outlined and approximate future location of Blockhouse No. 1 circled.

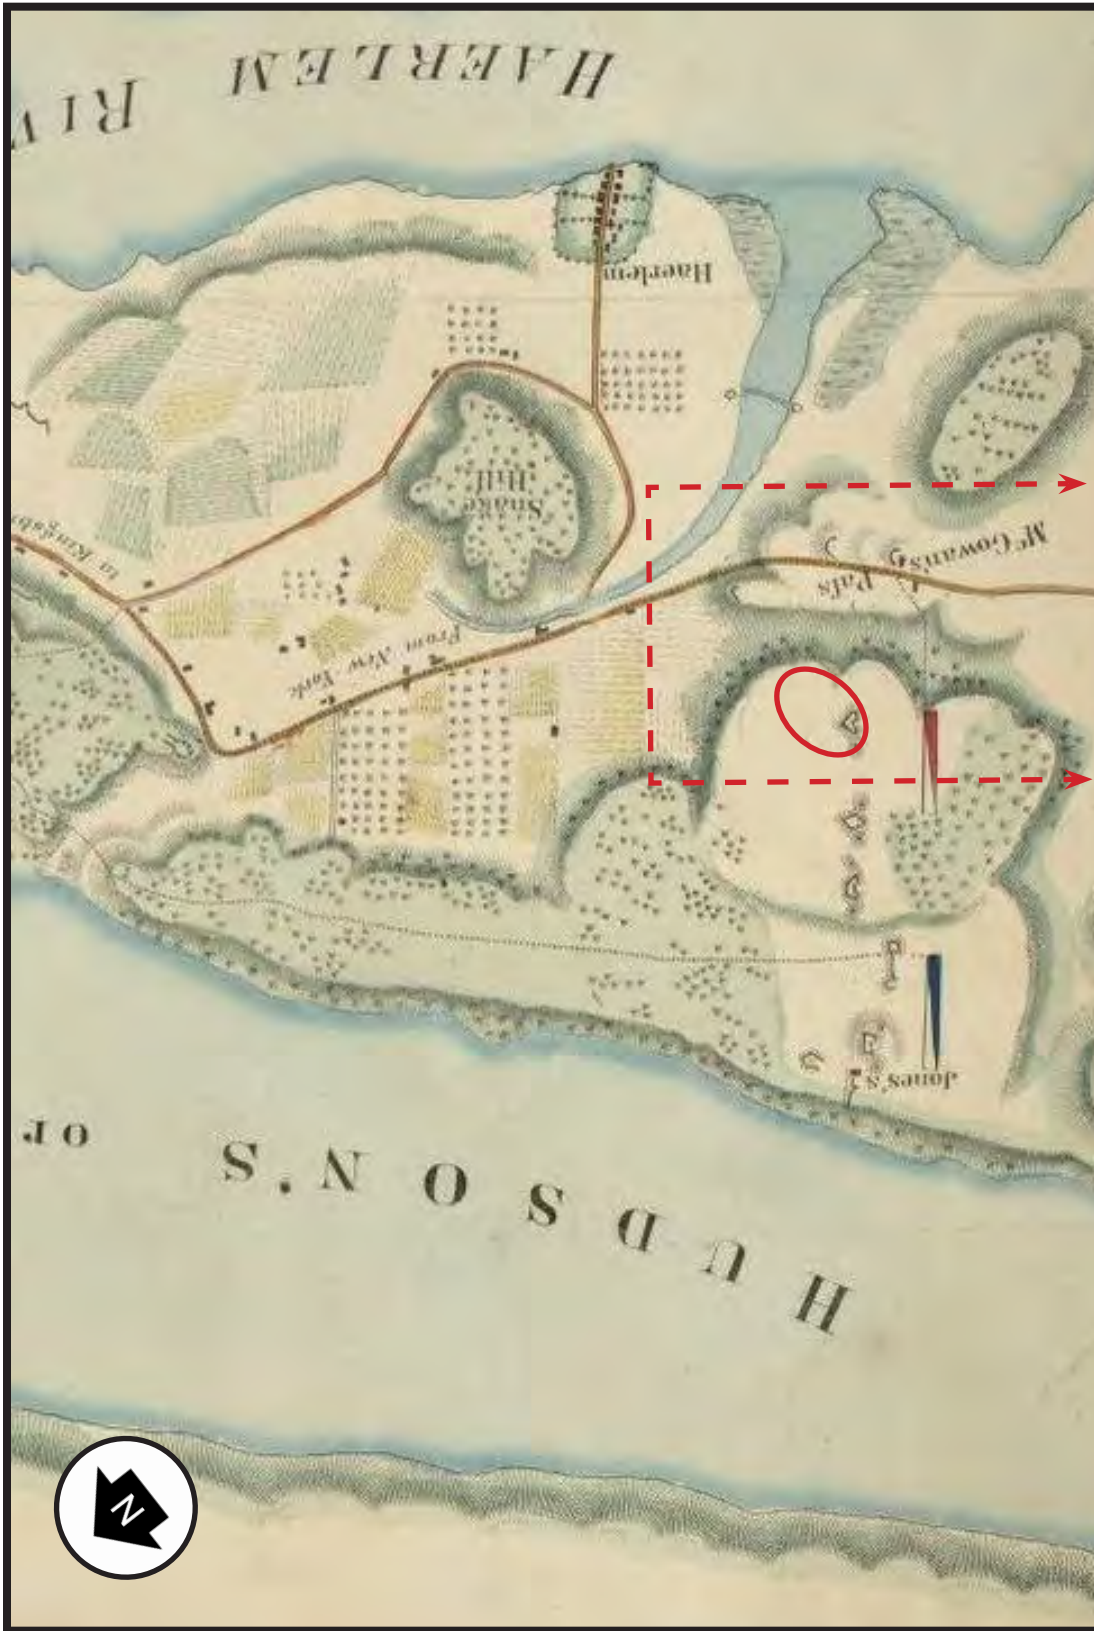
Figure 2.3. Detail of “Attacks of Fort Mifflin by His Majesty’s Forces under the Command of Genl. Sir Willm. Howe K.B., 16 Novr. 1776.” 1776. Scale 1 inch = 1700 feet (approximately). Approximate limits of Central Park outlined and approximate location of future Blockhouse No. 1 circled.

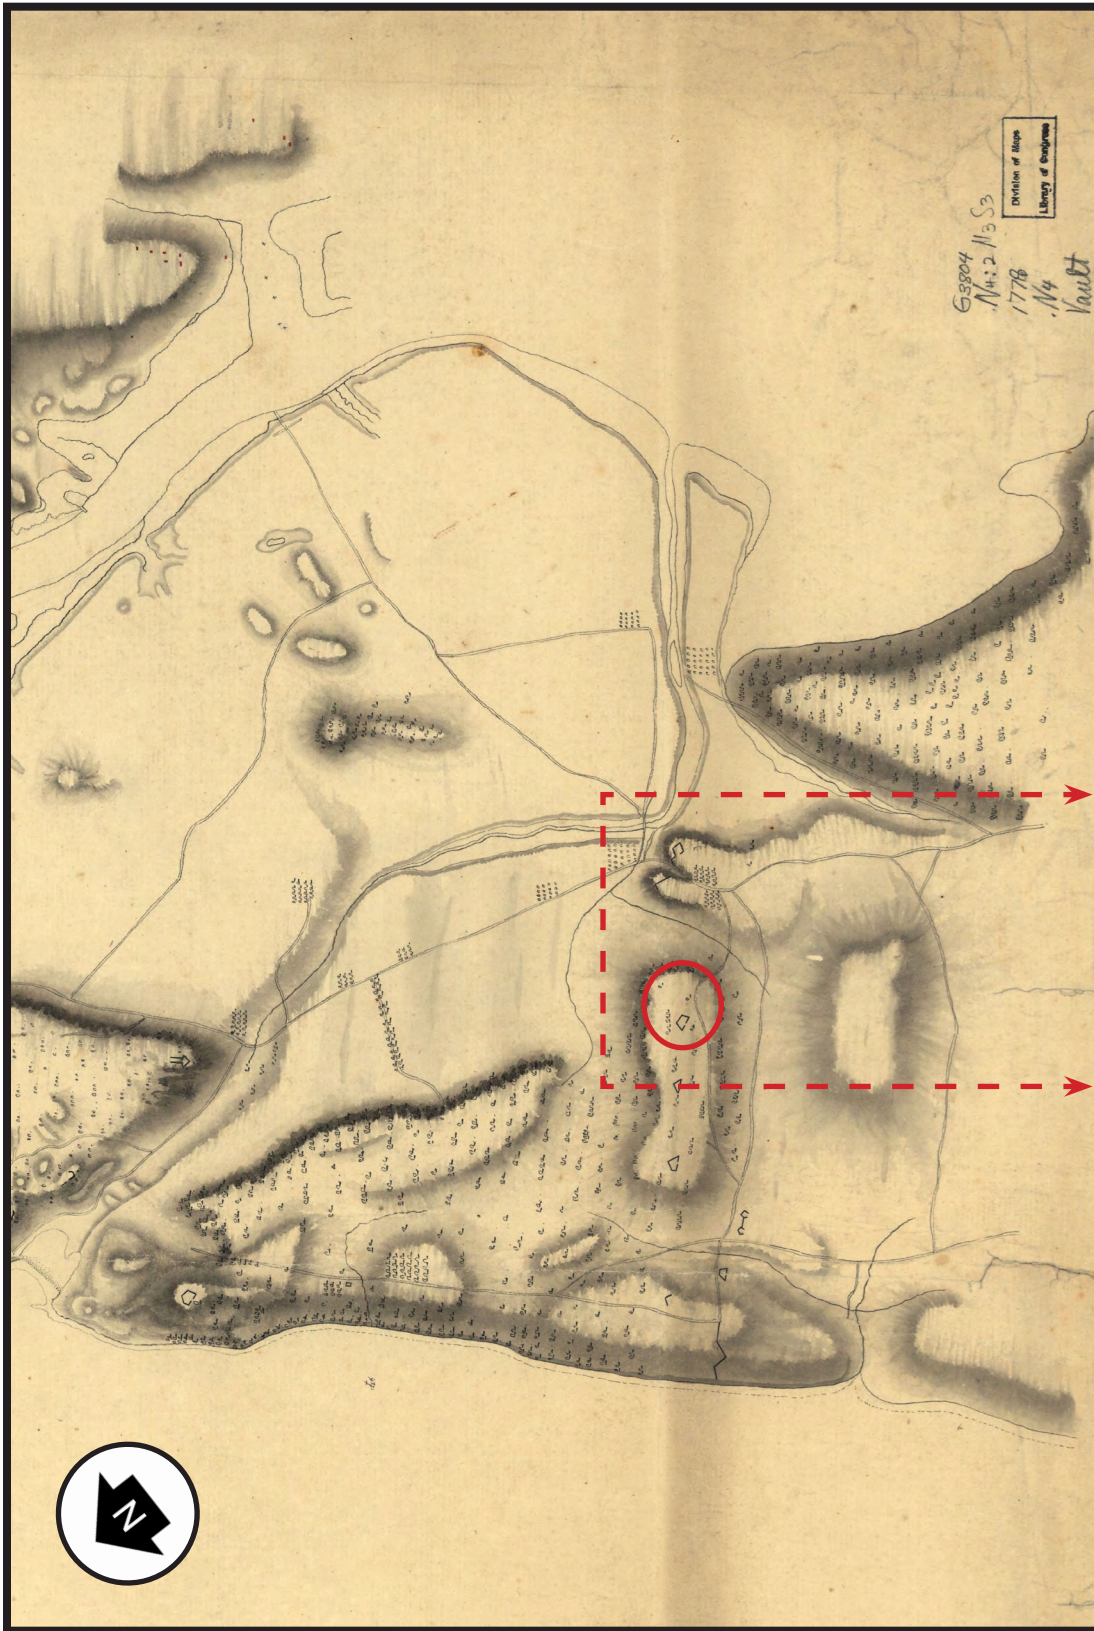
Figure 2.5. Detail of "Unfinished Map of New York Island." 1778. Approximate limits of Central Park outlined and approximate location of future Blockhouse No. 1 circled.

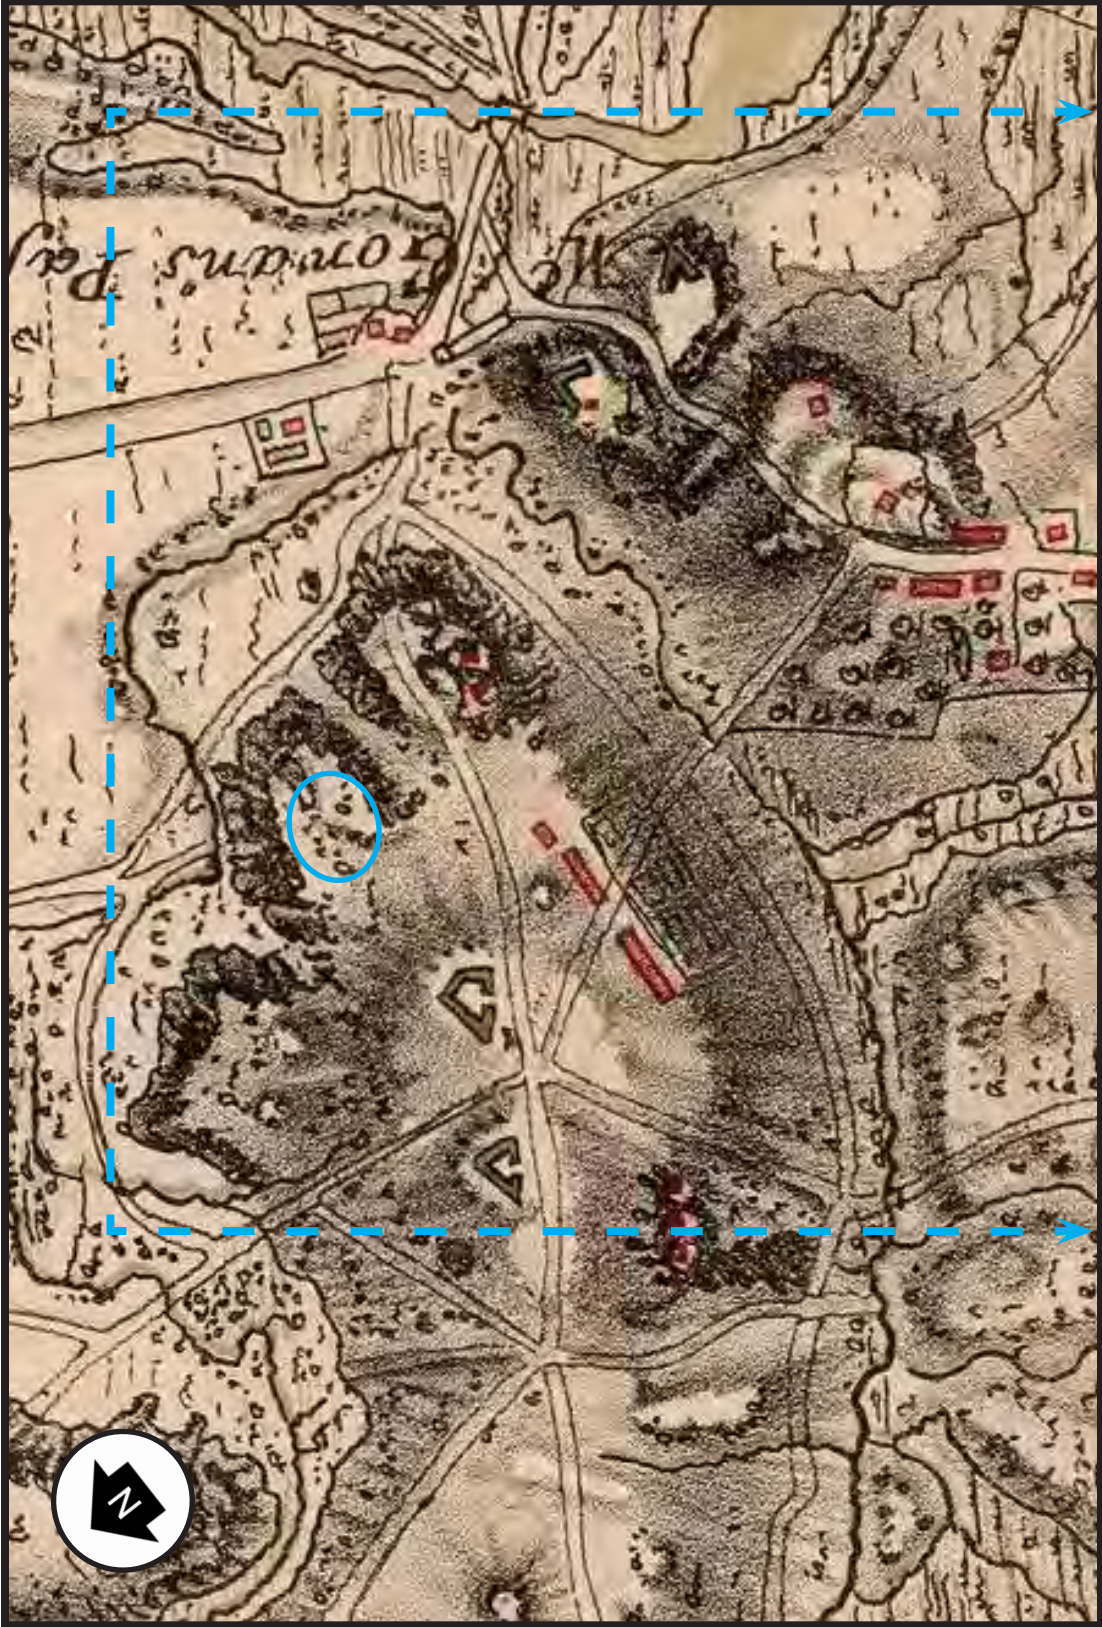
Figure 2.6. Stevens, B.F. (British War Office). Detail of "British Headquarters Map of New York & Environs." 1782. Approximate limits of Central Park outlined and approximate location of future Blockhouse No. 1 circled.

without any indication of buildings. The principal focus of the defensive system in this area is a pair of redoubts with an encampment nearby, all situated on what is today known as the Great Hill (Figure 2.6). Finally, a smaller-scale “spy” map sketched by Benjamin Tallmadge for the Continental Army in November 1782, as Washington contemplated one more major assault on New York City, indicates that McGowan’s Pass was still an important intermediate position in the network of British defenses in this final phase of the conflict (Figure 2.7).

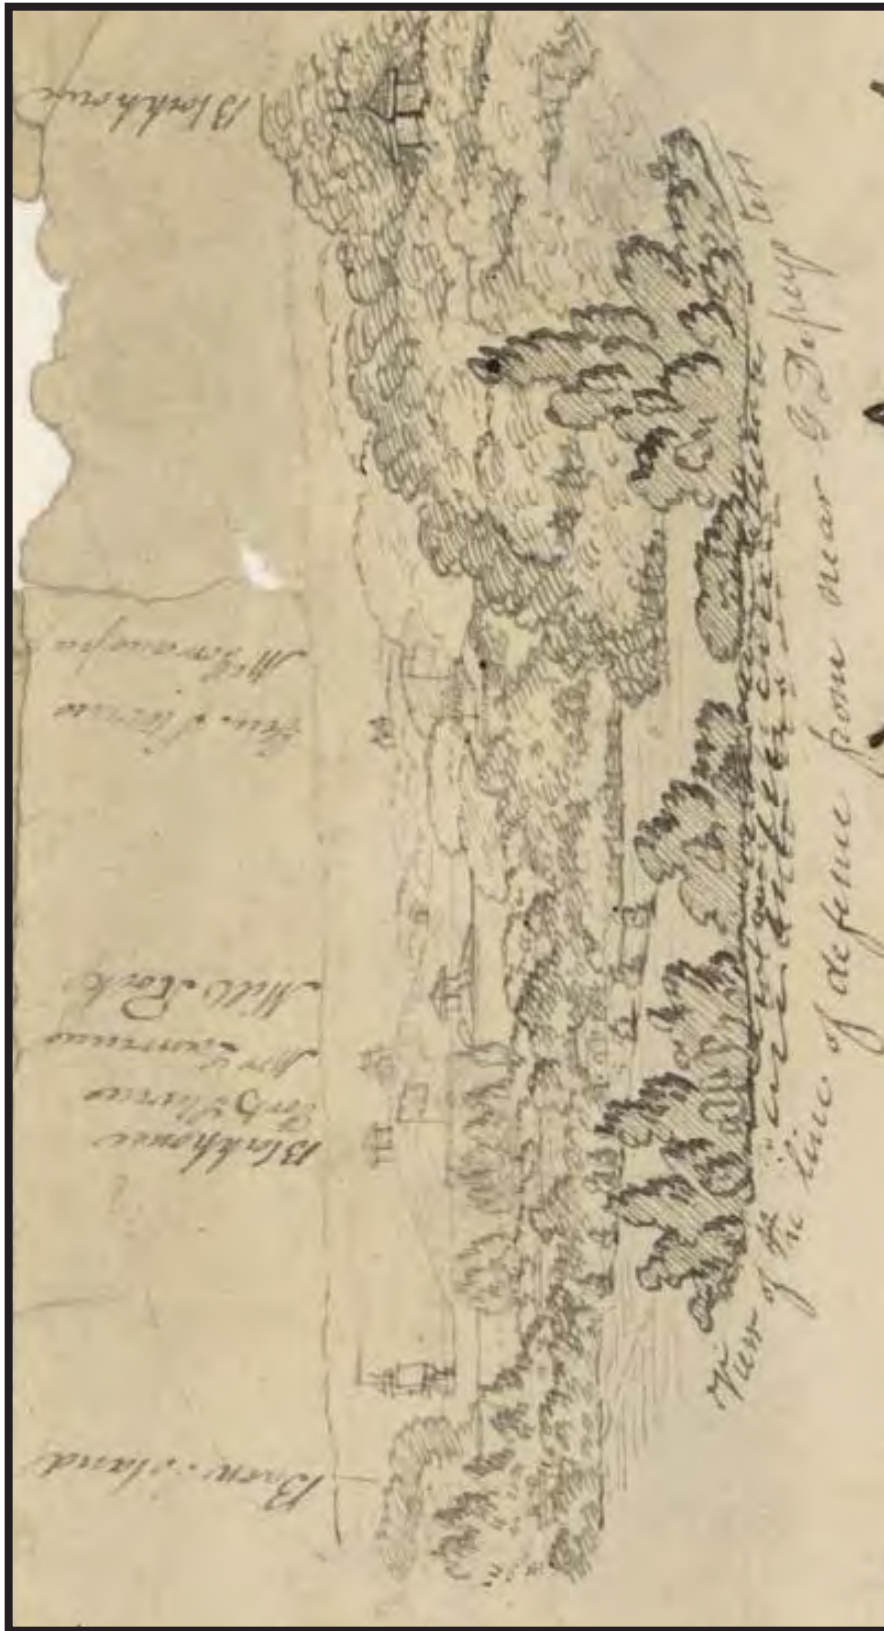
Figure 2.12. Renwick, James. Inset sketch "View of the line of defence from near G. Depeyesters" accompanying Military Topographical Sketch of Haerlem Heights and Plain. 1814. Blockhouse No. 1 is at the far right.

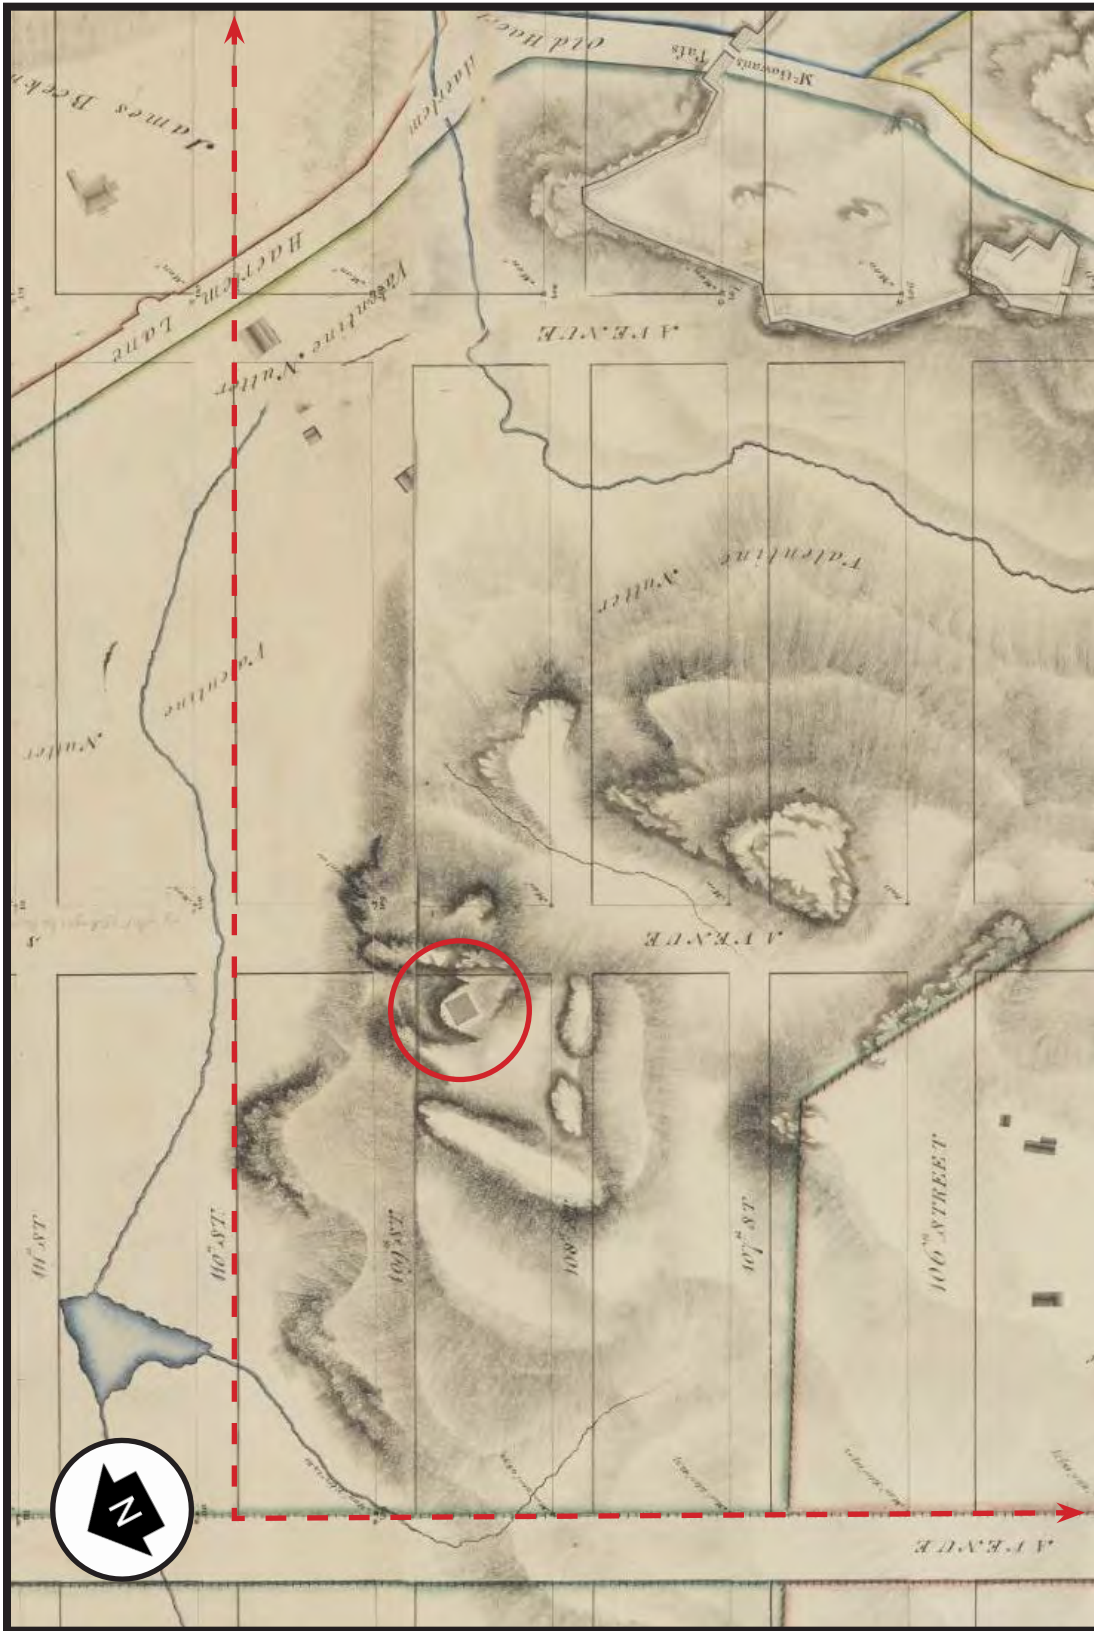
Figure 2.15. Randel, John. Detail of "Randel Farm Maps." 1818-20. Scale 1 inch = 335 feet (approximately). Limits of Central Park outlined and Blockhouse No. 1 circled.

After the war, Blockhouse No. 1 likely existed as something of a military curiosity or even "folly" on the 100-acre property of Valentine Nutter. The structure is clearly shown on John Randel's "Farm Maps," completed in 1818-20 (Figure 2.15), and one can imagine Nutter putting the building to some use, perhaps for storage of farm tools or lumber. Nutter died in 1836 and a map published in that year shows the blockhouse marked as "Tower," perhaps implying a certain level of intactness and accessibility (Figure 2.16). The outlines of the defenses at McGowan's Pass are also very clearly in evidence still, although much of the immediately surrounding bluff-top landscape is heavily wooded.

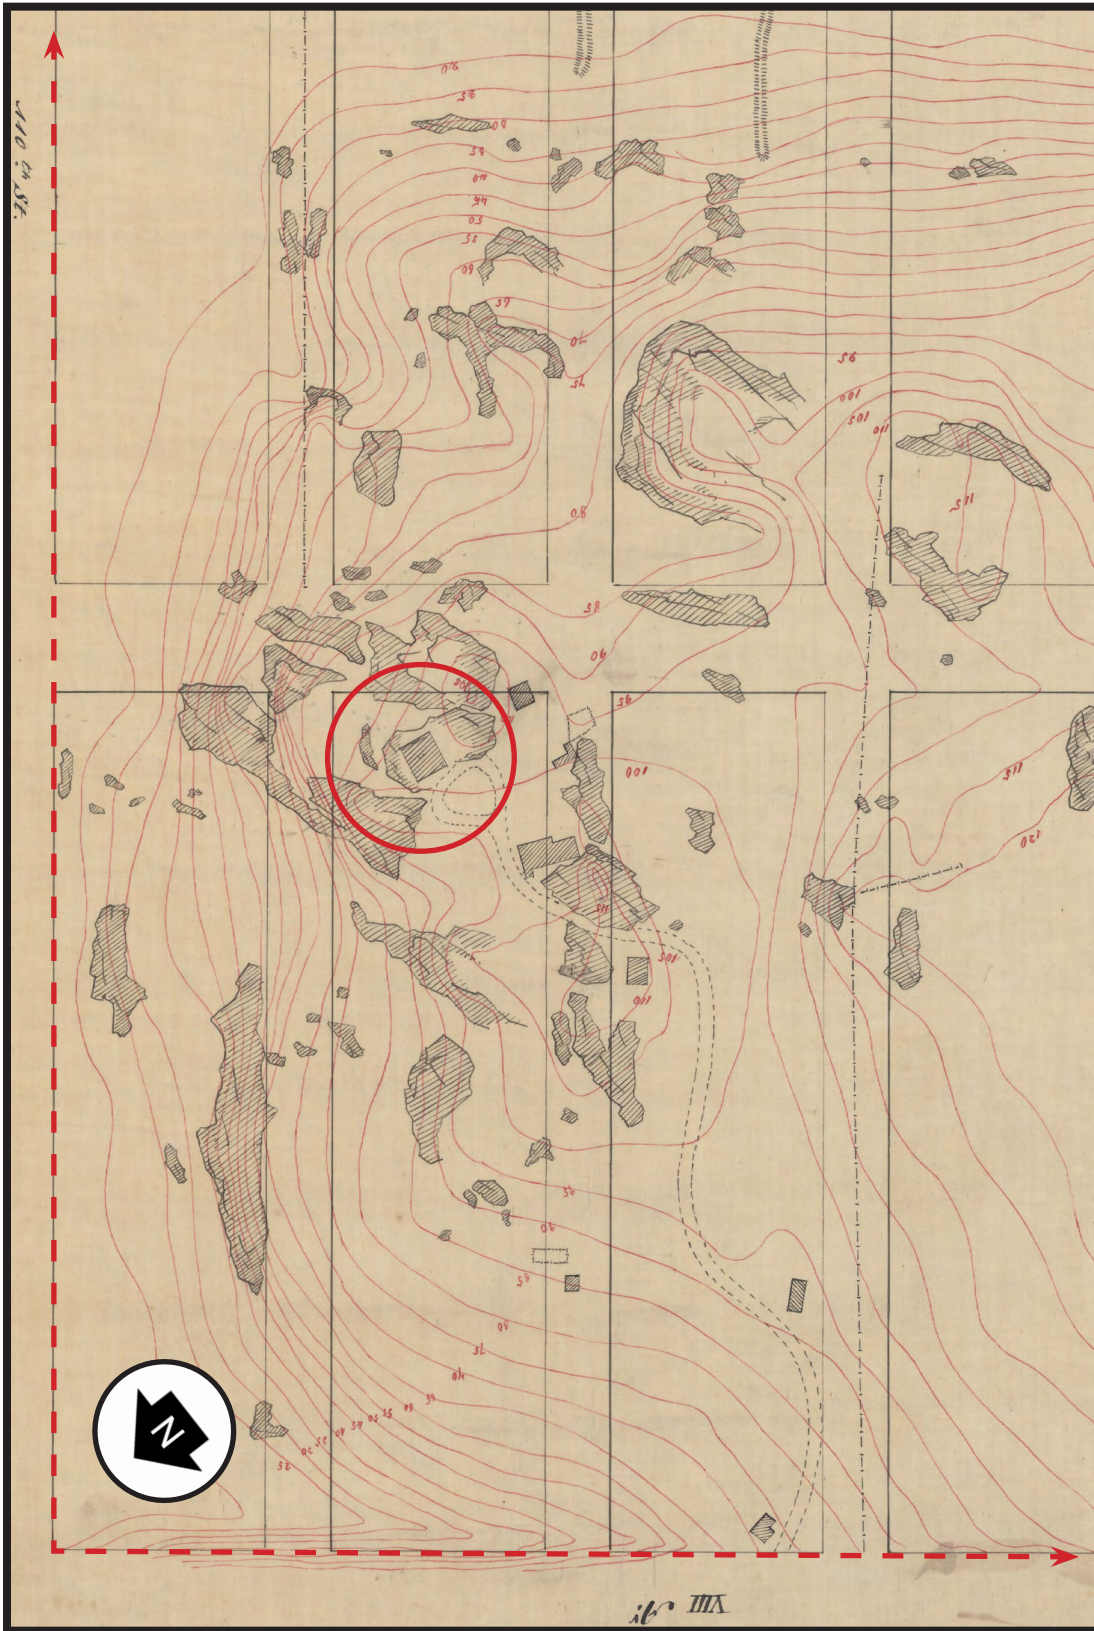
Figure 2.17. Detail of "Topographical Map of Central Park Extension from 106th to 110th Streets & from V to VIII Ave." 1860. Scale 1 inch = 220 feet (approximately). Limits of Central Park outlined and Blockhouse No. 1 circled.

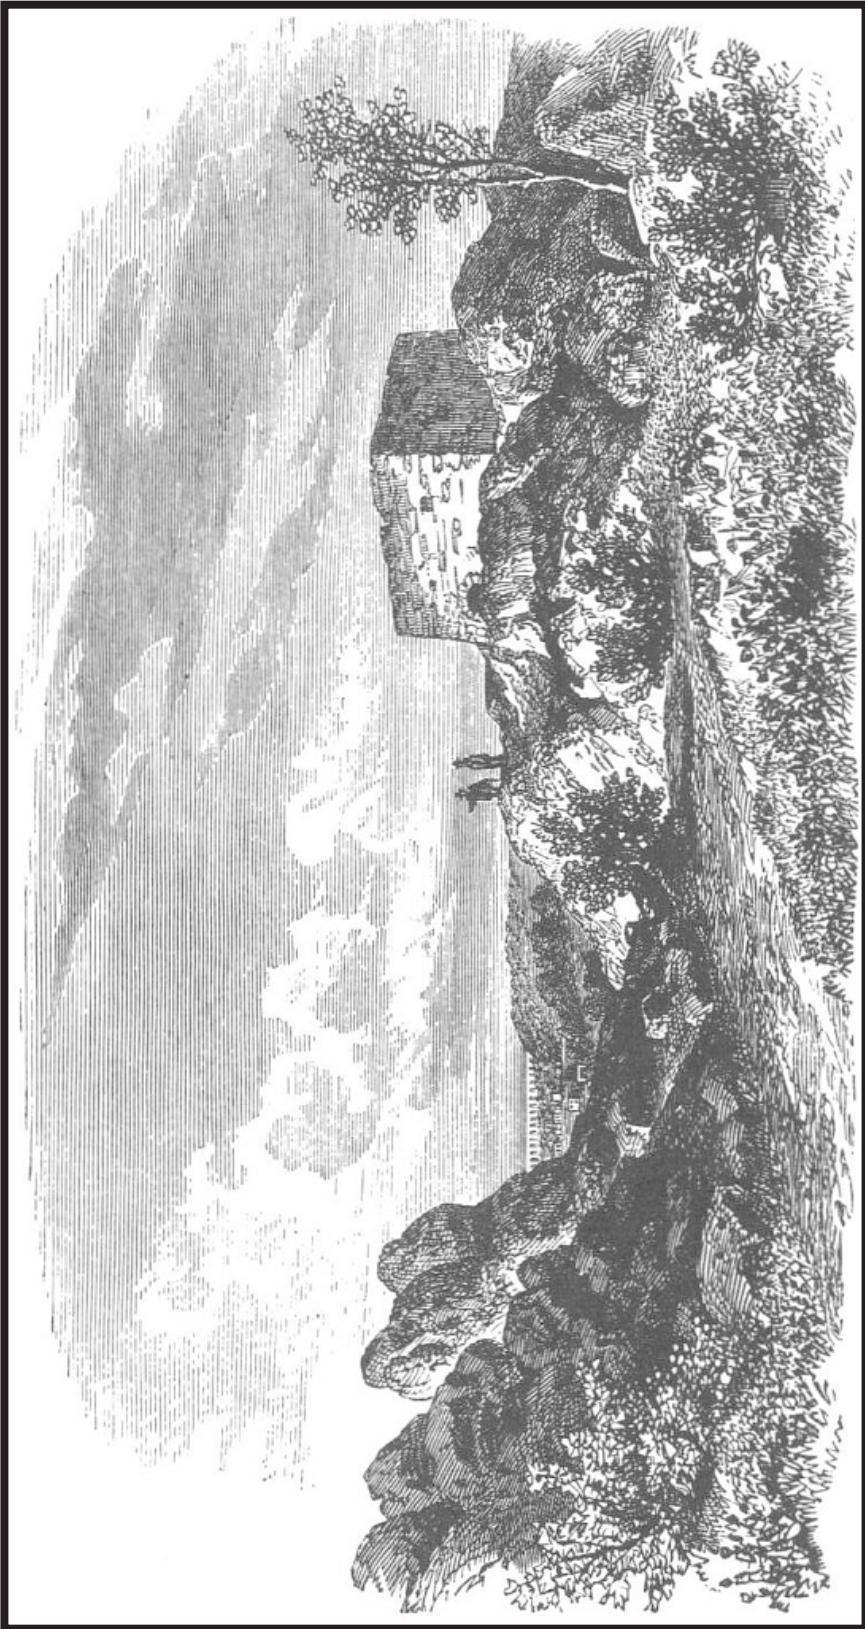
Figure 2.19. Lossing, Benson J. Remains of Block-House Overlooking Harlem Plains in 1860. 1868. This view is looking northeast; note the arch shown toward the northern end of the west wall, a feature for which no clear architectural or archaeological evidence has been found.

Also dating from around 1860 is the lithographic view titled “Remains of Block-house overlooking Harlem Plains in 1860” included in Benson J. Lossing’s *The Pictorial Field-Book of the War of 1812* (Figure 2.19). This view, looking northeast, is problematic for it appears to show an arched entry at ground level toward the northern end of the west wall. This entry has defied all architectural and archaeological interpretation (see below, Chapters 4 and 5), and one can only conclude that it is a loose and perhaps poorly memorized representation of the door that is visible in the west wall in the earliest surviving photographs of the blockhouse taken in the mid-1860s (Photographs 2.1 and 2.2). These photographs depict a door toward the southern end of the west wall (in the same location as, but a smaller version of the present-day door) to which access was evidently achieved through a moveable stair or ladder. Along with a third photograph from the mid-1860s (Photograph 2.3), these early views show the blockhouse with a low gabled roof and blocked gunports, both strong indications that the structure was sealed tight, consistent with its usage as a magazine. The Lossing view, in contrast, seems to show an unroofed structure, perhaps in the early stages of ruination, which in conjunction with the arched entry, suggests that some artistic license has been taken in the name of “picturesqueness” (Lossing 1868).

Excavation Unit 4 was located in the northwest corner of the blockhouse interior where, because of the slope of the bedrock, there appeared to be relatively deep stratigraphy, a site condition that had not been previously sampled by archaeologists. This unit was also placed to identify traces of supports for a late 19th-century interior staircase (documented in photographs and drawings), and to identify evidence of a potential arched entrance depicted in a historic view sketched in 1860 (see above, Figure 2.19).

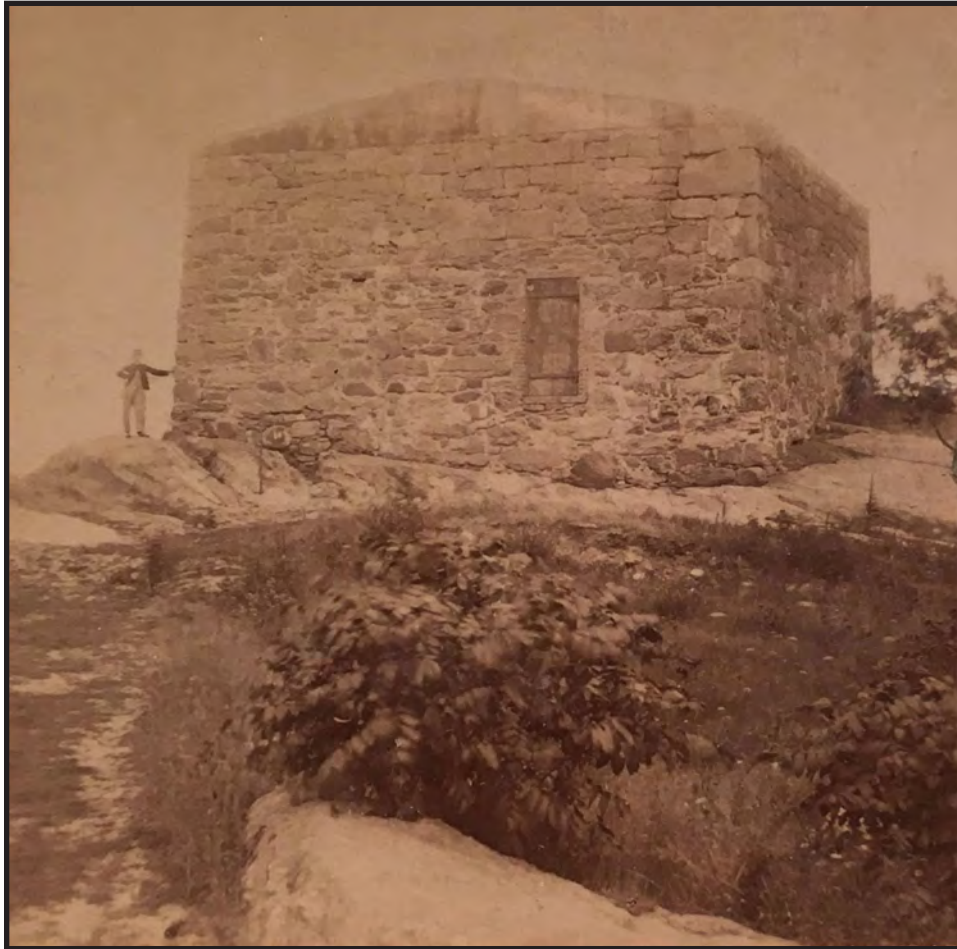
Photograph 2.1. Historic view looking east, *circa* 1865. Note shallow pedimented roof, blocked embrasures, iron door and absence of stair. The blockhouse at this time may still have been in use as a magazine for storing gunpowder. Source: E. and H.T. Anthony and Company, Stereographic View No. 1899 (Metropolitan Museum of Art, Herbert Mitchell Collection 2007.457.68).

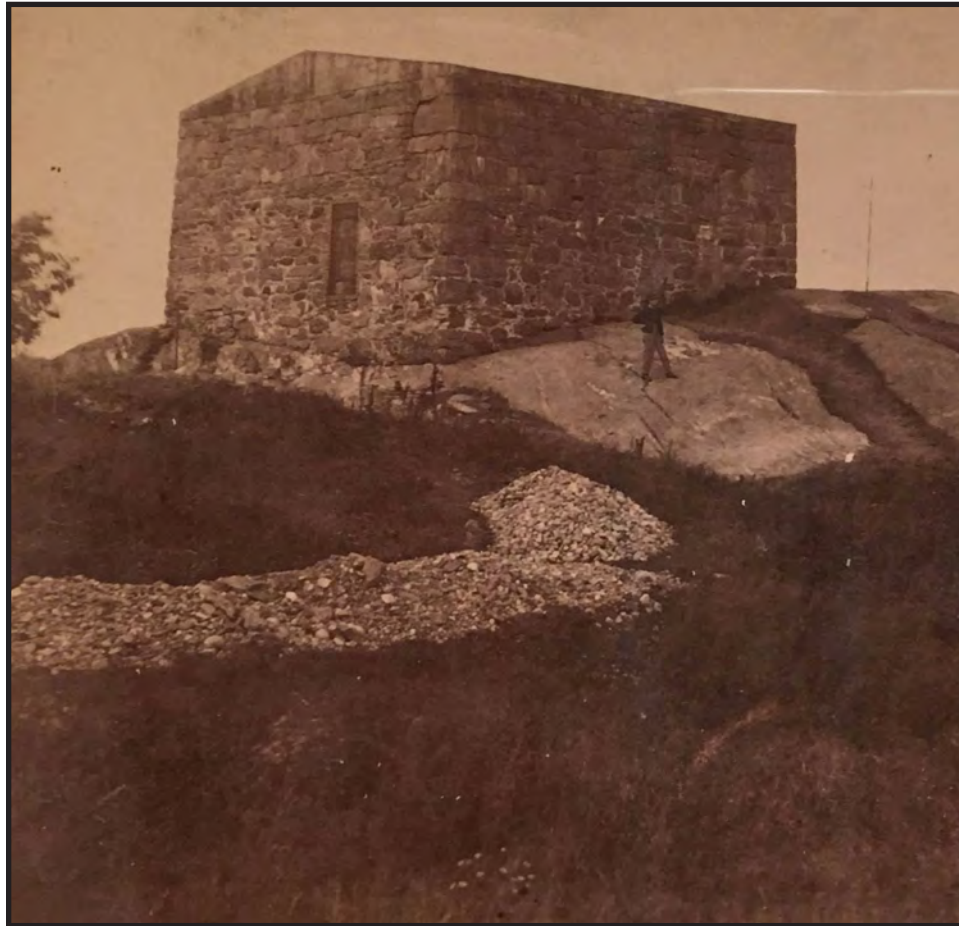
Photograph 2.2. Historic view looking northeast, *circa* 1865. Note shallow pedimented roof, blocked embrasures, iron door and absence of stair. The blockhouse at this time may still have been in use as a magazine for storing gunpowder. Source: E. and H.T. Anthony and Company, Stereographic View No. 1898 (Metropolitan Museum of Art, Herbert Mitchell Collection 2007.457.71).

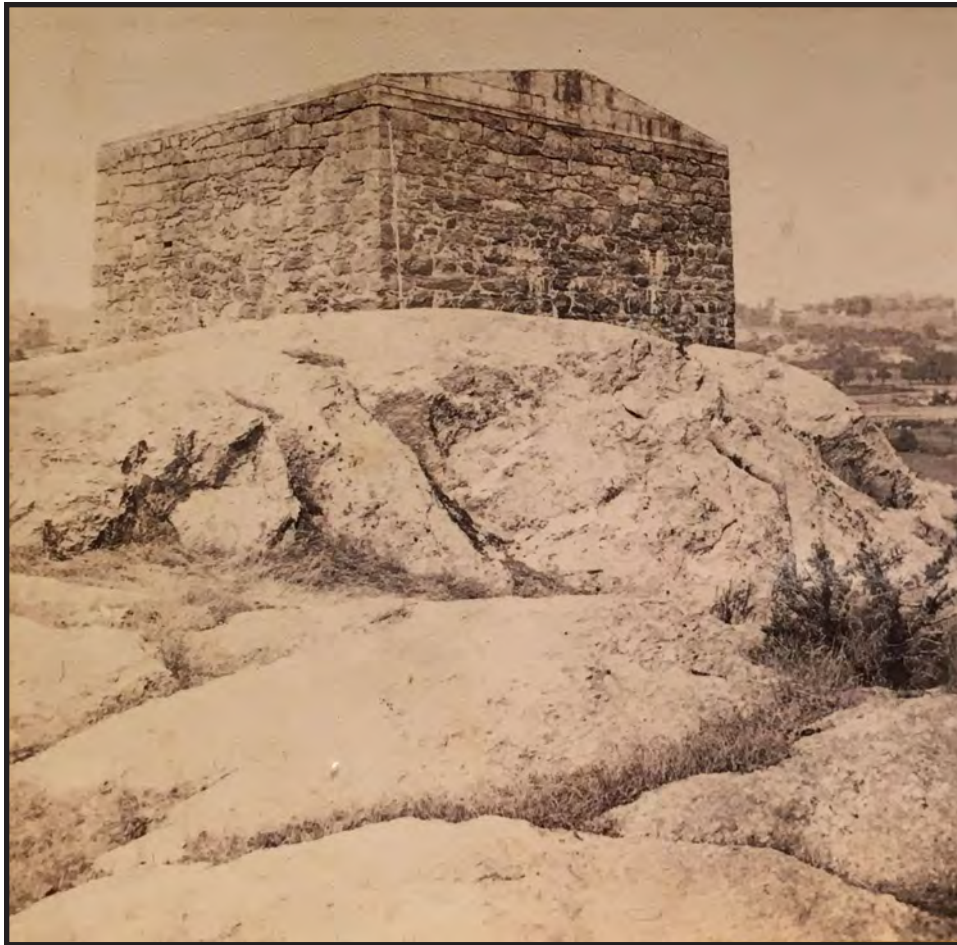
Photograph 2.3. Historic view looking southwest, *circa* 1865. Note shallow pedimented roof and blocked embrasures. The blockhouse at this time may still have been in use as a magazine for storing gunpowder. Source: Unknown Photographer, Stereographic View (Metropolitan Museum of Art, Herbert Mitchell Collection 2007.457.67).

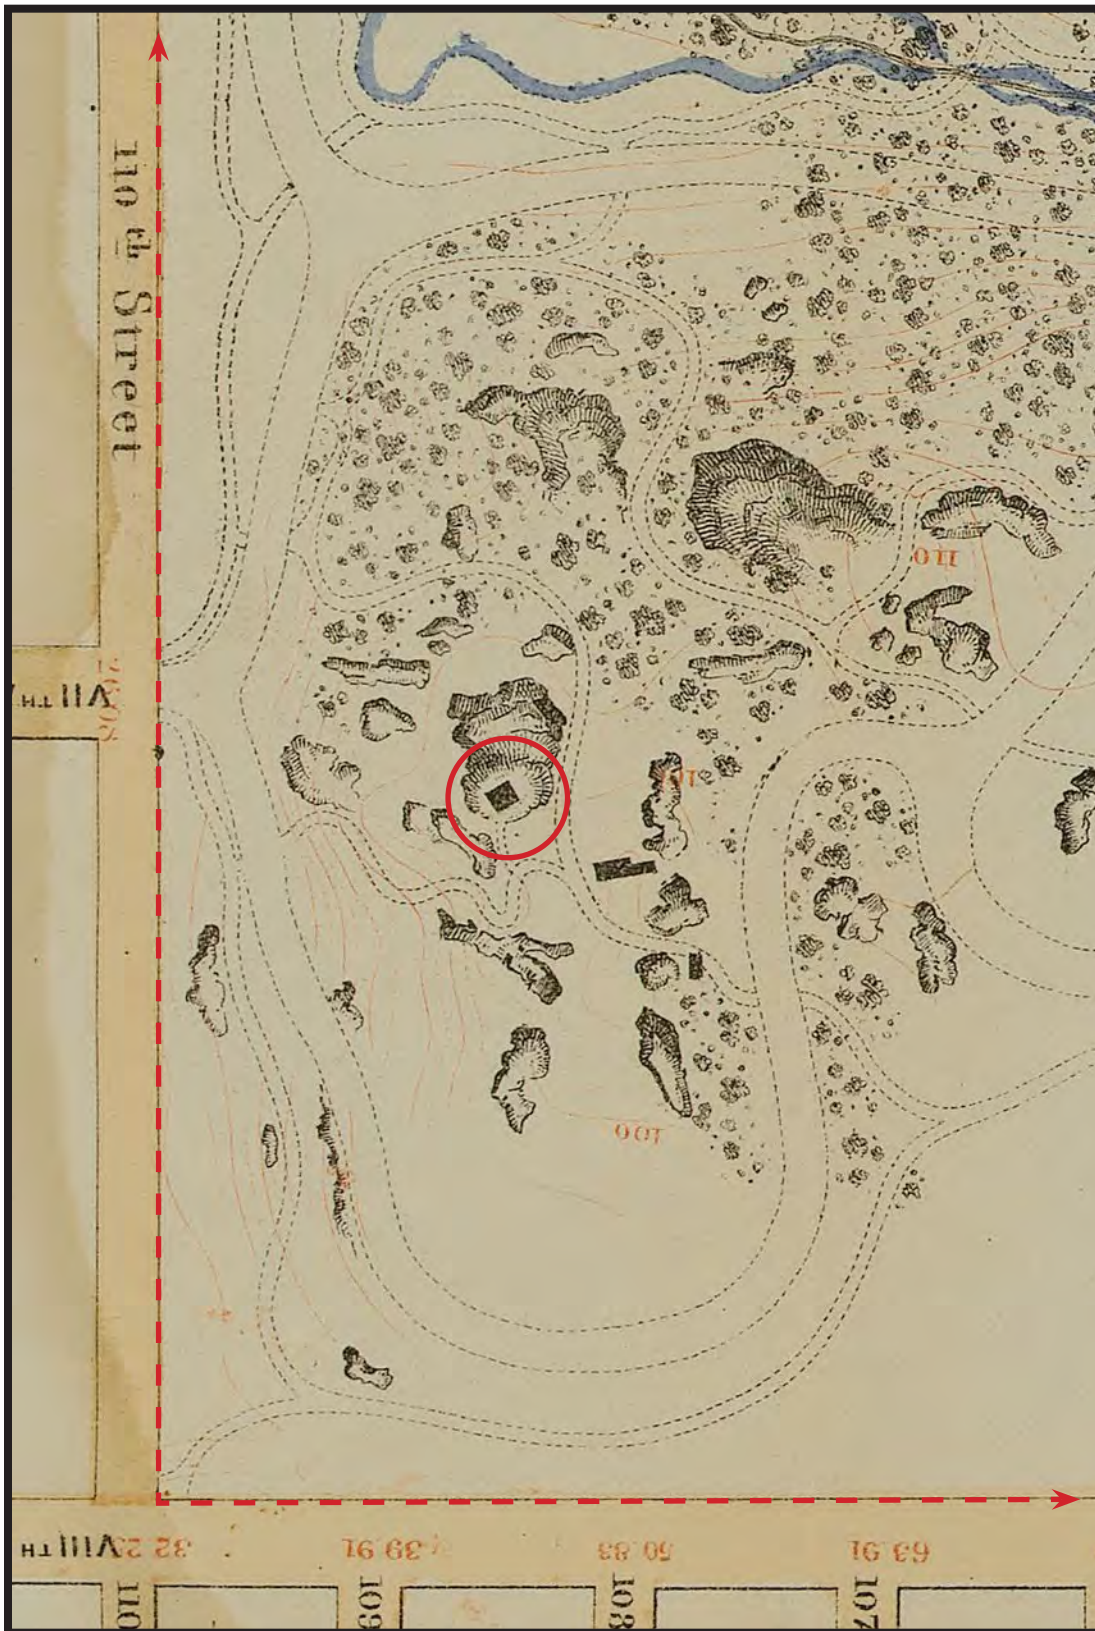
Figure 2.21. Detail from "Map of the Central Park." 1864. Scale 1 inch = 275 feet (approximately). Limits of Central Park outlined and Blockhouse No. 1 circled.

The mid-1860s photographs reveal that the rock outcrop on which the blockhouse was situated was largely devoid of vegetation. One wonders how much vegetation may have been stripped away to facilitate landscaping when the park was created, while there is, in one of the photographs (Photograph 2.2), a curious linear pile of stone rubble that may reflect demolition or impending construction of some sort. Early maps of the drives and paths in this portion of the park show some rather optimistic, projected path alignments around the blockhouse, notably to the north and northwest of the building, that would have been challenged by the natural topography (Figures 2.20 and 2.21).

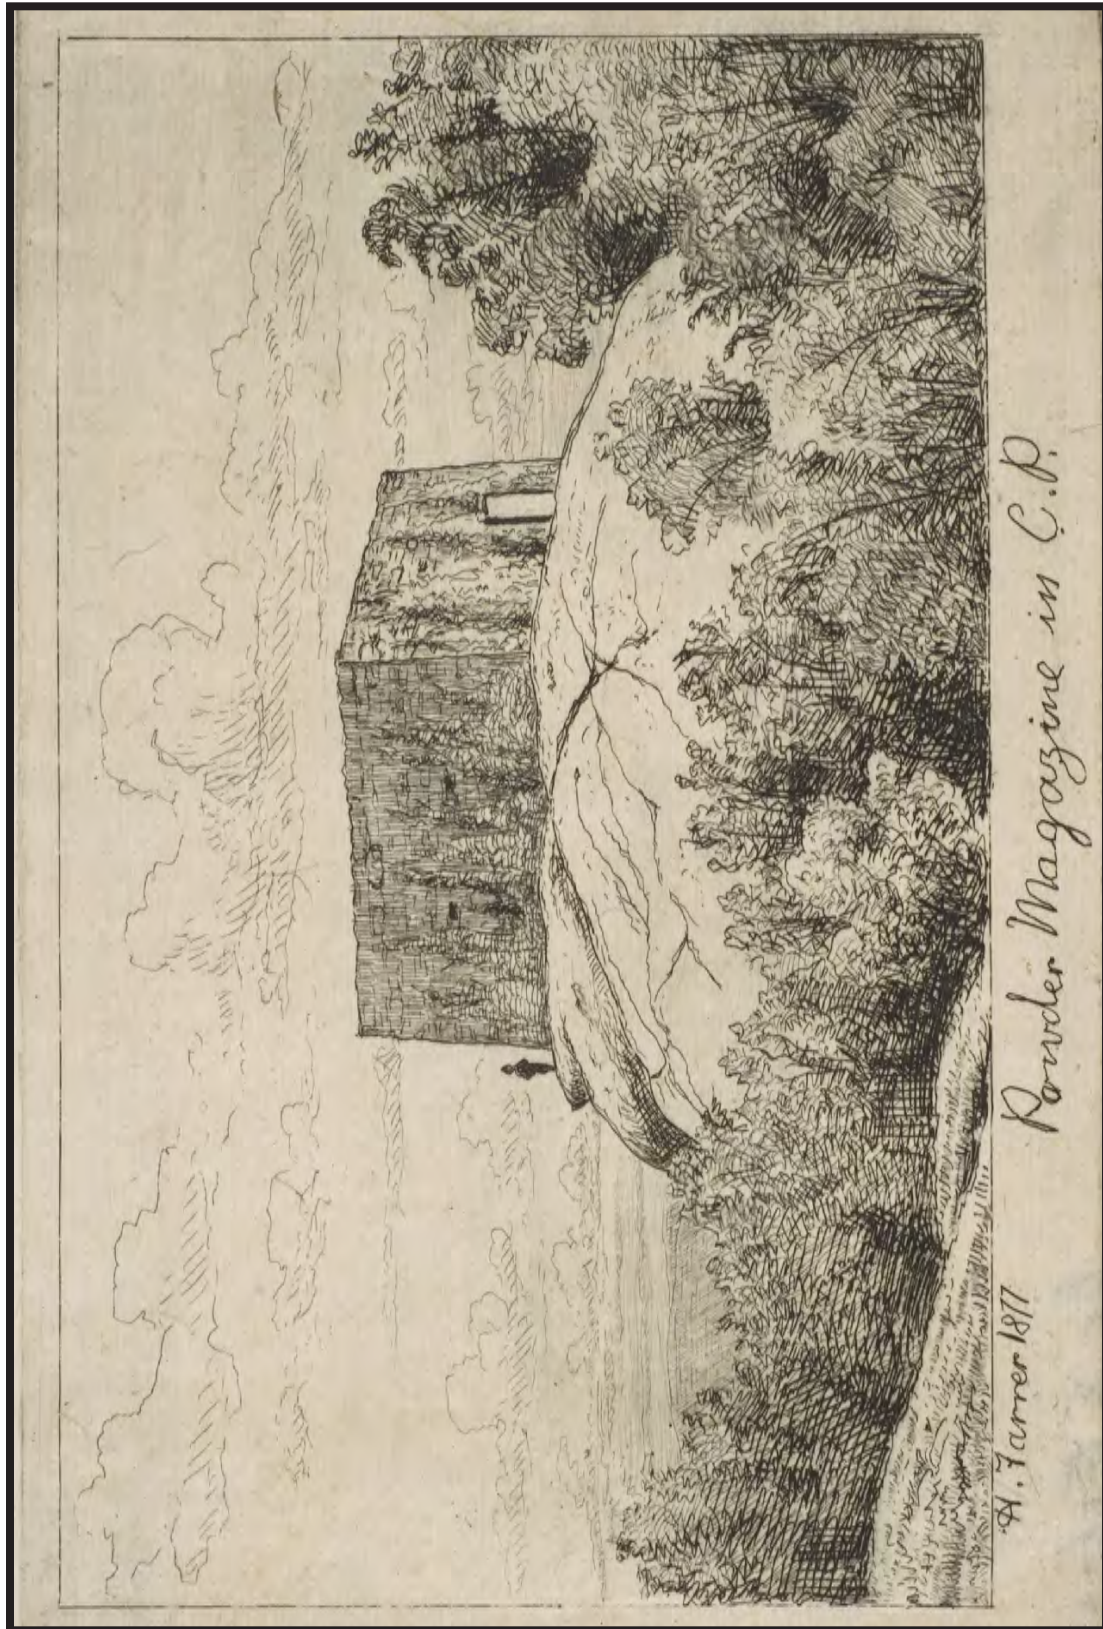
Figure 2.22. Farrer, Henry. Powder Magazine in C.P. 1877.

By the 1870s, Blockhouse No. 1 had evidently ceased its role as a magazine and was being welcomed into the park landscape as a quaint and sturdy ruin (Figure 2.22; Photograph 2.4). Coniferous plantings had been installed to the southwest of the building; a flagpole had been erected; and the doorway was accessible by a permanent exterior stair and open to visitors. However, the structure was also open to the elements and overrun with vines, most likely ivy, and no effort appears to have been directed toward its preservation or maintenance. As photographs and sketches betray, the blockhouse was a charming picnic spot with a hint of history.
