Historical Research, Laser Scanning
and Archaeological Investigations
Blockhouse No. 1
Central Park, New York

Prepared for:

Central Park Conservancy

October 2019

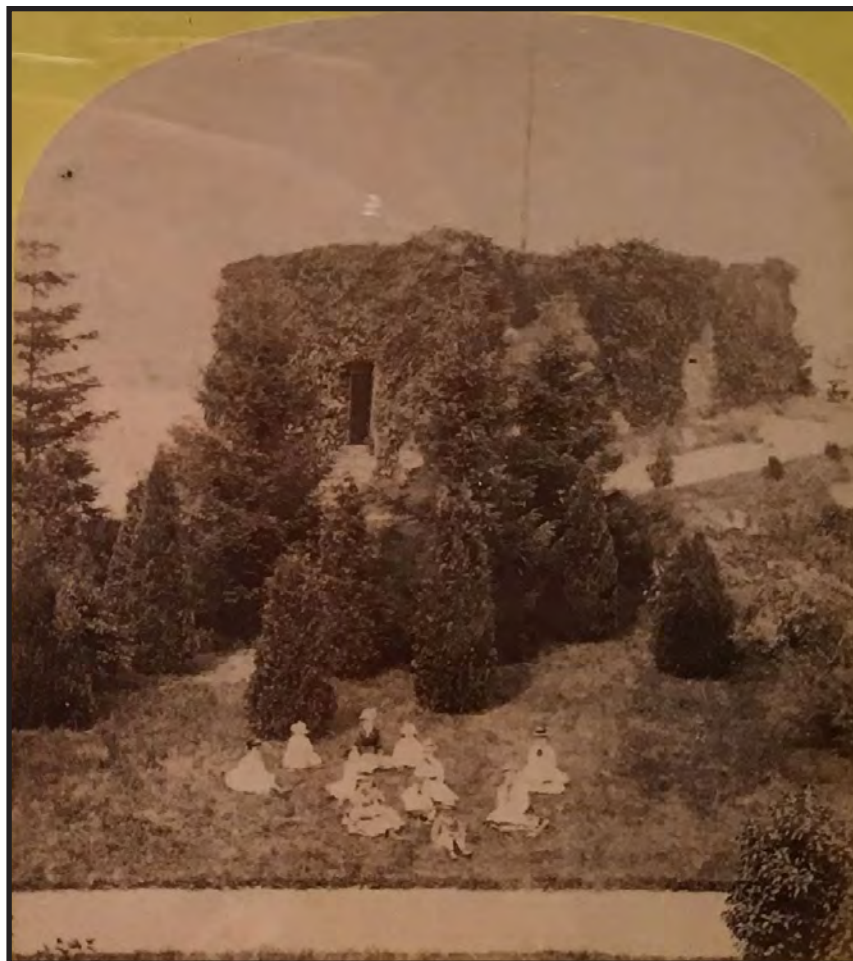
Photograph 2.4. Historic view looking northeast, *circa* 1875. Note flagpole in northeast corner of the building, stair leading up to doorway and apparent removal of pedimented roof. The blockhouse is clearly no longer in use as a magazine for storing gunpowder by this date. Source: Unknown Photographer, Stereographic View (Metropolitan Museum of Art, Herbert Mitchell Collection 2007.457.69).

By the 1870s, Blockhouse No. 1 had evidently ceased its role as a magazine and was being welcomed into the park landscape as a quaint and sturdy ruin (Figure 2.22; Photograph 2.4). Coniferous plantings had been installed to the southwest of the building; a flagpole had been erected; and the doorway was accessible by a permanent exterior stair and open to visitors. However, the structure was also open to the elements and overrun with vines, most likely ivy, and no effort appears to have been directed toward its preservation or maintenance. As photographs and sketches betray, the blockhouse was a charming picnic spot with a hint of history.

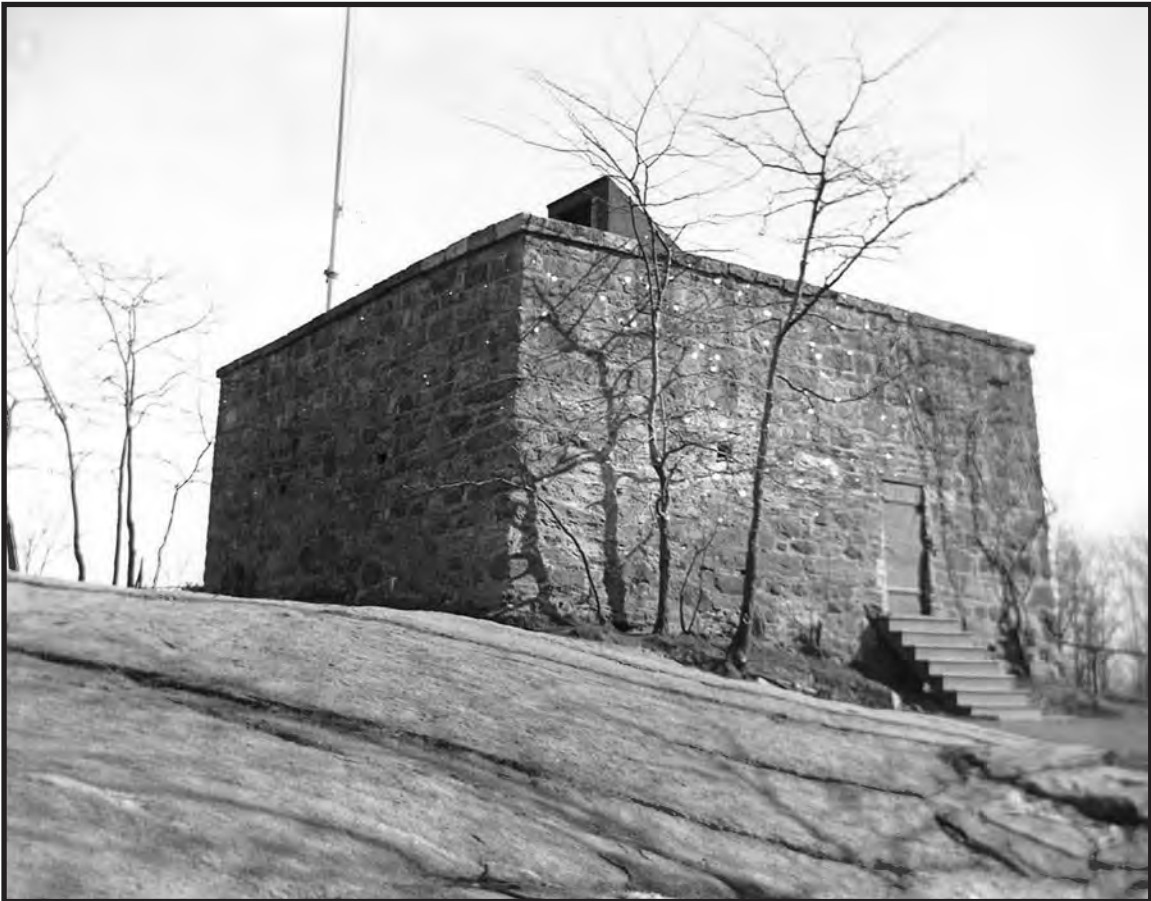
Photograph 2.5. Historic view looking southeast, 1899. Note flagpole in northeast corner of the building, interior stairway hood along west wall, restored masonry, embrasures and parapet, and wooden exterior stair leading up to iron door. Source: George E. Stonebridge (New-York Historical Society, George E. Stonebridge Collection 63861-4868).

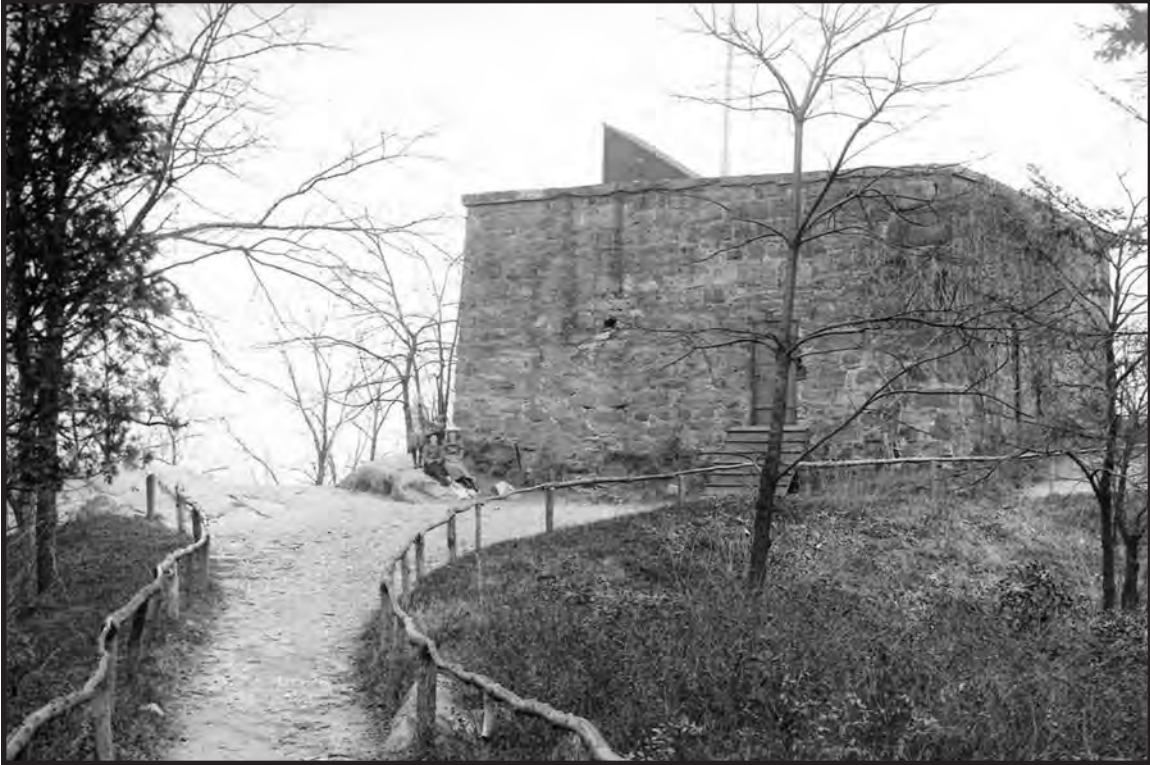
Photograph 2.6. Historic view looking east northeast, 1904. Note flagpole in northeast corner of the building, interior stairway hood along west wall, restored masonry, embrasures and parapet, and wooden exterior stair leading up to iron door. Source: Unknown Photographer (New-York Historical Society, R.S. Guernsey Lecture 20592).

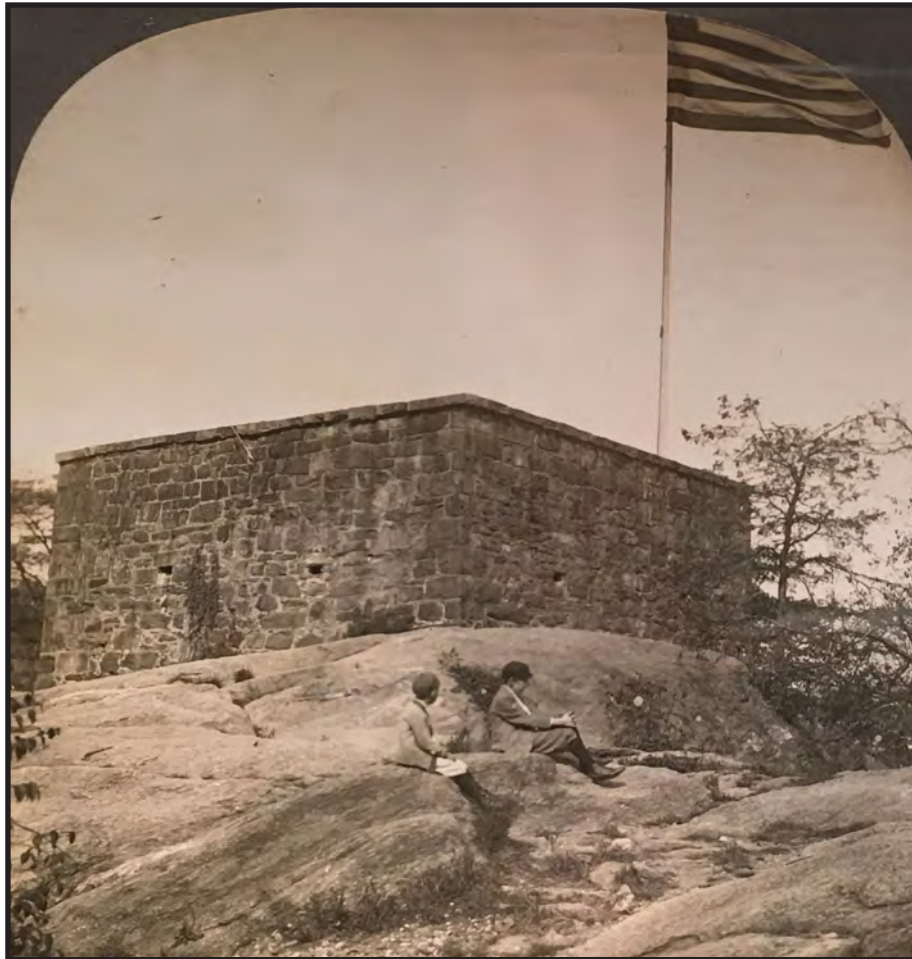
Photograph 2.7. Historic view looking northwest, 1909. Note flagpole in north-east corner of the building, restored masonry, embrasures and parapet. Source: Unknown Photographer, Stereographic View (Metropolitan Museum of Art, Herbert Mitchell Collection 2007.457.70).

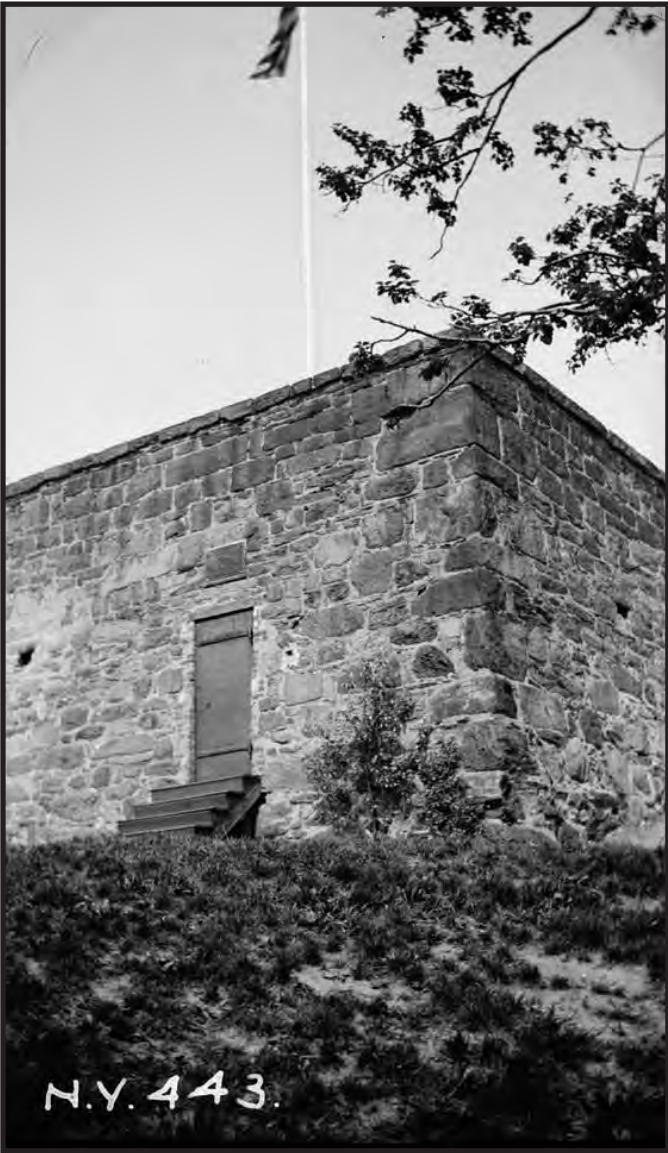
Photograph 2.8. Historic view looking northeast, February 16, 1936. Note flagpole in northeast corner of the building, absence of interior stairway hood along west wall, restored masonry, embrasures and parapet, and wooden exterior stair leading up to iron door. Source: Wakefield Worcester (Historic American Buildings Survey NY 443).

This tablet was still present in 1936 when both Blockhouses Nos. 1 and 4 were documented by the Historic American Buildings Survey (Figure 2.24; Photographs 2.8 and 2.9). Blockhouse No. 1 still appears to have been good repair in the mid-1930s, although the plan view recorded at this time shows no indication of the interior modifications made in the late 1890s. It is not known when the stair and observation platform were removed. Deterioration of the blockhouse, due principally to lack of maintenance, appears to have become a problem from World War II onward, persisting through much of the second half of the 20th century. Photographs from the early 1960s, however, show the basic shell of the blockhouse struc-

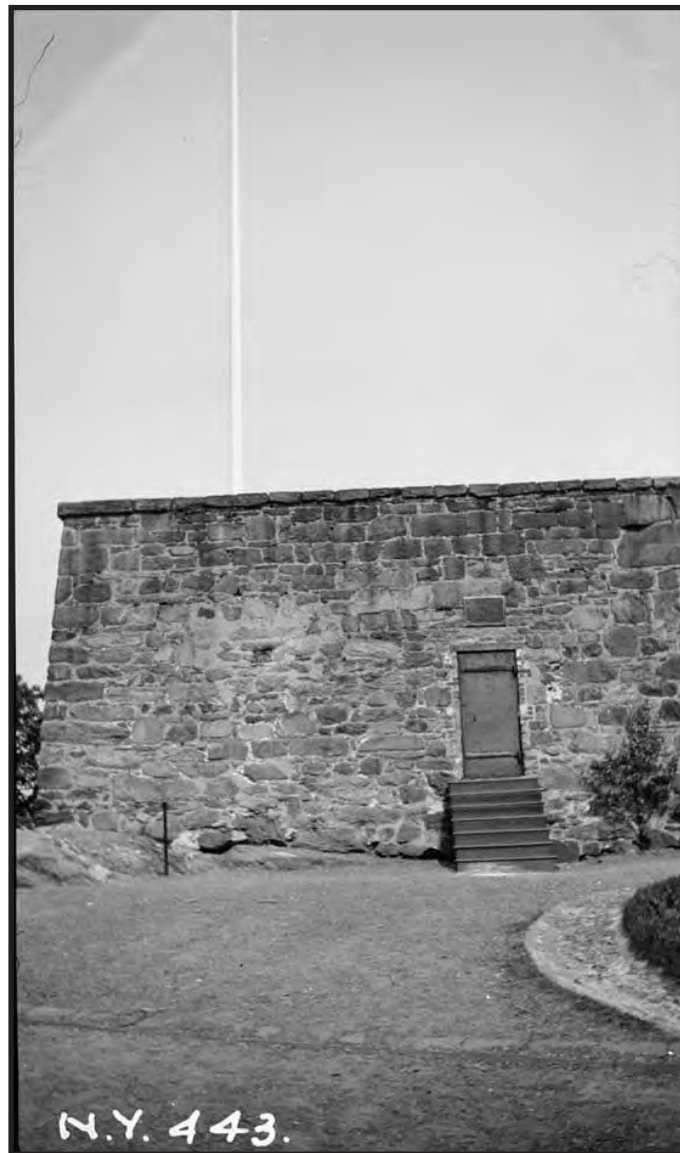
Photograph 2.9. Historic view looking east, May 12, 1936. Note flagpole in northeast corner of the building, restored masonry, embrasures and parapet, and wooden exterior stair leading up to iron door. Source: Arnold Moses (Historic American Buildings Survey NY 443).

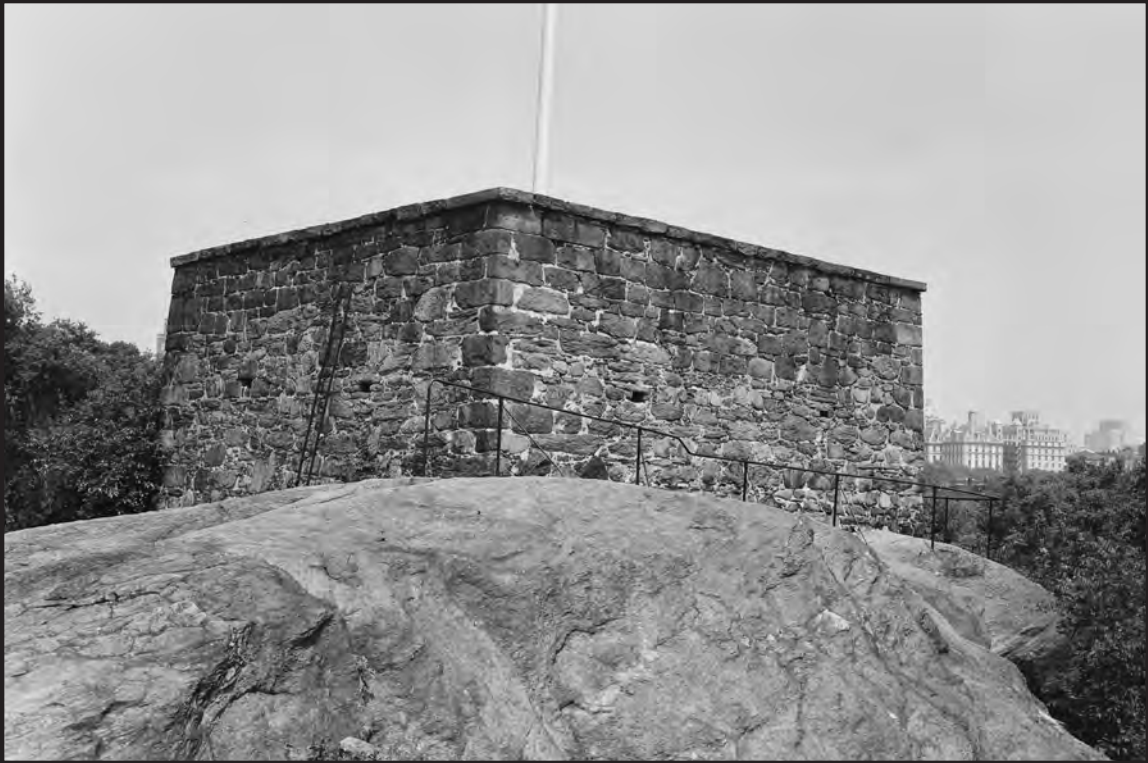
Photograph 2.10. Historic view looking southwest, May 1962. Note flagpole in northeast corner of the building, restored masonry, embrasures and parapet, iron railing and ladder. Source: New York City Parks Department (Central Park Conservancy 31592).

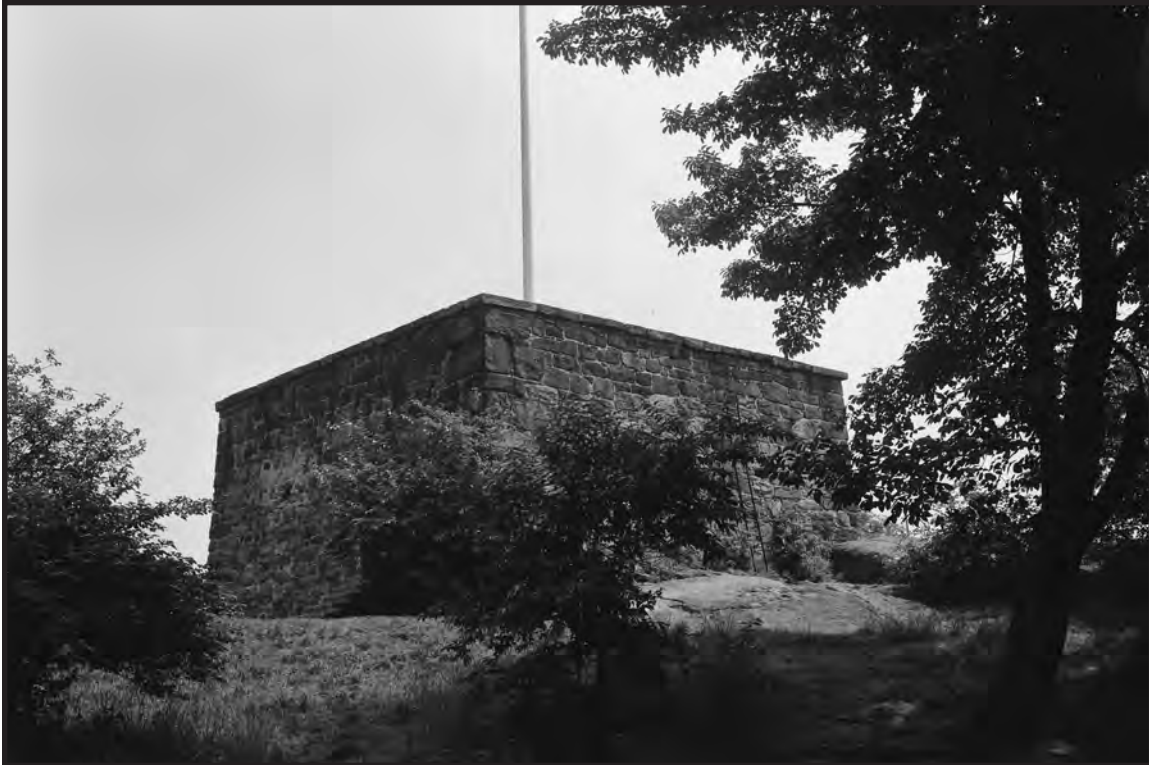
Photograph 2.11. Historic view looking northeast, May 1962. Note flagpole in northeast corner of the building, restored masonry, embrasures and parapet, iron ladder, and brick and stone exterior stair. Source: New York City Parks Department (Central Park Conservancy 31593).

ture to be in reasonable condition (Photographs 2.10 and 2.11). Again, it is not known when the entrance and door in the west wall were modified to take on their present-day appearance, although this occurred subsequent to 1936. The heightening of the doorway, removal of the door and installation of an iron grille evidently resulted in the removal of the Women's Auxiliary plaque, which is presumed to still be held in storage somewhere by the Department of Parks.

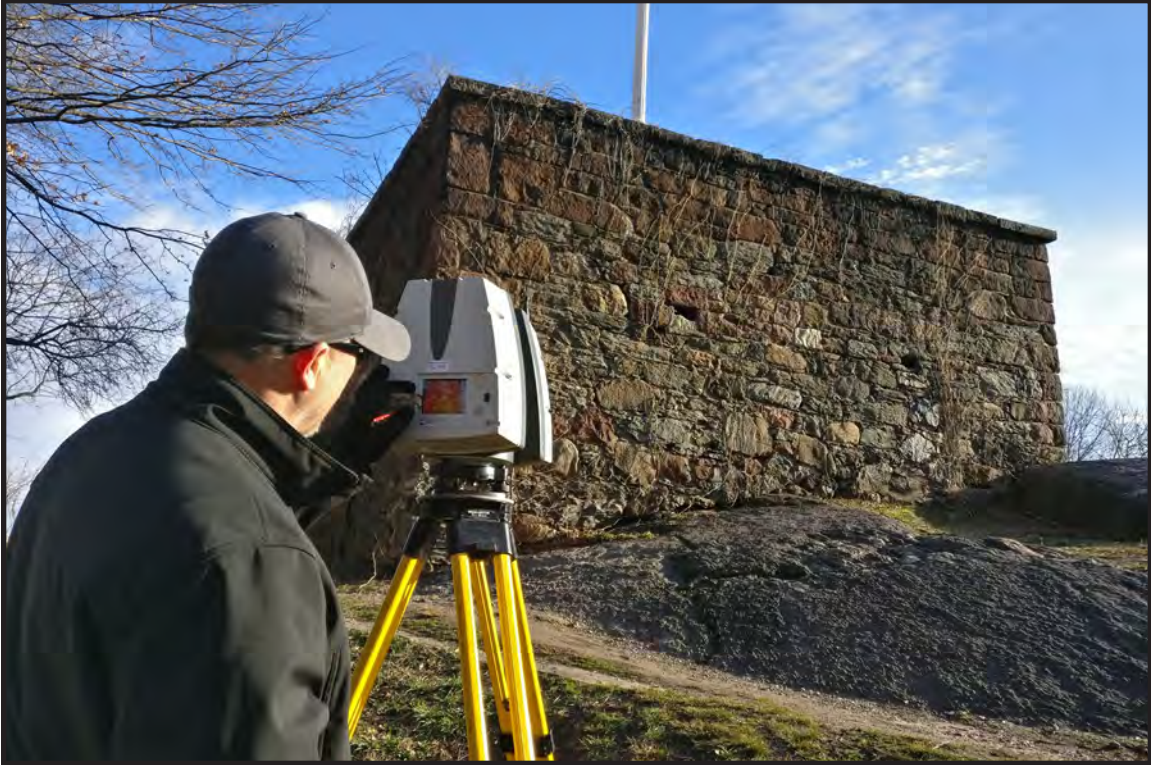
Photograph 3.1. View facing northeast showing digital laser scanning equipment being set up southwest of the blockhouse to scan the western and southern facades (Photographer: James Lee, March 2017 [HRI Neg.#17013/D1:002]).

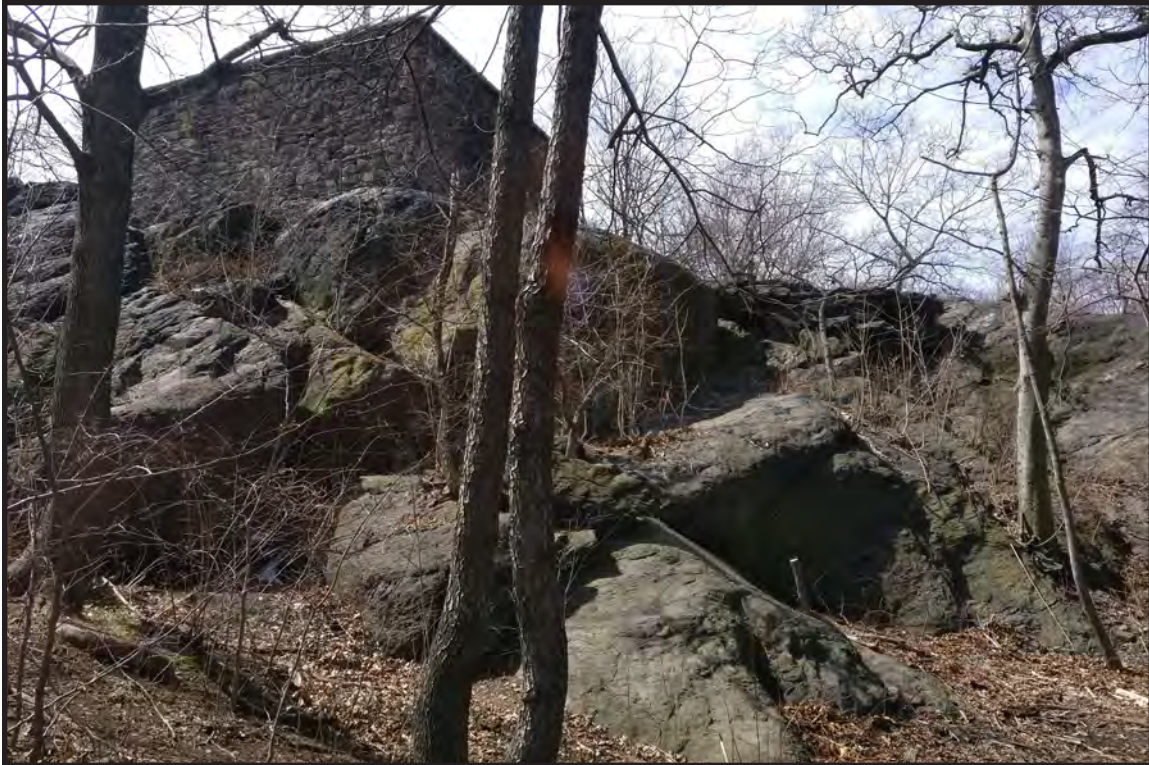
Photograph 3.2. View facing southwest showing the view up towards the blockhouse from one of the scanning locations (Photographer: James Lee, March 2017 [HRI Neg.#17013/D1:011]).

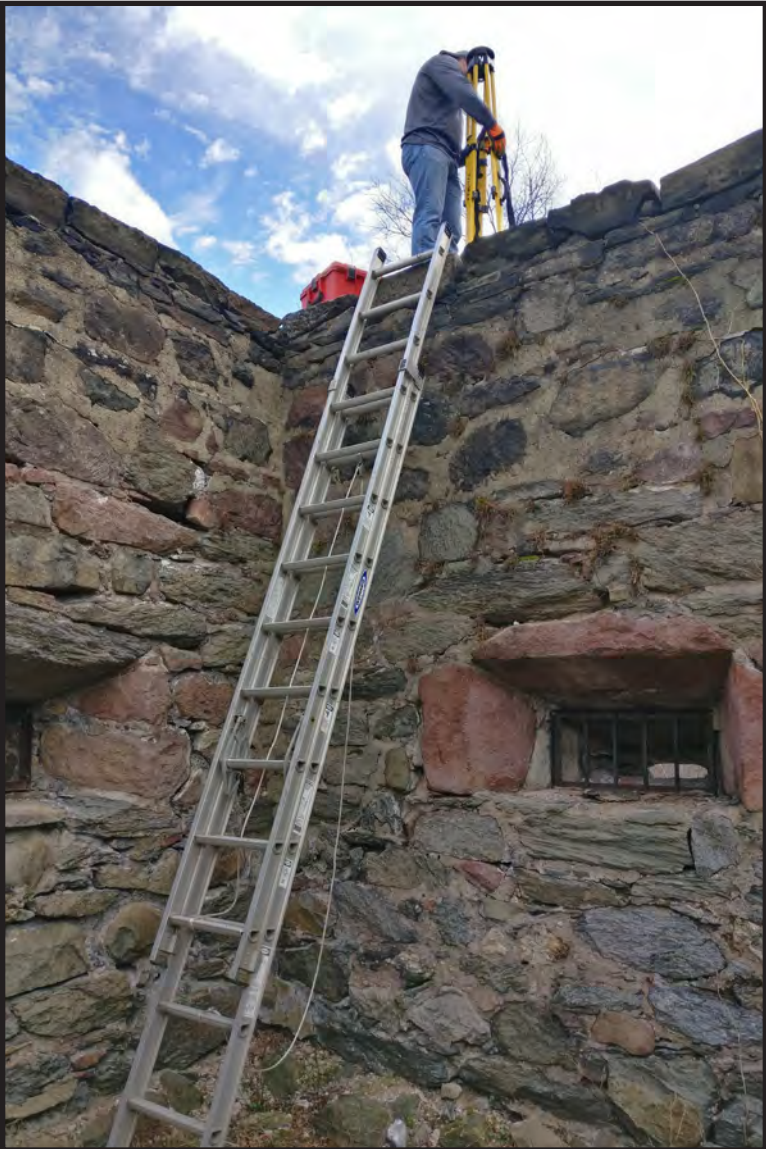
Photograph 3.3. View facing southeast showing digital laser scanning equipment being set up on top of the southern wall of the block-house to scan the top and interior (Photographer: James Lee, March 2017 [HRI Neg.#17013/D1:017]).

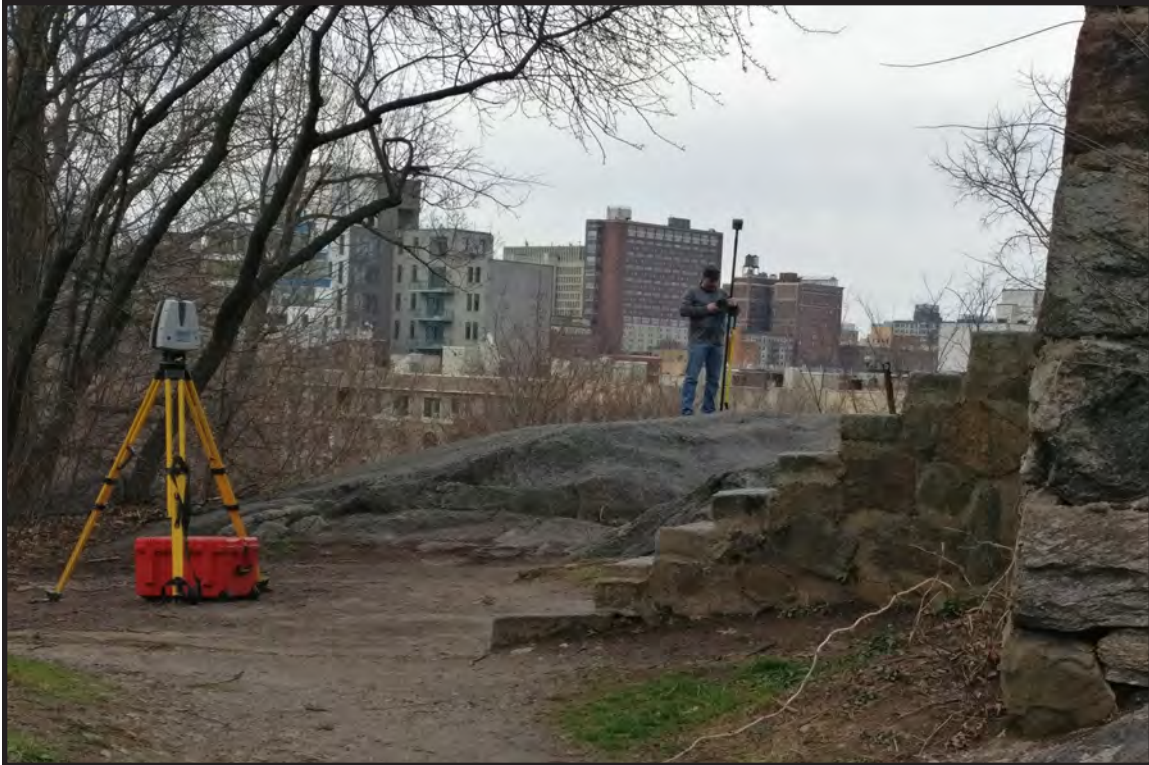
Photograph 3.4. View facing north showing GPS surveying of the datum for the topographic scan (Photographer: James Lee, March 2017 [HRI Neg.#17013/D1:024]).

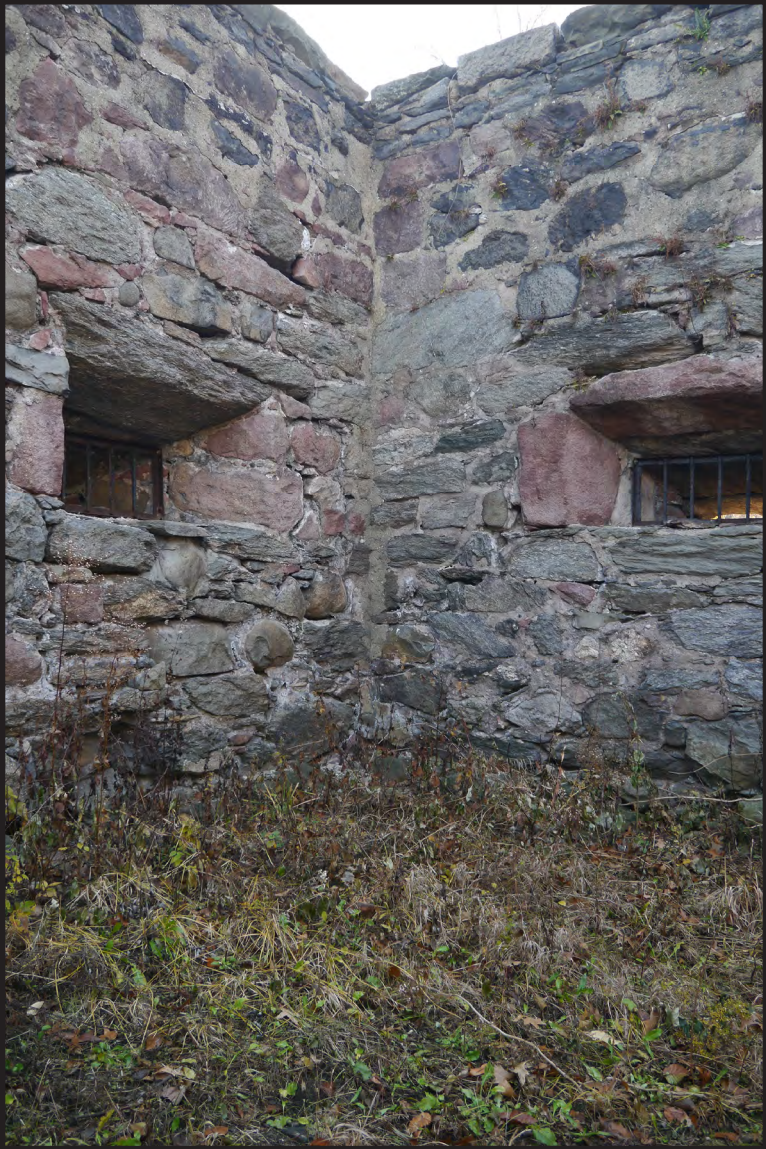
Photograph 4.1. View facing southeast showing the southeast corner of the interior of the blockhouse prior to the start of archaeological excavations (Photographer: James Lee, December 2017 [HRI Neg.#17070/D1:011]).

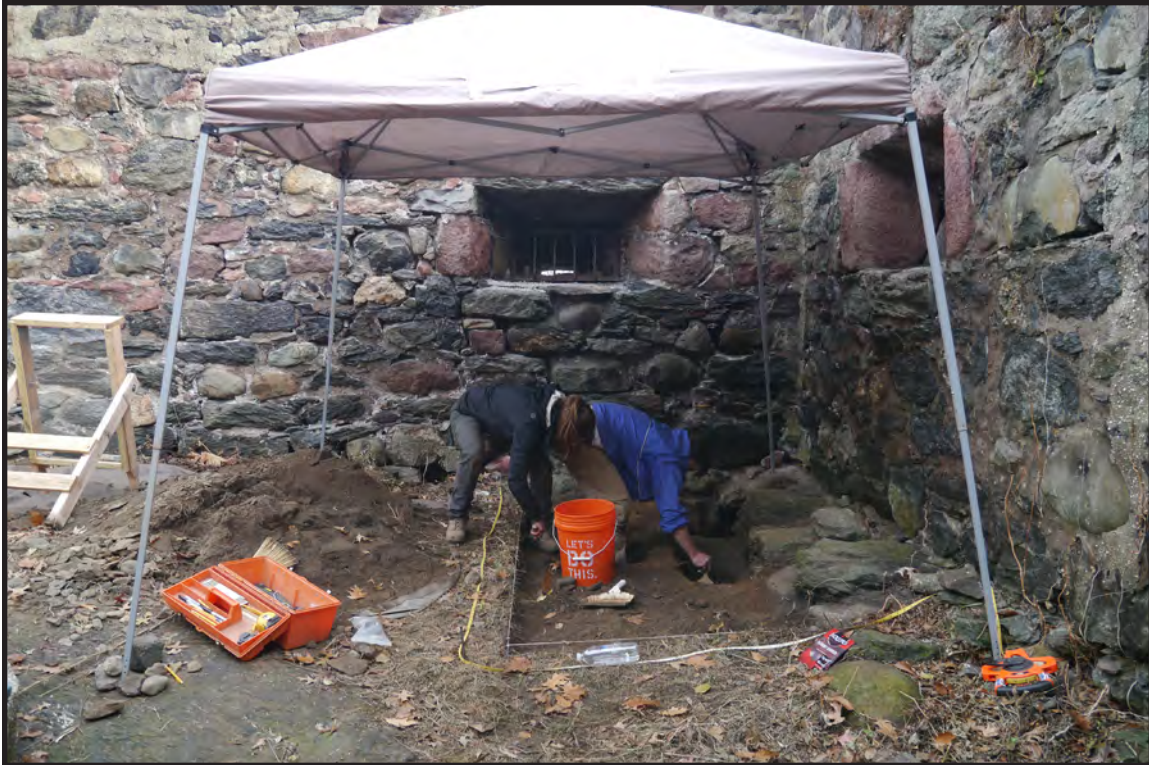
Photograph 4.2. View facing east showing Excavation Unit 2 in progress in the southeast corner of the blockhouse (Photographer: James Lee, December 2017 [HRI Neg.#17070/D1:048]).

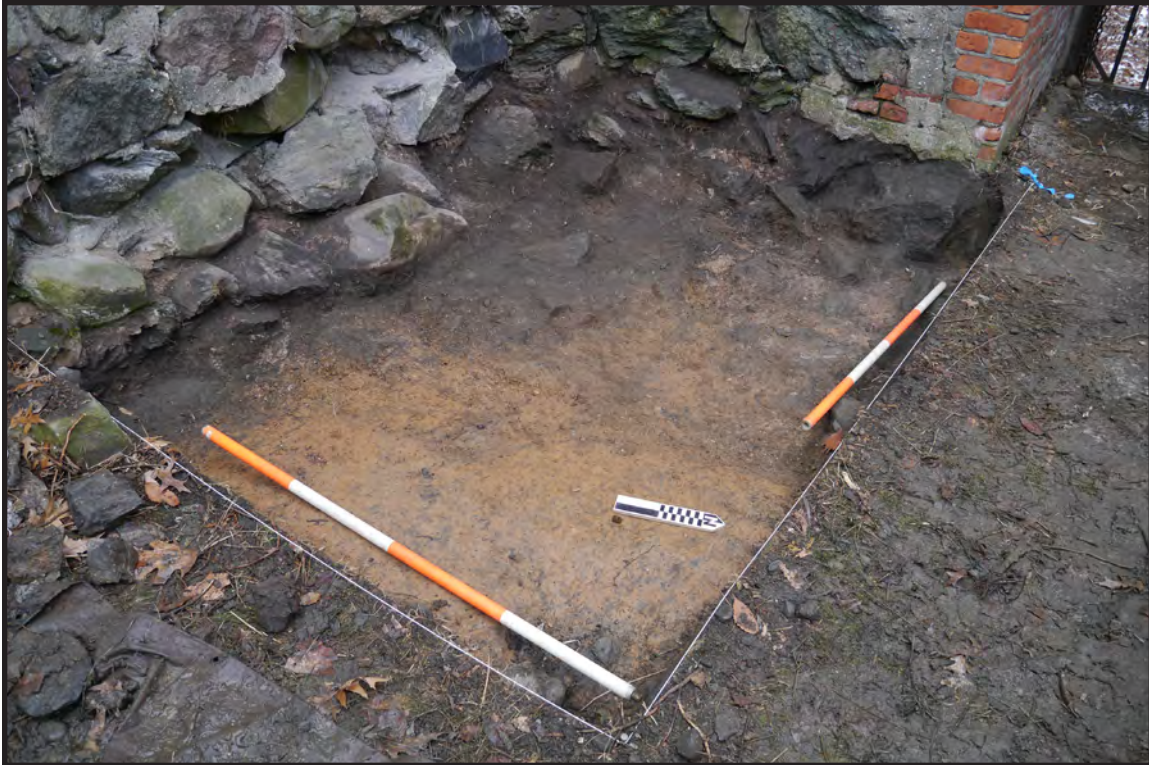
Photograph 4.3. View facing southwest showing Excavation Unit 1 after the removal of the topsoil; scales in feet and tenths of feet (Photographer: James Lee, December 2017 [HRI Neg.#17070/D1:230]).

This nine-by-six-foot unit was excavated in the southeastern interior corner of the blockhouse and encompassed Trench B excavated in 1995. After the debris, loose stones and vegetation were removed, the previously excavated Trench B was observed in plan set against the southern [100] and eastern [101] foundations of the blockhouse (Figure 4.1; Photograph 4.7). The backfill of this earlier excavation was removed as a cut [2] and fill [3] deposit. This context yielded 527 artifacts, mostly modern refuse; however, oyster shell fragments, corroded iron cut nails, bottle glass (including a thick dark olive green glass fragment) and a bone button were also retrieved.

After the removal of the topsoil [1] and excavation of the previously excavated trench, three additional contexts were identified in plan: a silty clay [4] was present across much of the unit; an area of rocky debris in a silty loam matrix [7] was identified in the northwest corner; and a pit [5/6/7] was identified in the center of the northeastern quadrant. Suspecting that the latter feature was a modern intrusion, this pit was bisected, excavated and sampled separately from the soils that surrounded it. The fill context [5] was a dark silty loam containing charcoal that appeared to be a modern firepit, possibly reused as a trash pit. At the very base of this context, which cut partially into Context 7 below, there was a plastic shopping bag. The feature yielded other modern artifacts, including beer bottle fragments and a piece of concrete. Although this fea-

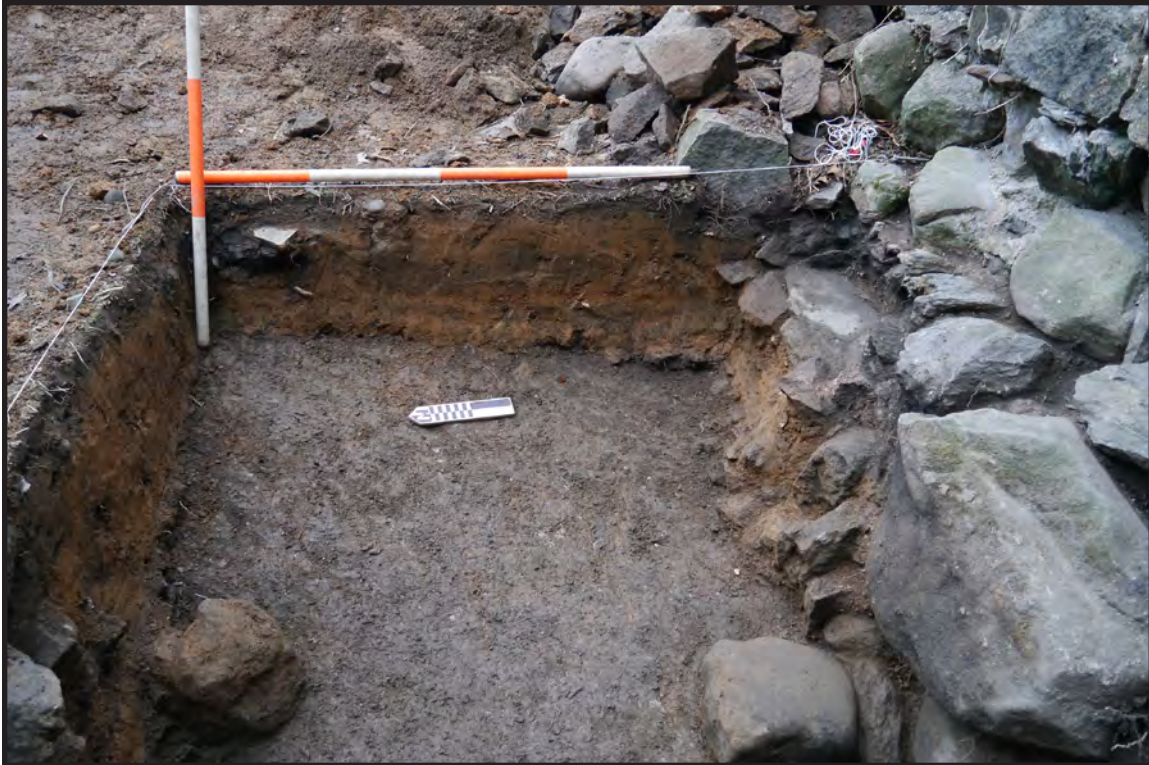
Photograph 4.4. View facing east showing the east profile of Excavation Unit 1 with clay directly overlying bedrock; scales in feet and tenths of feet (Photographer: James Lee, December 2017 [HRI Neg.#17070/D1:252]).

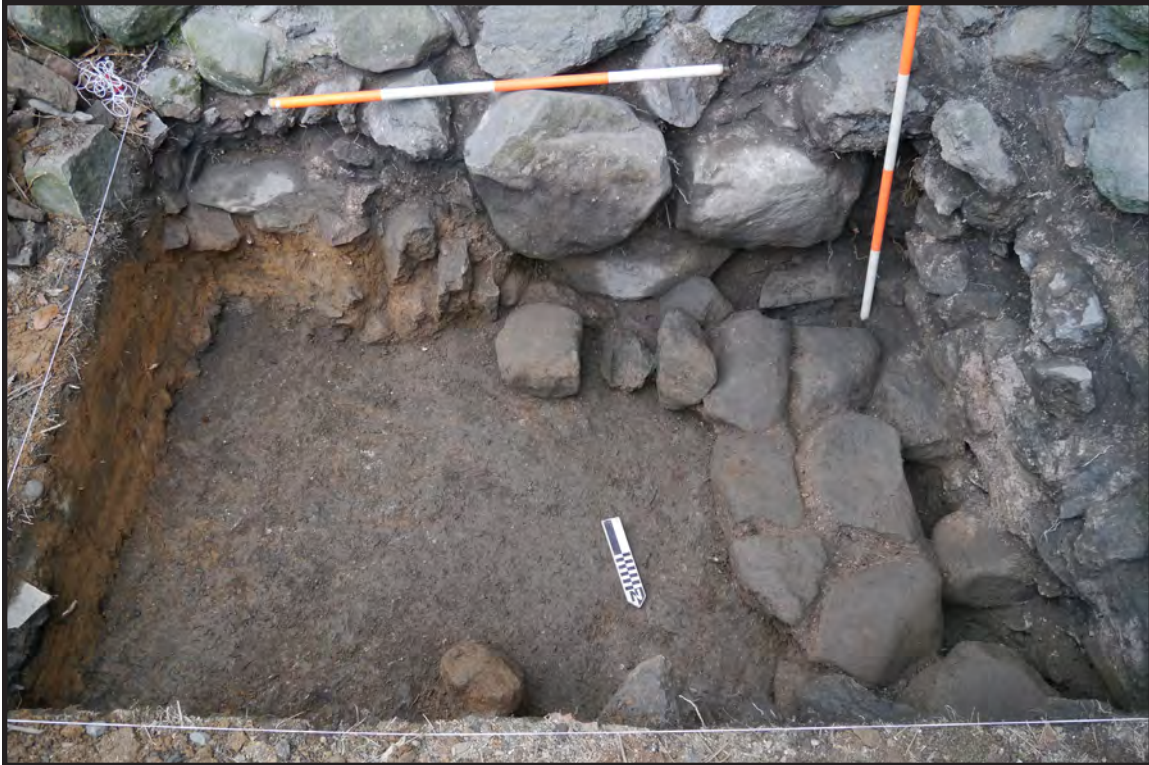
Photograph 4.5. View facing south showing Excavation Unit 1. Note the level stone pad set on bedrock at the western end of the unit; scales in feet and tenths of feet (Photographer: James Lee, December 2017 [HRI Neg.#17070/D1:245]).

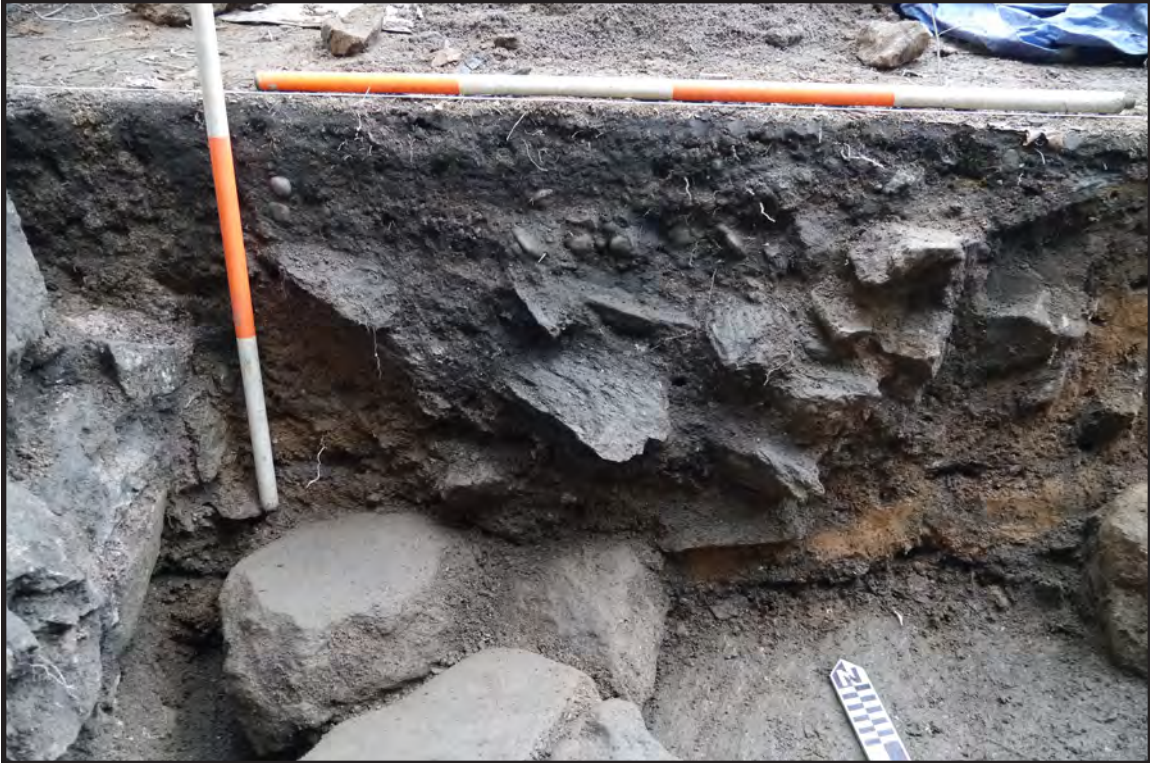
Photograph 4.6. View facing north showing the western portion of the north profile of Excavation Unit 1. Note the stone fill above the stone pad; scales in feet and tenths of feet (Photographer: James Lee, December 2017 [HRI Neg.#17070/D1:253]).

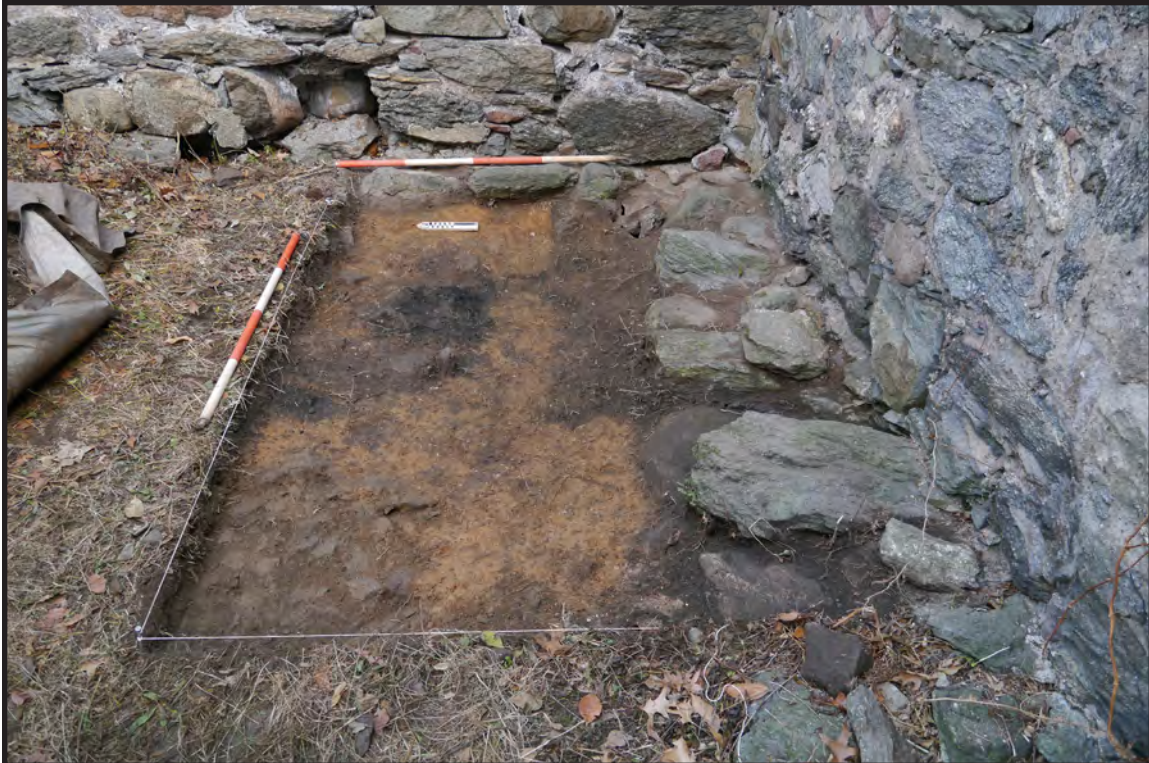
Photograph 4.7. View facing east showing Excavation Unit 2 after the removal of topsoil. Note the rectangular outline of Trench 8 and the circular modern firepit feature just west of the north arrow; scales in feet and tenths of feet (Photographer: James Lee, December 2017 [HRI Neg.#17070/D1:036]).

ture is of no consequence to the interpretation of the 19th-century history of the site, it was important to isolate this modern intrusion from the other, older contexts to avoid contamination.

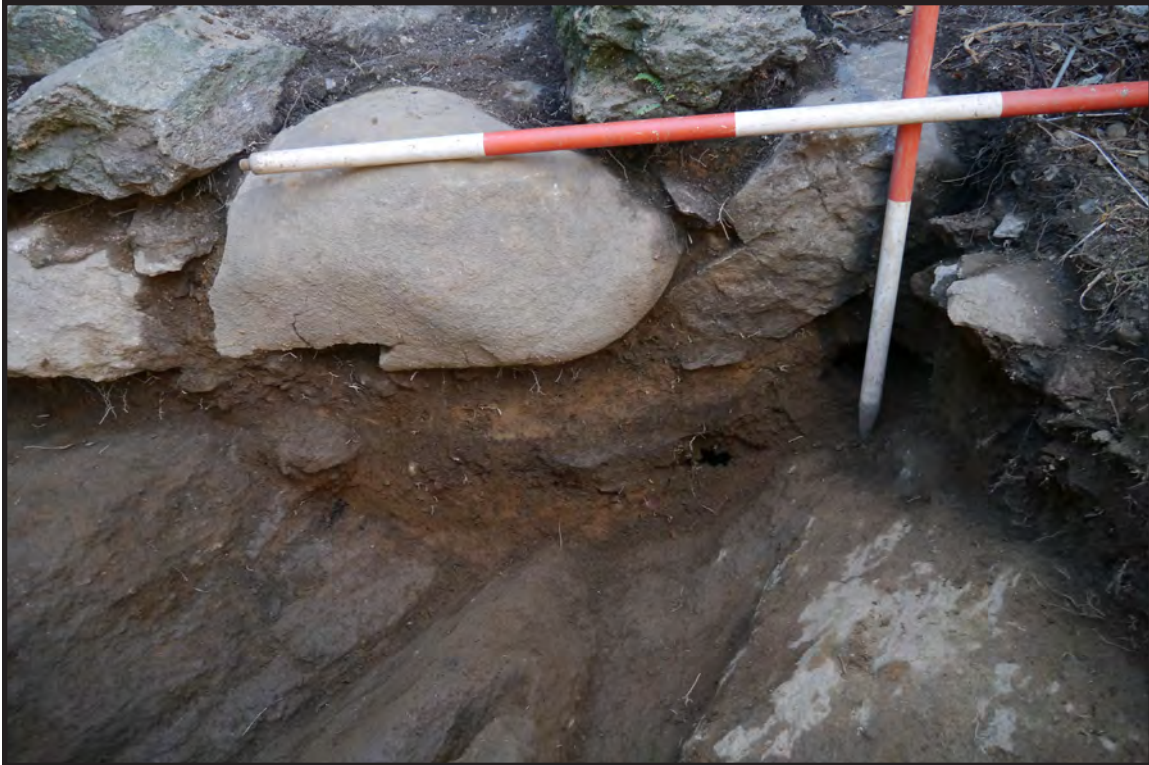
Photograph 4.8. View facing north showing the north profile of Excavation Unit 2; scales in feet (Photographer: James Lee, December 2017 [HRI Neg.#17070/D1:168]).

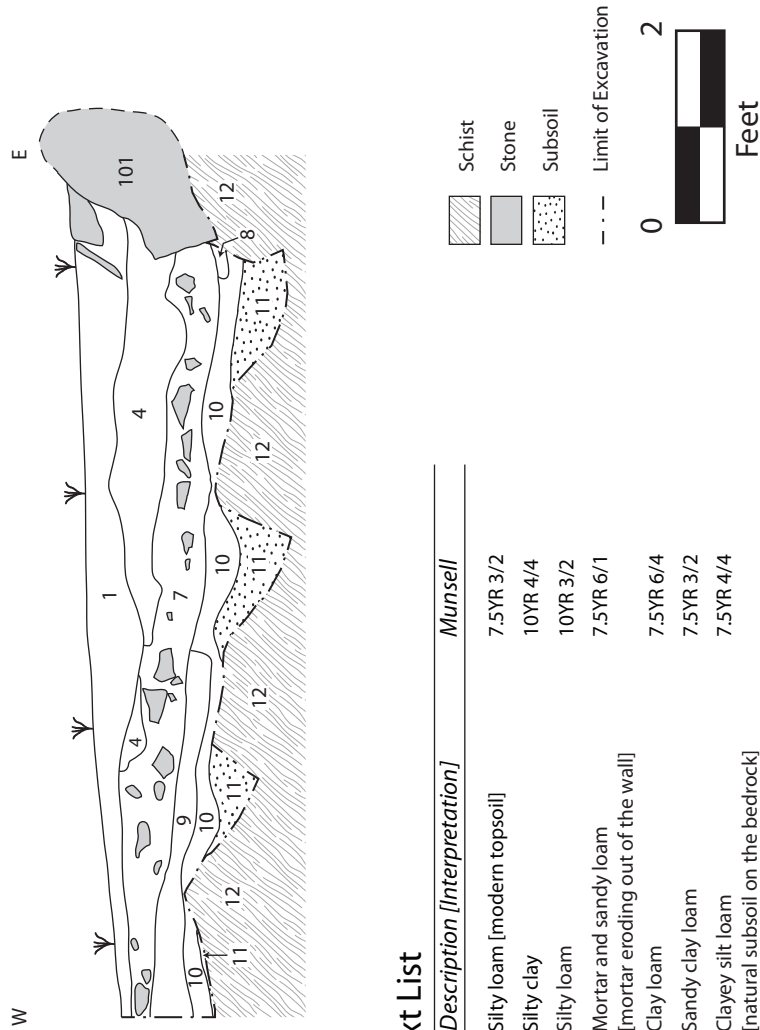
Figure 4.5. Excavation Unit 2, North Wall Profile.

Excavation Unit 2
North Profile

Context	Description [Interpretation]	Munsell
1	Silty loam [modern topsoil]	7.5YR 3/2
4	Silty clay	10YR 4/4
7	Silty loam	10YR 3/2
8	Mortar and sandy loam [mortar eroding out of the wall]	7.5YR 6/1
9	Clay loam	7.5YR 6/4
10	Sandy clay loam	7.5YR 3/2
11	Clayey silt loam [natural subsoil on the bedrock]	7.5YR 4/4
12	Schist [bedrock]	-----
101	Eastern foundation of Blockhouse	-----

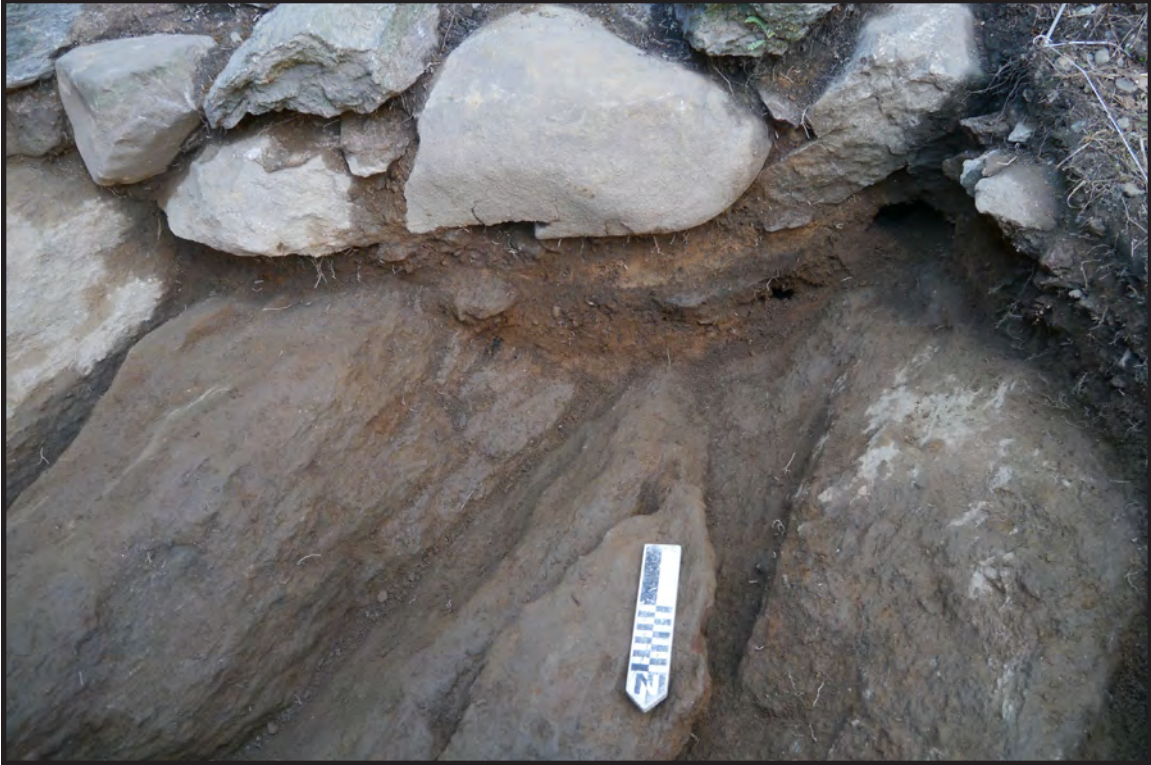
Photograph 4.9. View facing south showing the western portion of the southern profile of Excavation Unit 2. Note the stratigraphy present below the foundation shelf; scale in tenths of feet (Photographer: James Lee, December 2017 [HRI Neg.#17070/D1:063]).

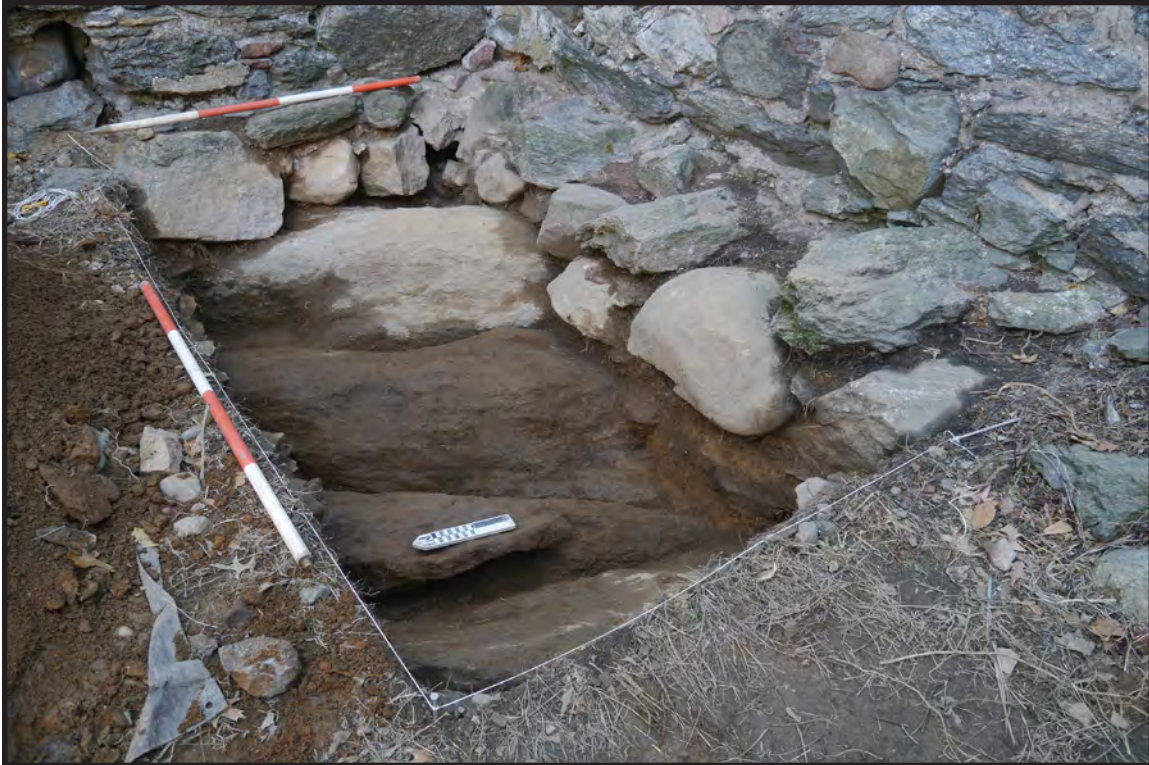
Photograph 4.10. View facing southeast showing Excavation Unit 2 fully excavated; scales in feet and tenths of feet (Photographer: James Lee, December 2017 [HRI Neg.#17070/D1:059]).
