Historical Research, Laser Scanning
and Archaeological Investigations
Blockhouse No. 1
Central Park, New York

Prepared for:

Central Park Conservancy

October 2019

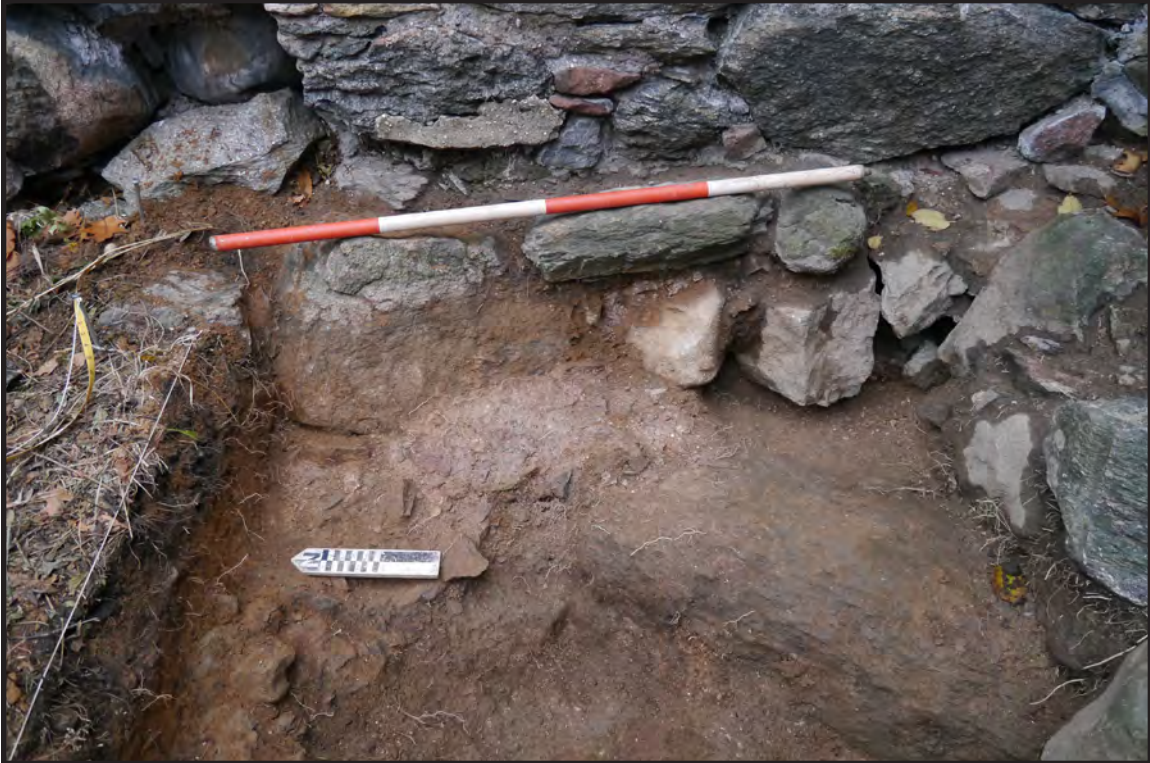
Photograph 4.11. View facing east showing the lens of decayed mortar in Excavation Unit 2; scales in feet and tenths of feet (Photographer: James Lee, December 2017 [HRI Neg.#17070/D1:055]).

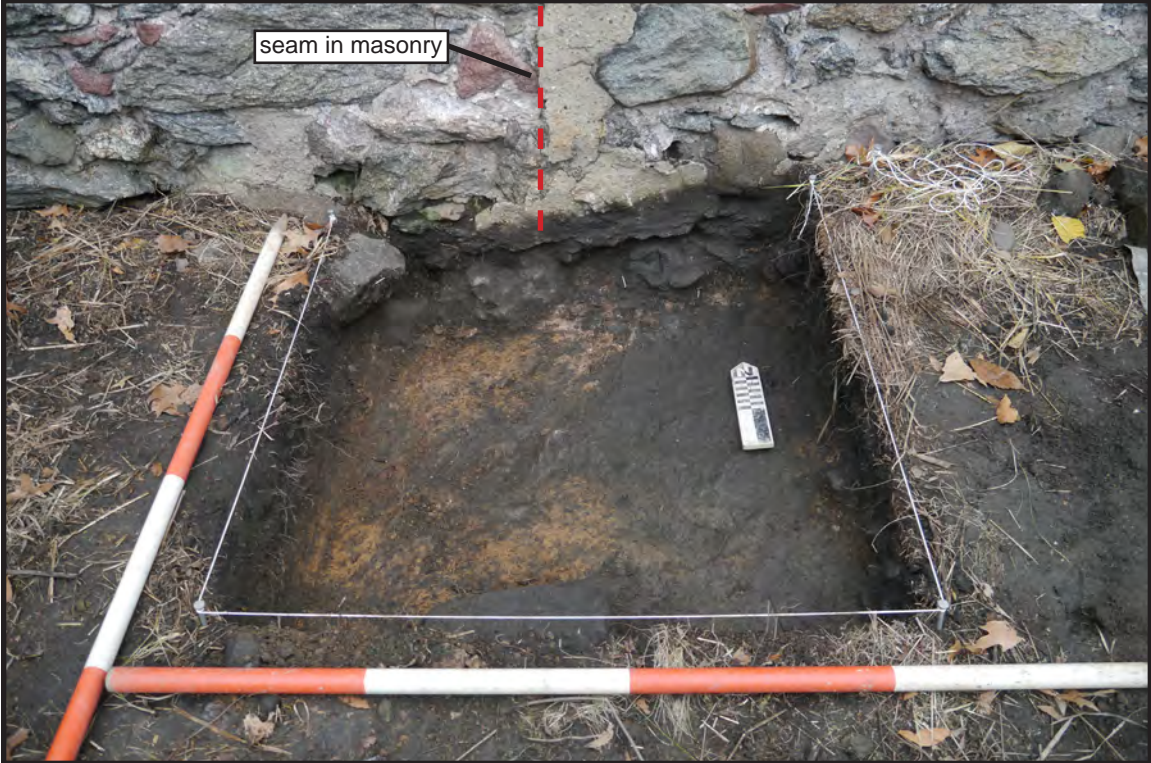
Photograph 4.12. View facing north showing Excavation Unit 3 and a clay layer directly on top of bed-rock. Also note the relationship between the mortared seam in the north wall of the blockhouse and the square stone projecting from the southern profile; scales in feet and tenths of feet (Photographer: James Lee, December 2017 [HRI Neg.#17070/D1:170]).

This three-foot-square excavation unit was placed in the center of the northern interior wall where a vertical seam filled with mortar is visible in the masonry (Figure 4.1). It was considered possible that this seam might represent an internal partition of the building and that evidence to support this might be present below the ground surface. The silty loam topsoil [1] overlay a silty clay loam in the western half of the unit and bedrock [3] in the unit's eastern half (Figure 4.6; Photograph 4.12). The bedrock was exposed at 0.5 feet below the ground surface in the eastern profile and sloped down to a depth of 1.05 feet in

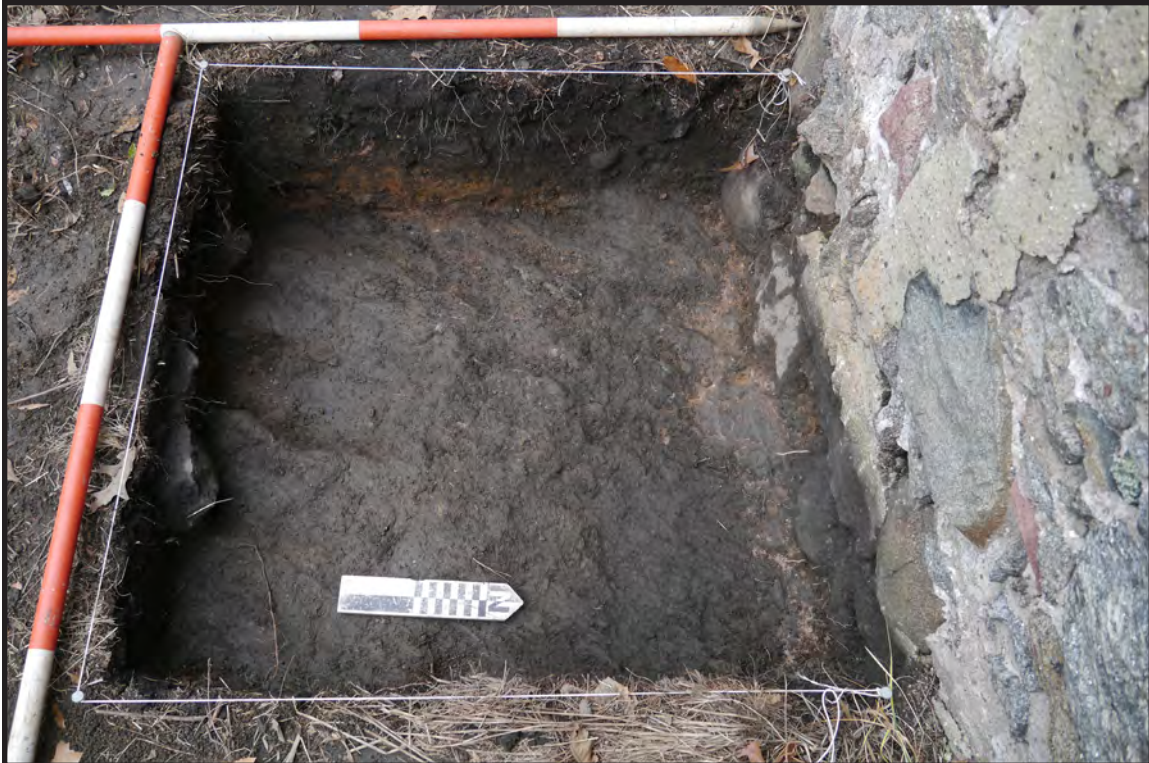
Photograph 4.13. View facing west showing Excavation Unit 3 fully excavated; scales in feet and tenths of feet (Photographer: James Lee, December 2017 [HRI Neg.#17070/D1:175]).

the western profile (Photograph 4.13). The silty clay loam [2] context abutted the northern wall [102] of the blockhouse and directly overlaid a lens of mortar that extended out slightly from under the wall on top of the bedrock (Photograph 4.14), suggesting it was deposited soon after this bedding mortar and the wall were put in place. Also worthy of note are two stones extending out of the southern profile. These appeared to have been roughly trimmed square and sit on the top of Context 2, within Context 1. They are situated roughly centered opposite the mortared seam and may have served as supports for a floor joist within the building.

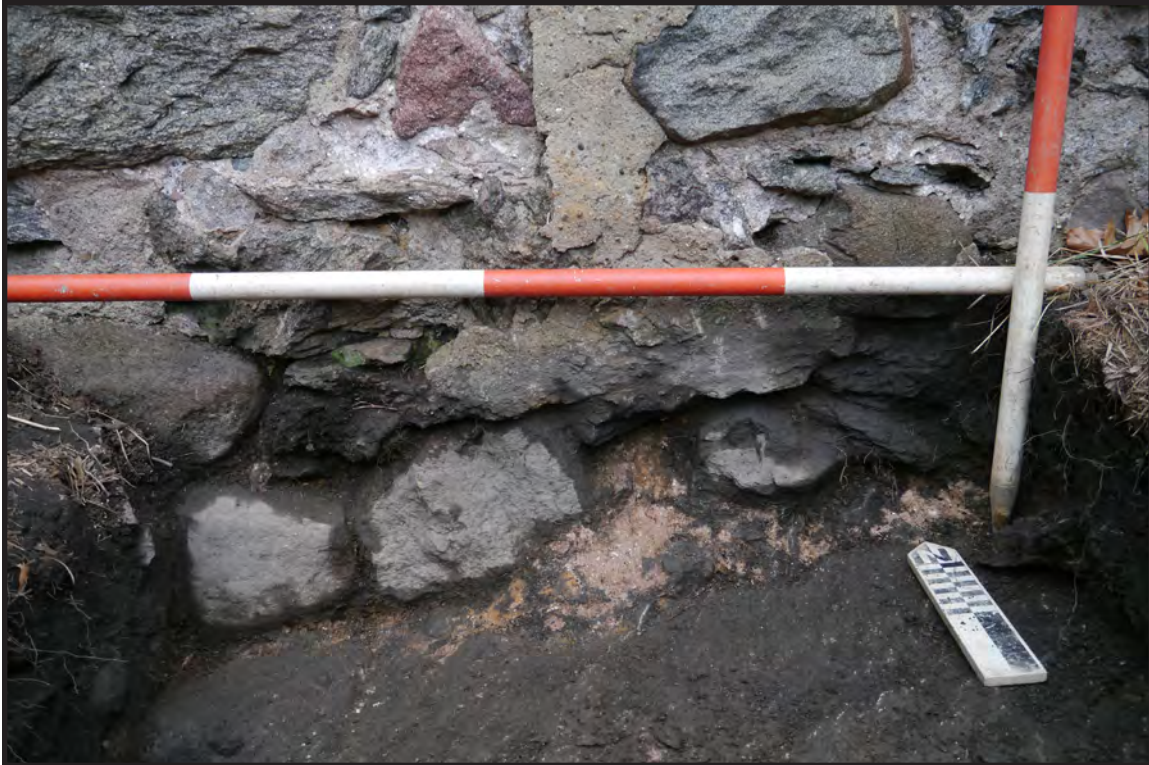
Photograph 4.14. View facing north showing Excavation Unit 3 and the bedding mortar observed between the bedrock and the bottom of the blockhouse foundation; scales in feet and tenths of feet (Photographer: James Lee, December 2017 [HRI Neg.#17070/D1:183]).

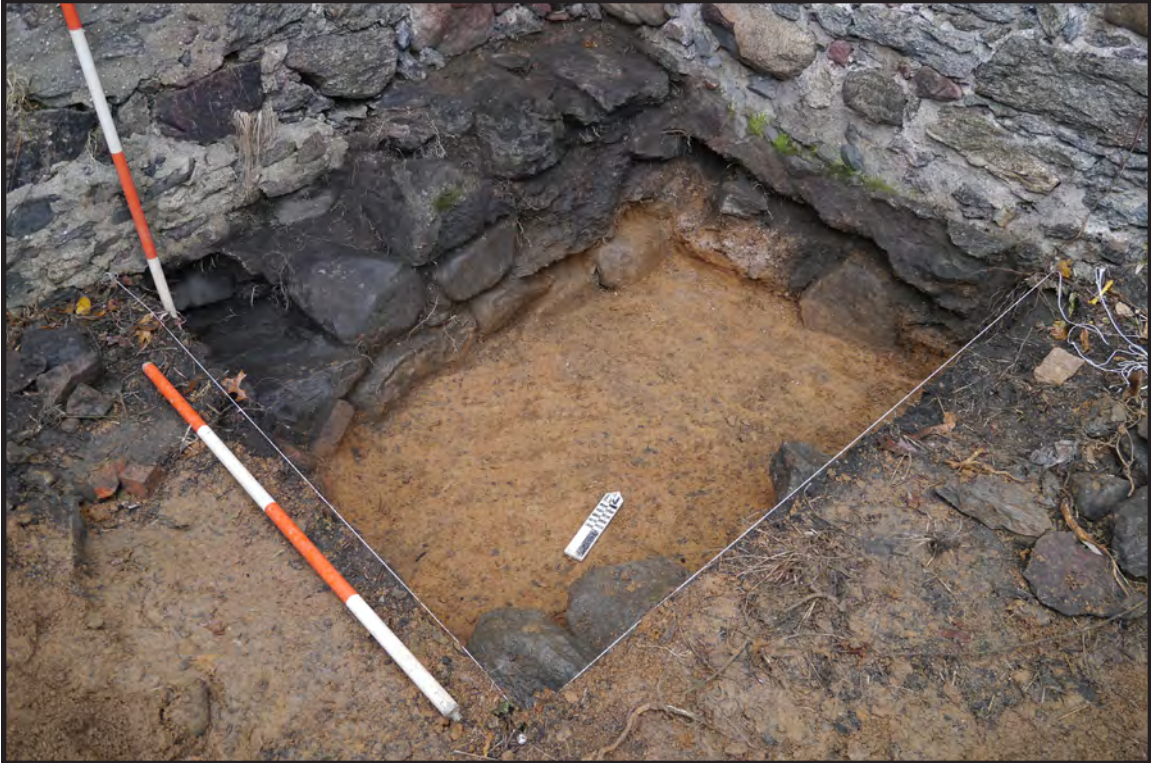
Photograph 4.15. View facing northwest showing Excavation Unit 4 with the topsoil context [1] removed, revealing the clay layer [2] below. Note the three stones in a row in the foreground within the eastern wall of the unit; scales in feet and tenths of feet (Photographer: James Lee, December 2017 [HRI Neg.#17070/D1:190]).

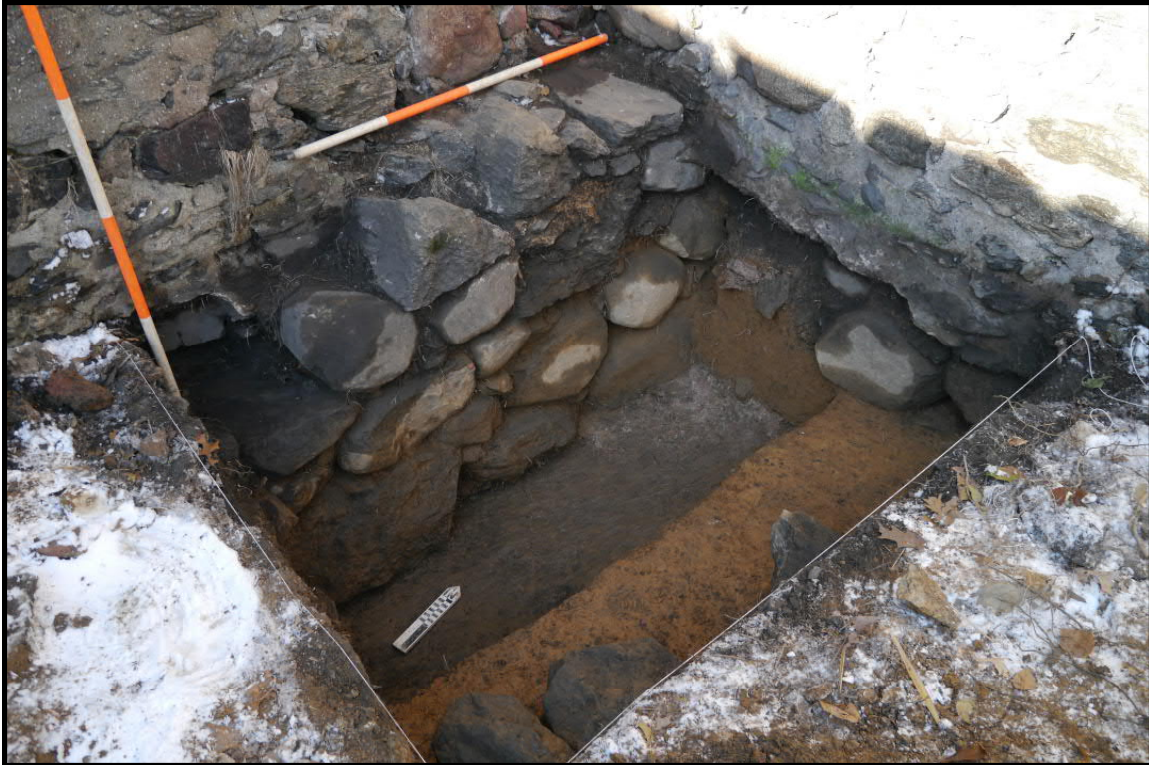
Photograph 4.16. View facing northwest showing Excavation Unit 4 fully excavated (Photographer: James Lee, December 2017 [HRI Neg.#17070/D1:205]).

The compacted Context 2 was bisected north-south and the western half of this context was excavated to bedrock [5] (Figure 4.8; Photograph 4.16). A rodent disturbance [3] was observed cutting into Context 2 at the southern end of this unit and in the southern profile. At the northern end of the unit Context 2 overlay a thick lens of decayed mortar that lay immediately on top of bedrock and extended under both the northern wall of the blockhouse [102] and the stone ledge of the western wall [103]. This lens is interpreted as a bedding mortar (Photograph 4.17). Context 2 also extended under the northern wall [102] just below the interior ground surface. This soil was not excavated in order not to undermine the wall's masonry, but probing suggested it extended for several inches under the northern wall.

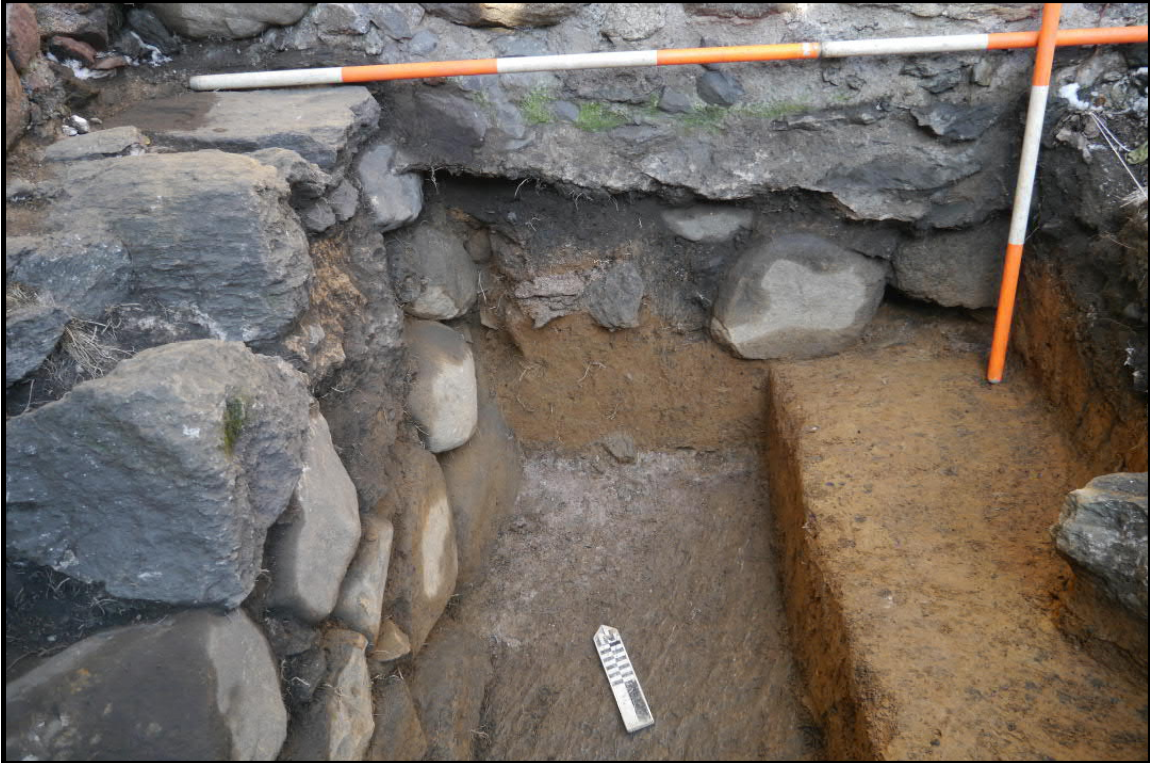
Photograph 4.17. View facing north showing the north profile of Excavation Unit 4. Note the mortar between the bedrock and clay fill; scales in feet and tenths of feet (Photographer: James Lee, December 2017 [HRI Neg.#17070/D1:210]).

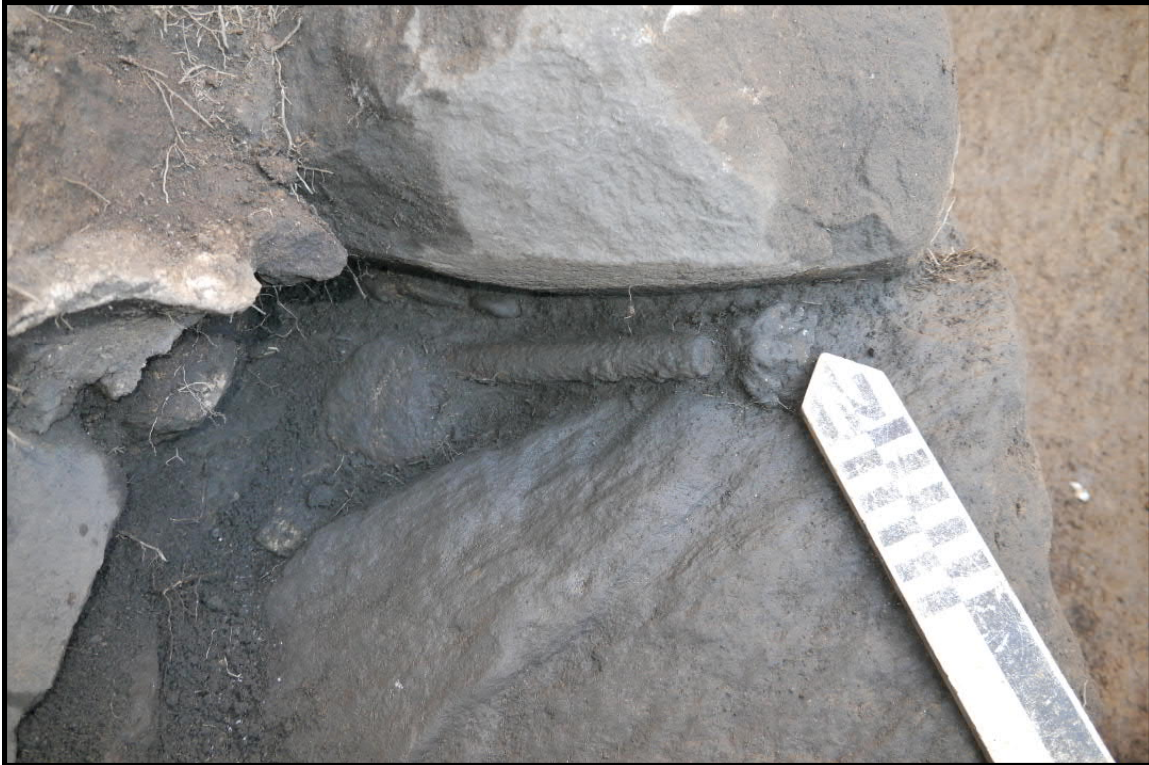
Photograph 4.18. View facing north showing an anchor bolt within the western blockhouse wall exposed in Excavation Unit 4; scales in tenths of feet (Photographer: James Lee, December 2017 [HRI Neg.#17070/D1:227]).

The stone ledge or shelf extended out generally 1.8 feet from the base of the western wall. The top of the ledge was lower in the southwestern corner of the unit where several courses of stone are missing. Within the shelf a bent iron rod was documented (Figure 4.7; Photograph 4.18). This rod was round in profile and extended up between mortared stones before bending over on top of the surrounding stones. It is interpreted as an anchor bolt, likely driven into the bedrock below and mortared into the basal courses of the blockhouse foundation.

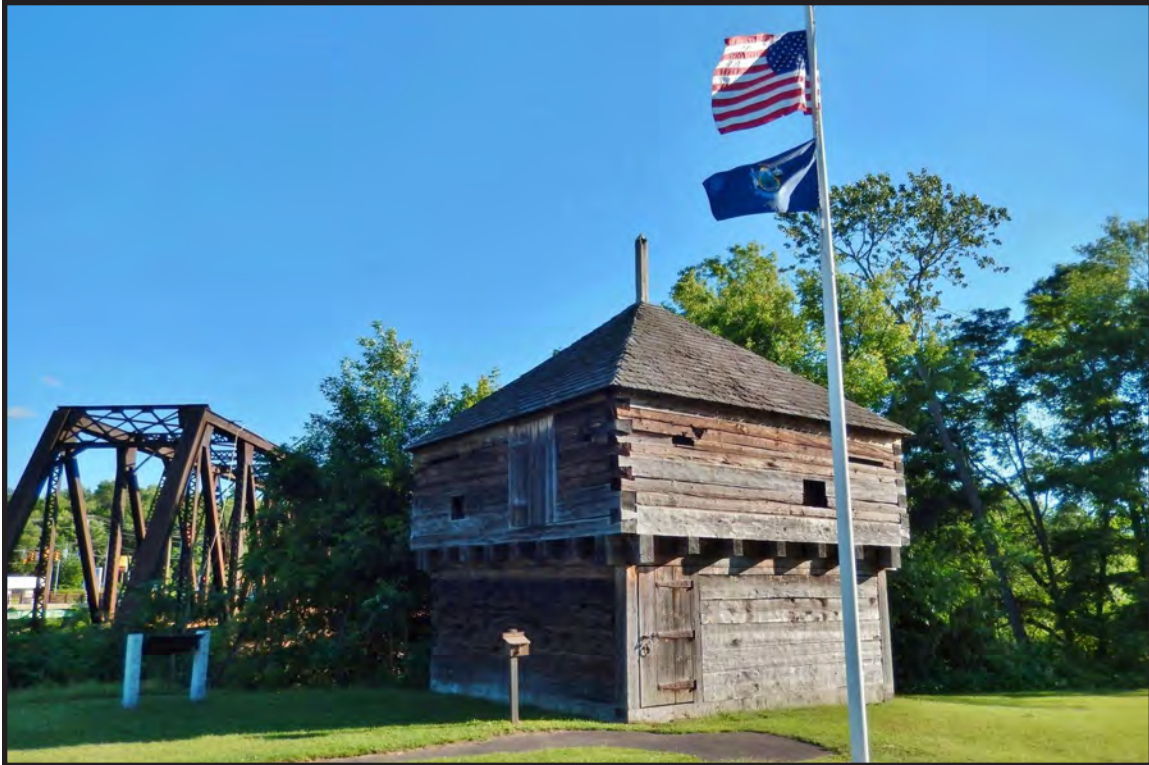
Photograph 5.3. The restored French and Indian War-era British-built blockhouse at Fort Halifax in Waterville, Maine, 2017. Source: <https://www.hmdb.org/marker.asp?marker=116133>

ings have their roots in British colonial blockhouses of the mid- to late 18th century, a fine restored example of which may be seen at Fort Halifax in Waterville, Maine (Photograph 5.3). Blockhouse No. 1 is best viewed as a much simpler and hastily constructed relative of the Fort Mackinac/Fort Halifax model.
