June 7, 2019

Re: Archaeological Investigation and Assessment  
Lasker Rink Reconstruction Project, Central Park, New York  
Report of Findings

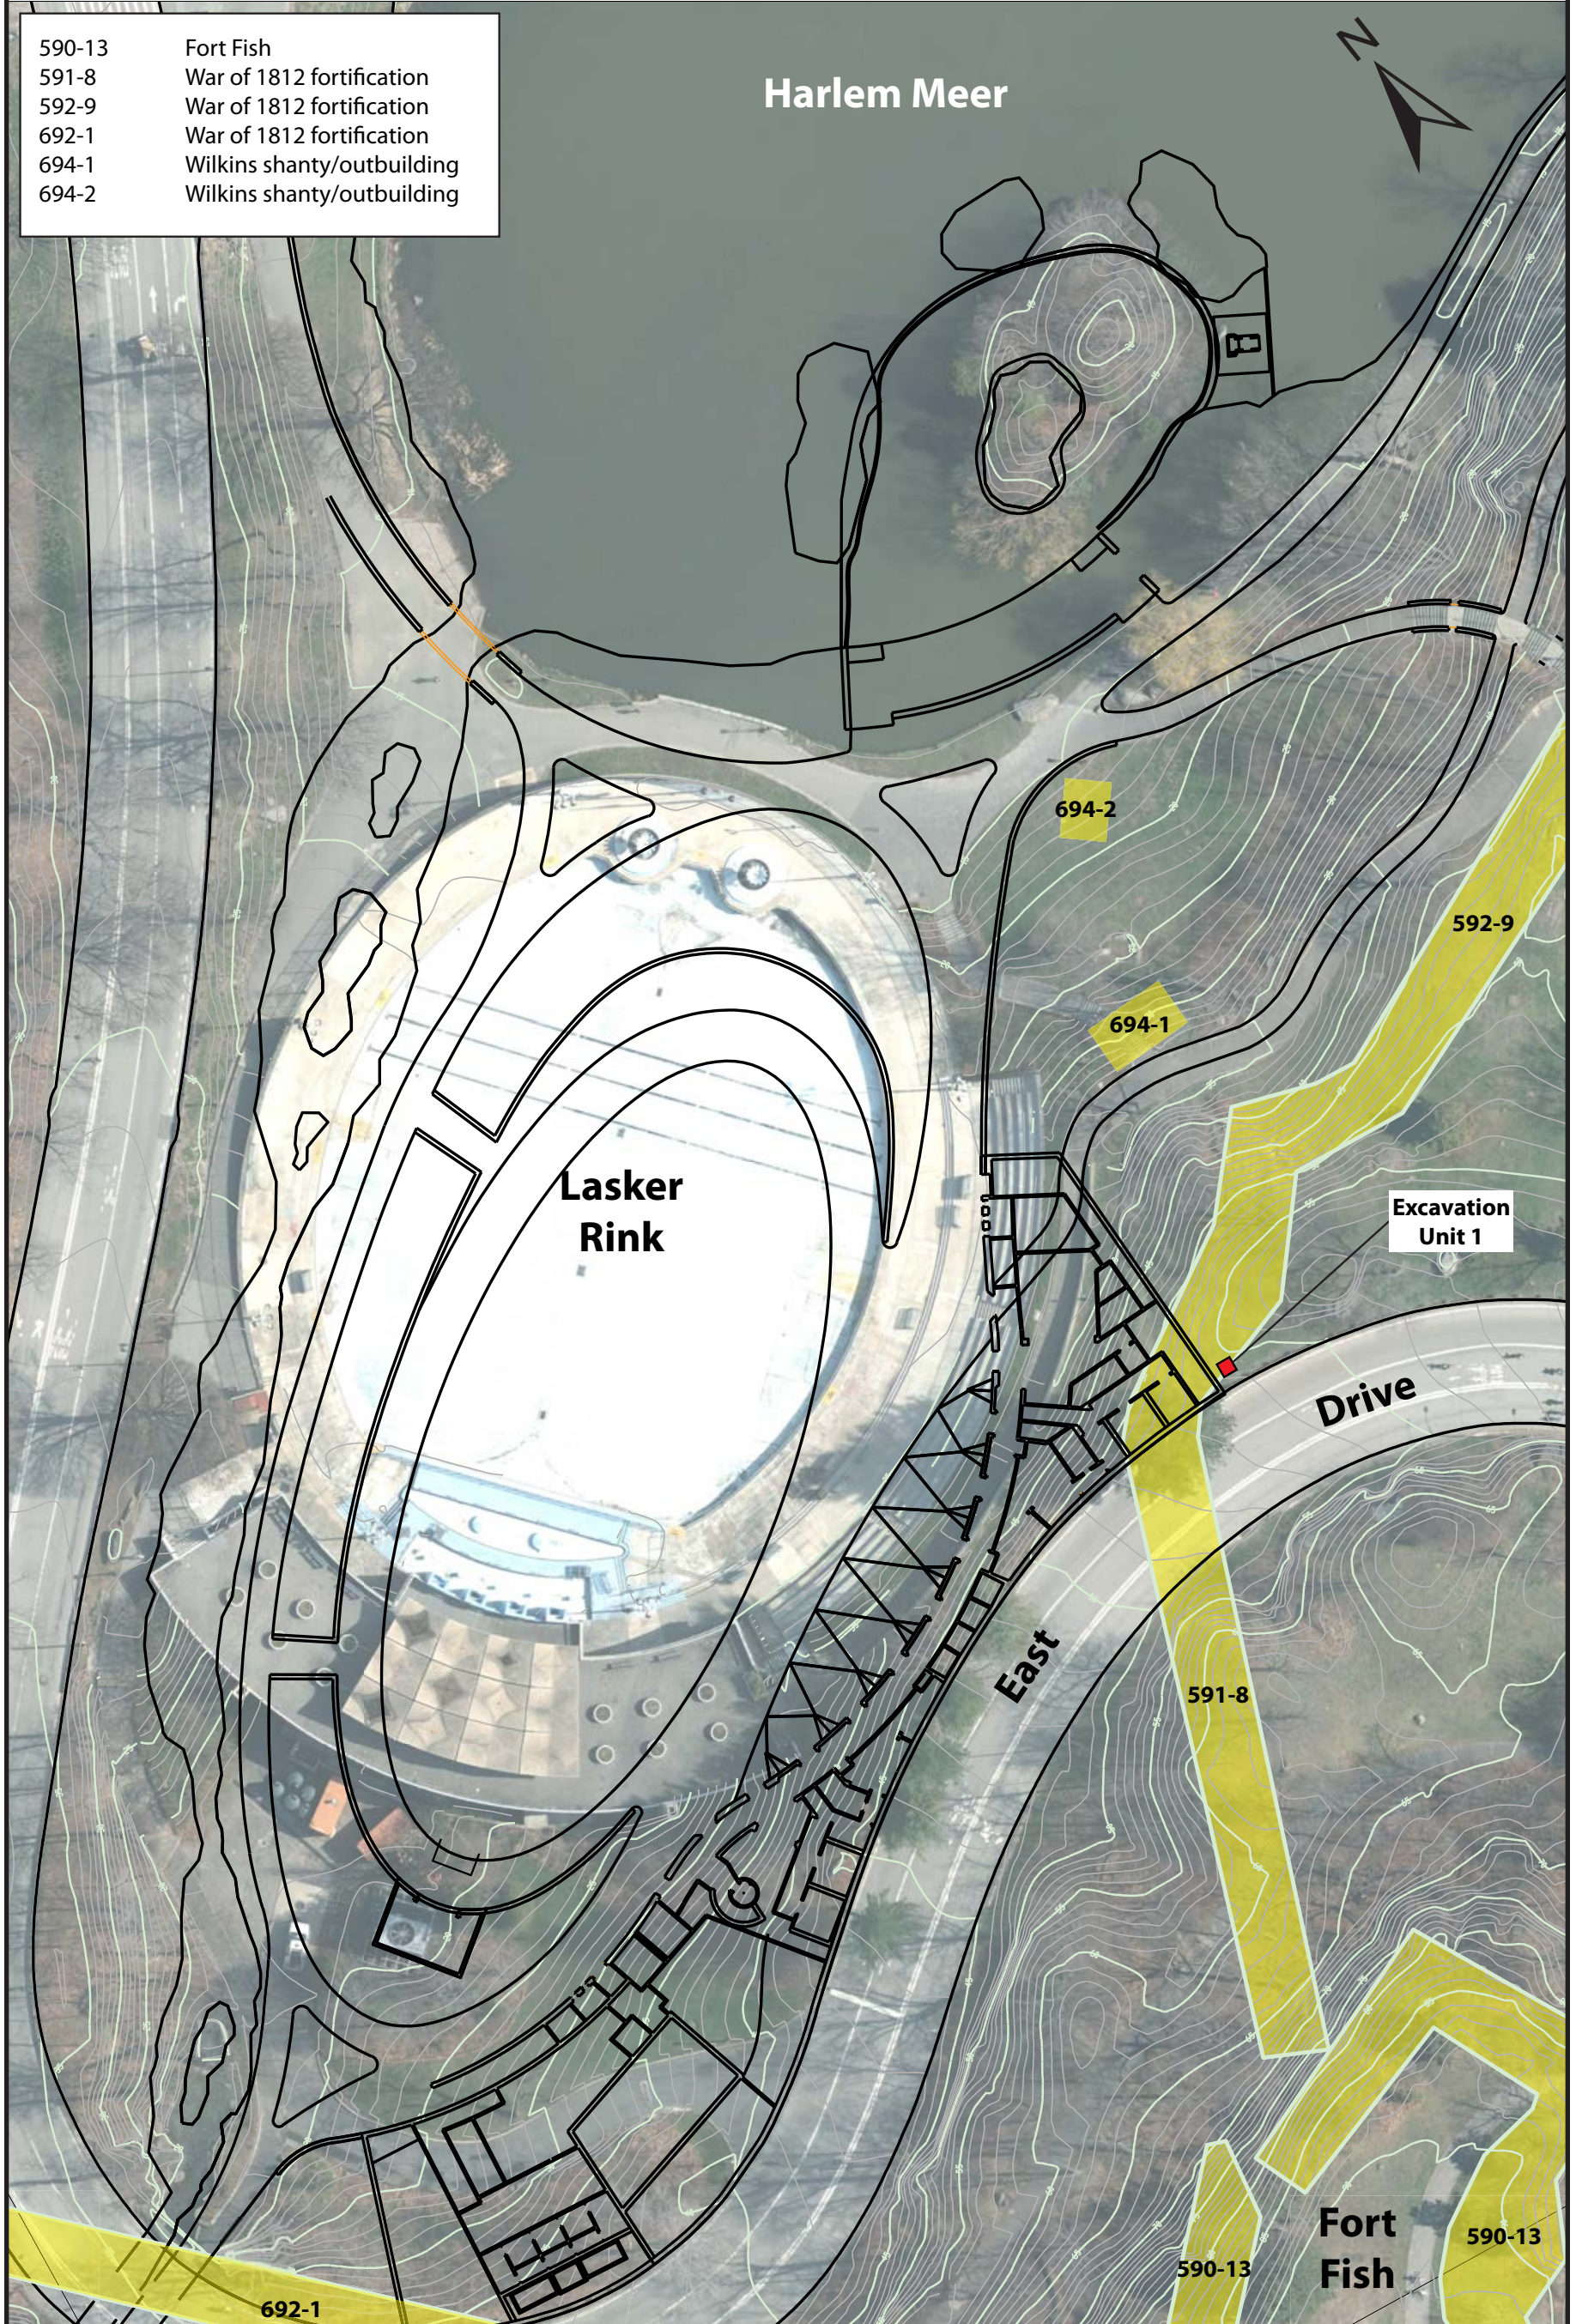
Figure 3. Lasker Rink Reconstruction Project: location of Excavation Unit 1 in relation to proposed new construction and project line of War of 1812 fortifications.  
 Source: Central Park Conservancy and Hunter Research, Inc. 2014.

Archaeological fieldwork was conducted on March 21 and March 22, 2019 and involved the manual excavation of a single five-foot-square excavation unit (Excavation Unit 1) (Figure 6; Photographs 1-6). Excavation commenced with the removal of a sandy loam upper deposit between 0.5 to 1 foot thick [Context 1]. This soil layer was considered to be a modern topsoil and overlay two distinct soil types: a mottled sand and pebble deposit [2] which was present across most of the unit; and a roughly circular, darker soil stain [3, 4] in the unit's southeastern corner [3] and [4] (Photograph 3). Upon further excavation, Context 3 was recognized as a probable cut for the planting (or removal) of a tree, while Context 4 represented the gray white sand fill of this cut. The portion of this tree planting hole that extended into Excavation Unit 1 measured roughly two feet across and was between 0.2 to 0.75 feet thick (Photograph 4).

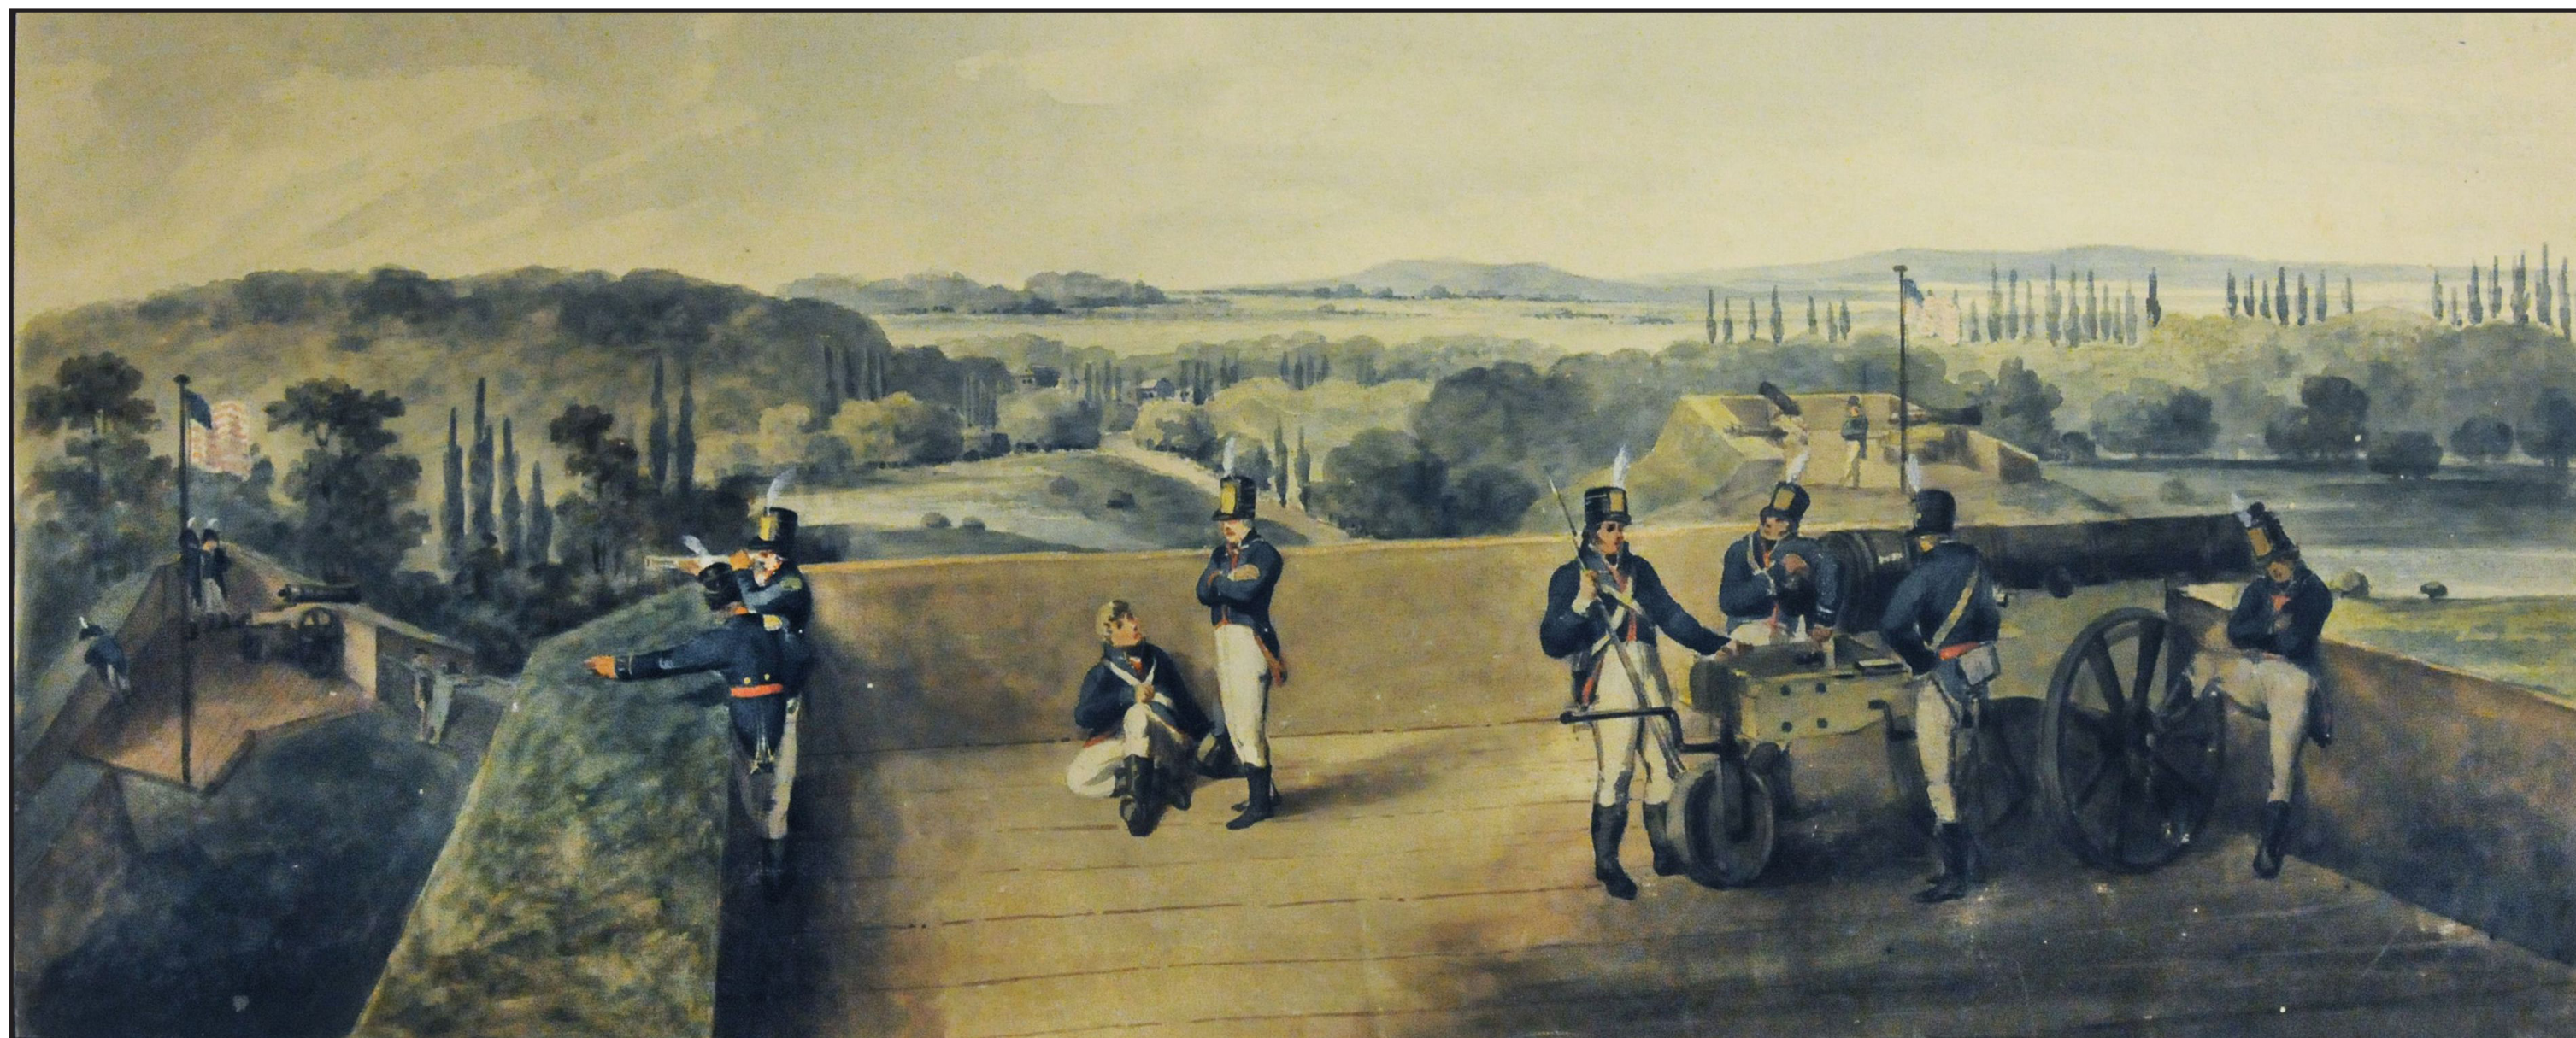
Figure 5. Holland, John Joseph. "View from Fort Fish at McGowan's Pass looking towards Harlem." 1814. Source: New-York Historical Society, Luce Center, Object No. 1889.13.

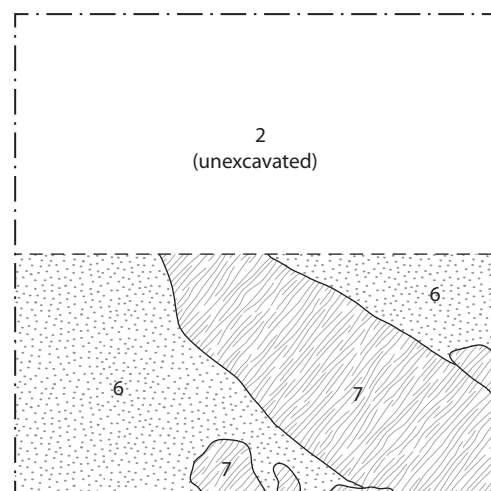
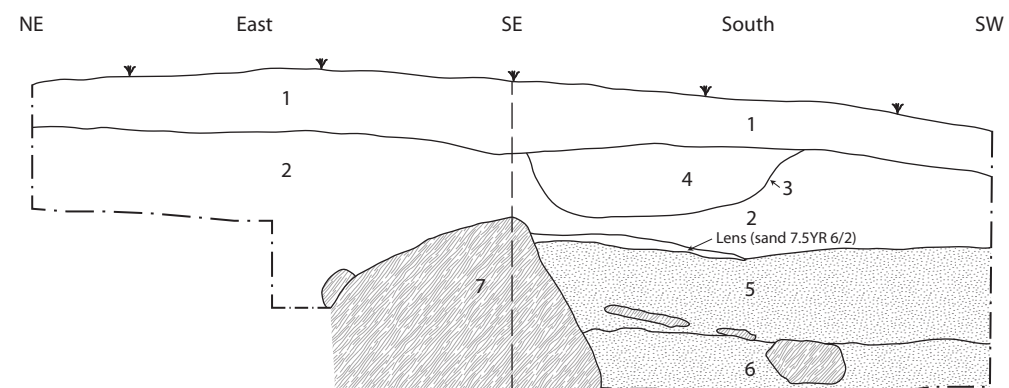
Figure 6. Plan View and East and South Profiles of Excavation Unit 1.

Context	Description [Interpretation] (Munsell)
1	Sandy loam [modern topsoil] (10YR 3/4)
2	Mottled sandy loam w/ pebbles [late 19th/20th century fill] (10YR 5/6, 10YR 3/4)
3	Cut, filled by context 4 [20th-century tree planting]
4	Sandy loam [20th-century tree planting] (2.5Y 6/1)
5	Mottled coarse sand glacial till w/ decayed bedrock and gravel [subsoil] (10YR 5/6, 7.5YR 6/2)
6	Mottled clayey sand [subsoil] (10YR 5/6, 10YR 5/3)
7	Schist [bedrock]

Context 2, the layer of lightly mottled coarse sandy loam and pebbles, extended to a depth of 1.5 feet below the ground surface. This layer was composed of a mixture of redeposited B horizon subsoil and glacial till, and likely resulted from grading related to the construction of the East Drive. Context 2 was fully excavated and found to overlie a coarse sand and gravel deposit mottled with white sand and regolith [5]. This material appears to represent the uppermost layer of an undisturbed B horizon subsoil, which in this section of the park is composed of glacial till. It extended to a depth of two feet below the ground surface and was fully removed from the southern half of Excavation Unit 1. Beneath Context 5, a cleaner, less mottled deposit of glacial till [6] was exposed, surrounding a large slab of *in-situ* bedrock (Photographs 5 and 6). This bedrock slab dipped down toward the northeast conforming to the prevailing grain of the bedrock in this area.

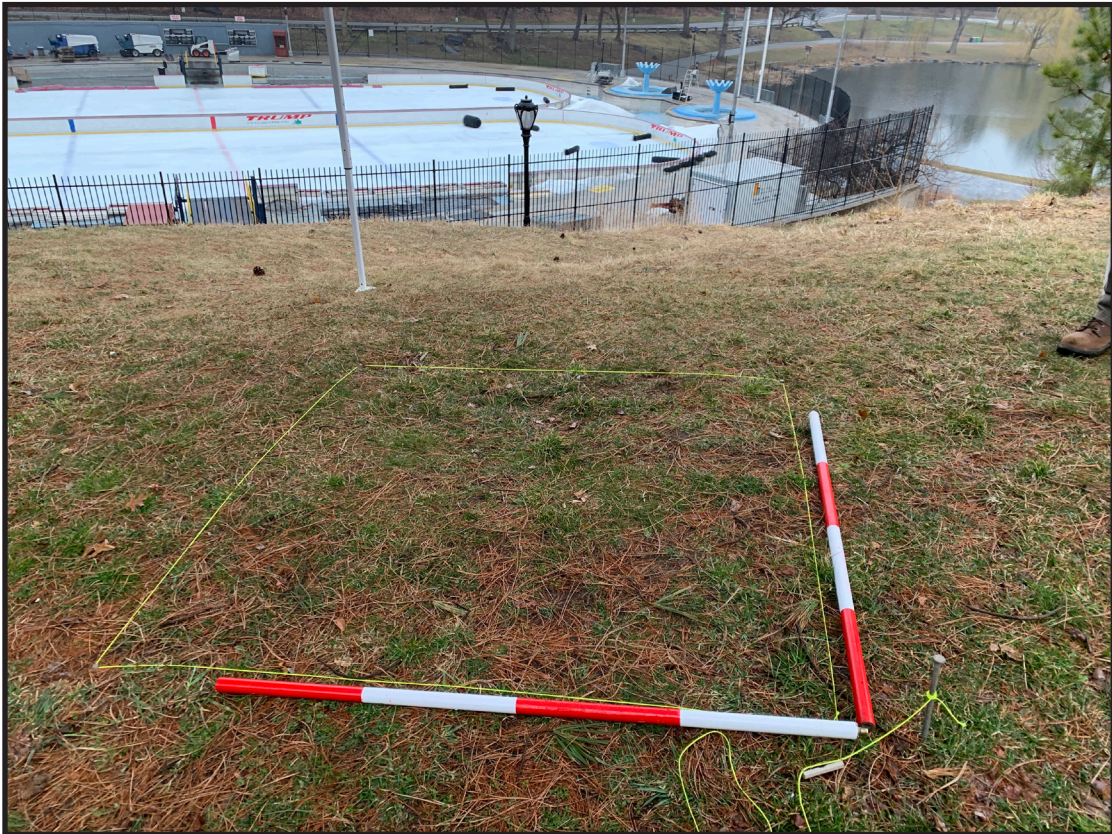
Photograph 1. View looking north showing the location of Excavation Unit 1 prior to excavation. The Lasker Ice Skating Rink is at the top of the view and the Harlem Meer is in the upper right corner. Scales in feet (Photographer: James Lee, March 2019 [HRI Neg.#19012/D2:011]).

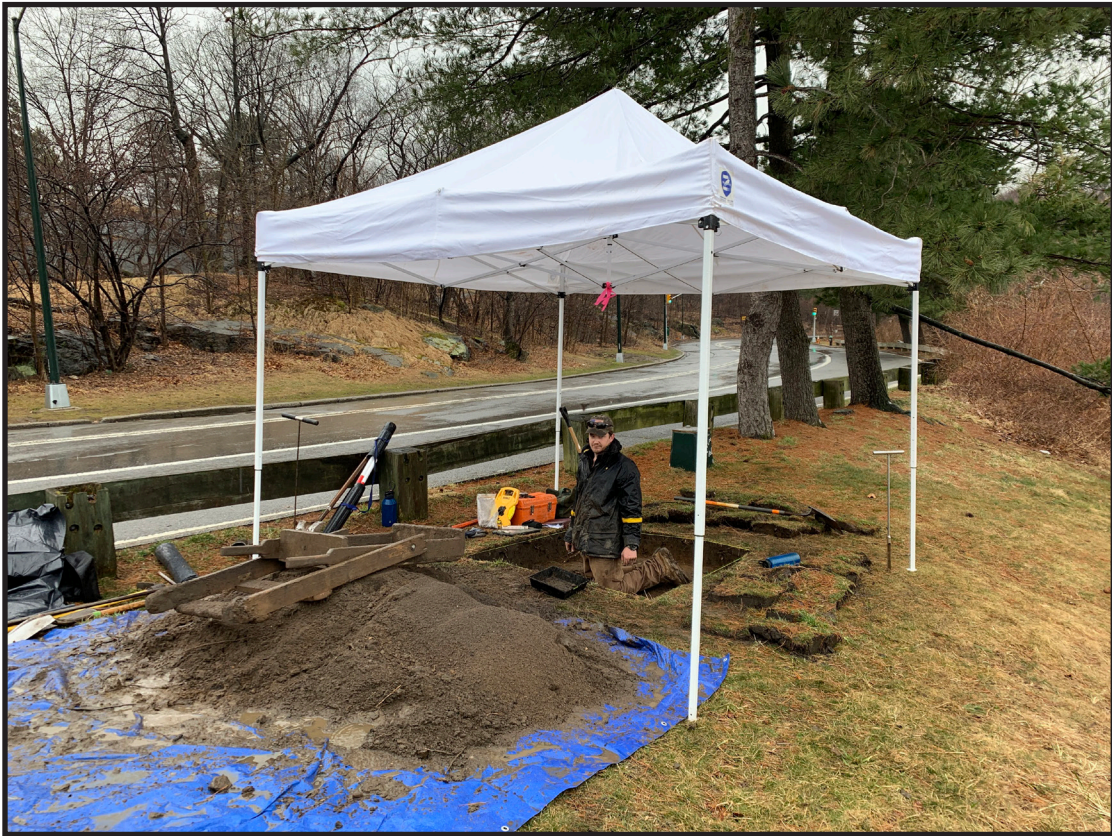
Photograph 2. View looking southwest showing Excavation Unit 1 at an early stage of excavation. The East Drive is beyond and Fort Fish is just out of view at the upper left (Photographer: James Lee, March 2019 [HRI Neg.#19012/D2:005]).

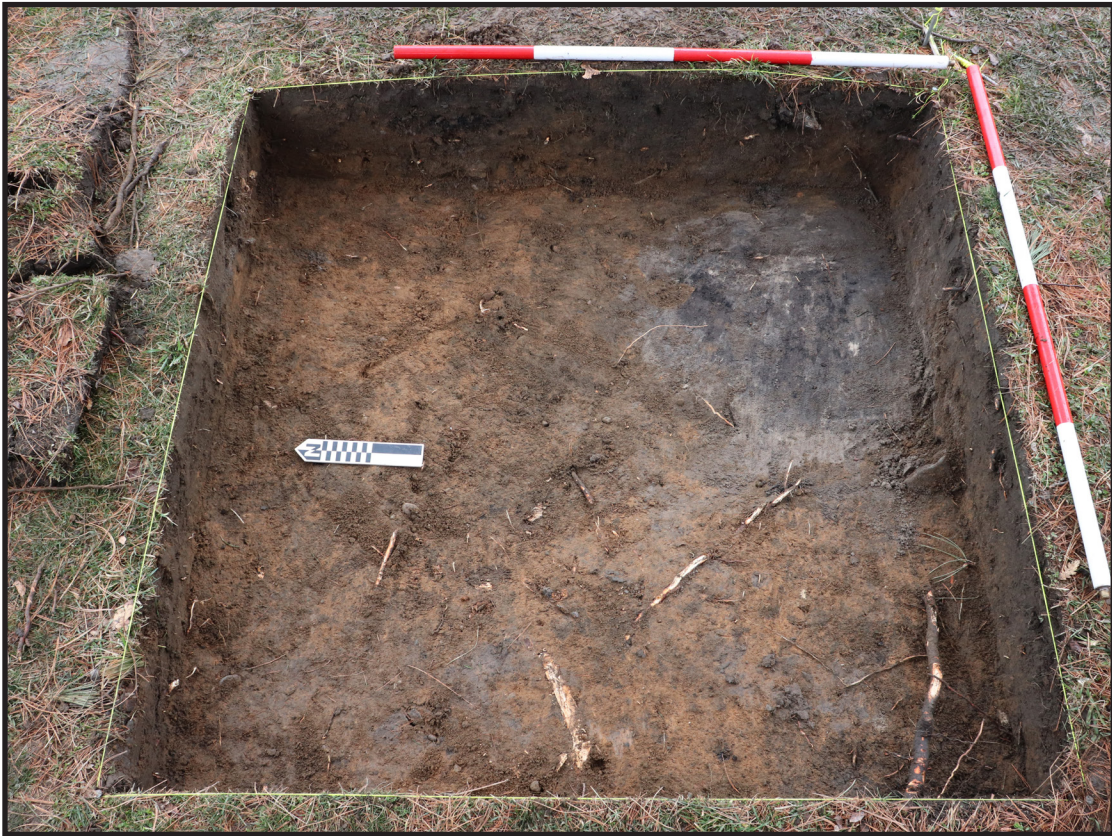
Photograph 3. View looking east showing Excavation Unit 1 at an early stage of excavation. The dark stain in the upper right corner [Contexts 3 and 4] is interpreted as the remains of a root ball from a former tree. The surrounding soil [Context 2] is a mix of modern topsoil and redeposited subsoil. Scales in feet and tenths of feet (Photographer: Michael Brown, March 2019 [HRI Neg.#19012/D1:003]).

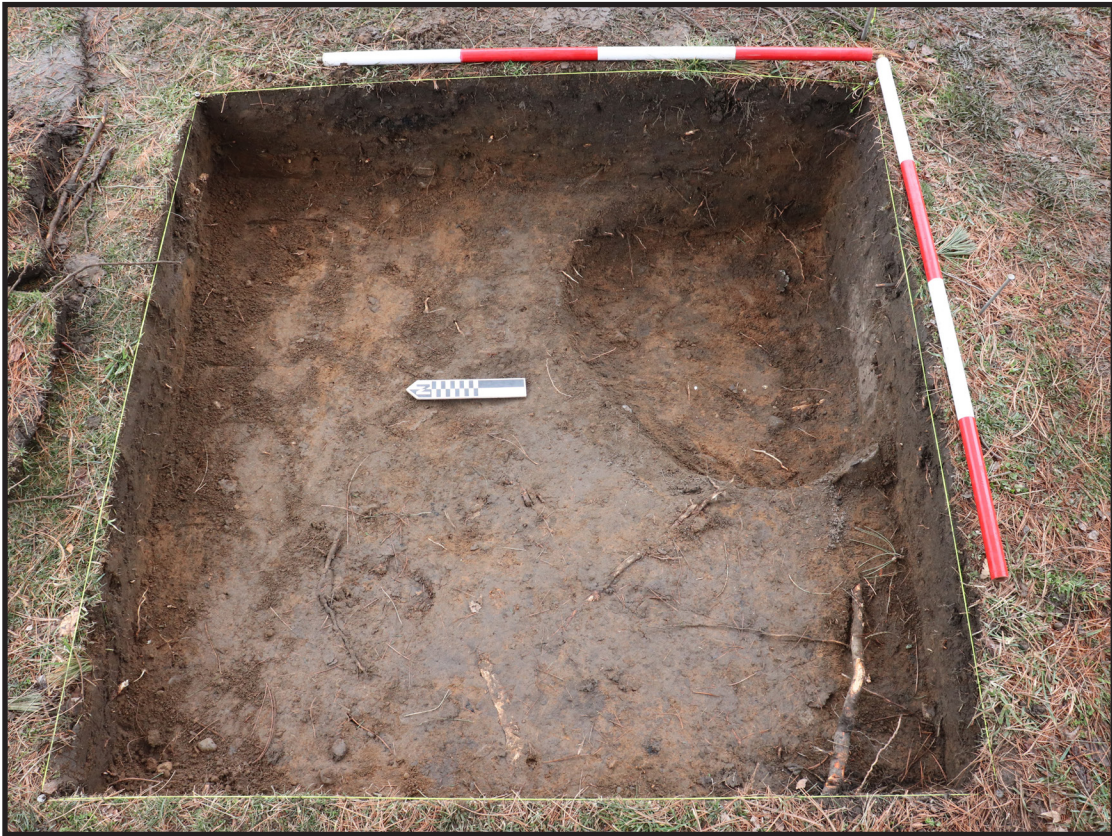
Photograph 4. View looking east showing Excavation Unit 1 following removal of the root ball from a former tree with its characteristic bowl-shaped outline. Scales in feet and tenths of feet. Scales in feet and tenths of feet (Photographer: Michael Brown, March 2019 [HRI Neg.#19012/D1:011]).

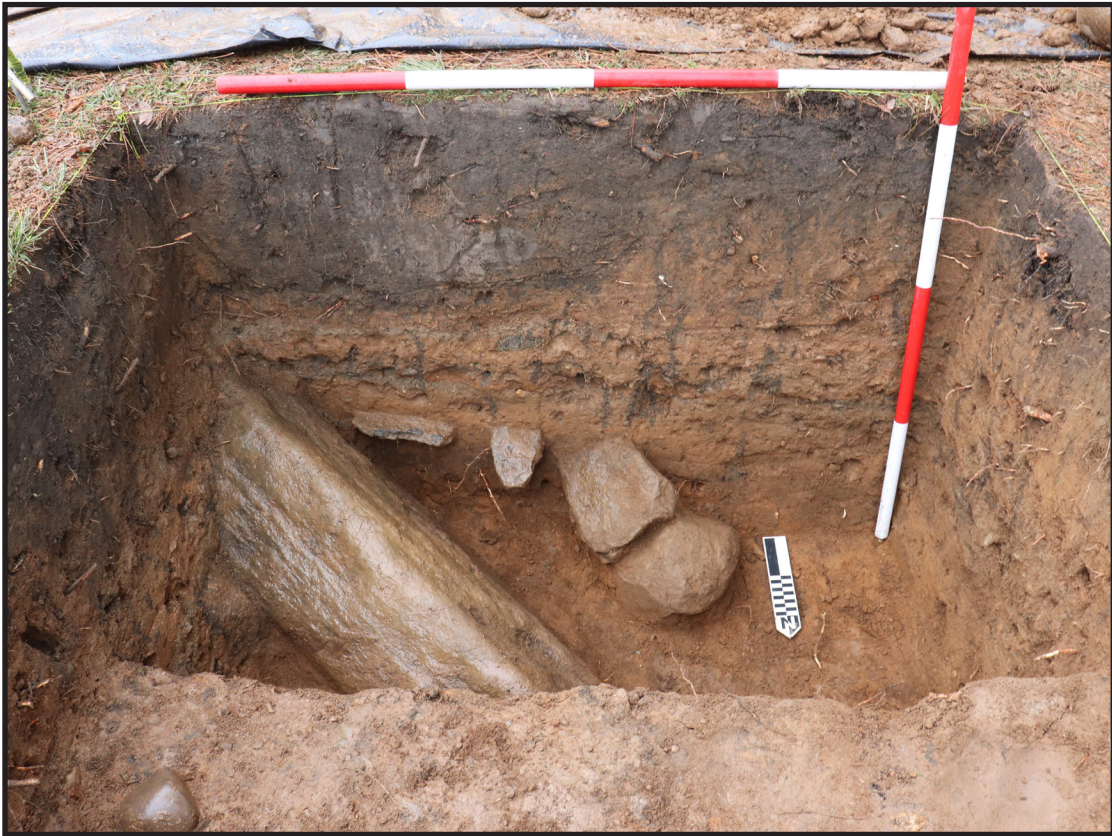
Photograph 5. View looking south showing the south profile of Excavation Unit 1. The outline and soils of the root ball [Contexts 3 and 4] are visible in the far left corner of the excavation unit; visible beneath the root ball and the underlying B horizon soils is a large outcropping of bedrock. Scales in feet and tenths of feet (Photographer: Michael Brown, March 2019 [HRI Neg.#19012/D1:015]).

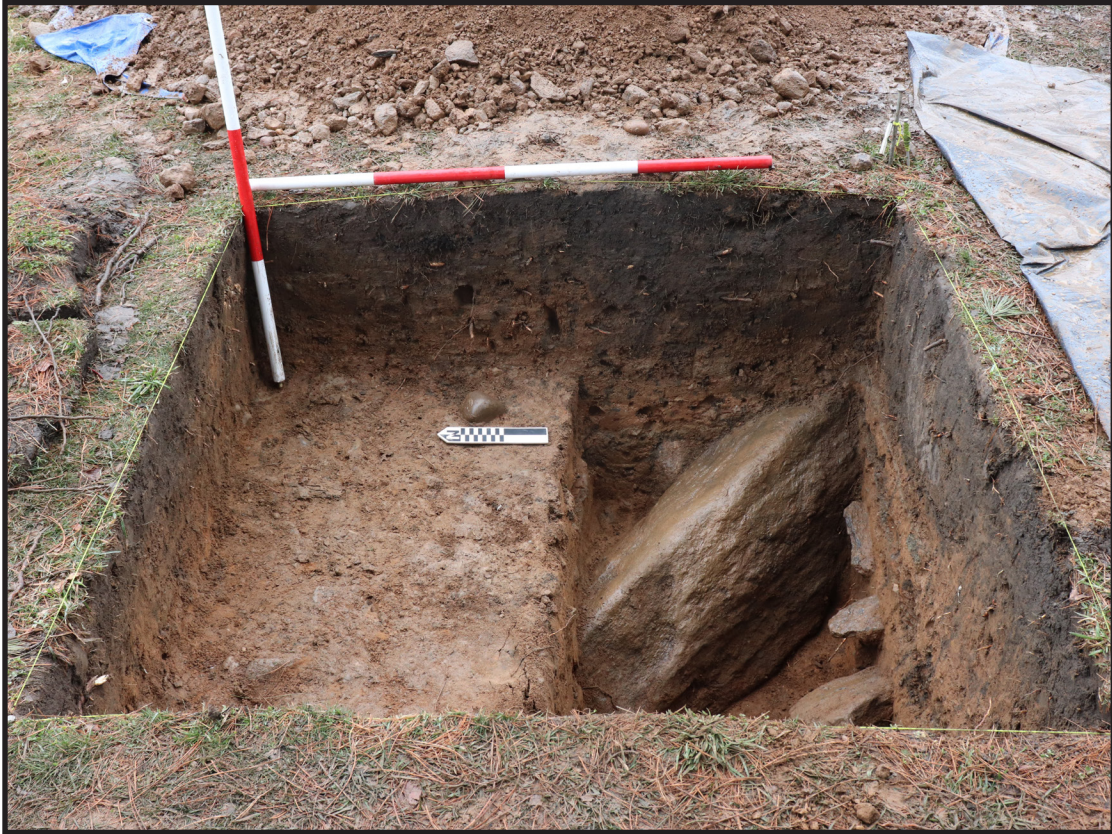
Photograph 6. View looking east showing the outcropping bedrock in the southeast corner of Excavation Unit 1. Scales in feet and tenths of feet (Photographer: Michael Brown, March 2019 [HRI Neg.#19012/D1:034]).
