**Archaeological Memorandum: Sidewalk Vault  
Documentation**

**Willoughby Square Open Space Project  
Duffield Street/Abolitionist Place sidewalk adjacent to  
Block 146, Lot 16 (formerly Lot 18, 213-221 Duffield Street)  
Brooklyn, Kings County, New York**

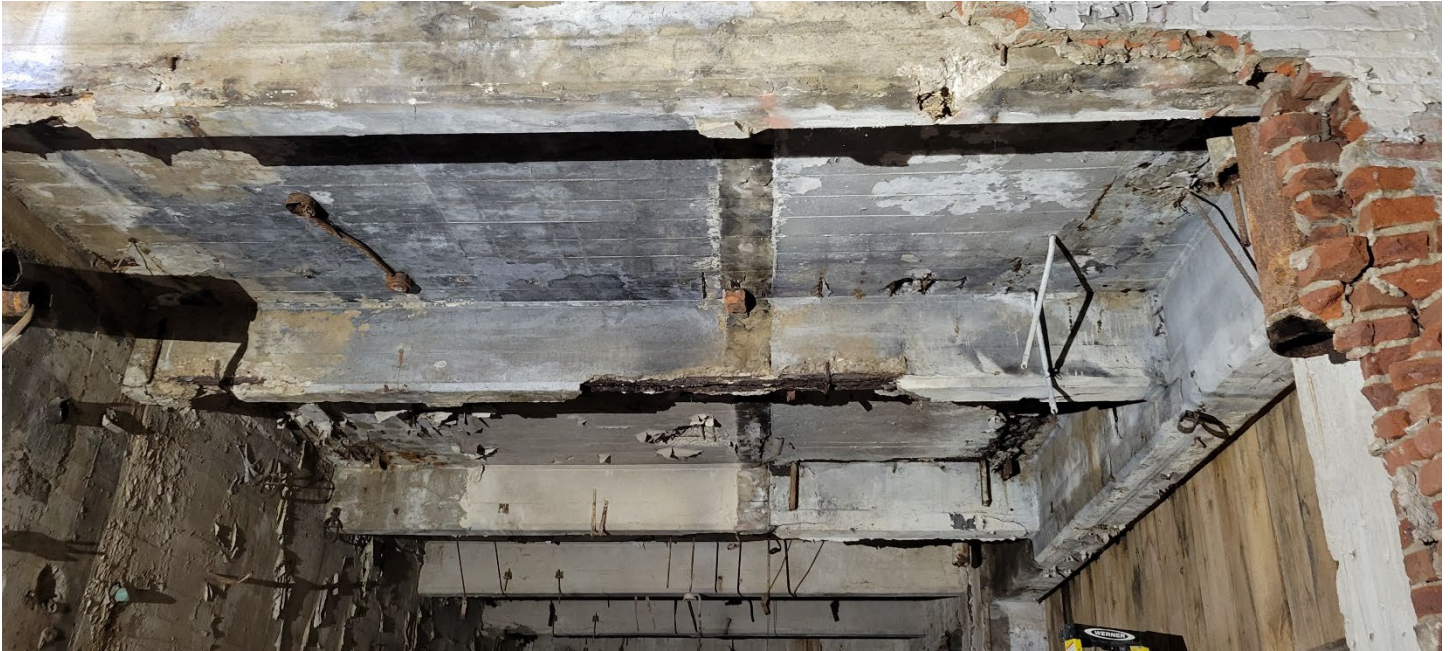
Photograph 1: Facing north to ceiling of Vault B from Vault C. Note: remnant of brick wall between Vault B and Vault C removed as part of this project (right).

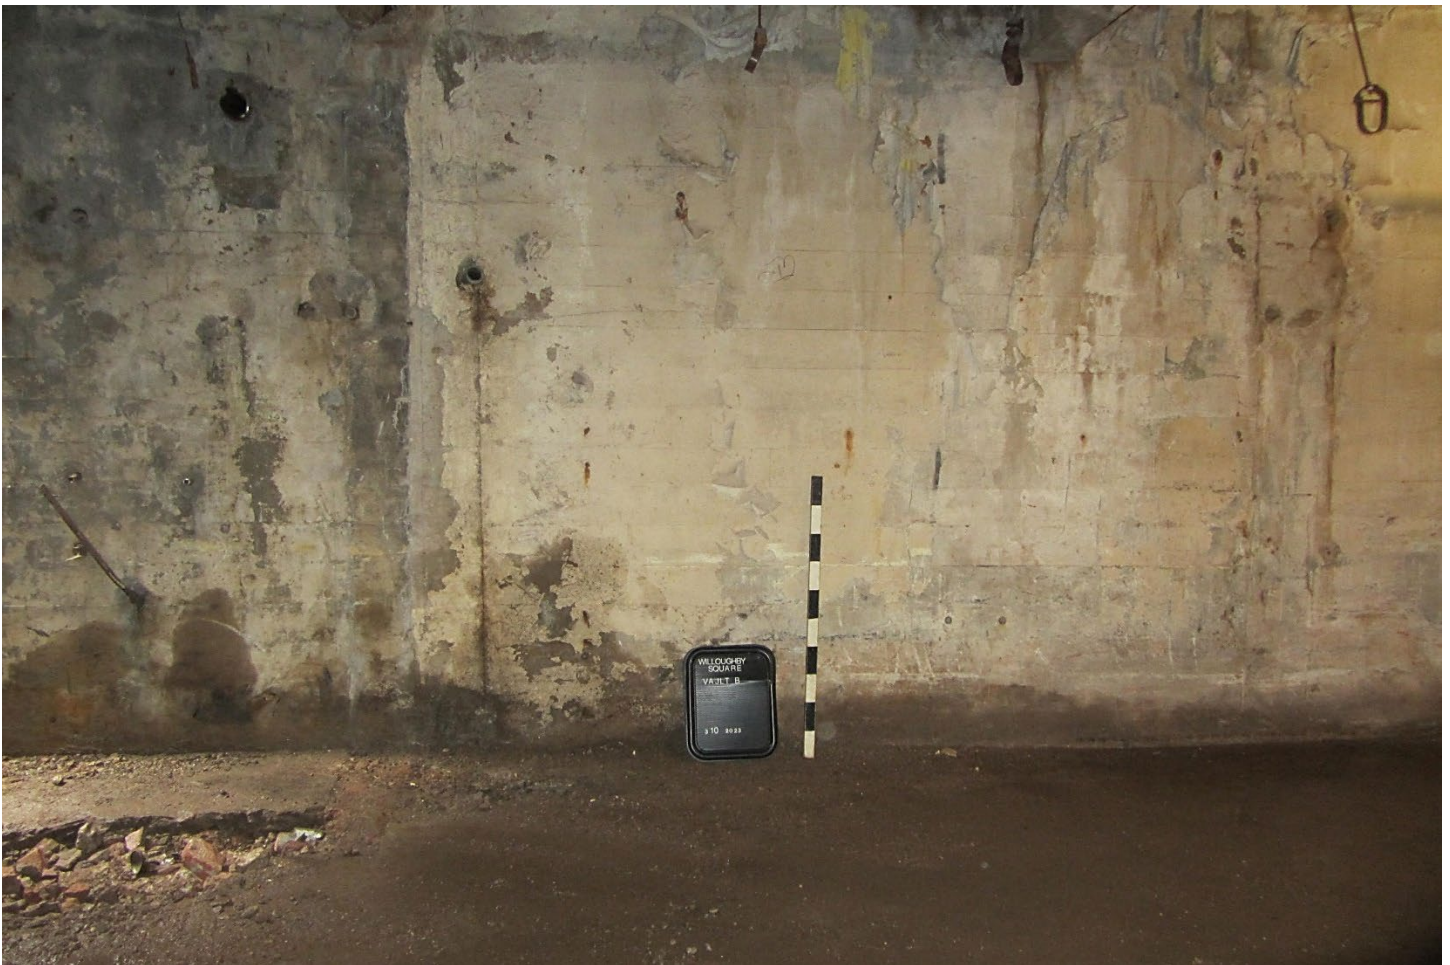
Photograph 2: Facing west to poured concrete west wall of Vault B. Note: break in poured concrete floor (bottom left) is filled with demolition debris from current project.

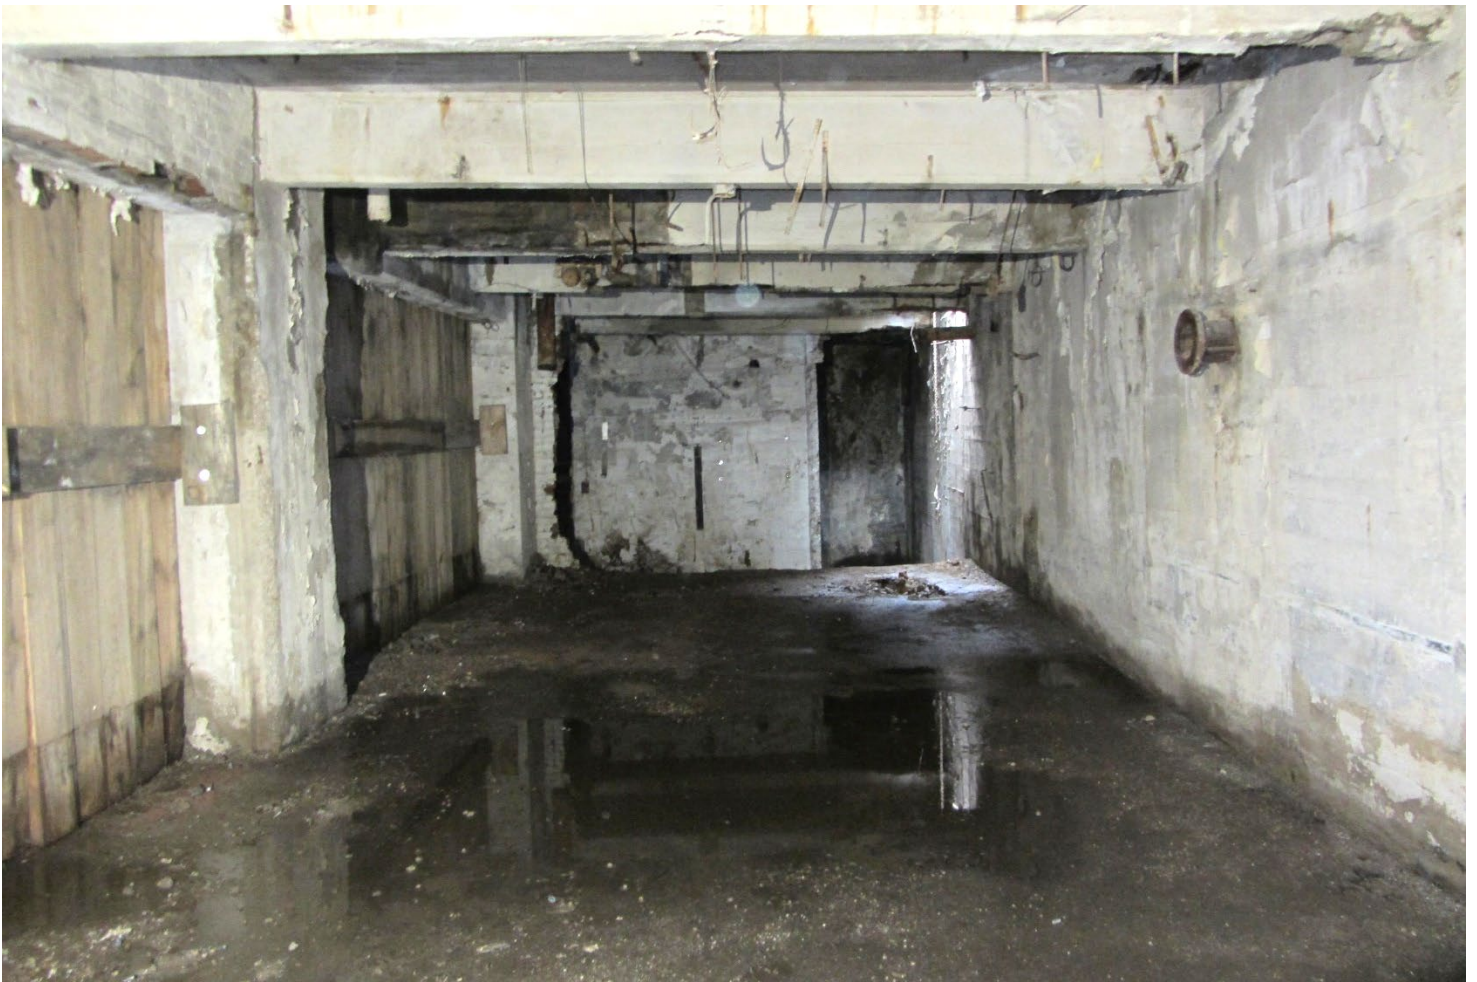
Photograph 3: Facing south from center of Vault B to south end of Vault B and north half of Vault C. Note: the eastern wall of Vault B (left) has two formerly bricked in openings that were removed and replaced with wood as part of this project.

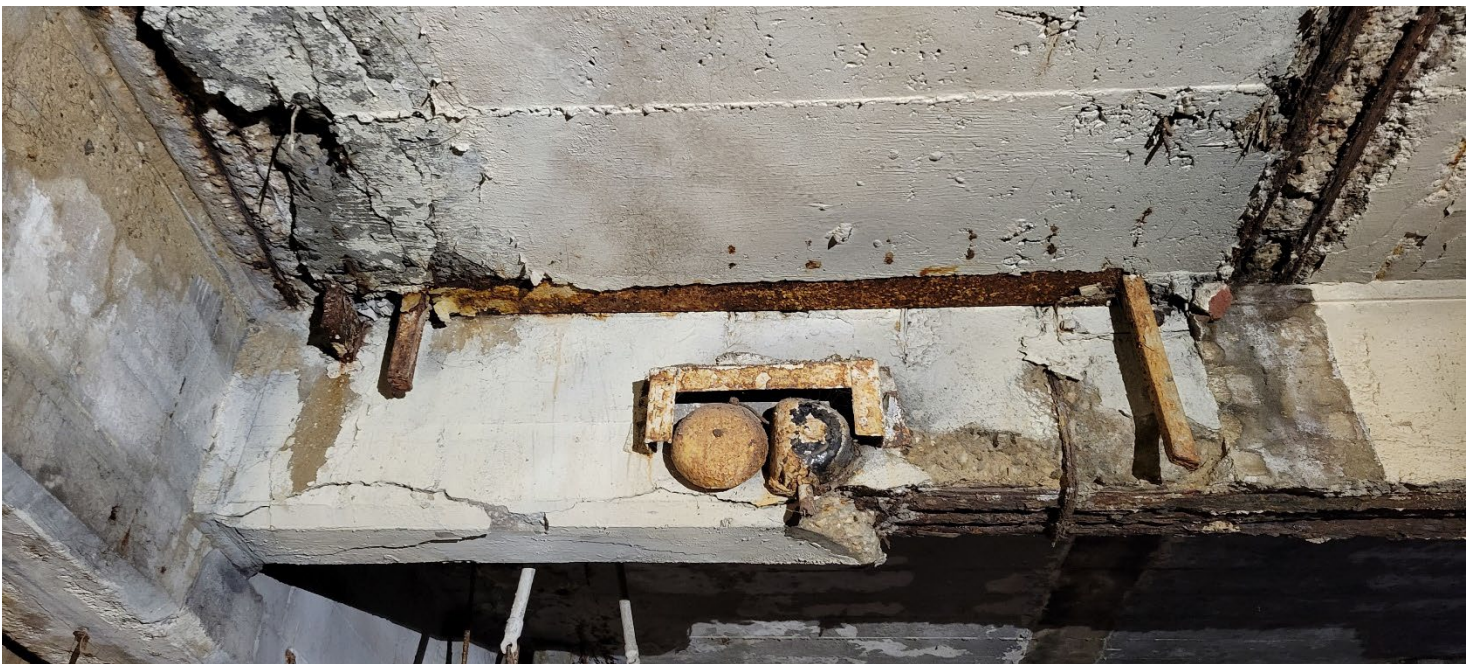
Photograph 4: Facing south to ceiling with remnants of alarm system mounted on poured concrete steel reinforced beam in Vault B.

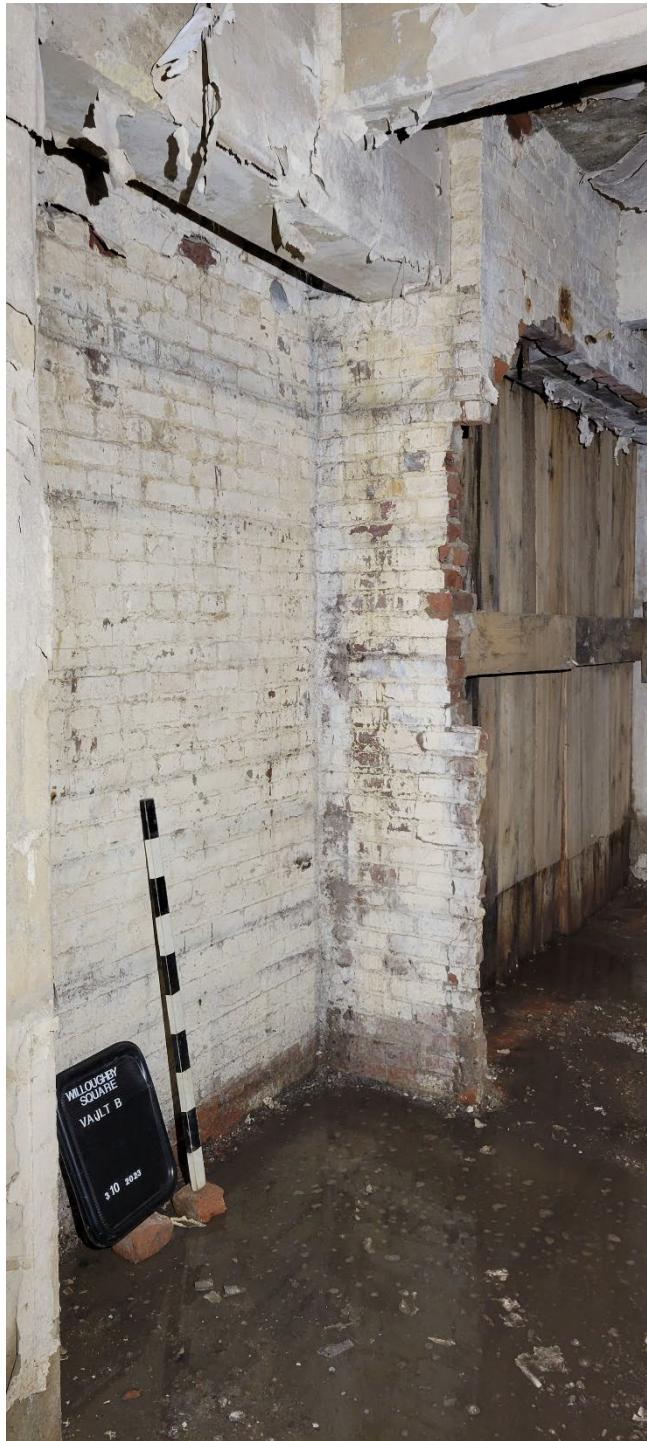
Photograph 5: Facing southeast to northeast corner of Vault B with bricked in former passageway (foreground). Note: formerly bricked in opening (background) was removed and replaced with wood as part of this project.

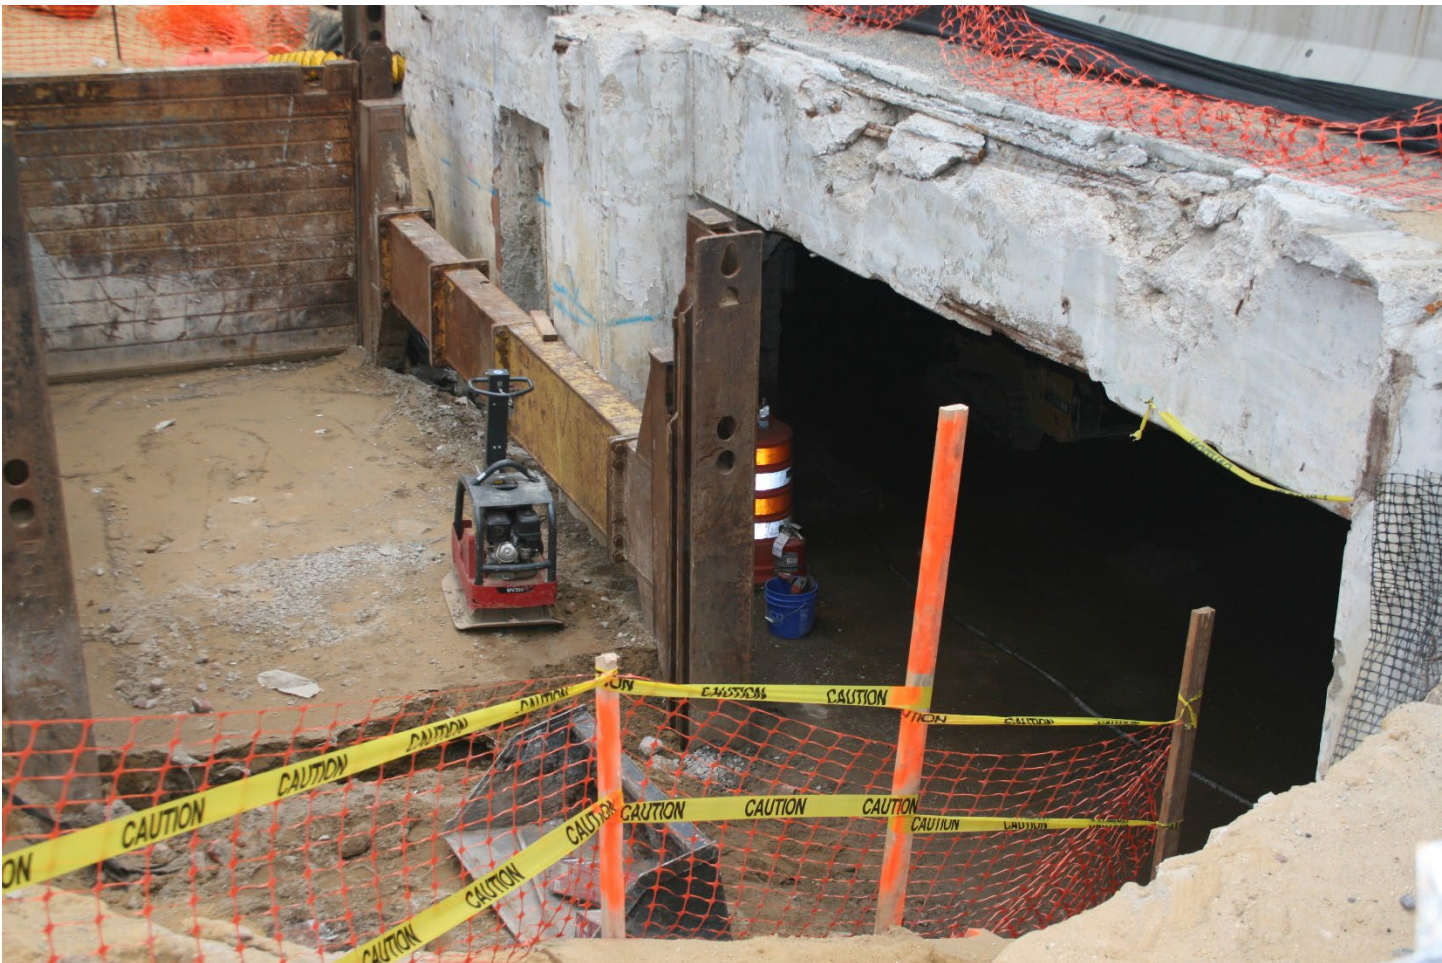
When Vault B was first opened as part of this project, a gas meter room with surrounding brick walls and an entry door were identified at the southwestern corner of the Vault and have since been removed (Figure 3). Brick dividing walls were situated at the southern end of the Vault and at the middle, but have since been removed. The west wall is poured concrete like the west and north walls of Vault A (Photograph 2). Two bricked in entries in the eastern wall were removed and replaced with wood panels as part of this project (Photograph 3). Electrical equipment can still be observed attached to various walls and the ceiling (Photograph 4). At the northeast corner of Vault B is a third bricked in entry door in situ that formerly provided access to the terracotta-lined passageway into the 1930s brick building at 217 Duffield Street (Photographs 5). From the outside, it would have appeared much like the existing bricked in entryway into Vault A (Photograph 6).

Photograph 6: Facing southwest to bricked in entrance (left) and formerly bricked in entrance (right) to Vault A.

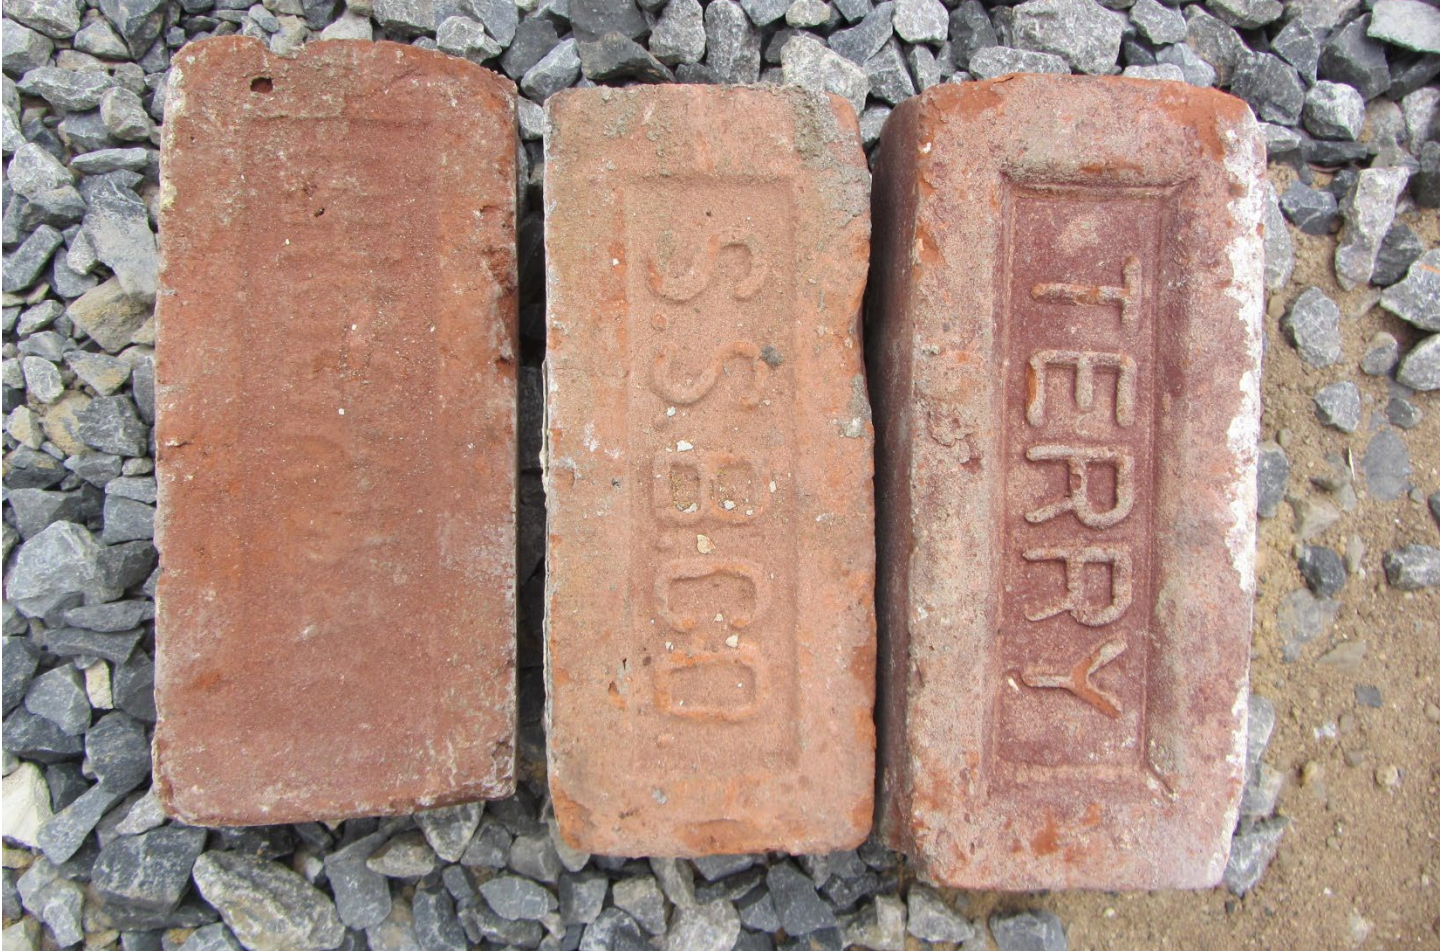
Many of the bricks removed from interior locations in Vault B and saved for review were found to lack stamping, but those with embossing bore the names TERRY, S.S.B. CO, and BROCKWAY (Photograph 7). These bricks are attributed to the Terry Yard on the Rondout in Kingston (1850-1902, after which they became Terry Brothers, embossed TERRY BROS), the Sutton and Suderly Brick Company in Coeymans (1885-1957), and the Brockway Brickyard just north of Beacon (1886-1931) (brickcollecting.com, hrmm.org). They suggest at the very least a post-1850 construction date, and more likely a post-1885 construction date since there was a random assortment of bricks from different time periods and earlier ones could have been reused. It is possible that brick walls could have been added at a later date, after Vault construction, to subdivide the spaces.

Photograph 7: Representative bricks removed from interior walls of Vault B.

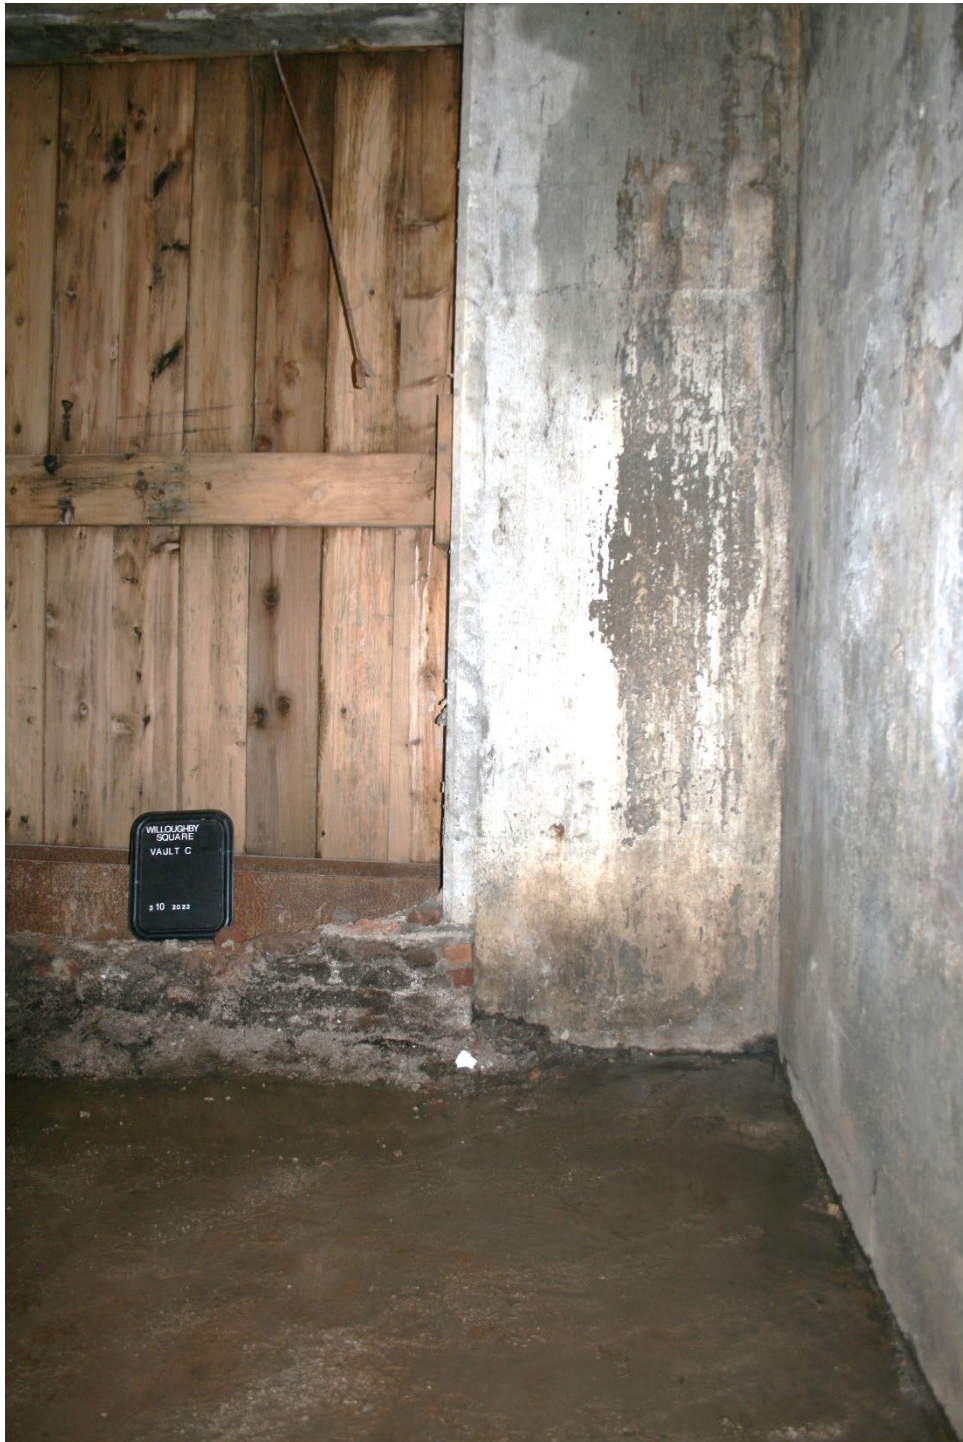
Photograph 8: Facing east to poured concrete east wall and opening in south half of Vault C, with southern wall at right. Note remnants of the formerly bricked in opening (beneath sign) with the remainder removed and replaced with wood as part of this project.

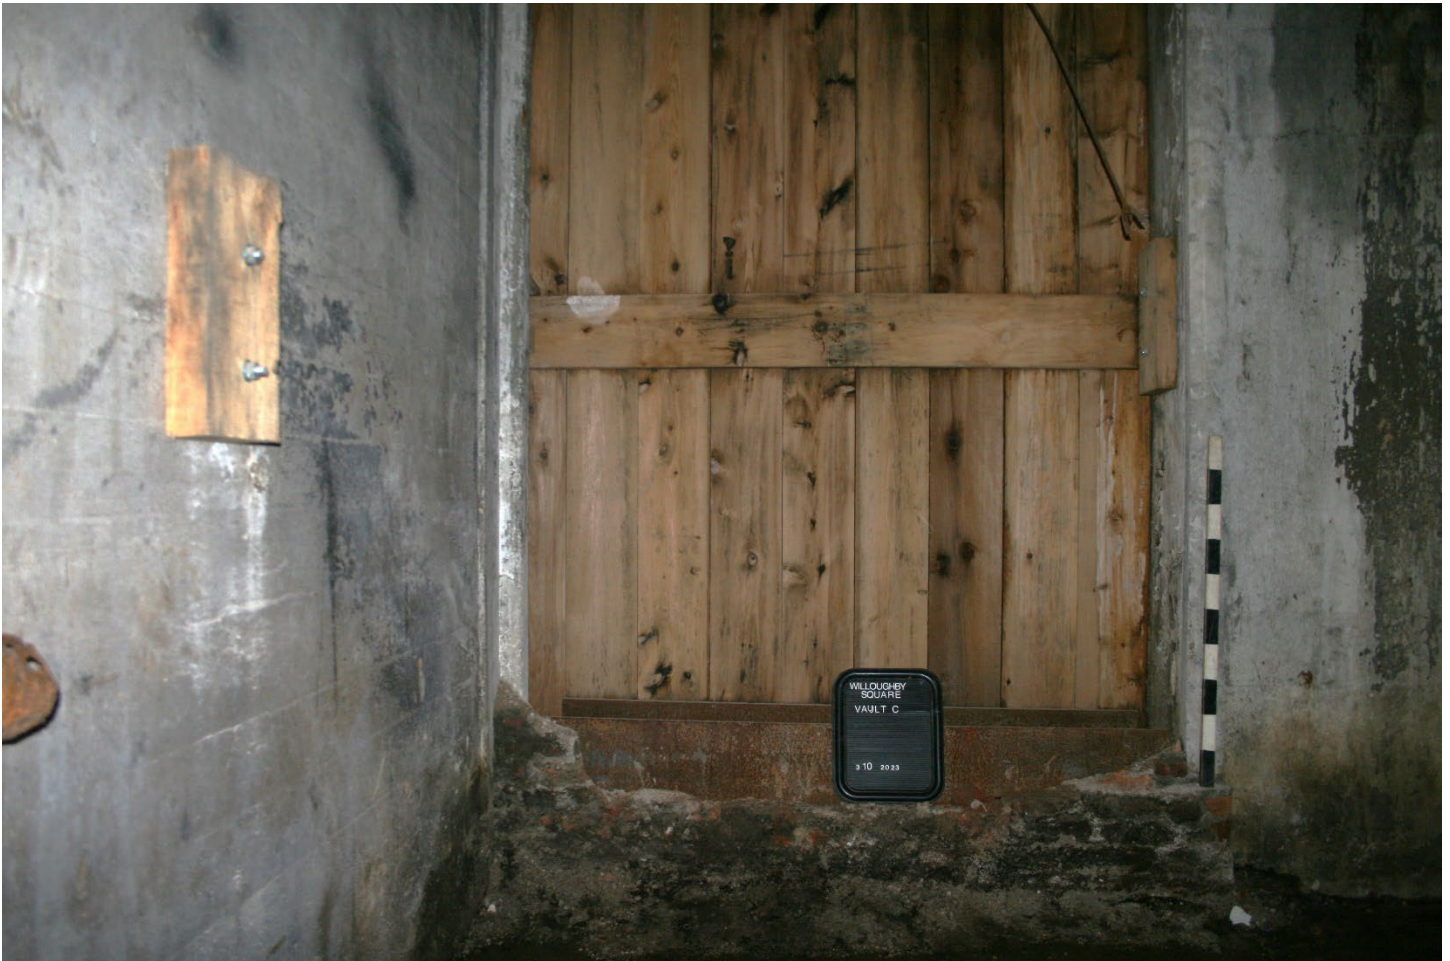
Photograph 9: Facing east to east wall and opening in south half of Vault C with poured concrete north wall at left. Note remnants of the formerly bricked in opening (beneath sign) with the remainder removed and replaced with wood as part of this project.

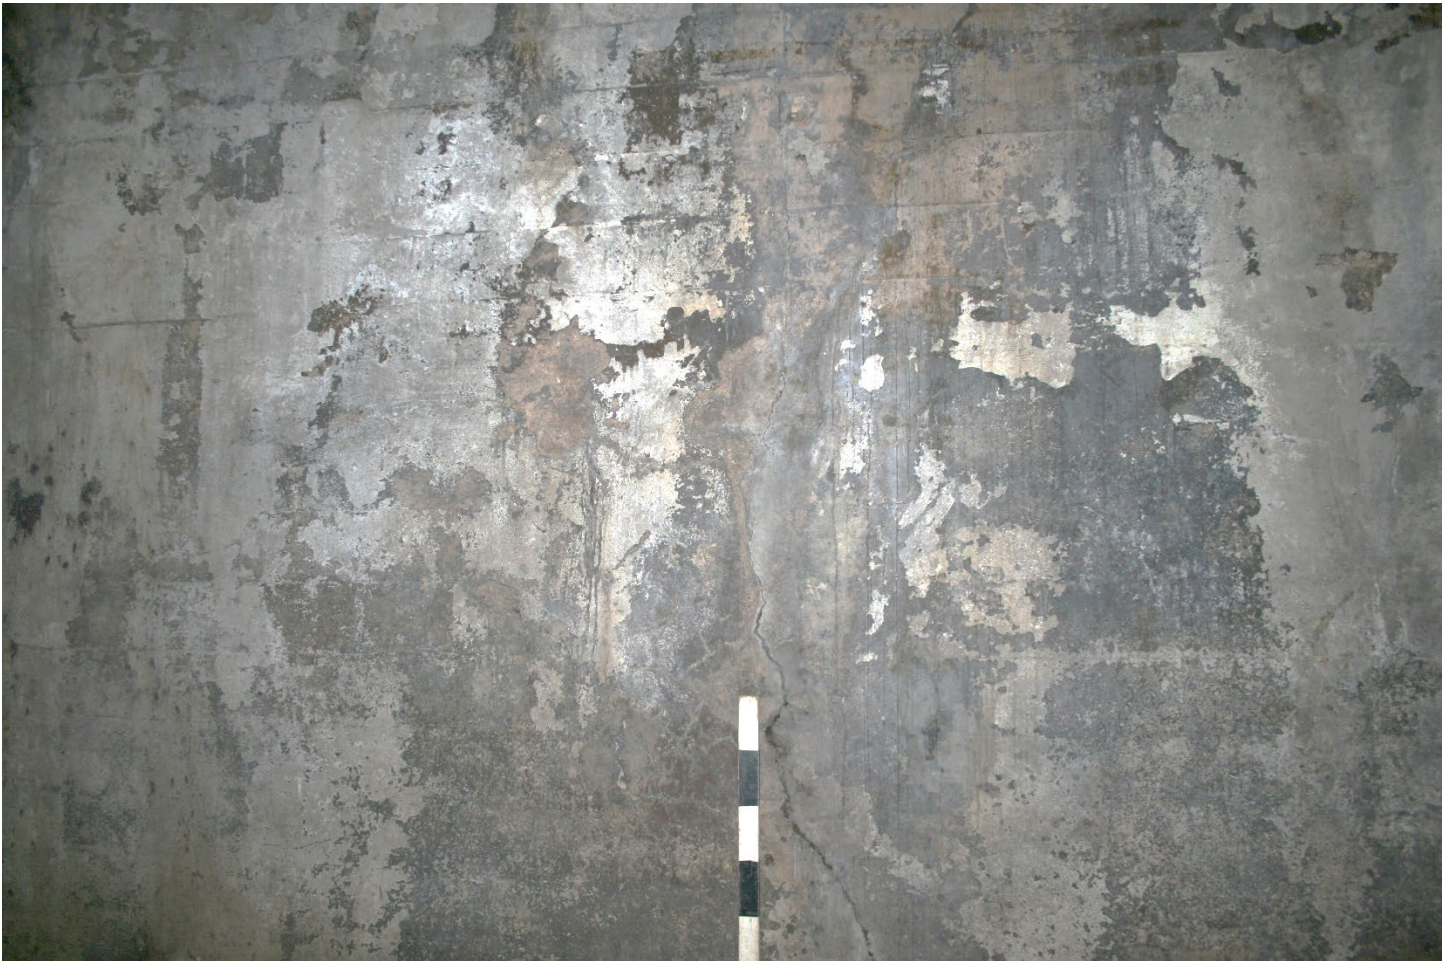
Photograph 10: Facing south to poured concrete south wall in south half of Vault C.

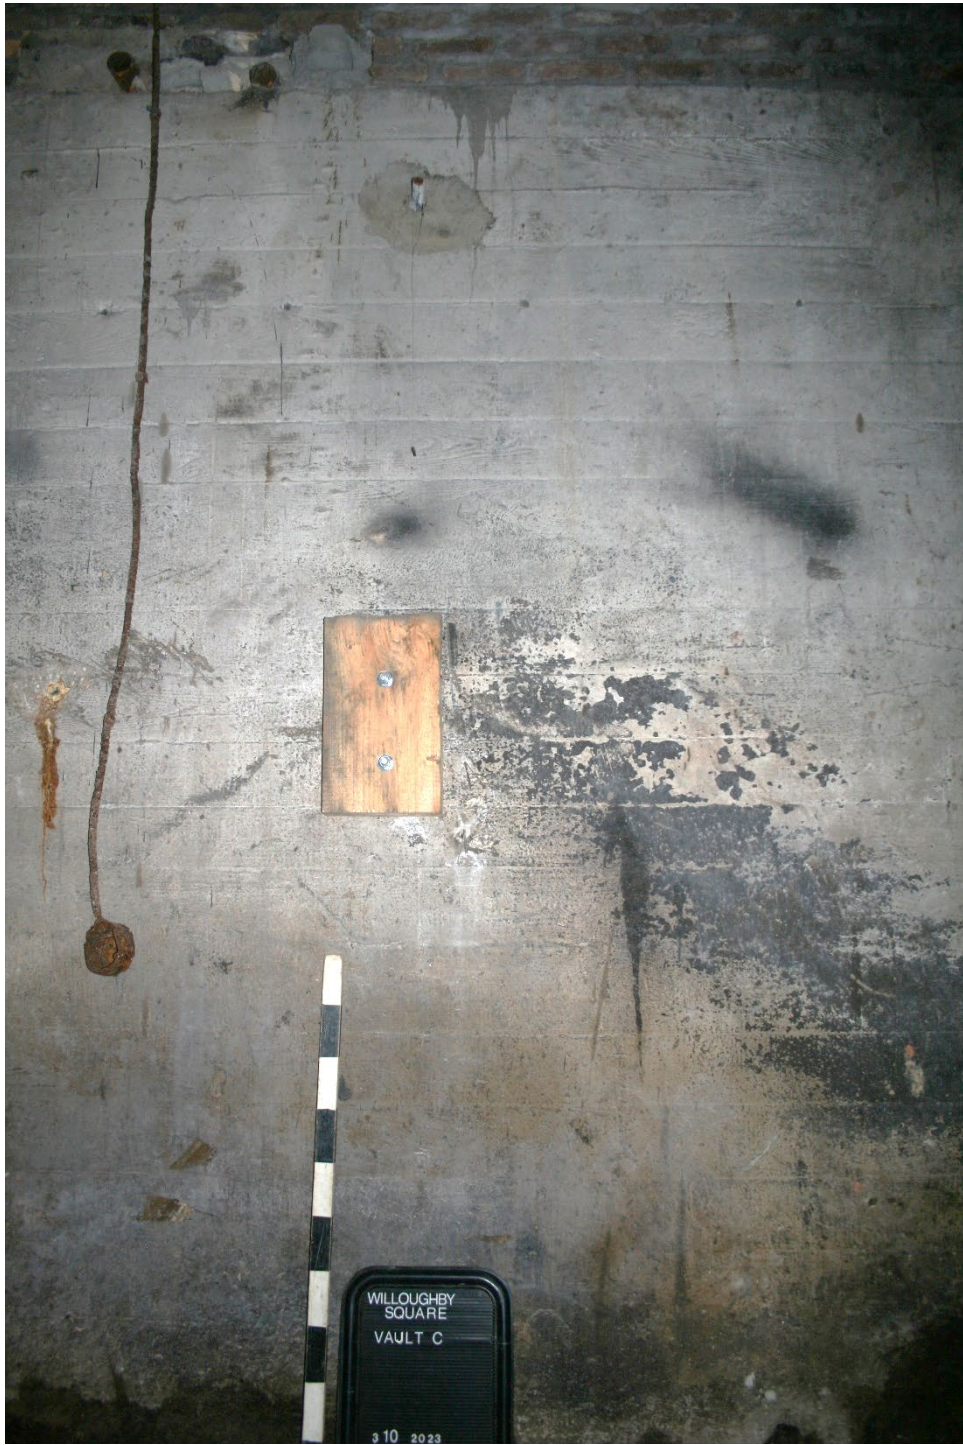
Photograph 11: Facing north to poured concrete north wall with brick infill at top in south half of Vault C. Note: this wall divides Vault C in two halves.

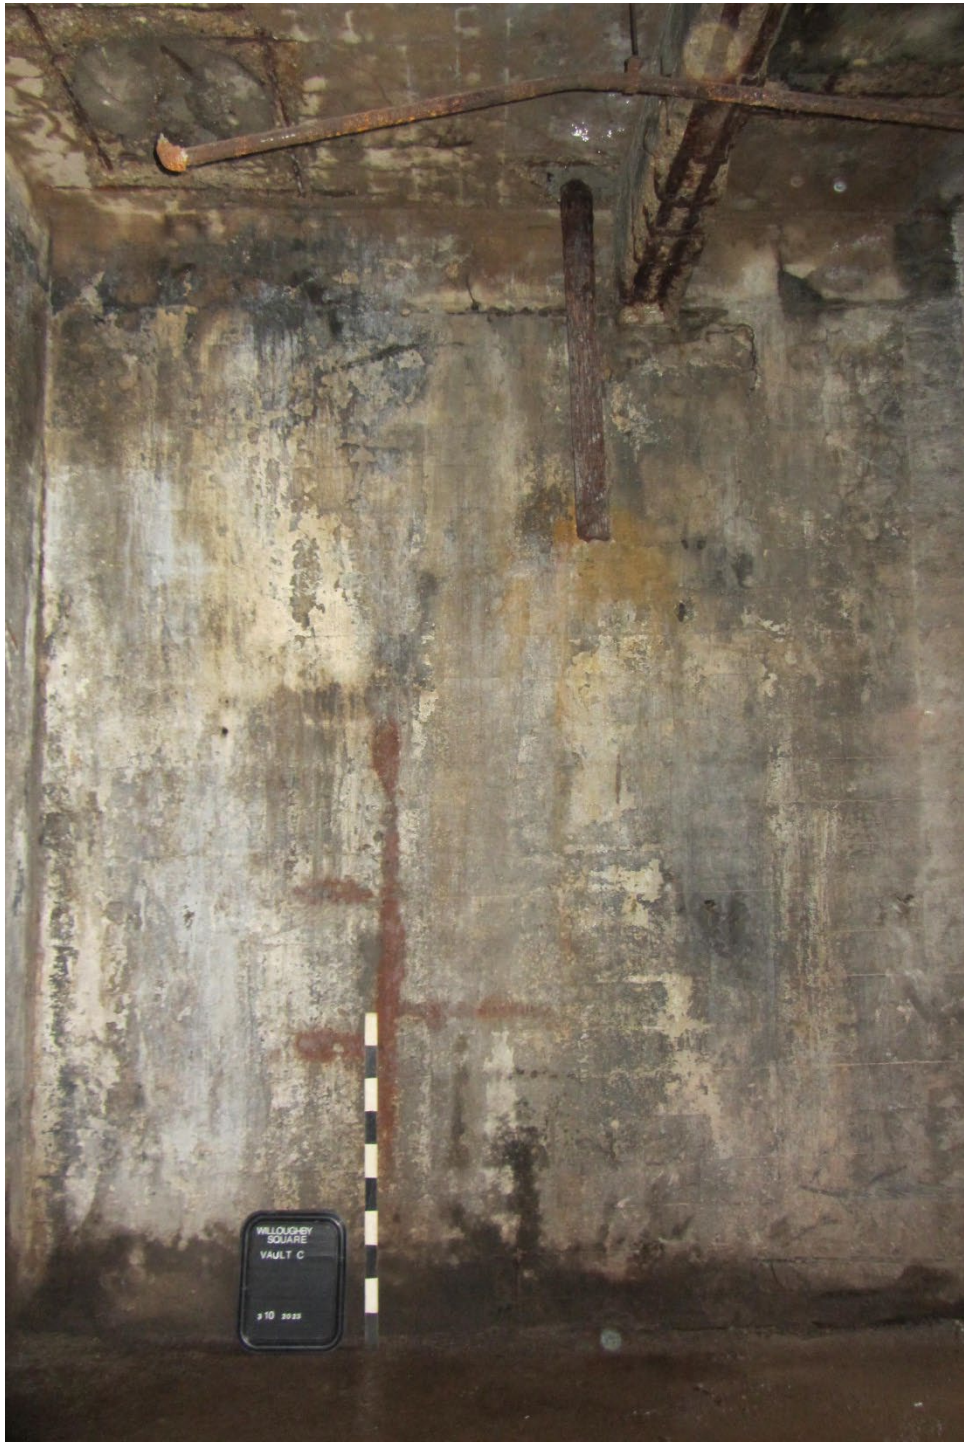
Photograph 12: Facing west to poured concrete west wall in south half of Vault C with formerly bricked in opening between the north and south halves of Vault C at right.

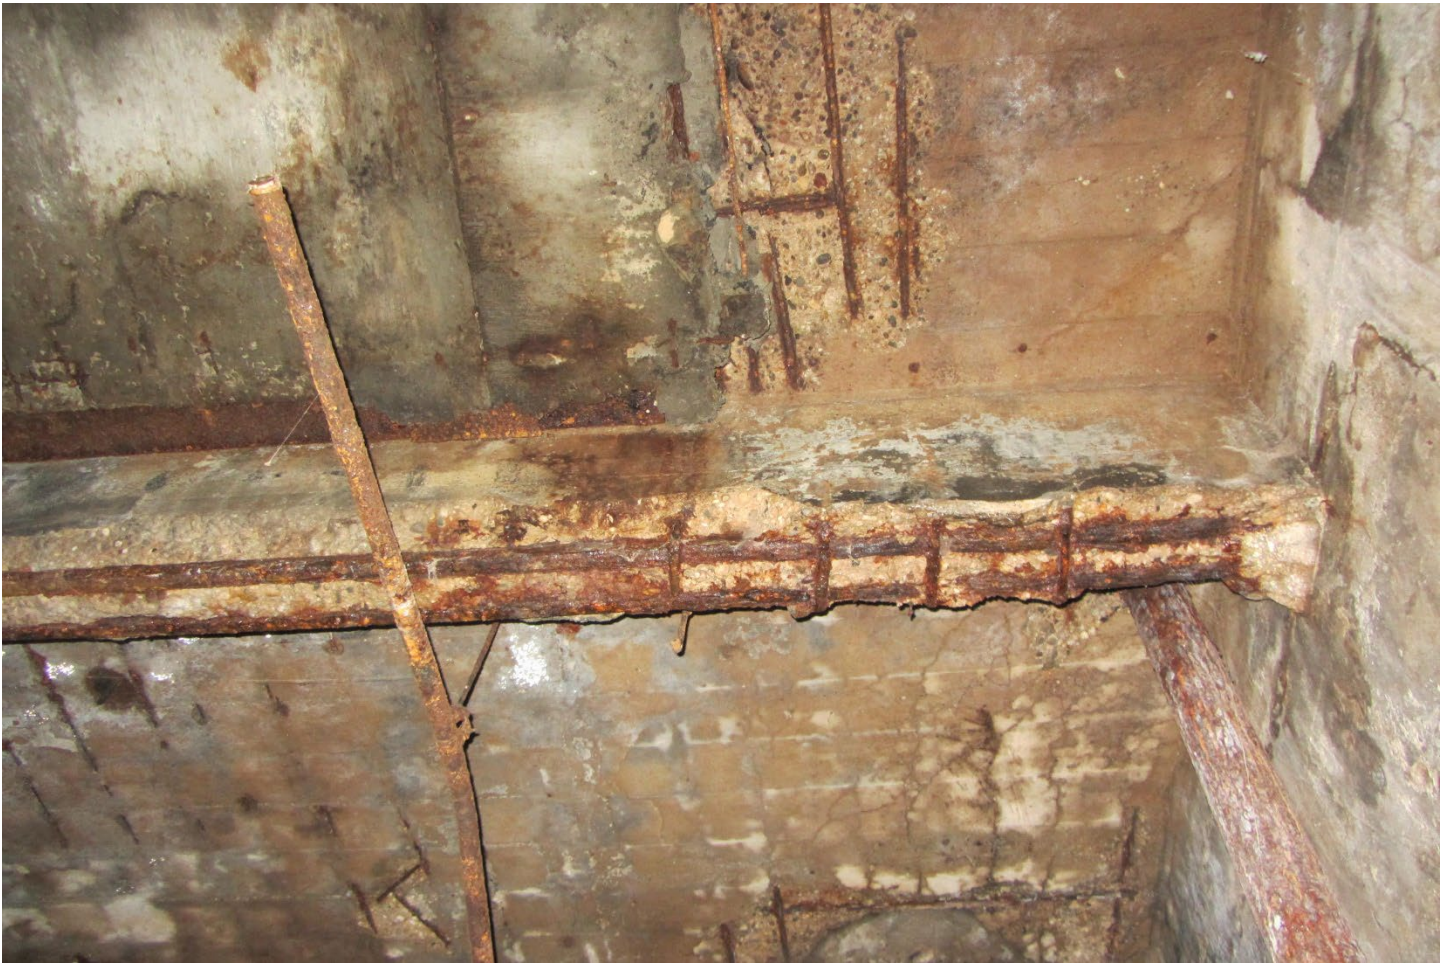
Photograph 13: Facing south to ceiling in south half of Vault C adjacent to poured concrete west wall (right).

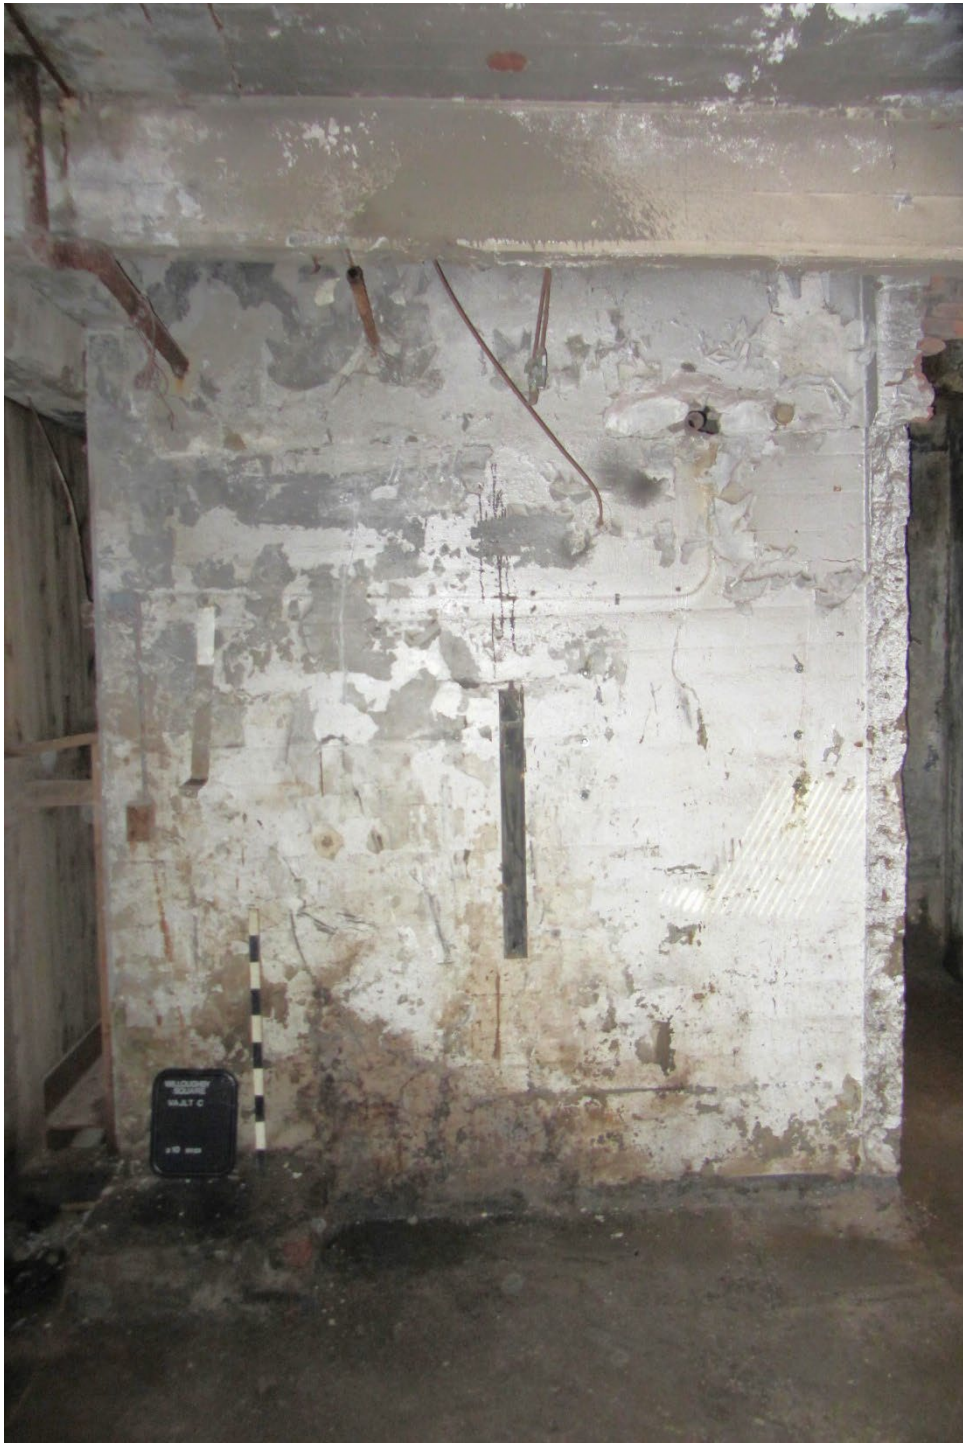
Formerly bricked in openings have been removed on the east and west sides of the dividing wall as part of this project, and utility conduits are visible punctuating the uppermost section of the wall (Photographs 14 and 15). Like the south half of Vault C, the north half also possesses a bricked in entry in the eastern wall, removed and replaced by wood as part of this project (Photograph 16). Remnants of the brick wall dividing Vault C from Vault B are visible just north of the wood door (Photograph 16-18). The lower section of the brick wall was left in situ and demarcates the 3 foot 1 inch elevation difference between the floors of Vaults B and C (Photograph 18).

Photograph 14: Facing south to poured concrete south wall in north half of Vault C. Note: this wall divides Vault C in two halves. Formerly bricked in openings at east (left) and right (west) were removed as part of this project.

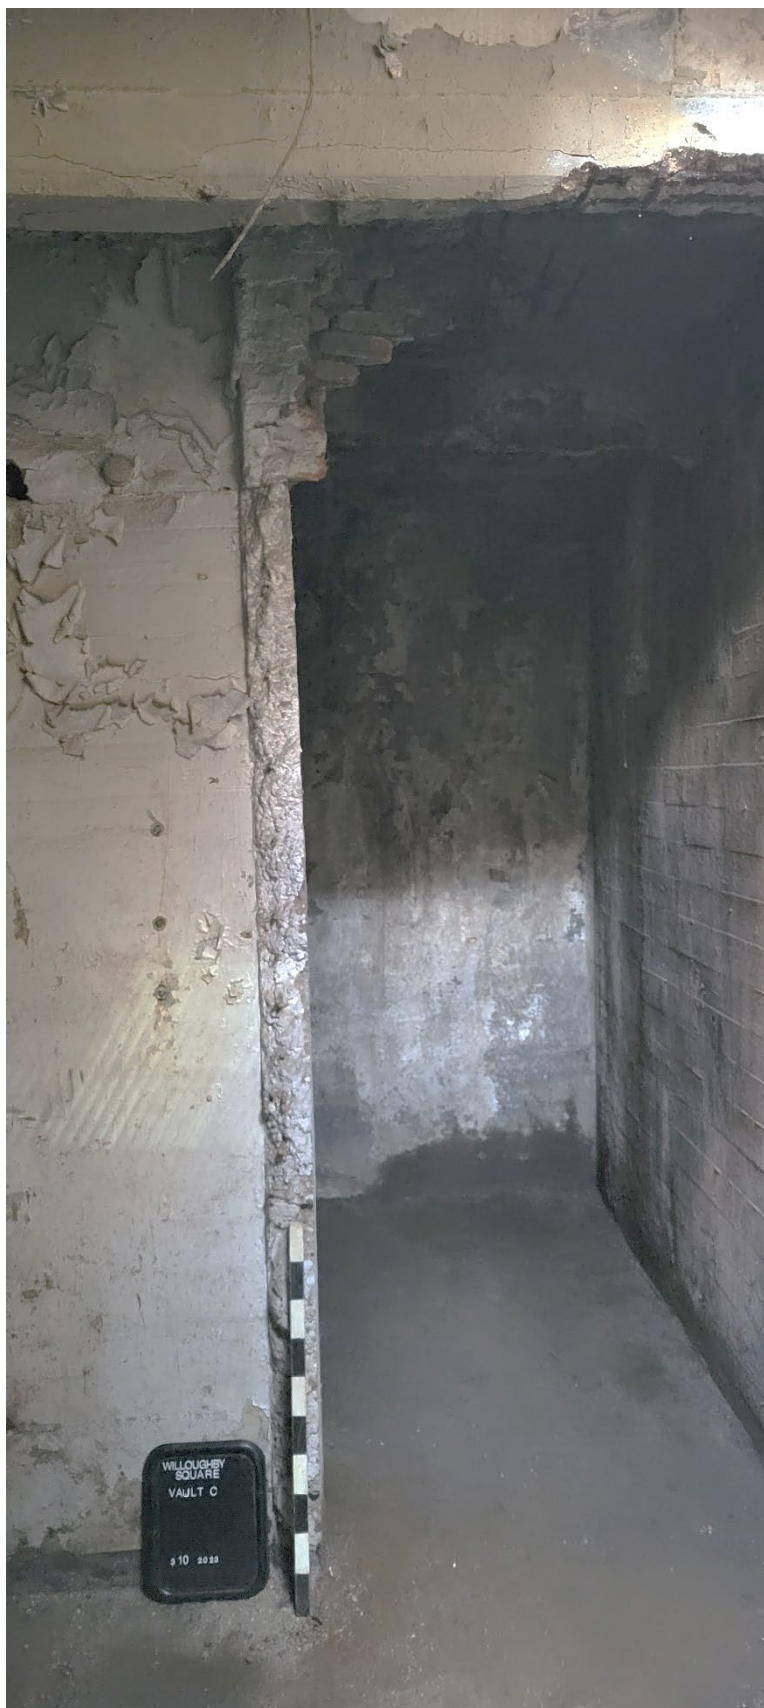
Photograph 15: Facing south to poured concrete dividing wall in north half of Vault C (foreground) and poured concrete south wall in south half of Vault C (background). Note: formerly bricked in opening at right removed as part of this project.

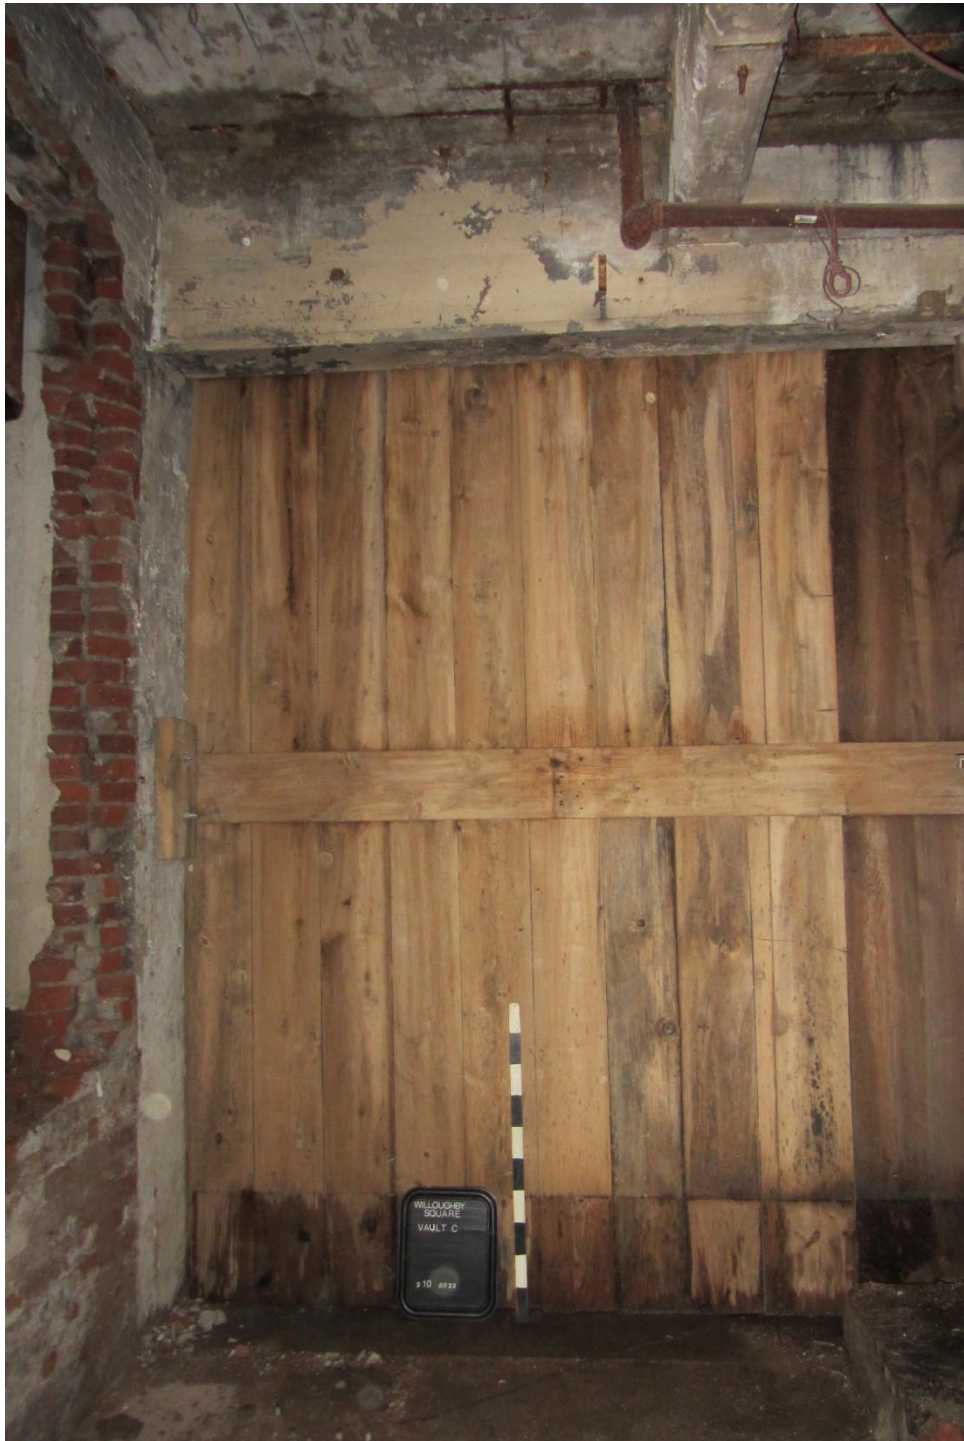
Photograph 16: Facing east to east wall (center) and opening in north half of Vault C with remnants of brick north wall (left). Note: the formerly bricked in opening in the east wall was removed and replaced with wood as part of this project.
