**Archaeological Memorandum: Sidewalk Vault  
Documentation**

**Willoughby Square Open Space Project  
Duffield Street/Abolitionist Place sidewalk adjacent to  
Block 146, Lot 16 (formerly Lot 18, 213-221 Duffield Street)  
Brooklyn, Kings County, New York**

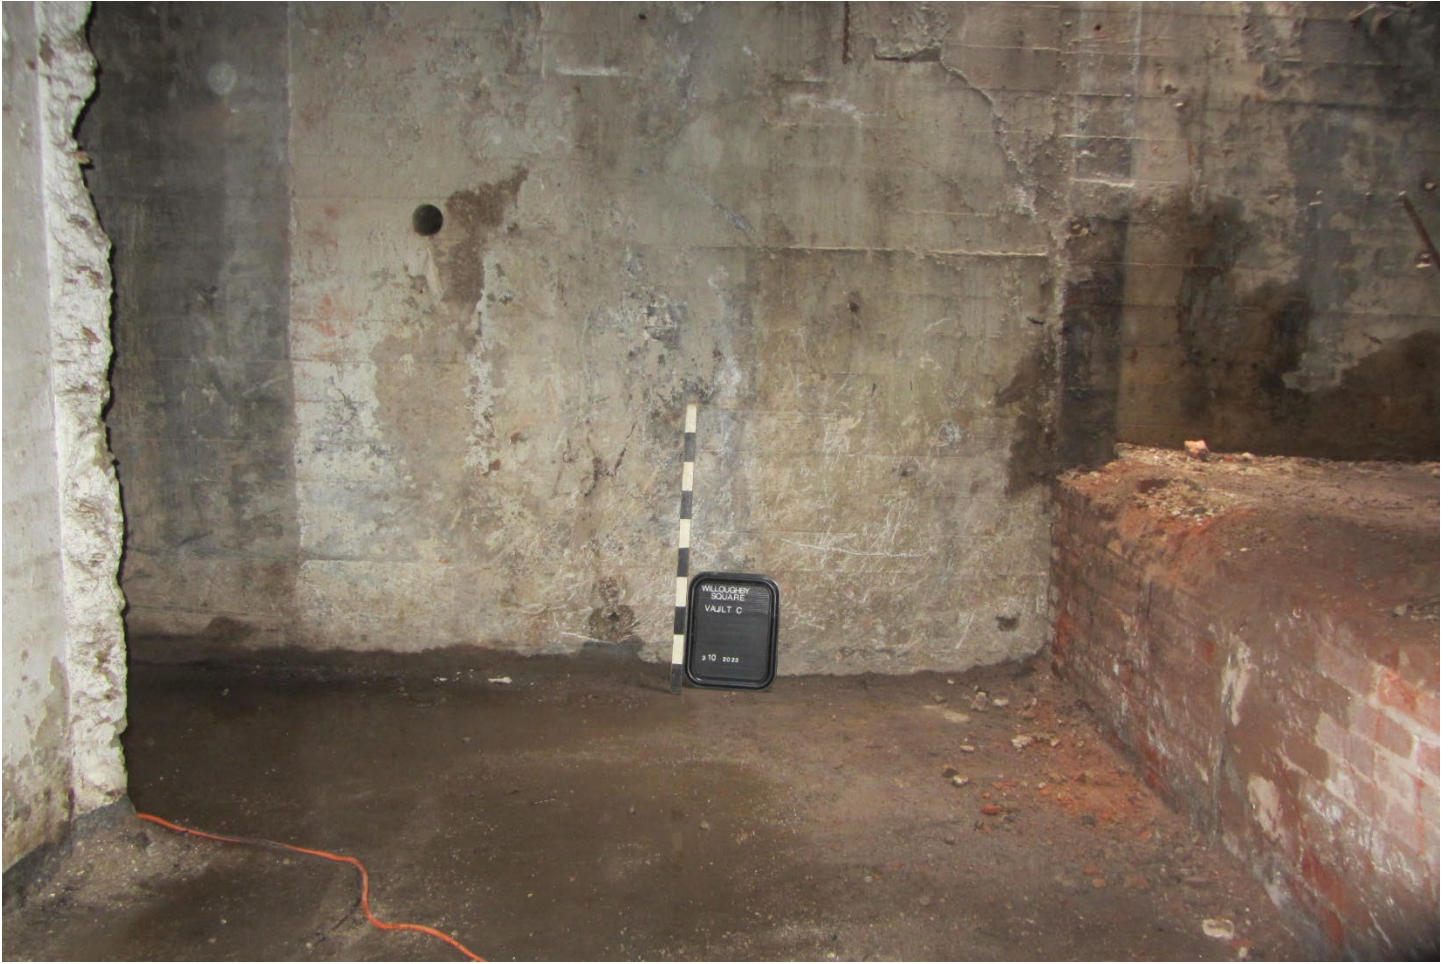
Photograph 17: Facing west to poured concrete west wall in north half of Vault C, with remnants of brick north wall (right). Note: base of Vault C is three feet below the base of Vault B to north (right).

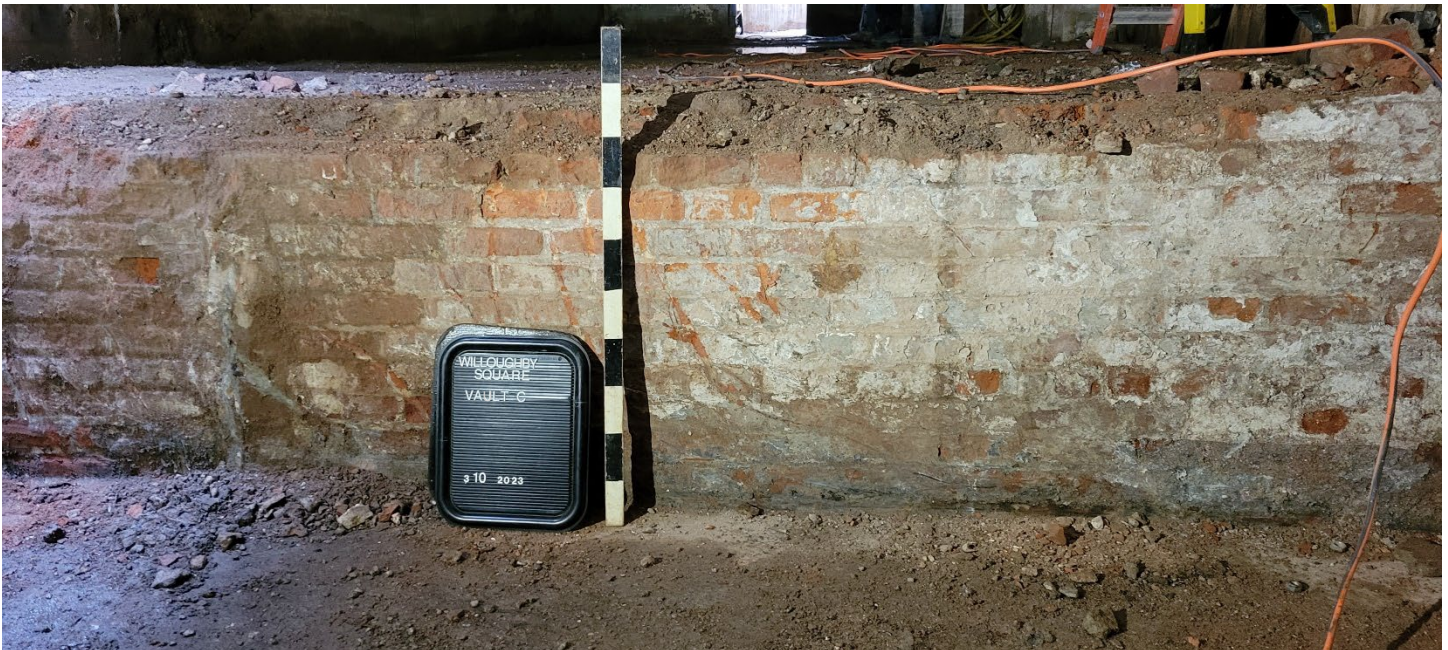
Photograph 18: Facing north to remnant of brick north wall in north half of Vault C. Note: base of Vault C is 3 feet one inch below the base of Vault B to north.

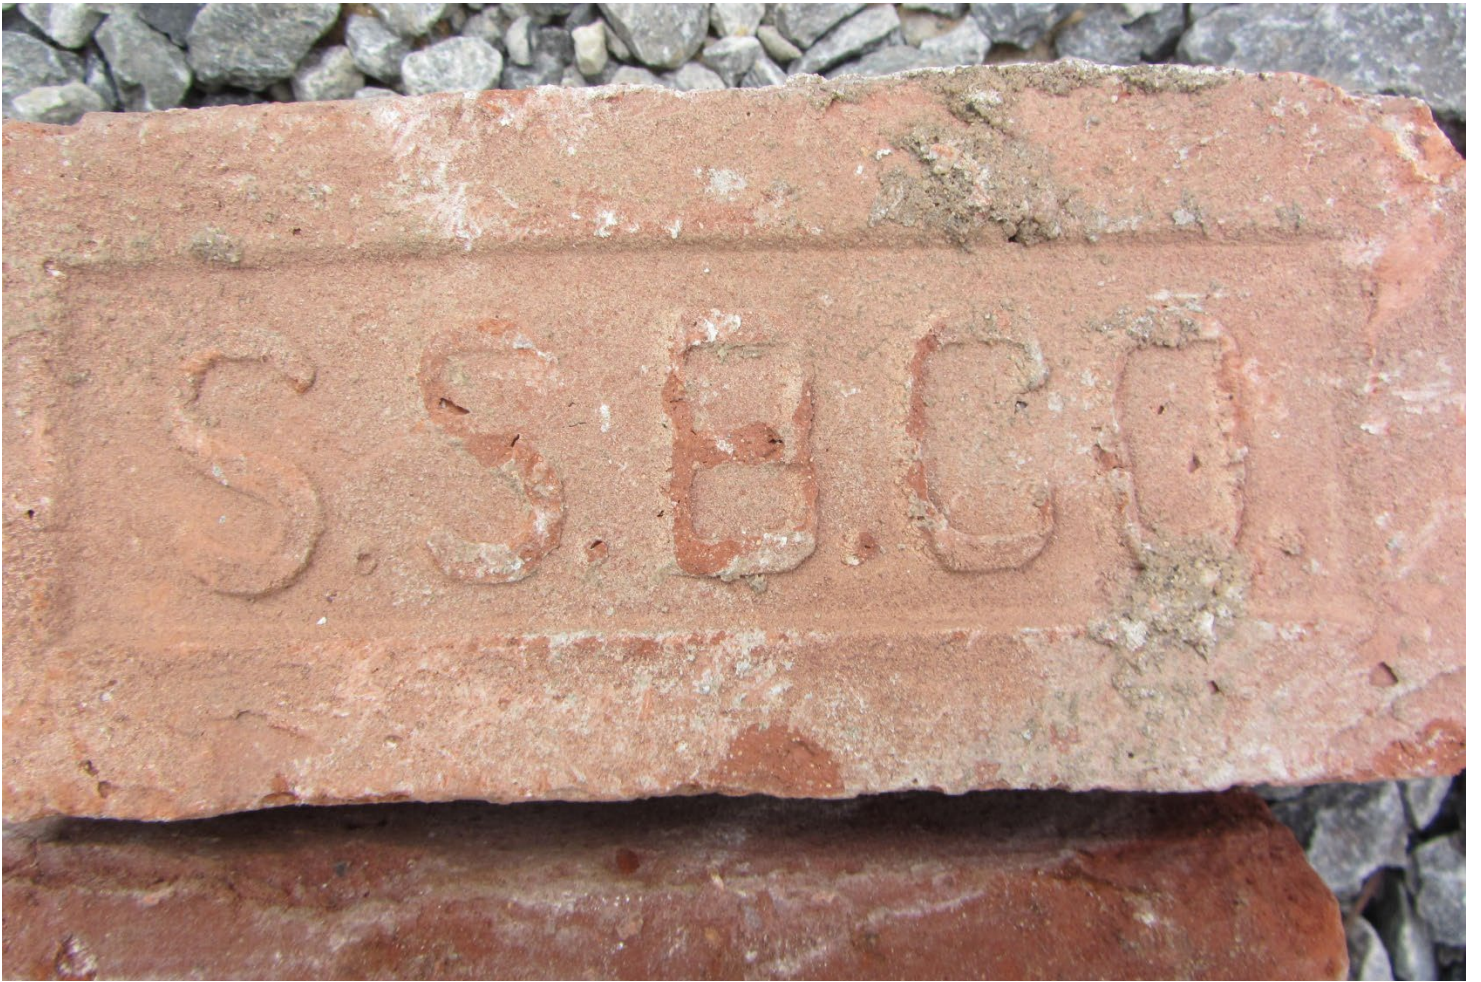
Bricks removed from Vault C that were embossed bore the names S.S.B. CO (1885-1957) and BROCKWAY (1886-1931) (Photograph 19). These strongly suggest a post-1885 construction date. However, the interior brick walls could have been added at a date after Vault construction, to subdivide the spaces.

Photograph 19: Representative brick removed from interior wall of Vault C.
