STAGE 1B ARCHAEOLOGICAL SURVEY
OF THE RED HOOK WATER POLLUTION CONTROL PLANT
BROOKLYN, NEW YORK

Prepared for:
Stone and Webster
Engineering Corporation
One Penn Plaza
New York, New York 10119

Prepared by:
Greenhouse Consultants Incorporated
54 Stone Street, 7th Floor
New York, New York 10004

November 1991

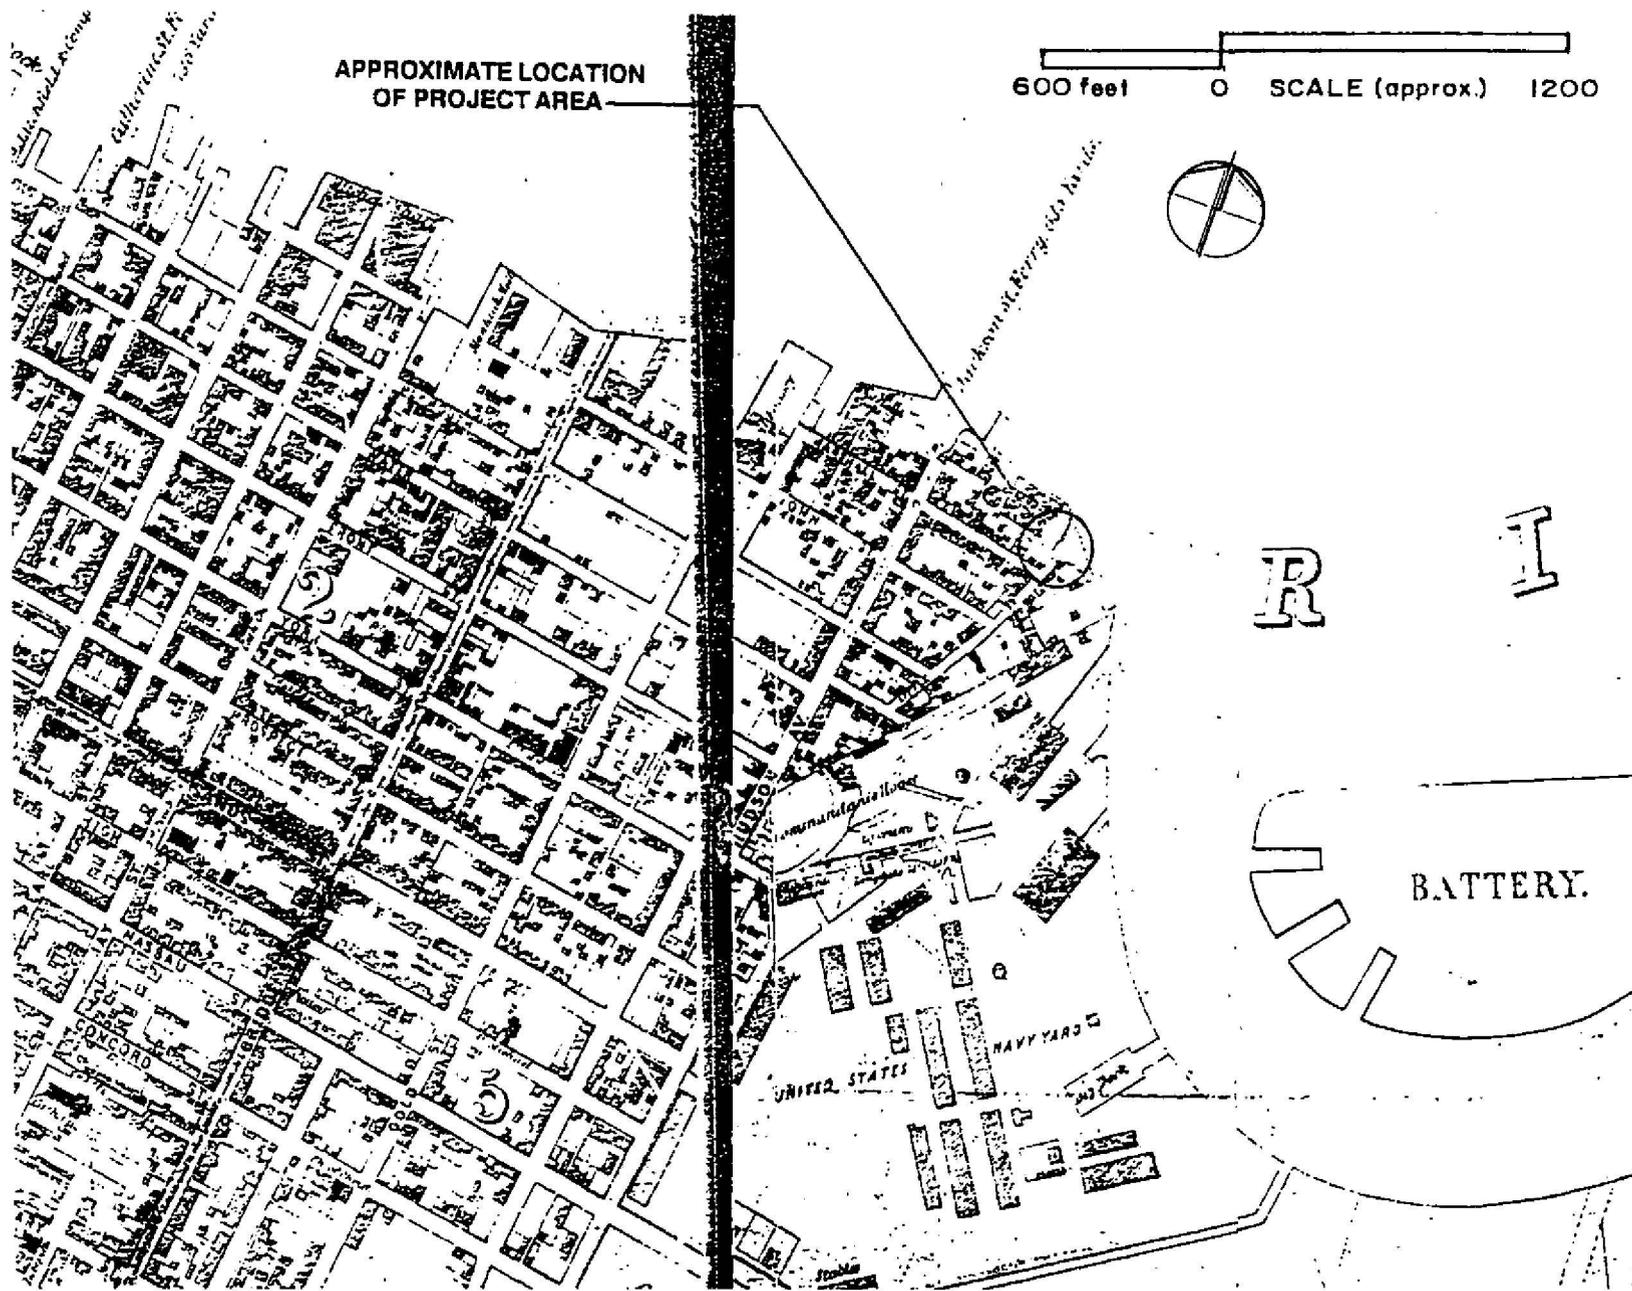
Figure 2

From the 1850 Dripps Map of the City of Brooklyn.

The nature of the two buildings depicted on the Dripps 1850 map were evaluated first. One difficulty in evaluating the project impact area stemmed from the fact that it is located in what was once part of the Brooklyn Navy Yard. All the Buildings Department's records for the Navy Yard have been turned over to the United States government. An effort was made to locate these records locally. However, it appeared they may be housed in Washington, D.C.. Therefore, information regarding the structures shown on the Dripps 1850 map was derived from deed indices, directories, sewer and water maps, and other maps.

Since the 1850 Dripps Map showed two structures on this parcel, evidence of whether the property owners resided on the parcel was sought. No evidence was found that the structures shown on the 1850 Dripps Map were residences. Brooklyn directories for the early 1850s were consulted. No mention of Samuel Evans could be found, and no other Evans was listed on Marshall or Little Streets. Henry Ruggles was listed in the directories for 1852/53 and 1853/54. Both directories stated that Ruggles was a merchant with a business at 172 Front Street in New York City who resided at 66 Cranberry Street in Brooklyn (Hearne and Hearne 1852, 1853). Since the 1855 Perris Atlas showed this lot as a lumber yard with a small office at the corner of Little and Marshall Streets, it is possible that one of the structures shown on the 1850 Map was the same as the structure shown in 1855. If so, it was probably an office for the lumber business that may have been used by another business previously. As the chain of title shows, ownership changed between the dates of these two maps.

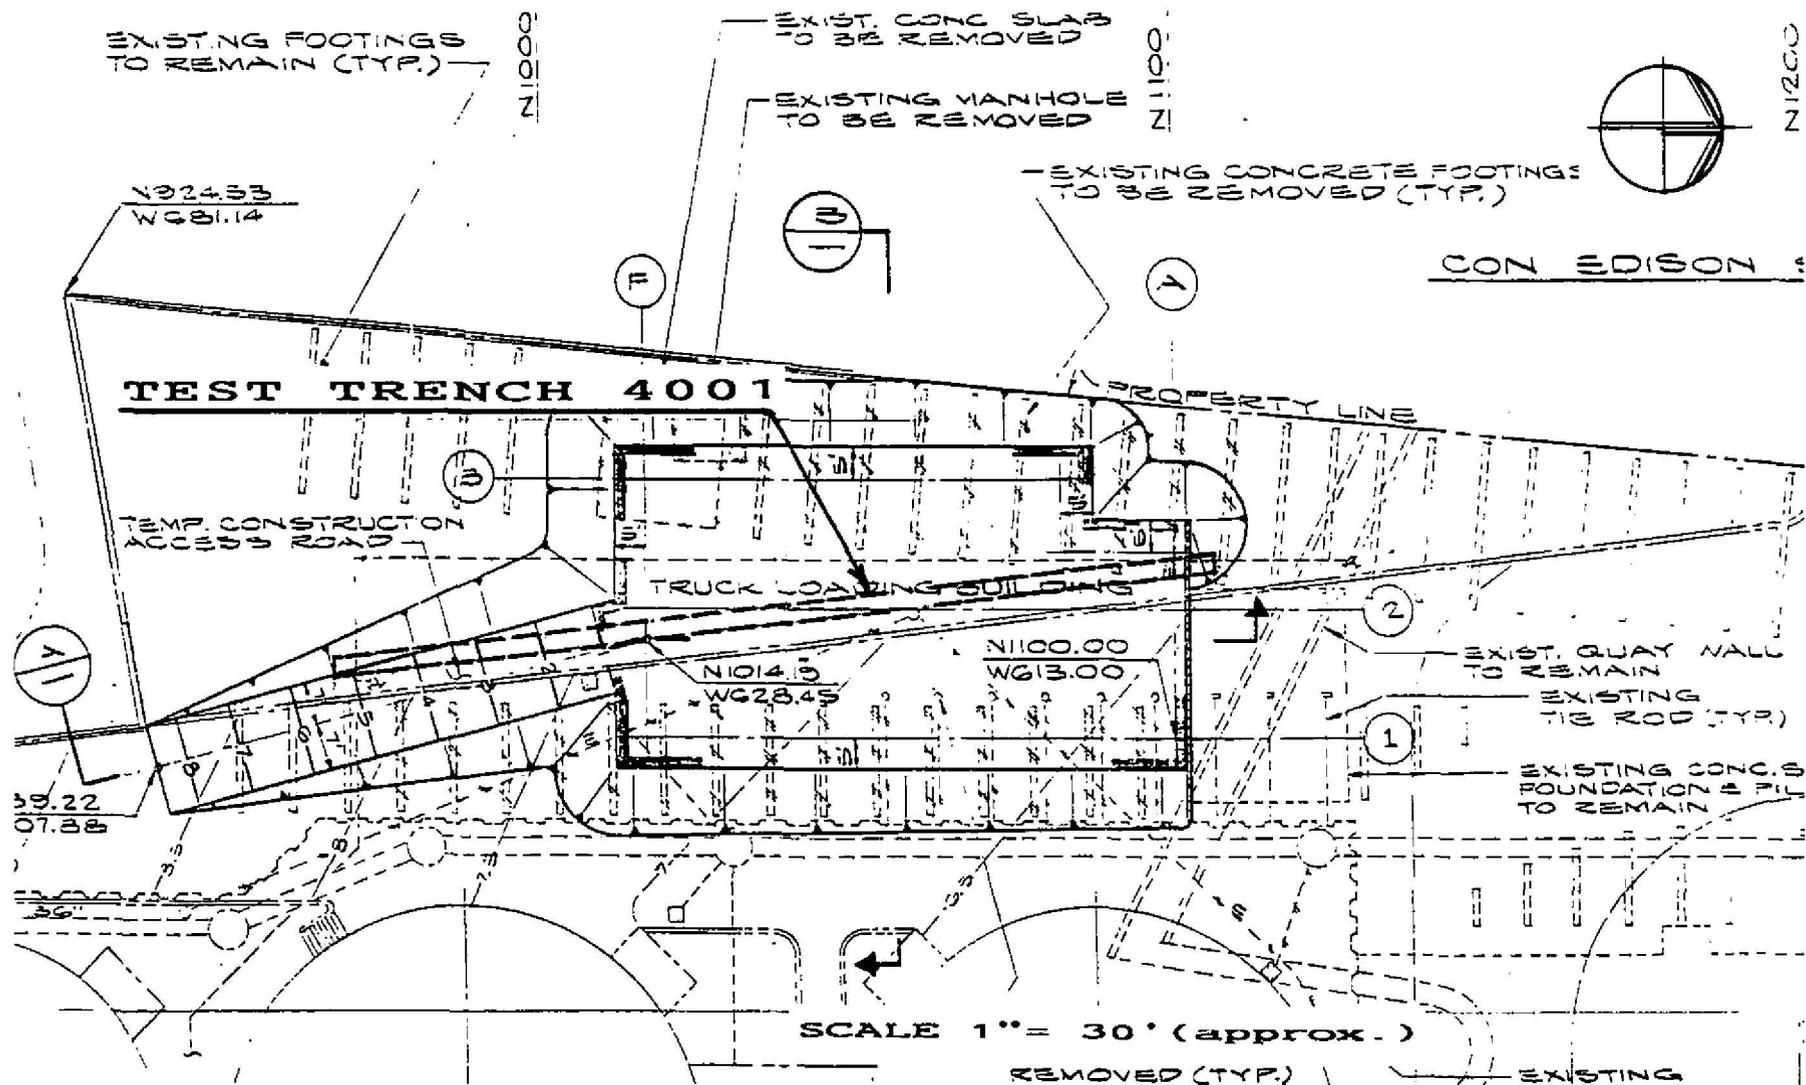
Location of archaeological test trench 4001 shown on current excavation plan.

Backhoe excavations were conducted as recommended at the Red Hook WPCP on May 6 and 7, 1991. One trench was placed. Figure 4 shows the location of the trench as excavated. It was approximately 130 feet long and three to five feet wide and excavated to a maximum depth of about eight feet (see Plate 1).

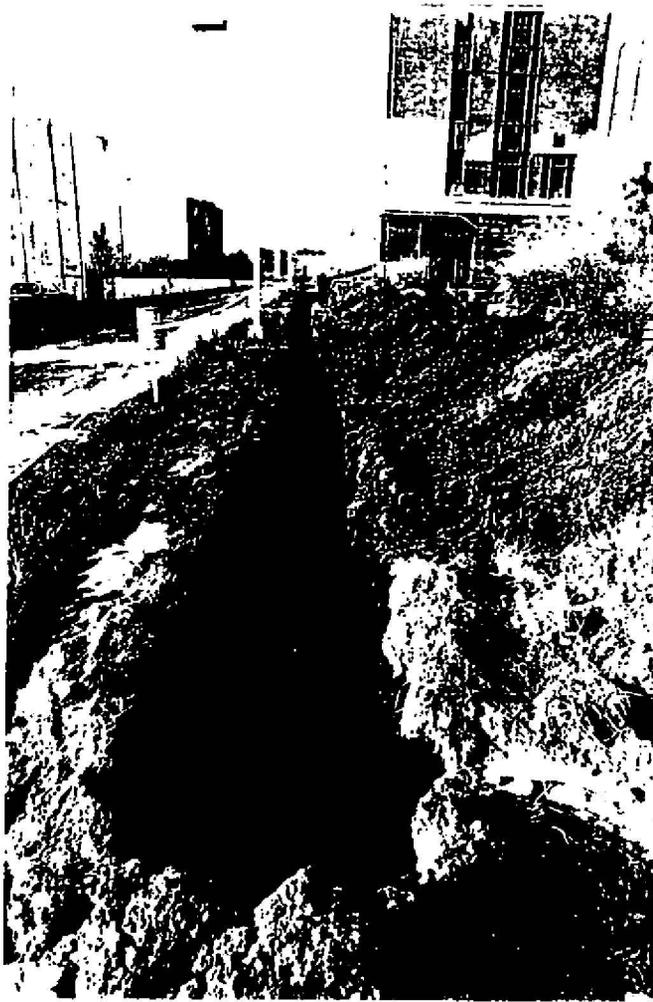
Plate 1 View of the completed test trench facing south.
