**PHASE IB ARCHAEOLOGICAL TESTING**

**ASTORIA COVE DEVELOPMENT**

**Department of City Planning 13DCP127Q**

**Borough of Queens, New York**

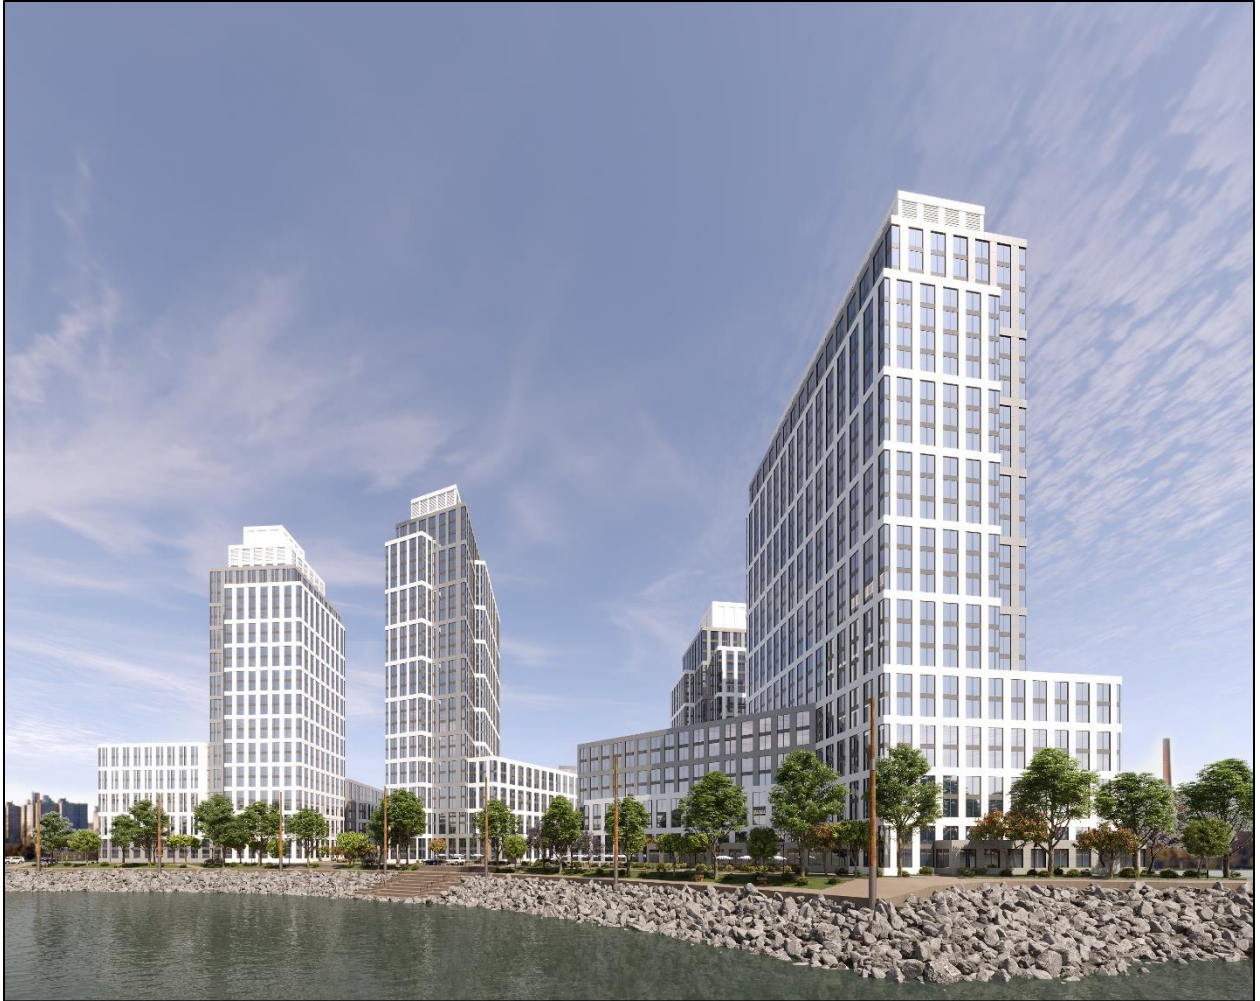
Fig. 2. Architect's rendering of the proposed Astoria Cove development (Courtesy of Fogarty Finger, Joseph Frankl Architects, landscape design by Ken Smith Workshop, in conjunction with SLiM Co).

The requested discretionary actions will facilitate a proposal by the Applicant to develop a new approximately 2,189,068 gross square foot (gsf) mixed-use development on approximately 377,726 sf of lot area. The proposed project would comprise approximately 1,689 dwelling units, of which 295 dwelling units would be affordable; approximately 109,470 gsf of local retail space, including an approximately 25,000 gsf supermarket; a site for an elementary school with approximately 456 seats (PK-5); approximately 900 accessory parking spaces, and approximately 83,846 sf of publicly accessible open space (Fig. 2, p. 7).

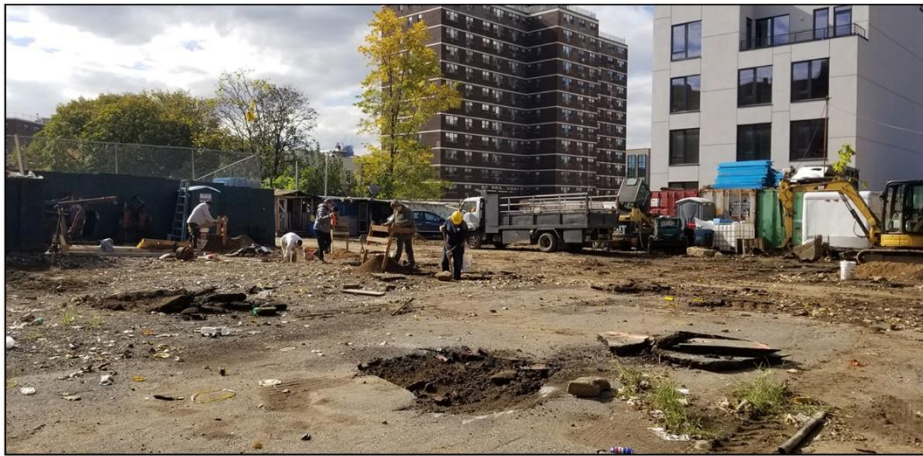
Fig. 9. (top) AREA H – View from the southeast side of the site looking west, with the 8<sup>th</sup> Street easement in the center. The area on the opposite side of the easement seen in this view is not part of the project site. TR 38 and TR 37 are in the foreground and TR 34 and TR 33 behind them. TR 32 has been backfilled.

These trenches are on the same transect as TR 12 and TR 15, from within the line of 8<sup>th</sup> Street eastward (Fig. 9, p. 18).

These trenches are on an east-west transect beginning in the line of 8<sup>th</sup> Street, continuing eastwards to the edge of the hilltop (Fig. 9, p. 18).

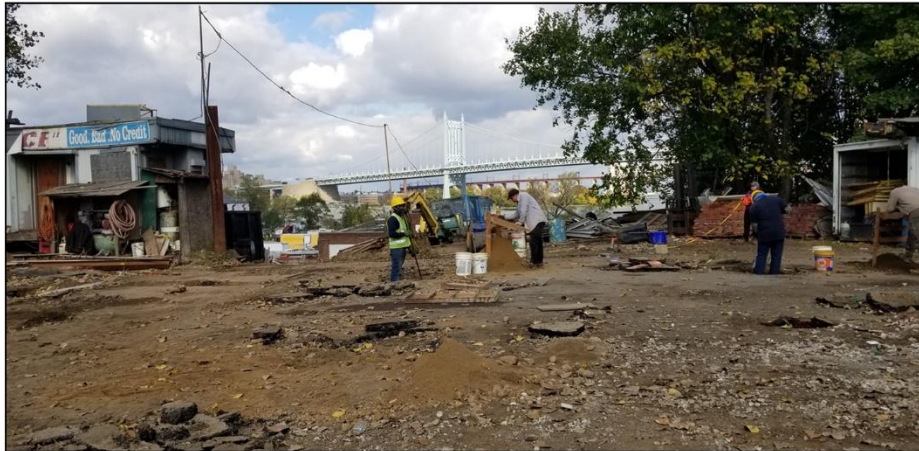
Fig. 10. (middle) AREA H – View from the northeast part of the site looking north towards the Robert Kennedy Bridge.

The area of these two trenches, on the northeast edge of hilltop, had to be cleared of large piles of wood and other building materials, as well as refuse before they could be excavated (Fig. 10, p. 18).

These trenches were east of the trailer, on the same transect as TR 8, TR 10, TR 13 and TR 17 (Fig. 10, p. 18).

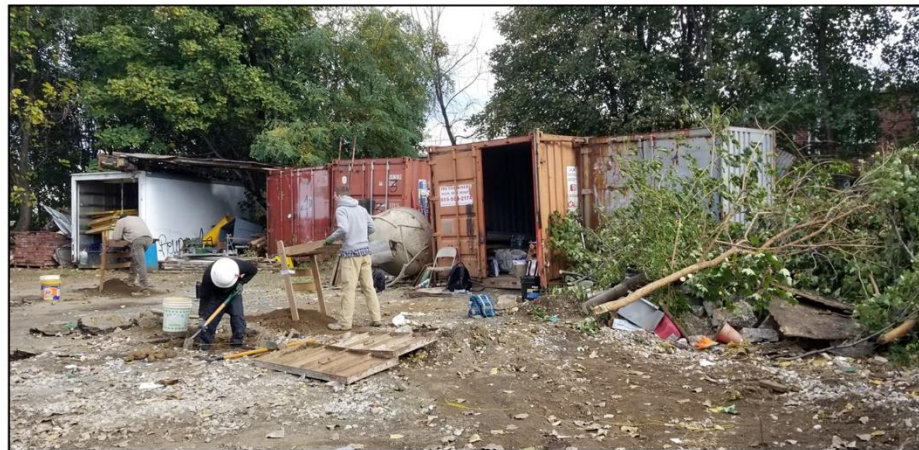
Fig. 11. (bottom) AREA H – View of the east side of the site looking east.

These trenches are on the same transect as TR 14 and TR 18 (Fig. 11, p. 18).

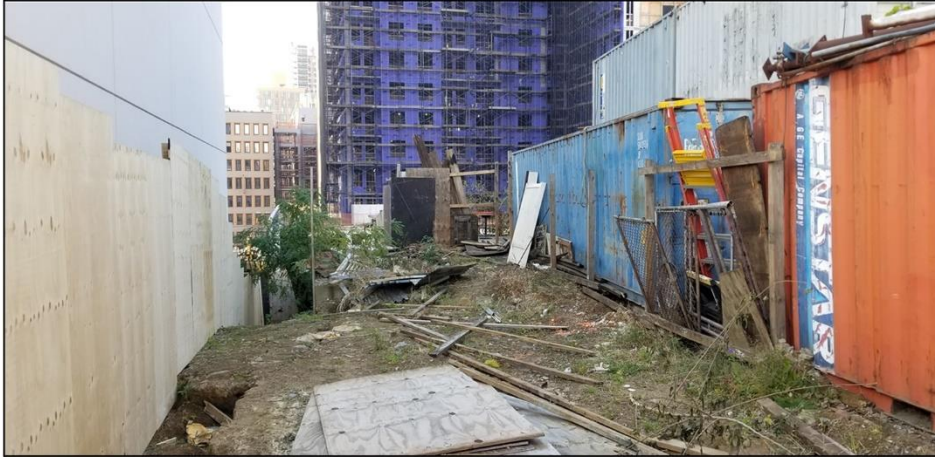
Fig. 12. (top) AREA H – Peripheral area not tested south of the Irregular Construction Fence, looking west.

a metal I-beam on the east side of the trailer, were eliminated because these areas had clearly been very disturbed (Figs. 12 and 14, p. 19) . TR 30, TR 35 and TR 39 were moved 10.0 feet west to maintain more regular spacing of the trenches on this transect and to permit the excavation of TR 39, whose original grid point was underneath a container (not shown on the MP).

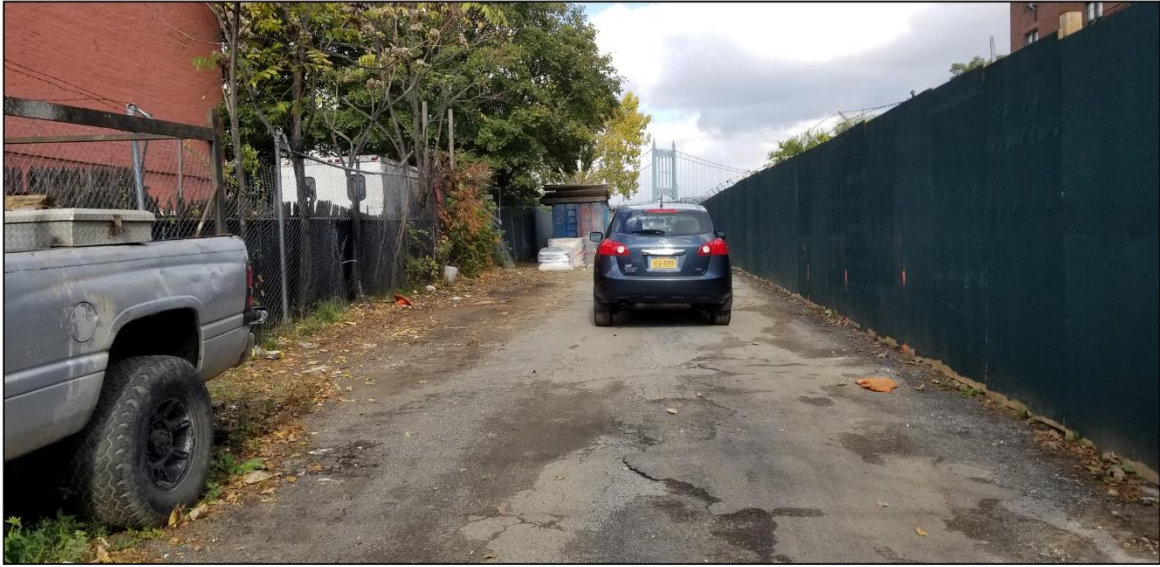
Fig. 16. (top) AREA R – View of the 8<sup>th</sup> Street Easement looking north from the south end of the Road.

Area R is an approximately 25 foot-wide accessway leading north into our area H (Figs. 16 and 17, p. 30). The purpose of the excavations here was to test for the presence or absence of a privy or cistern associated with the buildings depicted on 19<sup>th</sup> century maps in the eastern half of the 8<sup>th</sup> Street Easement, discussed in Section III, above. These features were not located, nor did we observe any other historic archaeological remains in this area that would warrant further investigation.

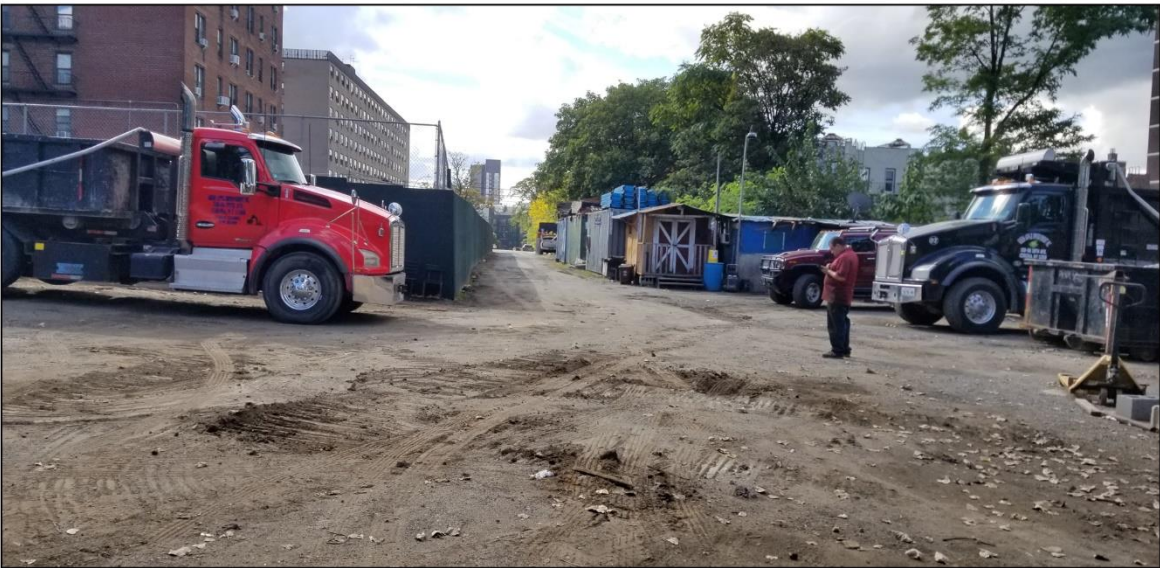
Fig. 17. (bottom) AREA R - View of the 8th Street Easement looking south from Area H.

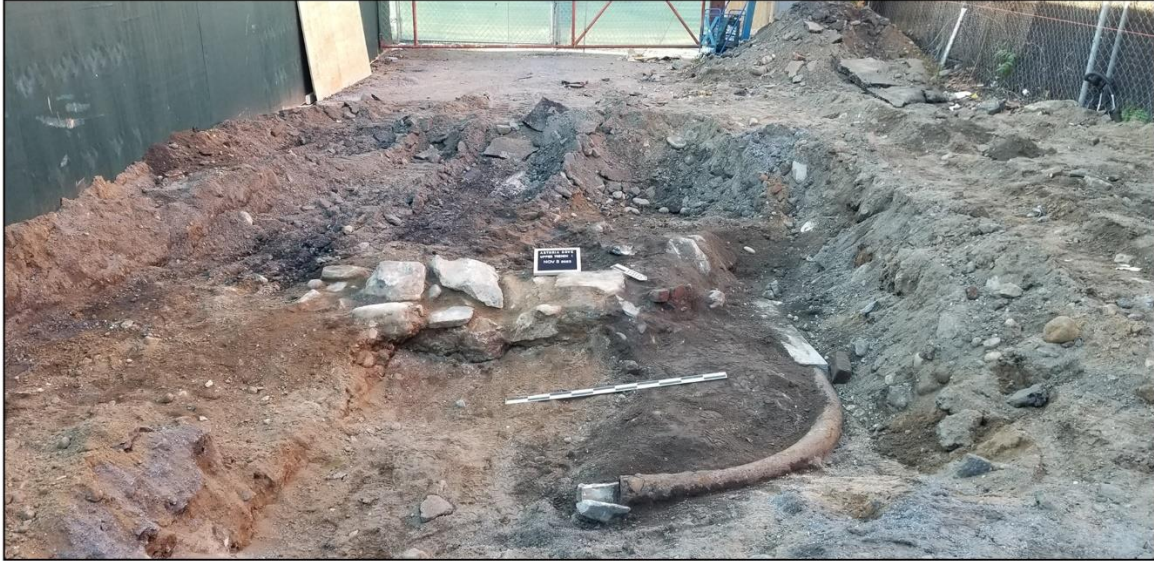
Fig. 18. (top) AREA R - View of the excavation with 27<sup>th</sup> Avenue at the top (south).

To excavate the pipe and any features possibly associated with it, the first trench was backfilled so the backhoe could manoeuvre in the narrow road. We opened an area approximately 14.0 feet north-south and extending across the eastern two-thirds of the roadway (Fig. 18, p. 31). We used a combination of backhoe and hand excavation in this trench. The south end of the pipe was inserted into a rectangular, cut stone block while its curved end terminated in a trough-like spout of molded concrete. South of the pipe was a tumbled row of large, block-like cobbles, possibly once part of a wall. These features lay in dark brown soil. We noted a few pieces of brick and a handful of artifacts consisting of fragments of glass bottles and non-diagnostic ceramic shards. On the eastern half of the area, the soil was yellowish-brown sandy silt. The trench was excavated to a depth of approximately two feet but no other intact features were found. The pipe does not appear to have been associated with a building. We concluded that the area was disturbed by the street repavings or other in-ground work, such as the laying of the pipe.

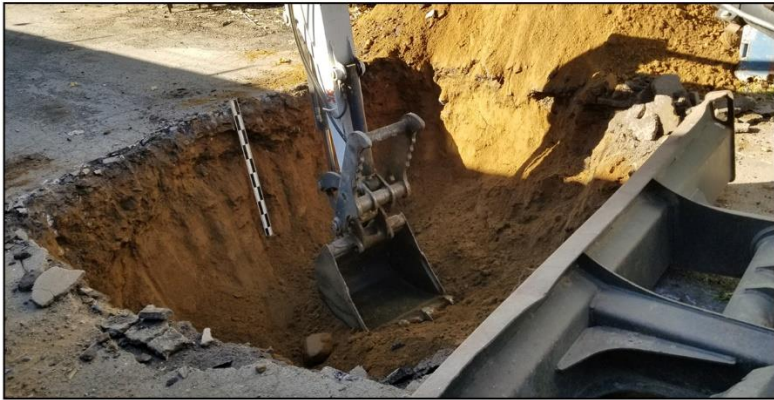
Fig. 19. (middle) AREA R – View of trench 2 at the end of excavation, looking southwest.

The southern of the two trenches, measuring approximately 10.2 feet east/west and 8.0 feet north/south, was filled with reddish-yellow silty sand below the asphalt. We excavated to 42.9 feet above msl, or a depth of about 5.0 feet in this layer without observing any material culture remains (Fig. 19, p. 31).

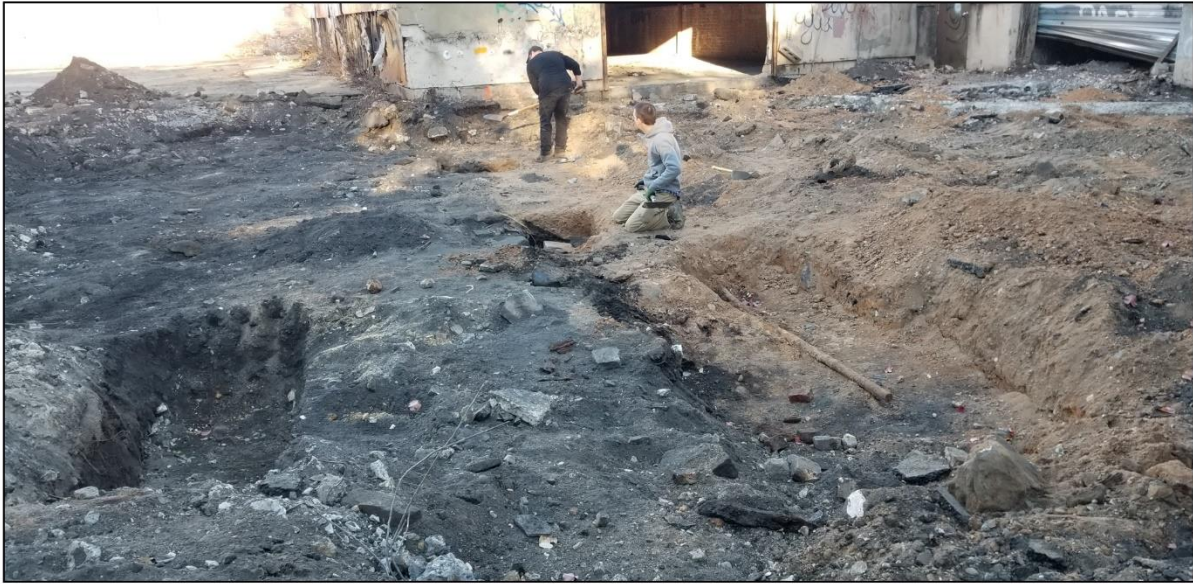
Fig. 29. (top) AREA B – View from near the southeast corner of the area looking west.

Immediately under the concrete, we observed a layer of very dark grey to black soil. This was clearly demarcated from the rest of the area, which was made up of reddish-yellow sand full of small stones (Fig. 29, p. 40). The very dark grey silt layer covered the narrow section exposed in front of the stucco building, which was approximately 12.0 feet wide, extended north just beyond the building's southeast corner and continued east across the yard to the east lot line.

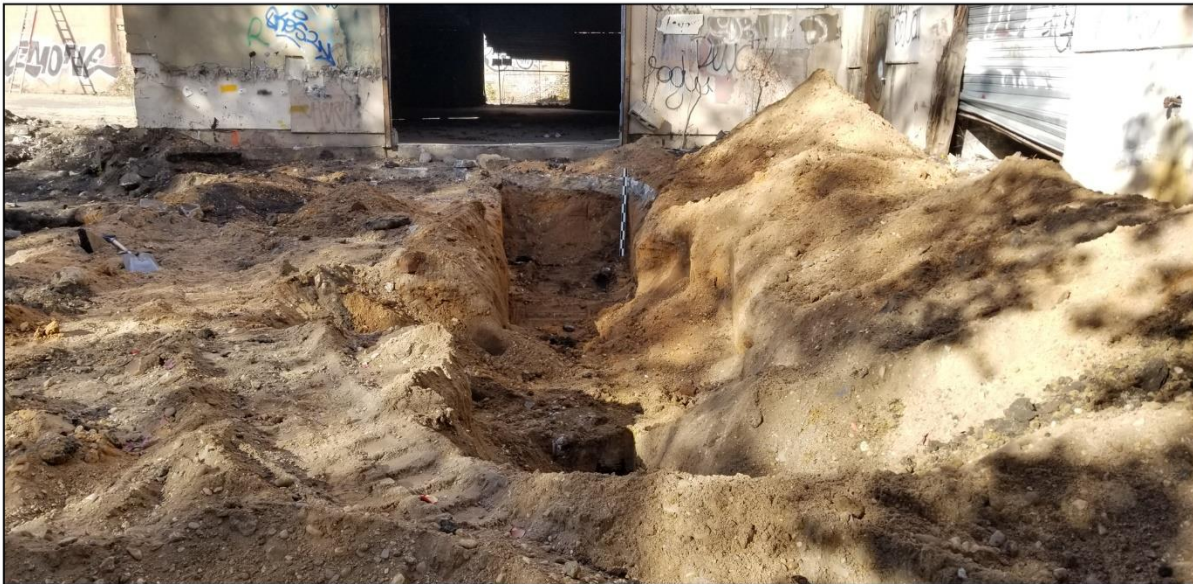
Fig. 30. (bottom) AREA B – View of the excavation trench in the middle of Area B looking west.

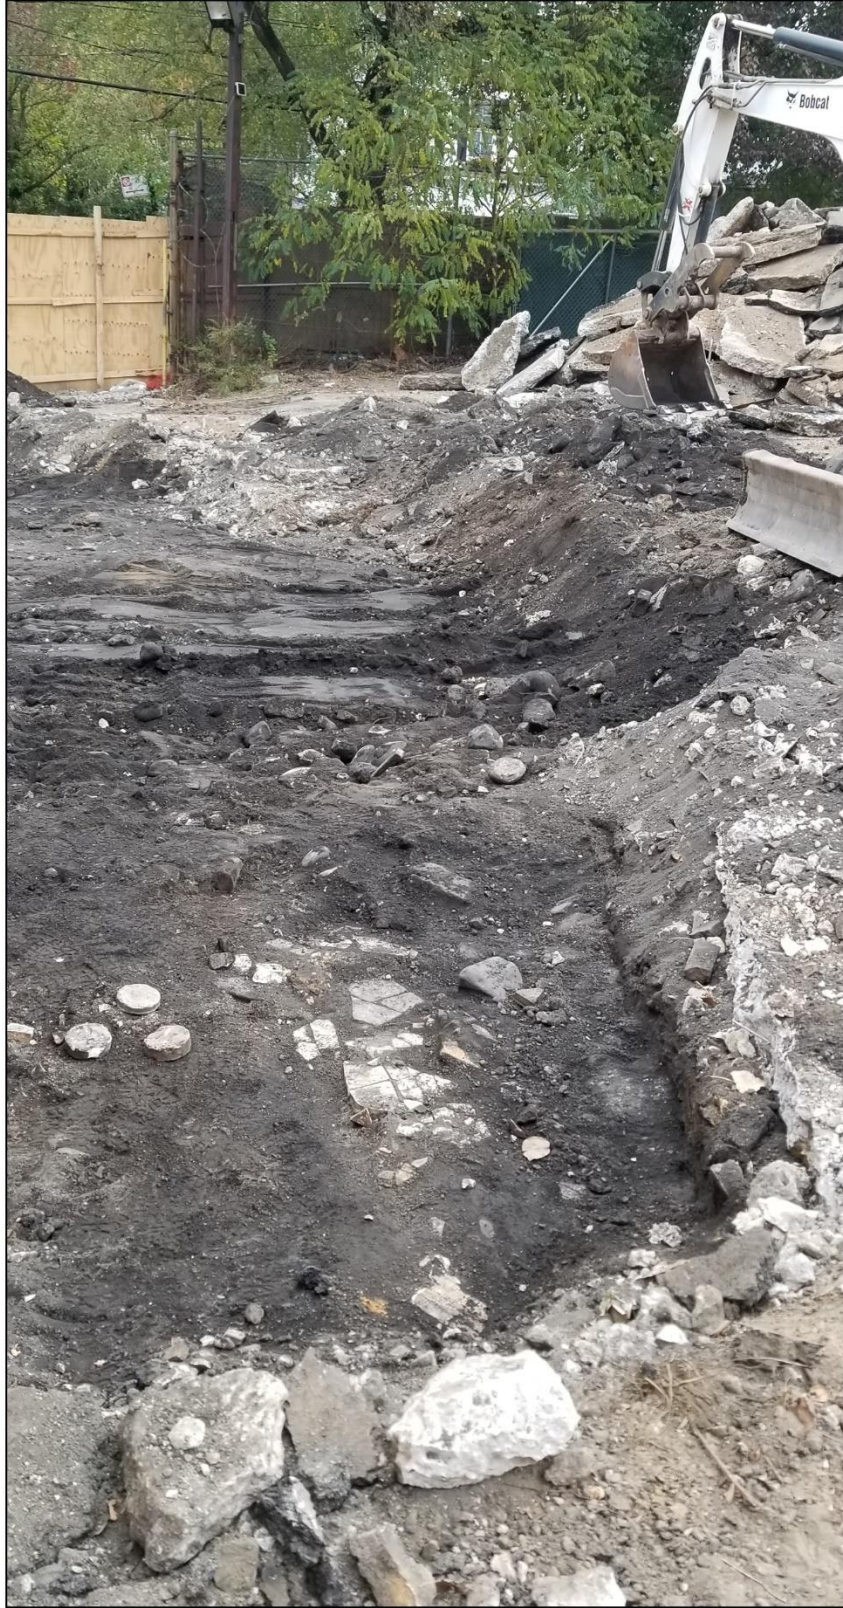
Fig. 31. AREA B – View of the southwest corner of the excavation with the marble fragments, looking east.

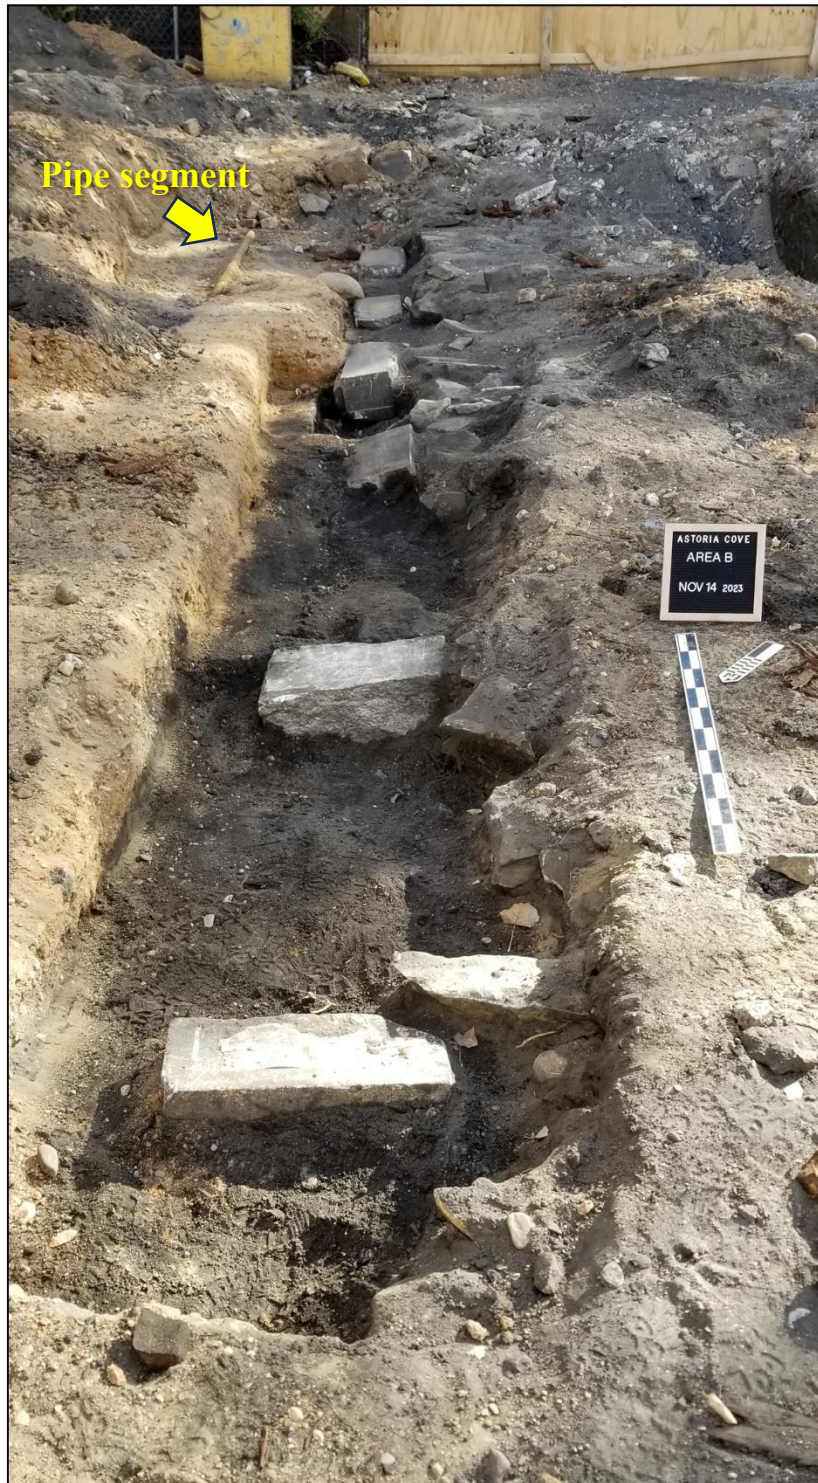
Fig. 32. AREA B – View of the row of stone blocks at the north edge of the Very dark grey soil looking east.

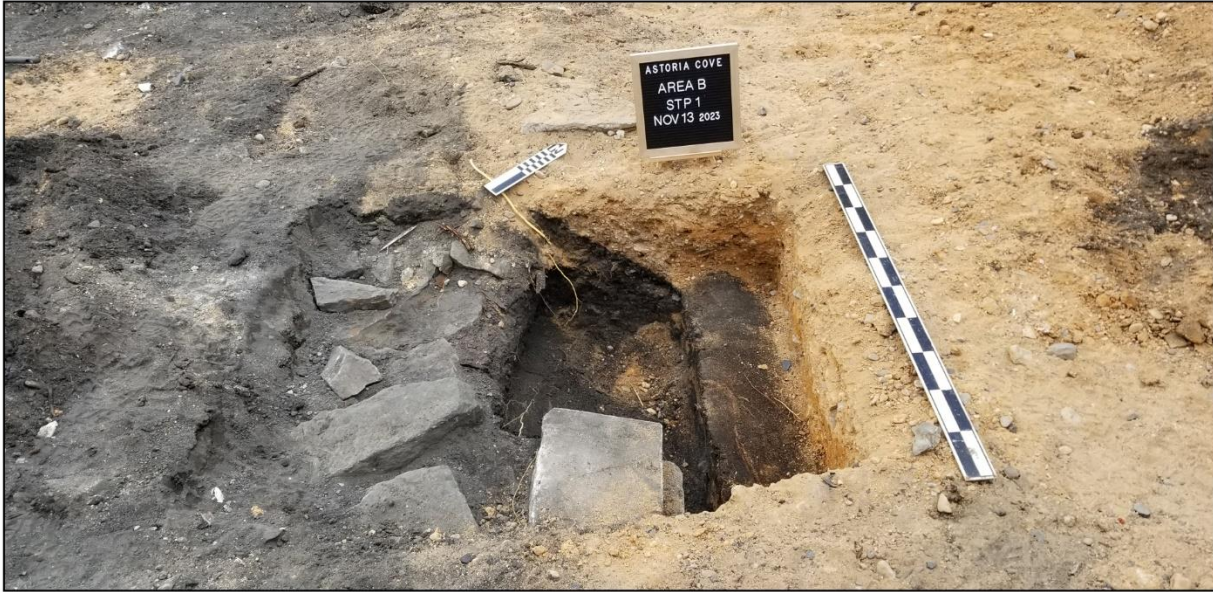
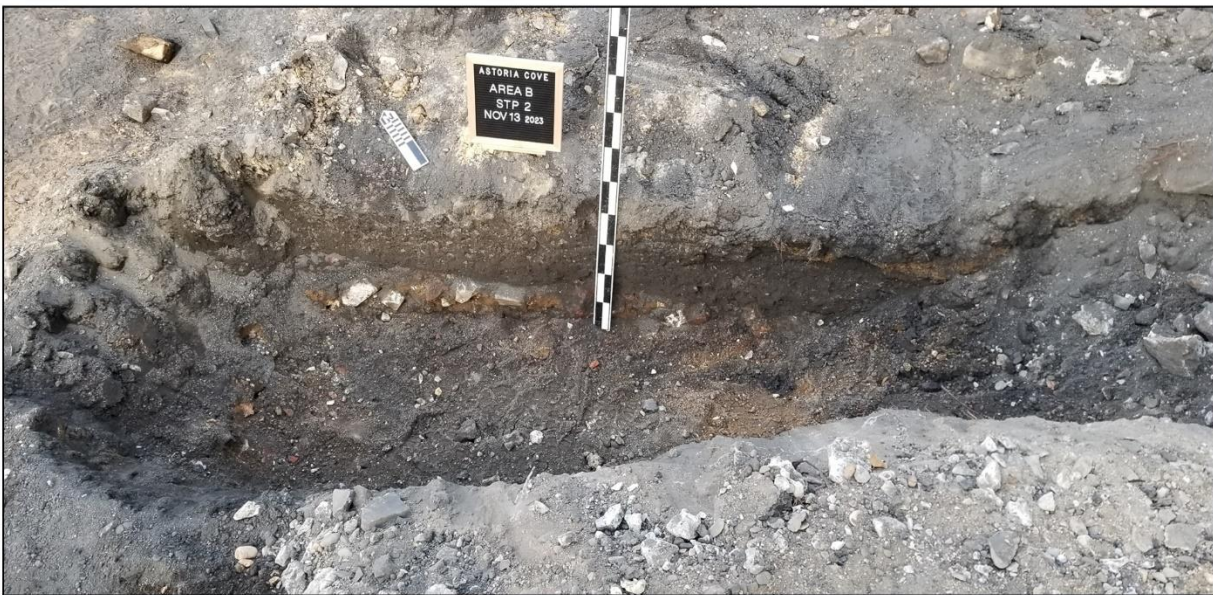
Fig. 33. (top) AREA B – STP 1 at the end of excavation.

Fig. 34. (bottom) AREA B – STP 2 at the end of excavation.

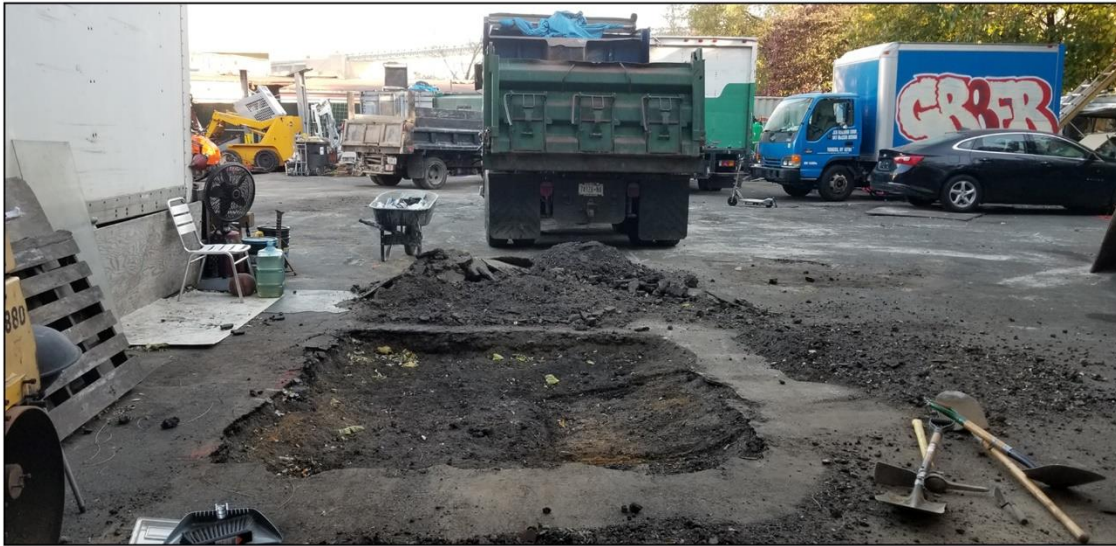
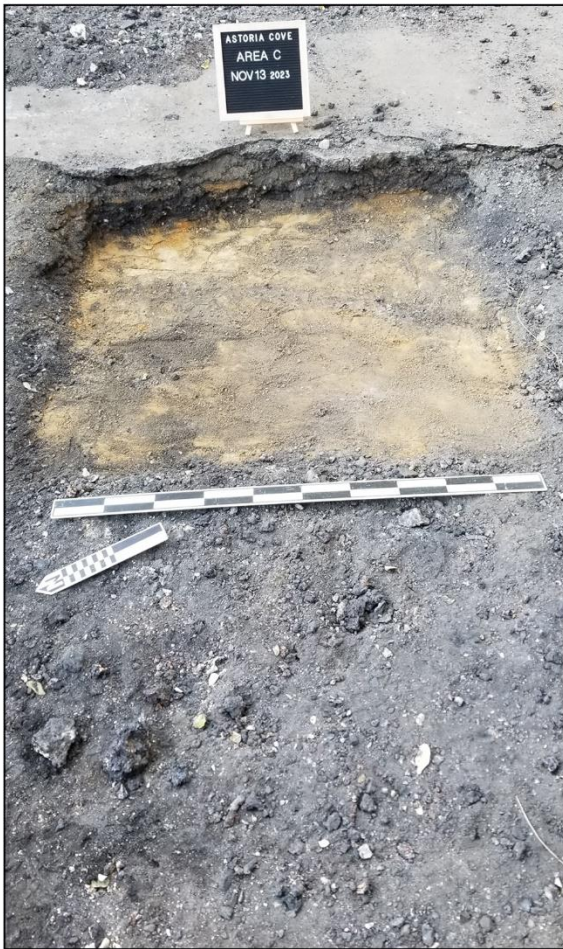
Fig. 35. (top) AREA C – View of the test trench looking north.

Fig. 36. (bottom left) AREA C – The clinker and slag layer around the excavation square below the concrete, and the yellow sand within the trench below it.

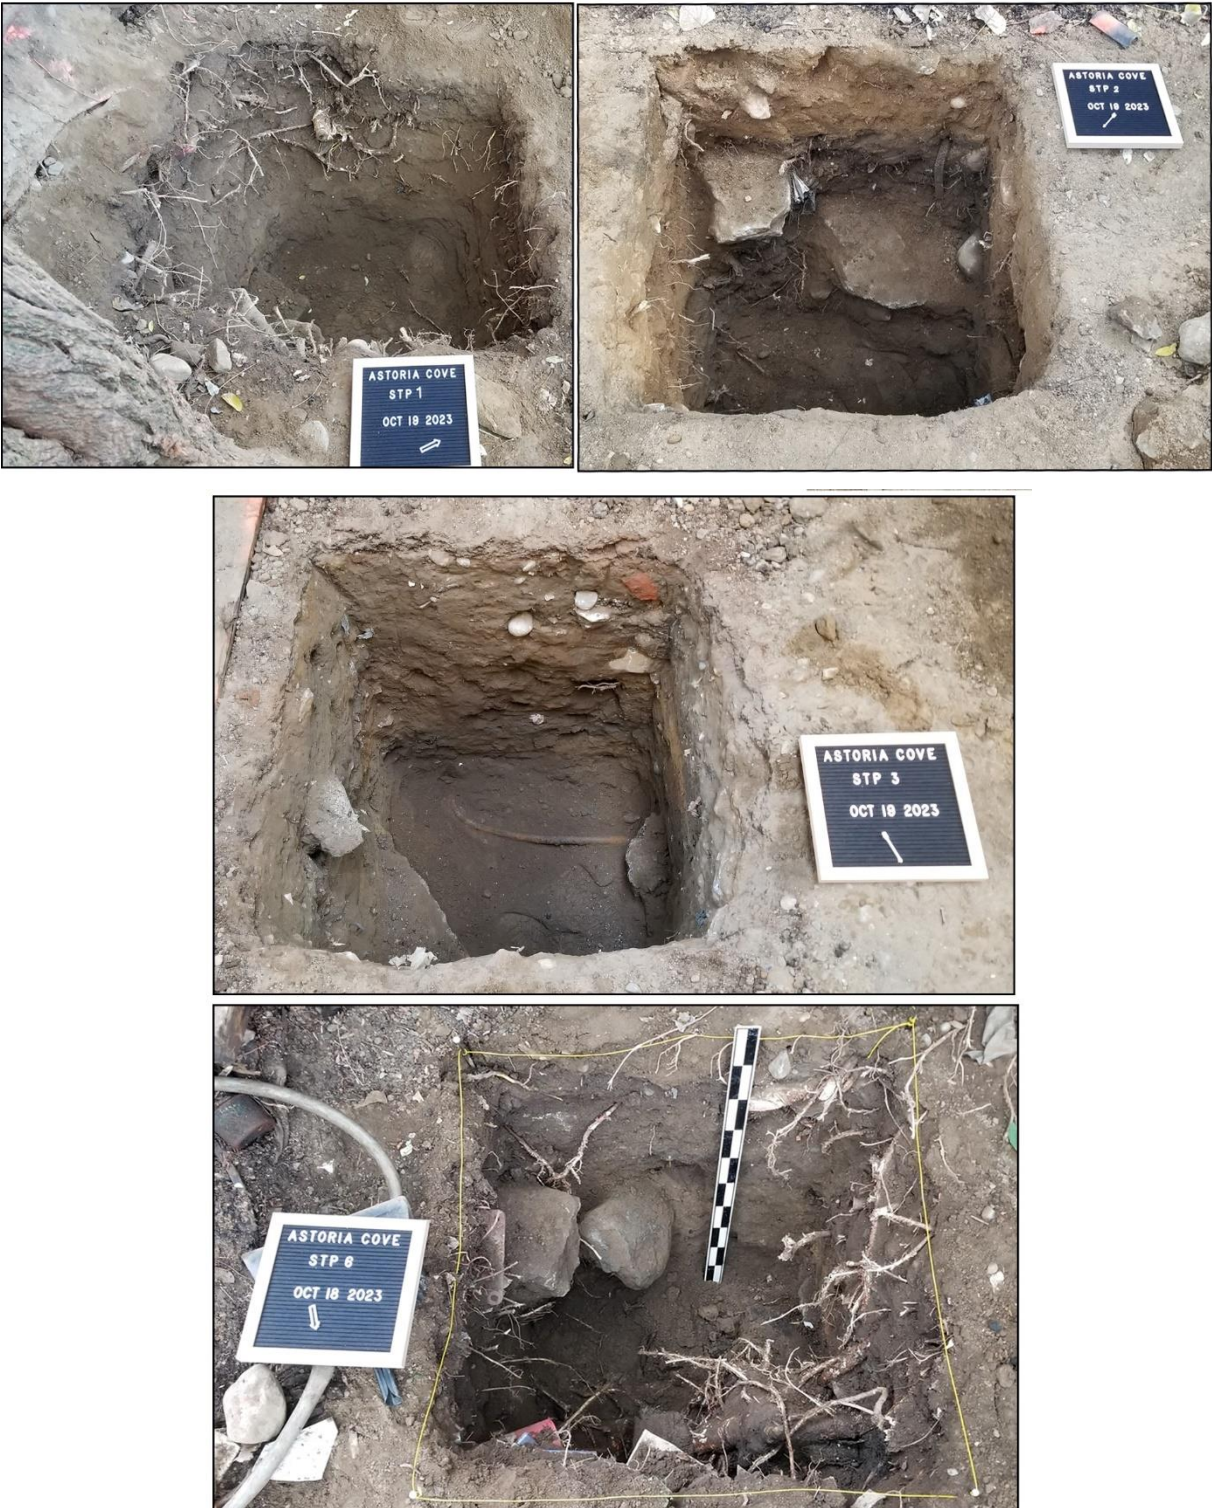
Fig. 36. AREA H – Test trenches, 1 (top left), 2 (top right), 3 (middle and 6 (bottom) at the end of excavation.

In TR 2, the top, 5.0-inch layer of asphalt and gravel was followed by an approximately 19.0-inch thick layer of yellowish-brown sandy silt mixed with medium and large cobbles. Below this was a brown, more compact layer of a similar sandy silt with large, slab-like cobbles. This trench was excavated to a depth of 4.0 feet (42.7 feet above msl). Plastic refuse was found throughout the soils removed from this trench.

In TR 3, below a 3.0-inch layer of gravel, there was an approximately 19.0-inch thick layer of yellowish-brown sandy silt. Within this layer, up to 3.0-inch-thick deposits of gravel were unevenly distributed between 14.5 and 23.0 inches below the surface (45.5 feet to 44.8 feet above msl.) Below this came a darker yellowish-brown, finer textured sandy silt, as noted in TR 2. At the bottom of this trench, 33.0 inches below the surface (43.8 feet above msl), we encountered a metal pipe. The trench was closed at this depth.

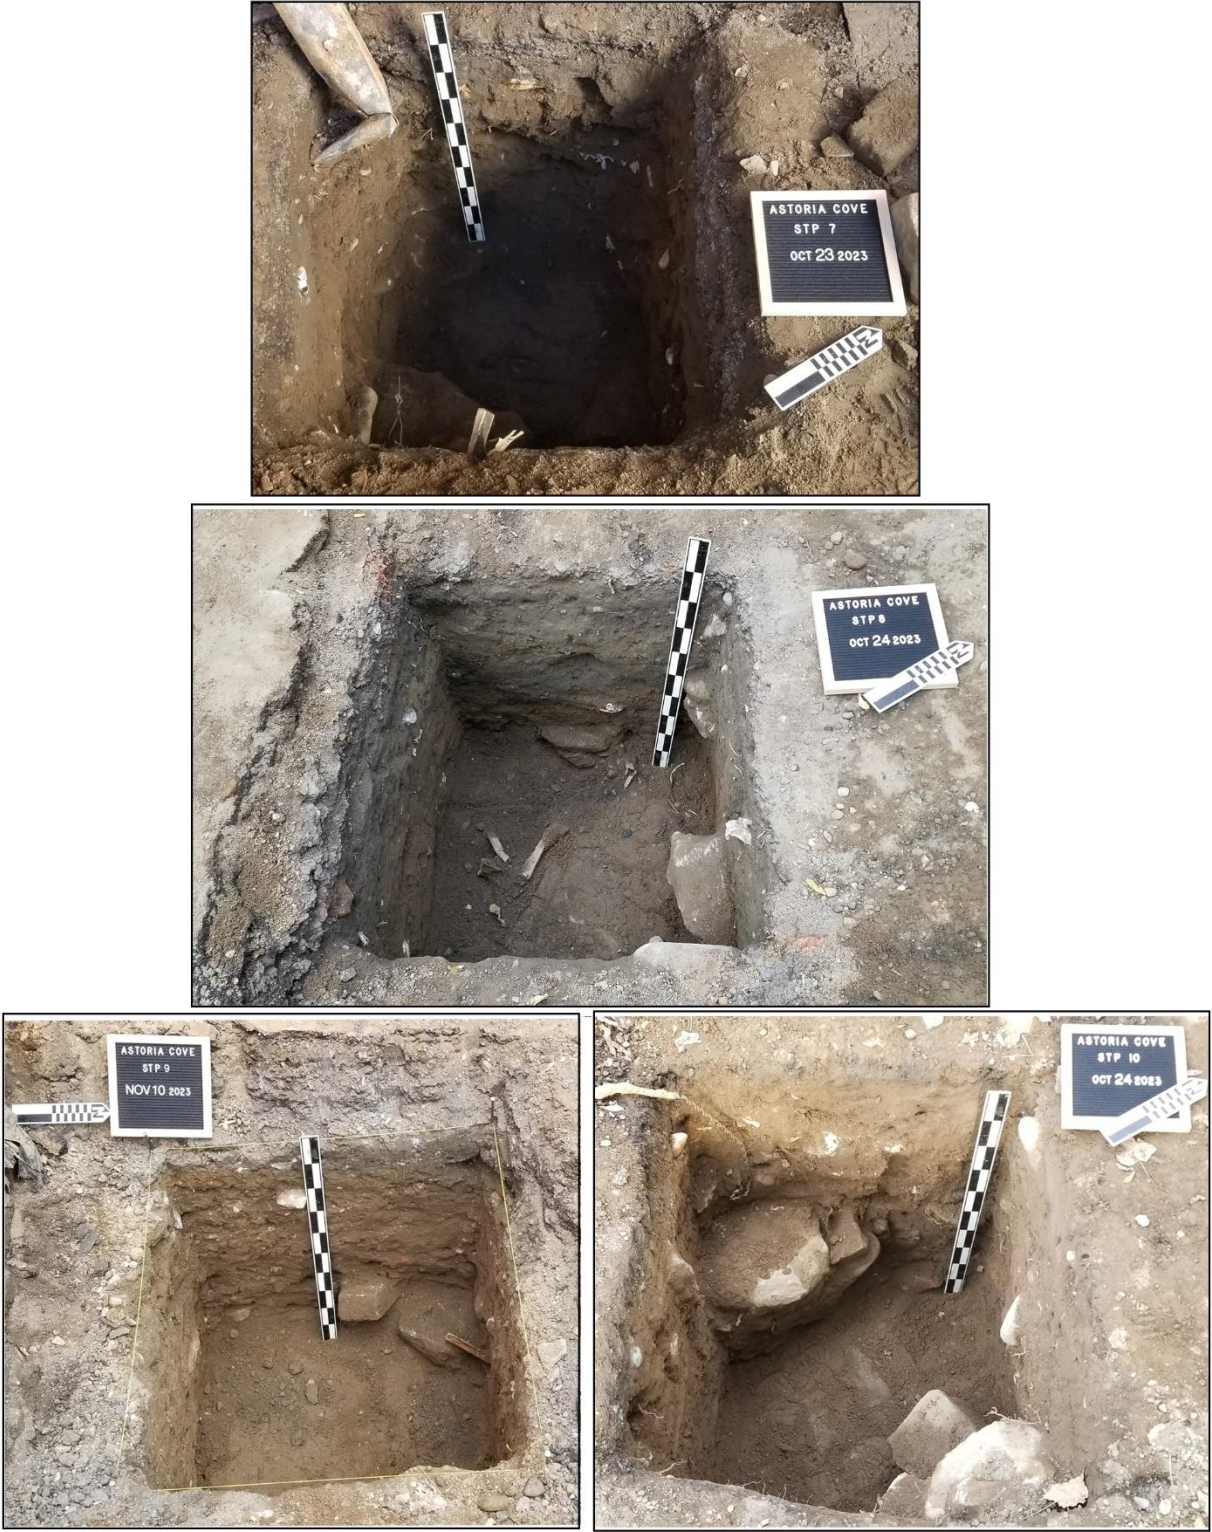
Fig. 37. AREA H – Test trenches 7 (top), 8 (middle), 9 (bottom left) and 10 (bottom right) at the end of excavation.

TR 7 contained a large metal beam on its west side. Industrial debris was noted throughout the trench, down to 4.0 feet depth, 42.9 feet above msl, at which point, the trench was closed.

In TR 8, the layer of yellowish-brown sandy silt mixed with grey began approximately 1.3 feet below the surface, 45.6 feet above msl. At 44.5 feet above msl, the quantity of large cobbles increased, on top of and within the following finer textured brown sandy silt layer. Metal detritus was noted throughout the deposit. A large piece of metal was encountered at 43.1 feet above msl, running across the bottom of the trench, together with large cobbles, and the trench was closed.

In TR 10, the asphalt layer was thinner than in TR 8, and the yellowish-brown sandy silt layer began approximately 46.6 feet above msl (6 inches below the surface). Large cobbles began at the top of the finer textured brown sandy silt layer, approximately 44.9 feet above msl (2.2 feet below the surface). Plastic garbage was noted throughout this layer. This trench was closed at 43.6 feet msl (3.5 feet below surface) when large cobbles blocked the bottom of the trench.

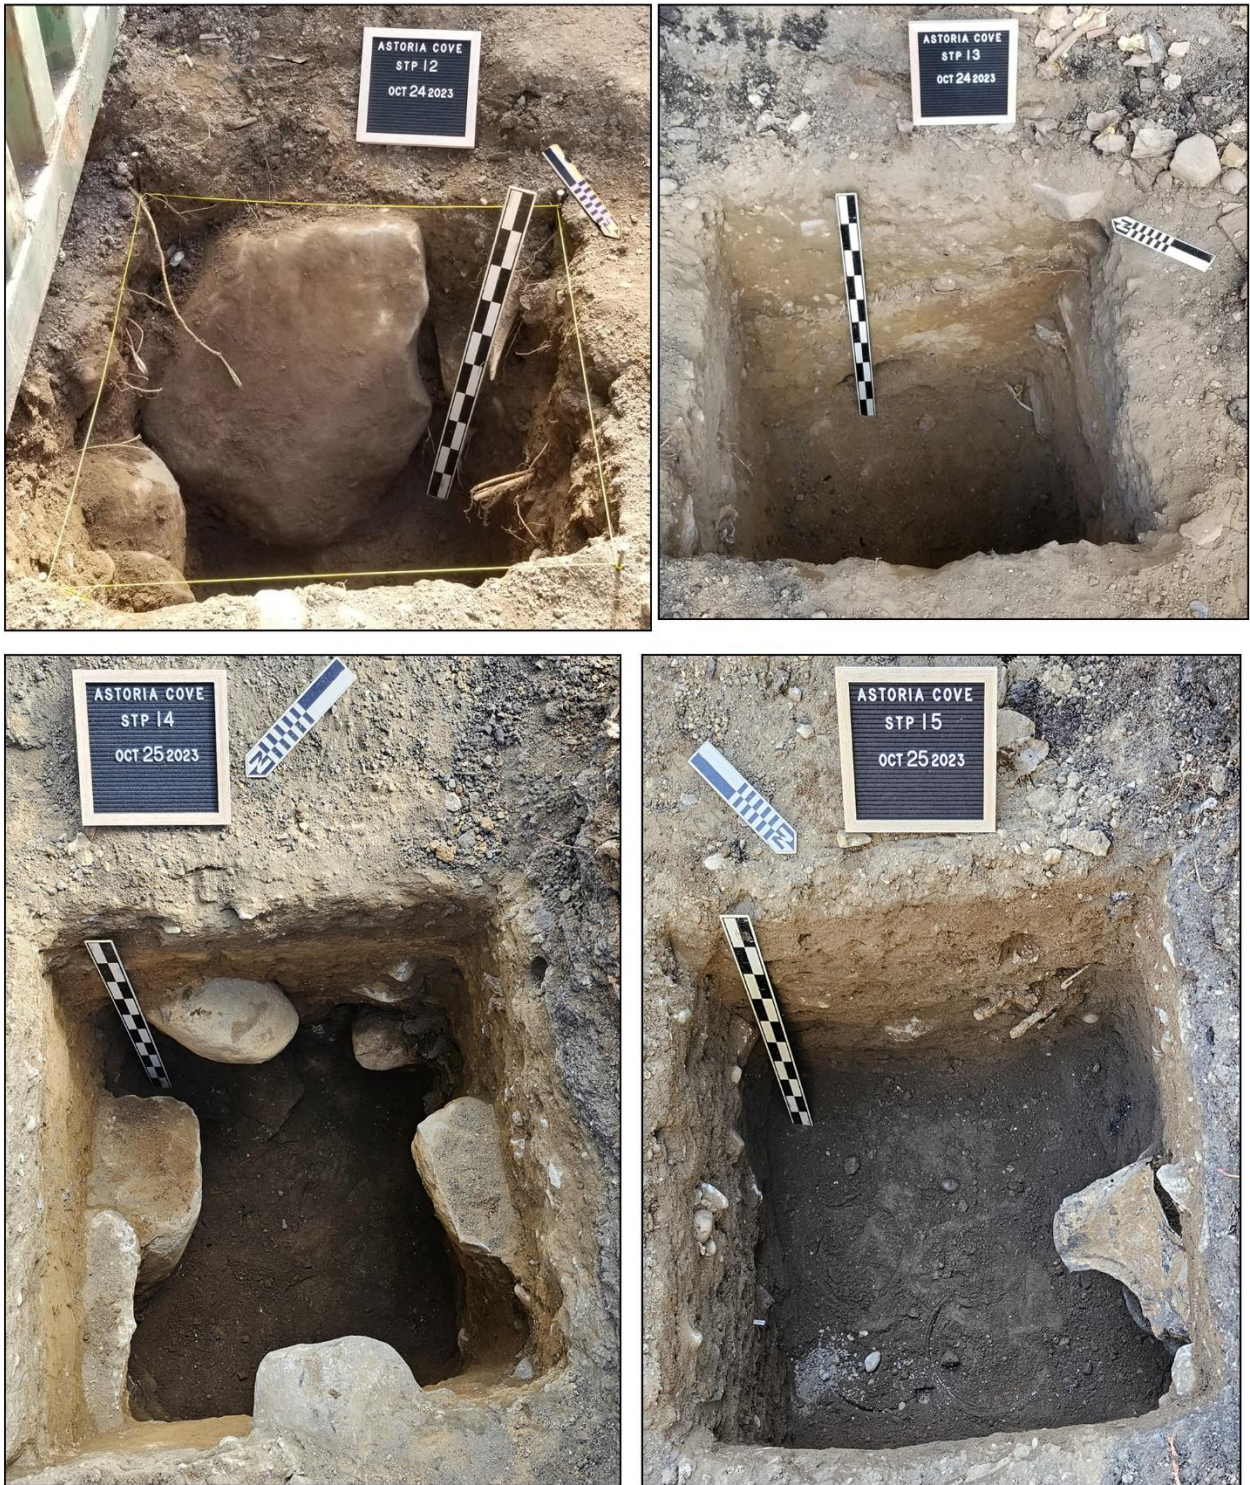
Fig. 38. AREA H – Test trenches 12 (top left), 13 (top right), 14 (bottom left) and 15 (bottom right) at the end of excavation.

In TR 13, approximately 9.0 inches of gravel below the asphalt was followed by yellowish brown sandy silt, with many roots in it, which continued to 43.9 feet above msl (42.0 inches below the surface), where the trench was closed. There were many roots and an increase in the amount of plastic, glass and metal refuse was observed at 44.4 feet above msl. There was an embossed brick stamped "JJJ", manufactured by the company Juan Jacinto Jova, dated ca. 1880s. We noted fragments of white ware.

In TR 14, the yellowish-brown sandy silt layer began approximately 8.0 inches below the gravel later and continued to a depth of 43.7 feet above msl (45.0 inches below surface). At the bottom was a darker, finer textured layer of dark yellowish-brown silty sand. Along with small amounts of mica, coke, a piece of unworked flint and clam shell, there were many tiny fragments of glass and ceramic, including green bottle glass, clear glass, whiteware, a sherd of transfer printed ware, and ceramic pipe fragments, these last found in the lowest layer. There was, however, still plastic detritus at this level, indicating that the material culture remains had been redeposited. This trench was closed at 43.4 feet above msl (4.0 feet below the surface).

In TR 12, below approximately 6.0 inches of the asphalt and gravel layer, a dark yellowish-brown sandy silt layer contained large cobbles and a boulder, which greatly reduced the area that could be excavated. The darker color of this layer may have been due to its moistness. At the bottom of the trench, beginning at 45.1 feet above msl (27.0 inches below the surface), there was a layer of ash and gravel fill. This trench was closed approximately 44.6 feet above msl (34.0 inches below the surface). A section of bathroom tile, a plastic bottle cap and glass were noted in the dark yellowish-brown layer.

In TR 15, below approximately 10.0 inches of the asphalt and gravel layer, the yellowish-brown sandy silt layer contained a great deal of building detritus, such as nails, glass and brick, as well as some housewares, including pieces of a printed glass vessel, the base of a bottle, a piece of white ware and further, non-diagnostic ceramic fragments. Pieces of shell were also noted. The trench closed at 43.9 feet above msl (4.0 feet below the surface).

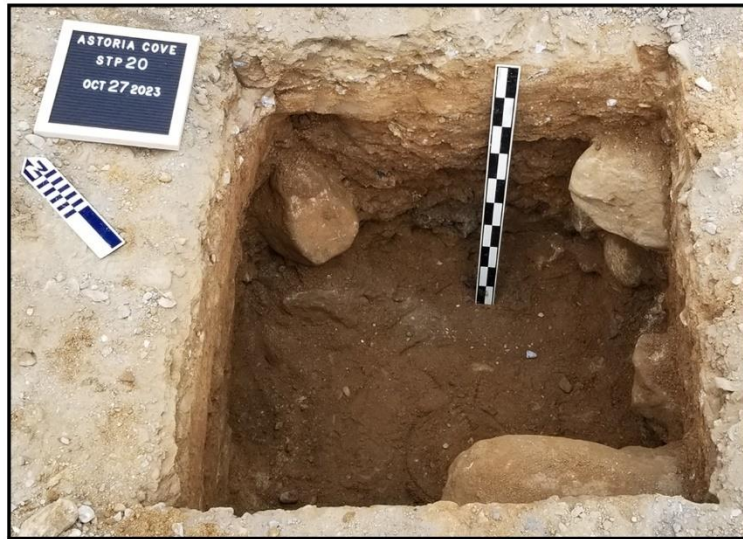
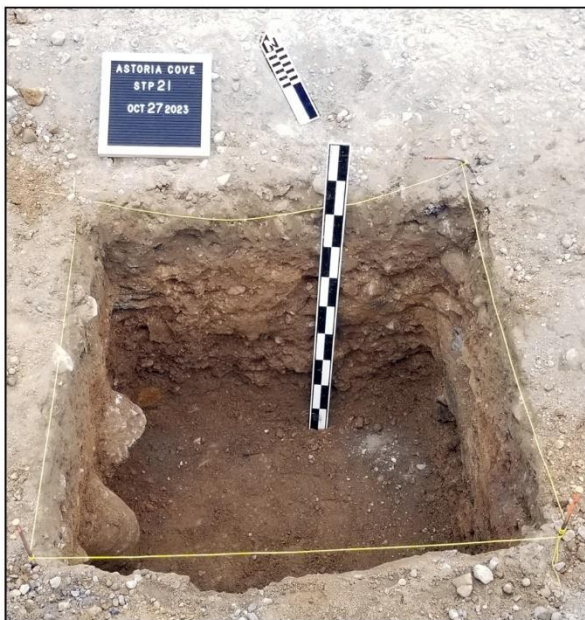
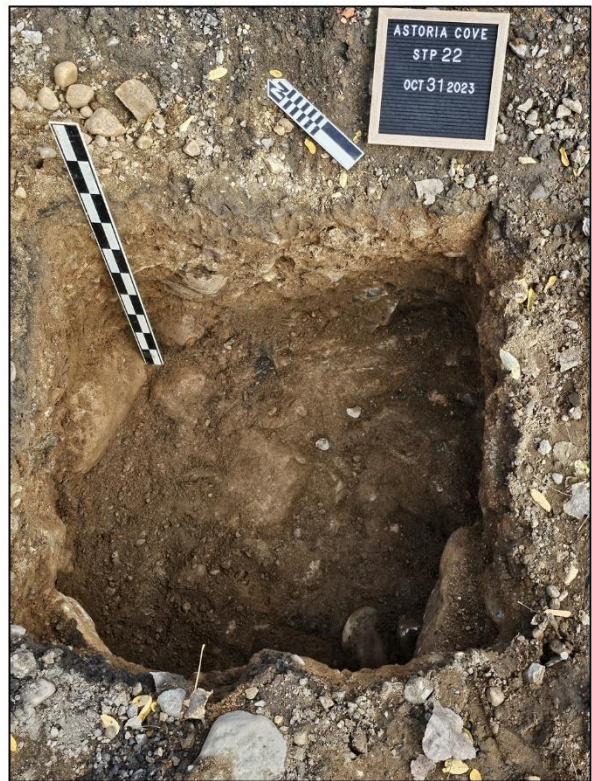
Fig. 40. AREA H – Test trenches 20 (top), 21 (bottom left) and 22 (bottom right).

**TR 22** (Fig. 40, p. 56)

This trench was excavated in the line of 8<sup>th</sup> Street, south of TR 21. There were a number of glass fragments and metal hardware in the yellowish-brown sandy silt layer, which began approximately 9.0 inches below the surface layer of asphalt and gravel. At 45.7 feet above msl (2.0 feet below the surface), the soil shaded to reddish-brown and the texture became coarser and sandier with more pebbles and small- and medium-sized cobbles in it. Since there no finds, down to 3.0 feet depth, this may have been virgin soil. The trench was closed at 44.7 feet above msl.
