**PHASE IB ARCHAEOLOGICAL TESTING**

**ASTORIA COVE DEVELOPMENT**

**Department of City Planning 13DCP127Q**

**Borough of Queens, New York**

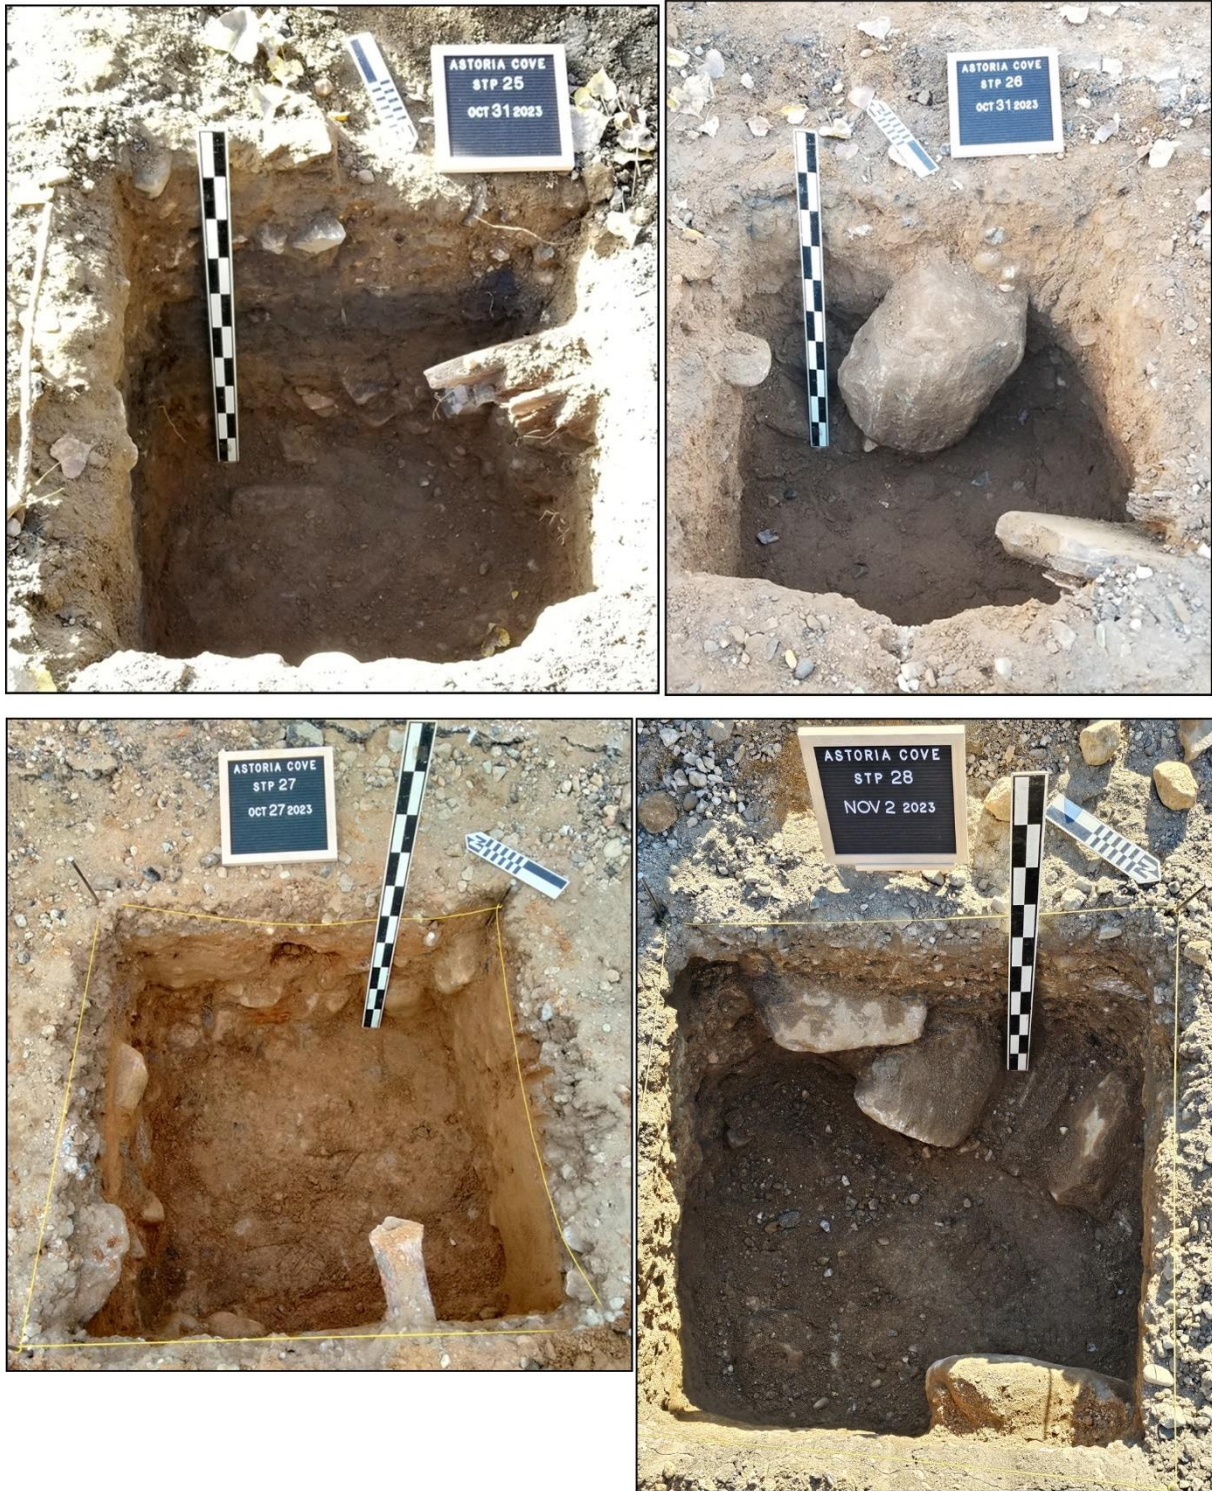
Fig. 41. AREA H - Test trenches 25 (top left), 26 (top right), 27 (bottom left) and 28 (bottom right) at the end of excavation.

In TR 25, below the asphalt and gravel layer, there was a great deal of wood building material in a matrix of reddish-brown soil containing many pebbles and small cobbles. This layer, between 47.5 and 46.8 feet above msl (16.0 and 24.0 inches depth), was followed by dark grey sandy silt, from approximately 46.8 to 46.4 feet above msl. Near the bottom of this layer, we found animal teeth (sheep/goat?) and ceramic fragments. Below 46.4 and the bottom of the trench, at 45.8 feet above msl, there was brown sandy soil with larger cobbles, possibly virgin soil. There were no finds in the lowest layer.

In TR 26, below approximately 9.0 inches of asphalt and gravel, was a layer of yellowish-brown sandy silt, somewhat coarser and sandier than observed in the other trenches and containing many small, medium, and large cobbles. This layer continued to the bottom of the trench, which was closed at 3.0 feet below the surface, 45.6 feet above msl. Aside from one small piece of glass and a sliver of ceramic, there were no finds.

In TR 27, below approximately 10.0 inches of asphalt and gravel, the yellowish-brown sandy silt layer contained many pebbles and small cobbles, though fewer than the trenches north of it, TR 26 and TR 25. At 22.0 inches below the surface, 46.6 feet above msl, we encountered a coarser, reddish-brown layer that appeared to be virgin soil. A few small pieces of glass were noted in the gravel layer, and a piece of metal, but there were no finds below these. The trench was closed at 45.5 feet above msl (33.0 inches below the surface).

In TR 28, below approximately 12.0 inches of the asphalt and gravel layer, there was a layer of coarse, reddish-yellow sand mixed with gravel and medium-sized cobbles. A piece of slag was noted but otherwise there was no construction debris or other material culture remains in this trench. The trench was closed at 45.0 feet above msl (3.0 feet below the surface).

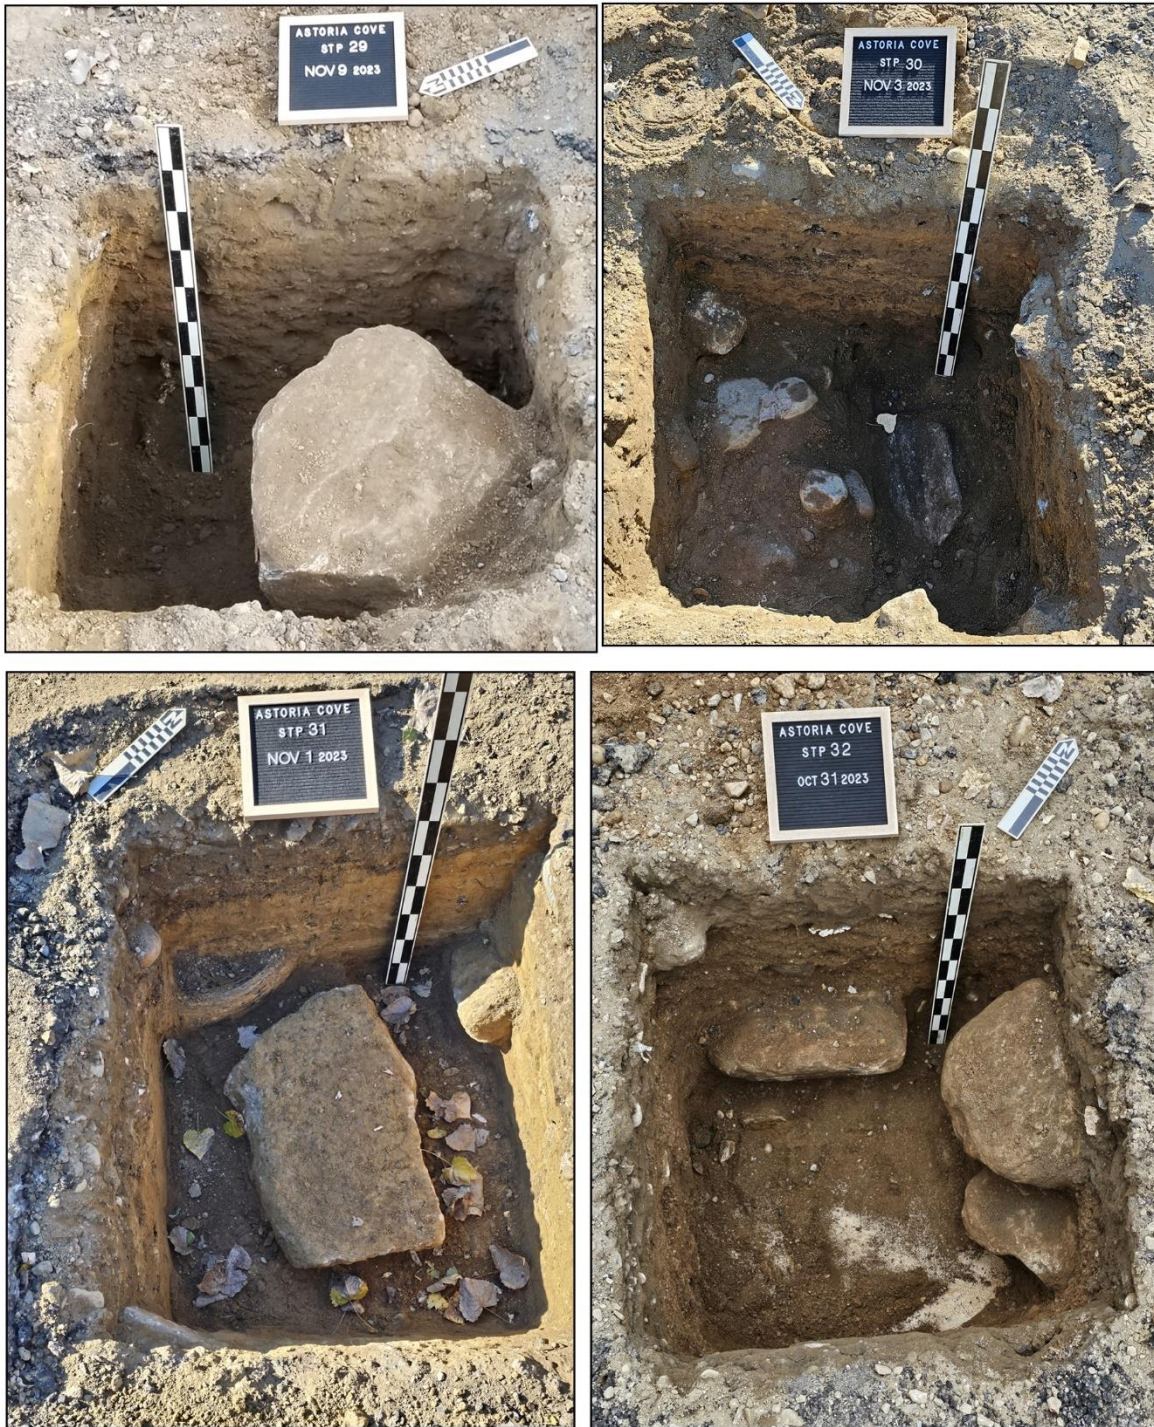
Fig. 42. AREA H – Test trenches 29 (top left), 30 (top right), 31 (bottom left) and 32 (bottom right) at the end of excavation.

In TR 29, below the approximately 6.0-inch gravel layer mixed with many small stones and dark grey silty soil, was a yellowish-brown to brown sandy silt layer that continued to the bottom of the trench, at 42.7 feet above msl (40.0 inches below the surface), where it was closed due to obstruction by cobbles. In the top layer, we noted nails and other metal detritus, fragments of brick, plastic and glass, and two small sherds of white porcelain. In the second layer, we observed larger pieces of metal detritus and brick together with two shell fragments. A boulder in this layer obstructed about one-third of the trench.

In TR 31, the top 11.0 inches contained greyish-brown silt mixed in with the gravel of the asphalt bed. This was followed by 8.0 inches of yellowish-brown sandy silt. At approximately 46.6 feet above msl (19.0 inches below the surface), we encountered a layer of brown silty sand. Industrial detritus was found throughout these layers, including window glass and construction debris, also a tire embedded in the northwest corner of the trench. At the bottom of the trench was a very large slab-like stone. This trench was closed at 46.9 feet above msl. (25.0 inches below the surface).

In TR 32, there was a layer of greyish-brown sandy silt below the asphalt and gravel, down to approximately one foot below the surface. This layer contained a paper-like material, possibly degraded linoleum, fragments of glass, roofing material and metal detritus. This was followed by a layer of reddish-yellow silty sand which continued to the bottom of the trench, which was closed at 3.0 feet below the surface, 46.1 feet above msl. This layer contained large cobbles.

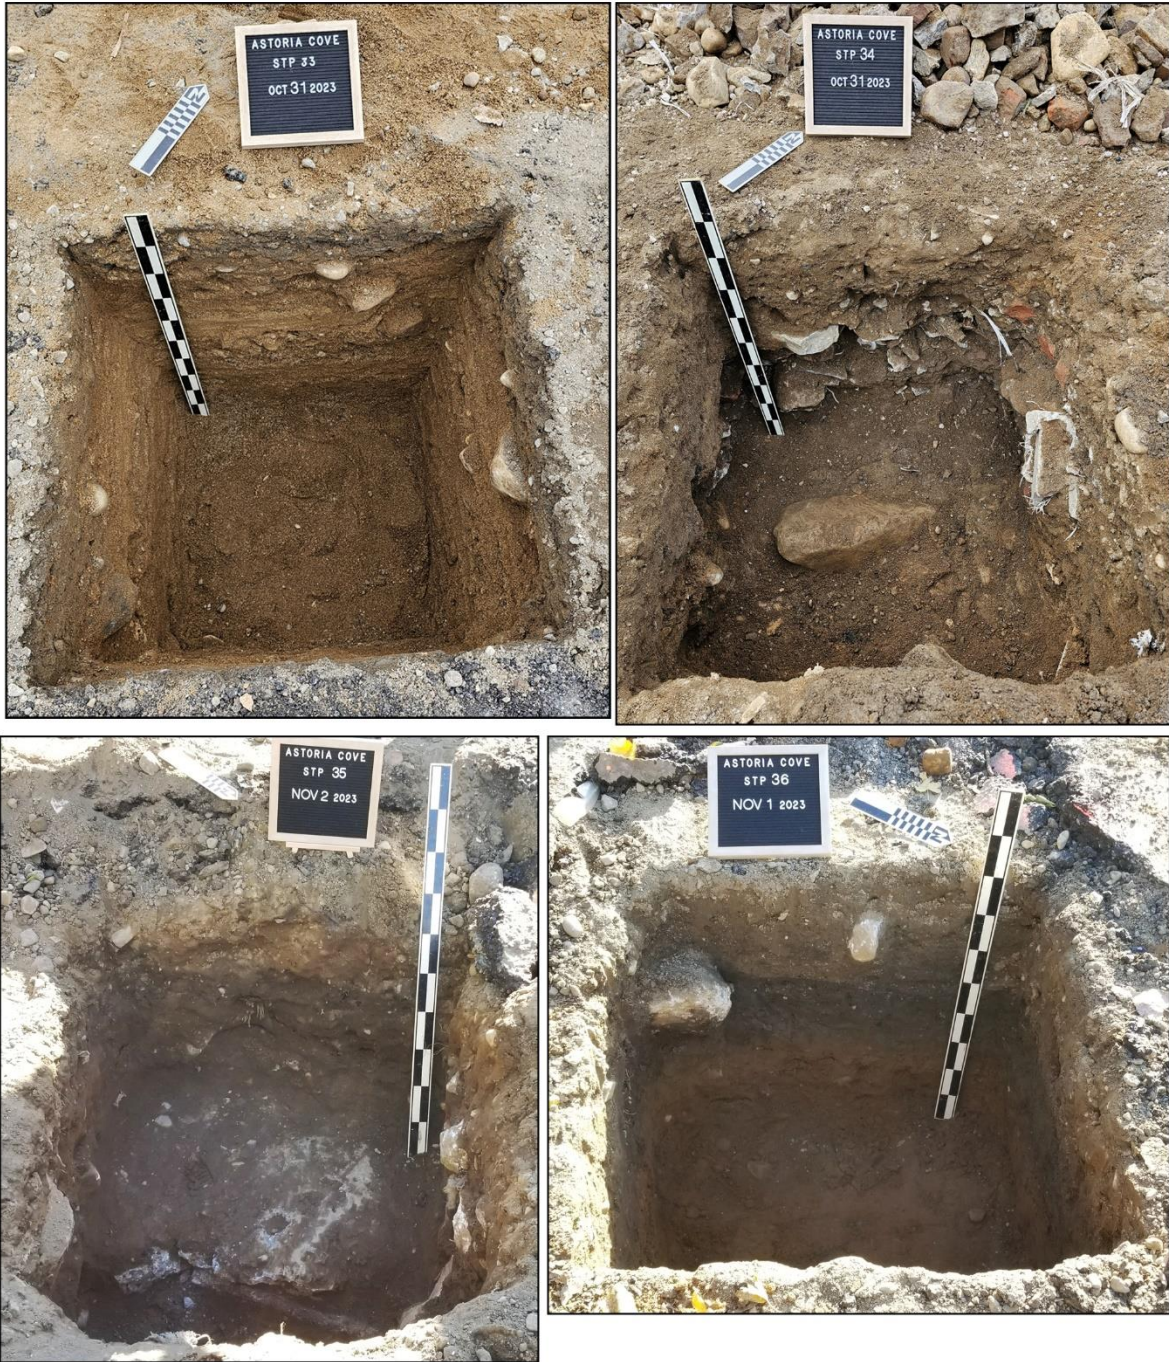
Fig. 43. AREA H - Test trenches 33 (top left), 34 (top right), 35 (bottom left) and 36 (bottom right) at the end of excavation.

In TR 36, below 12.0 inches of gravel and sand we reached the yellowish-brown sandy silt layer, which continued to about 20.0 inches depth, 48.4 feet above msl. This was followed by brown sand topped by a few medium-sized cobbles. In the gravel layer there were hand made nails, tile, and glass fragments. One piece of ceramic was found in the yellowish-brown sandy silt layer. The lowest layer was devoid of finds down to 45.6 feet above msl (35.0 inches below the surface), where the trench was closed.

In TR 33, the yellowish-brown sandy silt layer continued to 18.0 inches below the surface, 47.6 feet above msl, followed by a layer of yellowish-red sand mixed with cobbles to about 47.0 feet above msl. Below this layer, yellowish-brown sand with some gravel continued to 46.2 feet above msl (36.0 inches below surface), where the trench was closed. We noted a piece of graphite, impressed glass and metal hardware.

In TR 34, the layer below the approximately 8 inches of asphalt and gravel was the yellowish-brown sandy silt mixed with brownish-grey loosely packed silty sand containing many pebbles and small cobbles together with brick detritus, woven cloth bagging, a fragment of an oyster shell and plastic, probably all redeposited material. Approximately 47.3 feet above msl (2.0 feet below the surface), the soil became sandier and slightly darker in color. In this layer we noted more woven cloth bagging, fragments of glass and ceramics and a ceramic pipe stem. This trench was closed at 46.3 feet above msl.

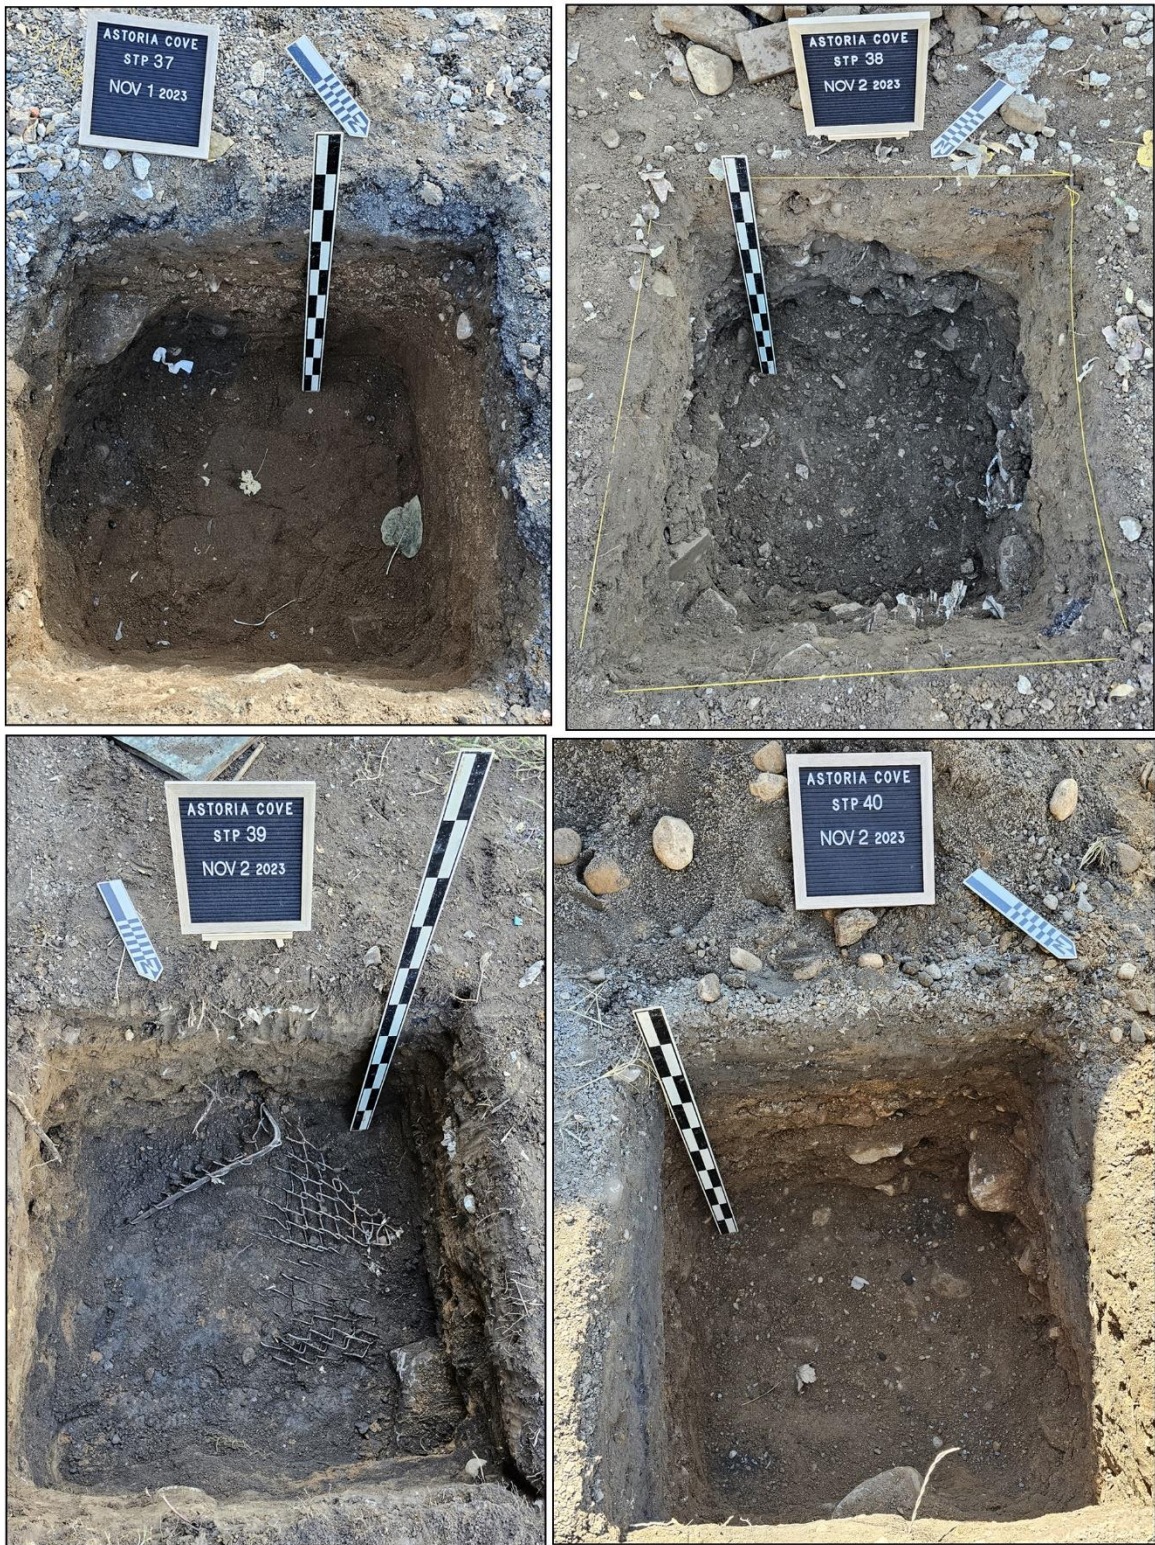
Fig. 44. AREA H - Test trenches 37 (top left), 38 (top right), 39 (bottom left) and 40 (bottom right) at the end of excavation.

In TR 39 contained fragment of shell, ceramic and glass in the top layer of grey soil. The second layer, composed of yellowish-brown sandy silt, was excavated to 46.7 feet above msl (24.0 inches below the surface). In this layer we noted a glass bottle rim and non-diagnostic ceramic fragments.

In TR 37, the first 11.0 inches were composed of grey soil fixed with gravel and small stones. This was followed by a layer of yellowish-brown sandy silt mixed with cobbles. At approximately 22.0 inches below the surface, 48.0 feet above msl, was a layer of sandy yellowish-brown soil. Except for three small pieces of ceramic found near the top of the surface layer, including white ware and one of transferware, at 48.6 feet above msl, there were no finds in the lower layers of this trench, and it was closed at 47.1 feet above msl (32.0 inches below the surface).

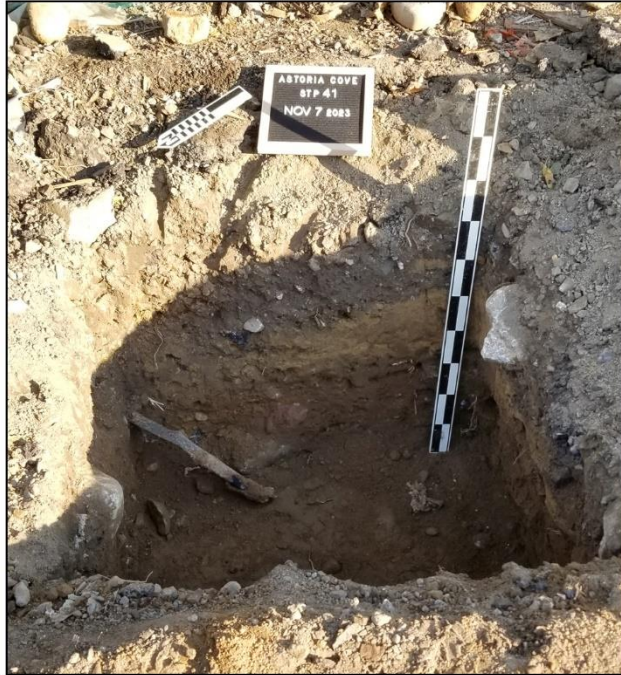
Fig. 45. AREA H – Test trench 41 at the end of excavation.
