# **145 Broome Street Senior Housing Development**

**145 BROOME STREET; BLOCK 341, LOT 62**

## **Phase 1B Archaeological Investigation**

**NOVEMBER 2023**

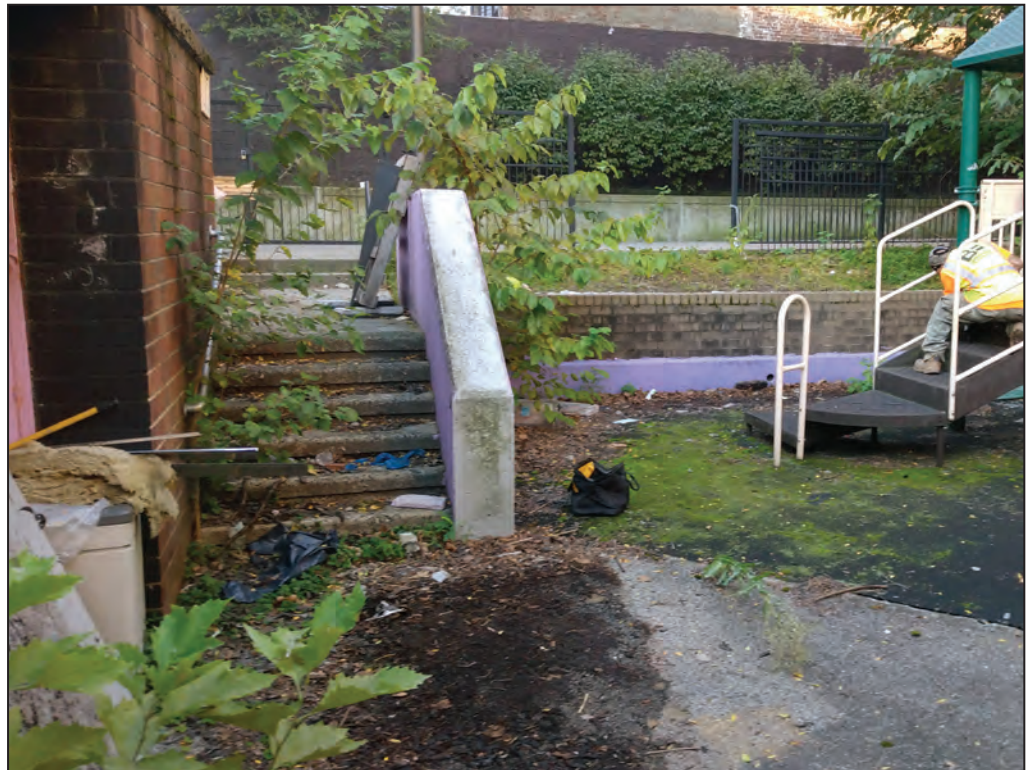
Facing southwest from back of 1-story building towards retaining wall and higher elevation public walkway. Note brick storage/utility structure and concrete stairs to the left and play area to the right. Trench 2 was excavated on the left side of photo **2**

occupied by a 6-story building to the west (**Photo 3**), and a higher elevation grassy area and public walkway to the south (about 31 feet NAVD88) (**Photo 2 and Figure 4**). There are two jungle gyms, which are both constructed on rubber matting, and a 1-story brick storage/utility structure in the test area (**Photos 2 through 5 and 9, 11, and 14**). A low brick retaining wall and two sets of concrete stairs separate the test area from the higher elevation grassy area and public walkway to the south (see **Photos 2 and 5**).

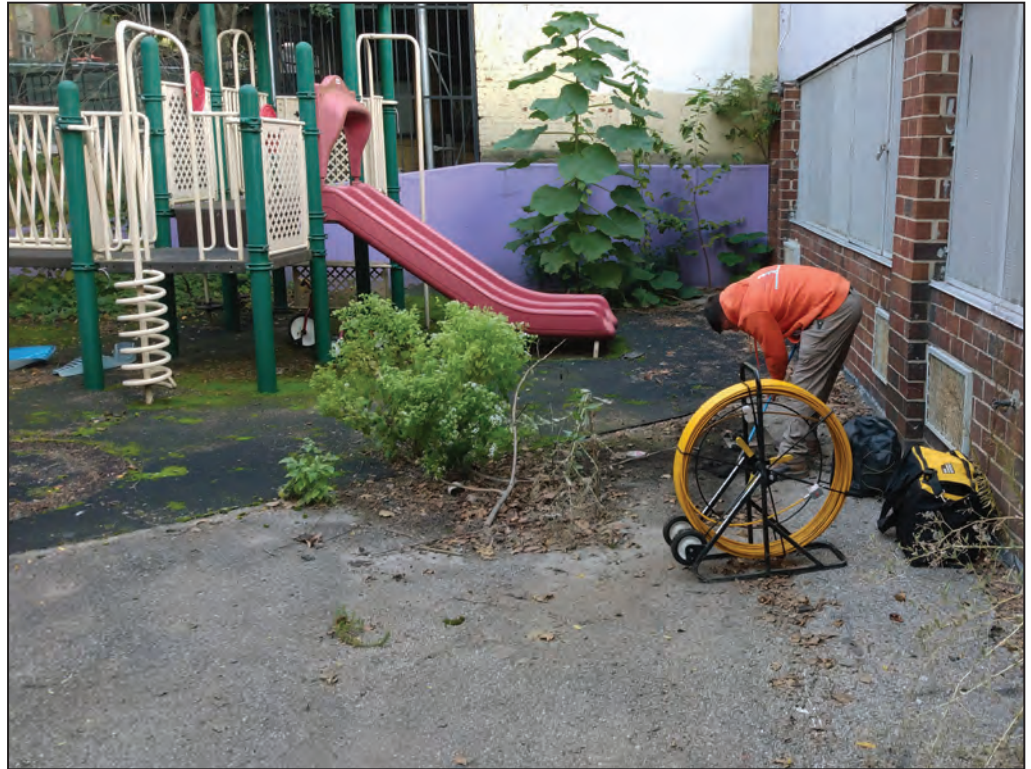
Facing west along back of 1-story building showing location of Trench 1 **3**

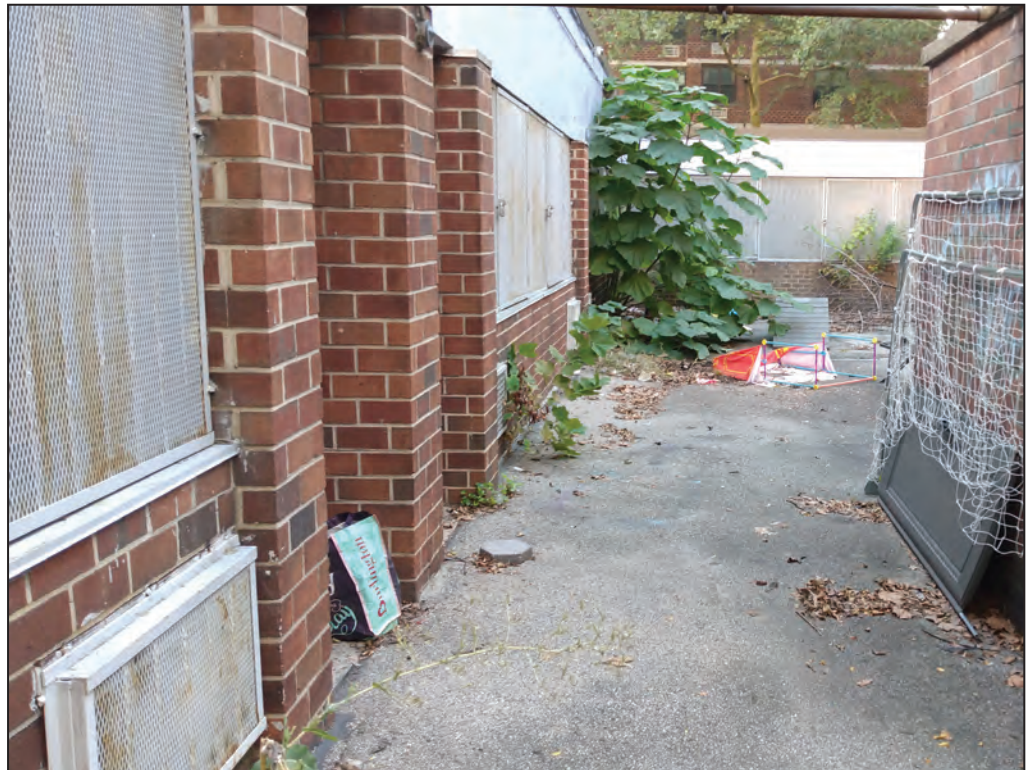
Facing east along back of 1-story building showing location of Trench 3. **4**  
Note brick storage/utility structure on the right

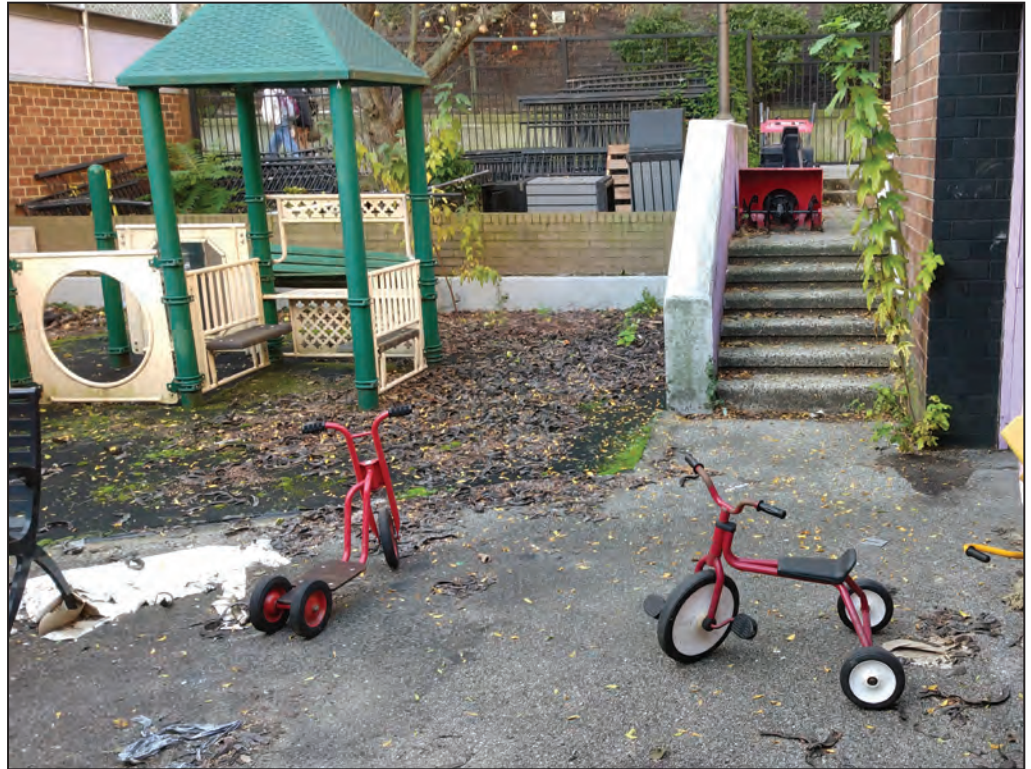
Facing southwest from back of 1-story building along east side of brick storage/utility structure (on the right). Trench 4 was excavated at the leftmost edge of this photo, adjacent to the rear wing of the 1-story brick building **5**

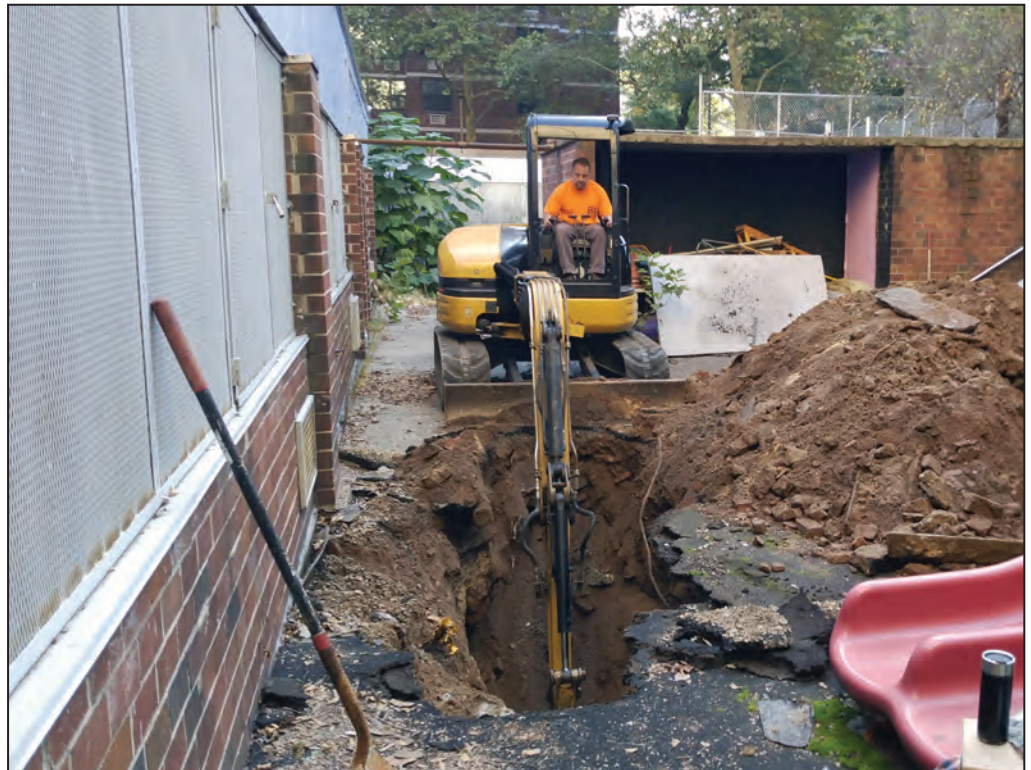
Facing southeast from back of 1-story building showing excavation of Trench 1. **6**  
Note loose brown urban fill with demolition debris

debris such as bricks, brick rubble, concrete, large segments of steel I-beams, and boulders of various sizes. Excavation of Trench 1 encountered a layer of apparently clean grey sand at a depth of about 9 feet below ground surface (17.5 feet NAVD88). However, due to the repeated collapsing of the loose brick rubble of the trench's walls, it was impossible to expose and photograph this layer (see **Photos 6 through 8**). An aluminum Coca Cola can and other modern refuse was observed in the fill. No evidence of shaft features; in situ historical artifact deposits; or original or buried ground surfaces were observed in this trench.

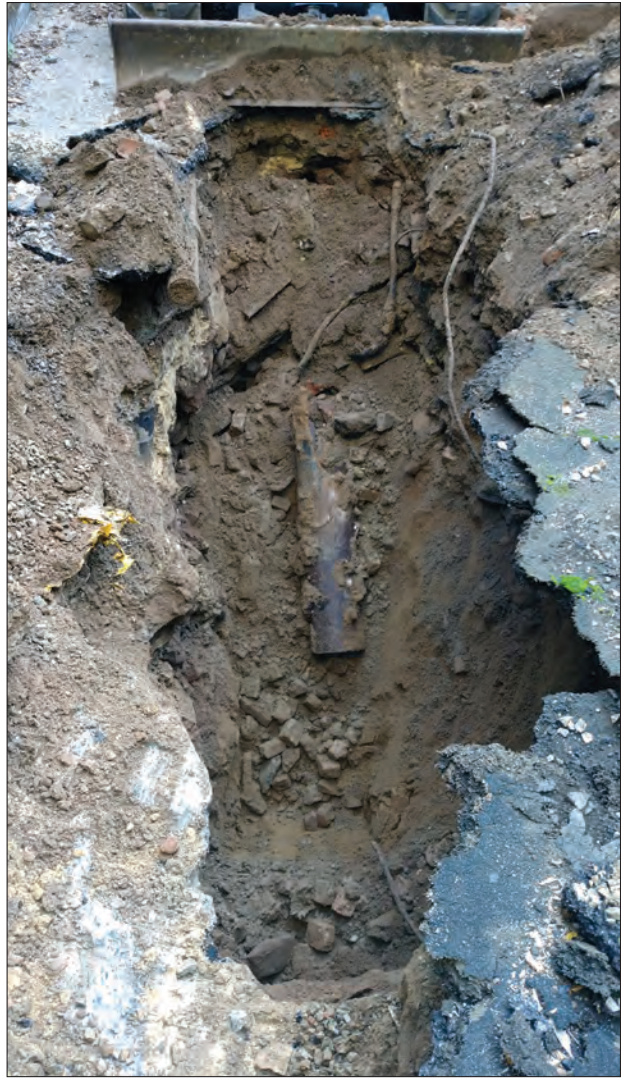
7

Northwest half of Trench 1 showing loose, mixed urban sandy fill, demolition debris, and a disarticulated drainage pipe. The isolated area of lighter brown sandy soil in the trench floor towards the bottom of the photo is approximately 9 feet below ground surface and appears to be undisturbed sand

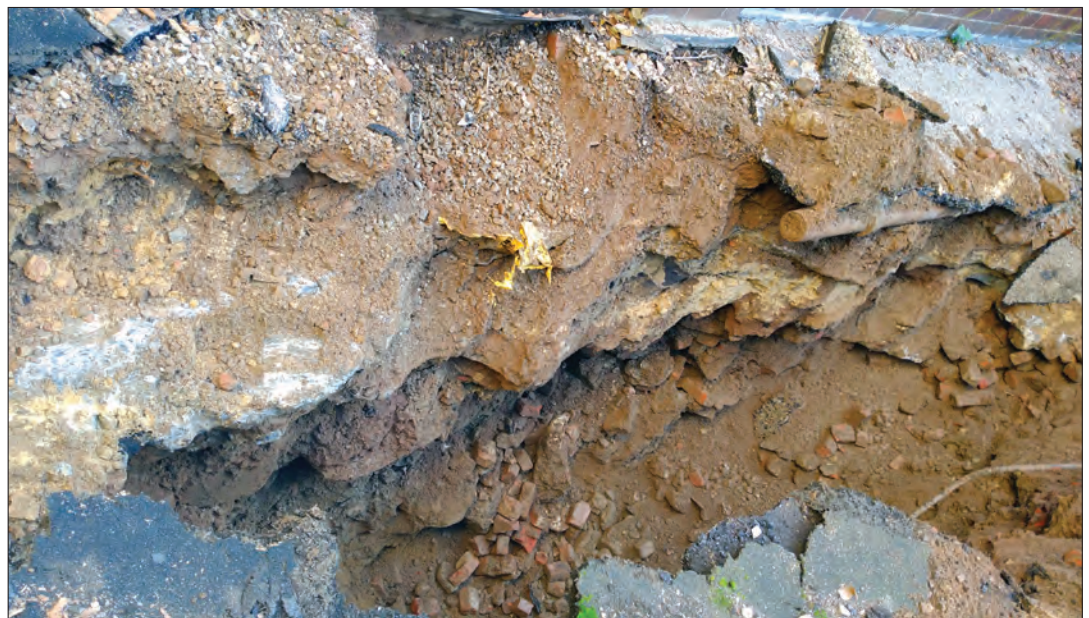
8

Detail of the north wall of Trench 1 showing collapsing soils undercutting the adjacent building's foundation

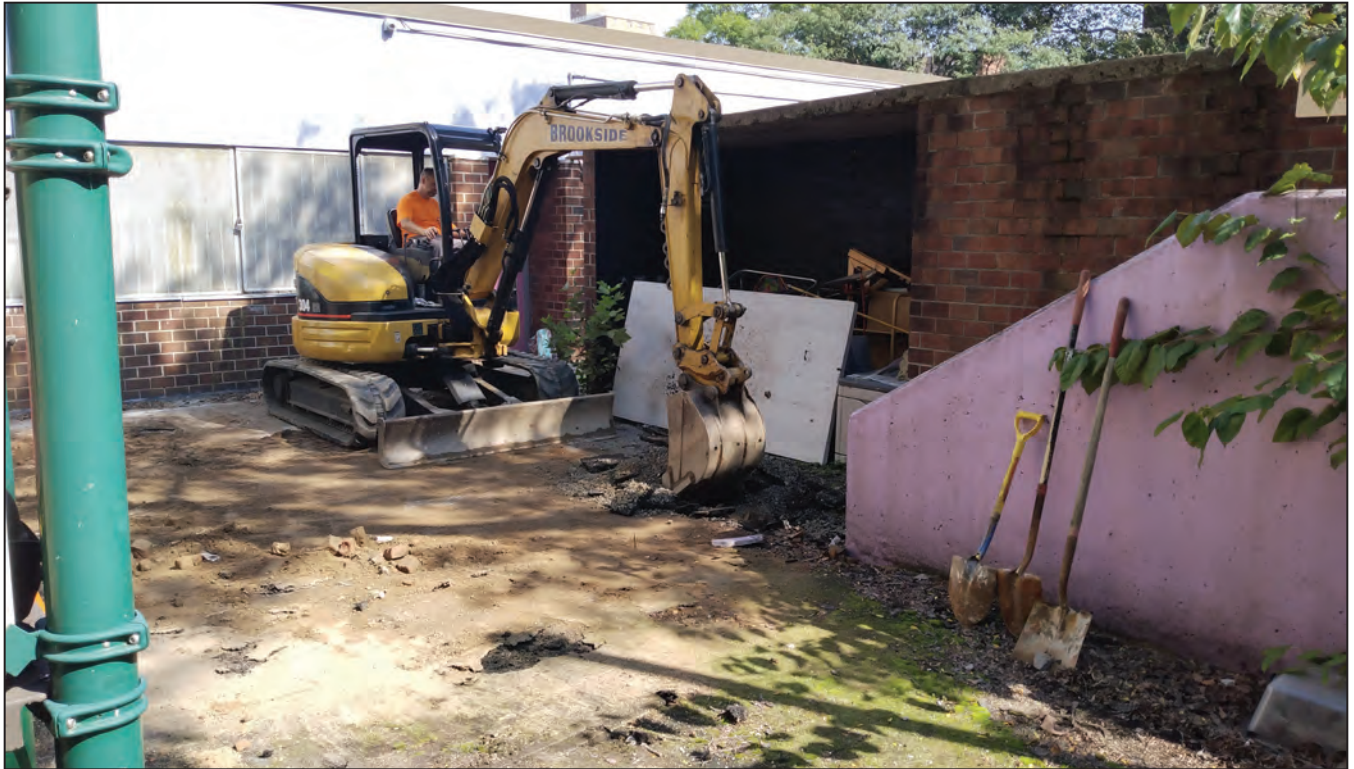
Facing east towards Trench 2, adjacent to the brick storage/utility structure 9

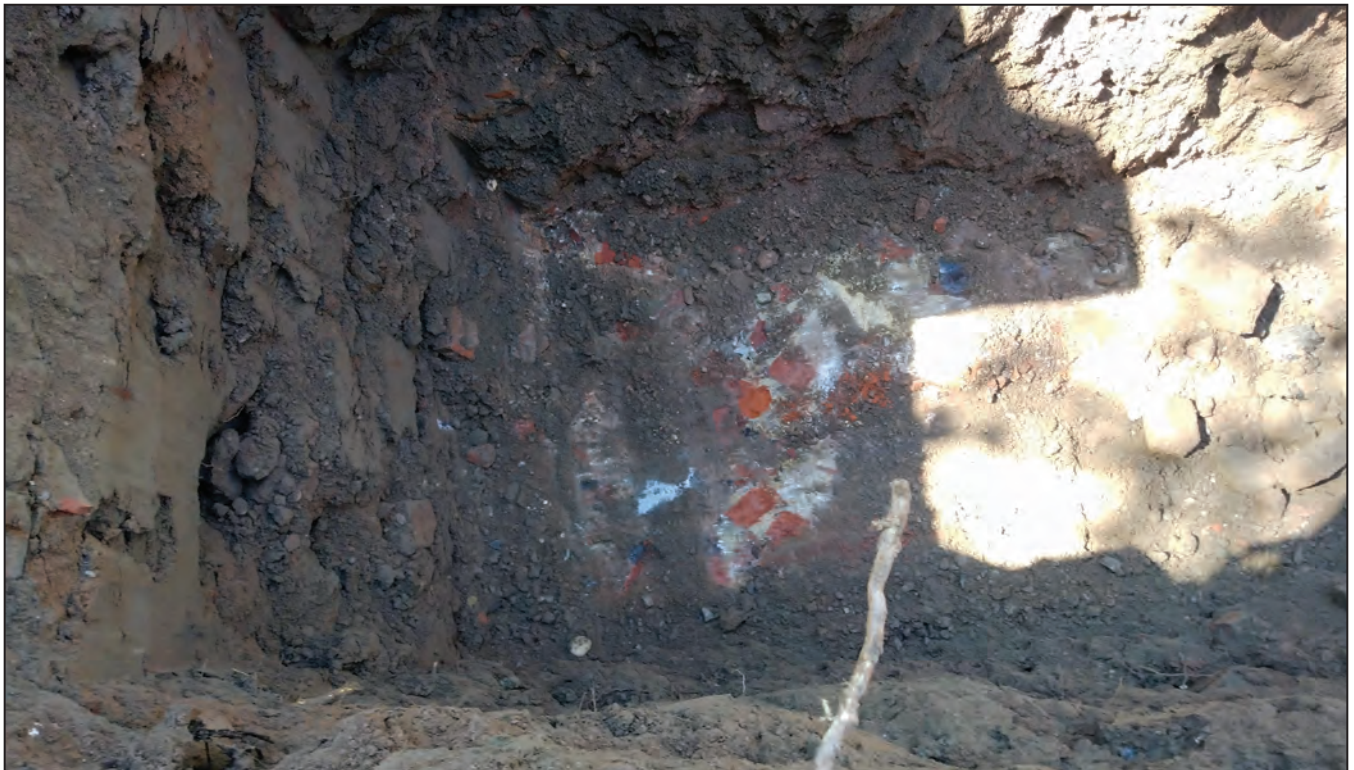
Detail of the floor of Trench 2 showing a concrete and brick foundation floor encountered at a depth of 6.5 feet below ground surface. The overlying soils consisted of loose sandy urban fill and brick demolition debris 10

Trenches 2, 3, and 4 each encountered solid concrete and brick foundation floors (see **Photos 10 and 13**). The foundation floor was encountered at a depth of 6.5 feet (20 feet NAVD88) in Trench 2 and at 8 feet (18.5 feet NAVD88) in Trenches 3 and 4. Once again due to collapsing trench walls, it was impossible to clear and photograph the foundation in Trench 4 (**Photo 15**). No evidence of shaft features; in situ historical artifact deposits; or original or buried ground surfaces were observed in trenches 2, 3, or 4.

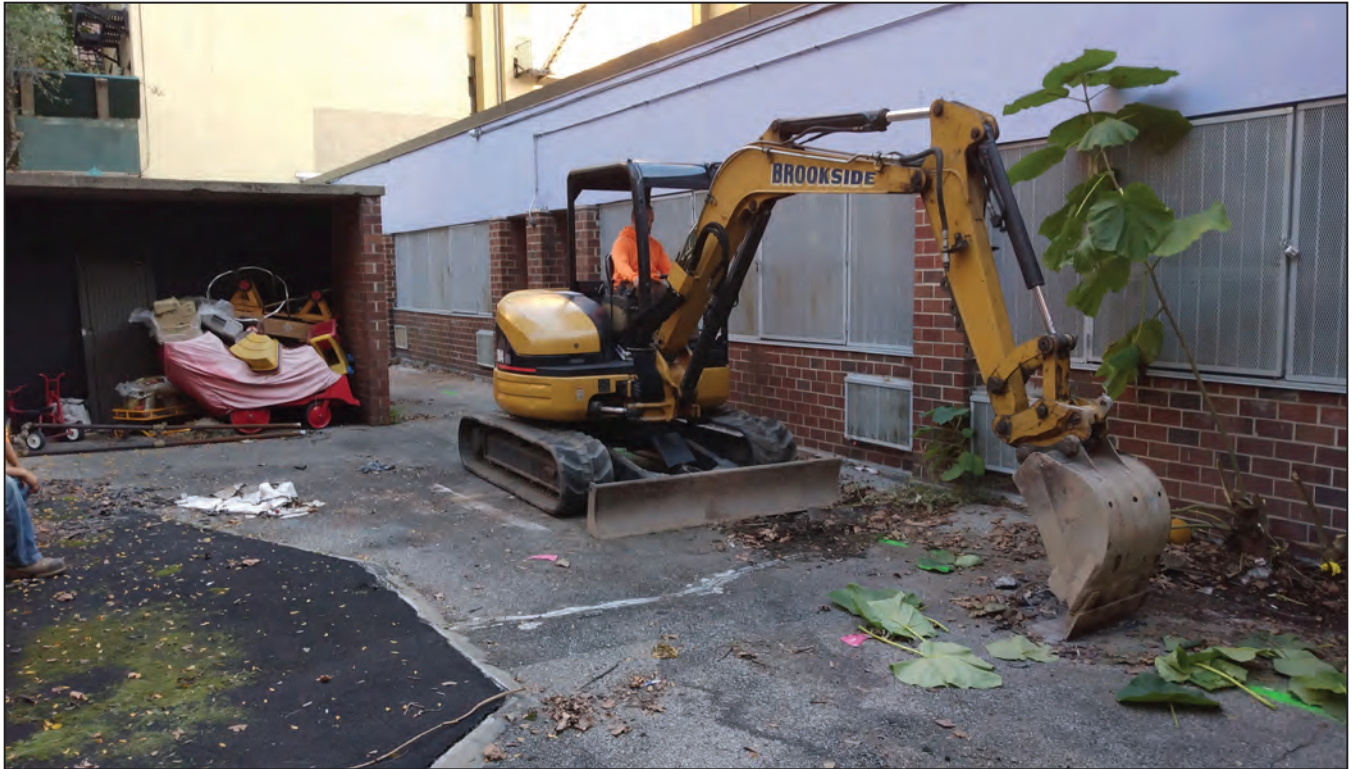
Facing northwest towards Trench 3, which was excavated adjacent to the 1-story brick building 11

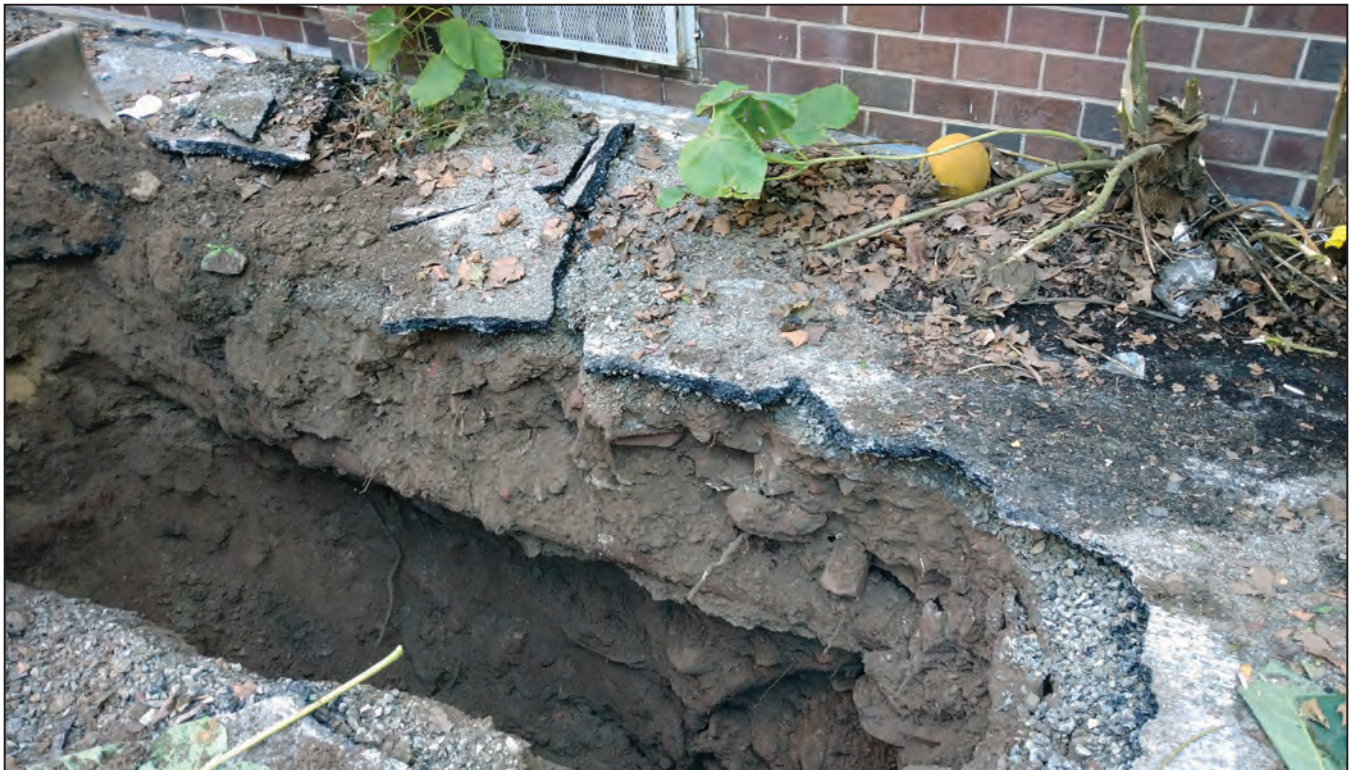
Facing northwest towards Trench 3 showing drainage line approximately 1.5 feet below ground surface and loose sandy urban fill and brick demolition debris 12

The geophysical investigation resulted in the identification of multiple utilities including natural gas, electric, water, and storm drain lines across the project site, all of which were marked with spray paint. The only subsurface feature identified in the study area itself was a drainage line adjacent to the rear wall of the 1-story brick building at a depth of approximately 18 inches (**Photo 12**).

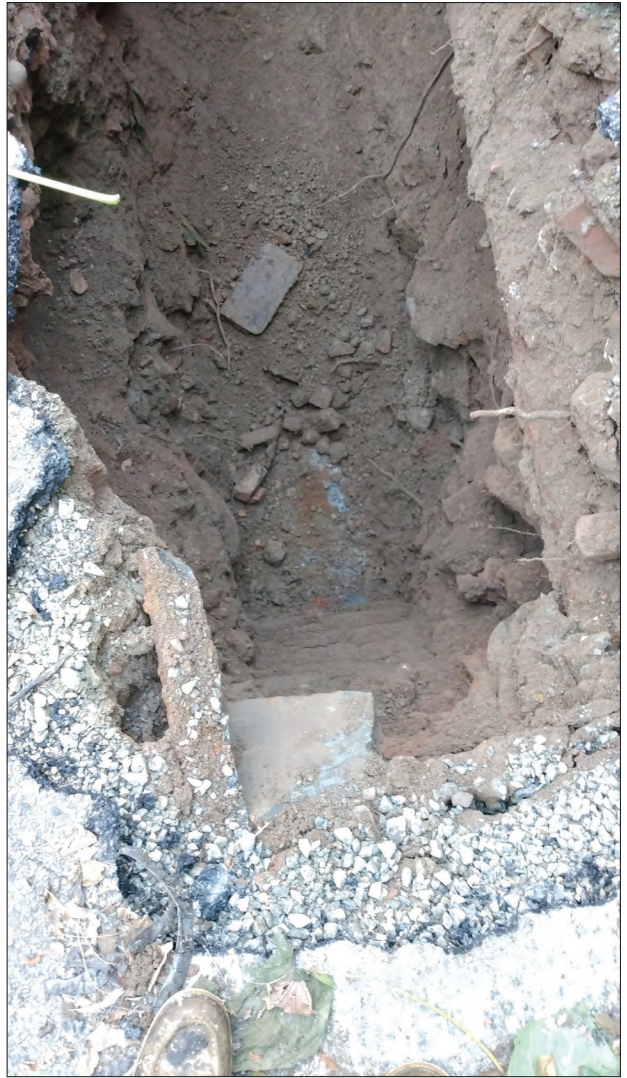
13

Detail of the floor of Trench 3 showing a concrete and brick foundation floor encountered at a depth of 8 feet below ground surface. The overlying soils consisted of loose sandy urban fill and brick demolition debris

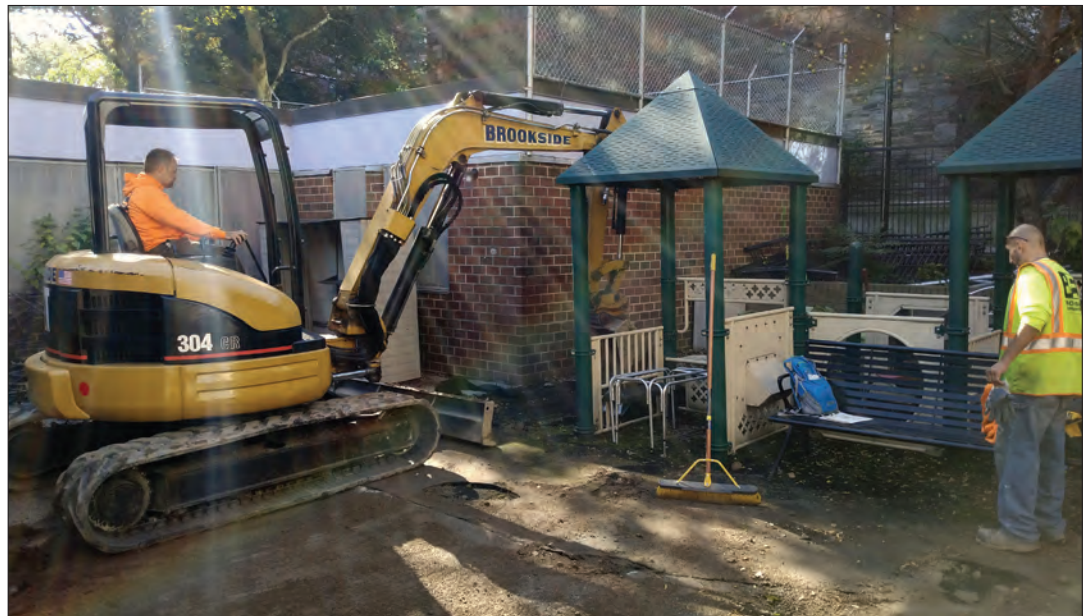
14

Facing south towards location of Trench 4, which was excavated adjacent to the rear wing of the 1-story brick building

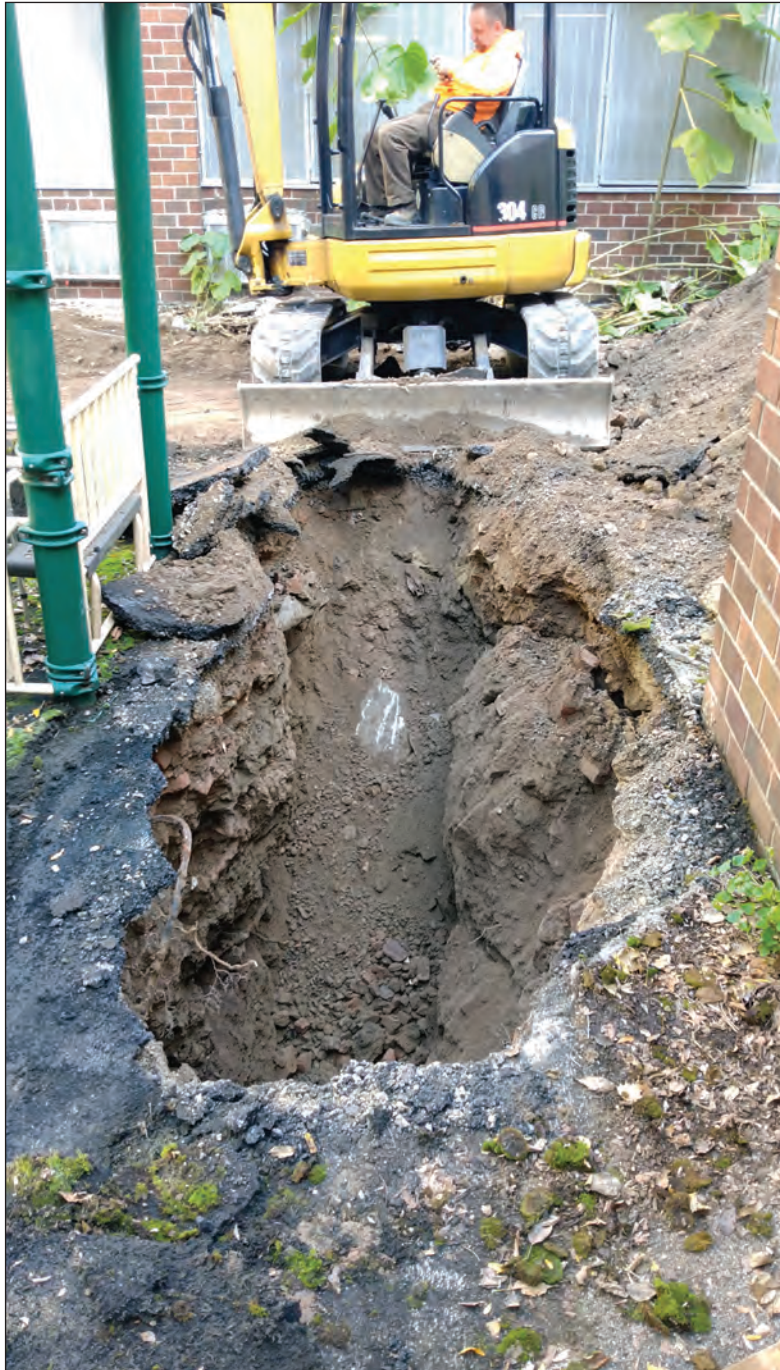
Facing northeast showing excavation of Trench 4. Note collapsing trench walls consisting of loose urban fill and brick demolition debris. A foundation was encountered at a depth of approximately 8 feet below ground surface in this trench though it was immediately obscured by collapsing walls. **15**
