37-16 Union Street Redevelopment

Block 4978, Lot 56

FLUSHING, QUEENS COUNTY, NEW YORK

Phase 1B Archaeological Investigation

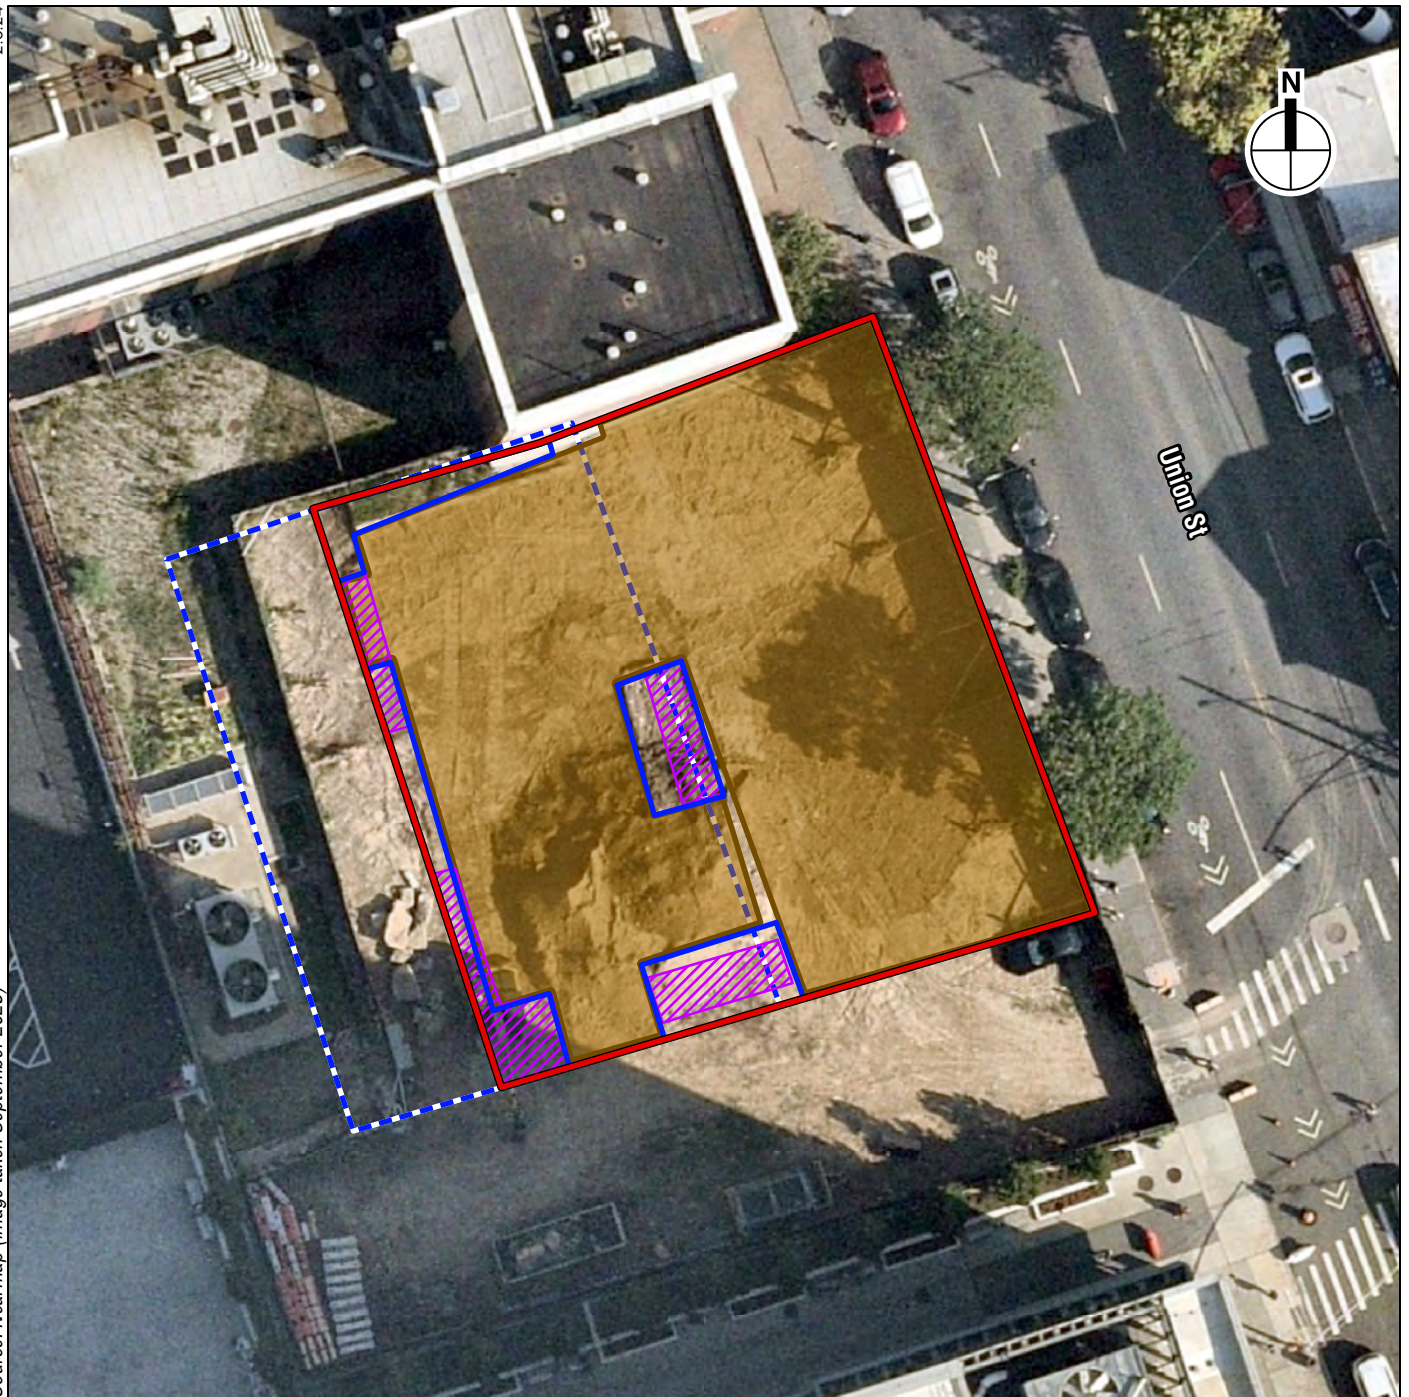
Archaeological Sensitivity and Testing Locations

- Project Site
- Original Churchyard Boundary
- Archaeologically Sensitive Areas Recommended for Monitoring
- Disturbed Area/Not Archaeologically Sensitive
- Excavated Area

All excavation completed in association with this archaeological investigation occurred within areas of archaeological sensitivity as depicted on **Figure 4**. As described previously, the excavation was completed in advance of construction and as such, only the areas of sensitivity were excavated as part of this investigation. No soils were excavated within the former church foundation, including the areas where the secondary burial deposit was recovered in 2019. The area of sensitivity in the extreme northwestern corner of the project site could not be tested because of obstructions associated with the extant foundation wall along the northern and eastern sides as well as the presence of utilities and the location of the property boundary along the western side. However, this area of sensitivity was the narrowest and most disturbed by the construction of the existing foundation and given the observations made in the areas to the south, it is no longer considered to be archaeologically sensitive.

As described previously, three of the four areas of archaeological sensitivity were entirely or partially excavated to a depth of 10 feet below the ground surface as part of this Phase 1B Archaeological Investigation (see **Figure 4**). Where possible, the extant foundation walls were used as a guide during the excavation. As described previously, because of the proximity of the property boundary to the extant foundation walls, the extreme northwestern corner of the project site could not be excavated. However, the observations of conditions adjacent to the foundation that were made elsewhere throughout the site suggest that the small area outside the foundation at the northwestern corner of the project site was likely disturbed during the construction of the foundation and is therefore not archaeologically sensitive. No evidence of human remains or possible grave shafts was observed in any of the areas excavated.

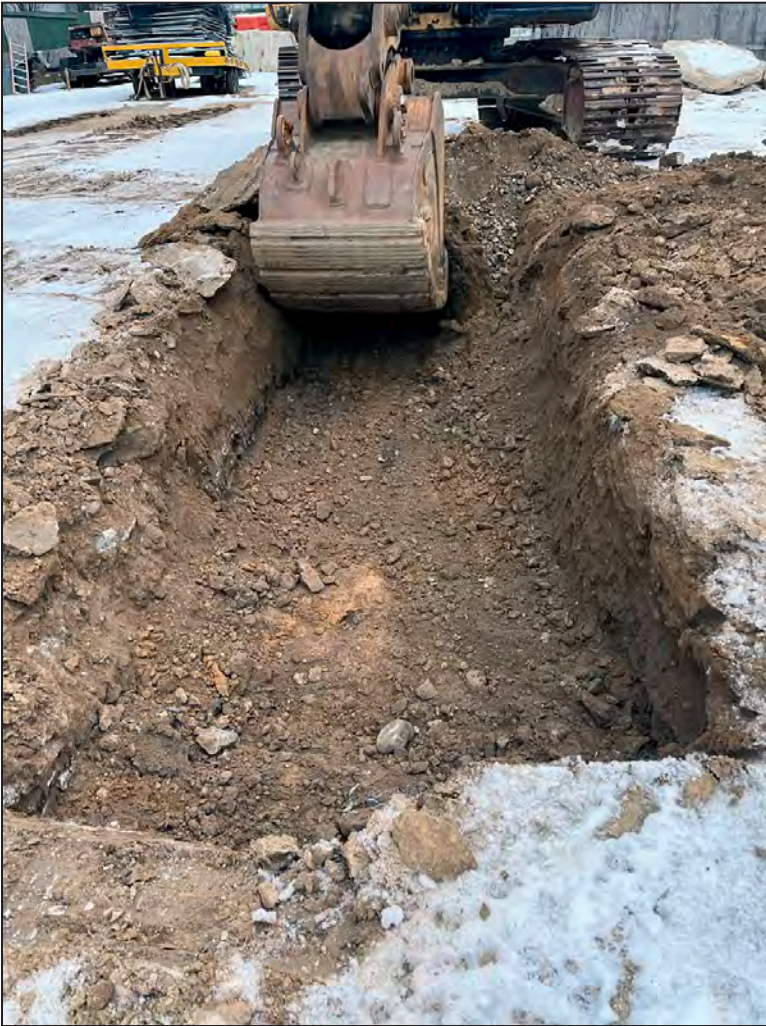
Looking east at the excavation in the southeast yard of the church, showing natural soils emerging approximately 3 feet below a layer of rubble 1

The former front yard of the church to the east of its main entrance was excavated between the foundation wall of the gymnasium to the east and the former church stairs to the west (see **Photographs 1 and 2** on **Figure 5**). This area represents the largest portion of the project site that was not disturbed by the construction of the church foundation. The excavated area measured approximately 23 feet in length and at least 7 feet in width and foundation walls were observed in the western and eastern ends. An approximately 3-foot-thick layer of debris and rubble was observed across the entire area. Below that depth was dark yellowish brown (10YR4/6) silty sand that appeared consistent with undisturbed glacial till. Excavation continued to a depth of 10 feet below the ground surface, at which point similar dark yellowish brown (10YR3/6) slightly silty coarse sand with rocks and cobbles was observed. The soils below the upper layer of fill all appeared natural and did not contain artifacts or refuse and were consistent across the full length of the area tested.

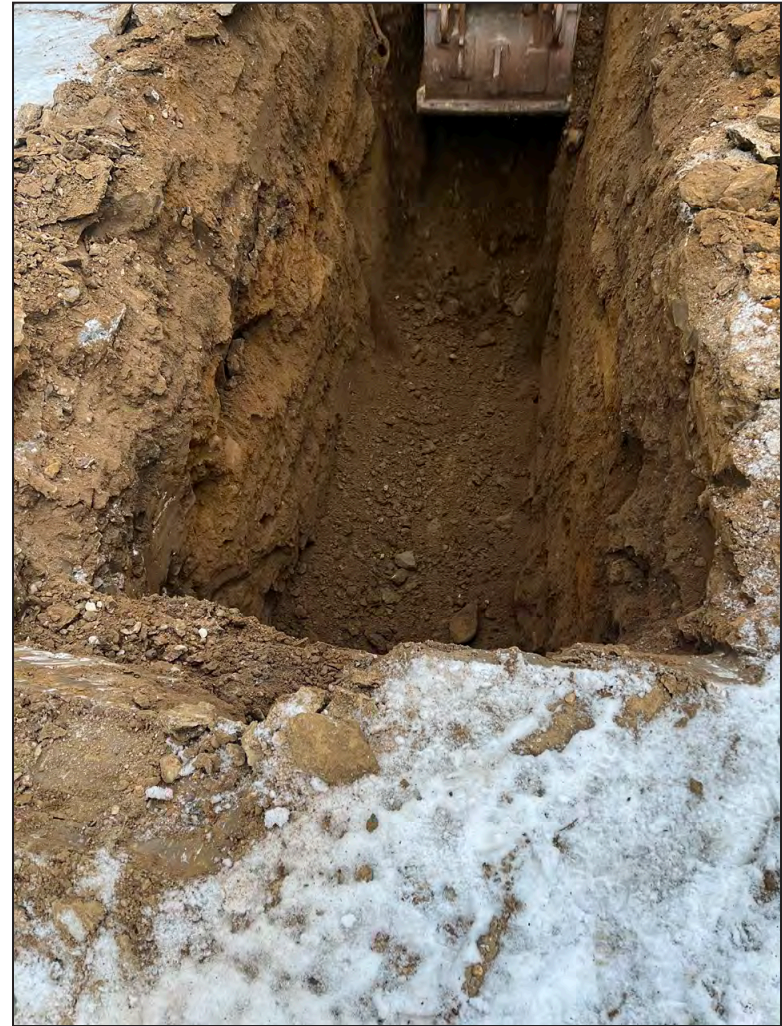
Same view after excavation to a depth of 10 feet below the ground surface 2

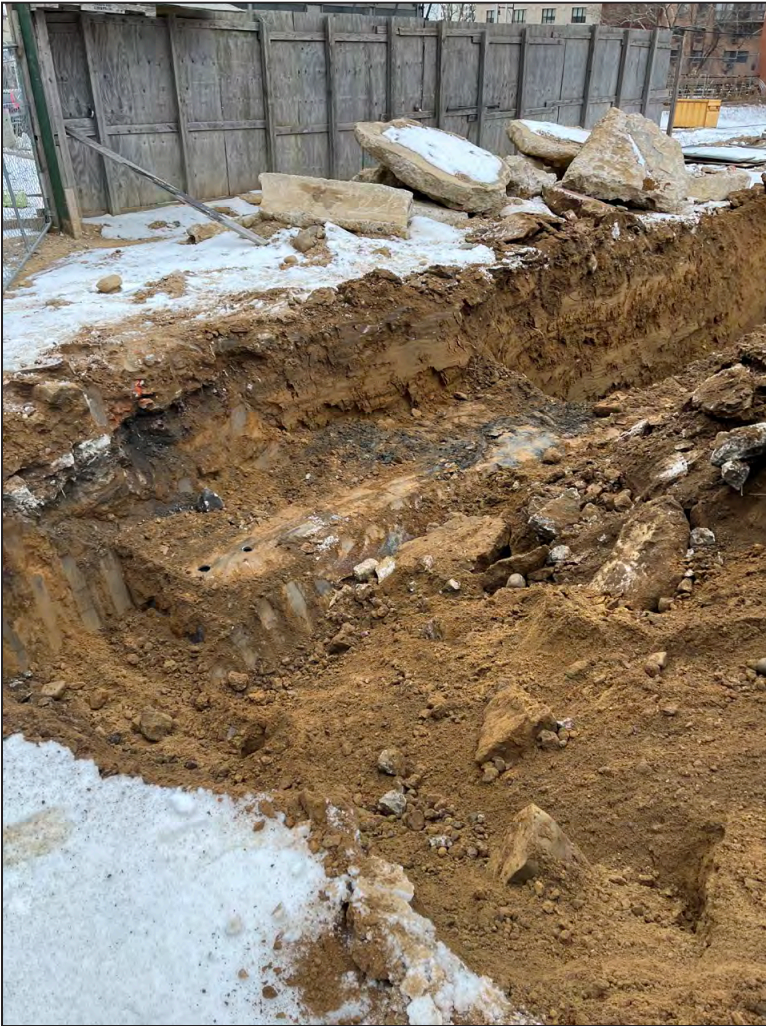
Looking northwest across the excavation at the southwest corner of the former church, showing the utility obstruction in the center and natural soils to the east (bottom right) and north (top right) **3**

In the area to the south of the church west of the church's main entrance stairs, nearly the entire front yard of the church was excavated (see **Photographs 3 and 4** on **Figure 6**). A 3-foot-thick layer of demolition debris and rubble was once again observed. Soils in this area were similar to those seen to the east, with a greater amount of rubble observed in the north wall closer to the former church foundation, which was exposed in the northern and eastern walls of the excavation. Remnants of a paved asphalt surface and possibly remnants of the adjacent sidewalk of what was formerly 38th Avenue were visible in the southern wall 1 to 2 feet below the ground surface. The majority of this area was previously disturbed by the installation of a large underground storage tank that appeared to extend to a depth of at least 7 to 8 feet below the ground surface between the church foundation and the former northern line of 38th Avenue. Excavation was terminated in the vicinity of the tank. To the east, the area was excavated to a depth of 10 feet, where dark yellowish brown (10YR4/4) coarse, damp silty sand was observed.

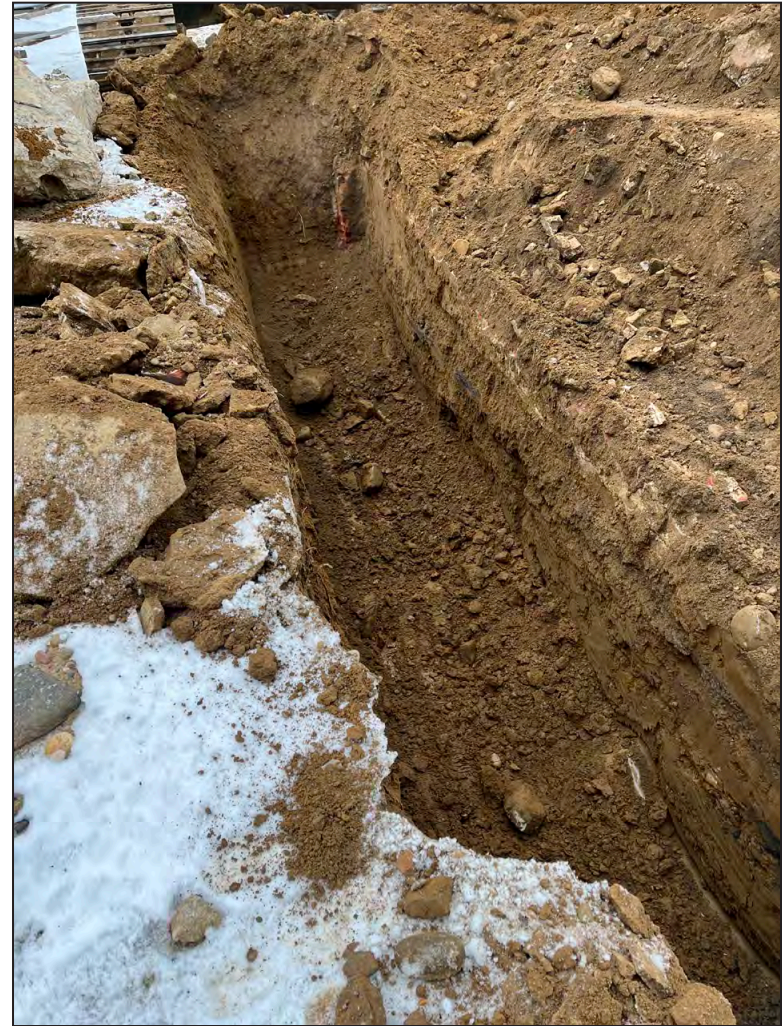
View north along the western side of the west wall of the church foundation (visible in the right wall) from a point near the southwest corner of the former church **4**

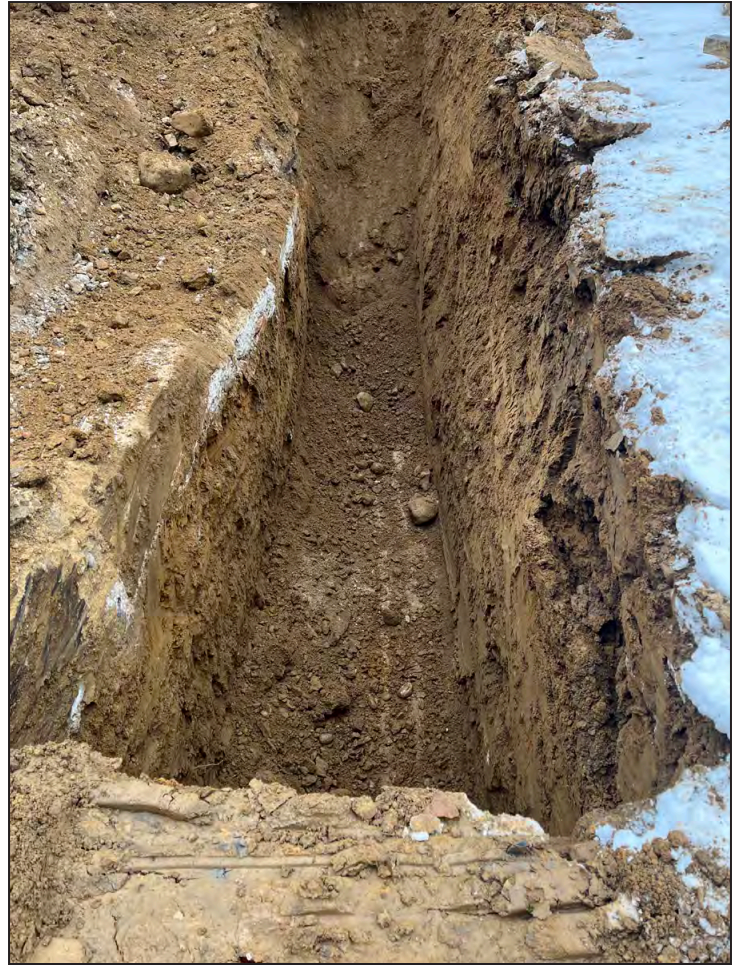
Looking south at the excavation along the western wall of the former church (at right)

Excavation occurred in a 3- to 5-foot wide area along the western side of the former church foundation, which was visible in the eastern wall of the excavation at a depth of up to 6 feet below the ground surface (see **Photographs 5 and 6** on **Figure 7**). The southern and northern ends of this area of sensitivity were excavated as part of this Phase 1B Archaeological Investigation. Much of this area contained demolition debris and rubble, especially in those areas adjacent to the foundation wall and in the vicinity of the area where stairs originally led to the church basement. West of the southwest corner of the church, yellowish brown (10YR5/6) silty sand was observed at a depth of 3 feet below the layer of rubble. At a depth of 10 feet, dark yellowish brown (10YR4/4) coarse, damp silty sand was observed. Near the northwest corner of the former church, soils were stained and disturbed to a depth of at least 10 feet in the vicinity of the former basement stairs. To the south of the stairs, soils were clean and natural, with dark yellowish brown (10YR3/6) coarse damp slightly silty sand with rocks and gravel observed at a depth of 10 feet below the ground surface.

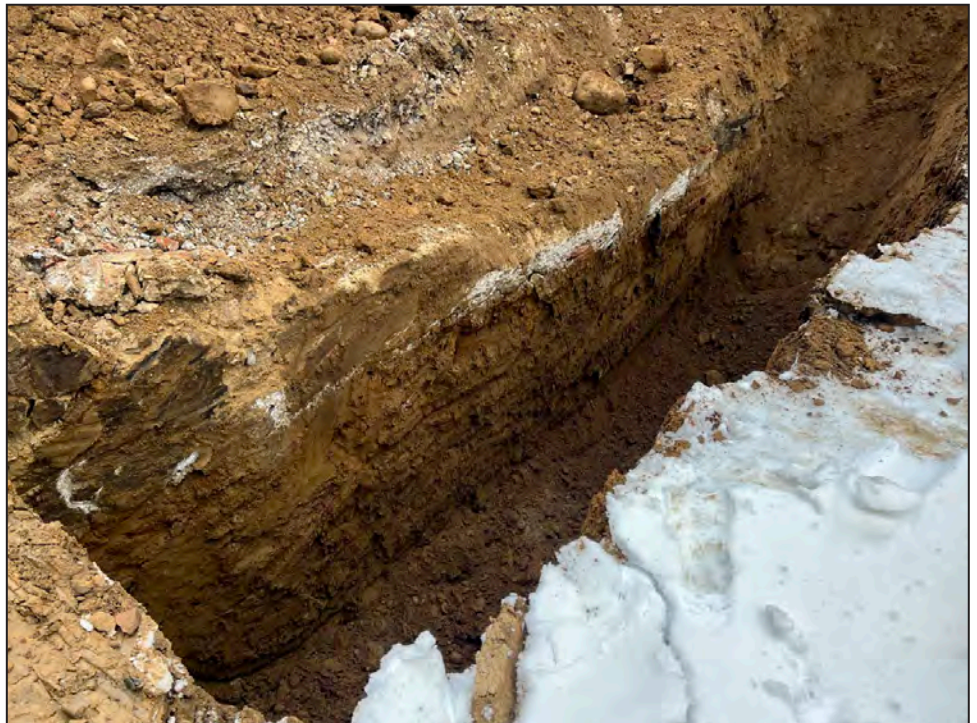
6

Looking southeast at the former foundation wall, showing disturbed soils adjacent to the wall

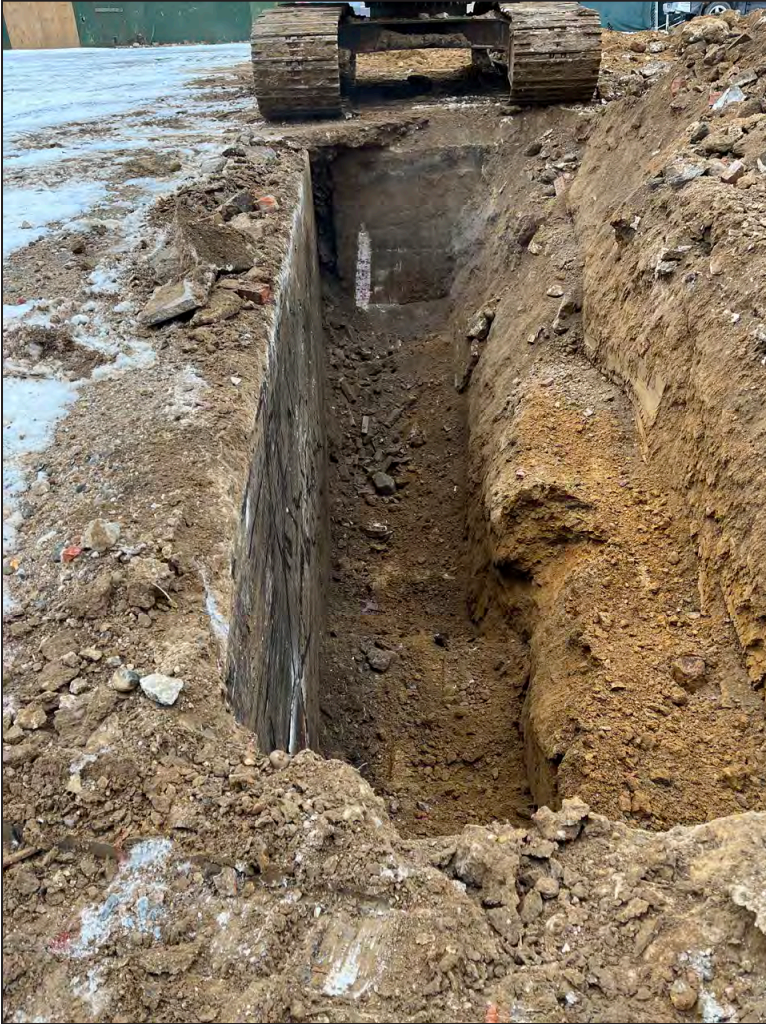
View south of the excavation between the foundations of the former church and gymnasium, with foundation walls visible in the east (left) and south (top) walls of the excavation 7

A portion of the small area formed between the former church and gymnasium foundations was excavated as part of this investigation and the gymnasium's foundation walls were observed in the eastern and southern walls of the excavation (see **Photographs 7 and 8** on **Figure 8**). Extensive demolition debris was observed in this area and rubble was densest adjacent to the former gymnasium foundation. Cleaner, more natural-looking soils were observed in the western half of this excavation. Dark yellowish brown (10YR4/6) coarse silty sand was observed at a depth of 10 feet below the ground surface.

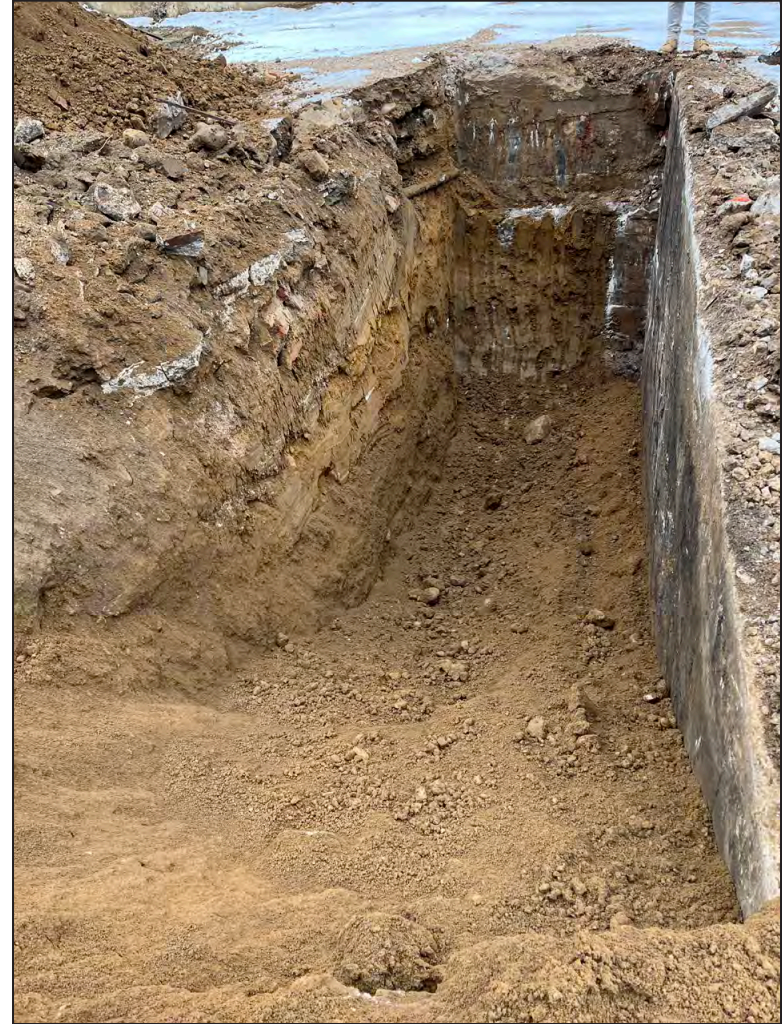
Looking in the opposite direction, showing more natural soils in the base of the excavation and along the western side 8
