**Phase IB Archaeological Monitoring as part of the Van  
Cortlandt House Museum, Fence Reconstruction Project,  
Van Cortlandt Park, Bronx, Bronx County, New York  
(NYC Parks Number: X092-322M)**

April 2025 (v1)

Phase of Survey: Phase IB Archaeological Field Monitoring

Location Information: Van Cortlandt Mansion, Van Cortlandt Park, Bronx, Bronx County, New York

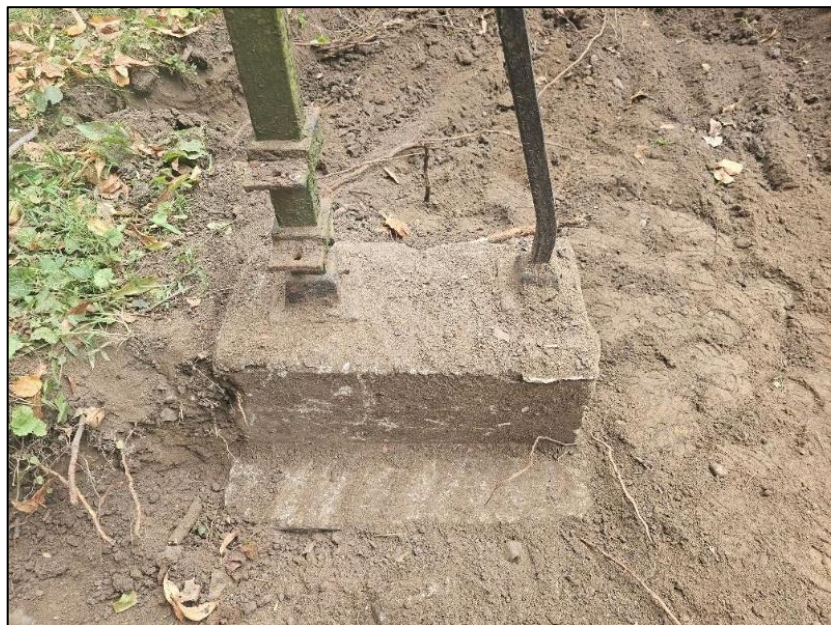
Image 1: Example of fence post footing.

Work on the fence project began on September 25, 2024, with removal of some of the existing footers. Generally, fence posts were not removed as these would be restored in situ (Image 1). Footers that were removed were hand excavated to approximately 18” below ground surface. These were then mechanically chipped for removal. Existing fence sections measured 7’ 6” in length between fence posts. These were removed and restored off-site. Removal of the fence sections was followed by footer/curb removal and excavation of 1’ of soil 5’ on either side of the fence due to possible lead paint contamination.

This one-foot excavation was mostly unremarkable. The upper layer consisted of organic matter and contained modern materials such as bottle glass or debris. Beneath this O horizon, a 10YR4/3 sandy loam was common throughout the project area. The following field results are presented by area, not chronologically for ease of discussion. These areas are the southeast quadrant, middle south; southwest quadrant; northwest quadrant and northeast quadrant with the museum gate being the divider. These areas and noted features are marked on Map 3.

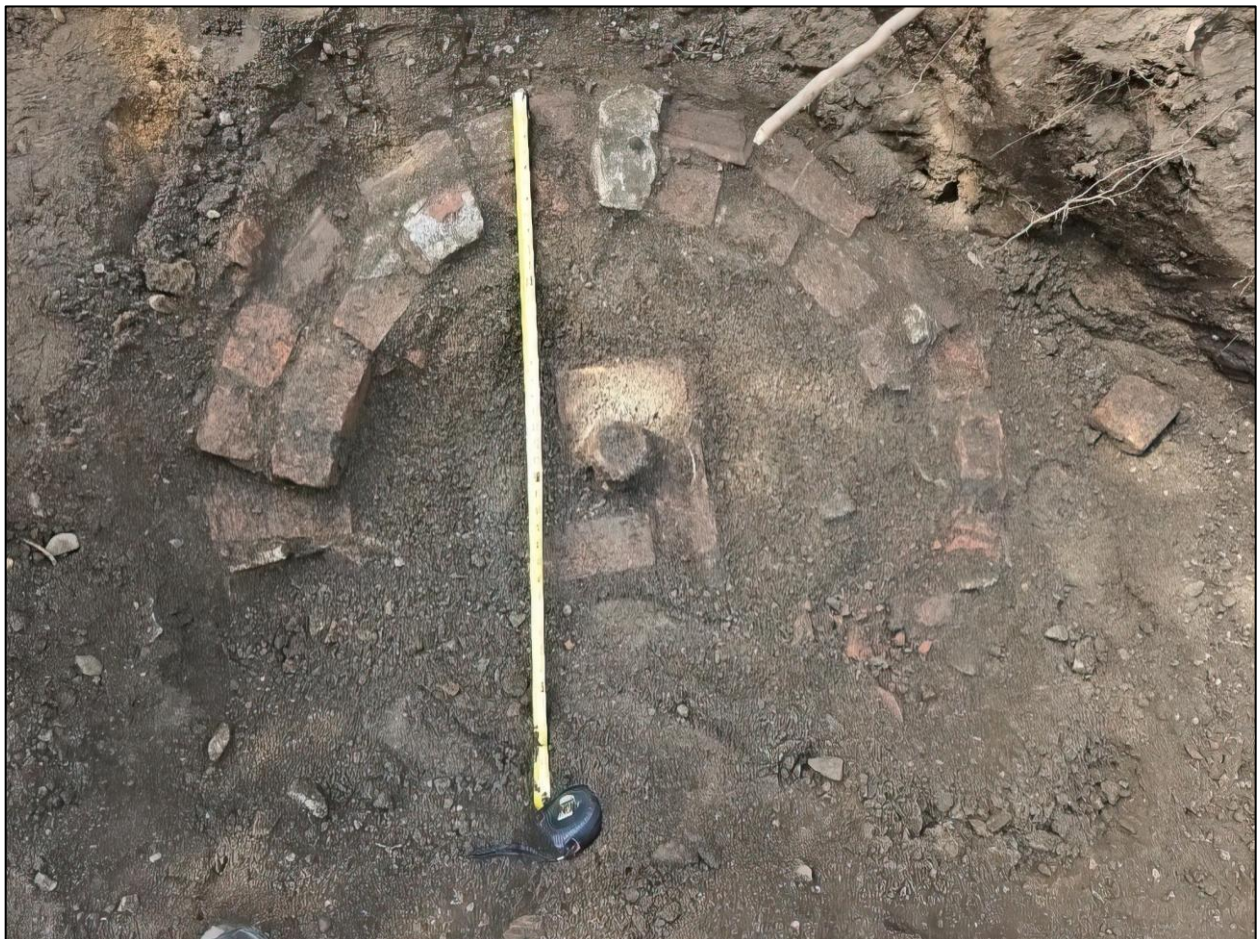
Image 2: Plan view of brick cistern with center box.

The most notable discovery within this area was that of a cistern or similar infrastructure along the exterior east fence line (Images 2 and 3). The feature initially presented as a brick semi-circle and was adjacent to a footer. It became apparent that the fence installation had damaged the nearest portion of the feature, providing a relative pre-twentieth-century date for the feature.

Excavation surrounding the feature exposed a metal-capped square center box measuring 8" x 12" bgs (32.24 NAVD88). The metal cap could have facilitated a pumping mechanism. Clearing soils alongside the box exposed a cement base 20" below the highest part of the metal cap (30.57 NAVD88). The diameter of the feature is approximately 3.5'. No artifacts were observed in this area.

Since construction would not impact the feature, no further work was undertaken. It was left in situ.

The one feature exposed was the brick cistern-like structure. Based on its location it, and apparent damage relative to the adjacent footer, this feature appears to pre-date the fence. This fence was installed in the early – mid twentieth century. The feature remains in situ.

However, if replacement is called for and impacts deeper and/or wider than the impacts depths of this project are planned, archaeological monitoring should be undertaken. Additionally, as demonstrated by the exposed feature, any work adjacent to the fence area that extends below one foot retains a moderate to high potential for the recovery of *in situ* material and/or stratigraphic remains.

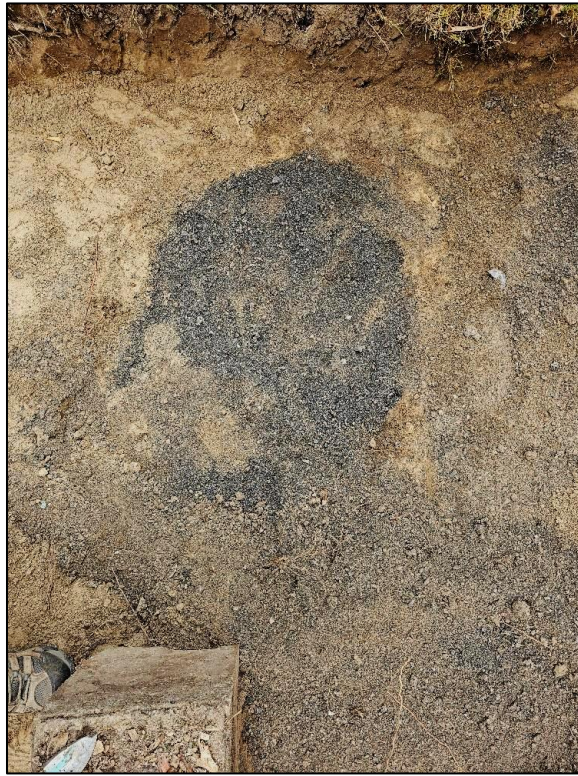
Image 4: Ash pit east of fence post footer.

Further south along the eastern fence line, modern glass fragments, animal bone, ceramic, and two marbles were noted approximately 60' north of the southeast corner. An ash pit, measuring 30" by 42", was exposed on the fence exterior, 7" from the east trench wall (Image 4). An STP was excavated in the middle of the ash pit, which terminated at 15" bgs. No artifacts or faunal remains were found within the pit.

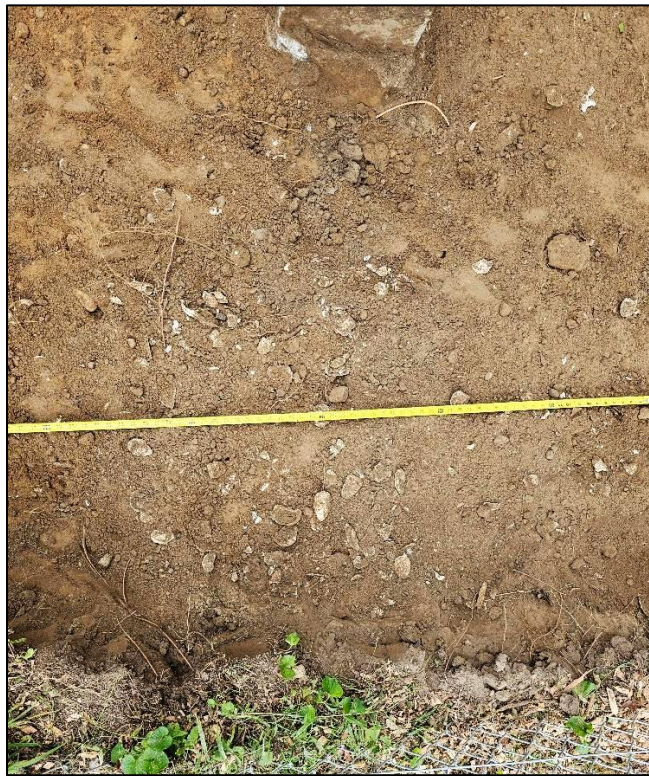
Image 5: Shell pit.

Along the interior southern fence line, a small 5' by 3' shell pit consisting of whole oyster shells was exposed at the southeast corner (Image 5). An STP excavated at the center point demonstrated the pit extended to 15" bgs. One non-diagnostic whiteware ceramic sherd was found within.

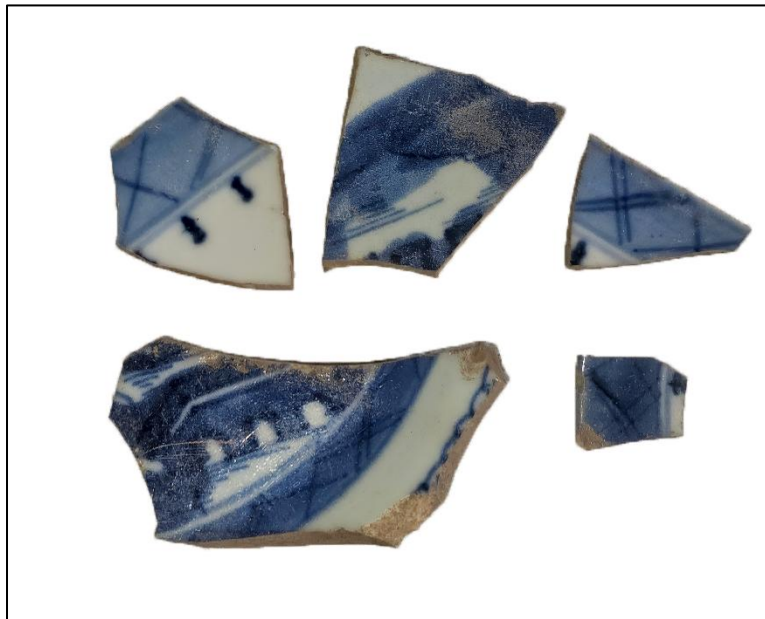
Image 8: Five Chinoiserie style patterned pearlware sherds.

Along the north side of the fence, east of the museum entrance, five ceramic sherds, offset from the statue protection box, were recovered. These blue decorated pearlware sherds appear to have a Chinoiserie style pattern, dated 1783 – 1873 (Image 8). Additional non-diagnostic ceramic fragments and large amounts of stone were present in this area. Modern materials were also observed, including glass, pop tops, and a machine-manufactured bottle.
