## **ARCHAEOLOGY MONITORING REPORT**

108 ST. EDWARDS STREET  
BLOCK 2034, LOT 135  
BROOKLYN, KINGS COUNTY, NEW YORK 11205  
LPC # LA-CEQR-K  
(DEPARTMENT OF HOMELESS SERVICES)

May 2025

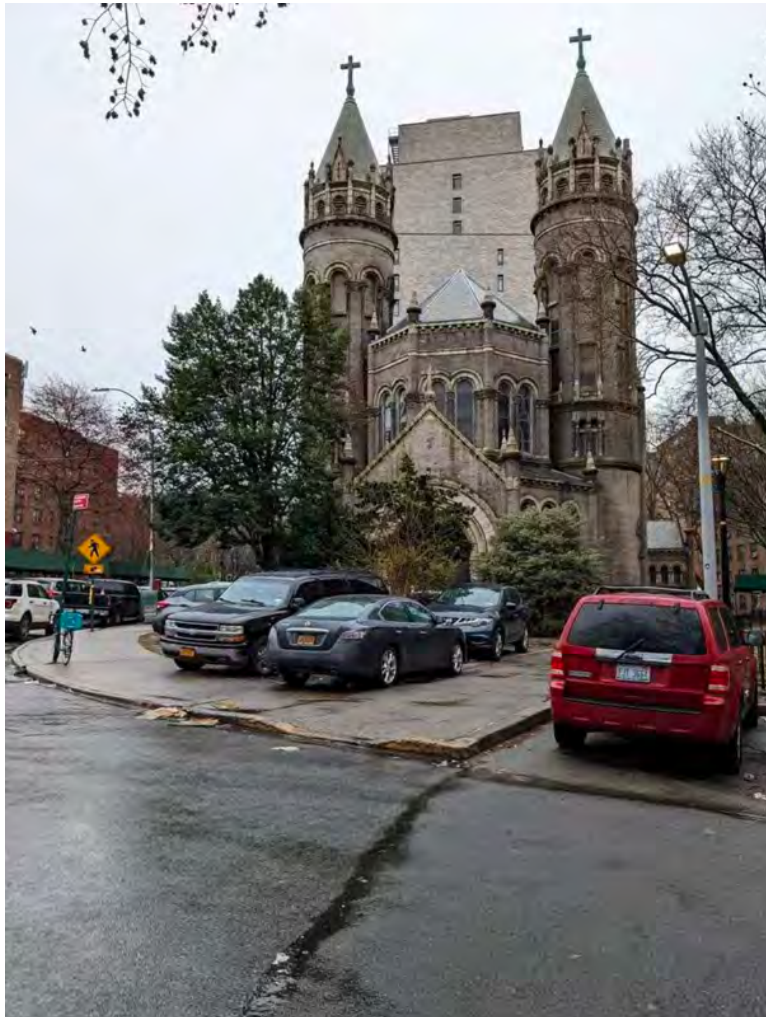
Photograph 1. Area 1 at the northern tip of the project site (raised area with parked cars) prior to excavation, looking southeast from St. Edwards Street and Monument Walk.

The historical activity in this location, including the construction and demolition of adjacent residential structures and later the construction of the large church likely impacted this location. In addition, the installation of the plinth for the stature and its surrounding iron fence directly in Area 1, clearly impacted the surface stratum. Finally, the concrete sidewalks, surrounding the area, at the southern end, and within the northern tip of the gore were paved and used for parking, as noted in Photographs 1 - 3, which likely further impacted the ground surface.

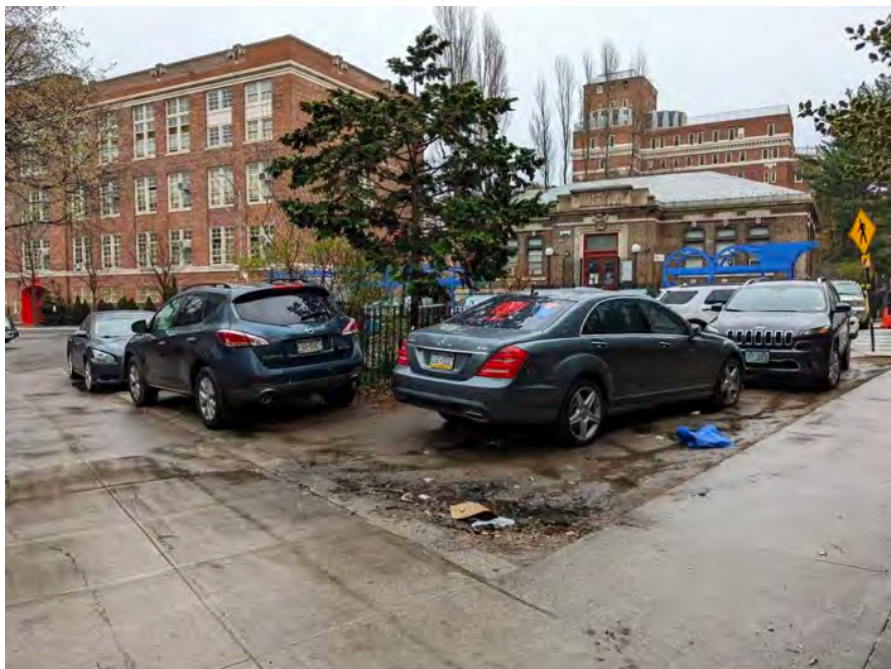
Photograph 2. Area 1 at the northern tip of the project site prior to excavation. The wrought iron fence surrounding the tree in the center formerly contained a religious statue on a pedestal/plinth. View looking northeast towards St. Edwards Street.

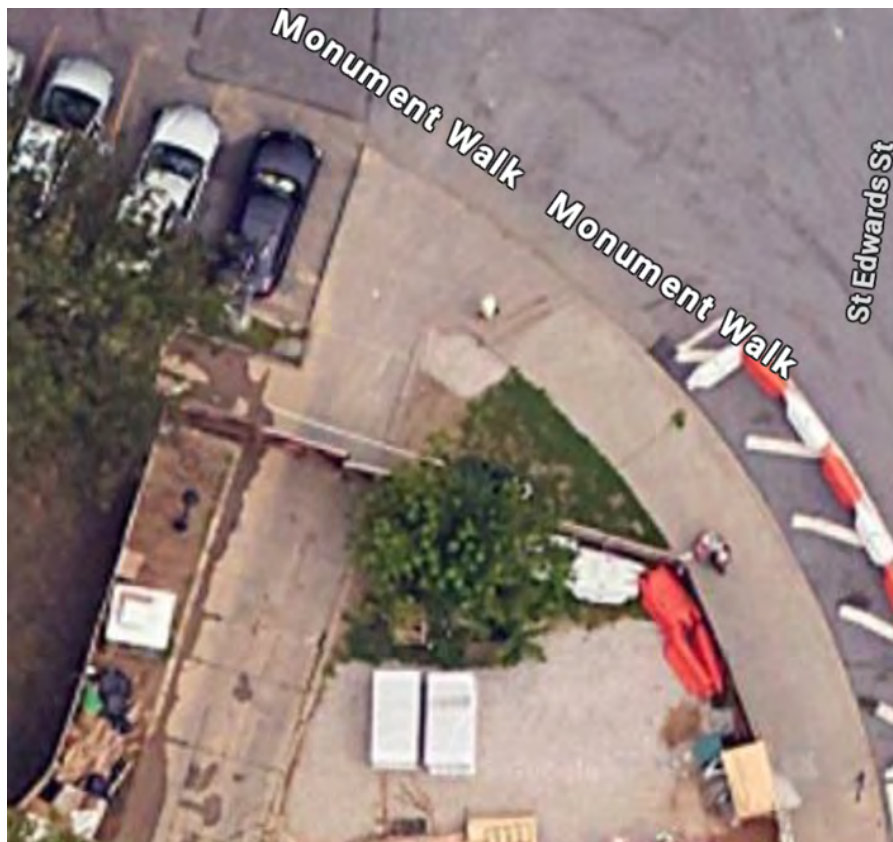
Photograph 3. Aerial photograph of the portion of the project site identified for archaeological sensitivity showing both the grassy and paved areas (Source: Google Maps, 2024).

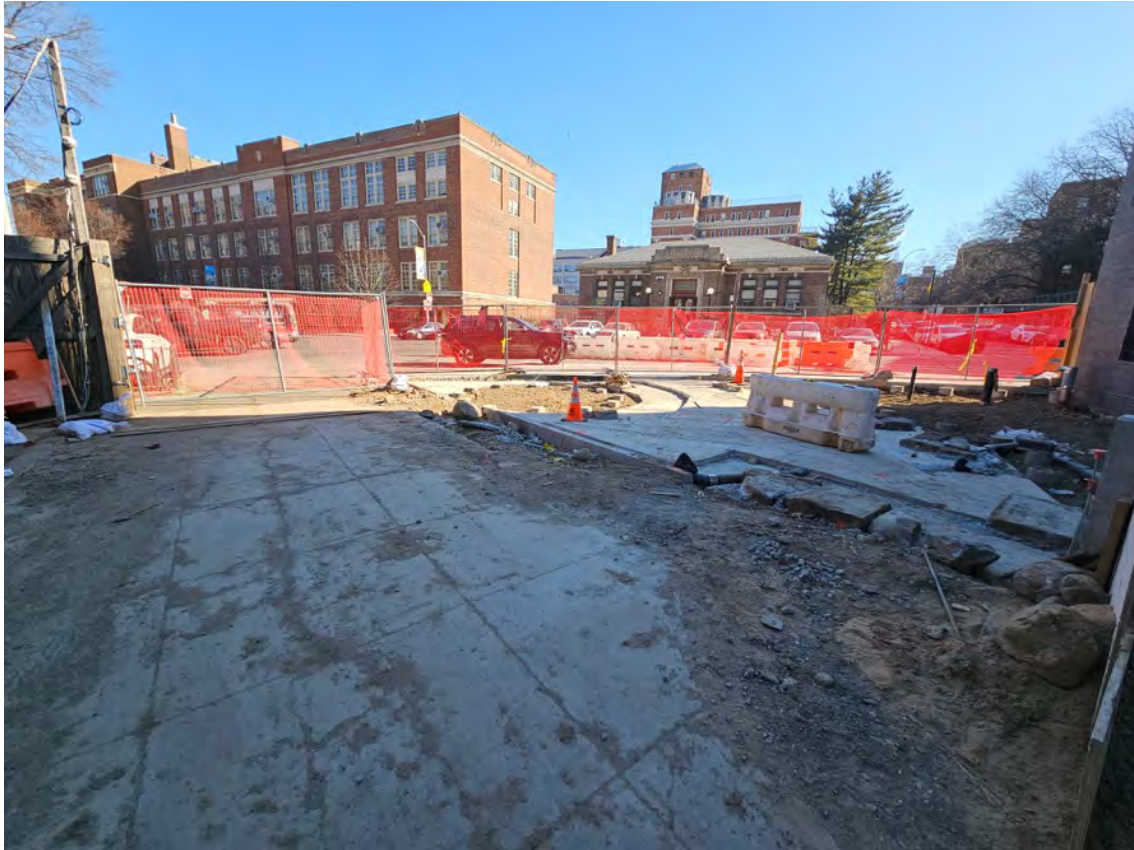
Photograph 5. Area 1, location after excavation and permanent soil capping, view looking northeast.

Disturbance from the concrete installations around, and partially within, this area introduced some of the sandy fill leaving only a thin veneer of topsoil (less than 10 cm) in the remaining grassy spots. Area 1 was excavated to varying depths and mottled fill soils were noted throughout the entire location beneath the surface (Photograph 4). No features or evidence of burial trenches were observed in Area 1. Following excavation, new bedding and a concrete surface was introduced to cap the deeper, contaminated soils within Area 1 (Photographs 5-6). During the church demolition, the former cornerstone for the church memorializing the creation of the parish and inscribed “St. Edwards 1891,” was retained and is photographed at the edge of a new concrete path to the new residential structure (Photograph 7).

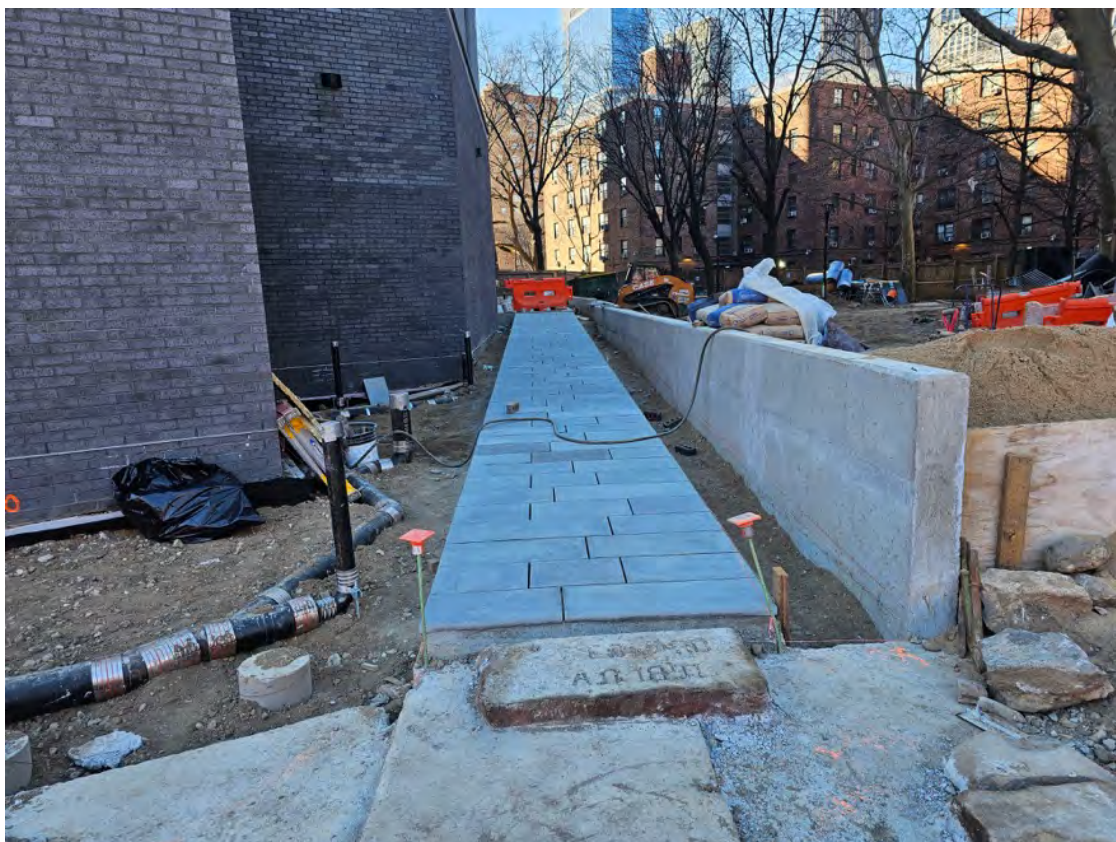
Photograph 7. Cornerstone of the former church inscribed “St. Edwards 1891.”

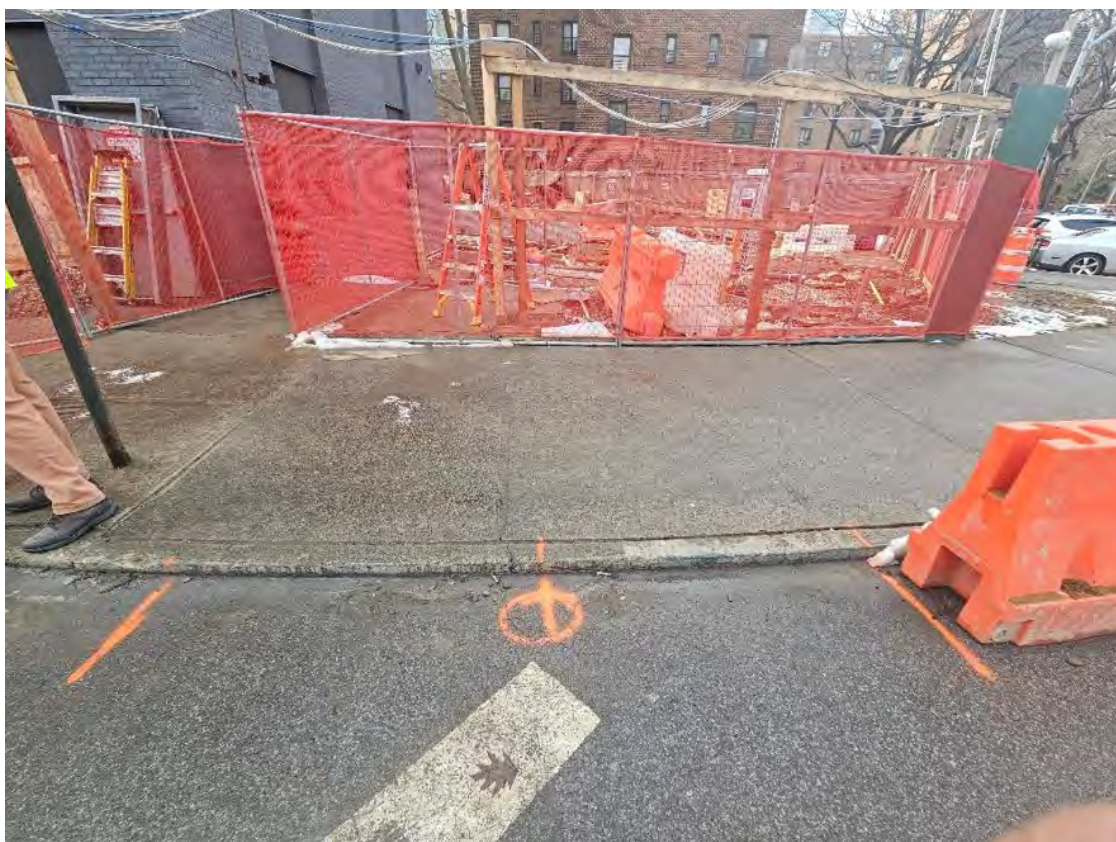
Photograph 8. Area 2, showing the identified location for Tree Pit in the sidewalk on St. Edwards Street.

This location was the site of the new curb installation and a tree pit (Figure 4). The section of the concrete sidewalk that was designated for the tree pit excavation measured 5 x 10 feet (152 x 304 cm) in size (Photograph 8). The stratigraphy encountered is presented in Table 2 below.

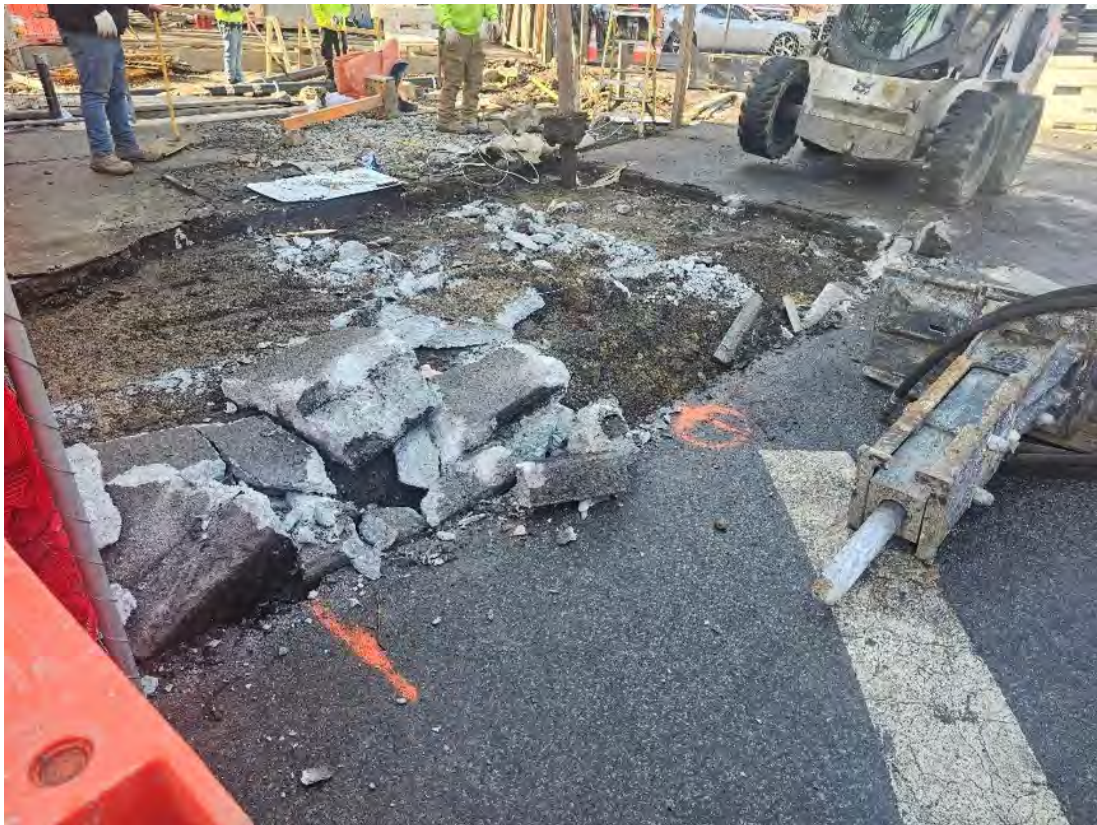
Photograph 9. Area 2, Tree Pit during the removal of the concrete sidewalk, exposing a thick fill stratum.

Following the mechanical removal of the concrete surface, the construction crew commenced the hand excavation of a thick fill stratum (Photograph 9). At a depth of 12 inches below the surface (inbs) (30.5 cm) a second concrete layer was encountered. Following the mechanical removal of the deeper concrete layer, a second thick sandy fill layer was exposed and excavated by hand to the final depth of 36 inbs (ca. 90 cm), the depth required for the tree planting (Photographs 10 and 11). For the curb installation near the tree pit, the crew excavated to a shallower depth, exposing the same fill strata (Photographs 11 and 12). No evidence of burial trenches or historic features were observed during the excavation activities in Area 2. The Tree Pit was temporarily refilled with clean fill during the paving of the new sidewalk (Photograph 13).

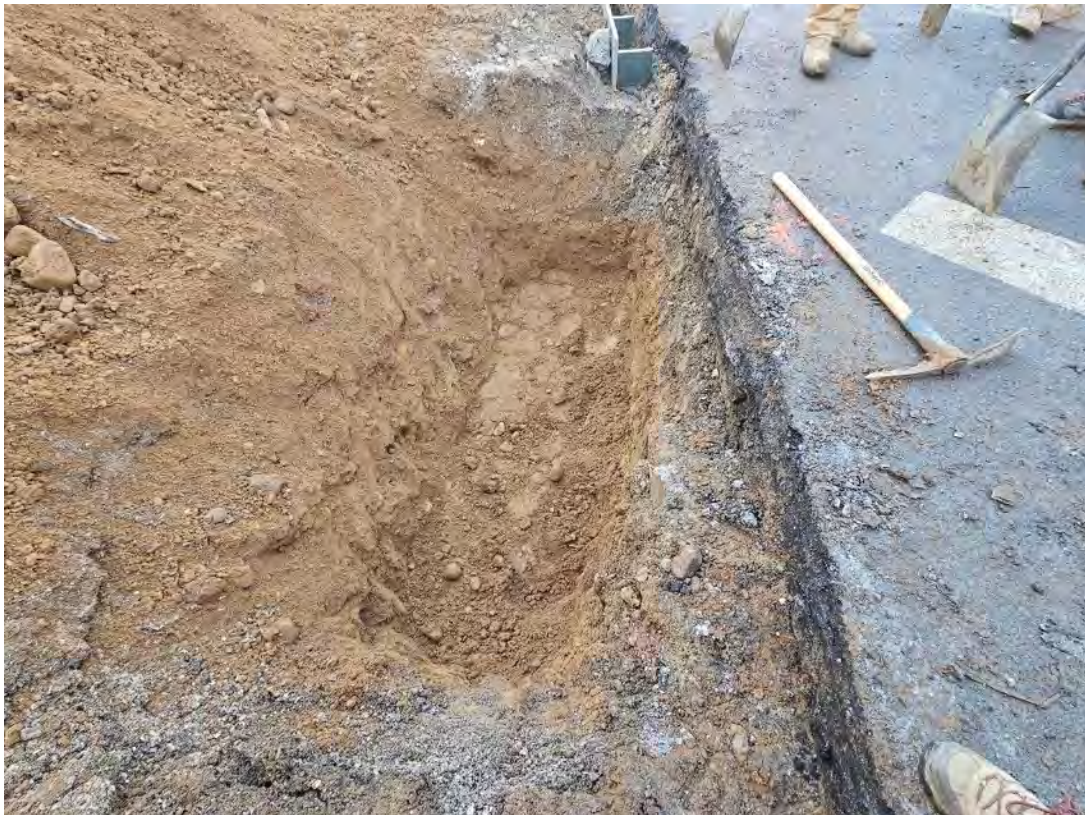
Photograph 10. Area 2, fill strata identified in hand excavated Tree Pit.

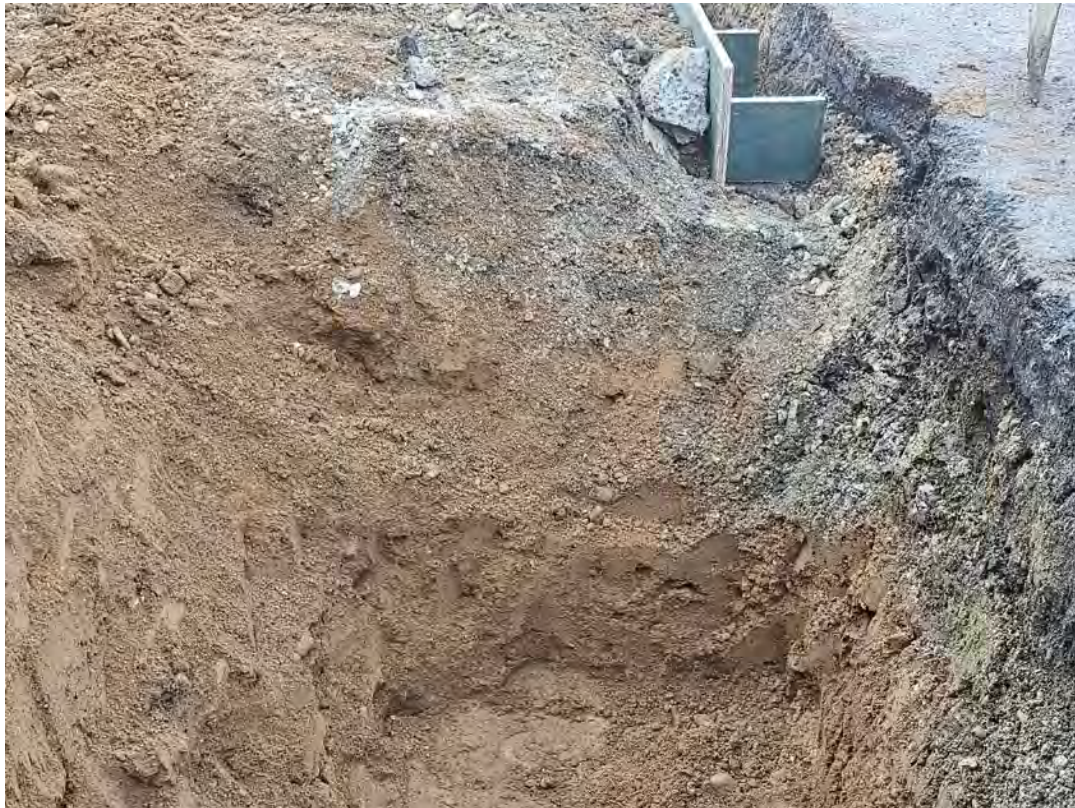
Photograph 11. Area 2, Profile of the north wall of the Tree Pit with edge of curb cut in background.

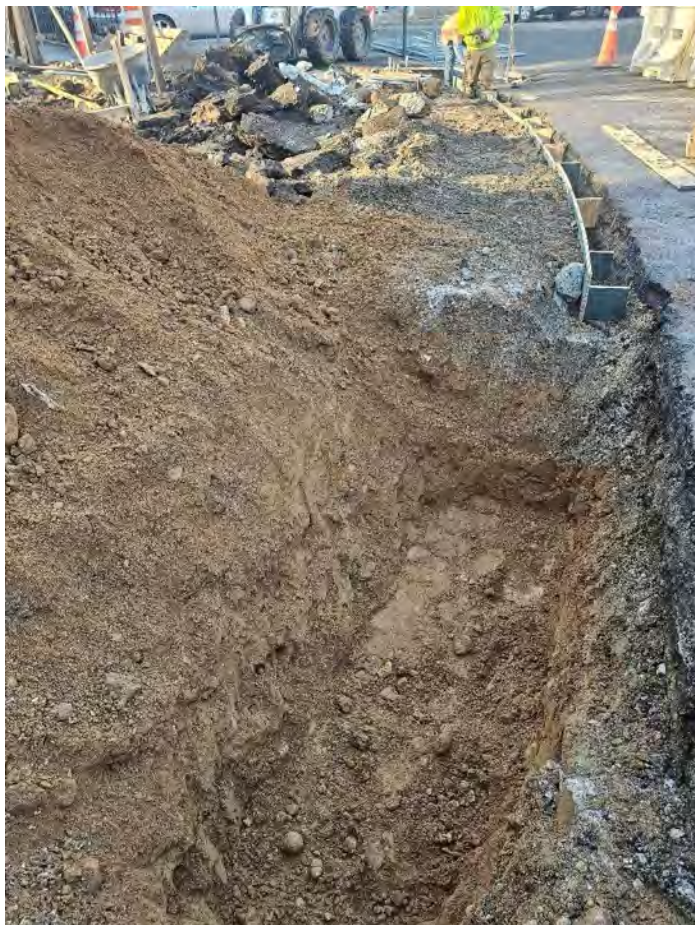
Photograph 12. Area 2, Excavated Tree Pit and full curb cut in background, view looking north.

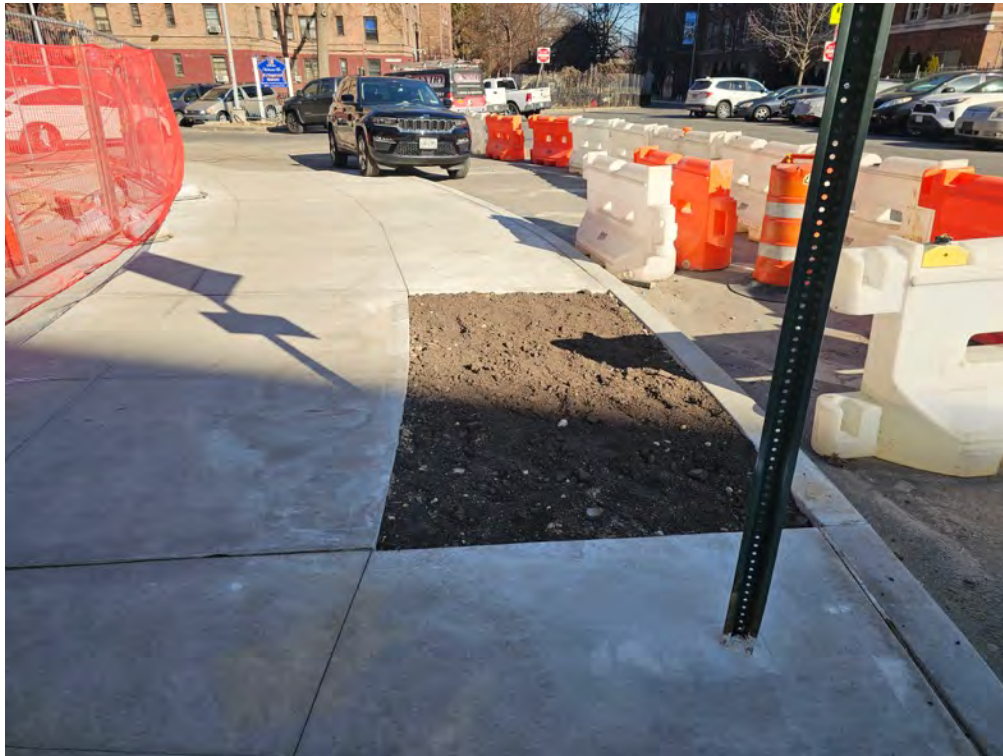
Photograph 13. Area 2, Filled Tree Pit and repaved sidewalk and curb, view looking north.

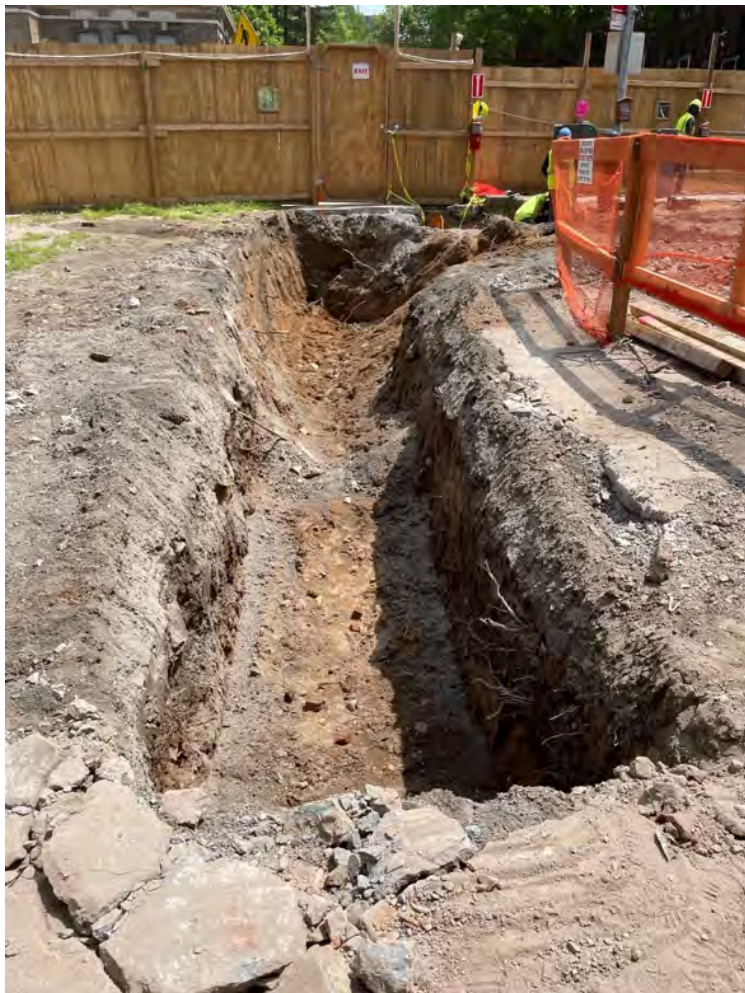
The mechanical excavation of the SOE Trench in the southern edge of the archaeological sensitivity zone was conducted in May 2023 (Figure 3; Photographs 14-15). The SOE trench, which measured approximately 25 x 4 feet (7.6 x 1.2 m) in size was monitored to a total depth of 5 feet (152 cm) below grade.

Photograph 14. Area 3, Support of Excavation Trench during archaeological monitoring, view looking east.

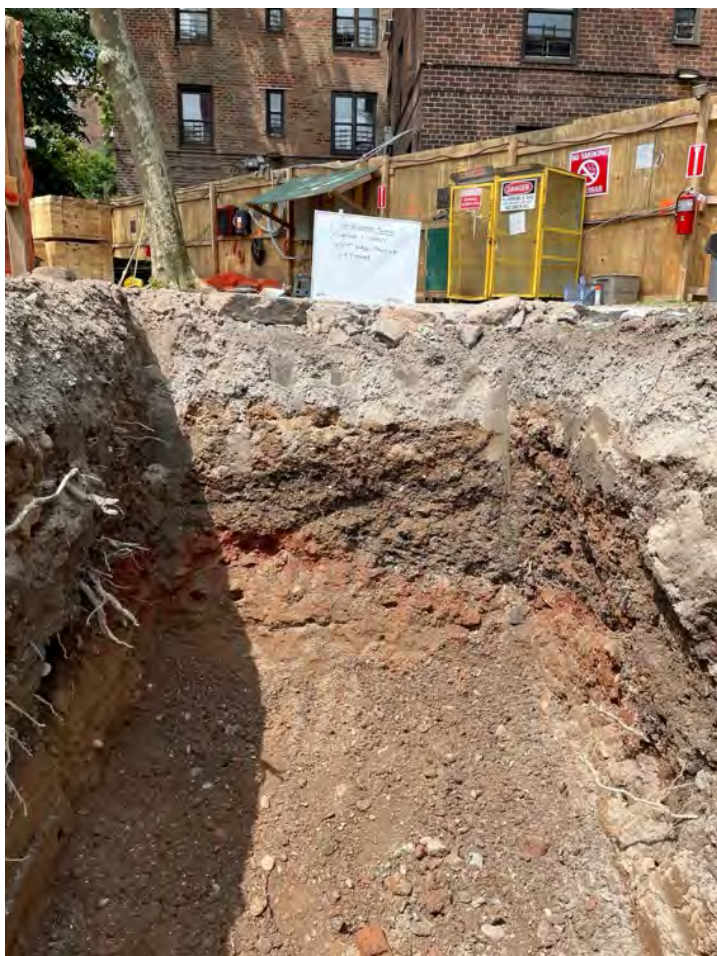
Along the north wall of the trench, excavation exposed a truncated brick wall of what was possibly a former 4 foot (1.2 m) square shallow privy vault near the western edge of the trench.

Photograph 15. Area 3, West Wall of the Support of Excavation Trench, showing limited remnants of the truncated brick feature at the southeast corner and north wall.

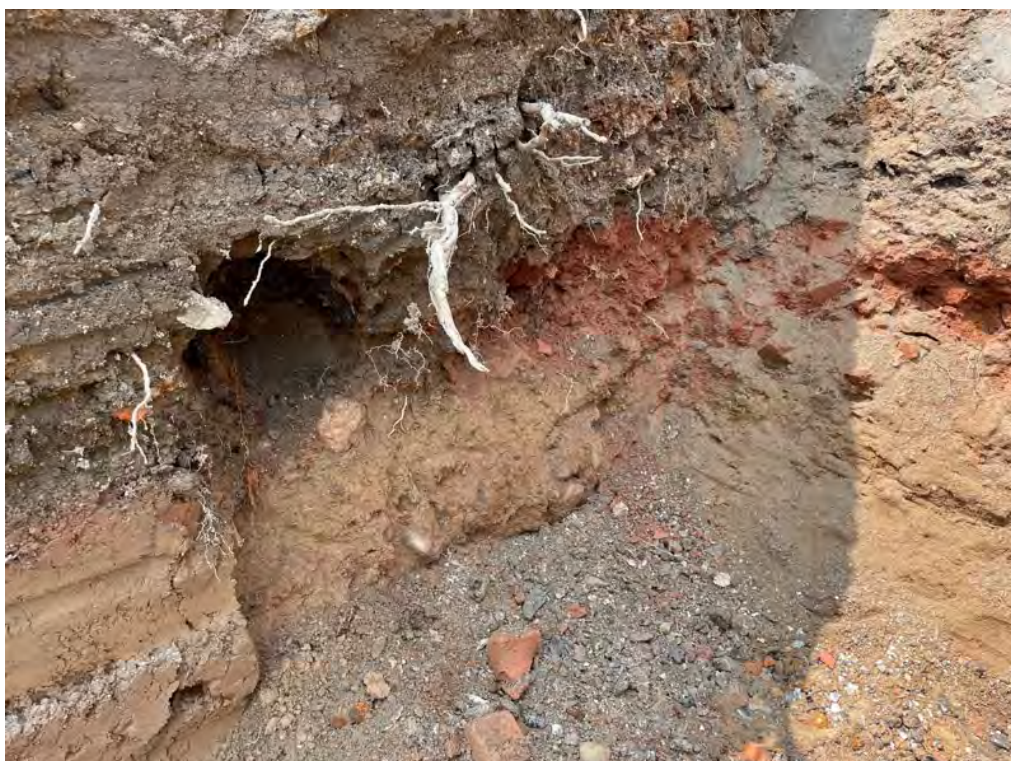
Probing found that the truncated wall ended just above the base of the SOE trench. When hand clearing the trench wall on the south side, a former broken cast iron sewer pipe was exposed adjacent to another truncated portion of the possible privy vault feature in the southwestern corner of the trench (Photograph 16). Probing at the base of this section of the feature also confirmed that it ended just above the depth of the SOE trench. Only a few remnant fragments of the metal pipe were noted in the trench fill, and it appears that the pipe might have been removed between the dates that the residences fronting on St. Edwards Street (formerly Canton St.) were demolished and the church was constructed. A small collection of artifacts (twenty), that included a complete bottle (Kutnows Powder) and two butchered animal bones, was found immediately adjacent to the bases of the remaining north and south brick walls of the feature (Photographs 17 and 18; Appendix). During the creation of the pipe trench for the installation of the cast iron utility pipe, the east and west walls of the feature were obliterated, and the north and south walls were truncated. This feature was likely further impacted by the removal of the utility pipe.

Photograph 16. Area 3, South wall of Support of Excavation Trench, showing remnants of truncated brick feature and cast-iron sewer pipe (at left).

This former feature was associated with one of the former residences at either 90 or 88 Canton Street. The feature was impacted by the installation of the cast iron sewer pipe, that appears to have run north-south through the back yards of both residences. At that time, the excavation of the pipe trench likely obliterated the feature, and the interior fill was scattered. The feature was likely impacted a second time during the demolition of the residences and removal of a section of the large cast iron pipe, further spreading the fill soils from the interior of the feature.

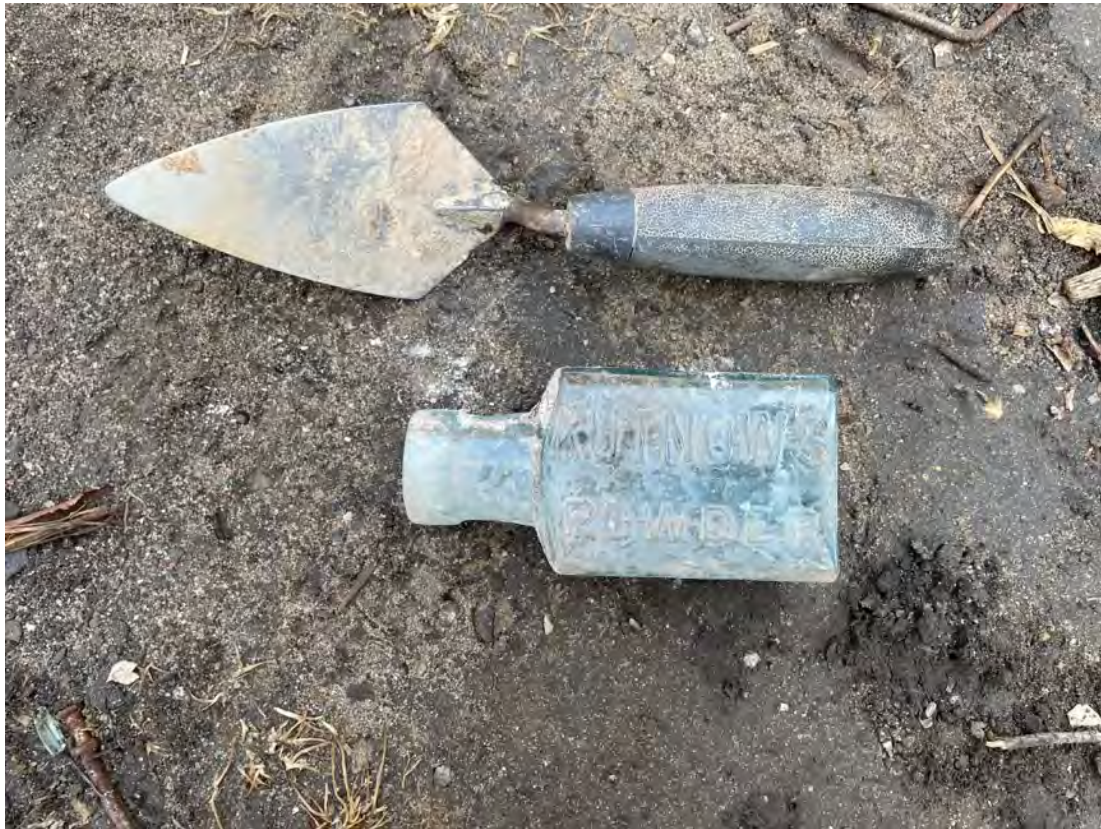
Photograph 17. Field photograph of complete bottle recovered from Support of Excavation Trench in Area 3.

All recovered artifacts date from the late 19<sup>th</sup> through the early 20<sup>th</sup> century, indicating that the feature was likely filled during the first decade of the 20<sup>th</sup> century. The complete recovered assemblage from the west half of the SOE Trench contained fragments of whiteware with blue transferprint decoration; only a single fragment had an indistinct partial maker's mark. The style and appearance of these fragments indicate a late 19<sup>th</sup> century production date. The only true diagnostic artifact was the Kutnow's Powder bottle.

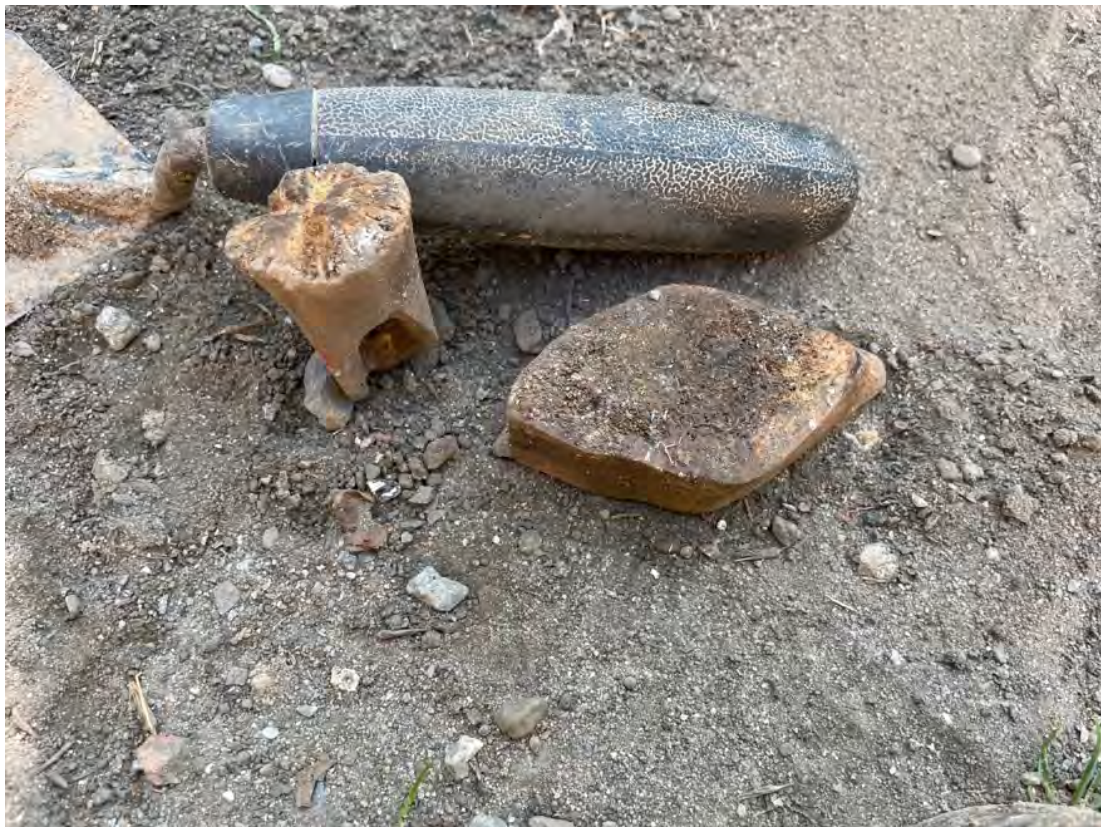
Photograph 18. Field photograph of Animal Food Bones recovered from Support of Excavation Trench in Area 3.
