# **HUNTER RESEARCH**

## PHASE IB ARCHAEOLOGICAL SURVEY

# NORTH END RECIRCULATION SYSTEM CENTRAL PARK, NEW YORK

**JUNE 2025**

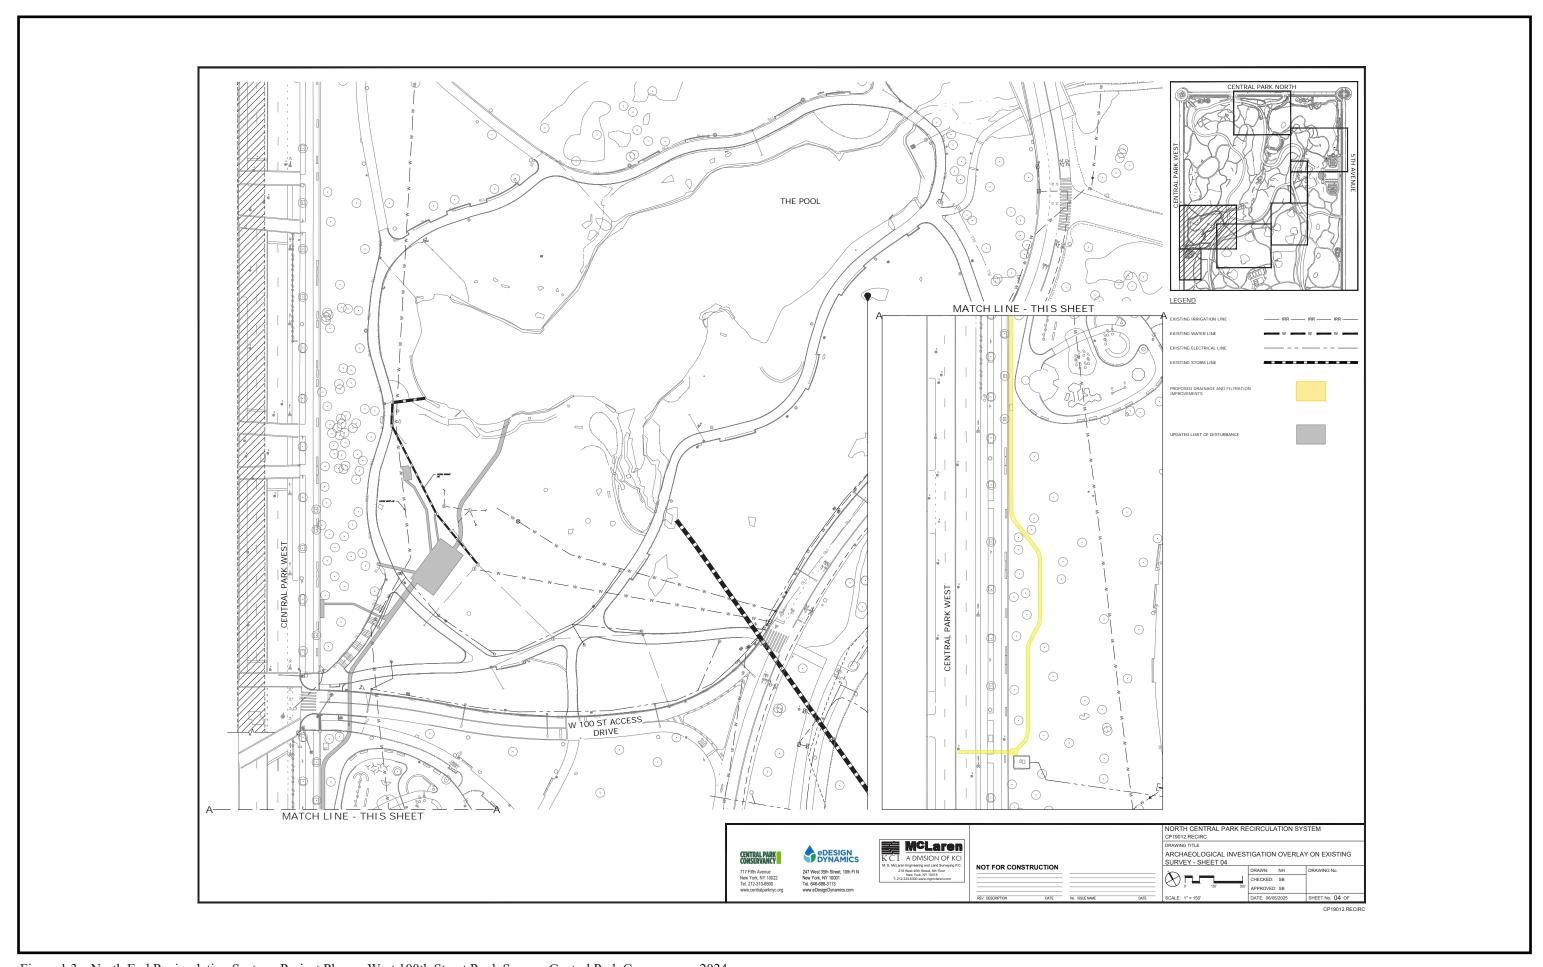
Figure 1.3a. North End Recirculation System, Project Plans – West 100th Street Pool. Source: Central Park Conservancy 2024.

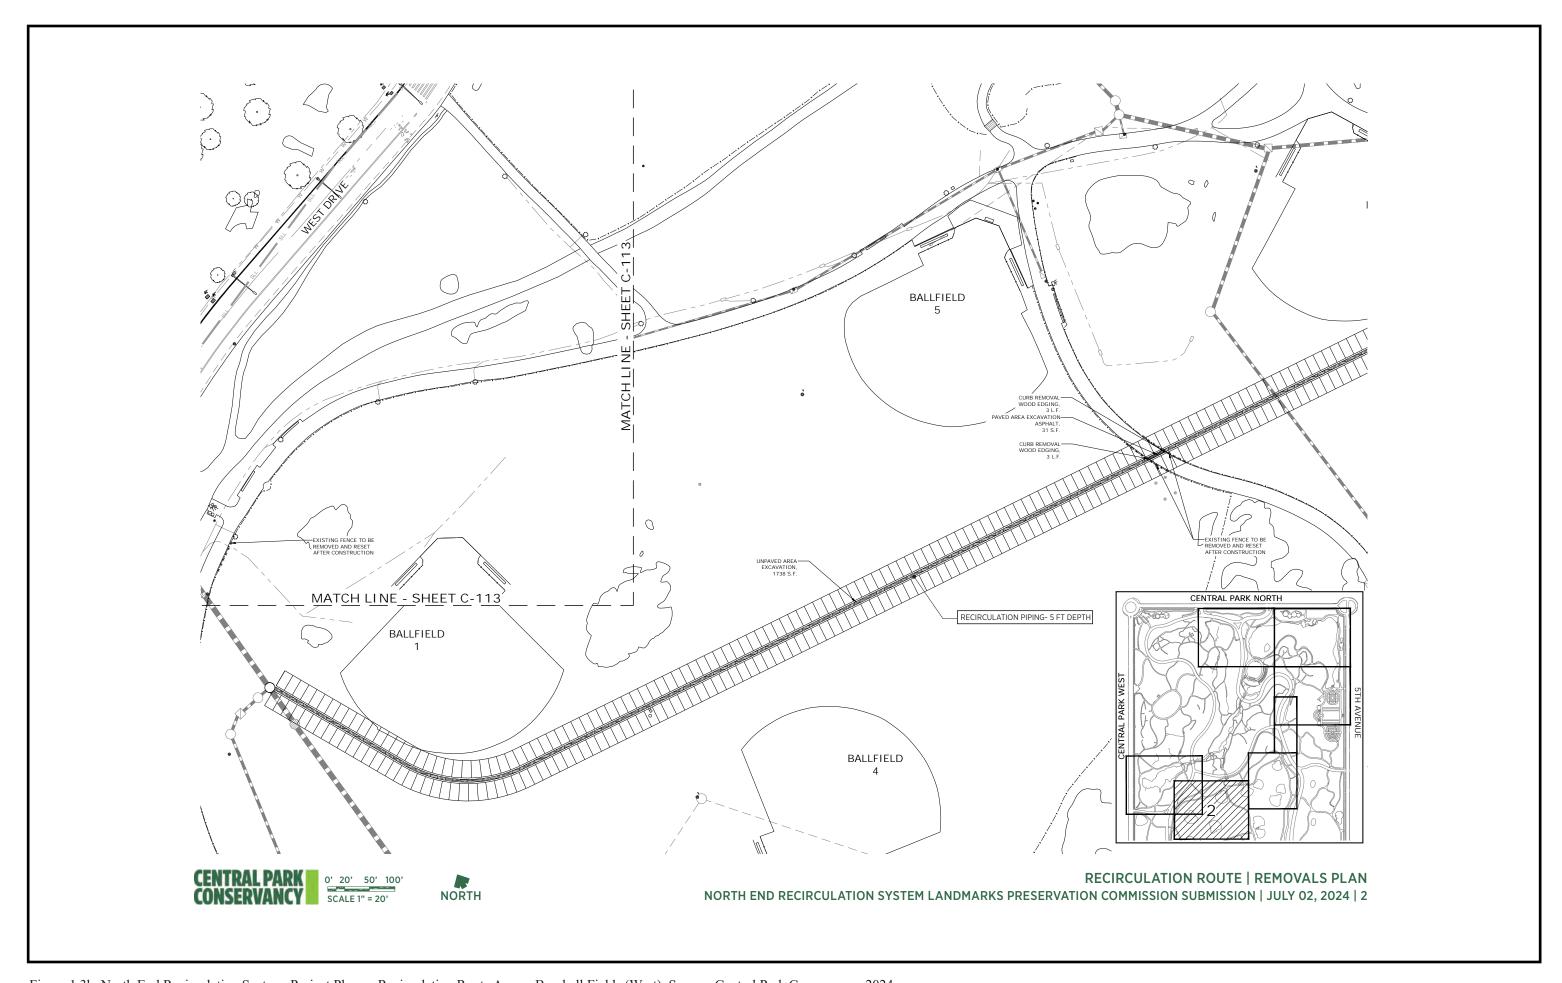
Figure 1.3b. North End Recirculation System, Project Plans – Recirculation Route Across Baseball Fields (West). Source: Central Park Conservancy 2024.

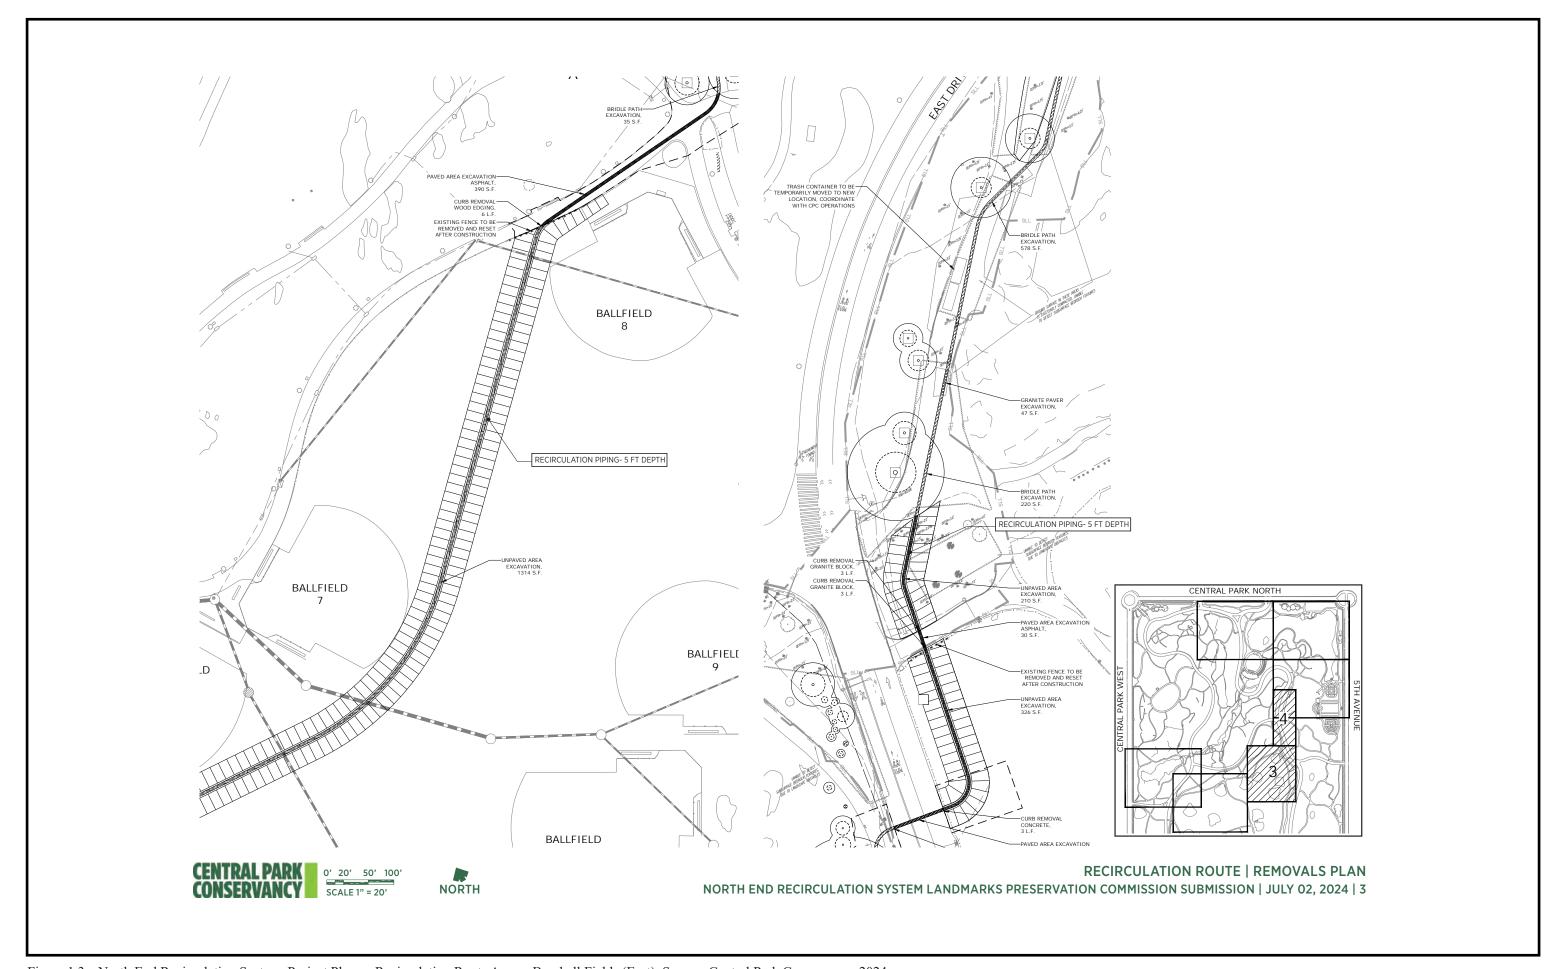
Figure 1.3c. North End Recirculation System, Project Plans – Recirculation Route Across Baseball Fields (East). Source: Central Park Conservancy 2024.

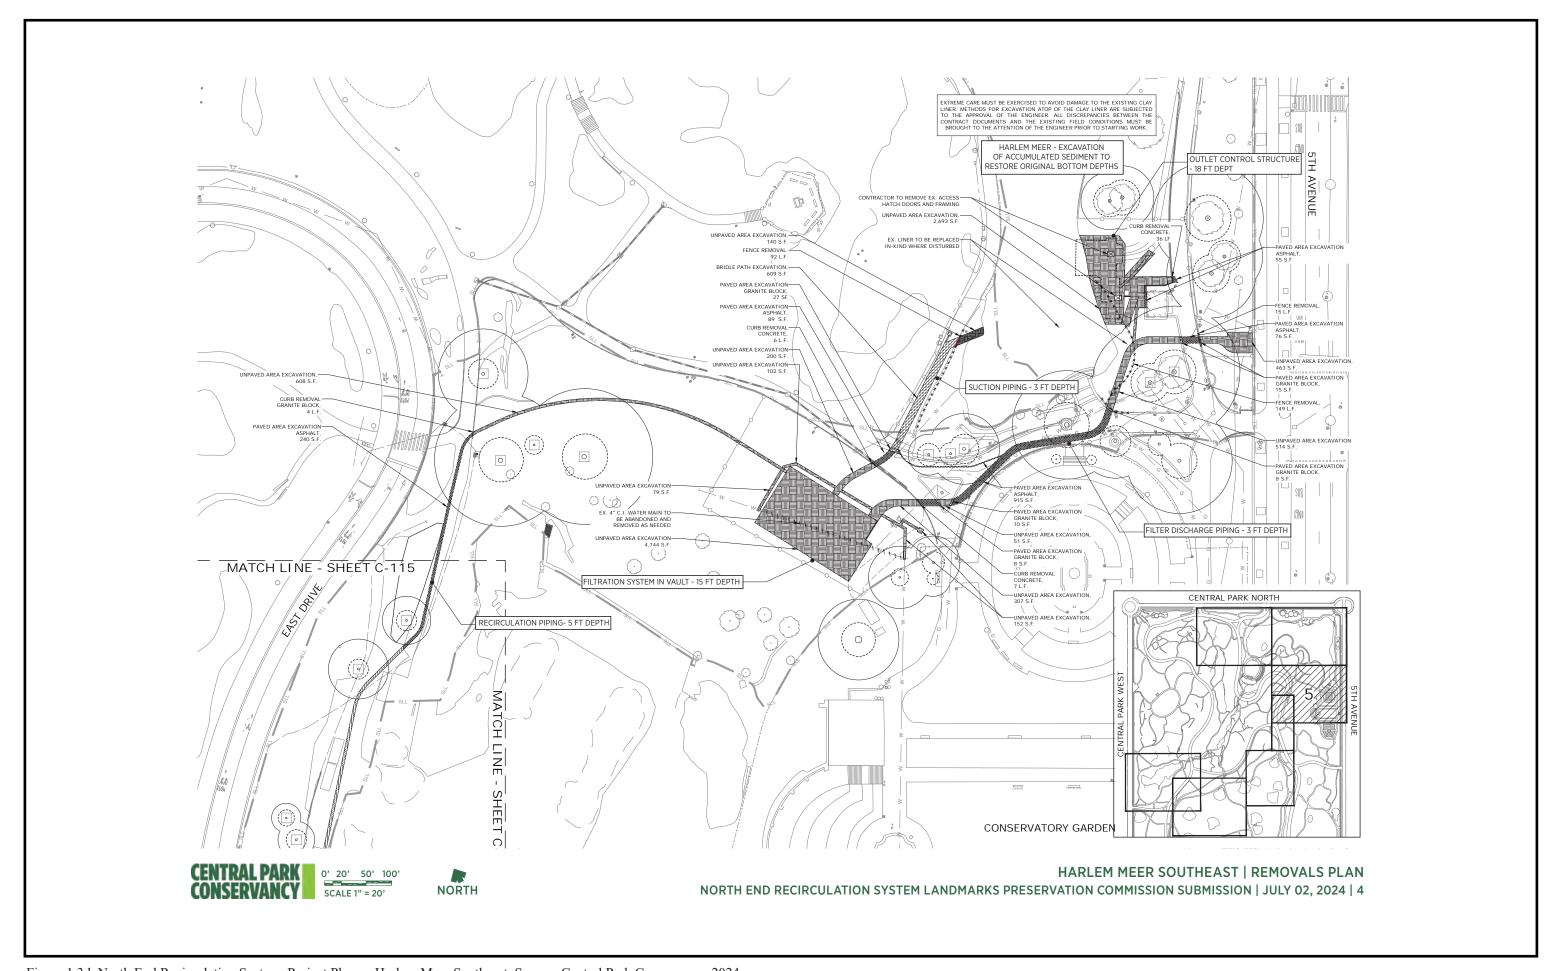
Figure 1.3d. North End Recirculation System, Project Plans – Harlem Meer Southeast. Source: Central Park Conservancy 2024.

- excavation of sediment from Harlem Meer (Figures 1.3d-1.3f);
- installation of a wet well with pump and pressure and discharge piping adjacent to the East Drive between the Adam Clayton Powell, Jr. Boulevard and the Malcolm X Boulevard entries into the Park (Figure 1.3f); and

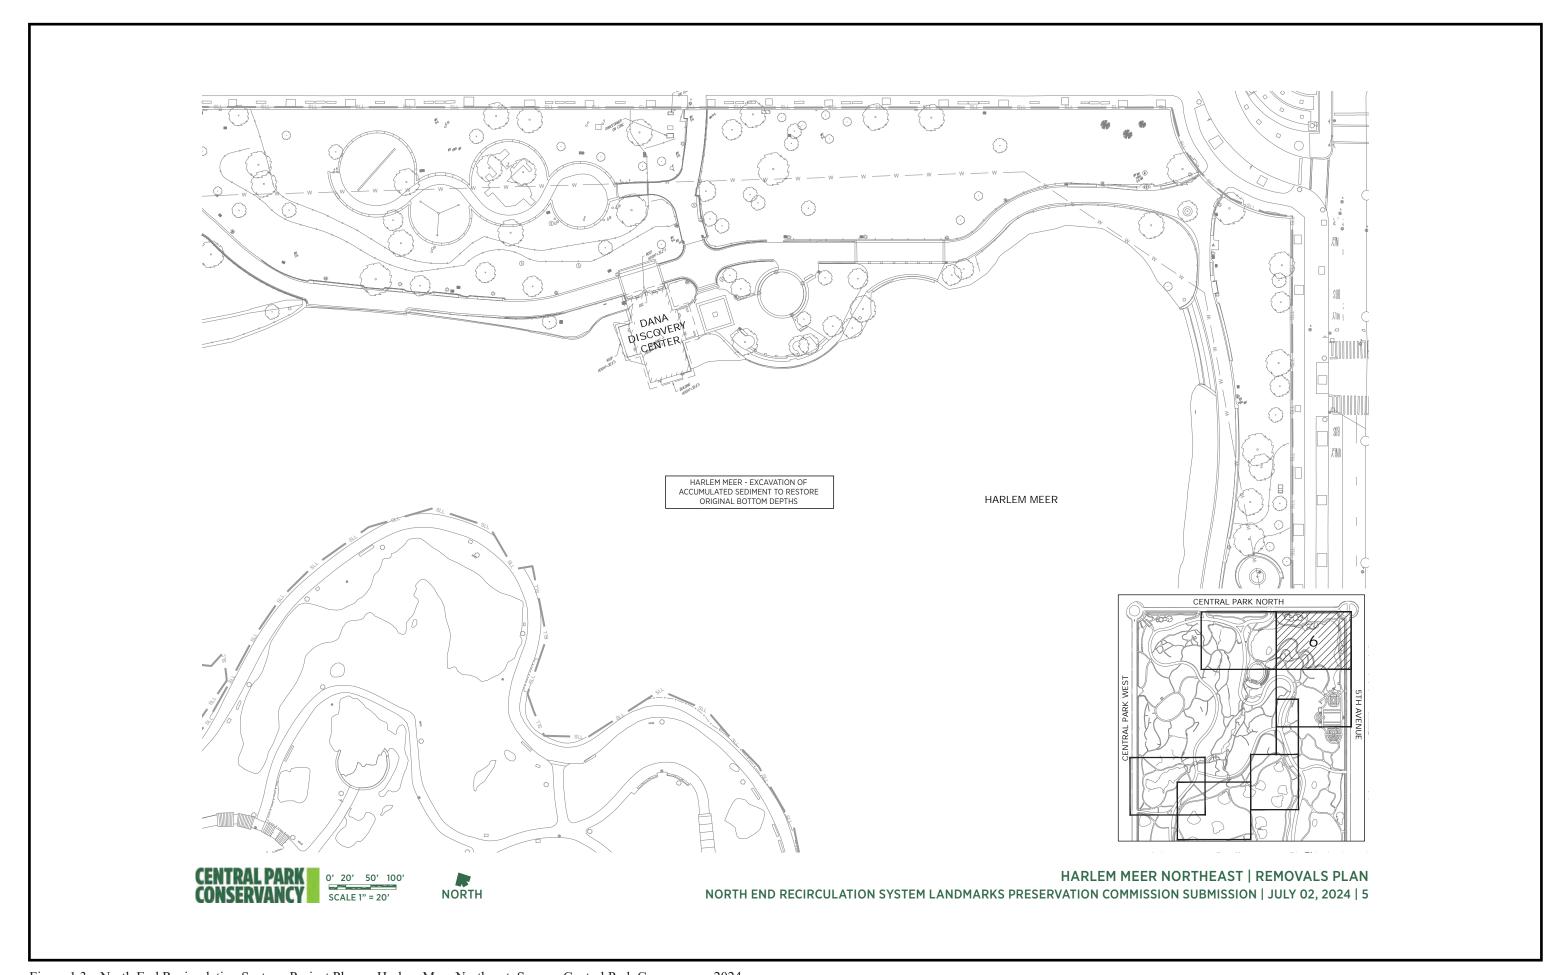
Figure 1.3e. North End Recirculation System, Project Plans – Harlem Meer Northeast. Source: Central Park Conservancy 2024.

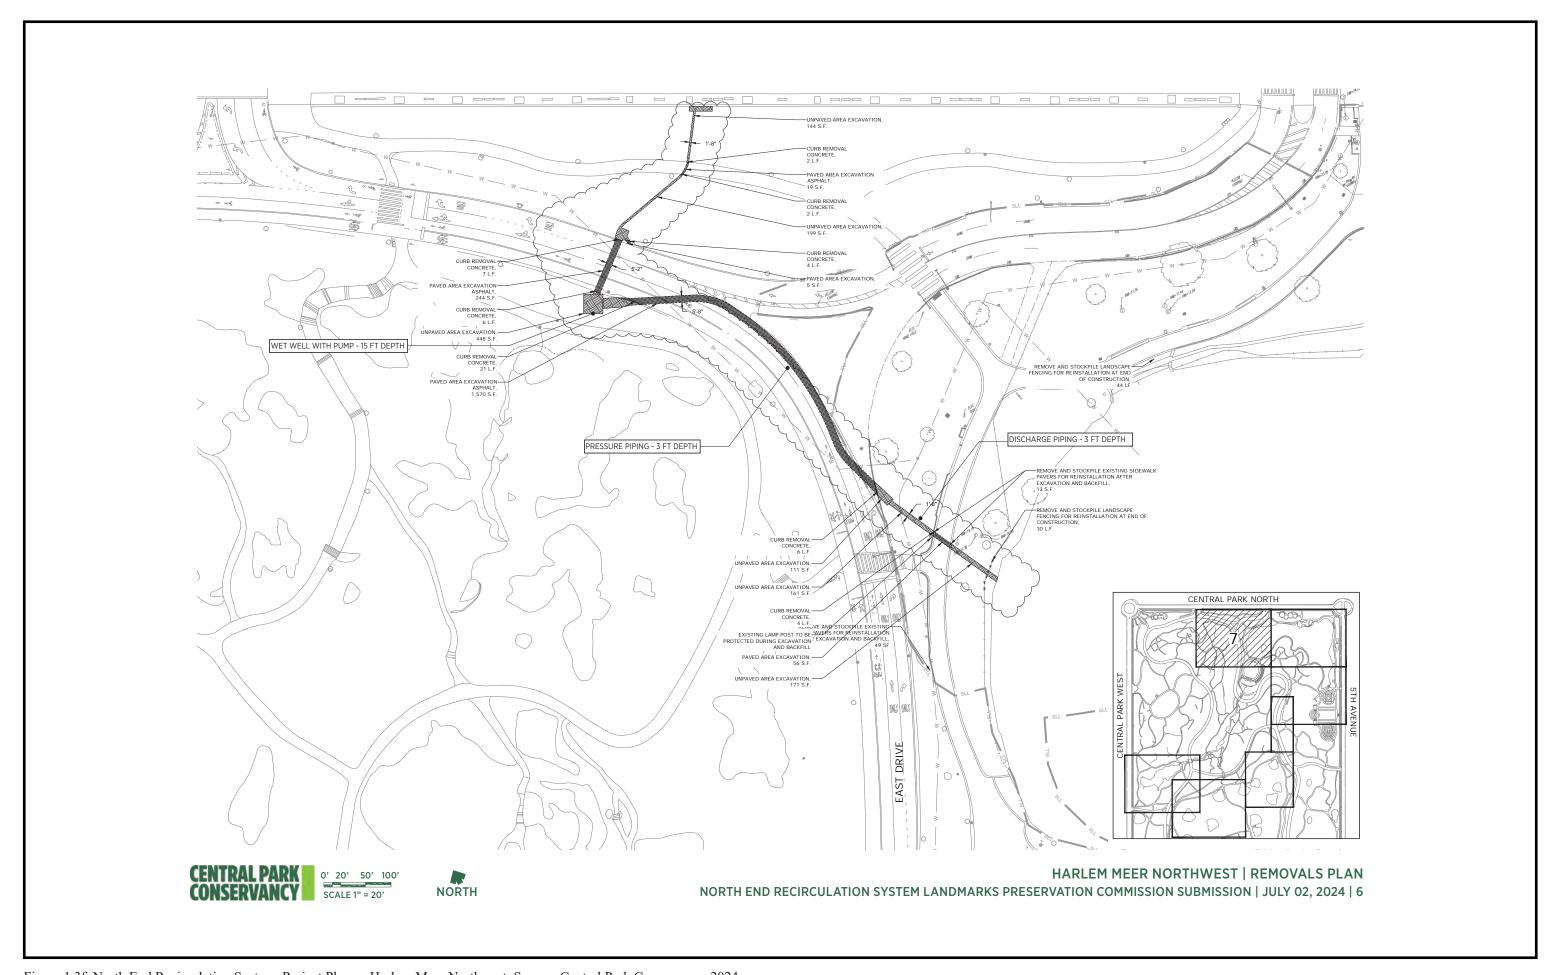
Figure 1.3f. North End Recirculation System, Project Plans – Harlem Meer Northwest. Source: Central Park Conservancy 2024.

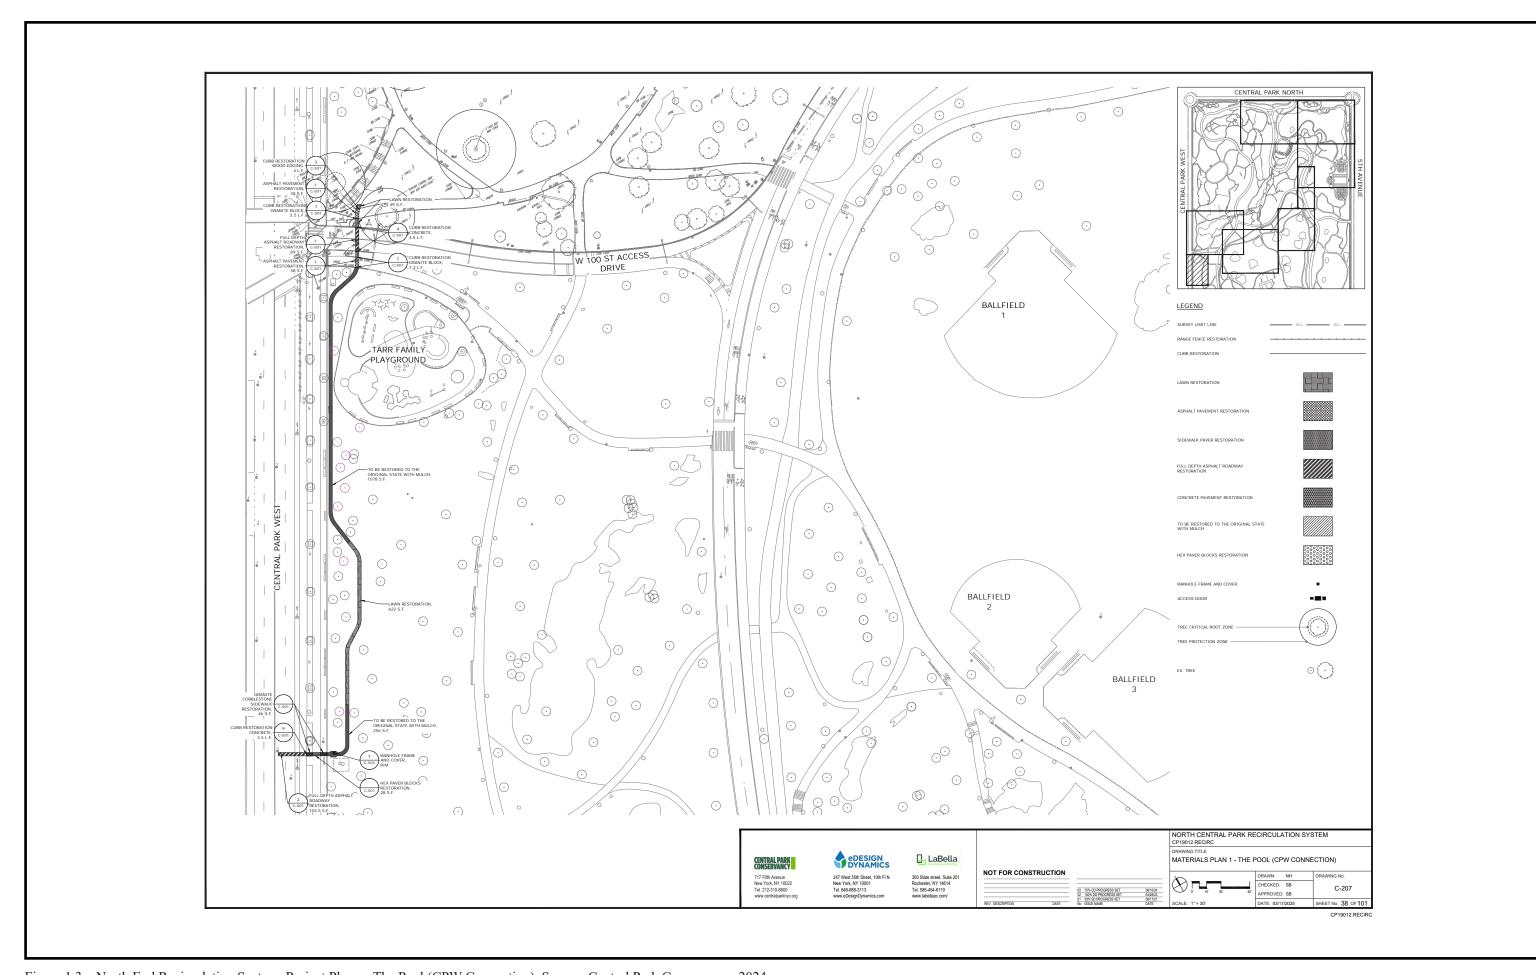
Figure 1.3g. North End Recirculation System, Project Plans – The Pool (CPW Connection). Source: Central Park Conservancy 2024.

- installation of a drain just inside the northwest Park boundary wall connecting the Pool to the main in Eighth Avenue at 98th Street (Figure 1.3g).

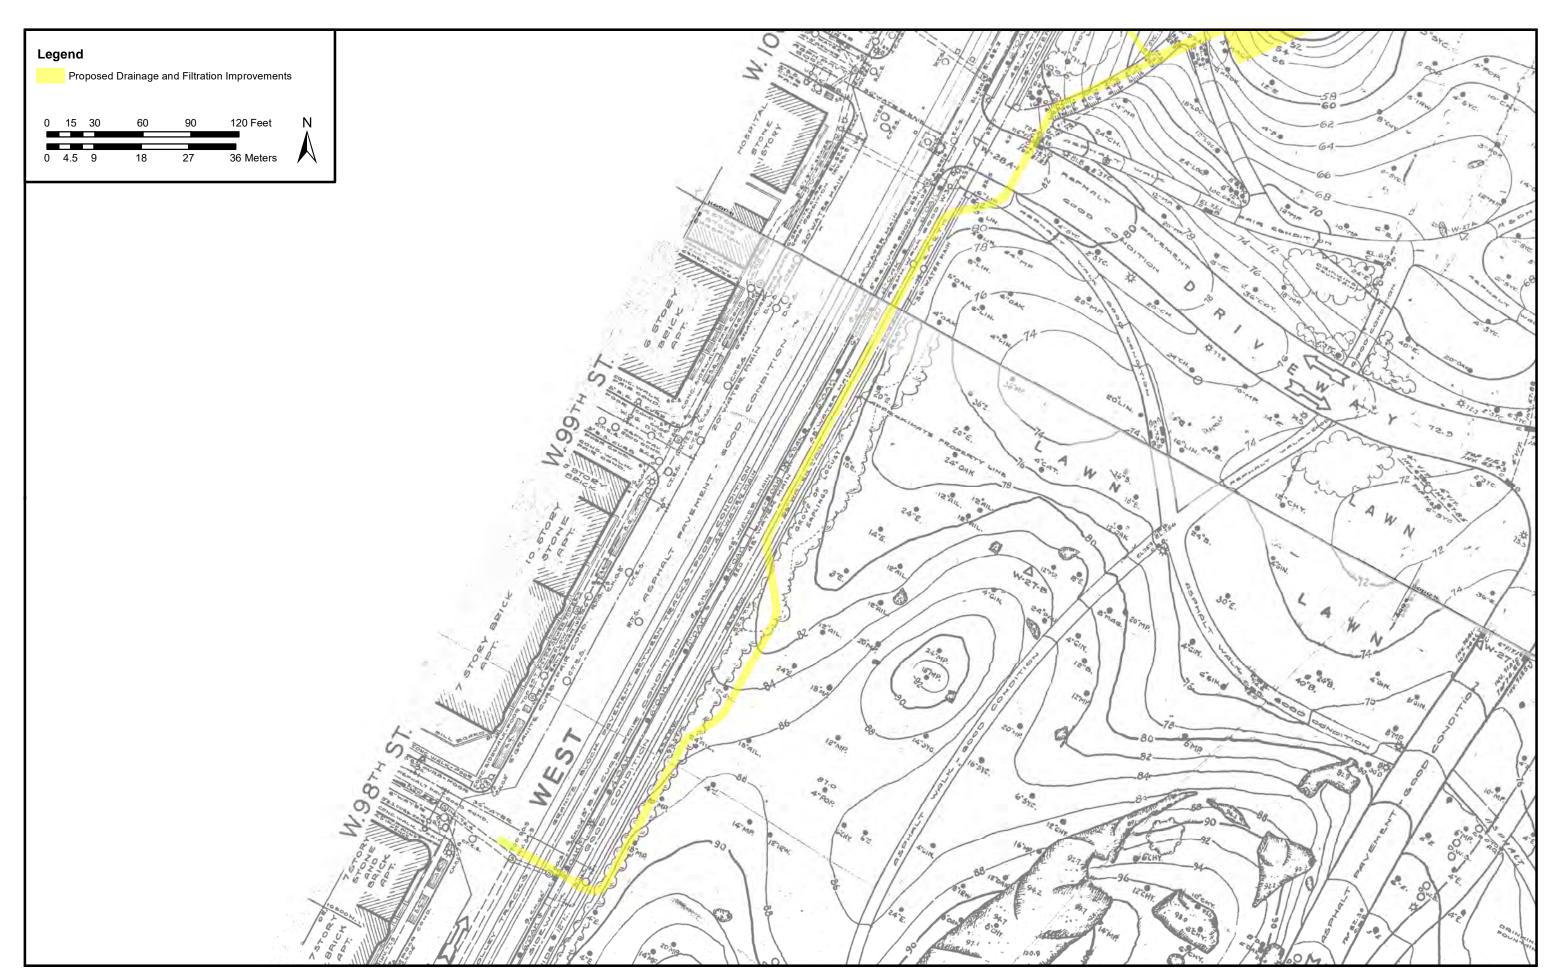
Figure 2.13e. North End Recirculation System, Project Plans, The Pool (CPW Connection), Superimposed on *Topographical Survey of Portion of Central Park*, *Boro of Manhattan*. Source: City of New York, Department of Parks 1935:Sheet M-T-10-105 and 107.

of Harlem Meer and the East Drive, as evidenced by the mid-1930s topography, pre-supposes extensive modification of the pre-Park landscape and its related drainage (Figure 2.13d). The extent to which the creation of the Park affected the pre-Park topography alongside Eighth Avenue between 98th and 101st Streets is less clear, although filling would appear to have occurred reducing the area of exposed bedrock in this area (Figure 2.13e).

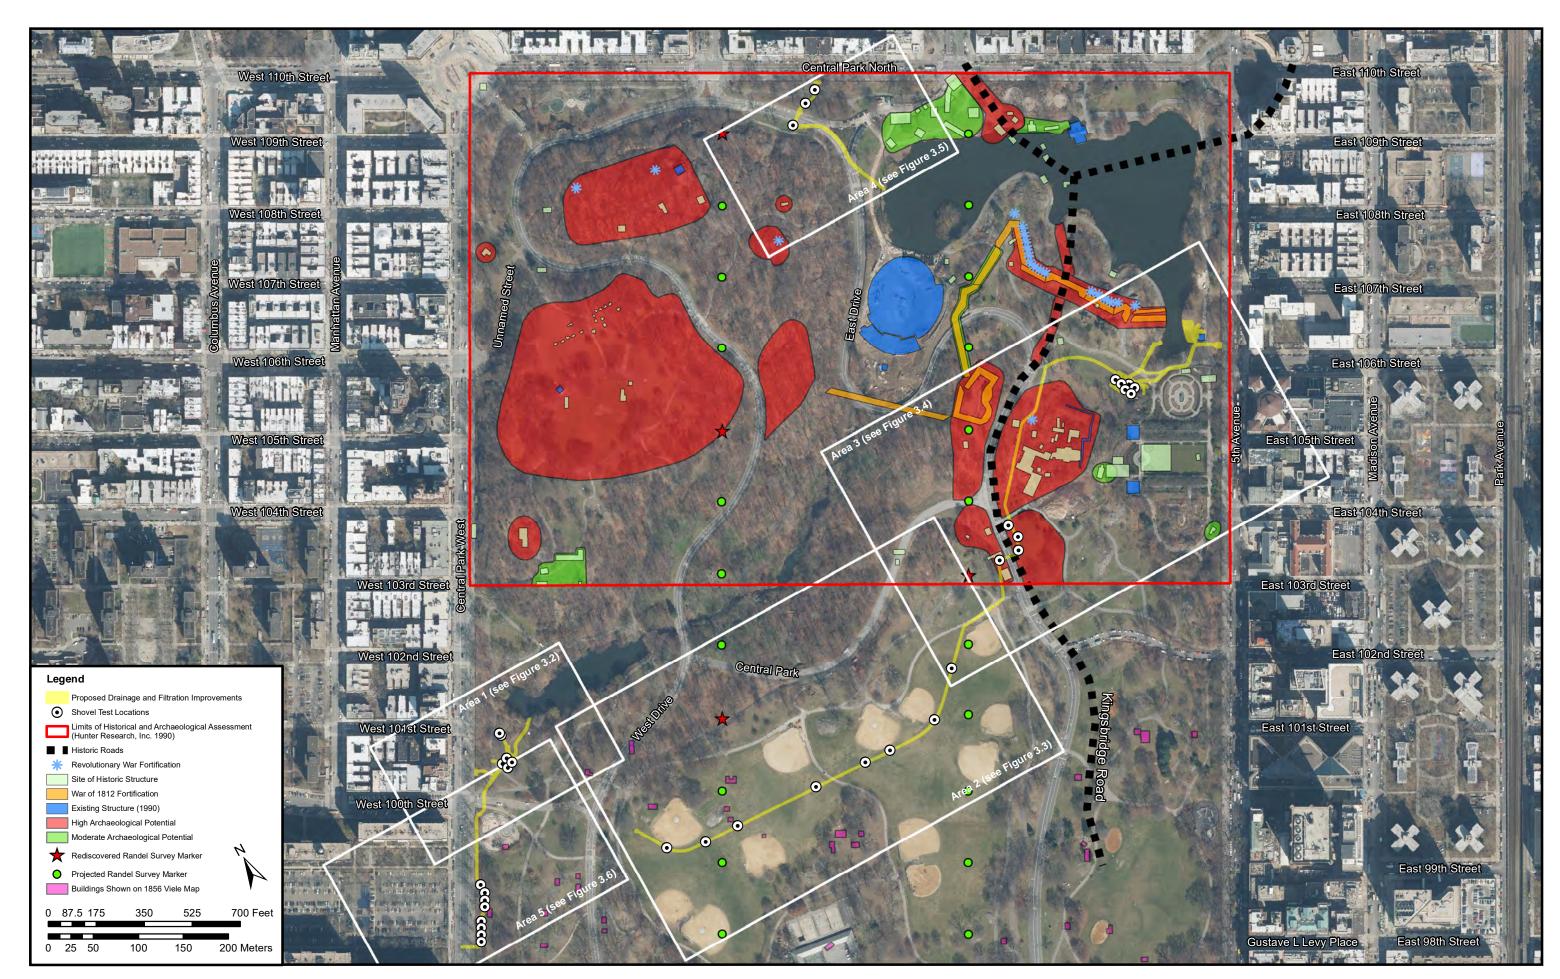
Figure 3.1. Aerial Photograph Showing the Overall Limits of Proposed Ground Disturbance and Locations of Archaeological Shovel Tests.

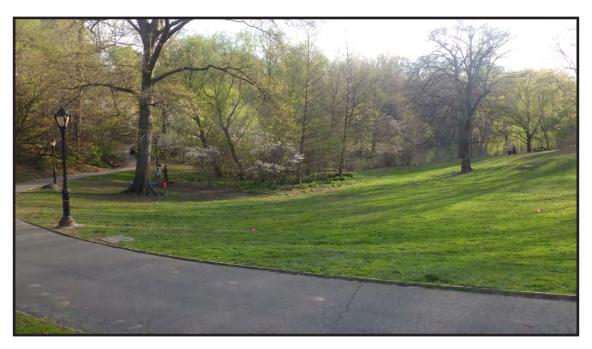
Photograph 3.1. View looking northeast showing Area 1 adjacent to "The Pool" on the west side of the park between 100th and 101st Streets (Photographer: Joshua Butchko, April 2025) [HRI Neg.# 25026/D1:027].

Area 1 (Filtration System and Piping near "The Pool" between 100th and 101st Streets). This area, presently a gently sloping, grassy swale, was rated as having a low potential for yielding significant prehistoric and historic archaeological resources on account of an extensive re-working of the landscape that occurred when the Park was created (Photograph 3.1).

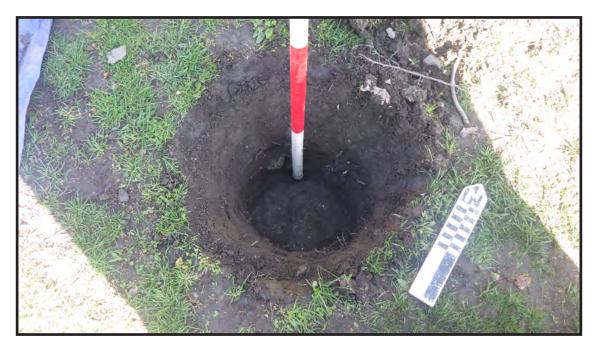
Photograph 3.2. View looking northwest showing Shovel Test 3 (Photographer: Joshua Butchko, April 2025) [HRI Neg.# 25026/D1:032].

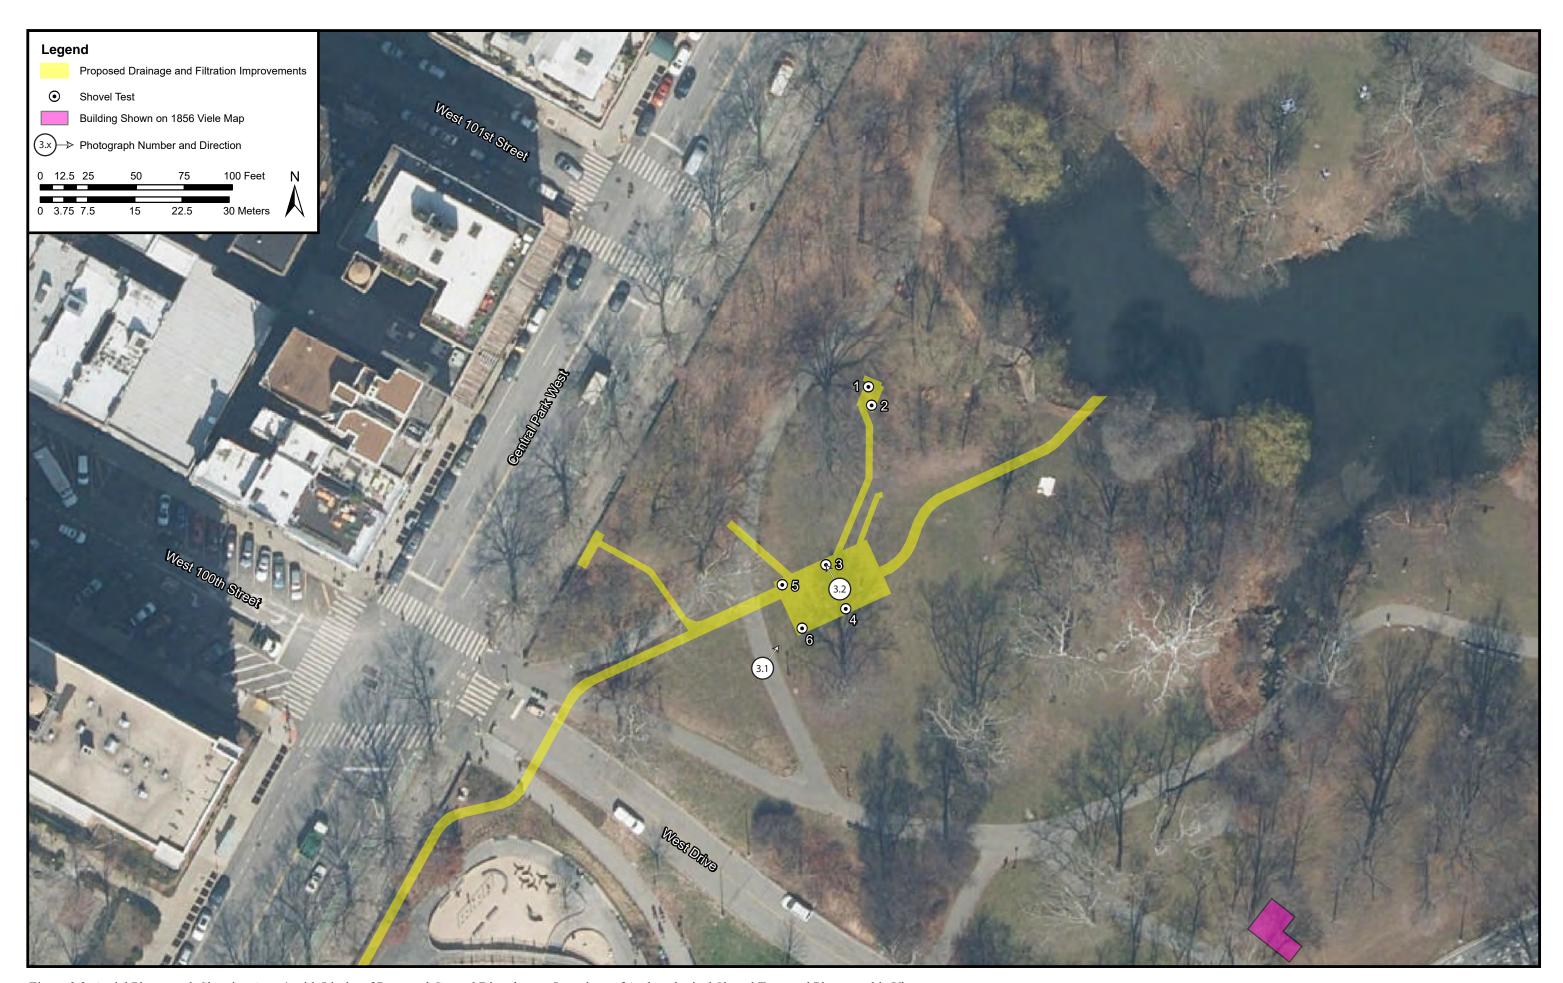
Figure 3.2. Aerial Photograph Showing Area 1 with Limits of Proposed Ground Disturbance, Locations of Archaeological Shovel Tests and Photographic Views.

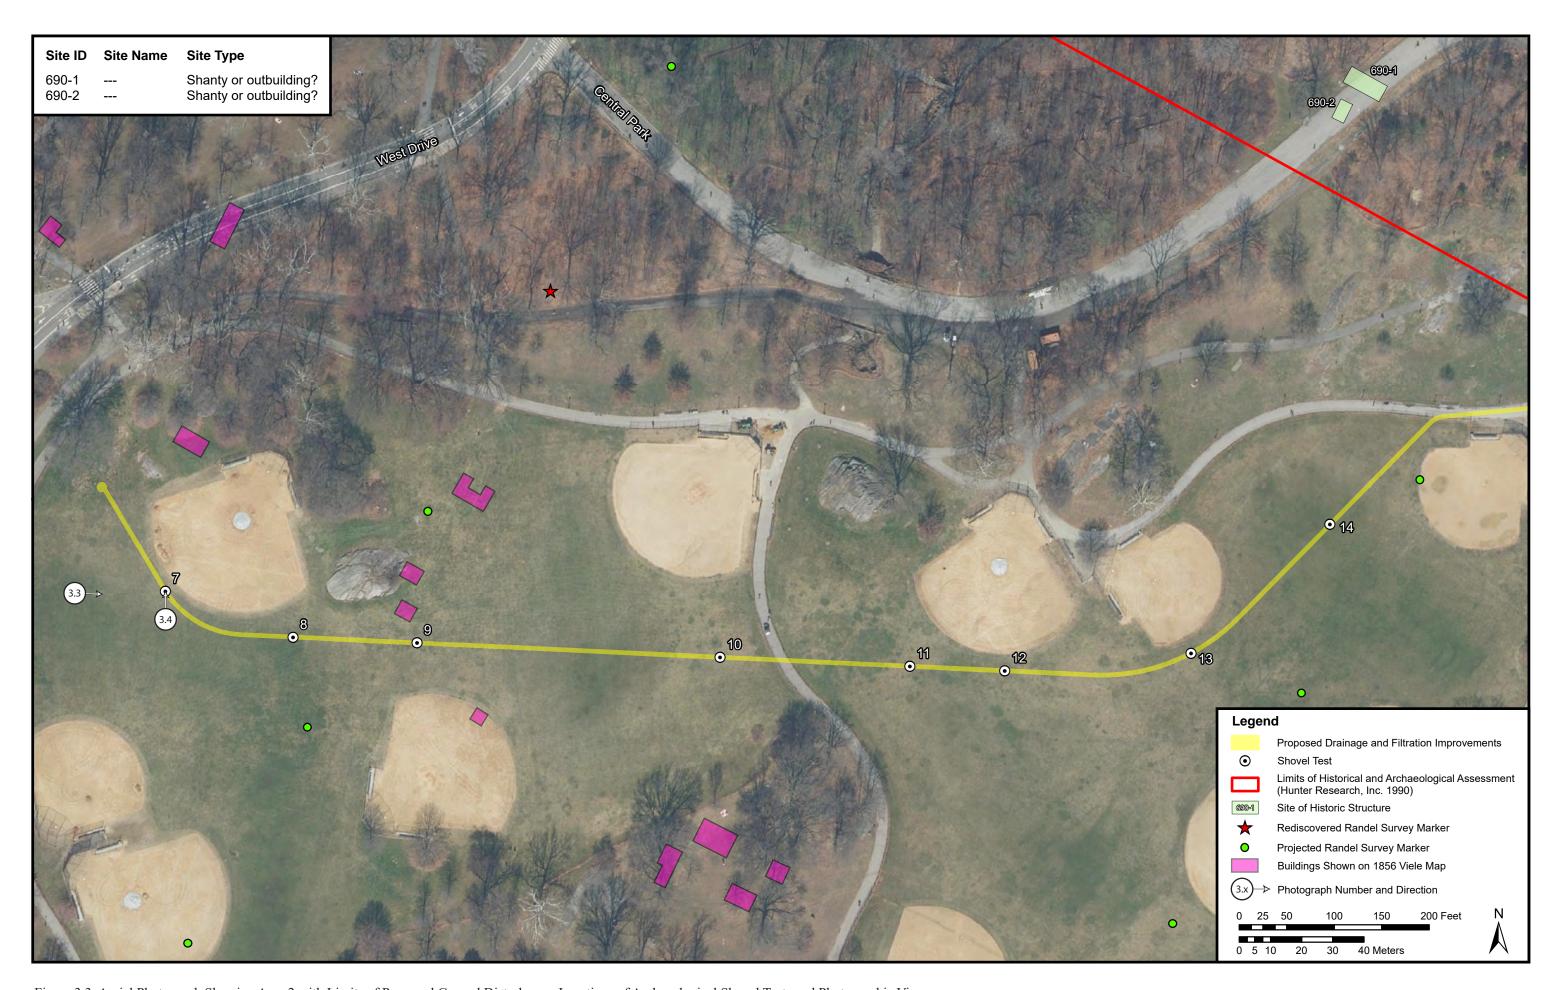
Figure 3.3. Aerial Photograph Showing Area 2 with Limits of Proposed Ground Disturbance, Locations of Archaeological Shovel Tests and Photographic Views.

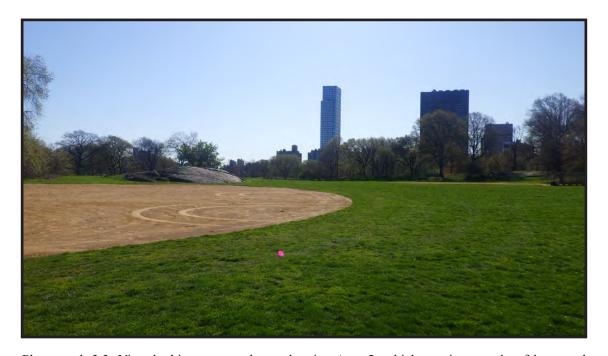
Photograph 3.3. View looking east-northeast showing Area 2, which consists mostly of lawn and baseball fields between the East and West Drives (Photographer: Joshua Butchko, April 2025) [HRI Neg.# 25026/D1:002].

Area 2 (Recirculation Piping Alignment across the Baseball Fields between the West and East Drives). This area, presently comprising well-maintained lawn and baseball fields, was rated as having a low potential for yielding significant prehistoric and historic archaeological resources on account of extensive filling of the land-scape that occurred when the Park was created (Photograph 3.3). Historic map analysis indicated that grades in this area have not substantially changed since *circa* 1860.

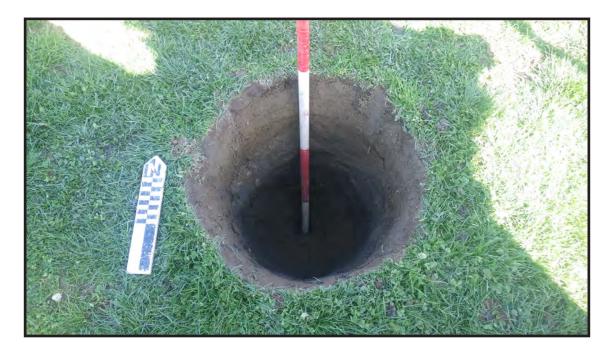
Photograph 3.4. View looking north showing Shovel Test 7 (Photographer: Joshua Butchko, April 2025) [HRI Neg.# 25026/D1:012].

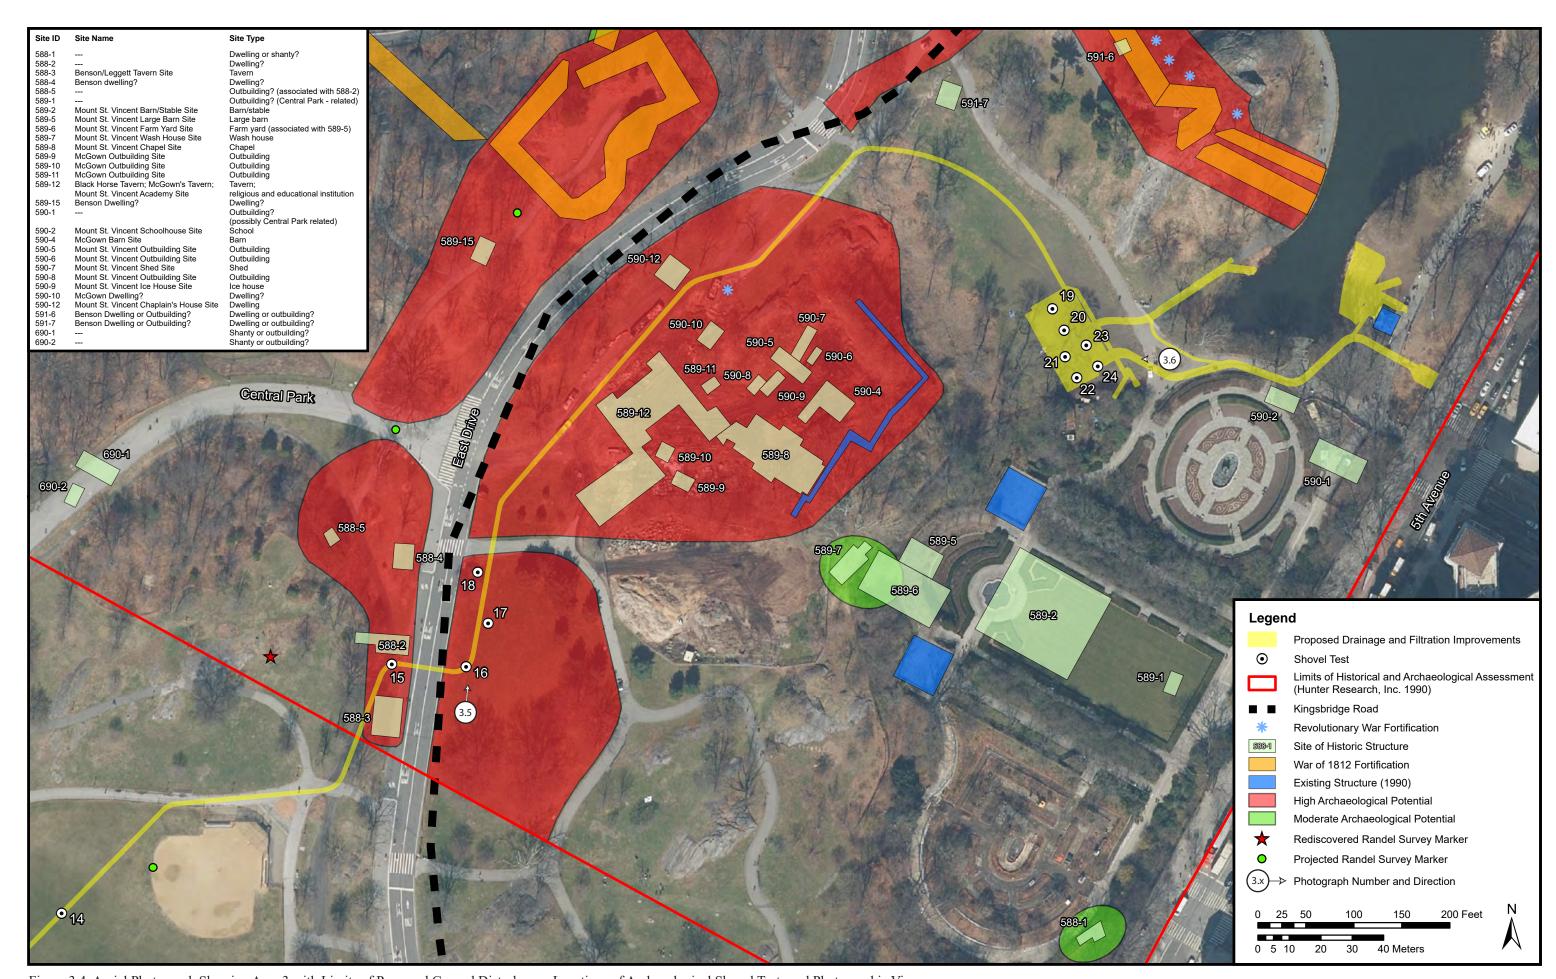
Figure 3.4. Aerial Photograph Showing Area 3 with Limits of Proposed Ground Disturbance, Locations of Archaeological Shovel Tests and Photographic Views.

Ten shovel tests (Shovel Tests 15-24) were laid out in areas of proposed disturbance to the southwest and northeast of Mount St. Vincent (Figure 3.4). Tests to the southwest (Shovel Tests 15-18) were placed in lawn or alongside paved pathways on either side of East Drive. Tests to the northeast (Shovel Tests 19-24) were placed in a sloping lawn at the base of the Mount adjacent to the Conservatory Garden. These latter tests were laid out at 25 and 50-foot intervals and offset, where necessary, to avoid existing utilities. In all these tests, excavation began with the removal of sod and dark brown silty loam with organic matter [Context 1]. In most of these tests, the topsoil [1] overlaid multiple, variable fill deposits of mottled silty, sandy and clayey loams. These fill deposits produced a moderate quantity of fragmentary cultural material, chiefly plastic and glass. In Shovel Tests 15 and 23, the fill deposits overlaid a rock impasse at a depth of approximately two feet below the ground surface. In Shovel Test 16, a dense, mottled clay fill layer extended to a depth of 3.6 feet below the ground surface. In Shovel Tests 17, 19-22 and 24, the fill overlaid a loamy sand or clay loam between 1.0 and 3.5 feet below the ground surface, a layer that was interpreted as the B Horizon subsoil. In Shovel Test 18, the upper fill layers overlaid a coarse sand with gravel that was interpreted as a C Horizon subsoil. This extended from two feet below grade to a depth of 2.6 feet.

this area remains of potential archaeological concern owing to the former presence of structures along the west side of the Kingsbridge Road (the course of which is today followed by the East Drive). Archaeological monitoring during construction is recommended for the 150-foot length of proposed piping heading west and south from the western edge of the East Drive toward the nearest baseball diamond (see above, Figure 3.4).

As noted in the earlier Phase IA-level assessment, the summit of Mount St. Vincent is also considered archaeologically sensitive and archaeological monitoring during construction is likewise recommended for the approximately 600-foot length of proposed piping alignment extending along the east side the East Drive to the northern rim of the Mount (see above, Figure 3.4).

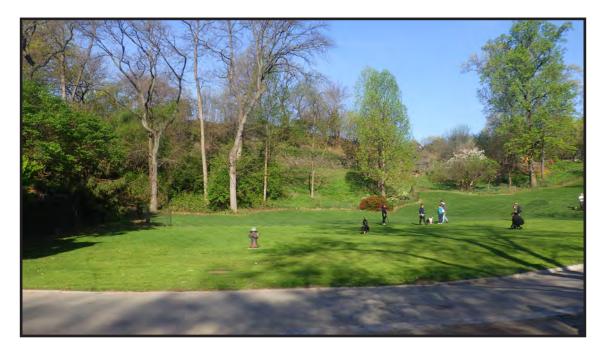
Photograph 3.6. View looking west showing the northeast portion of Area 3 at the base of Mount St. Vincent on its northeastern side next to the southern end of the Harlem Meer (Photographer: Joshua Butchko, April 2025) [HRI Neg.# 25026/D1:039].

Historic maps for the area around the southern end of Harlem Meer, where a filtration system, suction and filter discharge piping and an outlet control structure are proposed, show no evidence for earlier buildings or structures. While this entire area has been heavily modified, both during the original Park construction (e.g., the creation of the Meer, which involved re-contouring of the historic drainage, and paths), and in subsequent episodes of utilities installation, landscaping and pathway upgrades, there is some possibility that intact pre-Park archaeological deposits may survive in the flatter area at the base of Mount St. Vincent on its northeast side where the filtration system will be positioned (Photograph 3.6).

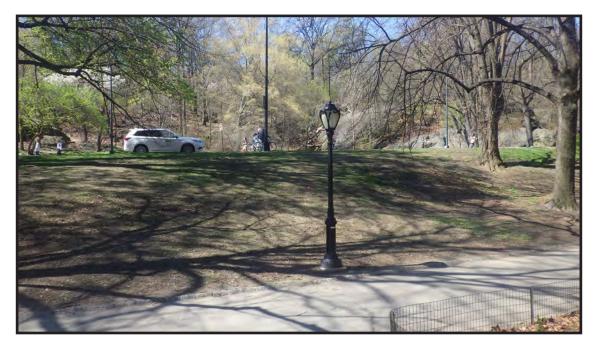
Photograph 3.7. View looking southwest showing Area 4; the vehicle is traveling along the East Drive and the base of the bluff is just visible in the trees beyond (Photographer: Joshua Butchko, April 2025) [HRI Neg.# 25026/D1:014].

Area 4 (Wet Well, Pump and Piping adjacent to the East Drive at the Northern End of the Park). Northwest of Harlem Meer, adjacent to the East Drive between the Adam Clayton Powell, Jr. Boulevard and the Malcolm X Boulevard entries into the Park, where a wet well with pump and pressure and discharge piping are to be installed, is an area where historic maps show no evidence for earlier buildings or structures (Photograph 3.7). This location lies near the base of the bluffs, well to the west of the main focus of the Montagne/Kortwright/ Nutter farm, and prior to the Park's creation was probably poorly drained, wet ground close to the confluence of Montayne's Rivulet and Harlem Creek. Creation of the Park appears to have entailed extensive filling of the valley of Harlem Creek to raise the grades of the East Drive and asphalt walks almost to the level of 110th Street.

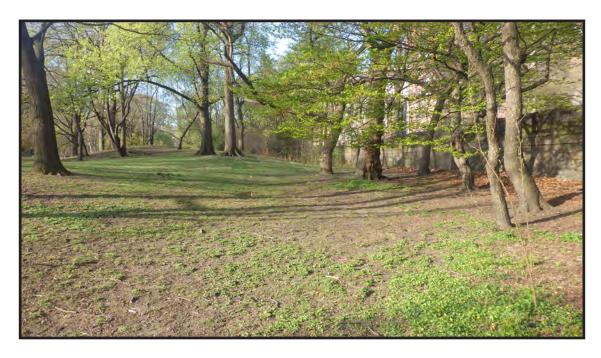
Photograph 3.8. View looking southwest showing Area 5; the park boundary wall along the east side of Eighth Avenue is at right (Photographer: Joshua Butchko, April 2025) [HRI Neg.# 25026/D1:030].

Area 5 (Drain inside the northwest Park boundary wall connecting the Pool to the main in Eighth Avenue at 98th Street). The planned alignment for the drain connecting "The Pool" to the main in Eighth Avenue at 98th Street passes between the Tarr Playground and the park boundary wall from 100th Street to just below 99th Street. This segment of the connecting line is considered to have negligible archaeological potential since ground has likely been heavily disturbed by wall and playground construction. However, the roughly 200-footlong stretch of the alignment extending southwest from the point just south of 99th Street where it veers southward further into the park and then parallels Eighth Avenue to the bend where it turns northwest at 98th Street, is of some archaeological concern (Photograph 3.8). There is a possibility that intact pre-Park historic and prehistoric cultural deposits could survive beneath Park landscaping fill in this area and the alignment also passes close to a building shown on the Viele map of 1856 (see above, Figure 2.10).
