# **HUNTER RESEARCH**

## PHASE IB ARCHAEOLOGICAL SURVEY

# NORTH END RECIRCULATION SYSTEM CENTRAL PARK, NEW YORK

**JUNE 2025**

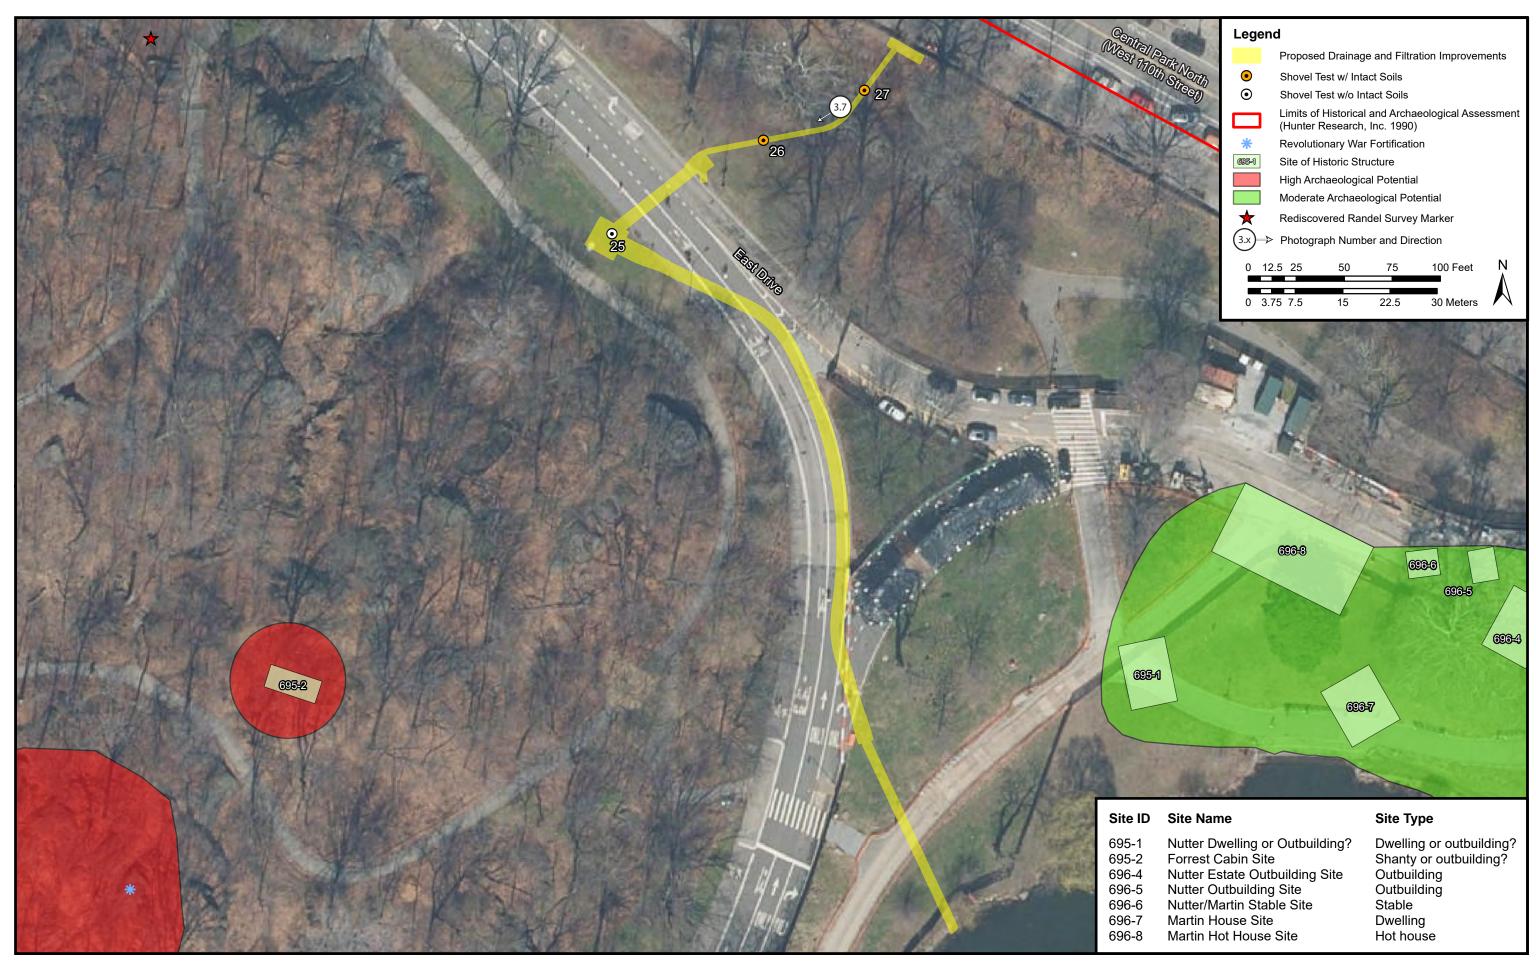
Figure 3.5. Aerial Photograph Showing Area 4 with Limits of Proposed Ground Disturbance, Locations of Archaeological Shovel Tests and Photographic Views.

Fieldwork involved the excavation of comprised eight shovel tests (Shovel Tests 28-35) laid out at roughly 25-foot intervals along the line of proposed ground disturbance (Figure 3.6). These tests revealed a soil sequence that consisted of sod and topsoil over an intact A horizon and a series of B horizon subsoil deposits. In one instance (Shovel Test 32), a layer of mottled sandy loam, interpreted as fill, was present between the topsoil

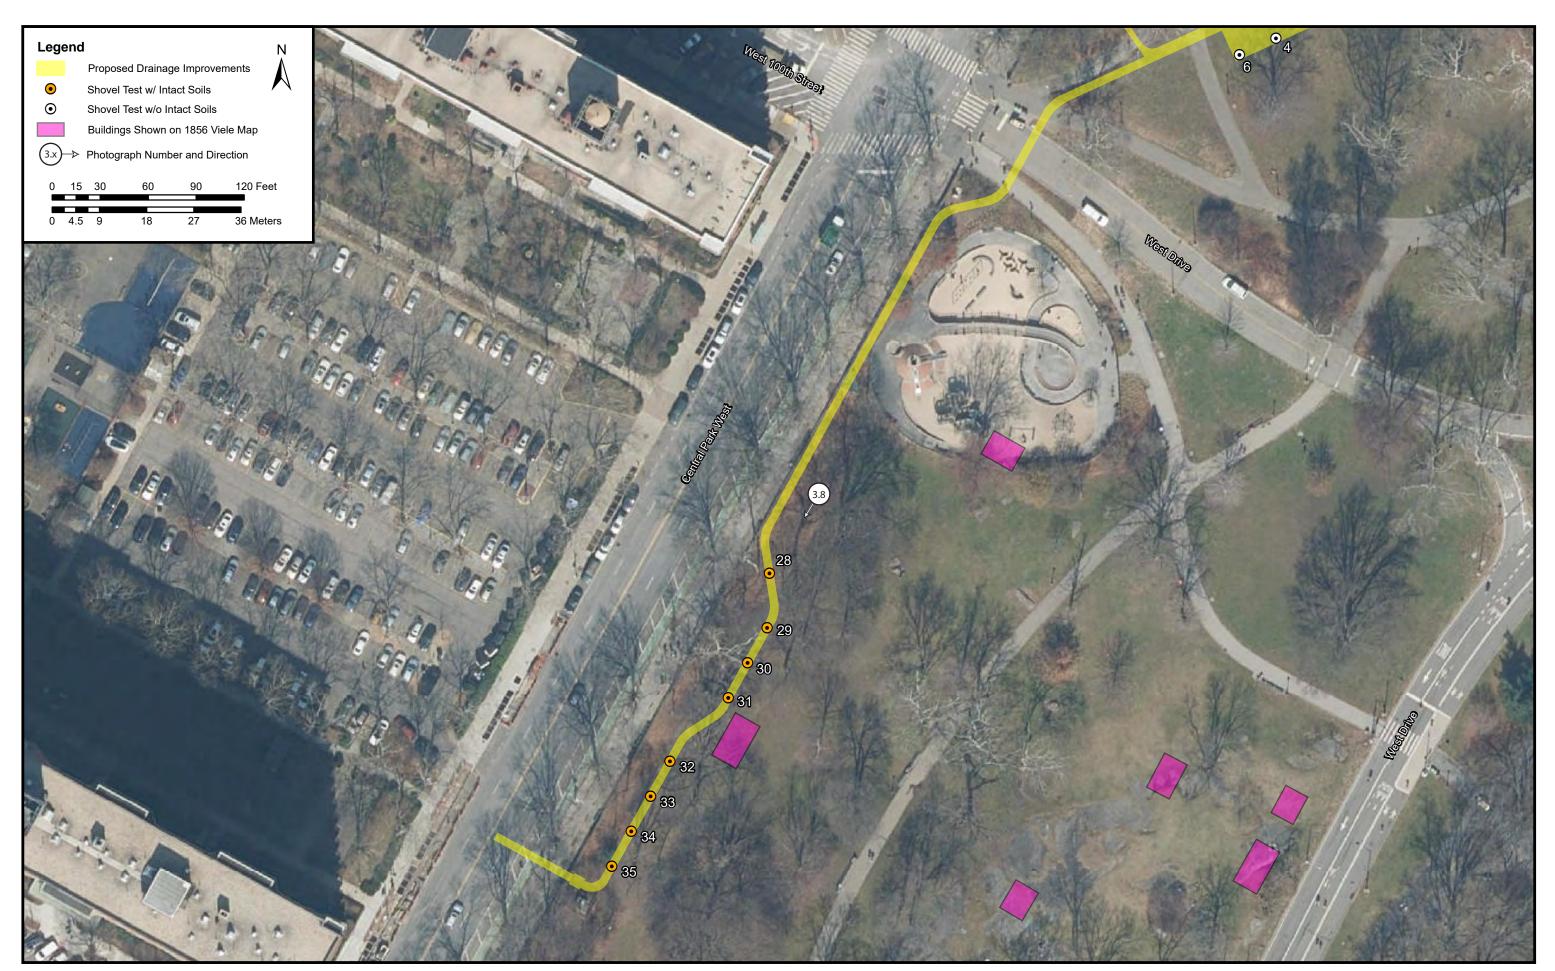
Figure 3.6. Aerial Photograph Showing Area 5 with Limits of Proposed Ground Disturbance, Locations of Archaeological Shovel Tests and Photographic Views.
