STAGE II
ARCHAEOLOGICAL SURVEY

THE ARCHAEOLOGY AND HISTORY
OF
LOWER FULTON AND JORALEMON STREETS
BROOKLYN, NEW YORK

WP 152 - RED HOOK WATER POLLUTION CONTROL PROJECT

CONTRACT 1A

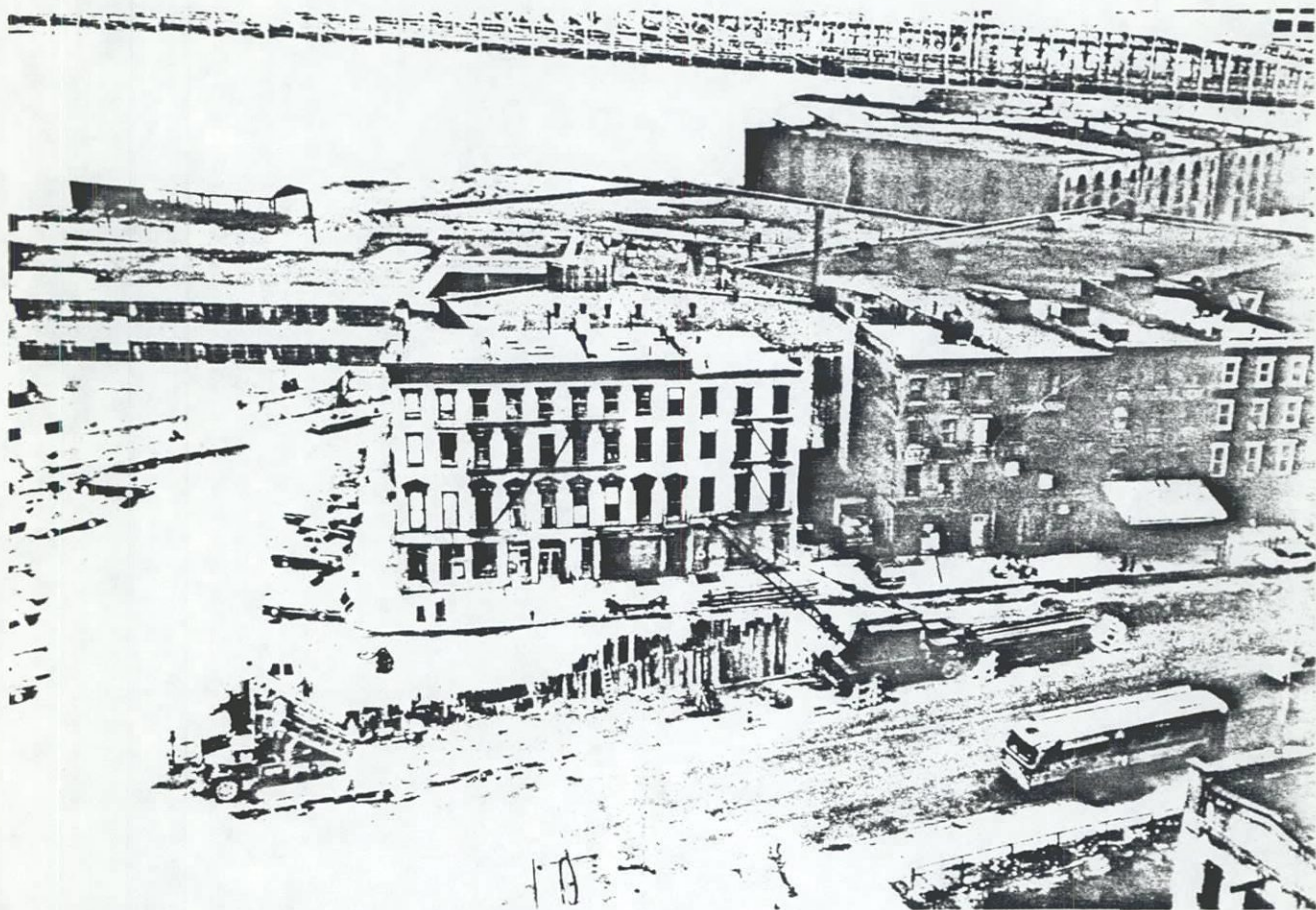
Figure 3. The Fulton Street sewer excavation. Looking north with the Brooklyn Bridge in the background.

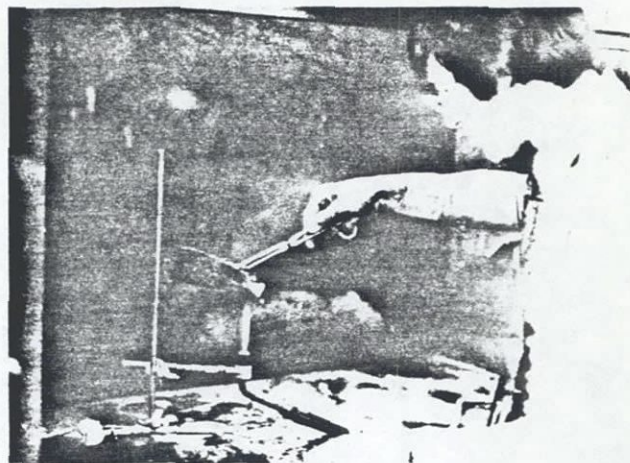
Figure 7. Unfolding the plate in the laboratory.

Photographs of the work in progress were taken as Professor Luton heat treated the specimen (FIG. 7). He used three different pairs of iron forceps and two different pairs of fine needle-nose pliers in the unfolding process, which was done on a table next to the chemical hood where the blow torch was situated. He bent the plate back to shape very cautiously by hand and with the use of the pliers, area by area and bit by bit, until the job was done. Professor Luton unfolded the specimen back to as much as what was the original shape as he dared, considering the fragility of the plate. It could not be bent back into the original curvature, as around a cap, without damage to the specimen.

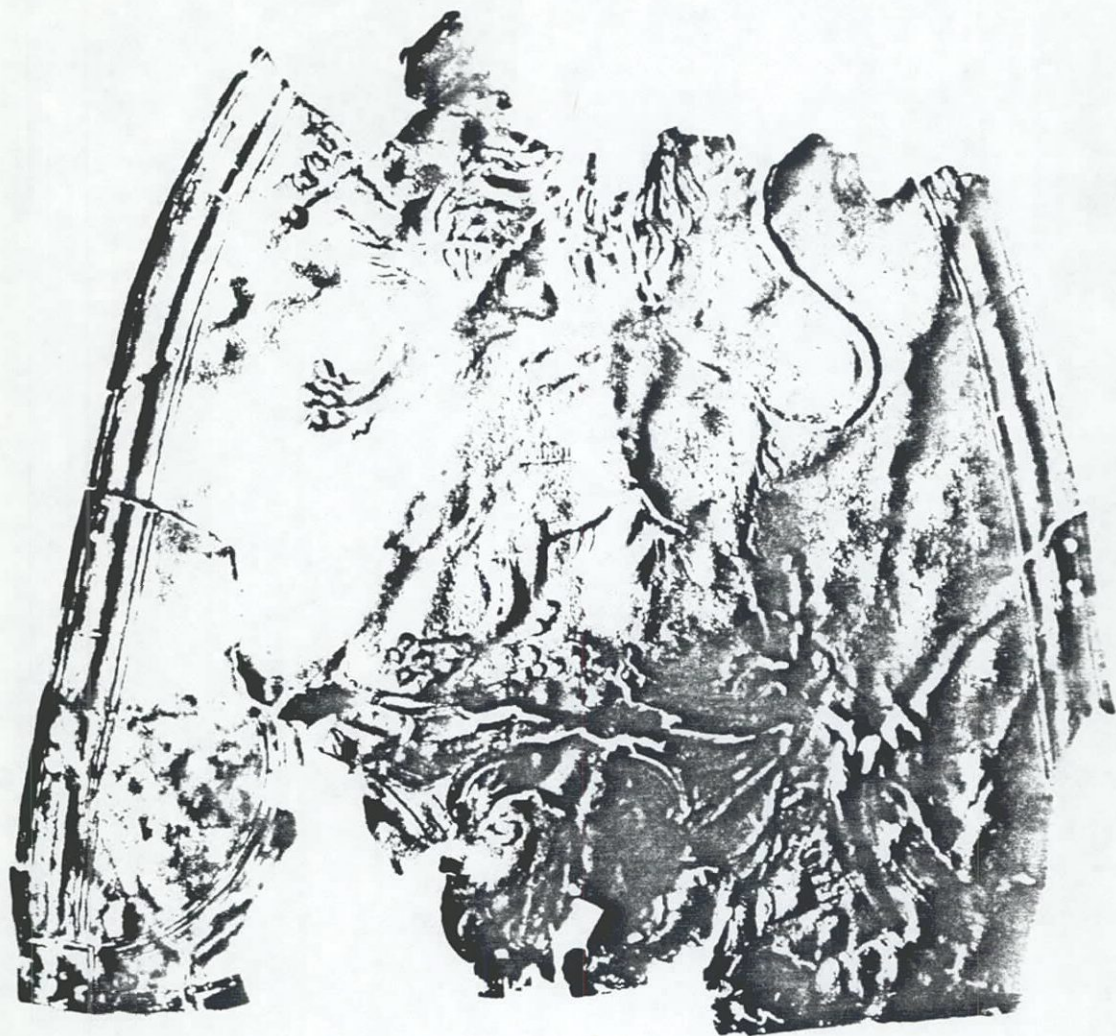
Figure 8. The Hessian plate from Fulton Street unfolded. The illustration is seven-tenths actual size.

Restored, or rather straightened out, the specimen is 8 $\frac{1}{4}$ inches (21 cm.) wide and 8 $\frac{1}{2}$ inches (21.6 cm.) long (FIG. 8). It is about $\frac{1}{64}$ inch (0.2 mm.) thick. Its original length or height is not known because the top part had been torn away. Presumably the plate had originally been curved, thus the width across the lower part had been less. As cleansed, the specimen shines with a bright golden color, and must have been a most handsome part of the Hessian uniform. It probably shone like a signal beacon in the field, and we can only visualize what a magnificent display a whole regiment of cap plates must have been in bright sunshine.

Examination of the plate shows that the rampant lion, as the dominant figure in the plate, is unfortunately headless since this part had been damaged. It fronts to the left and is in a walking attitude, front paws and legs raised and the tail raised and curved in an S shape. The flanks and the right hind leg appear to be flattened. Curiously, there are only four toes on the left forefoot, and the same on the right forefoot. There are three toes on the right hind foot, while the left hind foot seems to have four toes. For comparative purposes with other plates, the distance between the tip of the left forefoot and the tail on a line across the plate measures 4 $\frac{7}{16}$ inches (11.2 cm.). In its right forepaw the lion appears to carry something which is broken away with the top part of the plate. Beneath the lion is a field of banners and wreaths, in the center of which can be distinguished the initials F L in bold intertwined script. From side to side

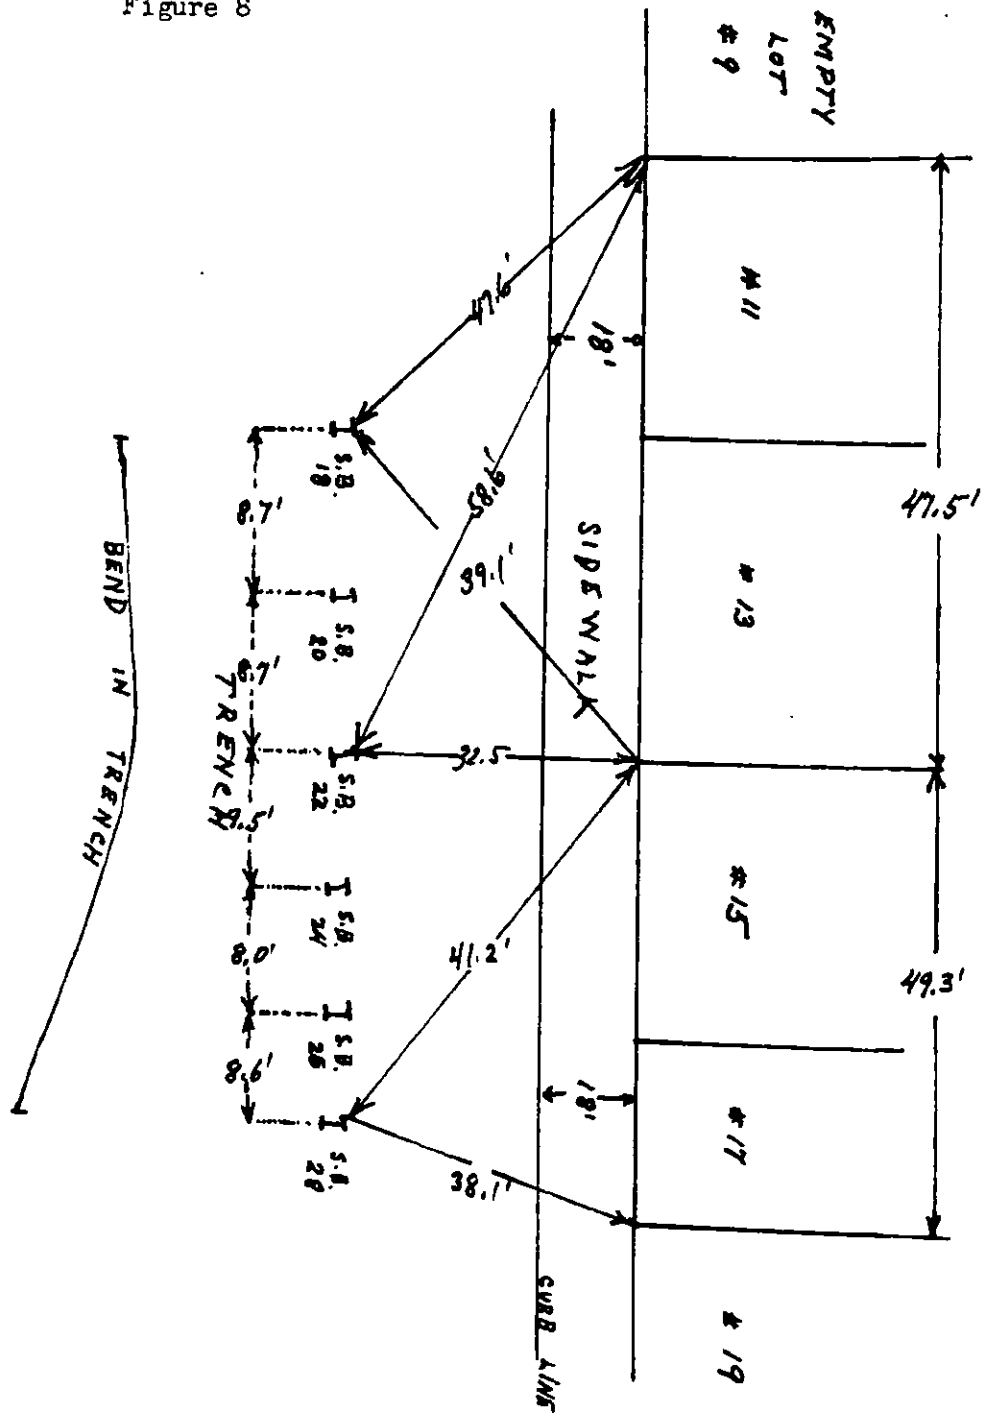
Measured locations of soldier beams Nos. 18-28 with reference to building fronts on Fulton Street, sketch map. March 3, 1979. Note bend in actual trench line. Ralph Solecki and Salvatore Calvanico.

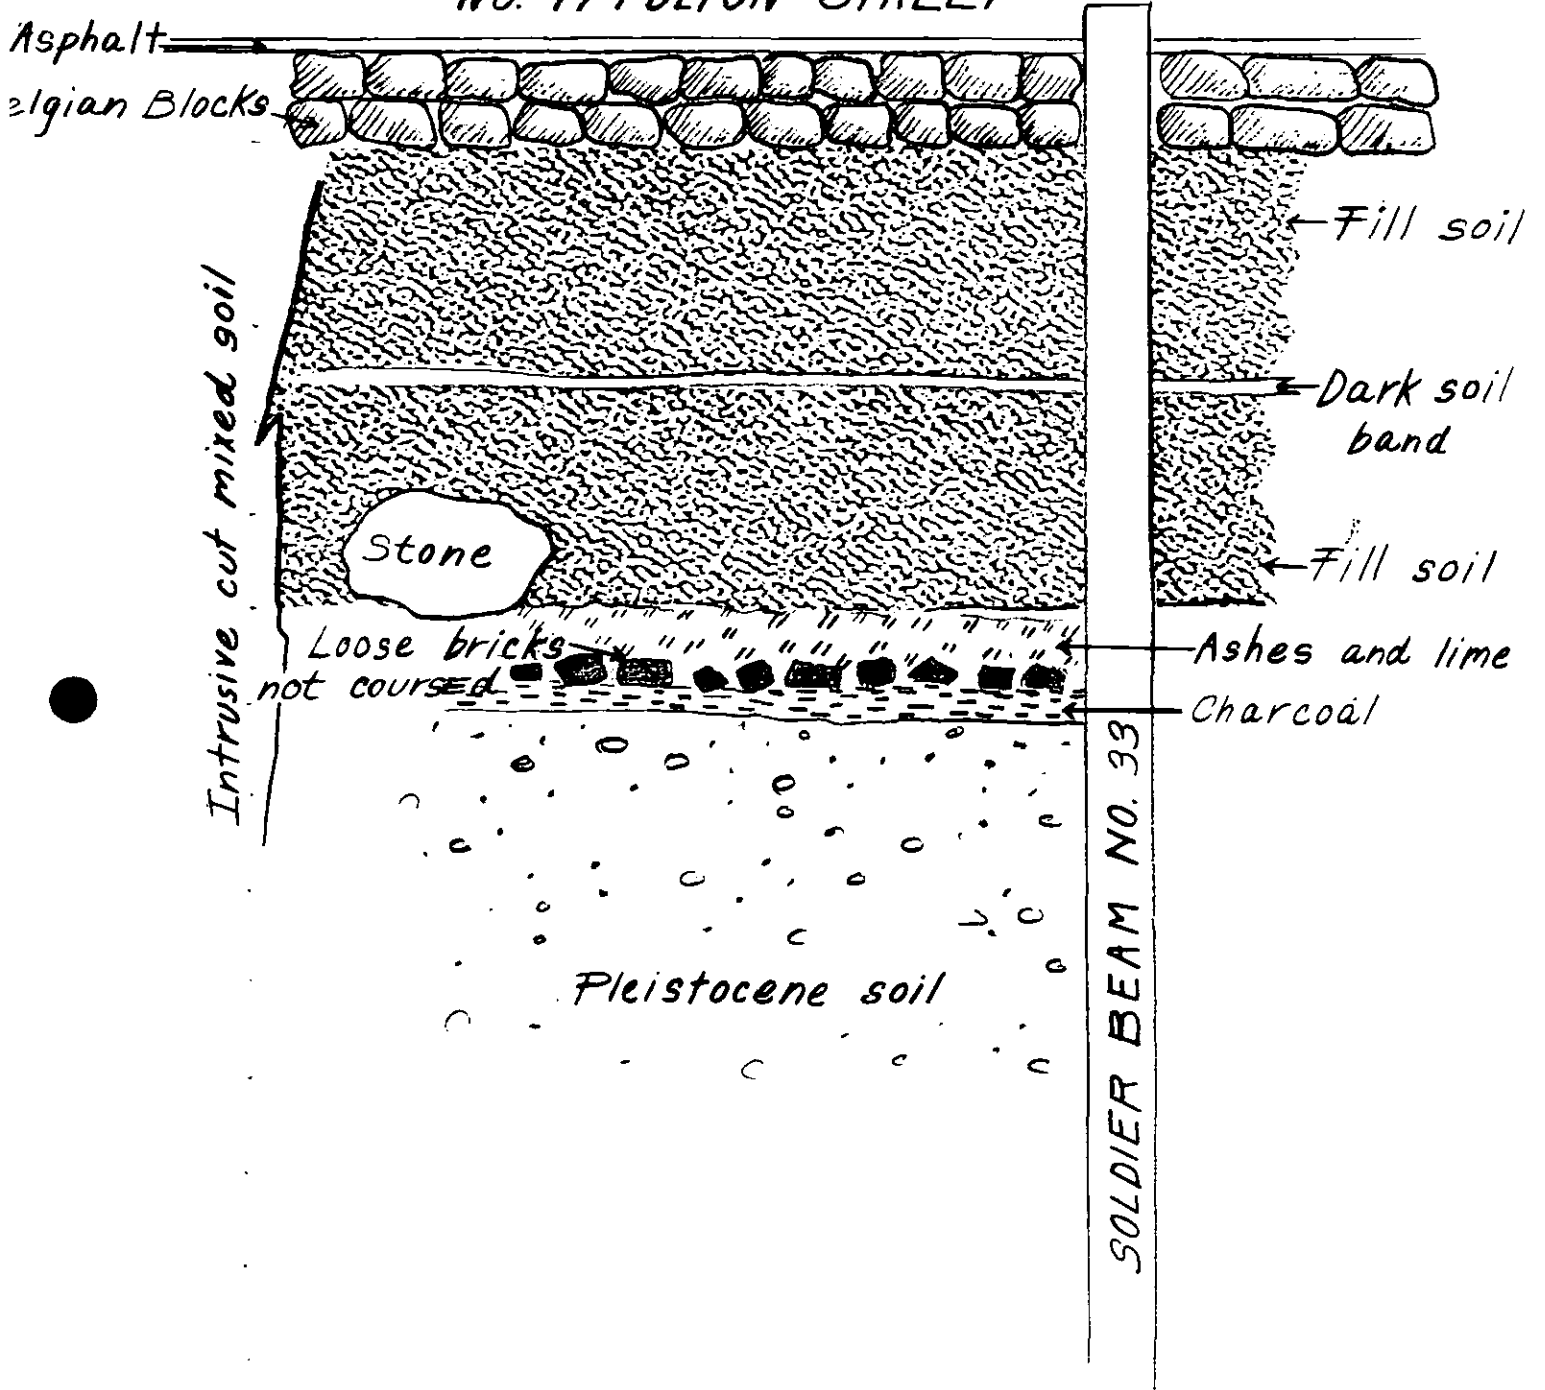
CROSS SECTION SOUTH FACE OPPOSITE
NO. 19 FULTON STREET

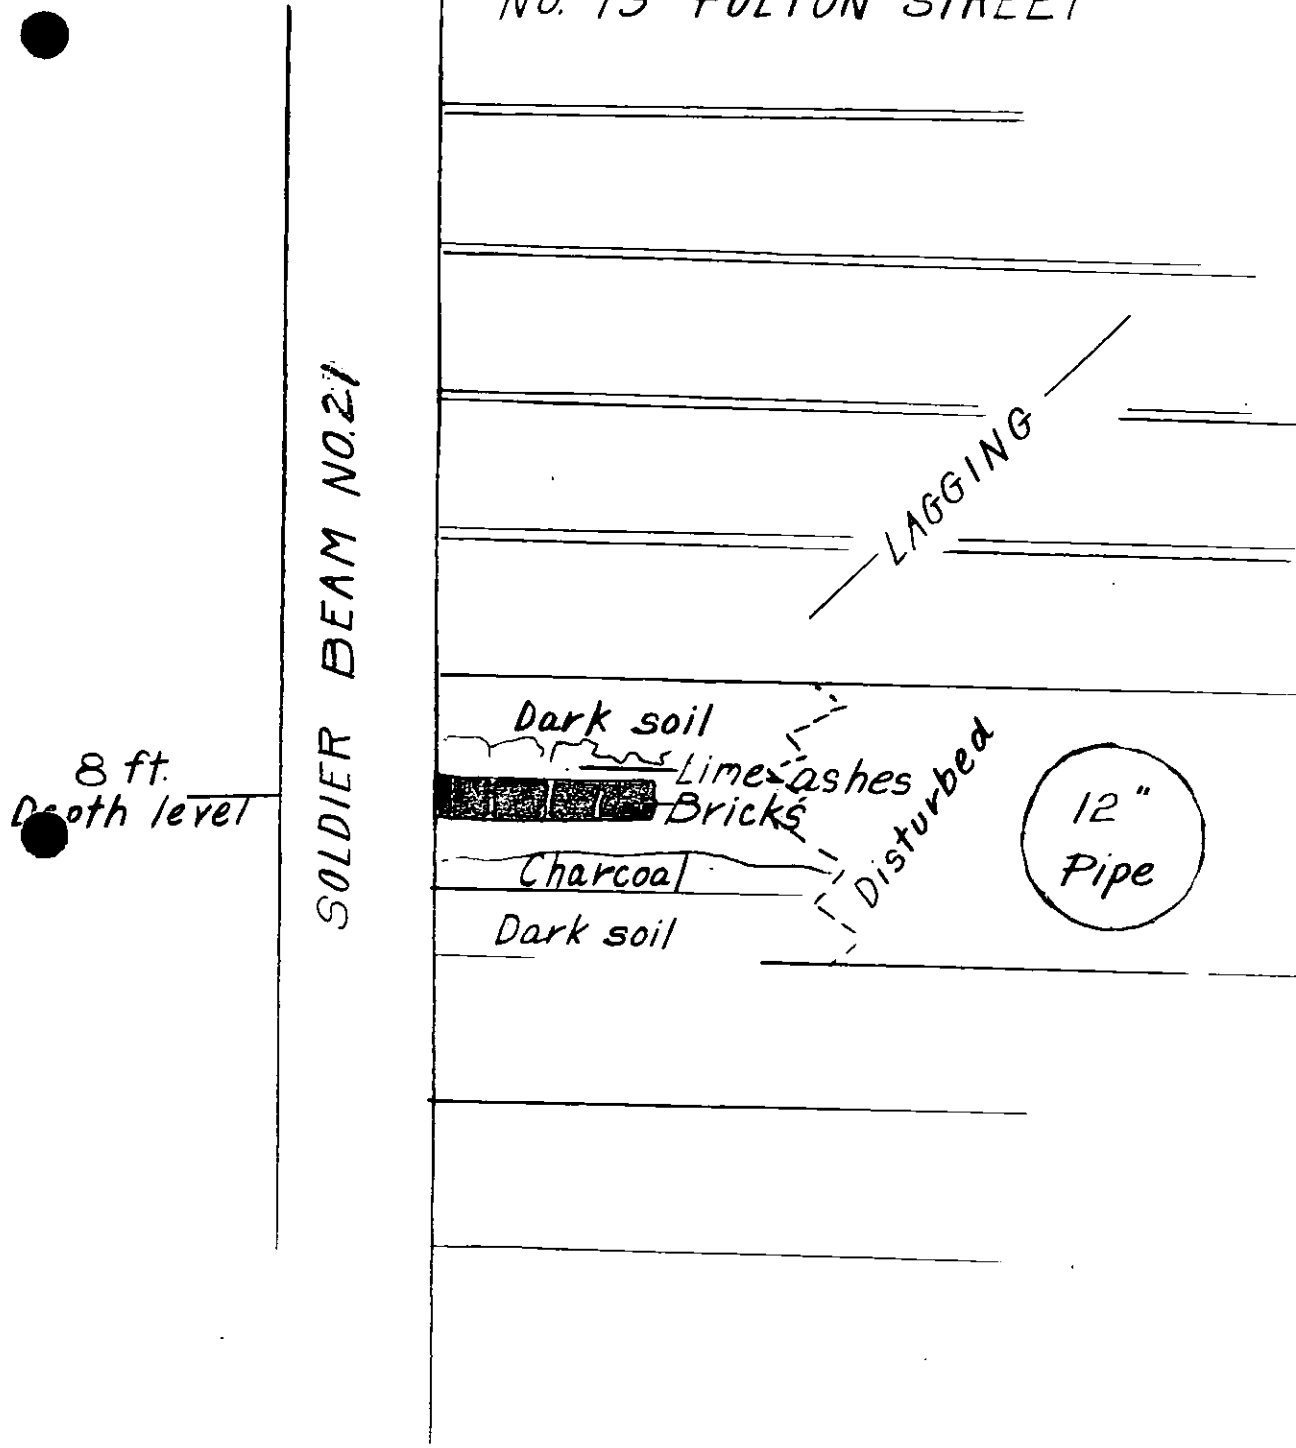
CROSS SECTION SOUTH FACE OPPOSITE
NO. 13 FULTON STREET

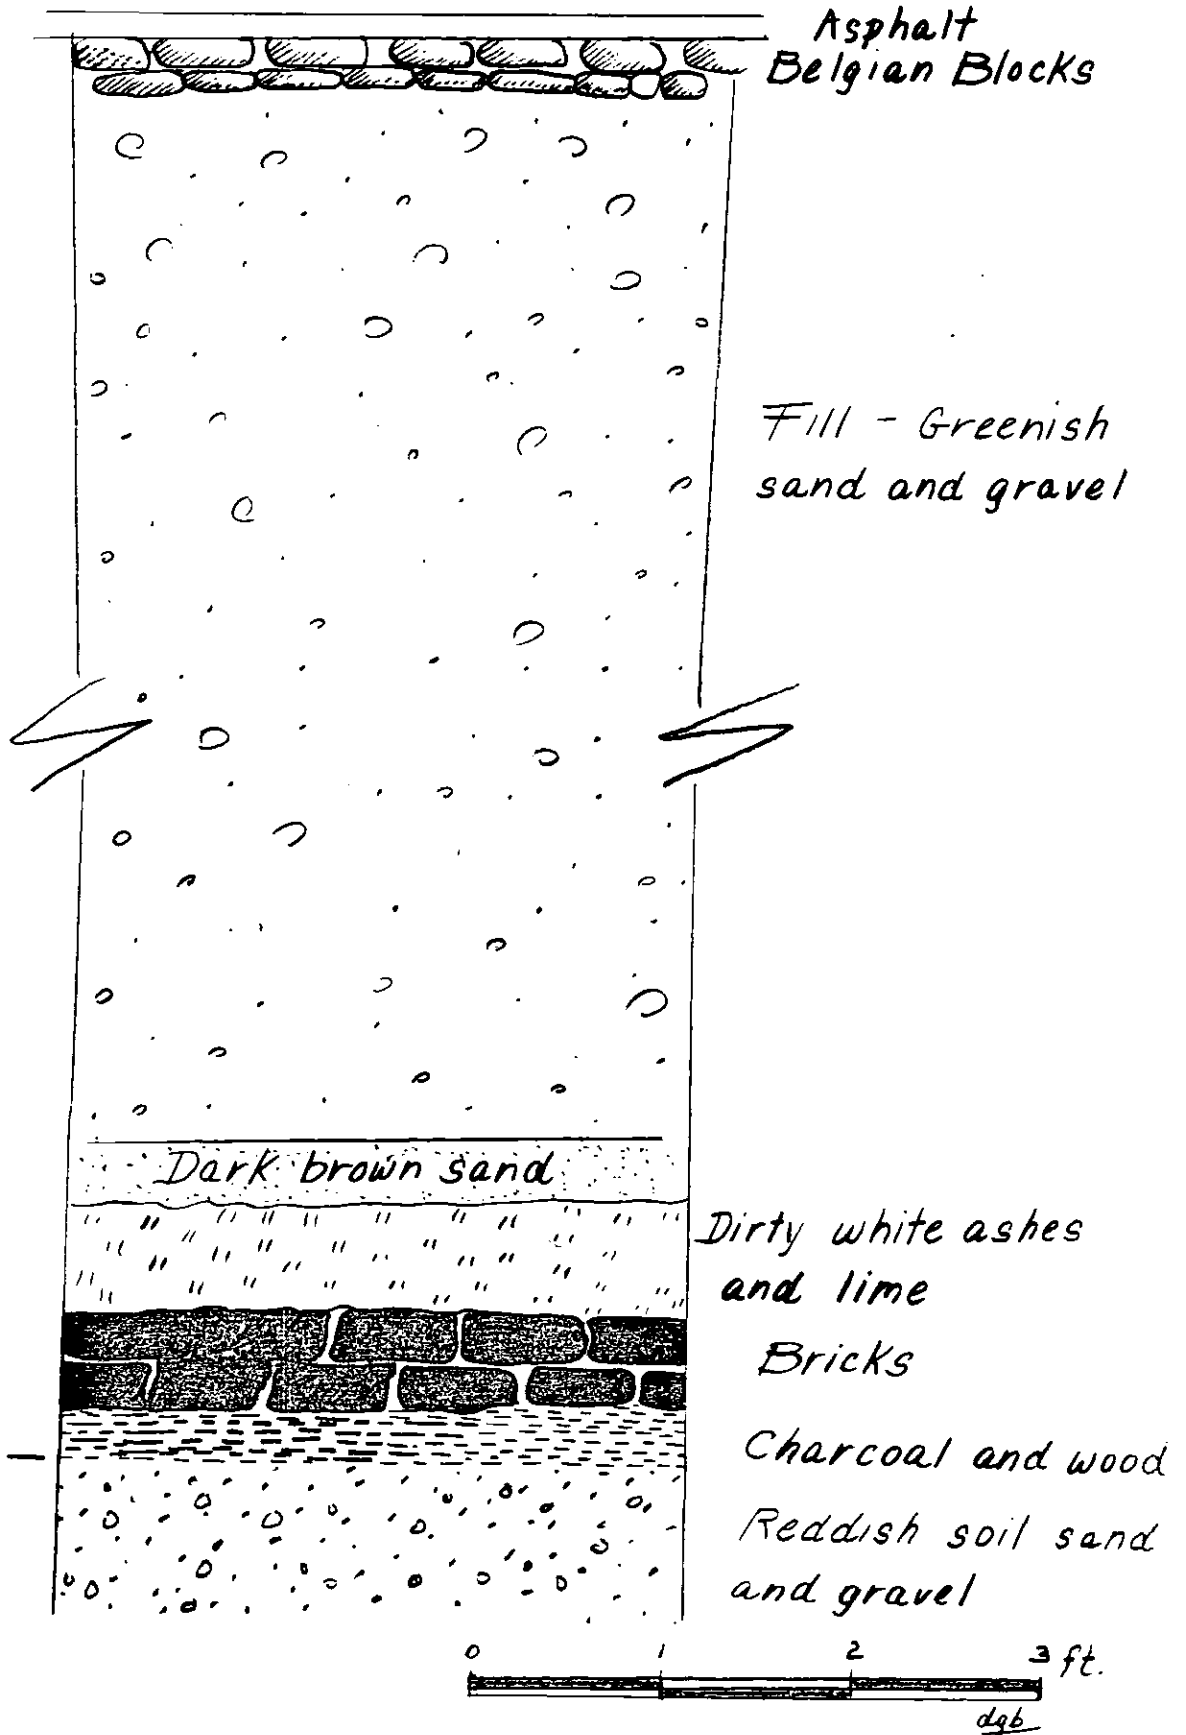
Fig. 16

SCHMATIC SECTION TRENCH
OPPOSITE NO. 17 FULTON STREET

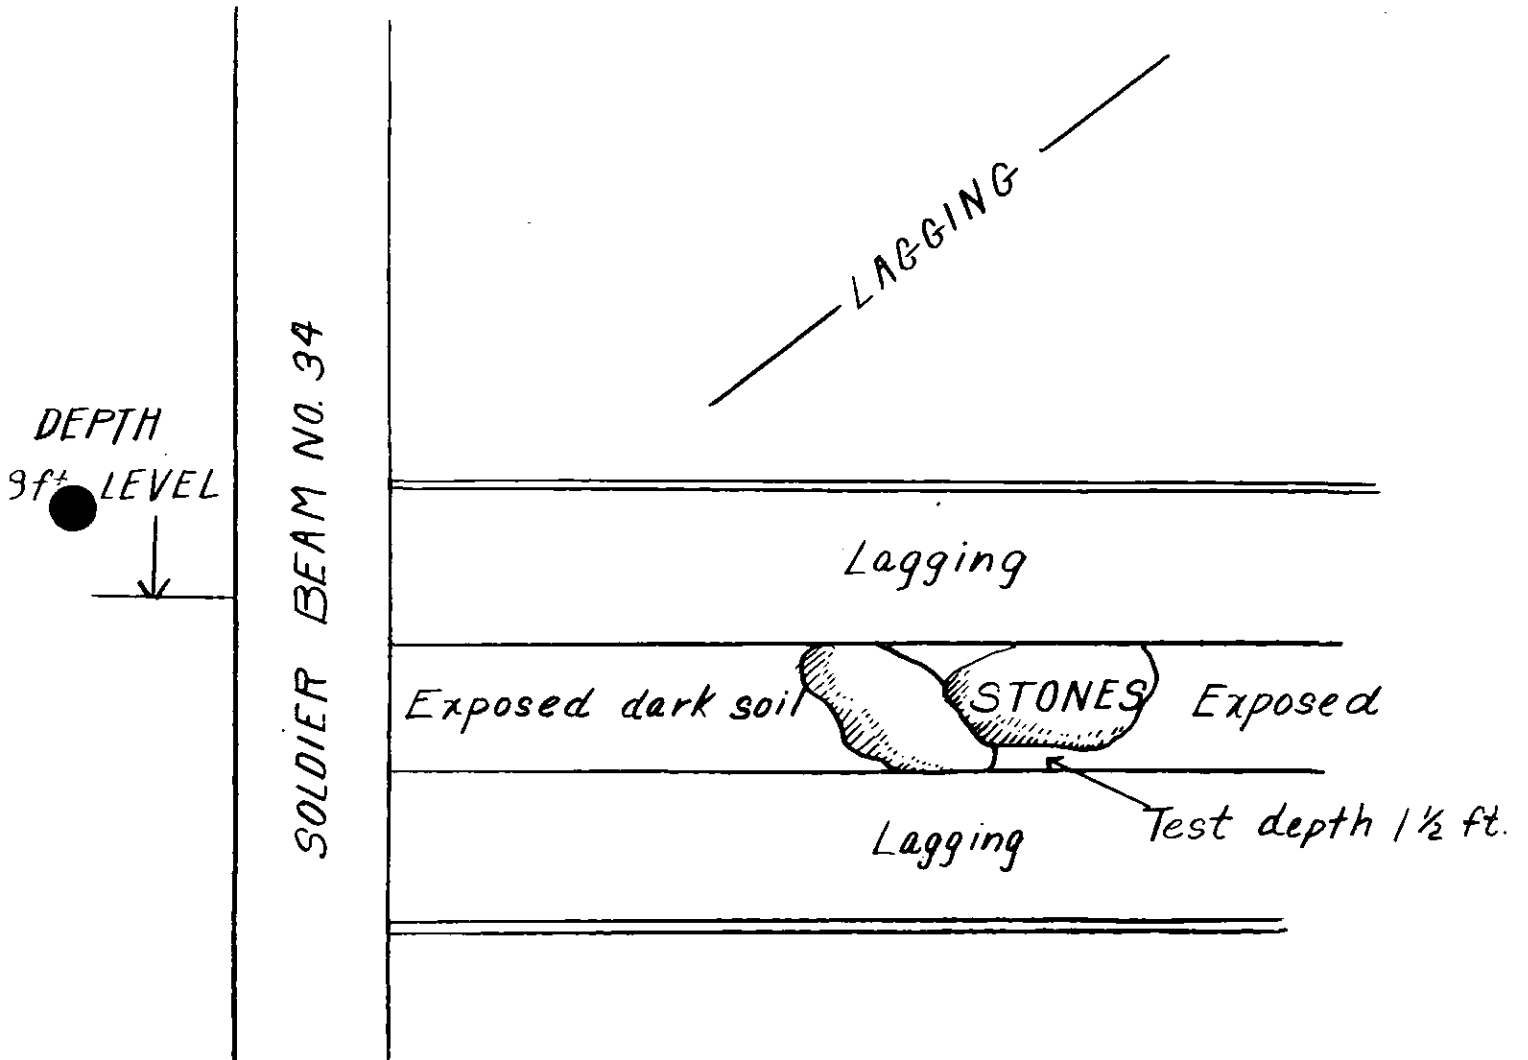
OCCUPATIONAL TRACES IN NORTH FACE
OPPOSITE WEST END NO. 19 FULTON STREET

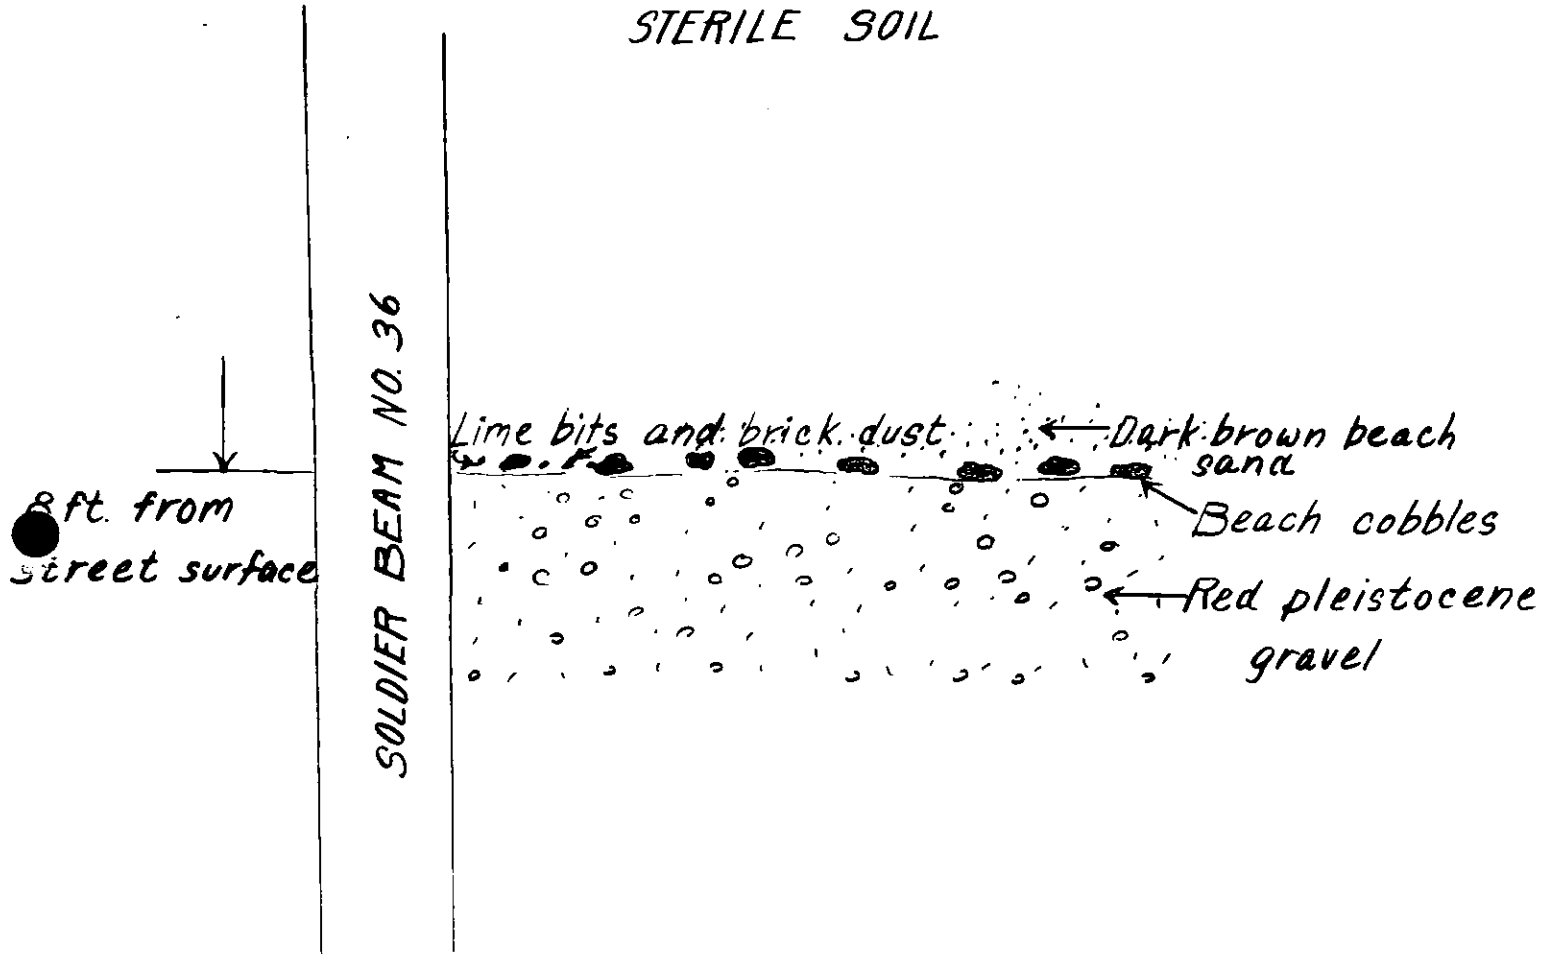
CROSS SECTION NORTH WALL OPPOSITE NO. 19 FULTON ST.
CONTACT SOILS BETWEEN OCCUPATIONAL SOIL AND
STERILE SOIL

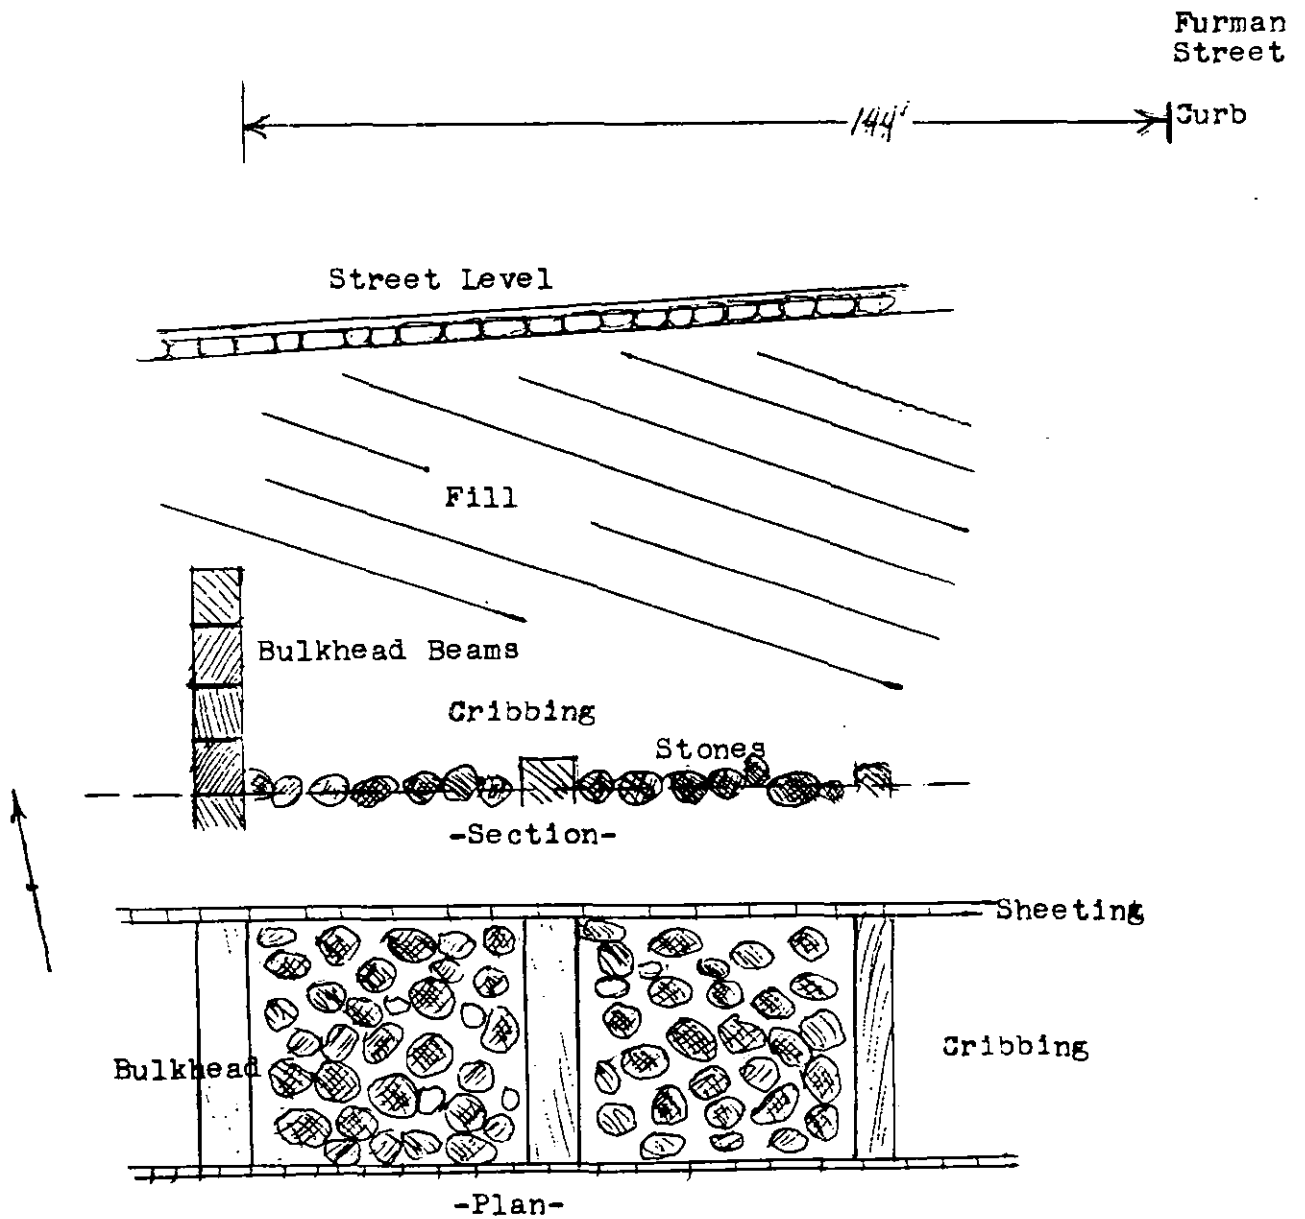
Section and Plan of Site "A", Joralemon Street
Excavation

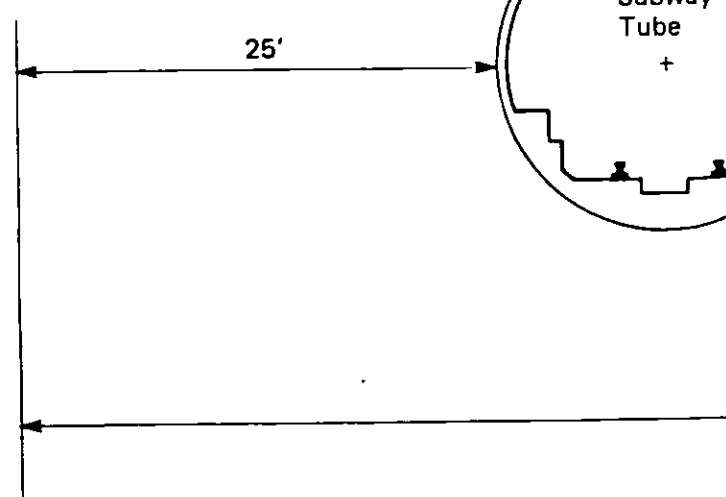
Tunneling Conditions
Face at Sta 32+10(±)

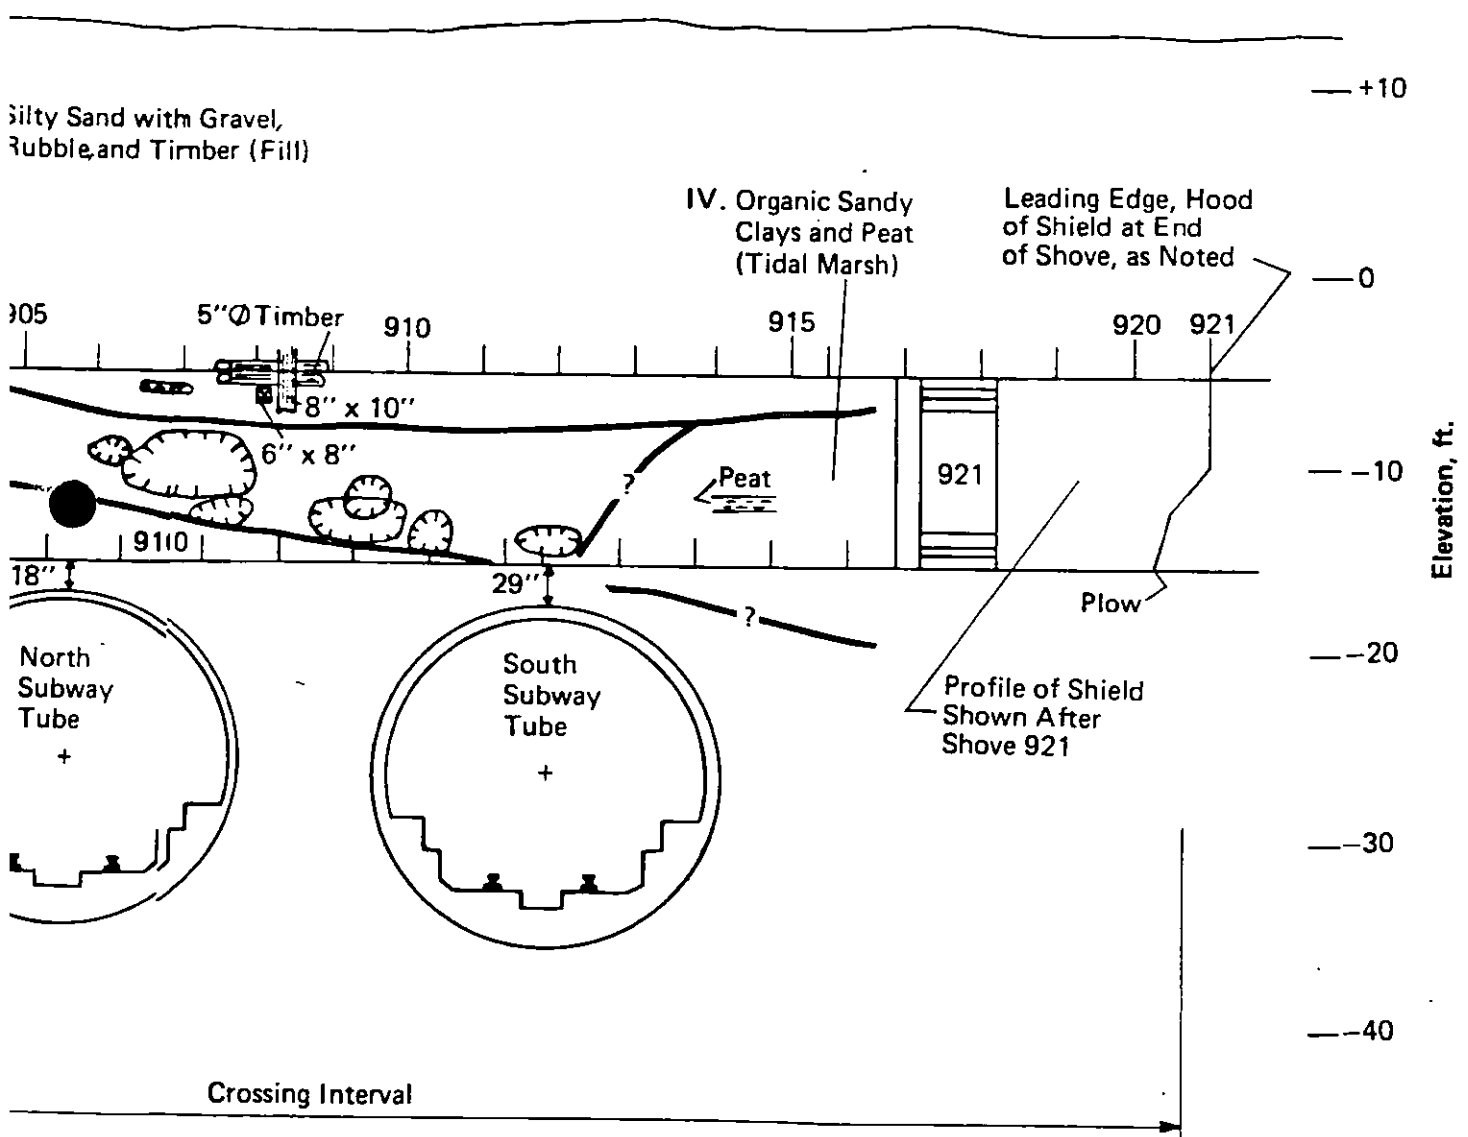
Figure 32
Shield Progress and Geologic Conditions

Red Hook Interceptor Tunnel
Joralemon Street Crossing
Parsons Brinckerhoff Quade & Douglas, Inc.
