HANOVER SQUARE
SITE
ARCHITECTURAL
ANALYSIS

Hanover Square Site

Architectural Analysis

MORTAR ANALYSIS OF FOUNDATION RUINS

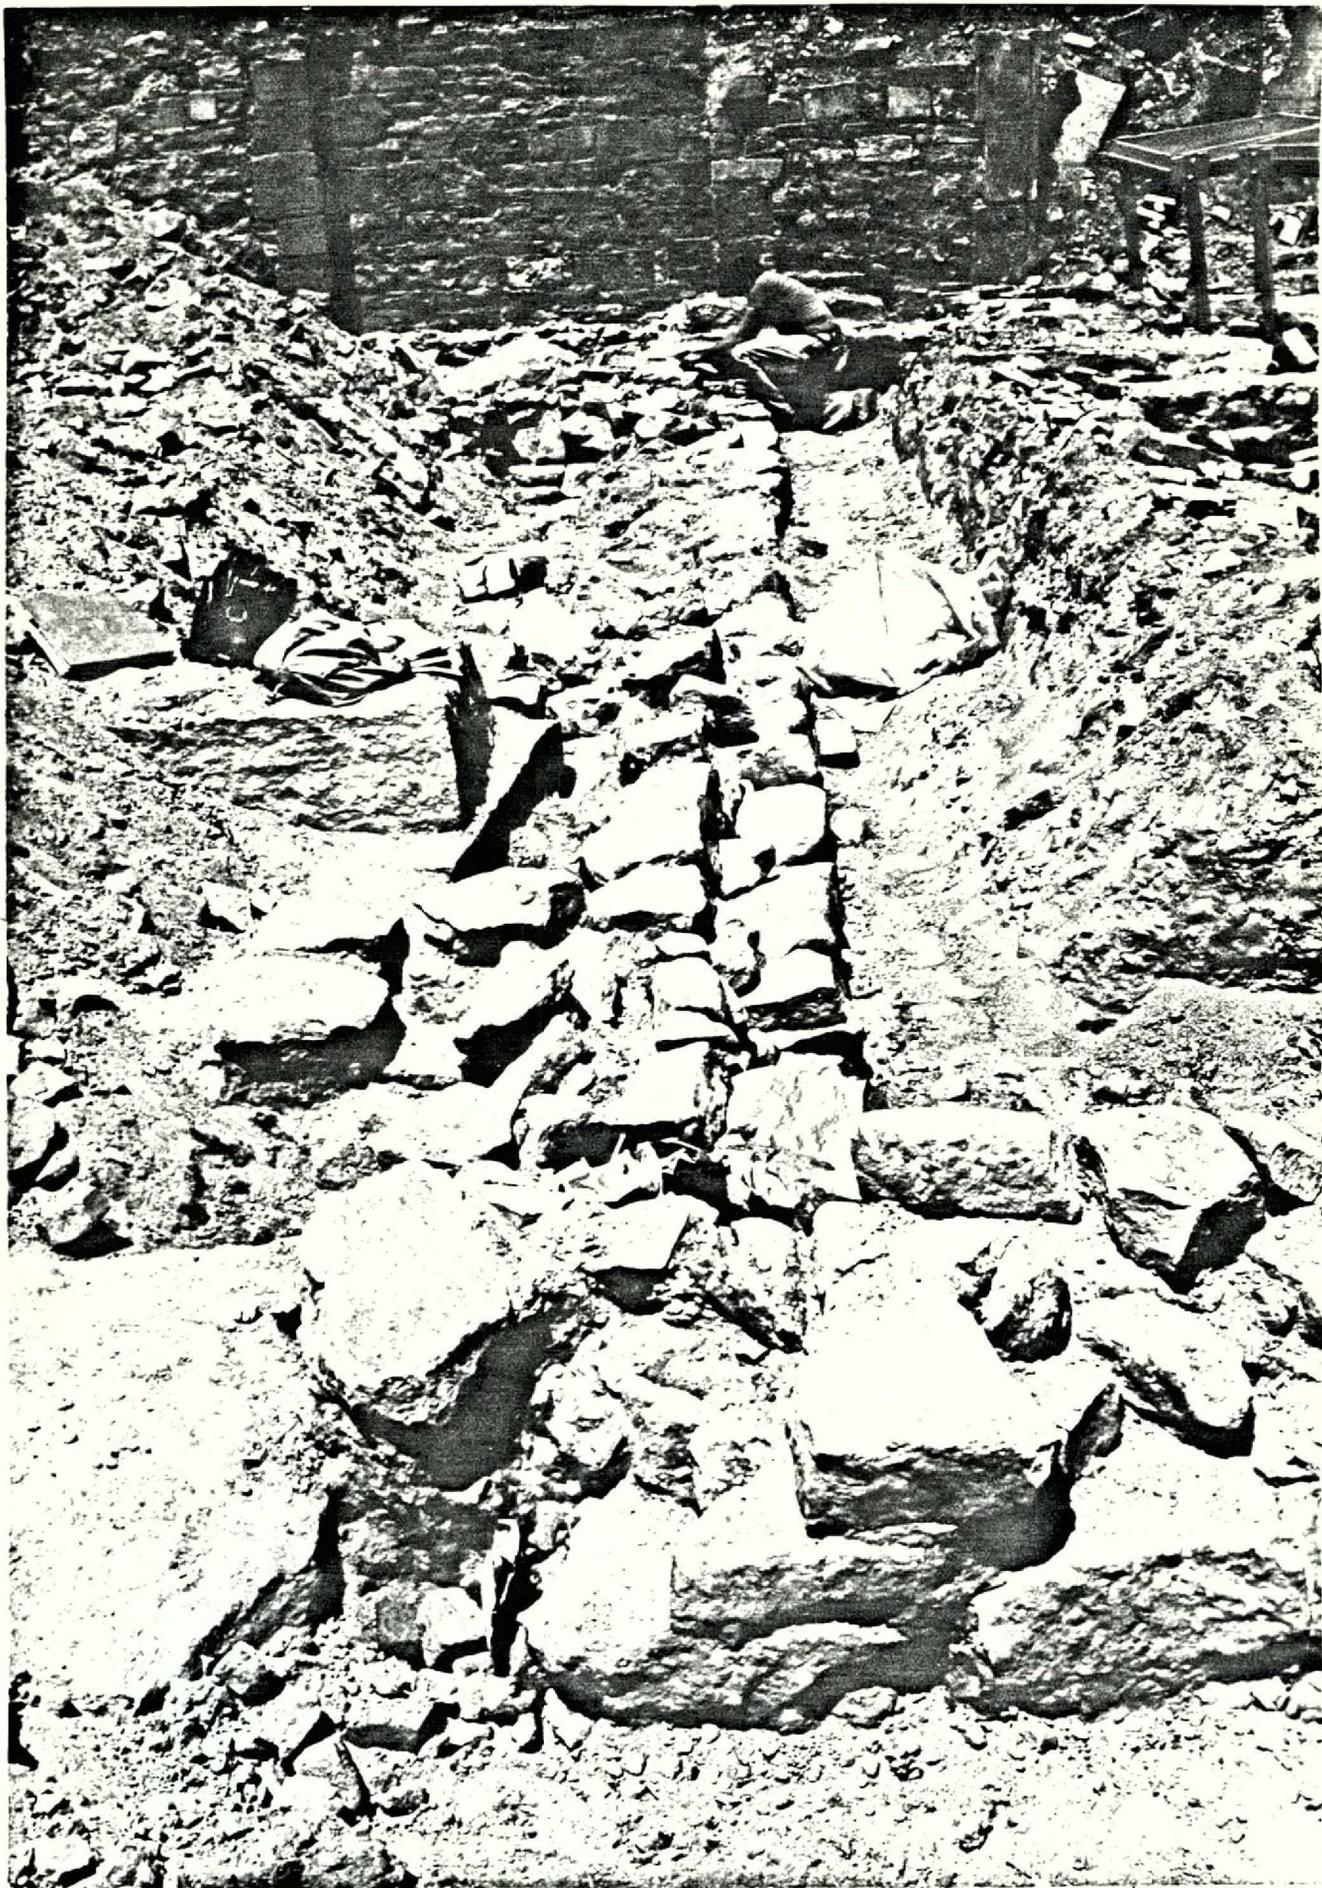
Lot 9/11, Early walls, west wall
looking north

Lot 9 & 11
EARLIEST WALLS

- Location** 4 walls of a house, a north, south; east, and west wall plus what appears to be a small extension, to the south of the main house
- Material** brownstone and schist - glacially deposited stone available locally from the 17th to the 20th centuries. There is also a small amount of coral in nearly all of the walls, amounting to less than 1%. Not a local material, it would have been imported to New York, probably in the form of ballast. The top two courses of the south wall belong to a later structure which was built on top of some of the old foundation walls. They (over

- Construction** The coursed rubble walls were laid up in an earth and lime mortar and pointed with mud. (see Appendix: Raymond Pepi, Mortar Analysis) The upper courses belong to a later wall and are laid up in a soft lime mortar.

- Type & Size** foundation walls, approximately 4' wide, extension walls approximately 2' wide
- Date** the walls were laid after the land was filled in, which occurred in about the late 1600's - the walls might be part of a house built for the Livingston family

- Notes** the foundation walls are deep, perhaps because of the nature of the landfill, which might not have provided enough support for a shallower wall.

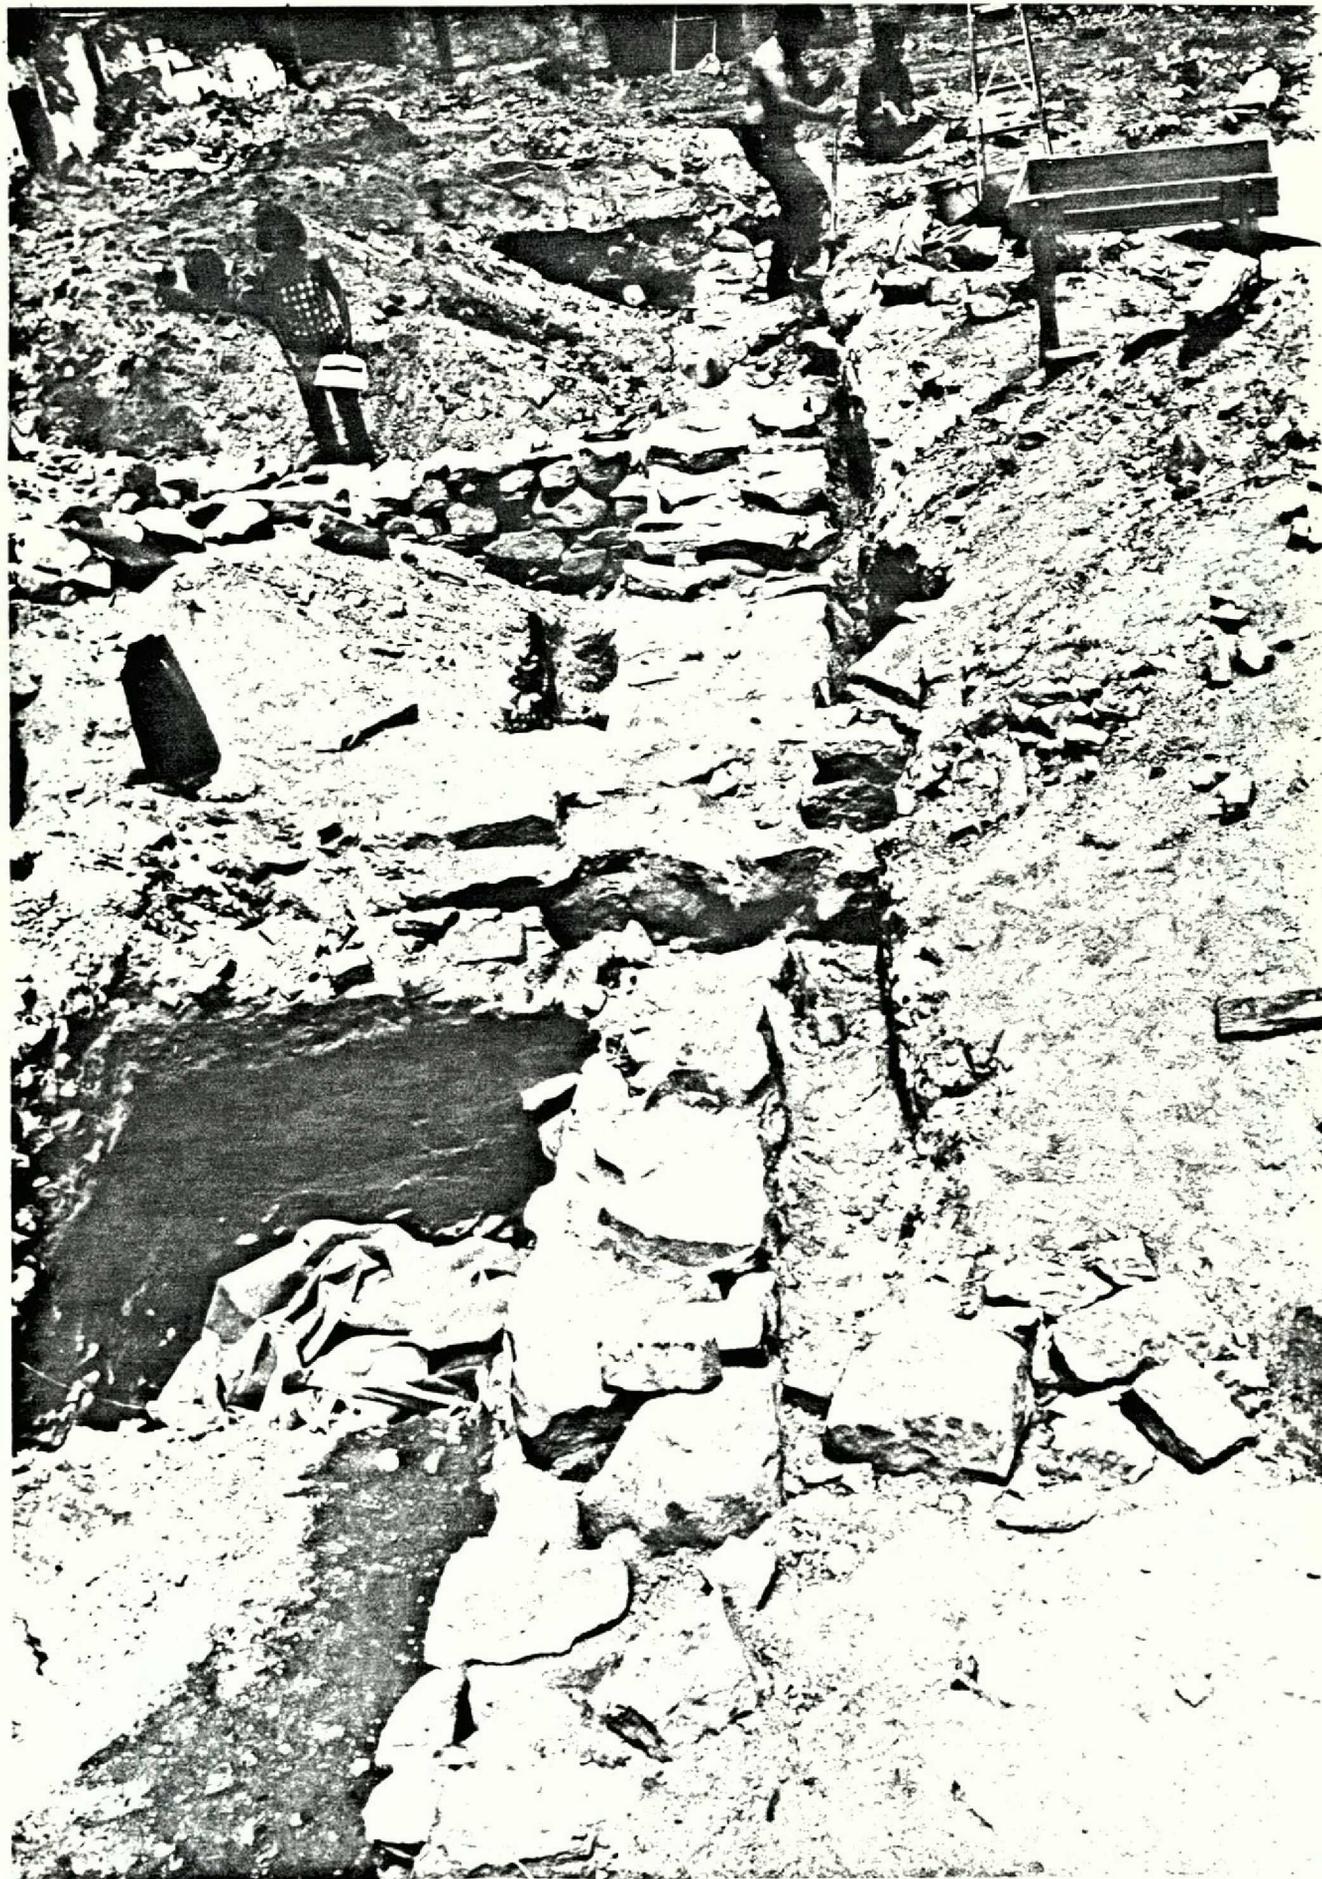
Lots 13 - 15, Early south wall
looking east

- Location** there is part of a south wall, which runs east/west, a fragment of an east wall, running north/south, and fragments of an extension to the south: a south wall, running east/west and a west wall, running north/south

- Material** brownstone and schist - glacially deposited stone available locally from the 17th to the 20th centuries. (Sidney Horenstein, Hanover Square Site consultation on stone, 1981)

- Construction** coursed rubble wall laid up in an earth and lime mortar, no evidence of mud pointing but this might have been disturbed with digging (see Appendix, Raymond Pepi, Mortar Analysis)

- Type & Size** foundation, 2-3', extension walls, 1½-2' wide
- Date** walls were built any time after the land was filled, which was probably in the late 1600's

- Notes** there are wooden structures made up of beams and planking in the rear of lots 13, 14 and 15, they are quite well-preserved, but there is still not enough of them left to explain their use. It is possible that they were pier structures, but they could have been used for some purpose in the yards as well. All the structures are at the rear of the lots on the west side, the stone extensions of lots 13 and 15 are on the east side.

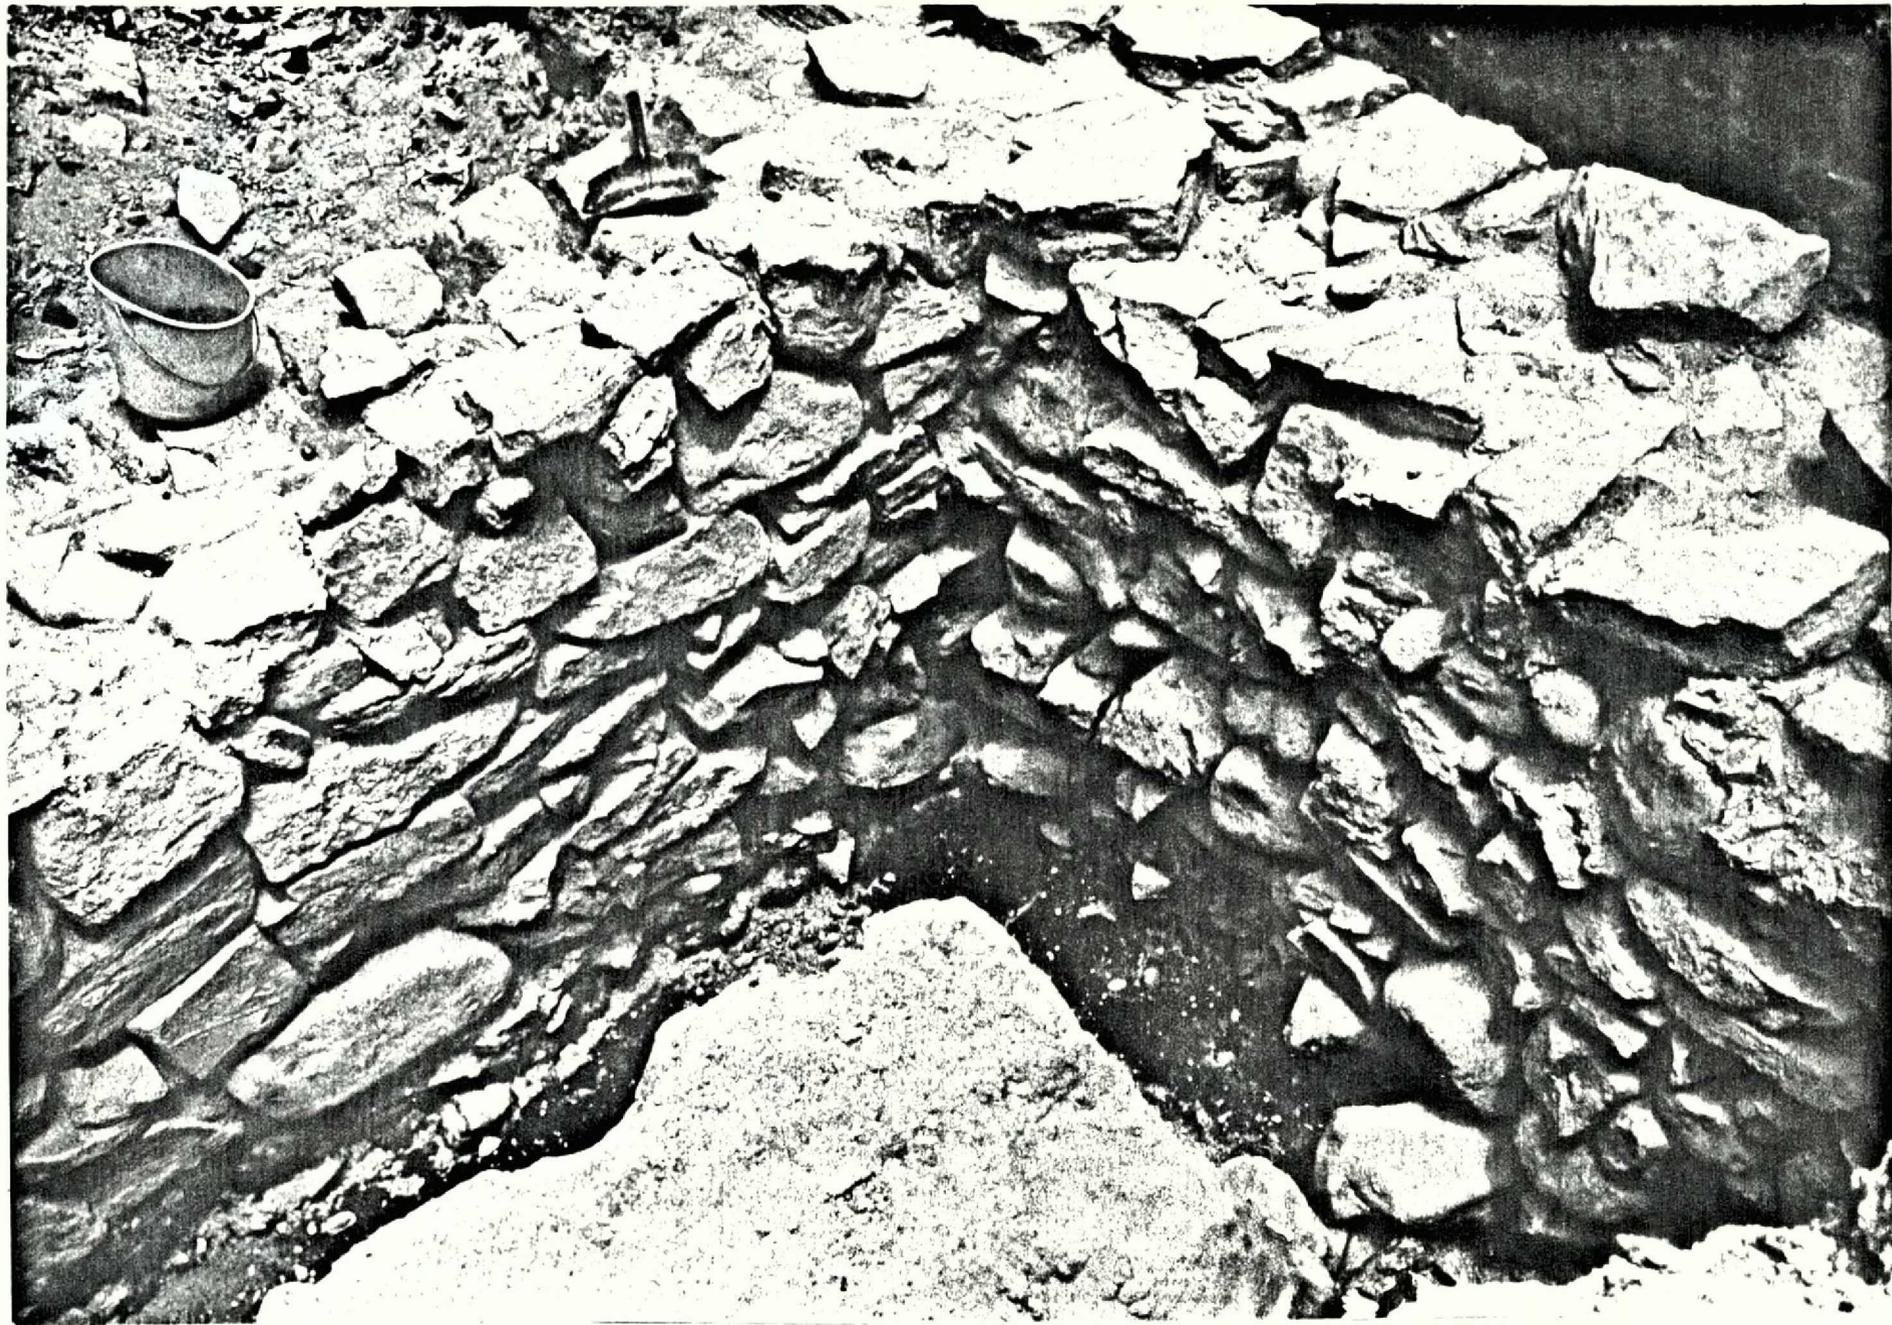
Lot 14, Early walls, looking south

- Location** a south wall runs east/west; an east wall runs north/south; there are fragments of a north wall and a west wall
- Material** schist and glacial boulder, some rocks out of the water with shells still attached - all stone locally available from the 17th to the 20th centuries (Sidney Horenstein, Hanover Square Site stone consultation, 1981)
- Construction** coursed stone rubble wall, laid up in an earth and lime mortar and pointed with mud (see Appendix, Raymond Pepi, Mortar Analysis)
- Type & Size** foundation, approximately 3', but the east wall varies, getting as much as 5' wide where an apparently later wall was built next to it, at the northern half of the lot.
- Date** the walls were built any time after the land was filled in, which was approximately in the late 1600's
- Notes** there is a wooden structure at the rear, west side of the lot, see lot 13 for description

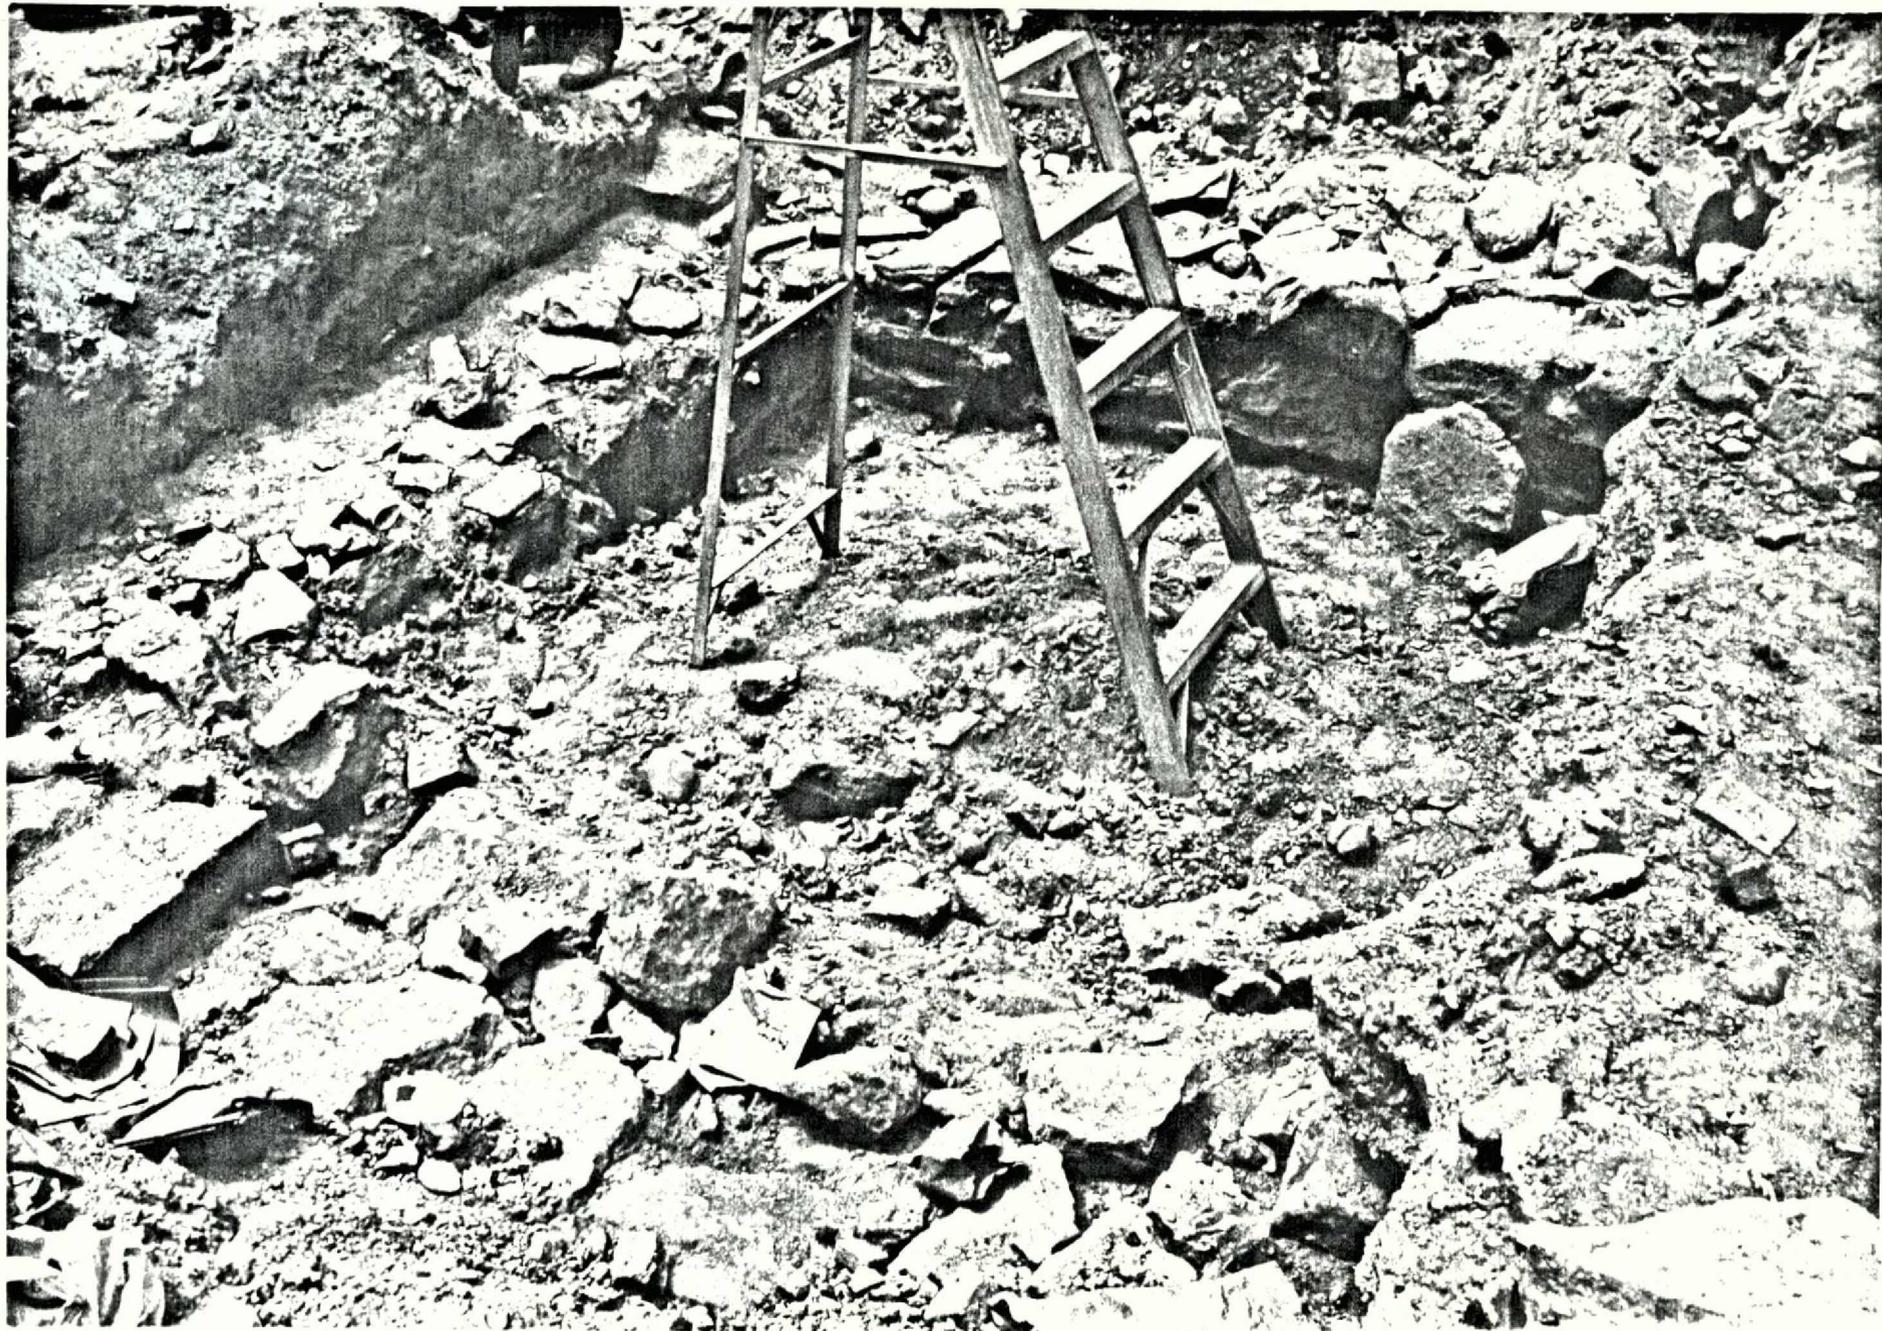
Lot 15, Early walls, south extension
looking north west

- Location** the south wall runs east/west, the west wall runs north/south. At the rear of the lot, three walls may or may not be part of an extension. Three south walls run east/west, two west walls run north/south. The northernmost west and south walls are connected, while the farthest south wall runs into lot 19. SEE SKETCH ON BACK

- Material** glacial schist and boulder, all locally available from the 17th to the 20th centuries, There is also a Hudson highlands rock in the extension wall, which was also available locally at the same time. The far south wall has a very small amount of coral (see lot 9/11) (Sidney Horenstein, Hanover Square Site stone consultation, 1981)

- Construction** coursed stone rubble laid up in an earth and lime mortar, it might have been mud pointed but there is no evidence of this now
(see Appendix, Raymond Pepi, Mortar Analysis)

- Type & Size** foundation, approximately 3' for the south wall, see lot 14 for the west wall; the extension walls are approximately 1½-2½' wide
- Date** the walls were built any time after the land was filled in, which was probably in the late 1600's.

- Notes** there is a wooden structure at the rear on the west side of the lot, see lot 13 for description

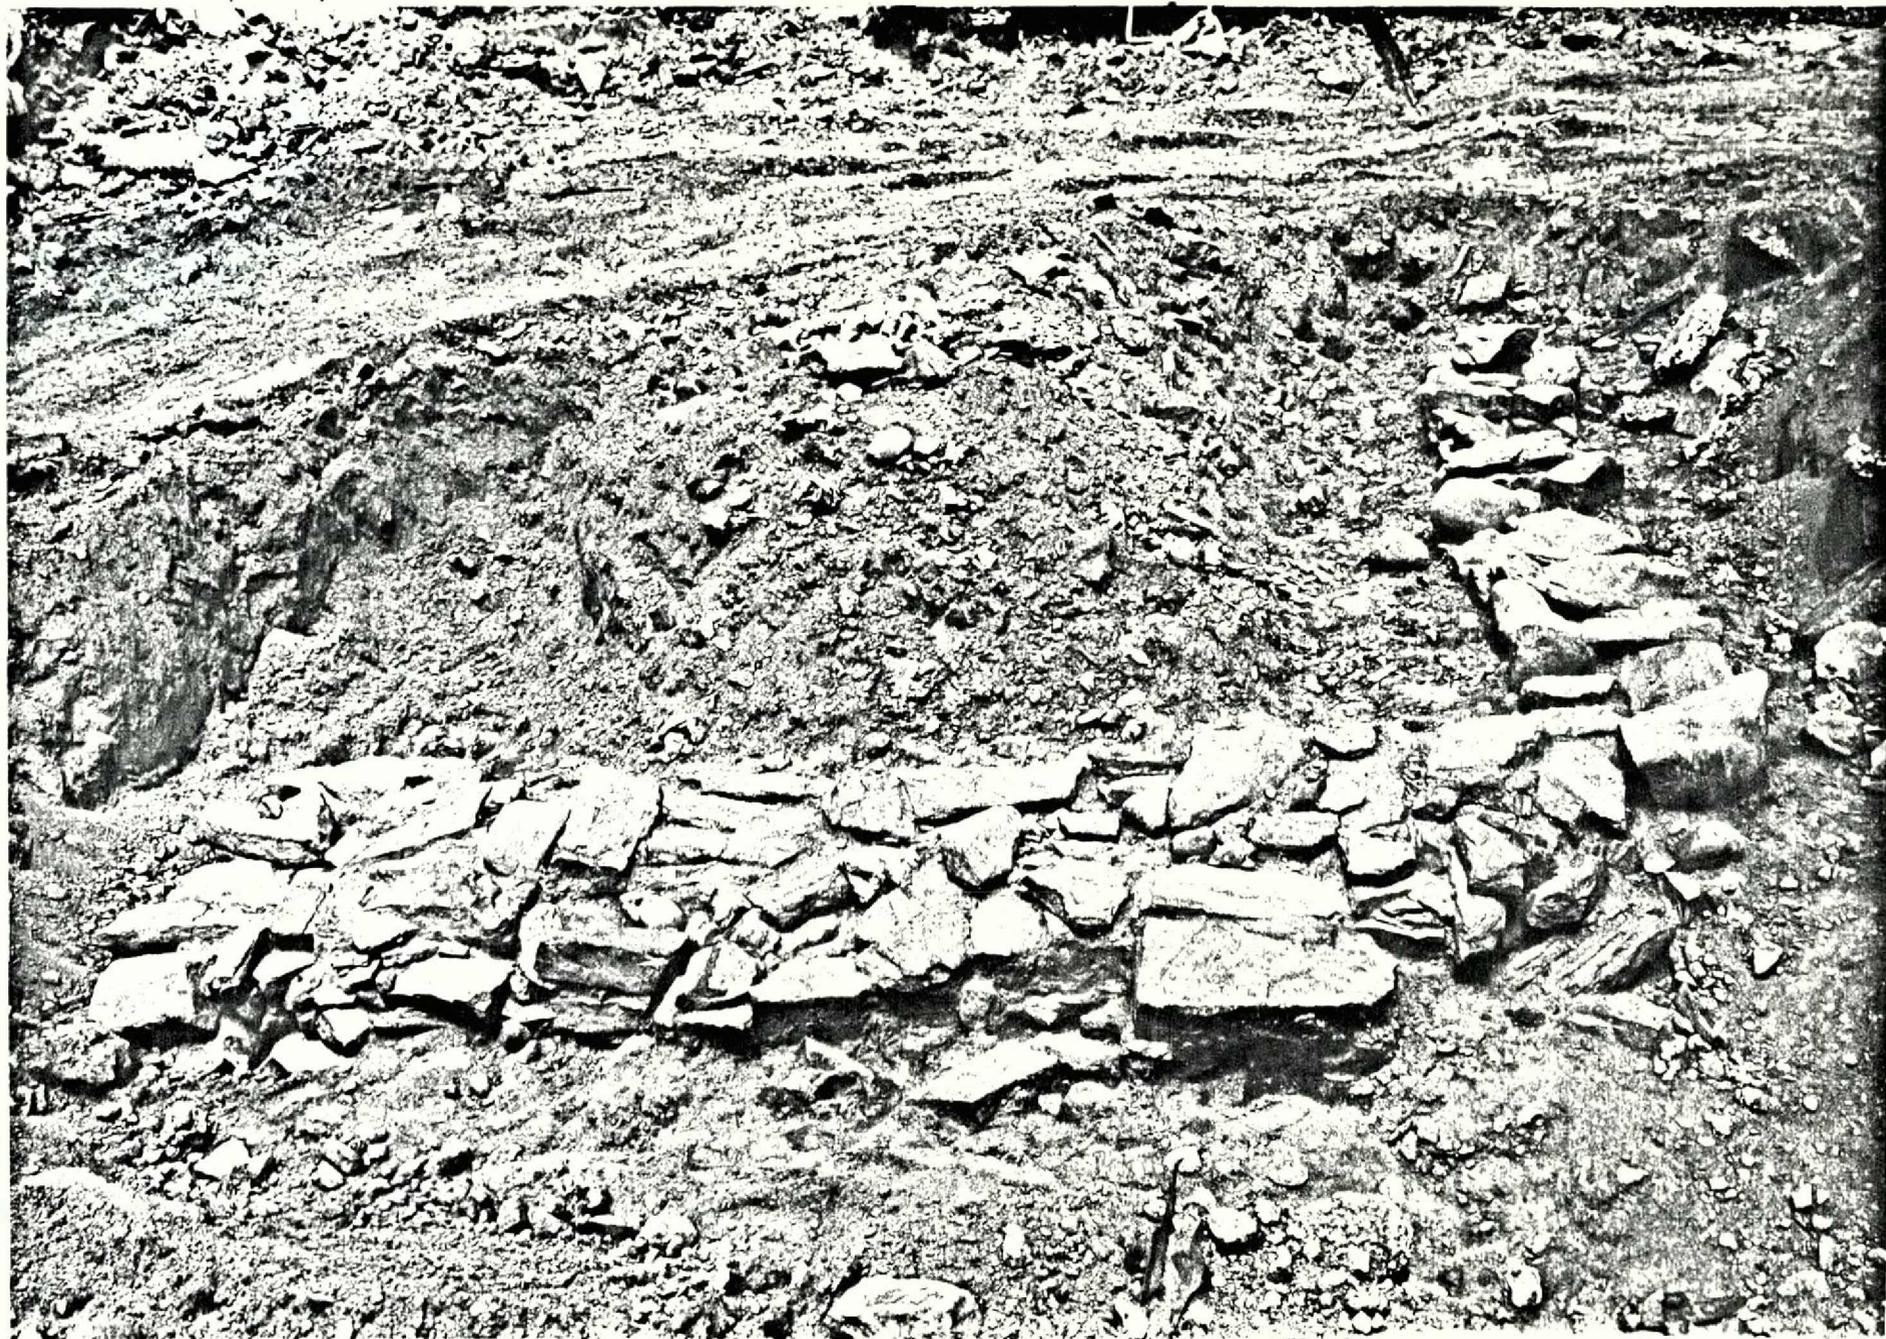
Lot 19, Early walls, south and west walls
looking east

- Location** the south wall runs east/ west, the west wall runs north/south; there is a fragment of a north wall at the north west corner; there is a far south wall, perhaps part of an extension, which runs east/west into the far south wall of lot 15
- Material** glacial schist and boulder, locally available from the 17th to the 20th centuries (Sidney Horenstein, Hanover Square Site stone consultation, 1981)
- Construction** coursed stone rubble laid up in a clay-like earth mortar, no evidence of mud pointing but the wall might have been packed with mud (see Appendix, Raymond Pepi, Mortar Analysis)
- Type & Size** foundation, 3-4' wide, the far south wall is 2-2½' wide
- Date** the walls were built any time after the land was filled in, probably in the late 1600's
- Notes**

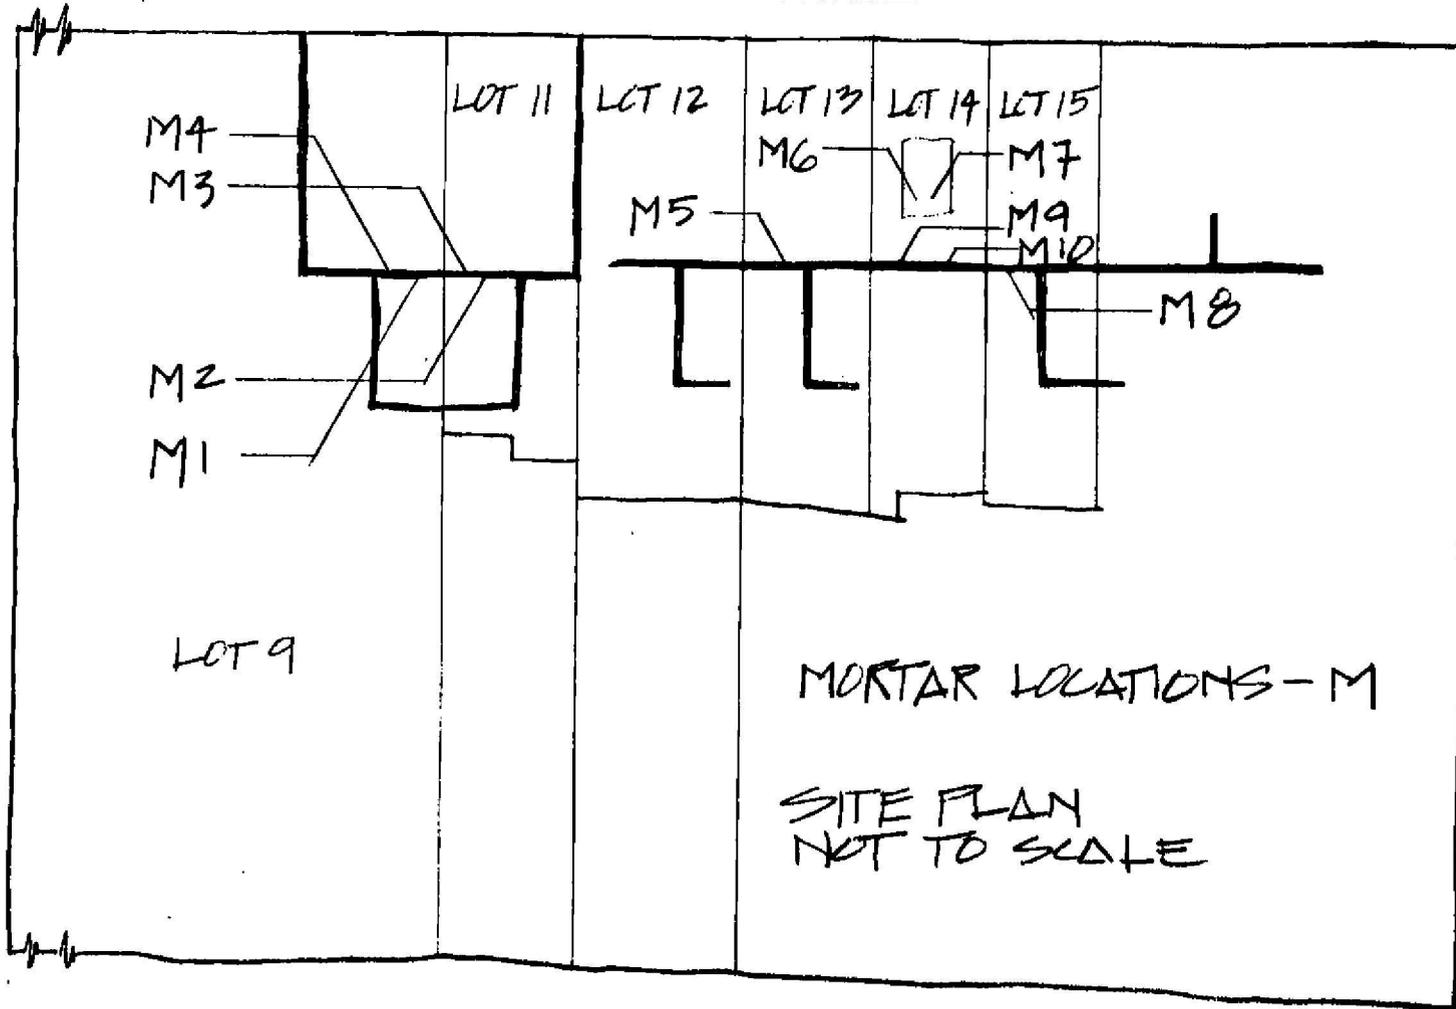
7 HANOVER SQUARE ARCHEOLOGICAL PROJECT

Historical documentation, primarily in the form of a site map, was made available by the archeological team excavating Hanover Square. This piece of research indicates that all of the foundation walls sampled were probably built in the late seventeenth or early eighteenth century (see site map).

SAMPLE #	LOT #	CATEGORY	LOCATION
1	9	mortar	south side foundation wall, approximately 3 feet below existing grade.
2	9	mortar	south side foundation wall, upper course.
3	9	mortar	north side foundation wall, upper course, bedding mortar beneath bluestone.
4	9	mortar	north side foundation wall, lower course.
5	13	mortar	rear foundation wall, north side, upper course.
6	14	sand	west wall of excavated pit
7	14	sand	east wall of excavated pit
8	15	mortar	south side foundation wall, lower cours.
9	14	mortar	north side rear foundation wall, upper course.
10	14	mortar	north side, rear foundation wall, upper course, about four feet from no. 9.

LATE SEVENTEENTH
EARLY EIGHTEENTH CENTURY — WALLS
