BLOCK 405. LOT 1.

174-180 AVENUE A & 501-505 EAST 11TH STREET.
. BOROUGH OF MANHATTAN.
NEW YORK COUNTY, NEW YORK

STAGE 1B ARCHAEOLOGICAL FIELD RECONNAISSANCE SURVEY

June 1997

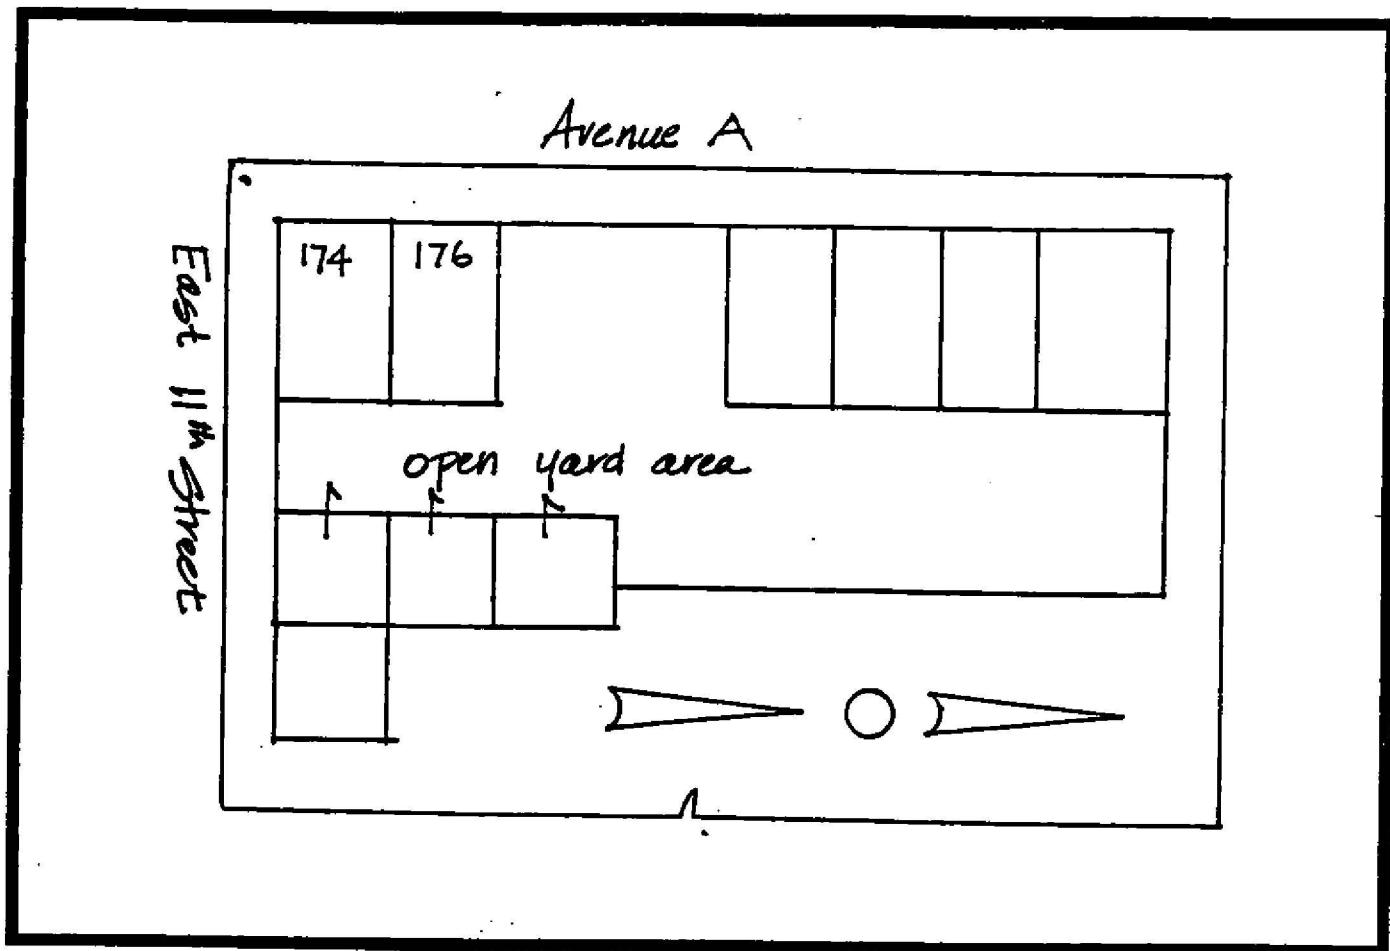
Detail of Block 405. 174-180 Avenue A and 501-505 East 11th Street (now Lot 1):

The earliest map consulted that shows structures located on the project area is Dripps' 1851 *Map of the City of New York*. In 1851 buildings corresponding with 174 Avenue A and 156 Avenue A had been built, along with the tenement buildings in the rear yards of those two dwellings. A tenement building had been built on the rear of the lot identified as 178 Avenue A, but no dwelling on the front of 178 Avenue A had been built, nor had any building been constructed on 180 Avenue A. The rest of the block north of 180 Avenue A had been built, but no rear yard tenements had been constructed behind these houses. The open yard area is identified. It ran from East 11th Street to East 12th Street. One small building east of the rear yard building on 174 Avenue A had been built.

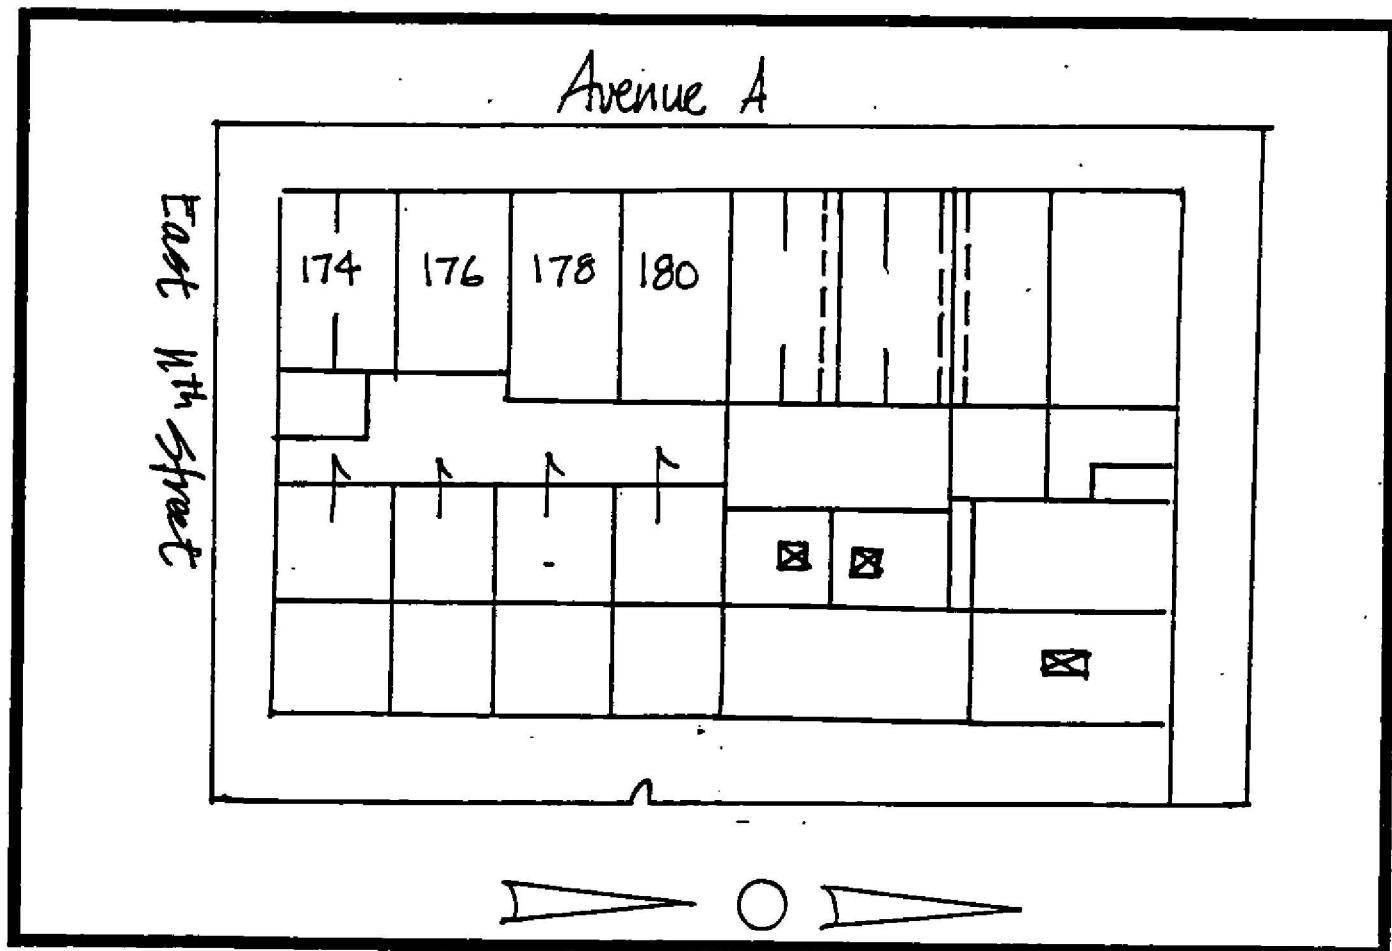
**Detail of Block 405. 174-180 Avenue A and 501-505 East 11th Street (now Lot 1):**

In 1853 the Perris *Atlas of New York City* showed that development was continuing on Block 405. Now the entire block facing Avenue A had been built. The building identified as 174 Avenue A now had an extension at the rear. The row of rear yard tenement buildings had been completed behind 174-180 Avenue A with access gained from East 11th Street through the rear yard of 174 Avenue A. An identical row of buildings had been built east of these buildings with access to East 11th Street. The rear yard tenements had entrances on the west side of the buildings. The number of stories is not stated, but later information indicates that they were 4 stories tall with a cellar foundation approximately 8 to 10 feet below curb grade. The map indicates that 174 Avenue A had been divided into apartments -- an indication, along with the additional buildings associated with present-day Lot 1, of increased density in the area.

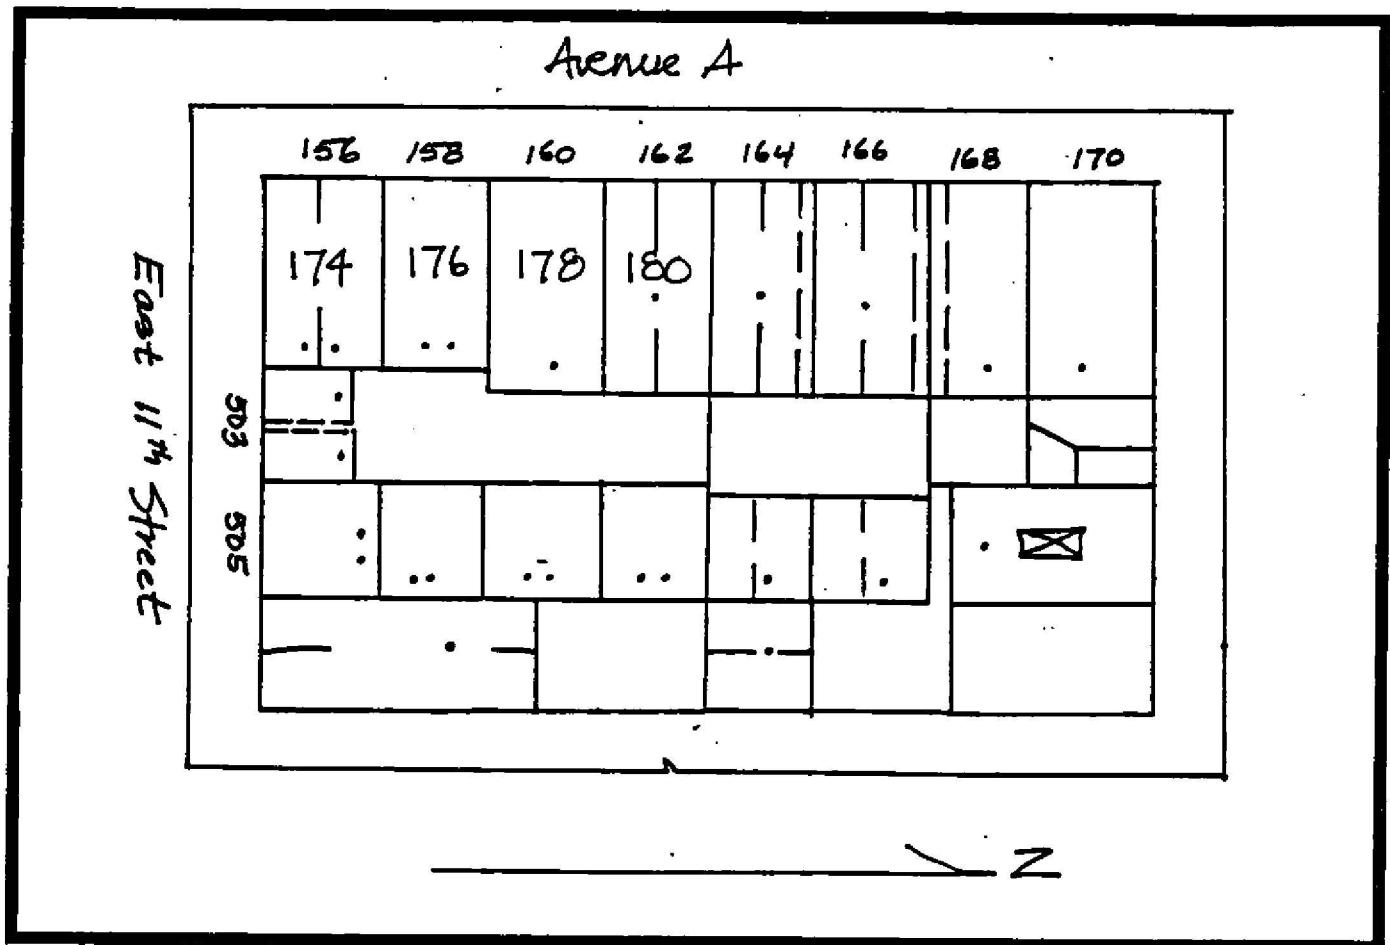
Detail of Block 405, 174-180 Avenue A and 501-505 East 11th Street (now Lot 1):

Further indications of the increase in density are seen in the 1857 Perris *Maps of the City of New York*. By this date 180 Avenue A (then identified as 162 Avenue A) had been divided into apartments. The extension on the rear of 174 Avenue A (then identified as 156 Avenue A) had been expanded to create a building identified as 503 East 11th Avenue. Access to the rear yard tenements was provided by way of a narrow passage through 503 East 11th Street. Since the expansion of the building had blocked the entrance to the southernmost of the tenement buildings, its entrance had been changed to become 505 East 11th Street.

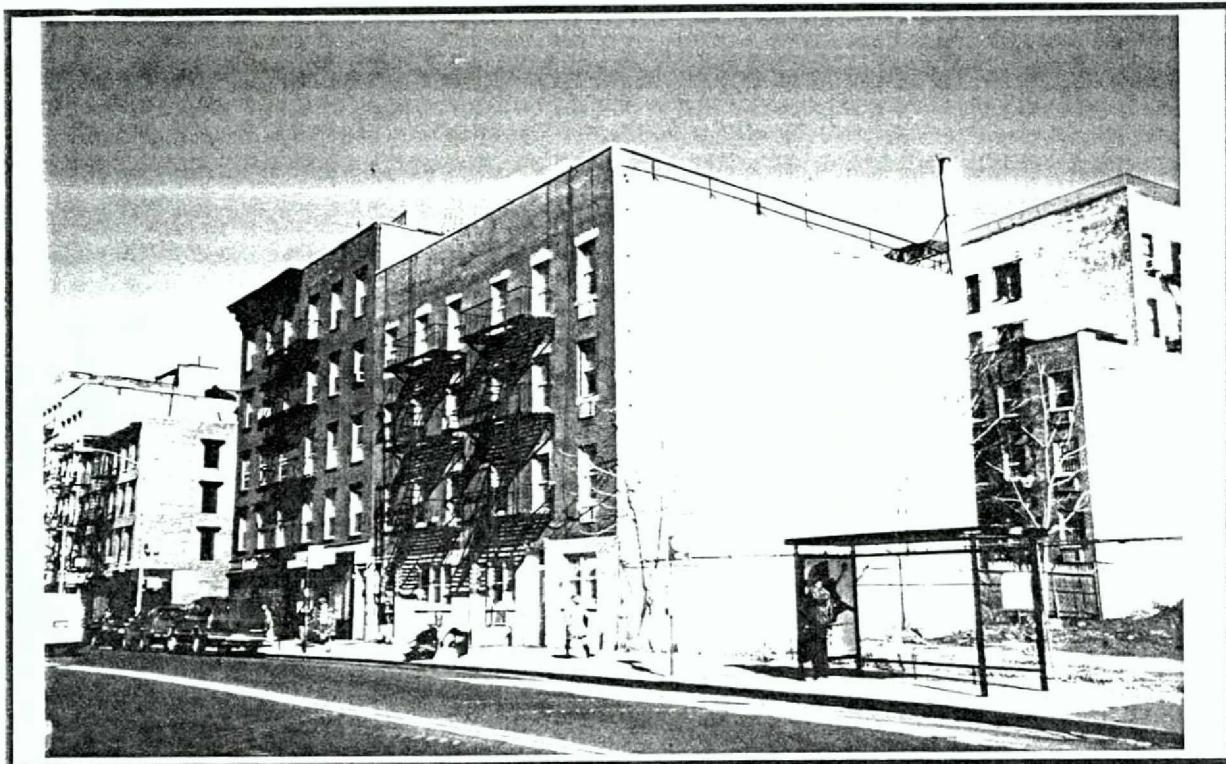
Photo 1: Buildings adjacent to site are similar to those that stood on the project area seen at right. View looking northeast from northwest corner of Avenue A and 11th Street.

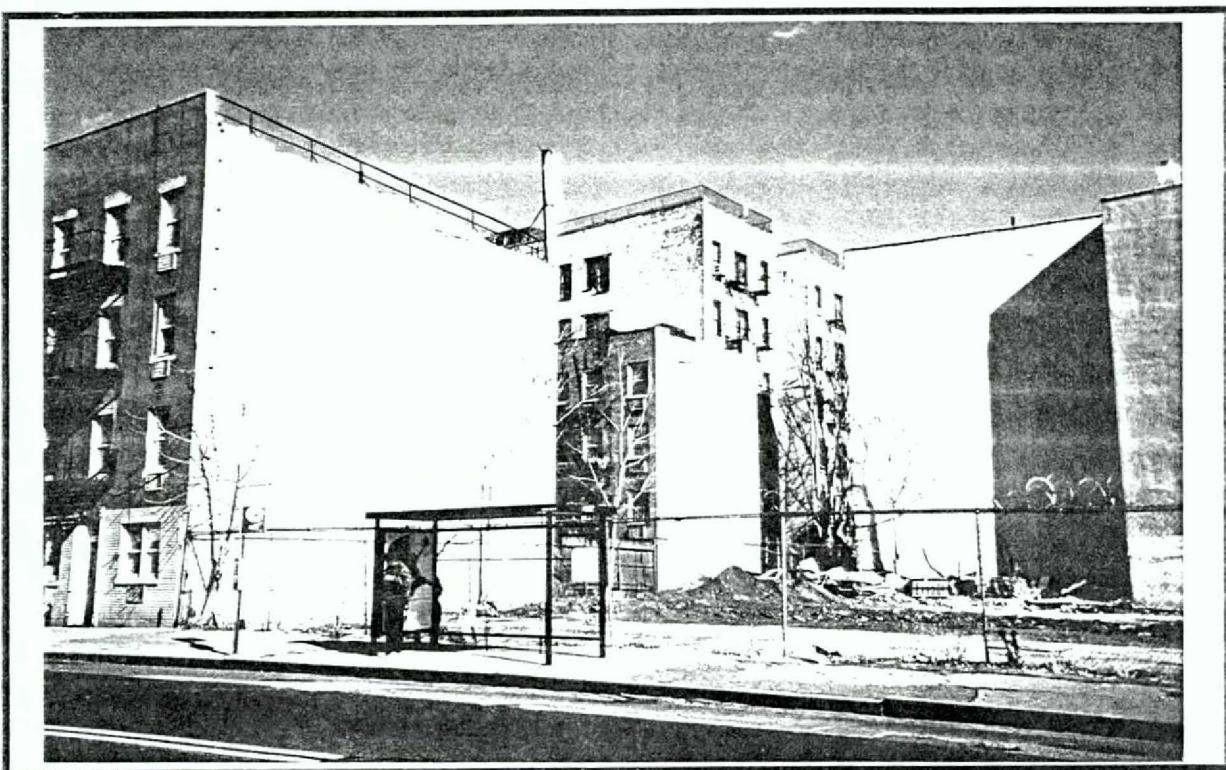
Photo 2: Project area at Avenue A and East 11th Street had recently been used as parking lot. Note dwellings at rear of lot to north -- similar to those previously within project area.

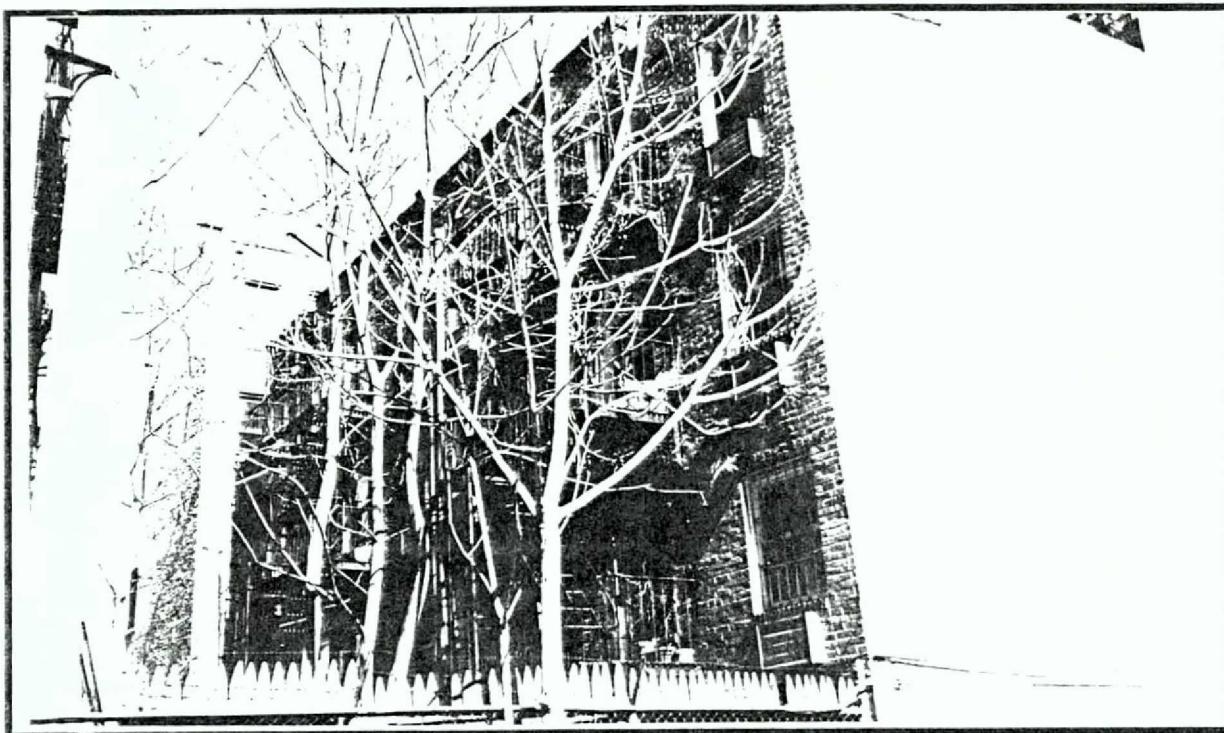
Photo 3: View of the dwelling units at rear of lots immediately north of project area. Access to these buildings is through dwellings on front of the lot.

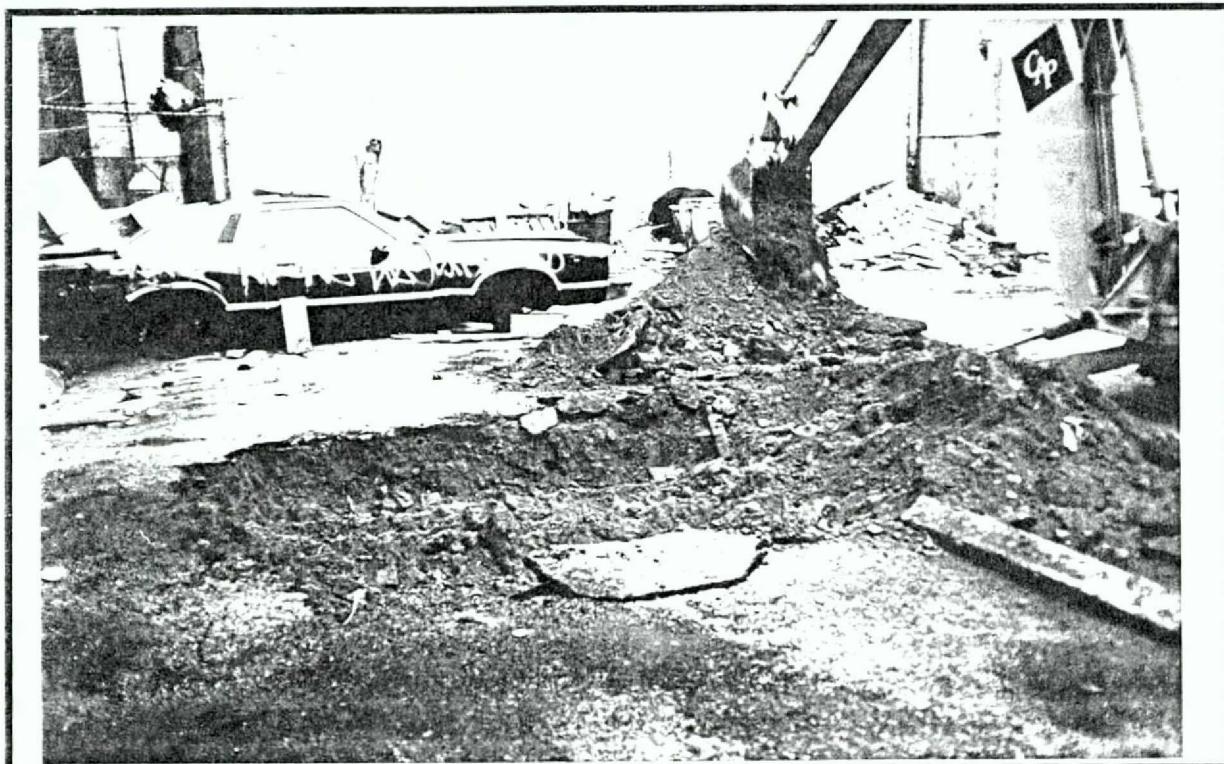
As expected, directly under the asphalt layer was a thin layer of yellow/orange sandy gravel. This layer was approximately 4" deep -- far too shallow in the opinion of the backhoe operator to serve as a subsurface for a parking lot. He attributed the buckling and uneven surface of the lot to this inadequate gravel layer. Immediately below the gravel was a one to two foot deep layer of red-orange very ground up brickbat with debris inclusions. Below this brickbat layer, evidence of destruction debris became immediately obvious. (Photo 5) Mixed with brick, glass, wood and sandy gravel were such objects as a broken television, plastic bags and soft drink bottles. Soils recovered from the trench were clearly deposited as unstratified fill when the houses were destroyed in 1984.

Photo 4: Backhoe carefully removed asphalt paving and layer of fill to determine level of overburden. Yellow/orange sandy gravel represented fill on which paving was laid.

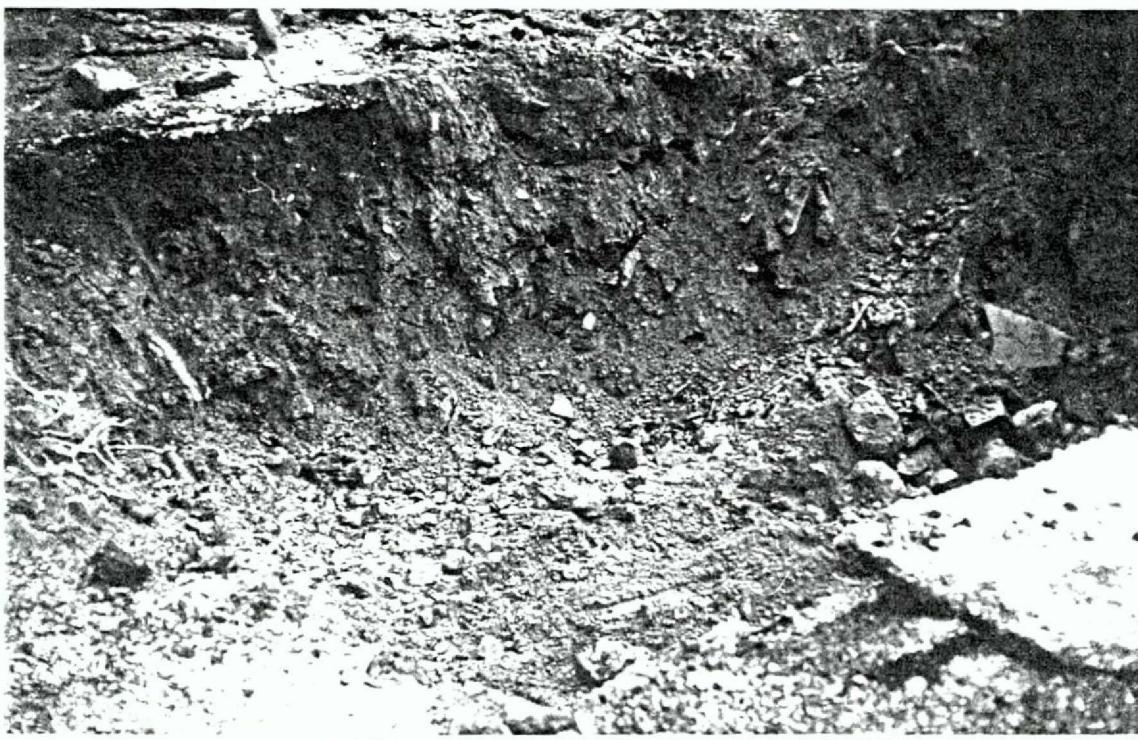
Photo 5: Below the fill was layer of red/orange very ground up brickbats with debris inclusions. Evidence of destruction episode was located below brickbat level.

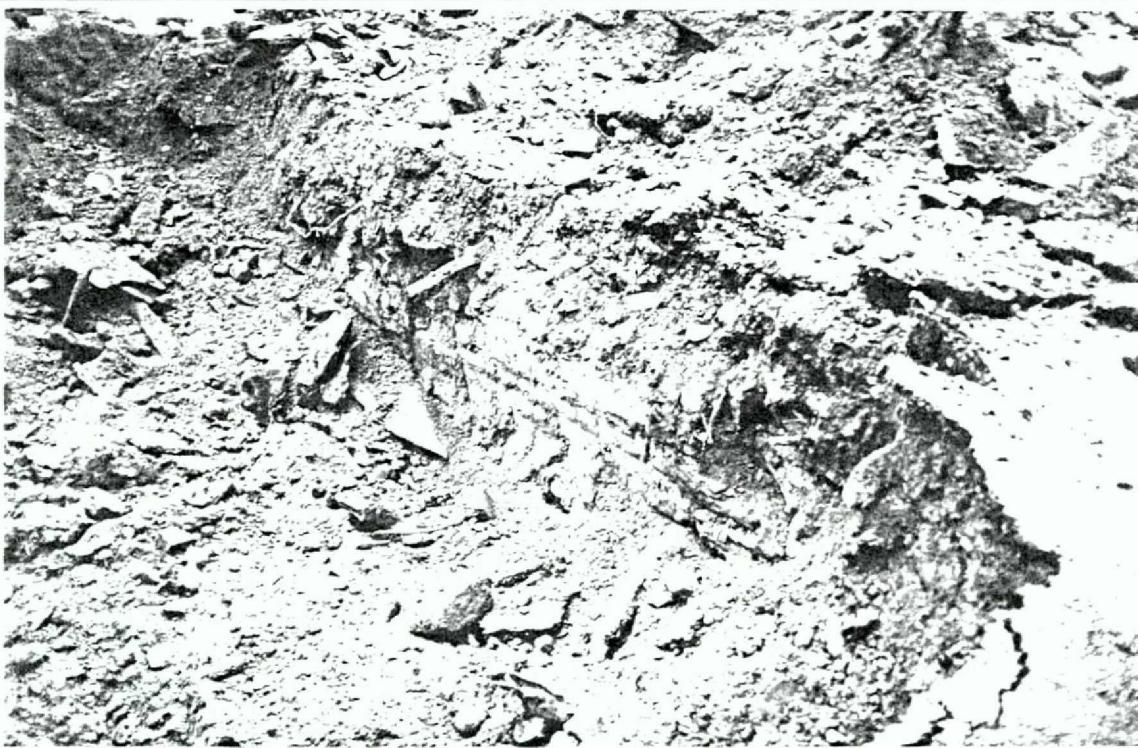
Photo 6: Excavation revealed brick foundations of houses formerly located at 176-180 Avenue A.

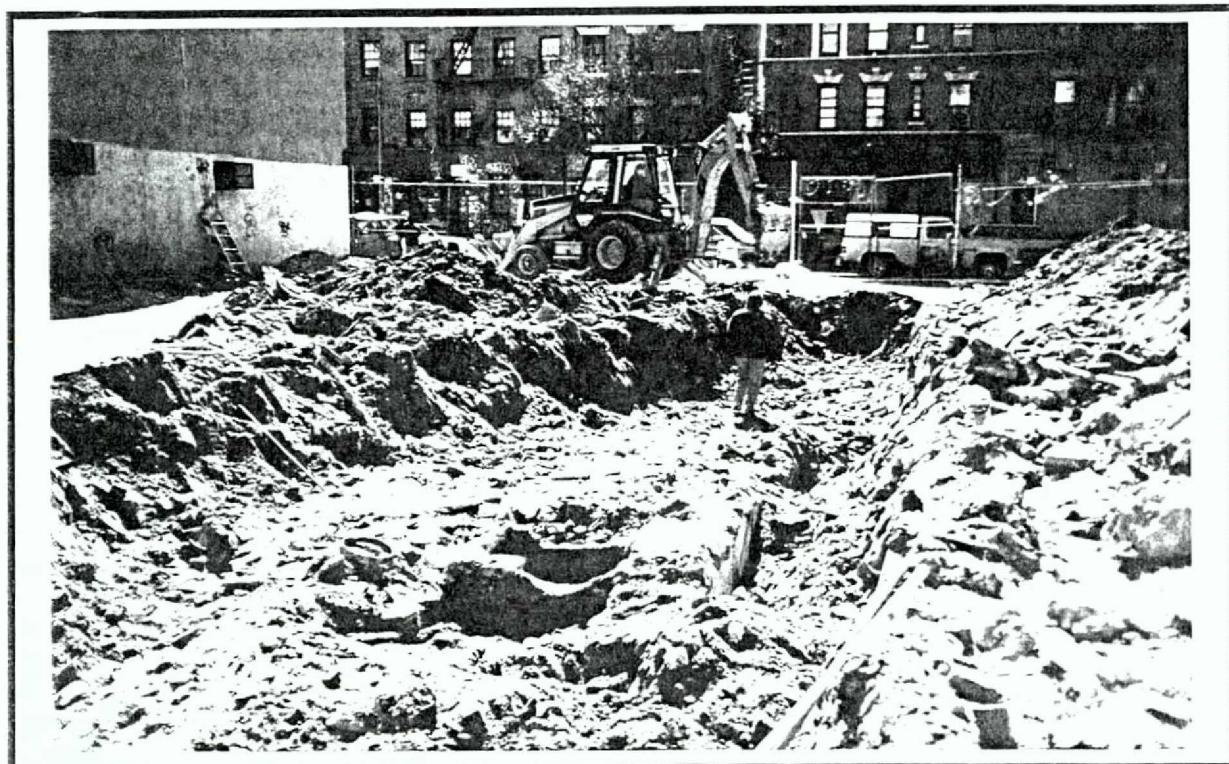
Photo 7: In an effort to locate any subsurface features 100% of the testable area was exposed by the backhoe.

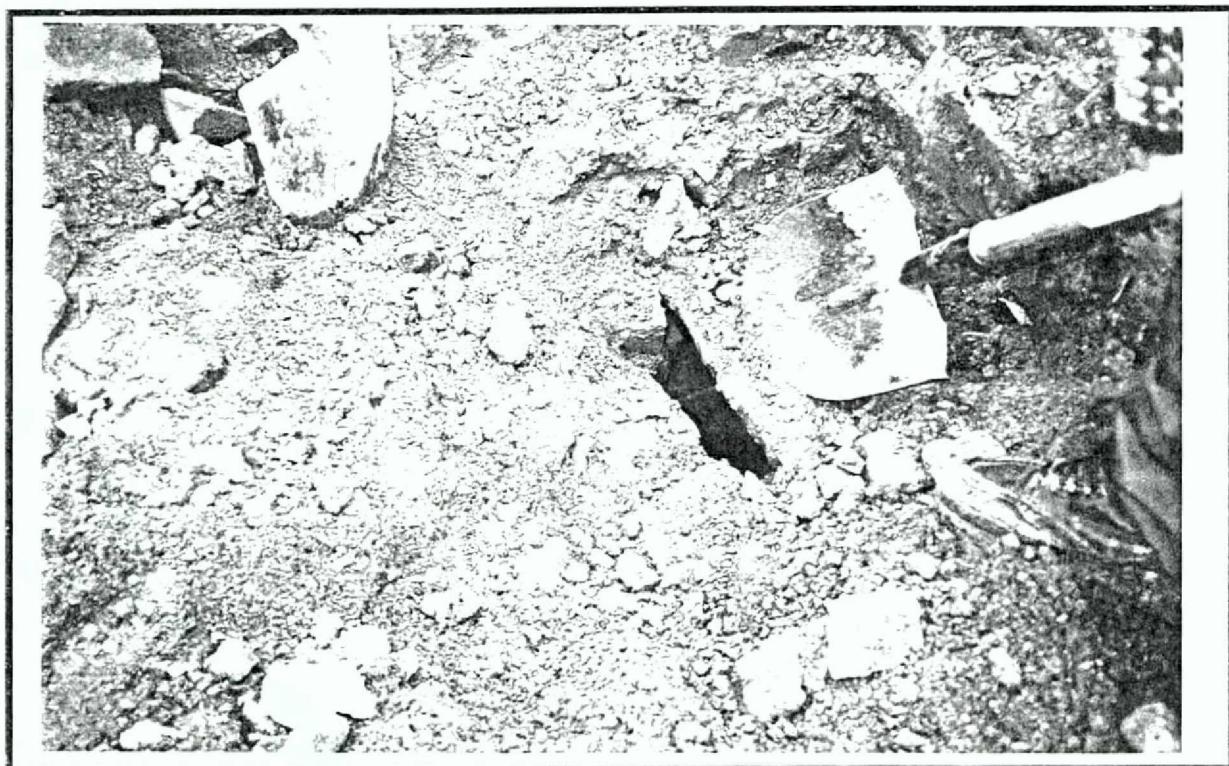
Feature 1 is located directly to the rear of the back entry stairs behind the row house that formerly stood at 178 Avenue A. It consists of two conjoined brick and mortar boxes measuring approximately three feet by six feet (see Field Reconnaissance Map and Photo 8-9). Each box therefore is approximately 3 feet square. When initially encountered the feature was capped with flat stones. After the capped stones were removed the contents were excavated to approximately four feet below site surface; the maximum extent of

Photo 8: When first exposed Feature 1 (located behind 178 Avenue A) was capped by stones.

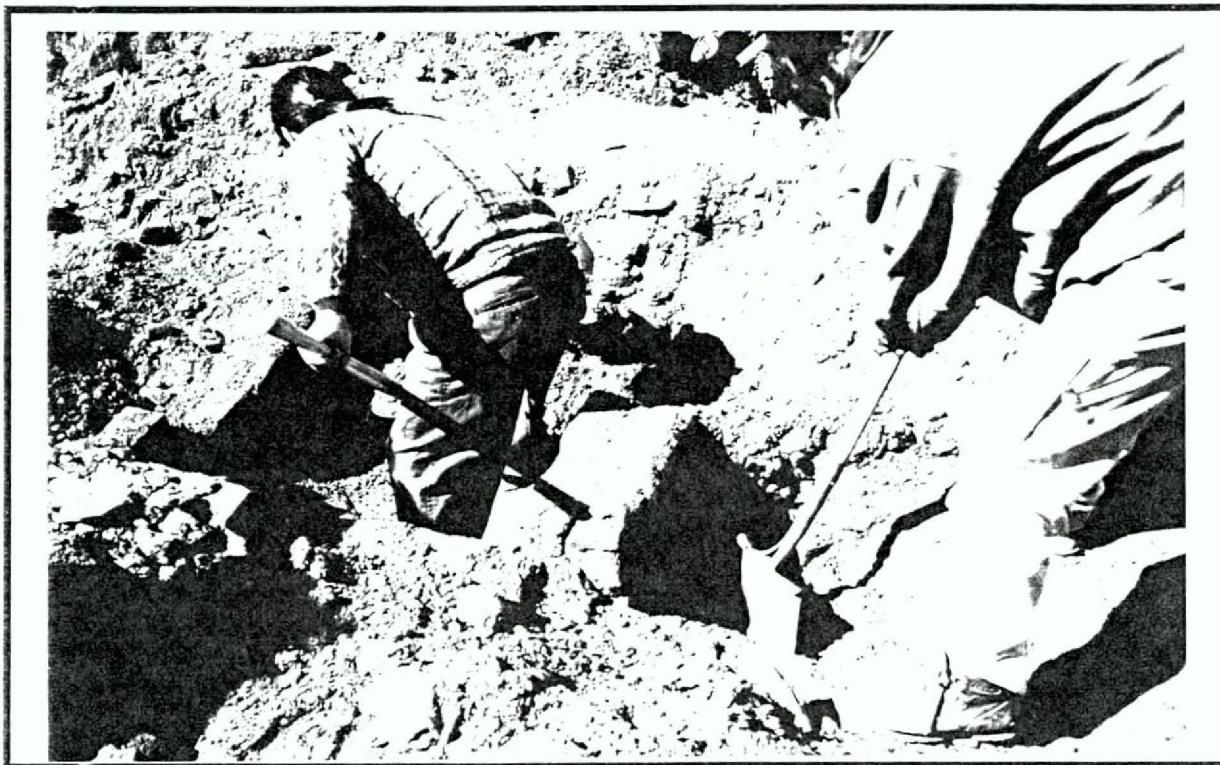
manual excavation without dismantling the structure. The brick containers yielded sandy fill with occasional clear glass inclusions, but no cultural material of significance.

Two features were encountered in the excavations. Feature 1, the conjoined brick box structure may have been paired privies. These would not have been communal

facilities, that is serving all of the houses and tenements, because they were attached to the brick foundation of the back entry stair well of the house at 178 Avenue A. If they were privies, they were associated only with this house. The depth of the feature supports the privy interpretation, although the 3' by 3' diameter is smaller than one would normally expect. Additional support for this interpretation is the fact that the deposit excavated from the feature interior was fine sand. Since the City of New York mandated during this time that privies should be emptied and filled with clean sand and sealed when no longer in use, the condition of the feature conforms to this code. Without further excavation, however, this interpretation cannot be confirmed.

Photo 9: Feature 1 was partially excavated revealing two conjoined brick and mortar boxes measuring approximately 3' by 6'.

There is some likelihood that the foundation identified behind 178 Avenue A may be a double privy, and may contained sealed deposits at a depth in excess of the 4' tested. All evidence, however, indicates that if this was a privy it was emptied and, as mandated by the City of New York, filled with clean sand when it ceased to be used. The archaeological potential of this feature is therefore assessed to be low.

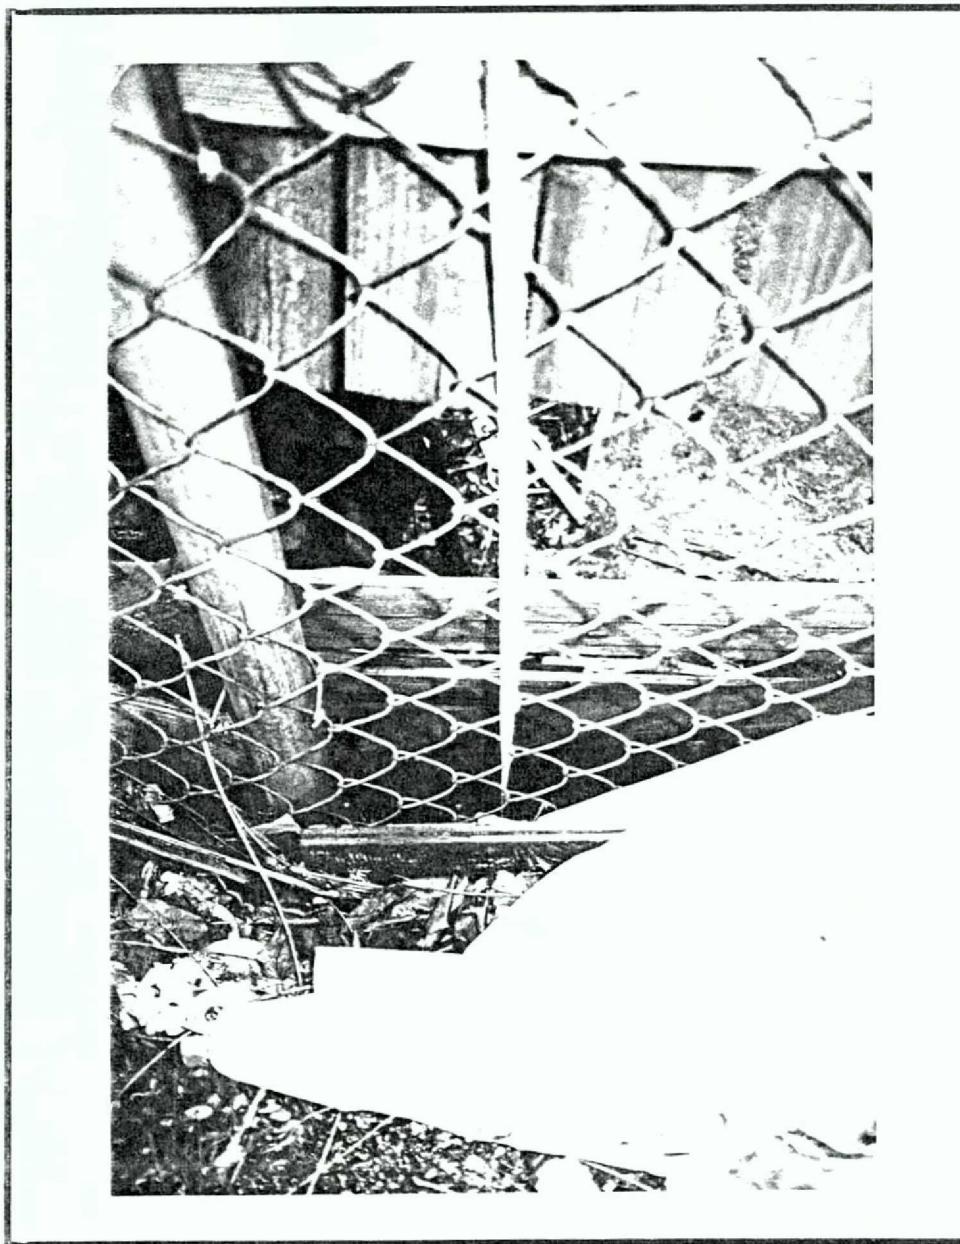
level of overburden. By extrapolating from street elevation and the ground level of the adjacent, extant row houses the overburden can be measured at approximately two feet above original surface. (Photo 11) This depth is well within the expected range after a destruction episode such as the one that removed these houses in 1984.

Photo 11: To determine the original ground level and extent of the overburden on which the asphalt had been laid measurements were taken at the fence line separating the project area from the adjacent row houses. The depth was approximately two feet -- well within the expected range.

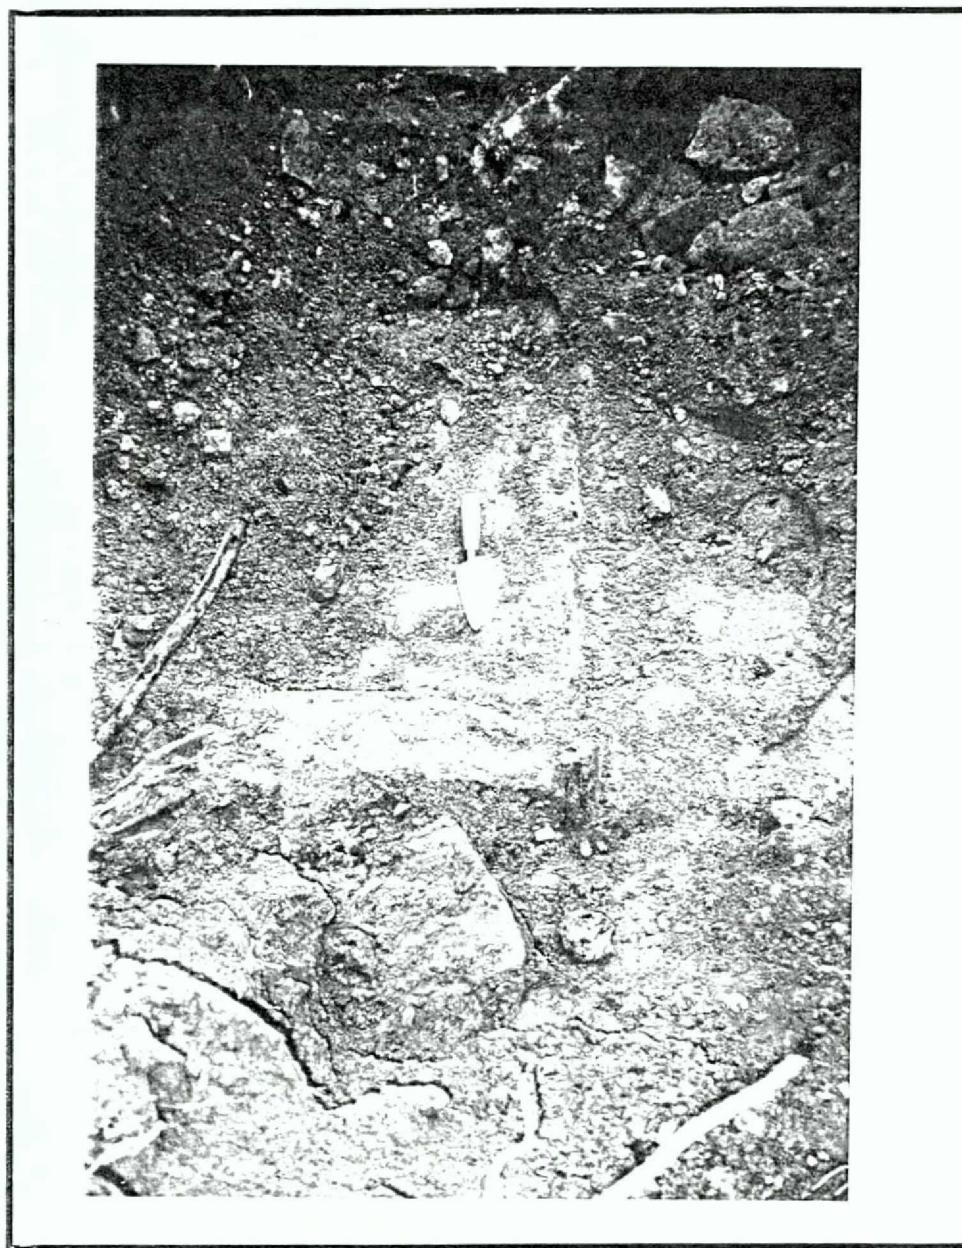
Trench #2 was located in the area that historic maps identified as the rear foundation walls for the street-facing row houses. As with the rear structures, the features emerged quickly in precisely the location expected. In rapid succession, the rear walls and stairwells associated with 176, 178 and 180 Avenue A were exposed. One seventy eight and 180 Avenue A retained their original configuration and construction materials (see Field Reconnaissance Map and Photo 6). The rear foundation of structure 176 Avenue A, however, exhibited substantial alterations including a modern concrete entry walkway, a modern brick repair on the rear stairwell and a change in rear window openings including bricking up the original window and creating an opening for a new one. (Photo 12) Soils behind structure 176 Avenue A were markedly different than those behind 178 and 180

Avenue A. Rather than the burned rubble encountered in most of the trench, the rear area of 176 Avenue A had a higher content of sandy fill. Both the modern construction and the differing fill set this row house apart from the others.

Photo 12: Foundations appeared at the expected intervals. Most were original, but at the rear of 176 Avenue A alterations had been made and a new entrance to the cellar constructed.

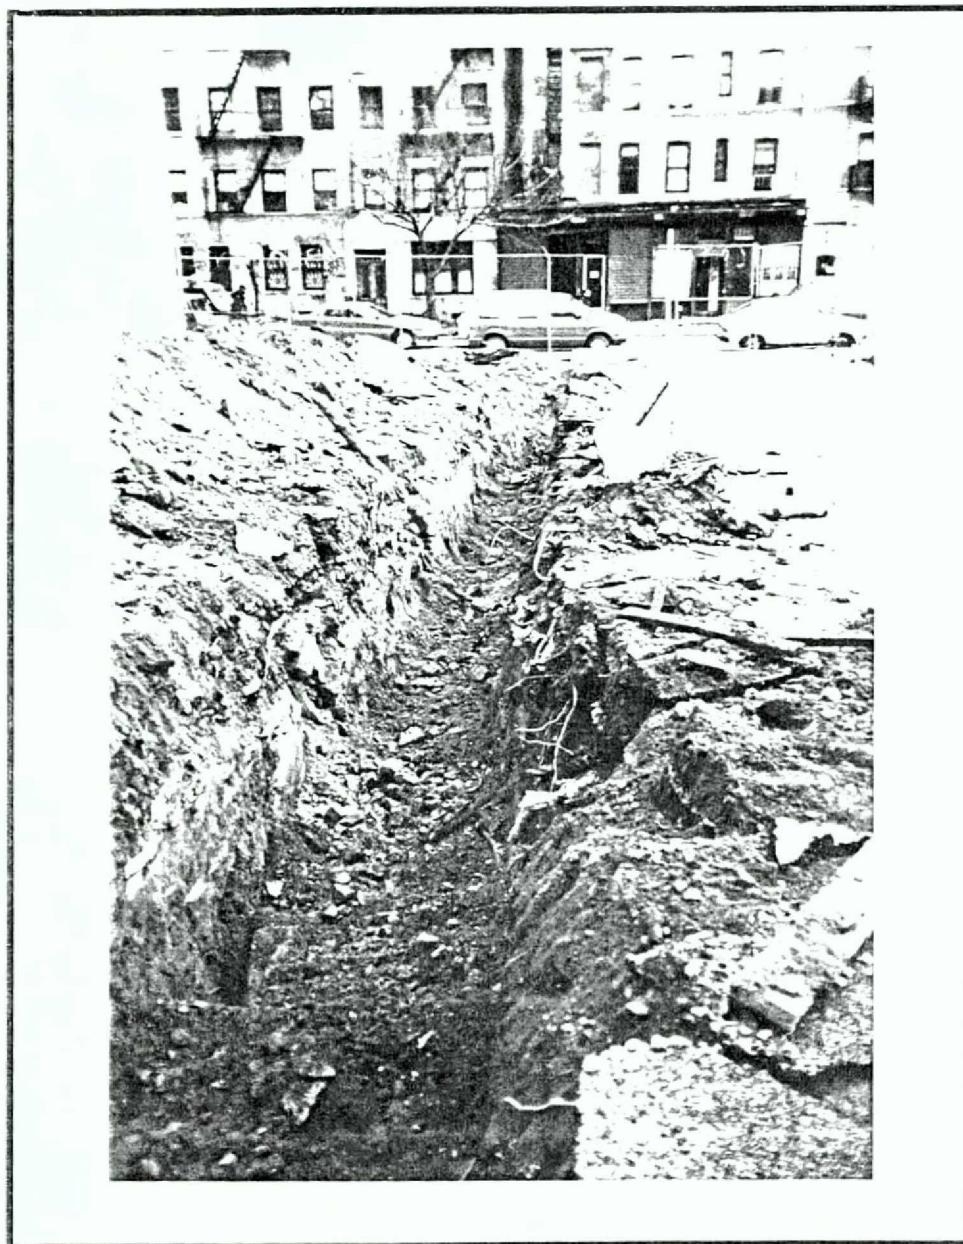
Trench #1 was intended to locate the front foundation of the rear tenement buildings that existed in the back of the lot, and these foundations very quickly emerged as the debris was removed by the backhoe. (see Field Reconnaissance Map) These foundations were remarkably intact, retaining the basement doorway openings at precisely the locations indicated in historic maps. The five foot wide trench did not reveal any privy or cistern features in front of these foundations. (Photo 13) Manual excavations into the base of the trench identified the fine yellow sand that made up the original subsoil in this part of lower Manhattan. An examination of these strata confirmed that the foundation holes had been excavated into this original fine sand. After measuring, examining and documenting the rear foundations, and in the absence of any features, Trench #1 was backfilled.

Photo 13: Trench #1 exposed the front foundations of the buildings located on the east side of Lot 1. These buildings corresponded with those seen in Photo 3.
