**STAGE 2 ARCHAEOLOGICAL
INVESTIGATION**

**CONGREGATION MOSHCISKER
CHEVRAH GUR ARYE MIKVAH**

**308 East Third Street (Block 372, Lot 27)
Borough of Manhattan
New York County, New York**

December 2003

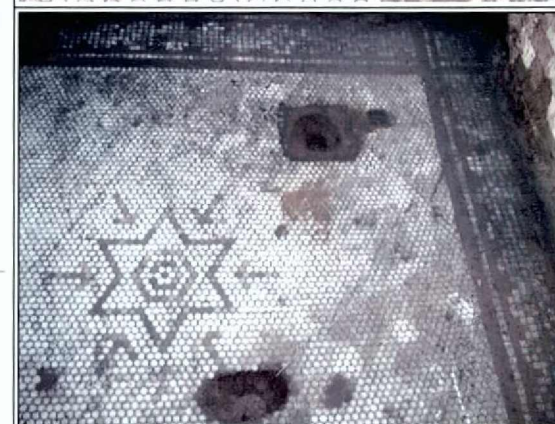
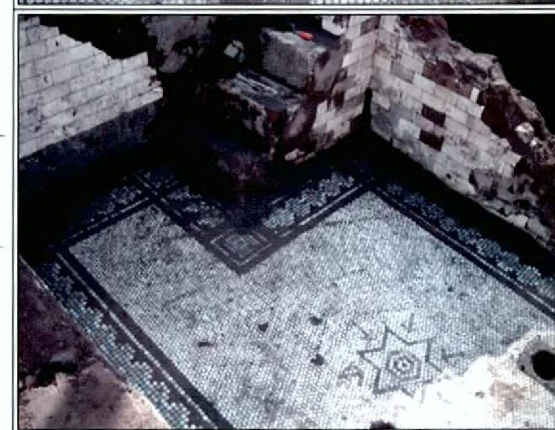
STAR OF DAVID design

Once the bath feature was completely exposed and cleaned, a number of details emerged which provided compelling evidence that the bath is, indeed a mikva. The small size was an initial indicator that this might be so. Once the floor was cleared and cleaned, a tiled Star of David emerged in the center (See Photos and Diagrams).

Diagram of Star of David Design on Bottom of Mikvah. Scale: 1 Inch = 2 Feet.

on bottom of Mikva
