East Harlem Triangle Urban
Renewal Area
Manhattan, New York

Archaeological Testing Report
CEQR #89-106M

December 1993

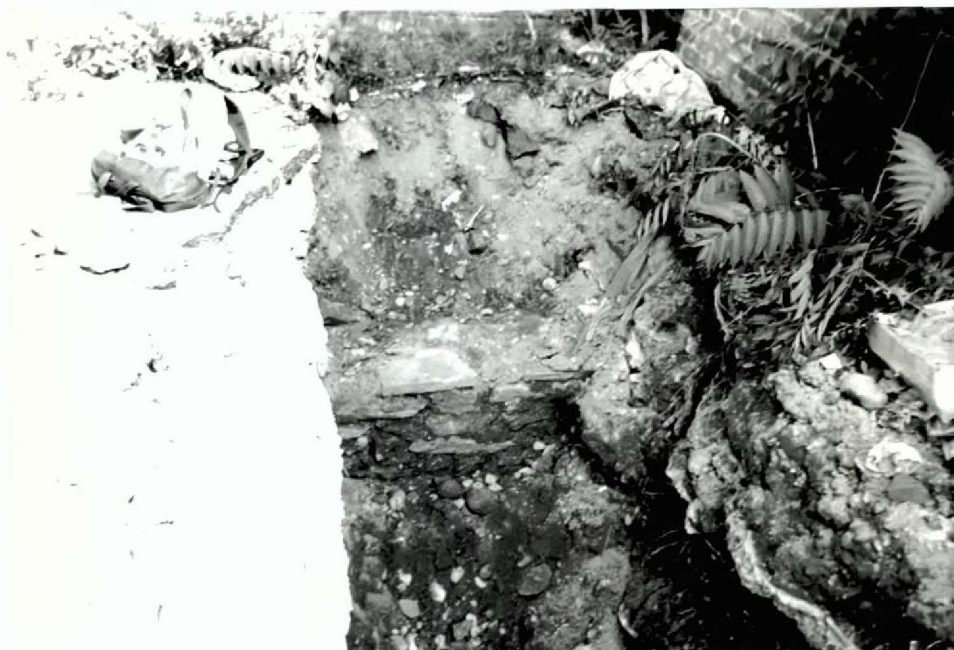
Trench 1: A stone lot wall, located on the lot line. It is about 18 inches wide and was exposed in the west section of the trench (Figure 3). The wall was encountered at about 3 feet below surface and continued down to the bottom of the trench. It ran in a north-south direction. No historic artifacts were found associated with this feature. See Plate 1 for a view of Backhoe Trench with this wall.

Plate 1 View of Backhoe Trench 1 looking west showing stone wall.

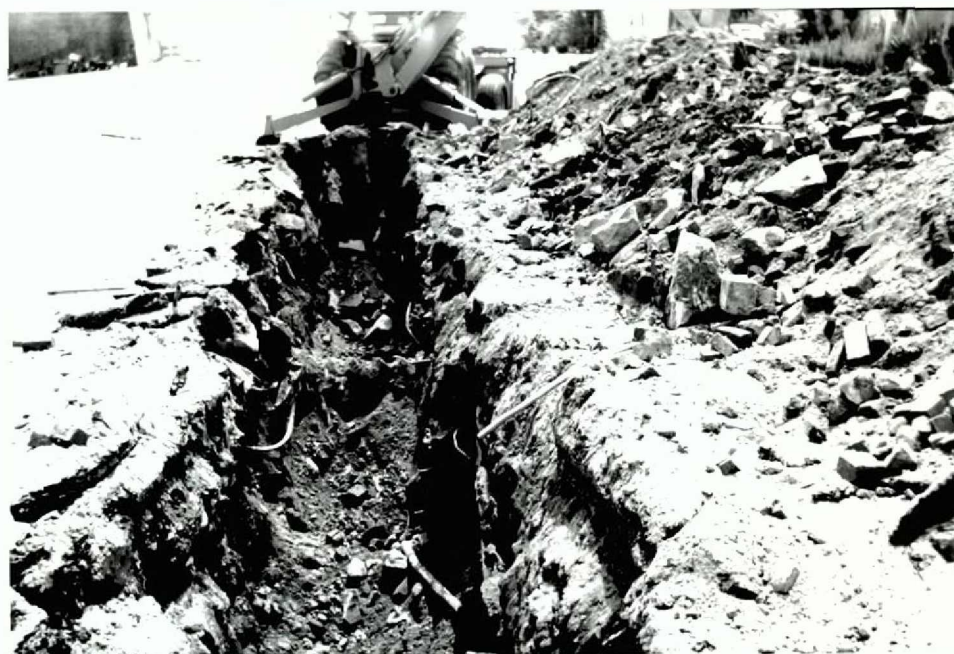
A second feature was exposed which consisted of a stone lot wall. This was also located along a lot line (Figure 3). It was exposed from three feet below surface to the bottom of the trench at approximately the middle of the trench. It was orientated on the north-south axis and was one foot wide. See Plate 2 for a view of Backhoe Trench 2 with this lot wall.

Plate 2 View of Backhoe Trench 2 looking east showing stone lot wall.

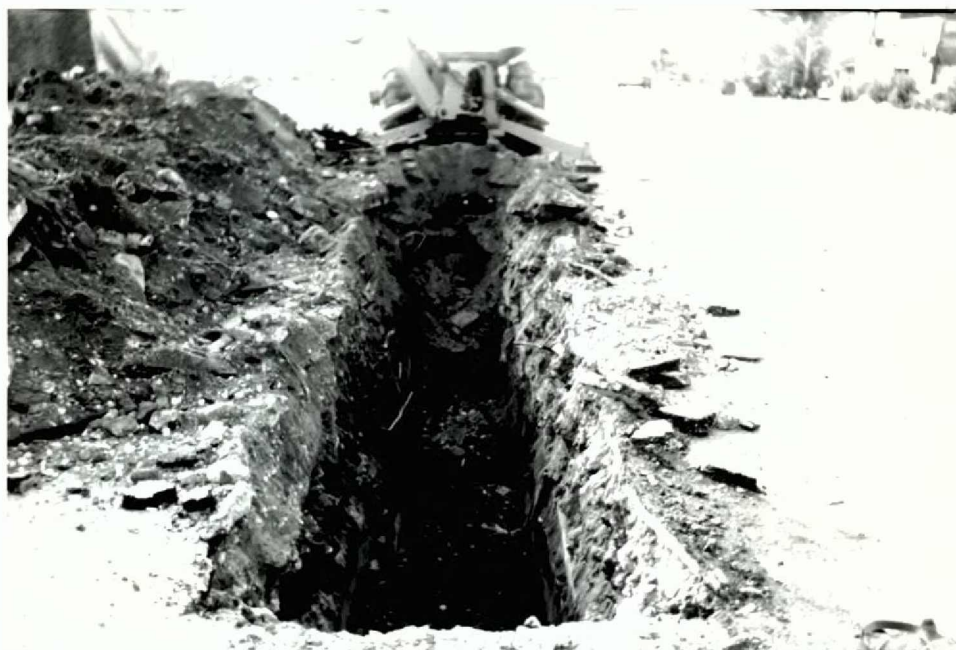
Trenches 1 through 4 had an original, intact soil of 7.5YR4/6-5/8 sand with river cobbles from 3 1/2 to 4 feet to the bottom of the trench at 5 1/2 feet below surface. Trench 3 had an additional stratum of 10YR5/6 sandy loam of probable river deposit, overlying the basal stratum (of 7.5YR 4/6 sand). Trench 3, levels 7 and Trench 4, level 4 had dark stains with some ash remains. This seems to represent a small fire that had occurred here and is associated with modern debris.

Plate 3 View of Backhoe Trench 3 looking east.

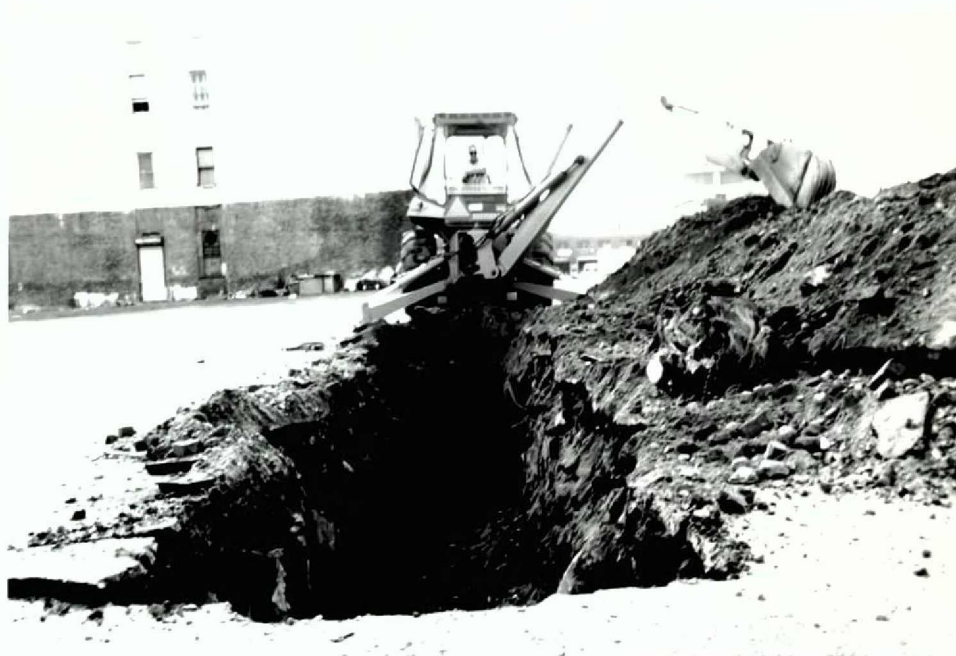
Plate 4 View of Backhoe Trench 4 looking east.

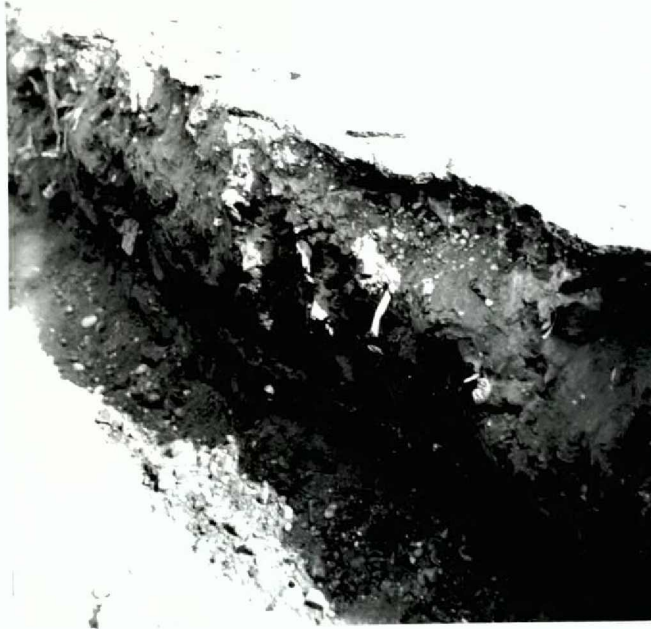
Trench 6 had a fill and rubble stratum from 0 to about 4 feet below surface. The underlying, undisturbed soil was a 10YR 4/3 sandy loam with river cobbles and gravel.

Trench 6: A brick wall was exposed on the north wall of this trench from just below the surface down to the bottom of the trench. It ran east-west and into the trench sidewalls (Figure 3). Since the trench was about 6 feet wide, the length was at least the same and probably longer.

Plate 6 View of Backhoe Trench 6 looking north.
