The Buried History of City Hall Park: The Initial Archaeological Identification, Definition and Documentation of Well-Preserved 18th. Century Deposits and the Possible Structural Remains of N.Y.C.'s First Almshouse

Joel W. Grossman, Ph.D. Principal Investigator.
Grossman and Associates, Inc.
201 East 16th. Street, 6th Floor.
New York, N.Y. 10003

Draft: August 1989;
Final: May 1991

PROJECT NO. PW-292-44

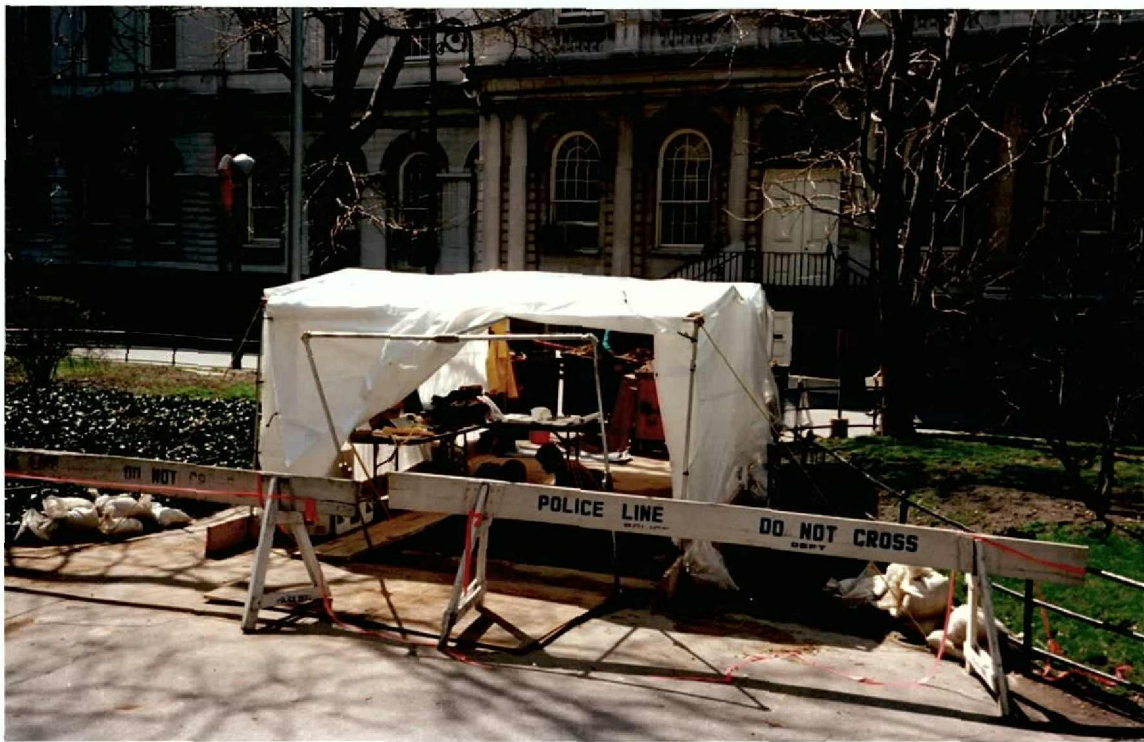
Plate 2. Closeup field view showing location of excavation units delimited by police barricades and protected by portable shelter. City Hall Building in background.

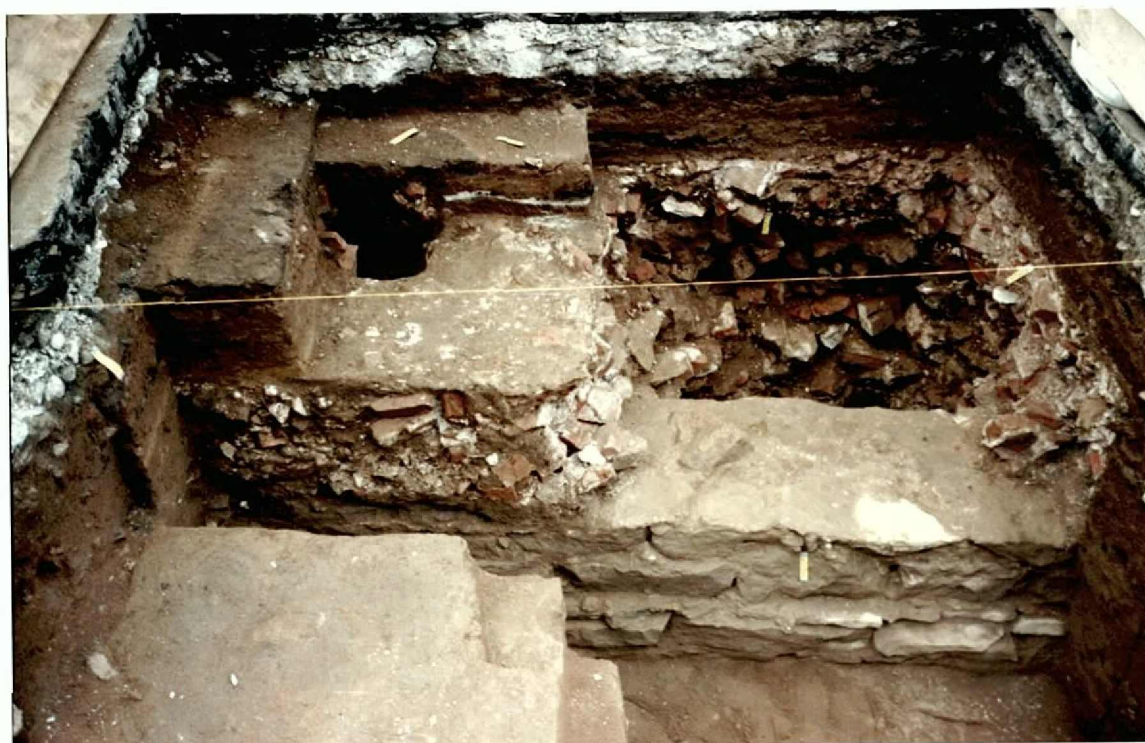
Plate 3. General view of excavation unit looking south showing stratification of archaeological deposits below street pavement, and quartersectioned intrusive 19th century post-hole Feat. 5006 (left); foundation fill Feat. 5004 (center).

The actual wall foundation was assigned Feature 5007, of Strata Group VIII, and measured an average of 50cm (19.7in) in height, and an average of 50cm (19.7in) in width (See Plate 3). The length could not be recorded as the wall extended to both the east and west, beyond the limits of the excavation unit.

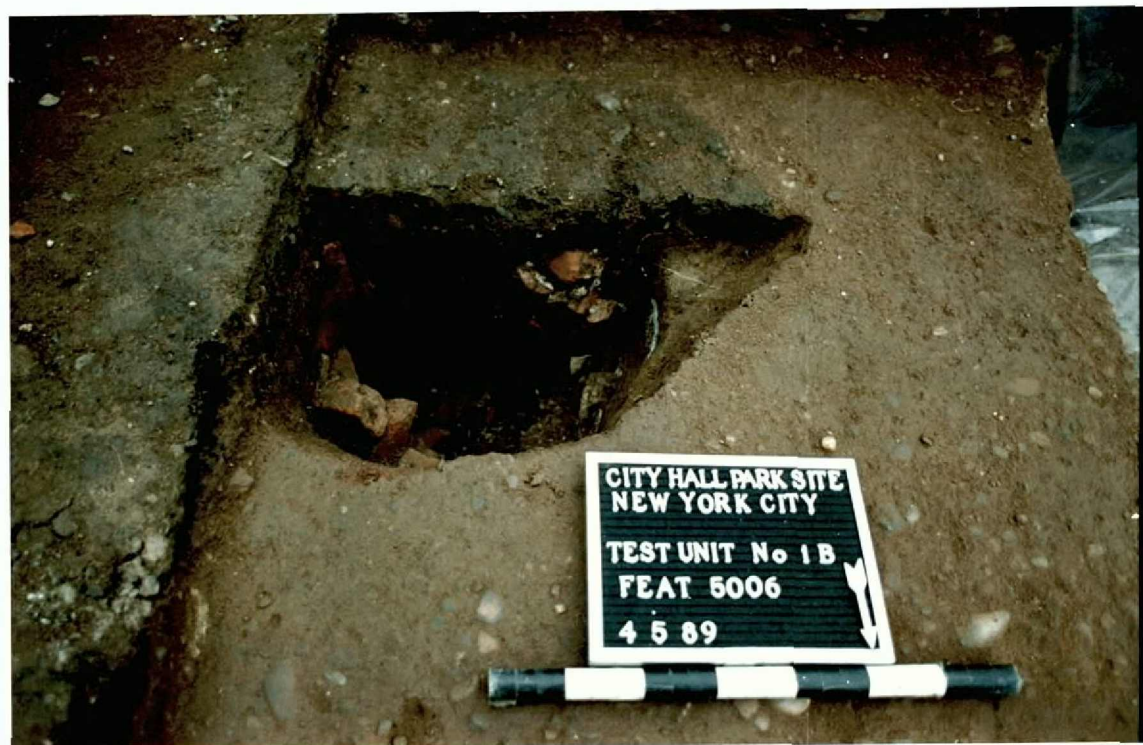
Plate 4. Field view showing quartersectioned intrusive 19th. century post hole, Feature 5006.

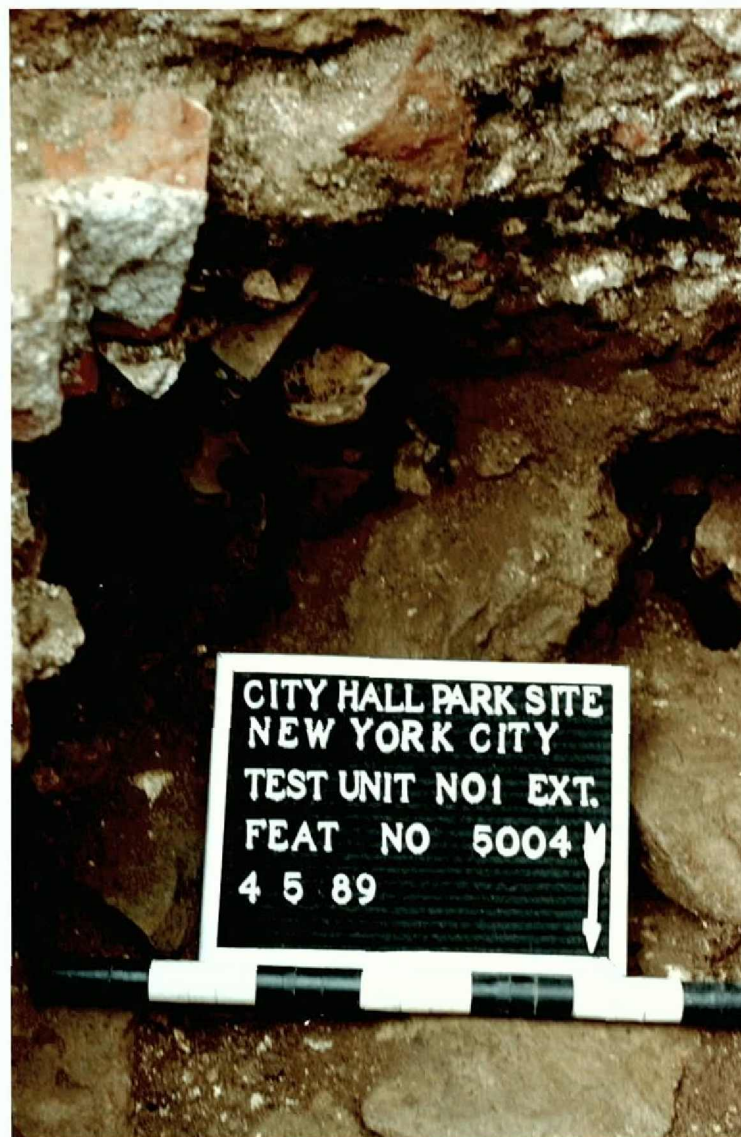
Plate 6. A closeup view of the brick rubble fill, Feat. 5004, showing portions of the proximal third half of a human ulna and a clam shell imbedded in the rubble fill (left of center).

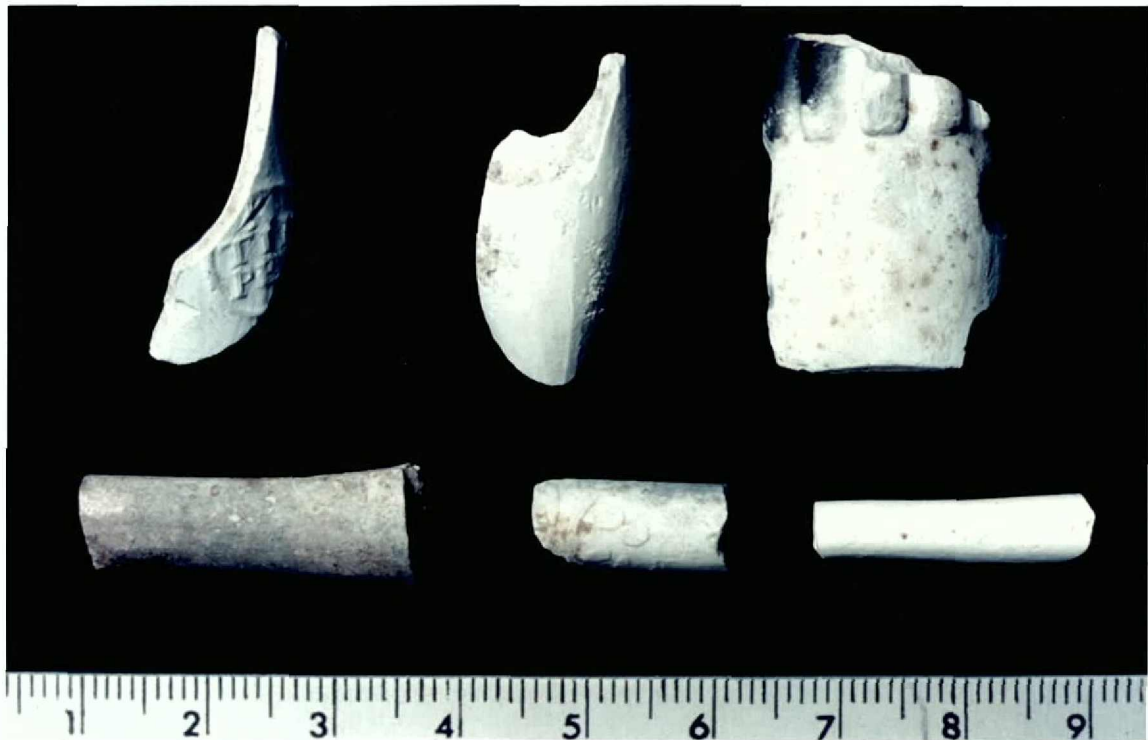
Plate 9. Top left: Feat. 5003 (charcoal lens) pipe bowl Fragment, Robert Tippet Factory (English manufacture: 1740-1780, Stone 1974: 148-149). Top Right: Feat.5001 (builder's trench) Decorated pipe bowl fragment, upside down, no date.
Bottom row: Feat. 5001 (builder's trench) Various pipe stems, center stem decorated.

Feature 5003, a charcoal lens designated Cx.1.12, contained only one fragment of undecorated creamware (1762-1820), and a pipe bowl fragment with an embossed "R. Tippet" maker's mark, dating to the period 1740-1770 (Stone 1974: 105; See Plate 9). These earlier dates are not terribly significant, however, since the feature is within Cx.1.12, which, by the other associated ceramics, postdates 1795.

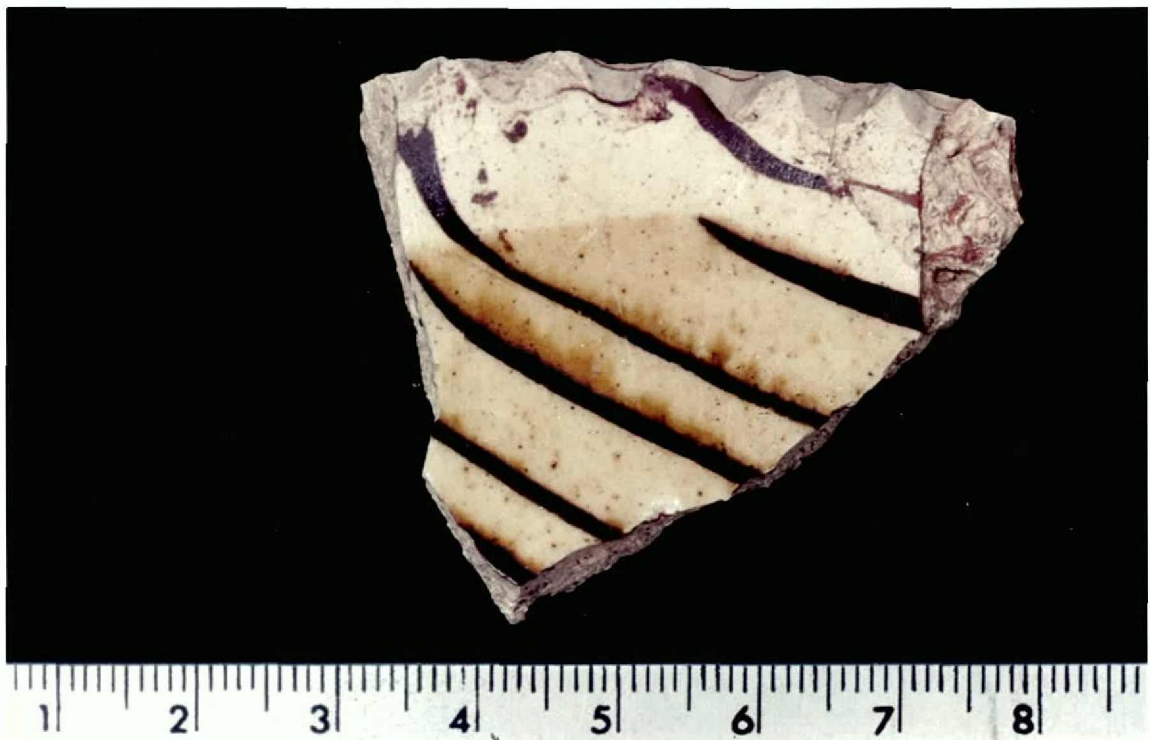
Plate 10. Feat. 5004, (brick rubble/fill) "Pie Crust" rim fragment of English buff-bodied, slip-trailed earthenware. Probable third quarter of 18th century, (Noël Hume 1985: 107).

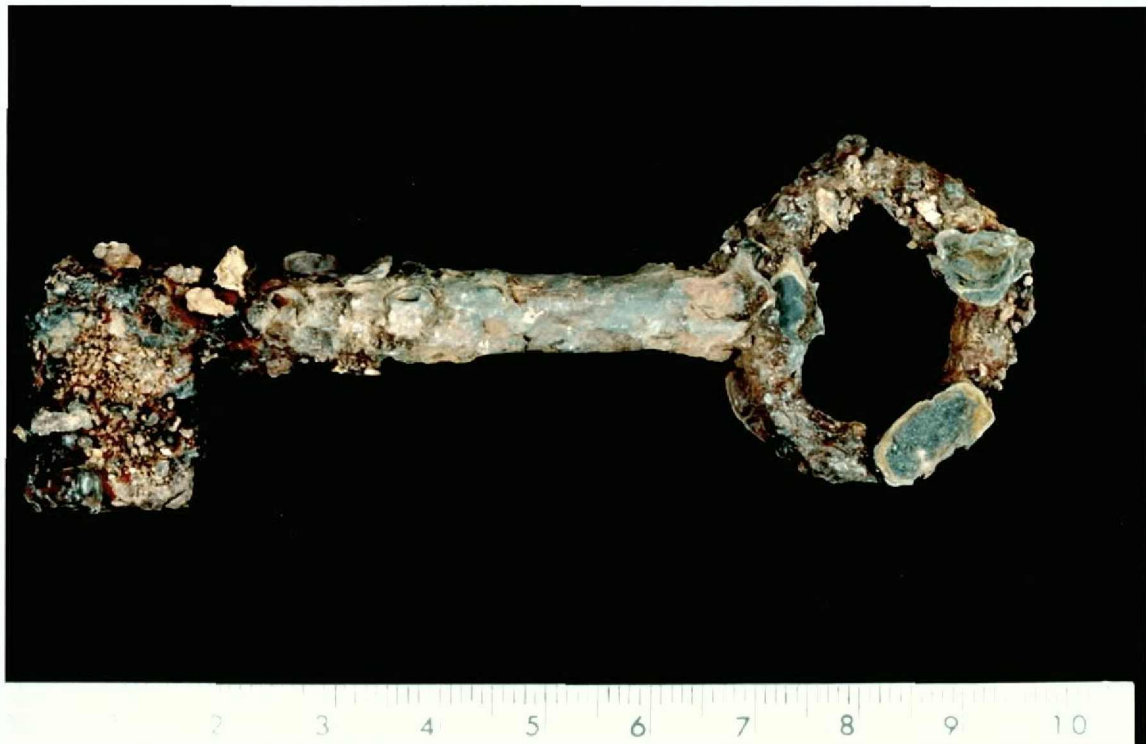
Plate 11. Iron key from post-destruction rubble of Feat 5004, in the fill of building interior, deposited in third quarter of 18th century.

The excavations also uncovered fragments and whole bricks with kiln-fired, glazed headers, as well as a whole brick with a bull-nose on the one header side, indicating the existence of a possible arch. Furthermore, the discovery of an 18th century key in the interior rubble basement fill, suggests proximity to a door along this section of the north wall (See Plate 11 and Plate 12).

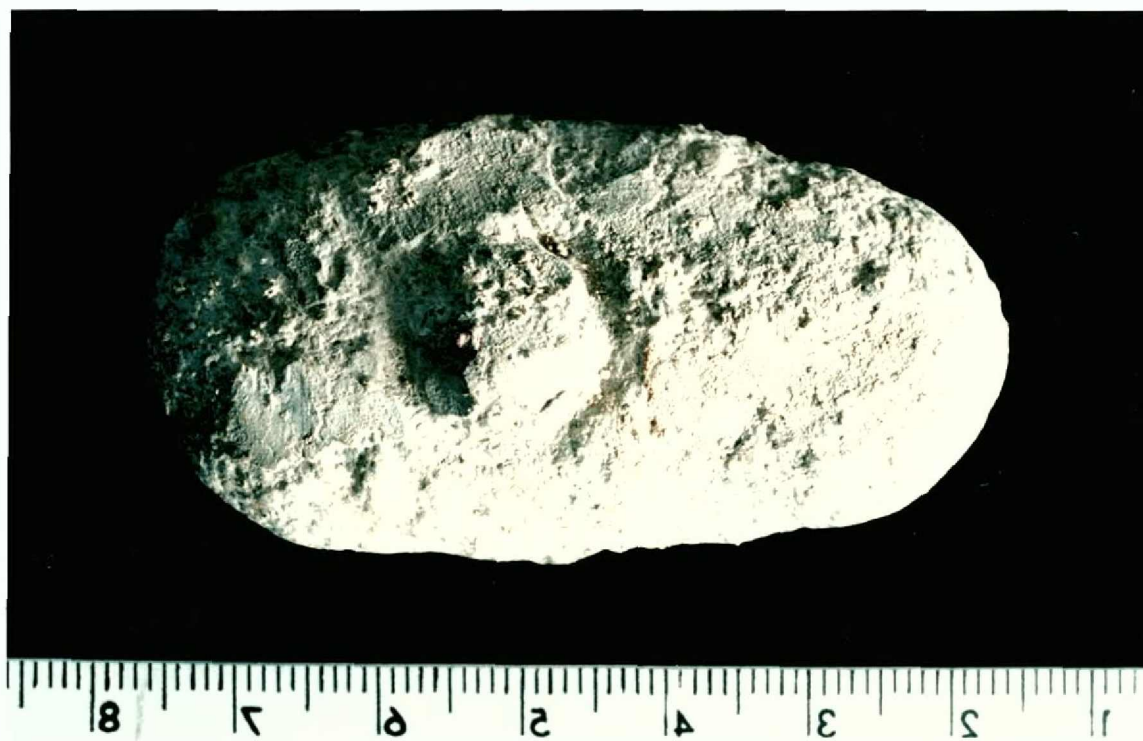
Plate 13. Cx. 1.19 (brick rubble/fill). Unidentified lead object, possible weight.

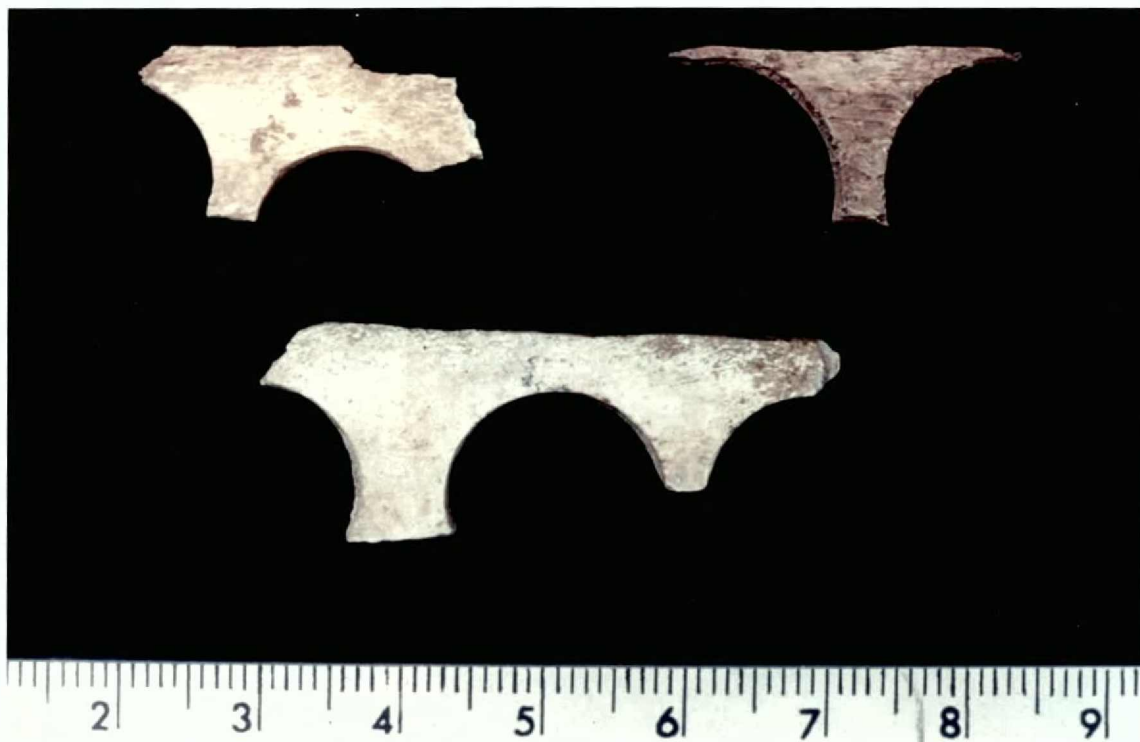
Plate 15. Bottom row: Feat. 5004 (brick rubble/fill). Bone button blank, no date.
Top row: Bone button blanks.

These artifacts included 7 copper alloy straight pins and three bone button blanks, all found associated with the brick rubble fill in the interior of the colonial building (See Plate 14 and Plate 15). Similar bone button blanks were found at a Revolutionary War era barracks site at West Point, New York. During the revolution, American soldiers manufactured bone blanks "cut from meat bones by means of a carpenter's brace and a bit, and these blanks were covered with cloth by means of which they were sewn to the garment." (Calver and Bolton 1950:44 and 53). In addition, one bone button back with an off-set rim was found in the post-1765 oyster-shell-filled refuse pit which was stratigraphically and chronologically associated with the occupation phase of the colonial building. The presence of these artifacts suggests that activity related to clothing production is consistent with early published accounts referring to the performance of craft activities by the Almshouse residents who were required to work for their food and lodging during their residence.
