REPORT ON PHASE 1A
ARCHAEOLOGICAL DOCUMENTARY RESEARCH
AND PHASE 1B ARCHAEOLOGICAL TESTING
OF THE DYCKMAN FARMHOUSE MUSEUM PARK
LOCATED AT 204TH STREET AND BROADWAY,
(Blocks 2241, Lots 33, 34, 35 and 40),
MANHATTAN, NEW YORK

Submitted by: Linda Stone, MA, RPA
249 East 48th Street, #2B
New York, New York 10017

August 29, 2003

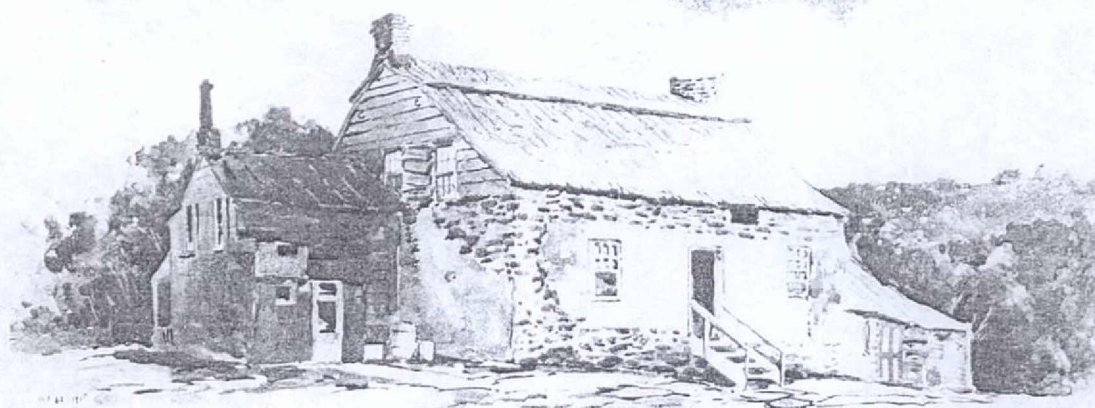
The derelict condition of the same house - the one which had sheltered many Dyckmans and comforted William when he came home after the Revolution. Perhaps the girls, seeing it as they came and went from "Mon D  ar," felt it deserved a better fate. The slave quarters were destroyed before restoration.

Plate 3 Watercolor by Grant Wright of a rear view of Dyckman Farmhouse facing east, circa 1915 (Romer 1981: 80).

Dassler et al. quote Dean and Welch as noting the rear porch was "destroyed about 1880" (1991: 46). This can also be seen on Plate 3. By the year 1892, Kingsbridge Road (Broadway) was lowered by about fifteen feet in front of Dyckman House. Plates 5 and 4 depict the condition of the house both before and after the road was lowered, respectively. On May 28, 1894, 204th Street was officially opened (Topo Bureau card file). It was originally called Hawthorne Street (Bolton 1914: 5). The new street configuration is shown on Figure 13. It depicts the farmhouse and shed still standing within the area of the current park. The map also shows two of the outbuildings would be destroyed by the construction of Hawthorne Street (now 204th Street). The corncrib seen on Figures 10 – 12 is no longer standing by 1893.
