ARCHEOLOGICAL SENSITIVITY STUDY

FARLEY / PENN STATION NEW YORK

AN ARCHEOLOGICAL SENSITIVITY STUDY OF THE PROPOSED PENN STATION REDEVELOPMENT PROJECT NEW YORK, NEW YORK

SEPTEMBER 1994

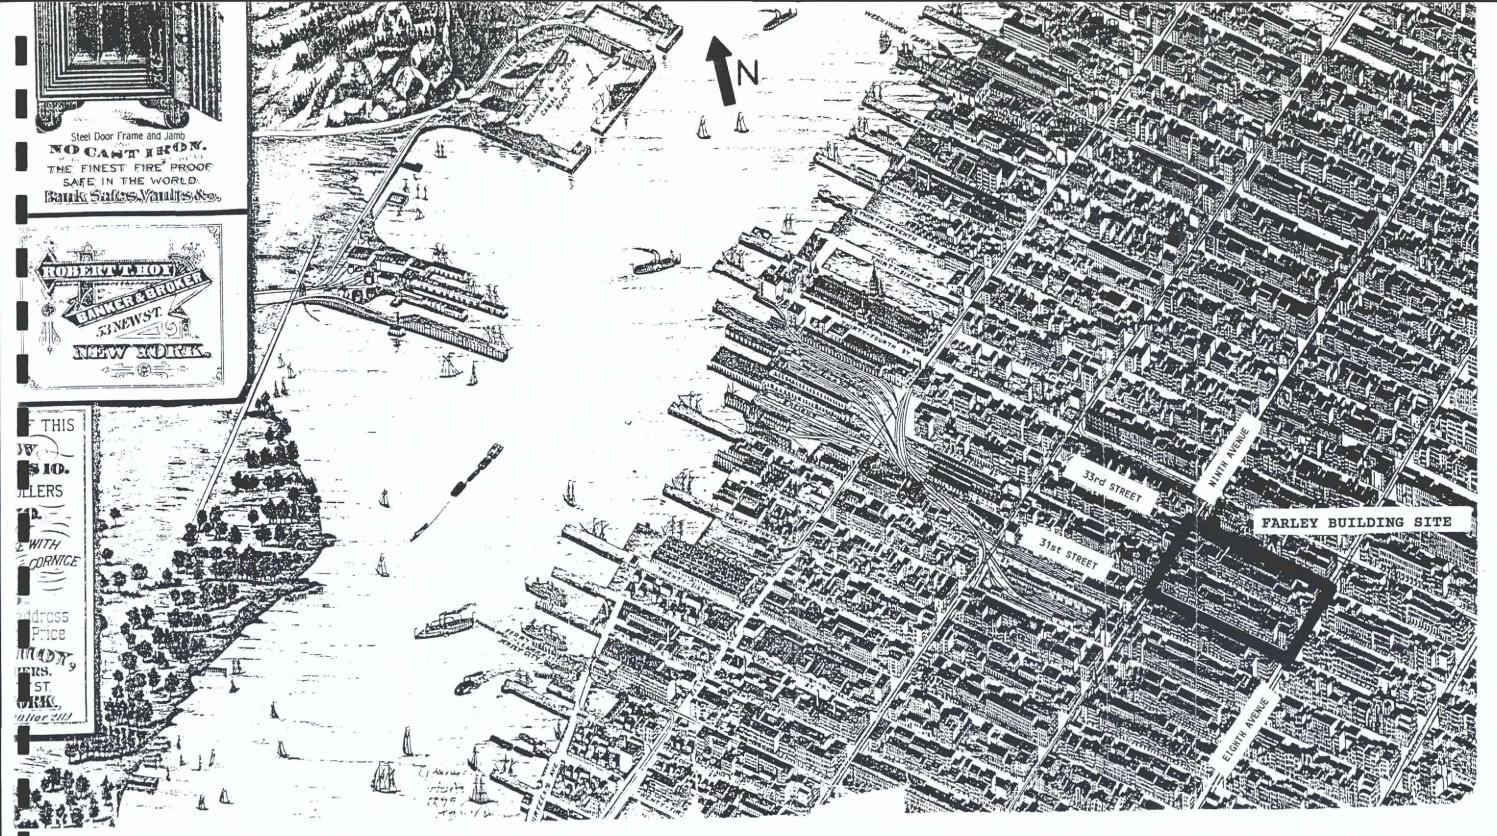
FIGURE 2. Portion of bird's-eye view showing the residential nature of the Farley Building site in 1879 (Galt & Hoy 1879; No Scale).

The Farley Building site remained residential throughout the remainder of the nineteenth century (see Figure 2). Between 1870 and 1885, many of the original dwellings may have been replaced or altered. In 1885, several brick buildings possessed stone facades, which were probably brownstone. These may represent entirely new structures or it is possible that stone facades were added to the existing buildings. Similar changes occurred to a few additional residences after 1885. The North Presbyterian Church was enlarged sometime between 1885 and 1890 and then again at the turn of the 20th century. This reflects the increasing population and growth of the neighborhood surrounding the Farley Building site (Dripps
