SUMMARY REPORT OF 1981-1983
ARCHAEOLOGICAL EXCAVATION,
THE SCHERMERHORN ROW BLOCK

Bureau of Historic Sites,
New York State Office of Parks, Recreation,
and Historic Preservation
and
New York City Public Development Corporation

Historic Sites Research
Princeton, New Jersey

July 1991

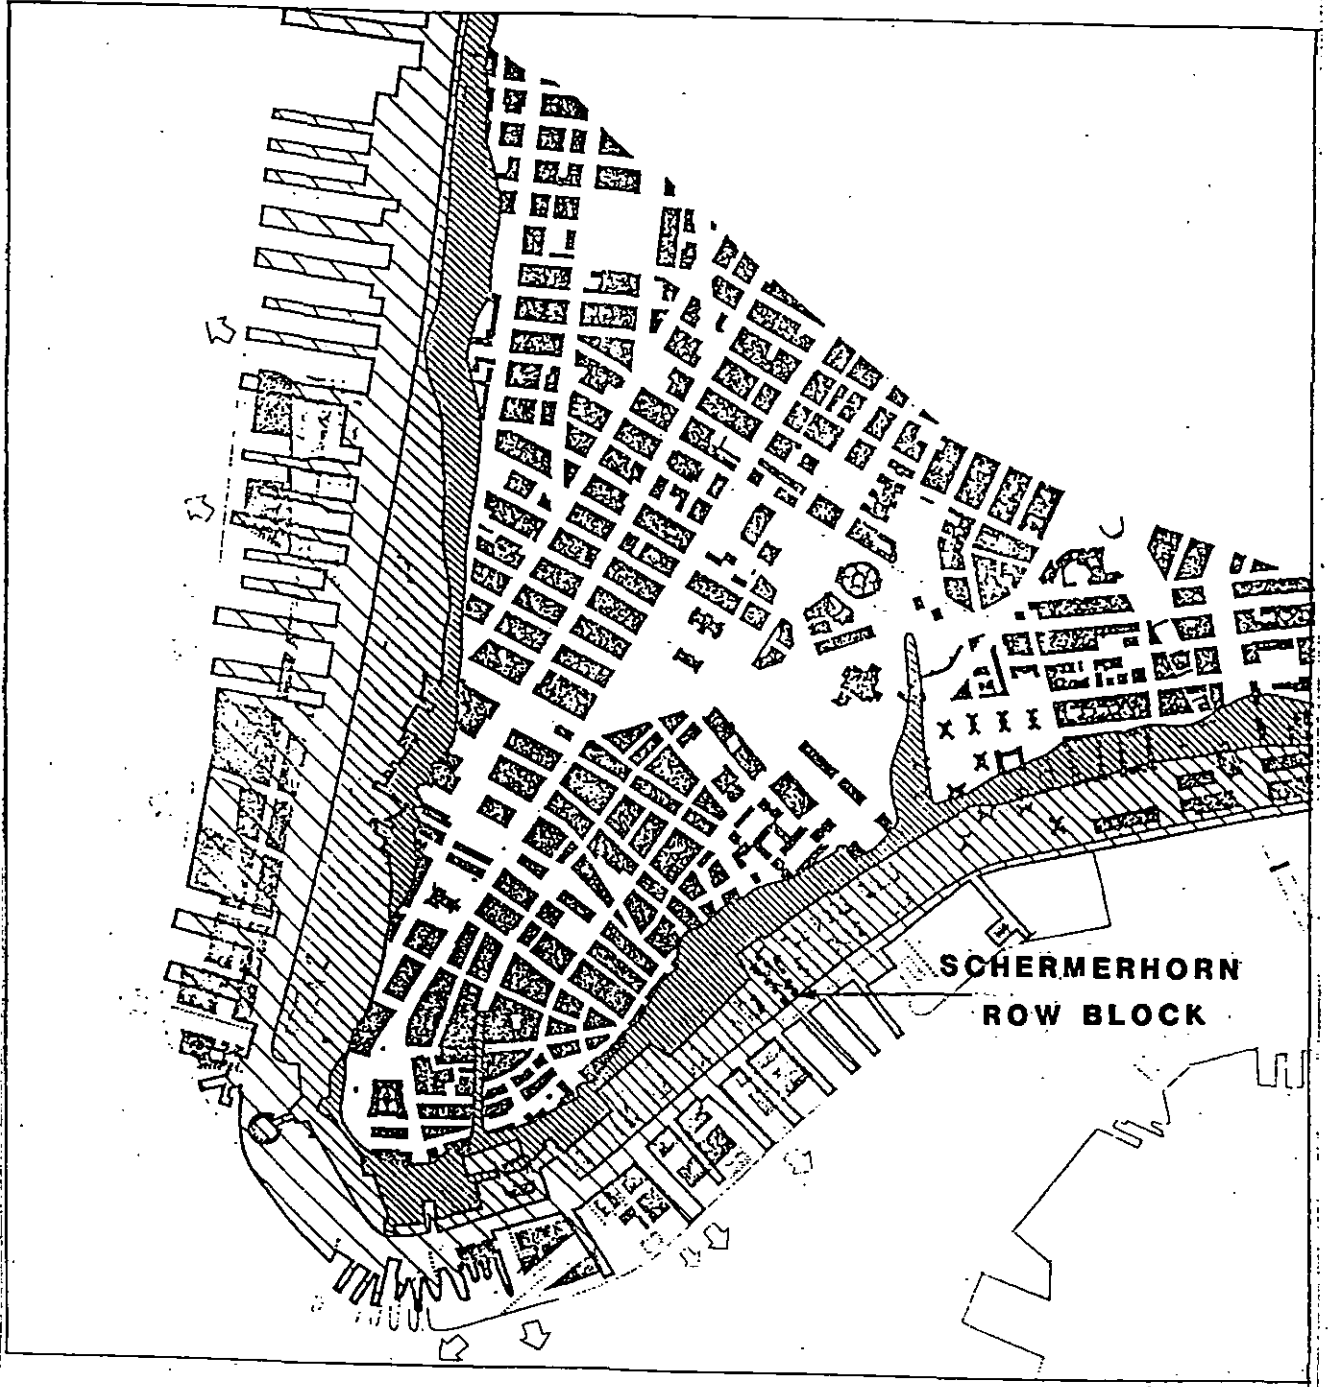
LANDFILL

Diagram showing progressive land fill of the Manhattan waterfront. (Baiter 1975: 4)

A 20th century summation is shown in very schematic and simplified form by Baiter (1975: x, 4), which indicates further expansion between the mid-19th and late 20th centuries (see Figure 3). Clearly, this process has been an integral part of the character of New York for more than three centuries, and the landfill archaeologically sampled at Schermerhorn Row in the summer of 1977 is not only part of the fabric of this city but is symbolic of the expansion of "real estate" and of urban "improvement" upon natural topography which lies at the heart of Euro-American culture.

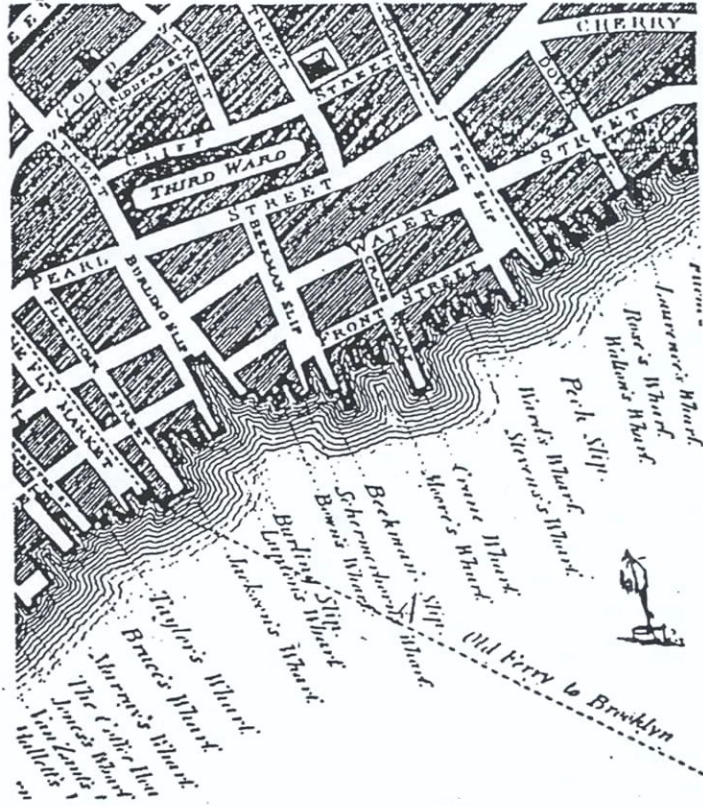
FIGURE 6.

The Taylor-Roberts Plan of New York (detail), 1797.
 (The New York Public Library.)

(From Rosebrock 1975: 9).
 The Site Block is on the waterfront,
 between "Burling Slip" and "Beekman's
 Slip." At the time of this map, only
 the western end of the Site Block was
 filled. Piers or wharves extended
 east into the East River.

This last process can be illustrated by some historical and reconstructed maps. New Amsterdam in the mid-17th century occupied only the tip of Manhattan below Wall Street, and land expansion was limited to a few wharves and a sea-wall on the East River along the line that is now lower Pearl Street (see MacCoun 1909 and Kouwenhoven 1953: 41). By the time the detailed Ratzer map was made in 1767 (Figure 5), extensions of the city had spread north as far as the "Collect Pond" marked "Fresh Water" on the map), and the East River waterfront had been expanded from the irregular original shoreline to the shoreline (marked on the 1767 map by Dock Street, Hanover and Queen (Pearl) Street to Water Street, and in several places beyond that to "Burnets Key" (later Front Street). Two decades later the city grid pattern had expanded north past the "Fresh Water Pond" and along the East River (see 1789 map). Front Street existed as far north as Burling Slip, with piers and fill extending beyond it. The 1797 map (Rosebrock 1975: 9) shows Front Street existing intermittently north of Burling Slip (Figure 6).

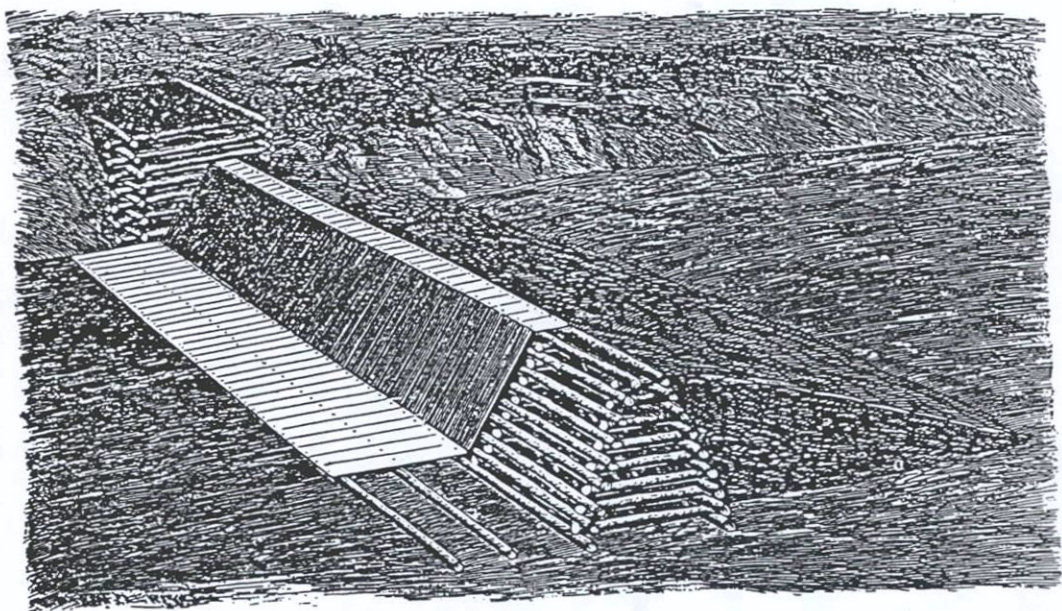
FIGURE 8. A CRIB DAM WITH PLANK COVERING
(LEFFEL 1881; 22)

CRIB DAM WITH PLANK COVERING.

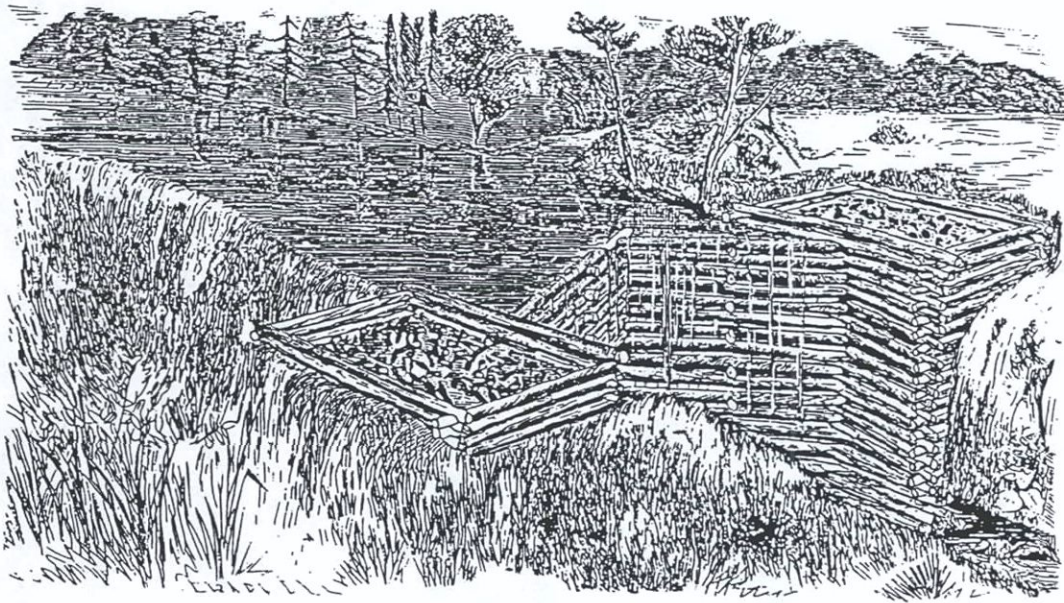
A CRIB DAM.

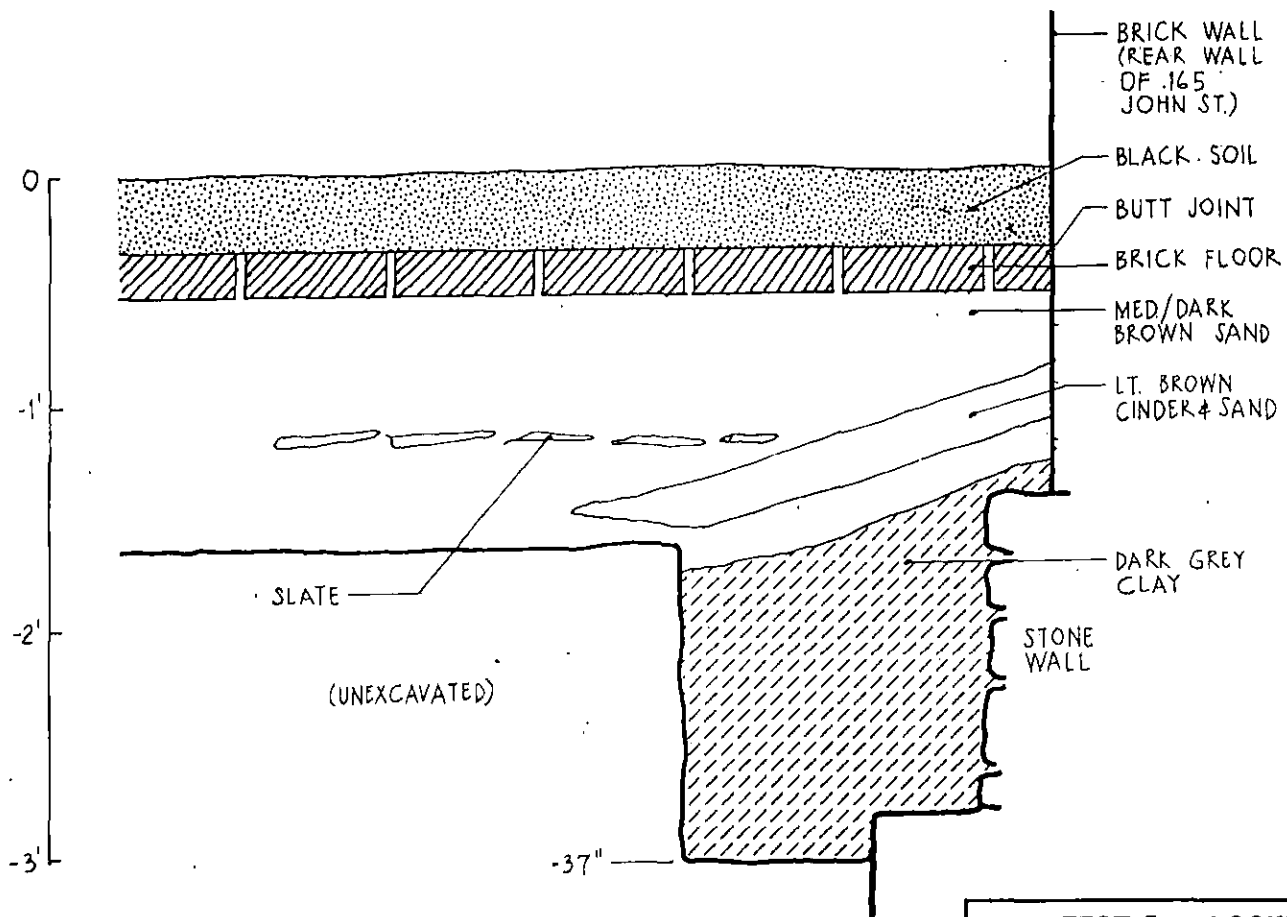
TEST 5 - LOOKING EAST	
165 JOHN ST.	
SCHERMERHORN ROW ARCHAEOLOGY	
SOUTH STREET SEAPORT DISTRICT NEW YORK, NEW YORK	
HISTORIC SITES RESEARCH	JUNE 1991 JP

The dark grey sandy clay found here, starting between 1 and 2 feet below the dirt surface, is interpreted as landfill equivalent to the "black muck" found at a similar depth in Test 3 dug in 1977 in the cellar of the original building. Test 5, dug in 1981, was located about 25 feet northwest of the 1977 test.

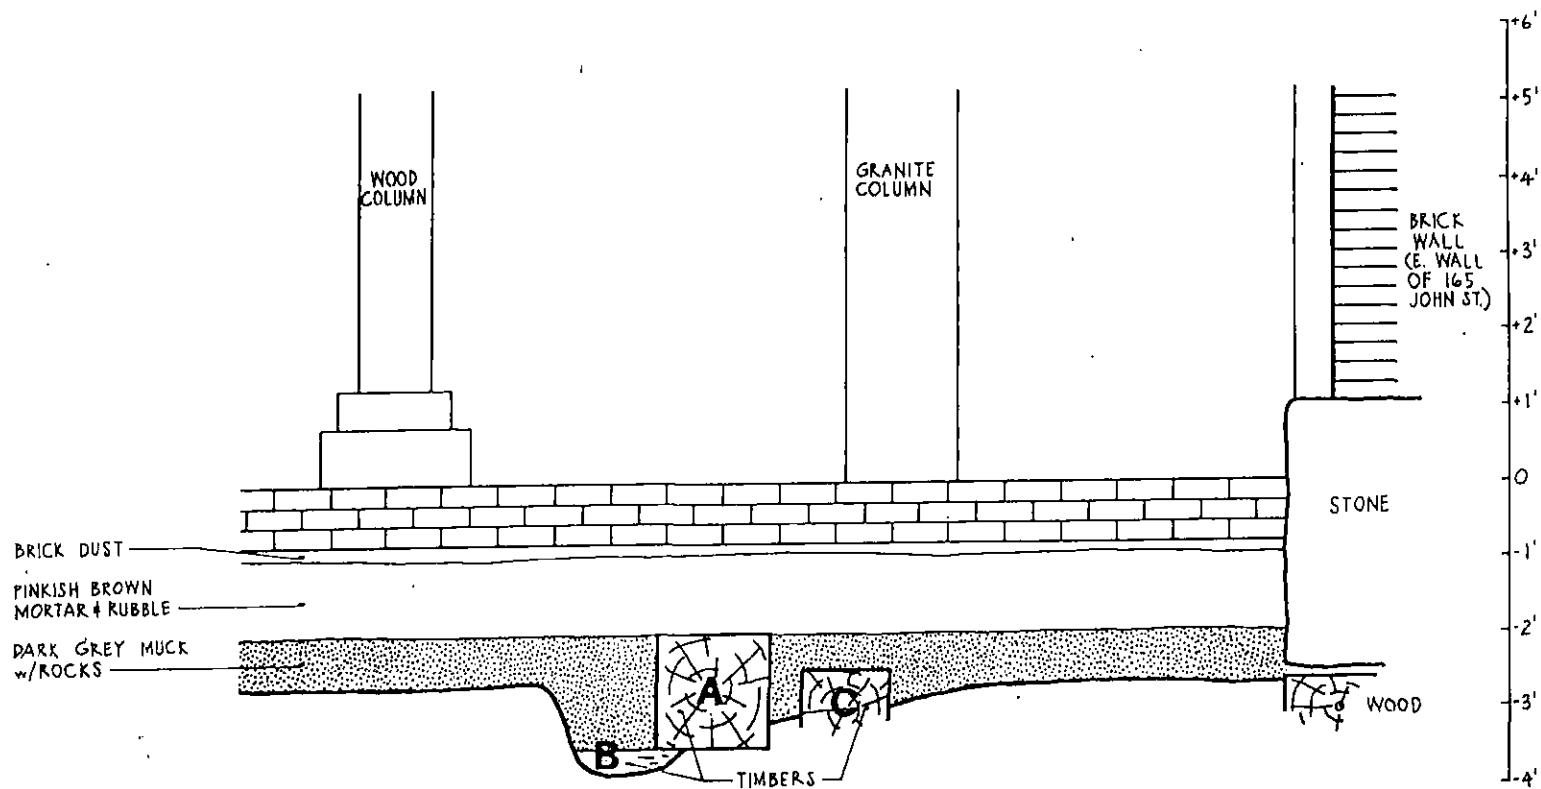
TEST 28 - LOOKING WEST

It was suggested by J. Pokorny that the timbers were wall support for the rear wall of the Codwise building that existed from about 1811 to 1849 at this address. Their position supports that, because it would make a building about 52 feet long, with a 10 foot wide rear courtyard, which is an arrangement similar to those of structures preserved from the first period of construction (ca. 1810-1811). When the new, taller, flat-roofed buildings were erected at 167 and 171 John Street in 1849-1850, the entire lot was utilized to the rear line, with light shafts placed at back corners. The absence of a rear courtyard in this later construction may reflect economic pressure to utilize valuable real estate or a response to technological change, such as the elimination of rear yard privies.

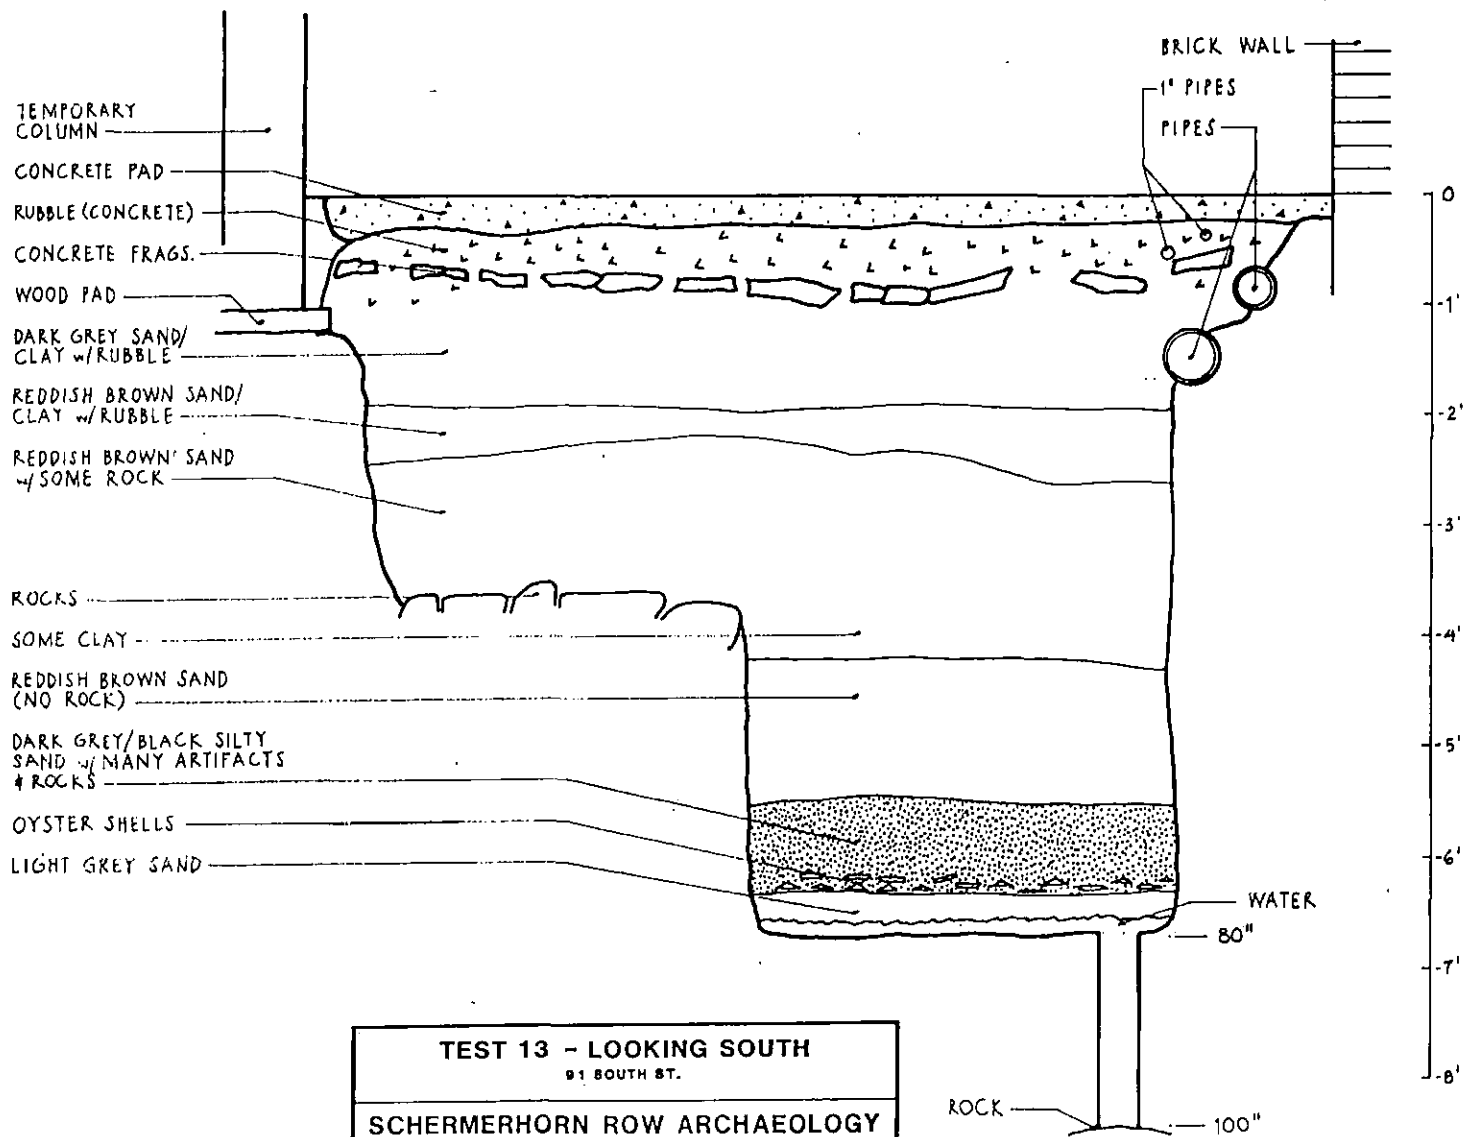
TEST 13 - LOOKING SOUTH

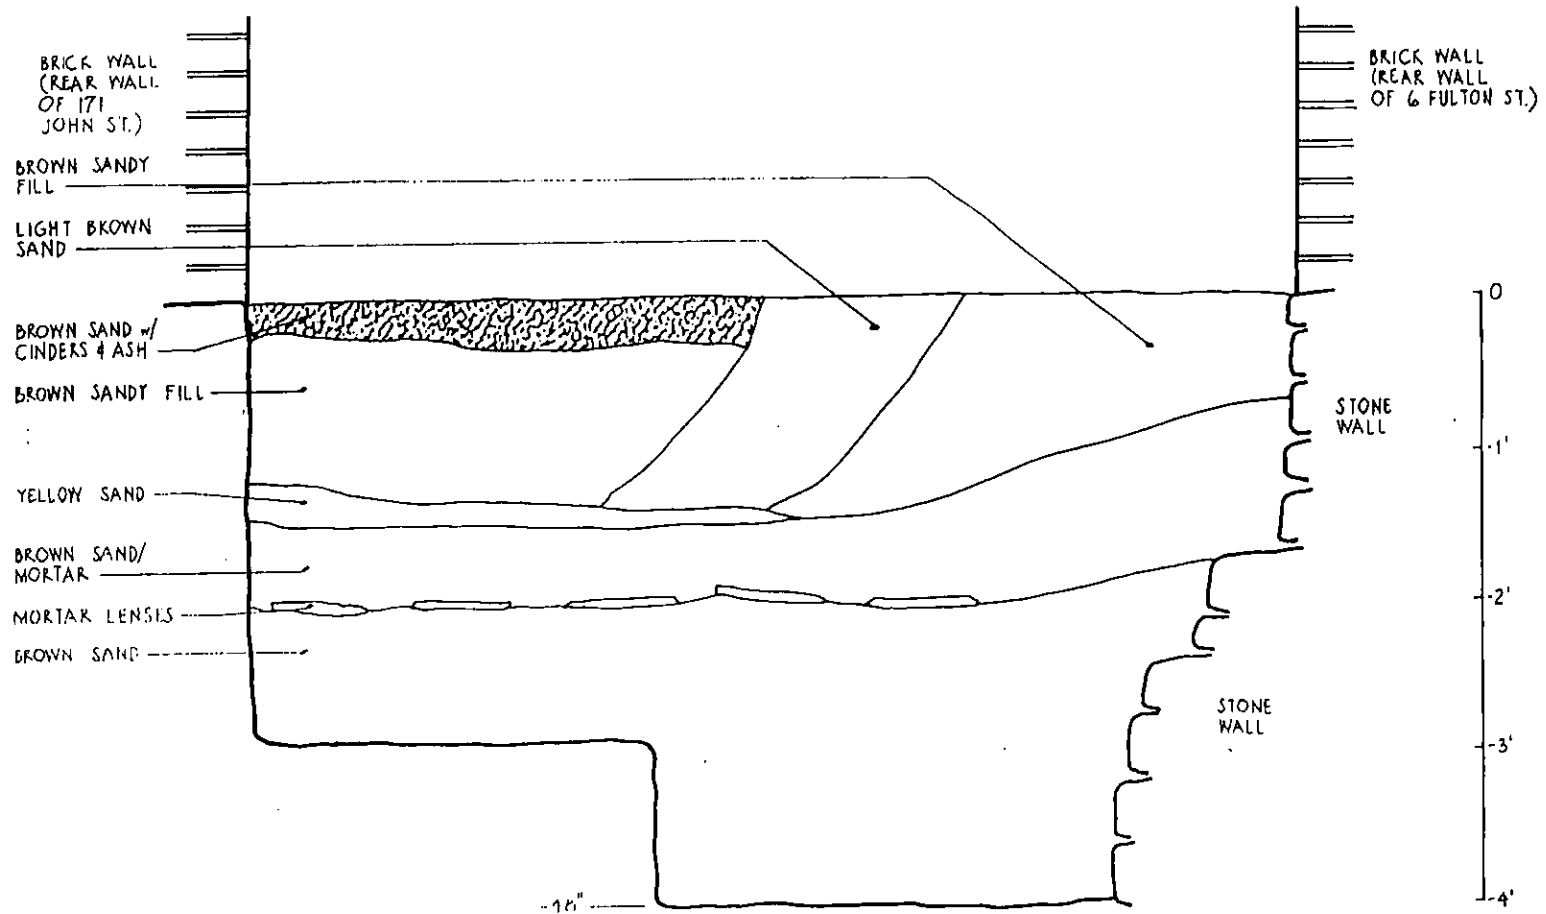
TEST 38 - LOOKING WEST 6 FULTON ST.	
SCHERMERHORN ROW ARCHAEOLOGY	
SOUTH STREET SEAPORT DISTRICT NEW YORK, NEW YORK	
HISTORIC SITES RESEARCH	JUNE 1991 JP

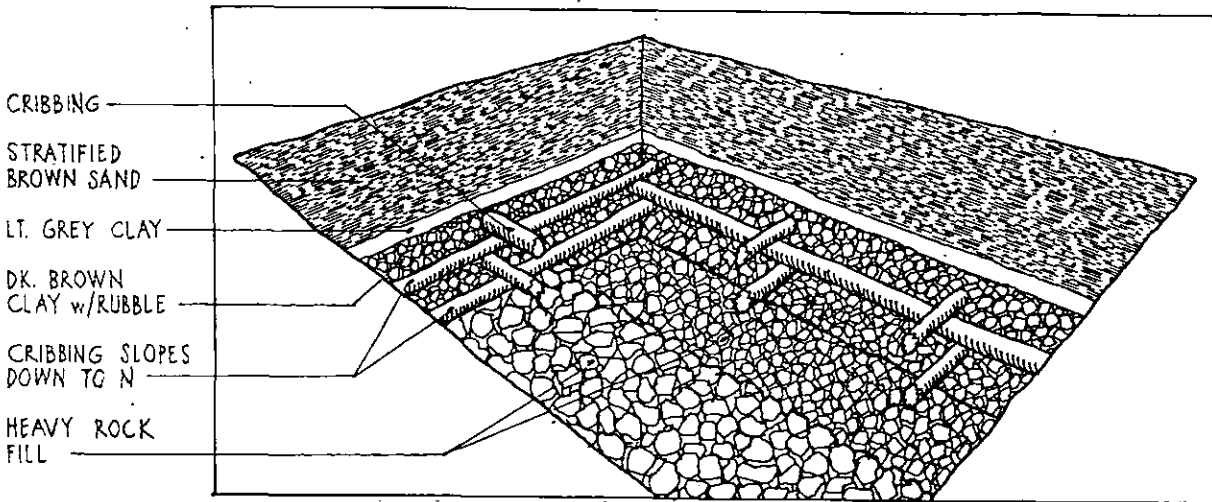
**CRIBBING AS EXPOSED AT SOUTHEAST CORNER OF BLOCK
(PLUMBERS' TRENCH J)**

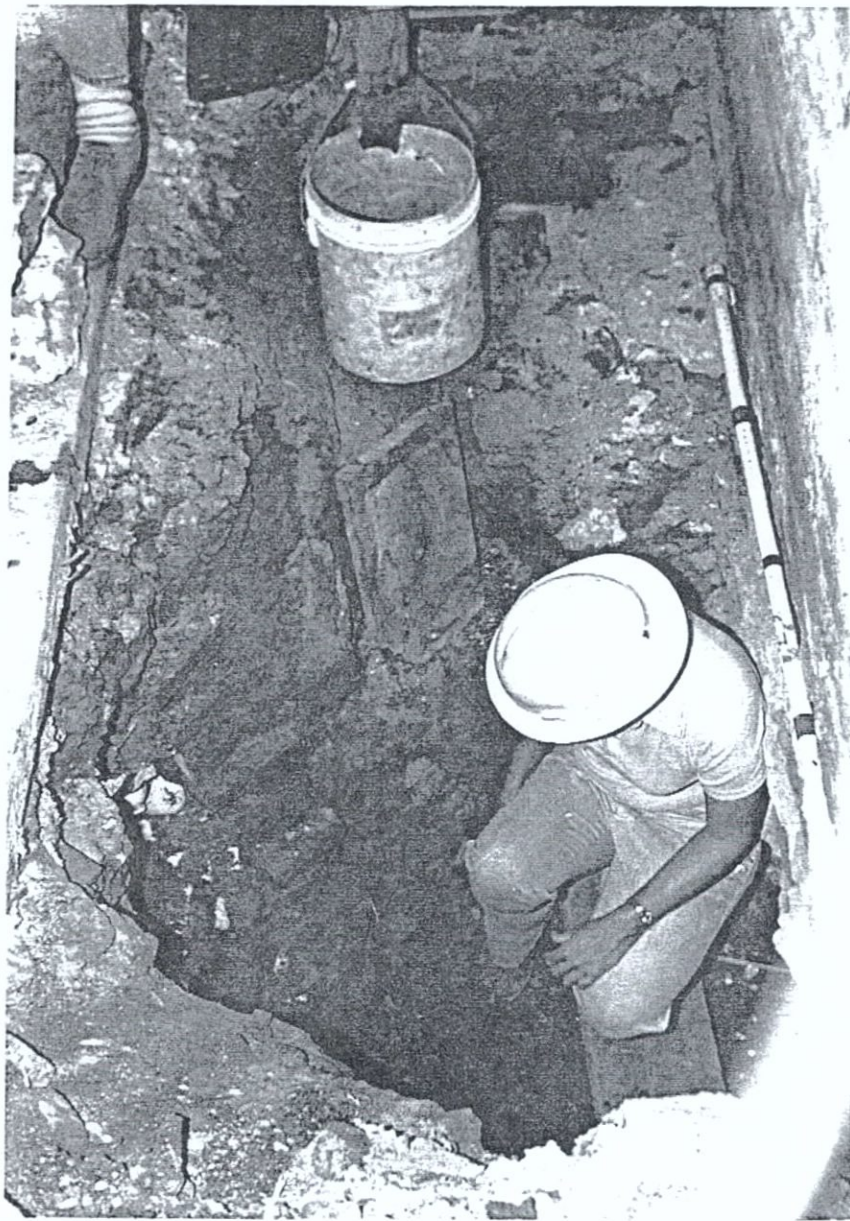
PLATE 3. This plate illustrates the brick cistern encountered during excavation of Test 26. Inside, the archaeologist is using a trowel to scrape clean the inner surface of this feature and remove its contents, while a crew member removes soil for screening. Visible at left in the side wall of the cistern are partial and whole ironstone vessels, which were recovered in large number from this cistern (18 Aug. 1982, Roll 246, exp. 34).

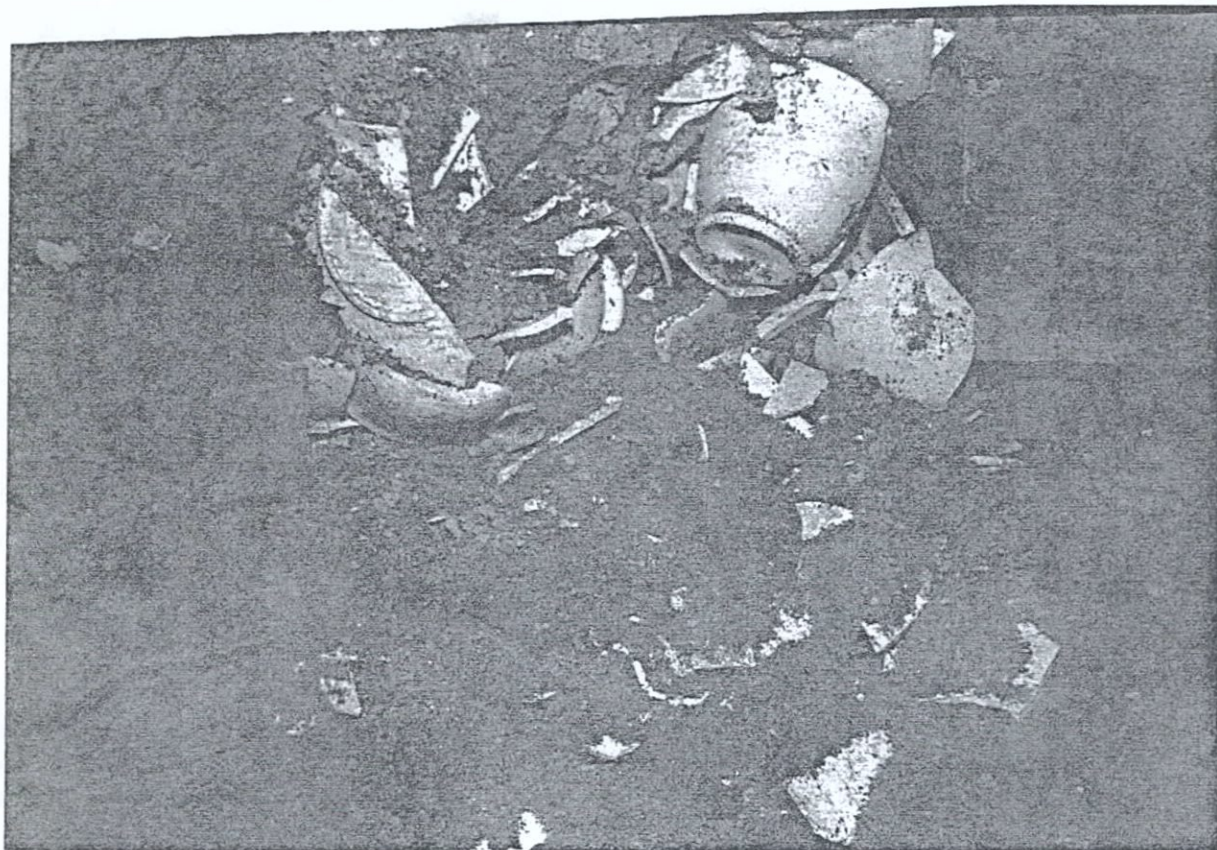
PLATE 4. This is a detailed view of some of the deposit of ceramics found in the cistern in Test 26, in the courtyard between 8 Fulton and 171 John Street. Mostly of ironstone, these sherds were recovered from an ashy fill matrix. At right and left, the red brick courses of the walls of the cistern are visible (18 Aug. 1982, Roll 246, exp. 32).

Test 26 exposed a brick feature uncovered by the plumbers' trench in the courtyard area behind 8 Fulton Street. The profile showed the east part to be circular, with a bee-hive or cone shaped closure at the top. An arm was created by a western appendage. In the field notes this was called a "privy," however it was most likely some kind of cistern. As constructed it was closed at the top and plastered with a sandy mortar on the exterior (see Plan, Profile, and Plates 1 through 5). The deposits inside it were filled with ironstone and whiteware dishes after abandonment.

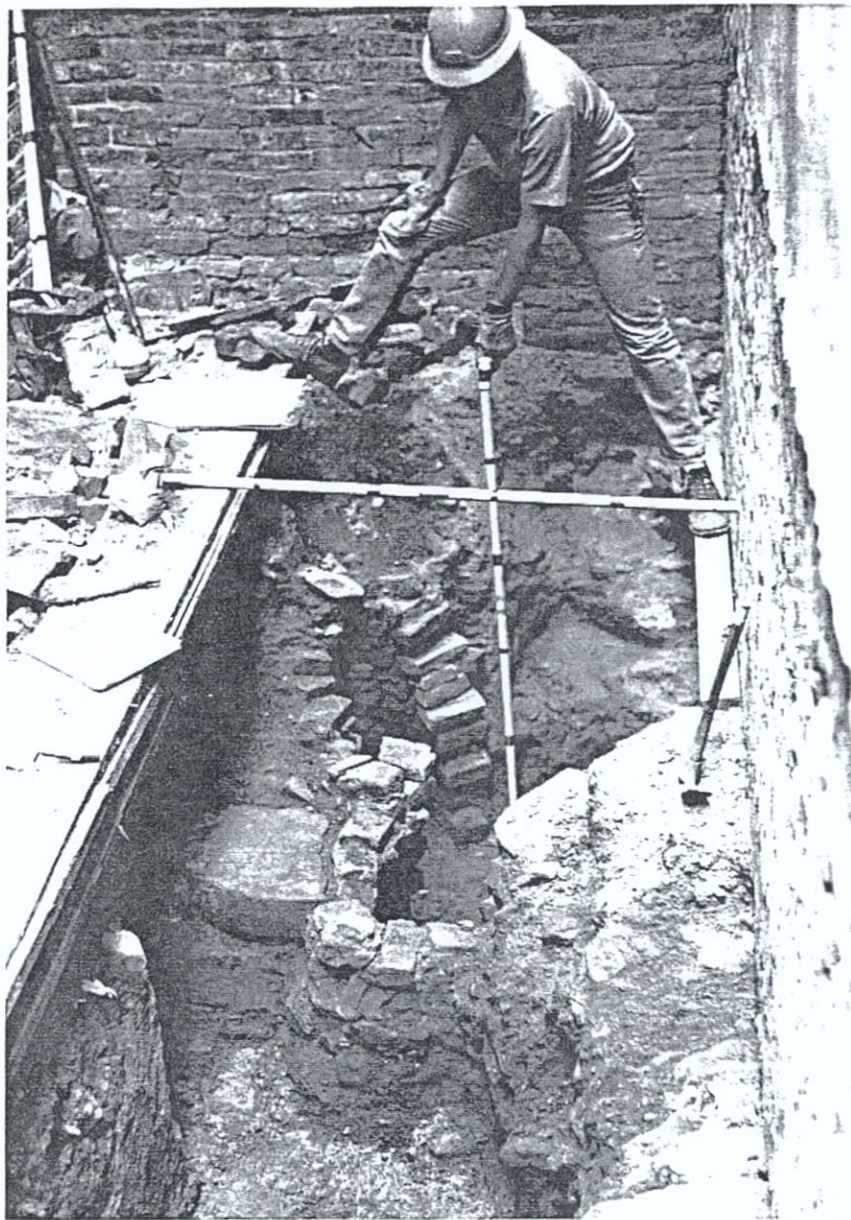
PLATE 5. This photograph shows (from near to far) Tests 27, 32, and 26 in the courtyard behind 8 Fulton Street at the completion of excavation. At back is the extension of the wall separating 8 and 6 Fulton Street, while at right are the back walls of 167 and 171 John Street. Features exposed and visible here include the brick walls of two (?) cisterns, and, to their left, a portion of a millstone used as a cistern cap. The crew member is using scaling rods marked at one foot intervals to measure the breadth and depth of the excavation units (View toward east, 8 Sept. 1982, Roll 251, exp. 40a).

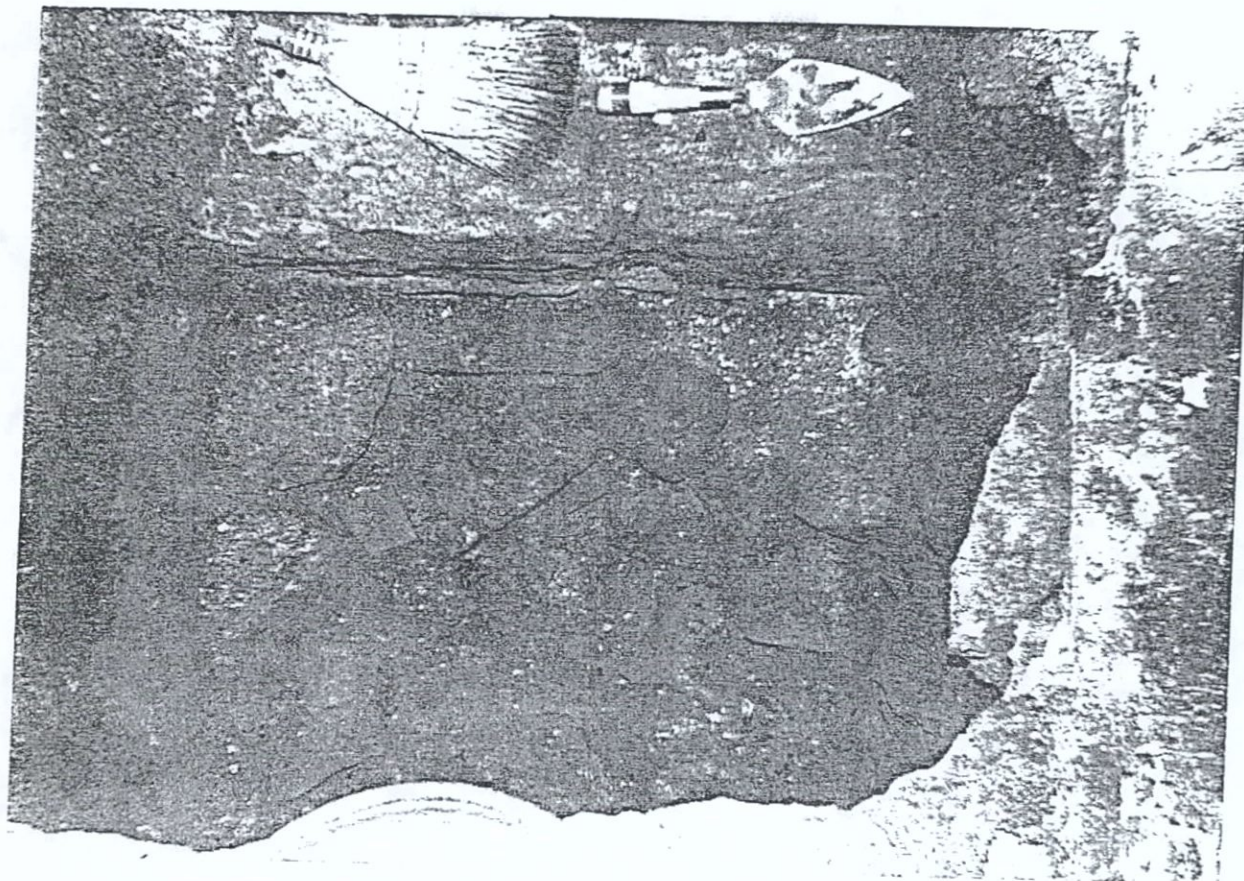
PLATE 7. This view looks west into Test 7, which was located inside 12 Fulton Street, against its western wall with 14 Fulton Street. The base of this wall is clearly visible at top, while below a stratum containing much stone and rubble can be seen. A whisk broom and trowel are included for scale (22 Oct. 1981, Roll 202, exp. 3a).

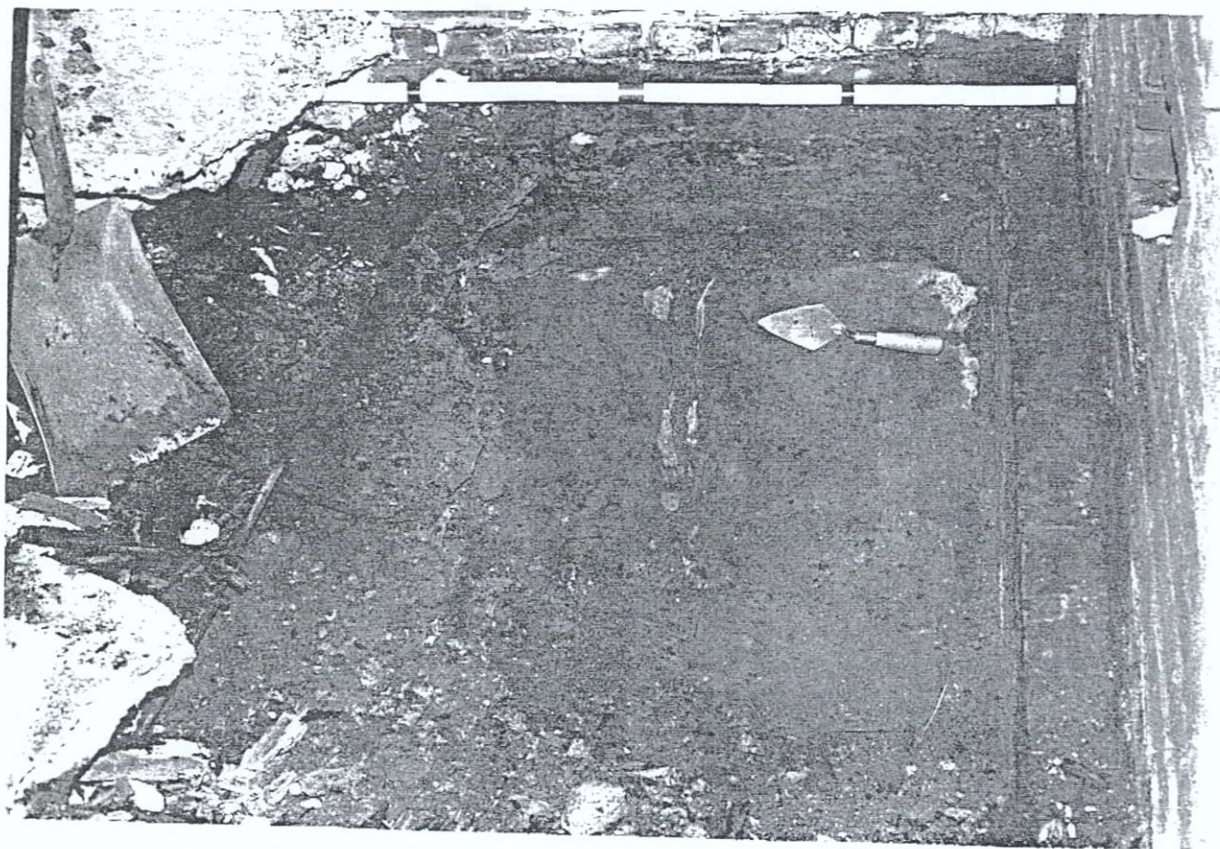
PLATE 8. This plate looks east into Test 1, excavated in the rear portion of 191 Front Street. In the brick wall at right, a rectangular aperture is visible. This was formerly used for chimney clean-out. Excavation has paused at this level on top of a stone slab, on which the trowel is resting, one of many such slabs encountered in Tests 1-4 (1 Oct. 1981, Roll 200, exp. 18a).

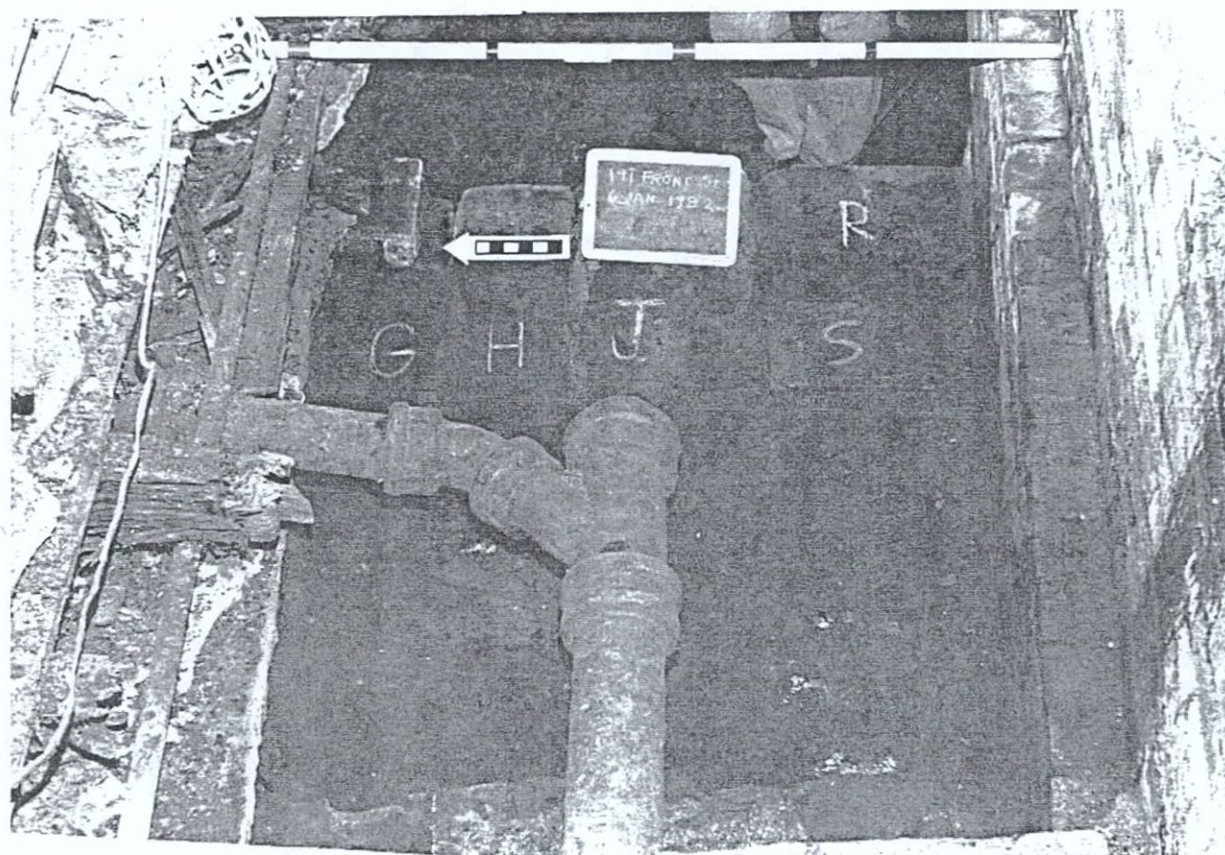
PLATE 9. This plate was taken from Test 4, looking east towards Test 3, in the rear area of 191 Front Street. Two stone walls are visible, both running horizontally, one at the bottom of the photograph and the other in its middle. The top stones of the latter have had letters written on with chalk for reference. A modern sewage pipe runs east before turning north (View toward east, 6 Jan. 1982, Roll 214, exp. 31).

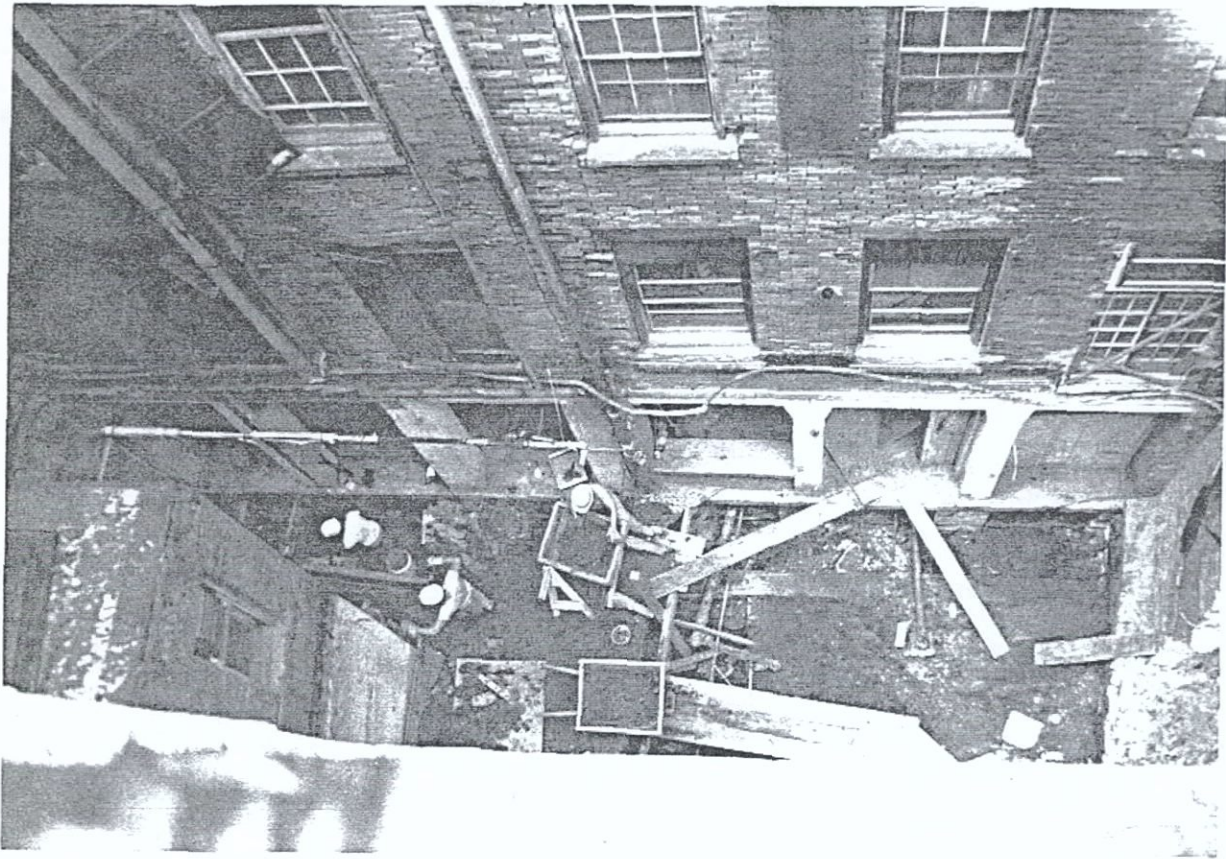
PLATE 10. Taken from an upper floor window of 165 John Street, this photograph looks down upon testing in the courtyard behind 189 (at left) and 191 Front (at right). Excavation of Tests 19 East and 19 West proceeds at left. By this time, the lowering of the courtyard had taken place, and access from the street floor level of the Front Street addresses was thus by means of board ramps (View looks west, 24 June 1982, Roll 236, exp. 14).

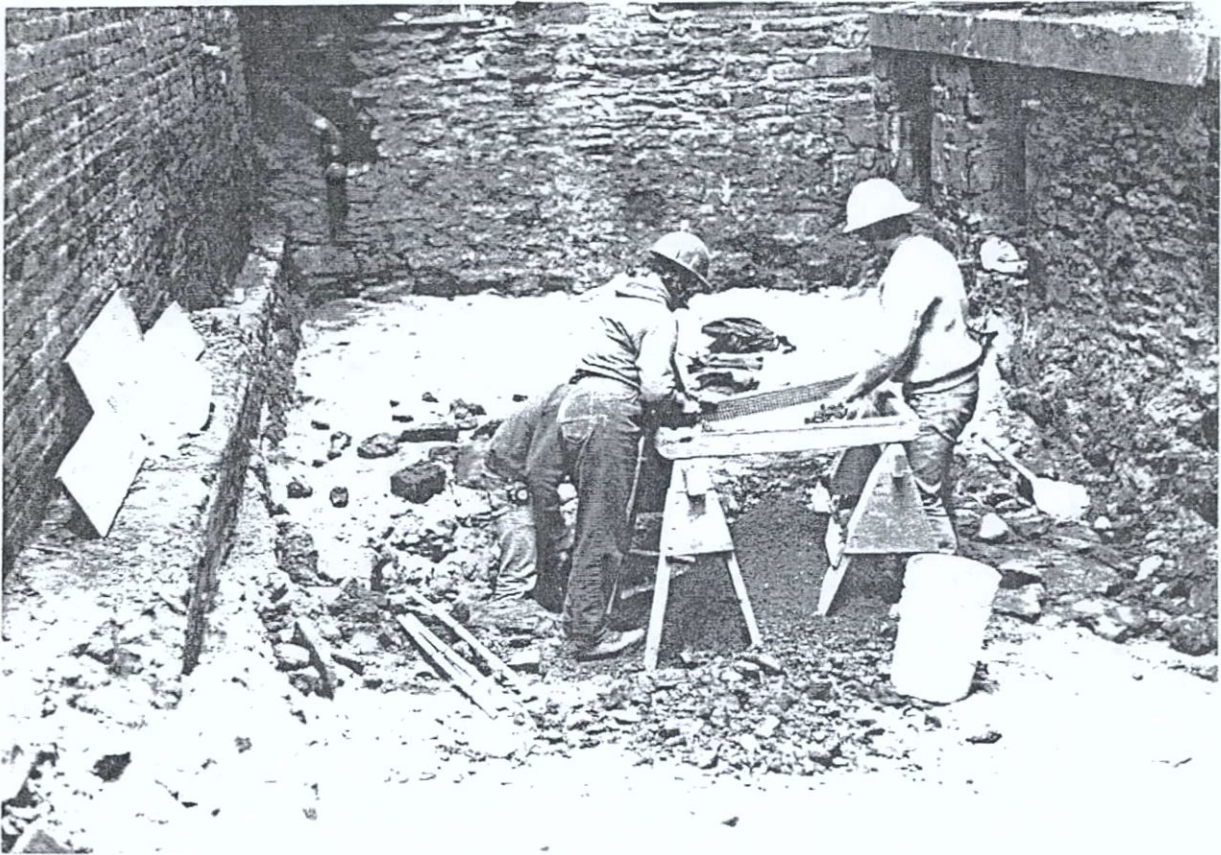
PLATE 11. This plate shows another view south into the 189 Front Street courtyard. This entire area had been excavated approximately 8 feet by construction crews, and at right exposed cellar windows and, at top, the wide stone sill marking the building floor level of 189 Front Street can thus be seen. Historic Sites Research crew is screening soil from Test 42, while one assistant works inside the test (10 Nov. 1982, Roll 268, exp. 24).

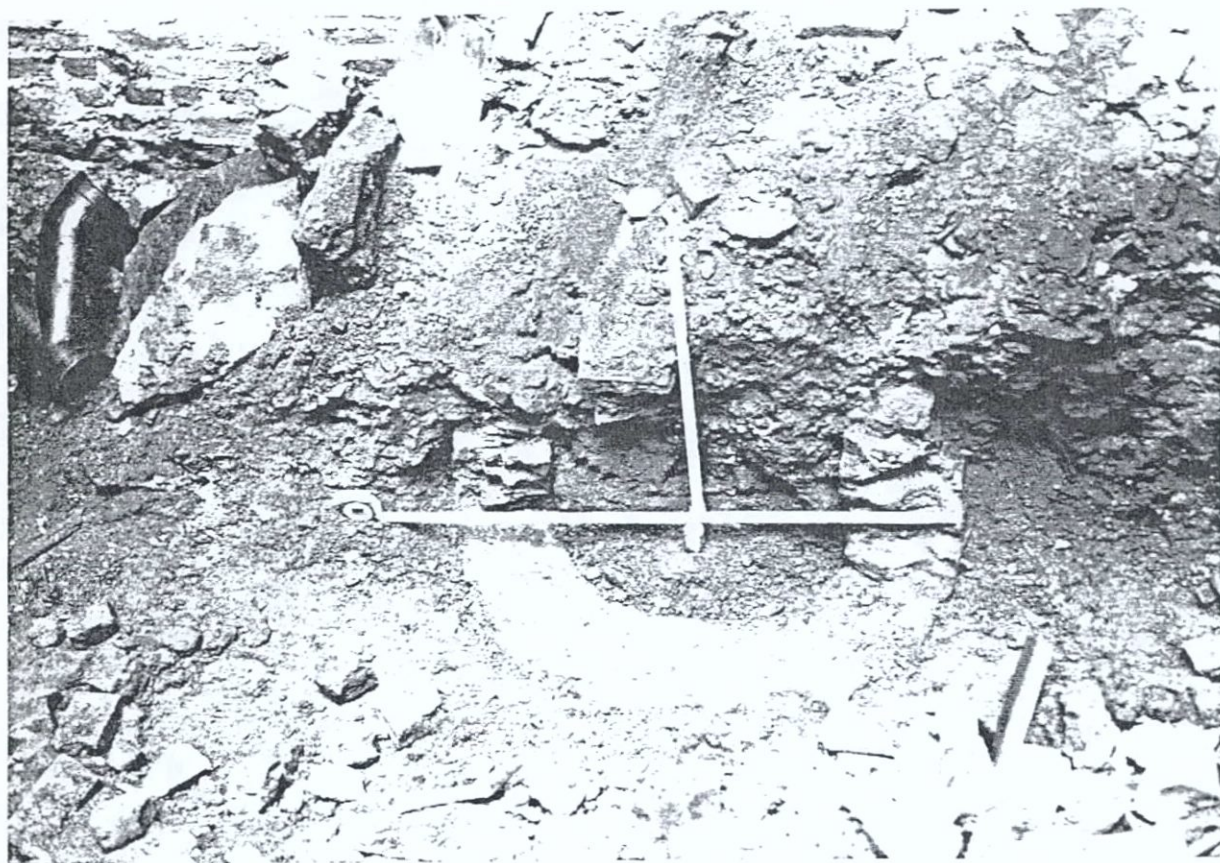
PLATE 13. A circular brick cistern was exposed in Test 39, in the central courtyard. Behind the rubble pile, the back wall of nearby 12 Fulton Street is visible in the upper left (View looks north, 13 Oct. 1982, Roll 257, exp. 7).

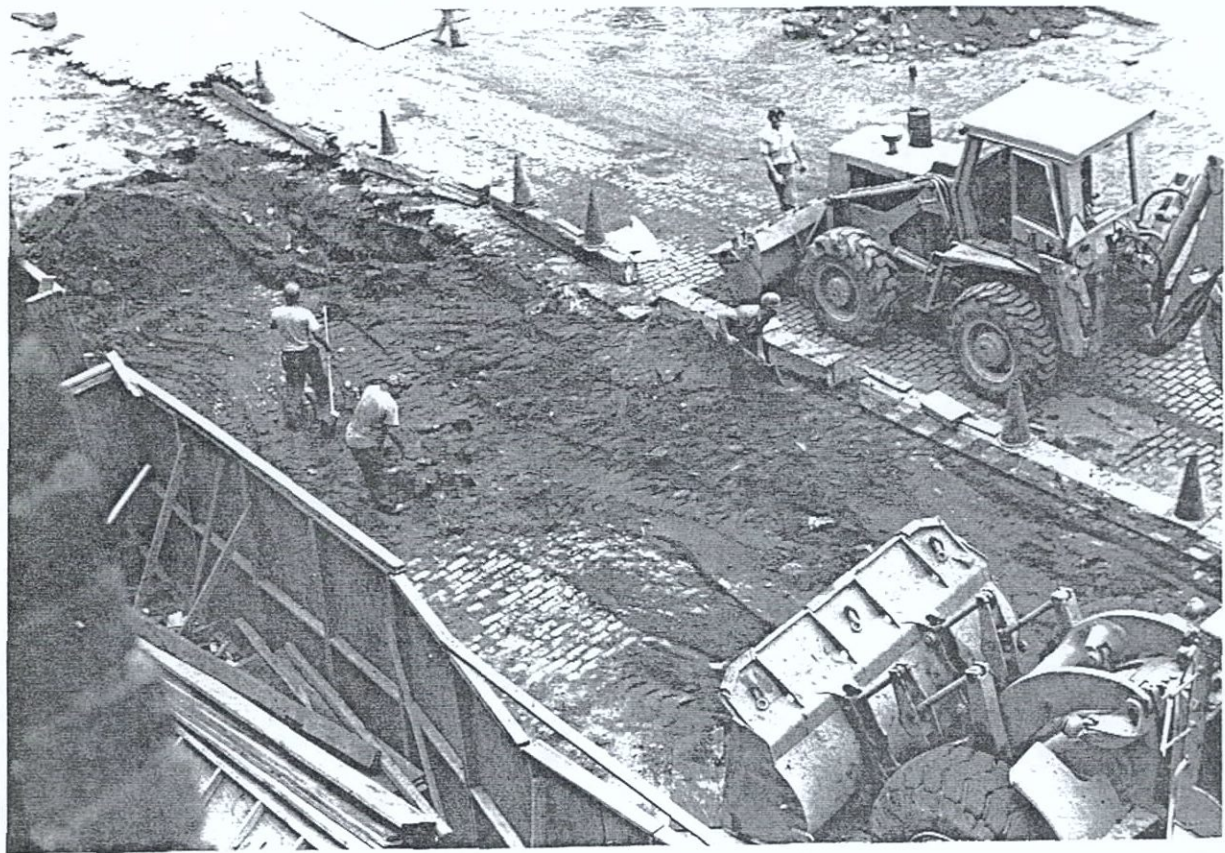
PLATE 14. Taken from one of the buildings along Fulton Street, this photograph shows excavation and backdirt removal within the road itself. The wooden fence visible here restricted access to the project block (View looks northwest, 1 Sept. 1982, Roll 249, exp. 9).
