SUMMARY REPORT OF 1981-1983
ARCHAEOLOGICAL EXCAVATION,
THE SCHERMERHORN ROW BLOCK

Bureau of Historic Sites,
New York State Office of Parks, Recreation,
and Historic Preservation
and
New York City Public Development Corporation

Historic Sites Research
Princeton, New Jersey

July 1991

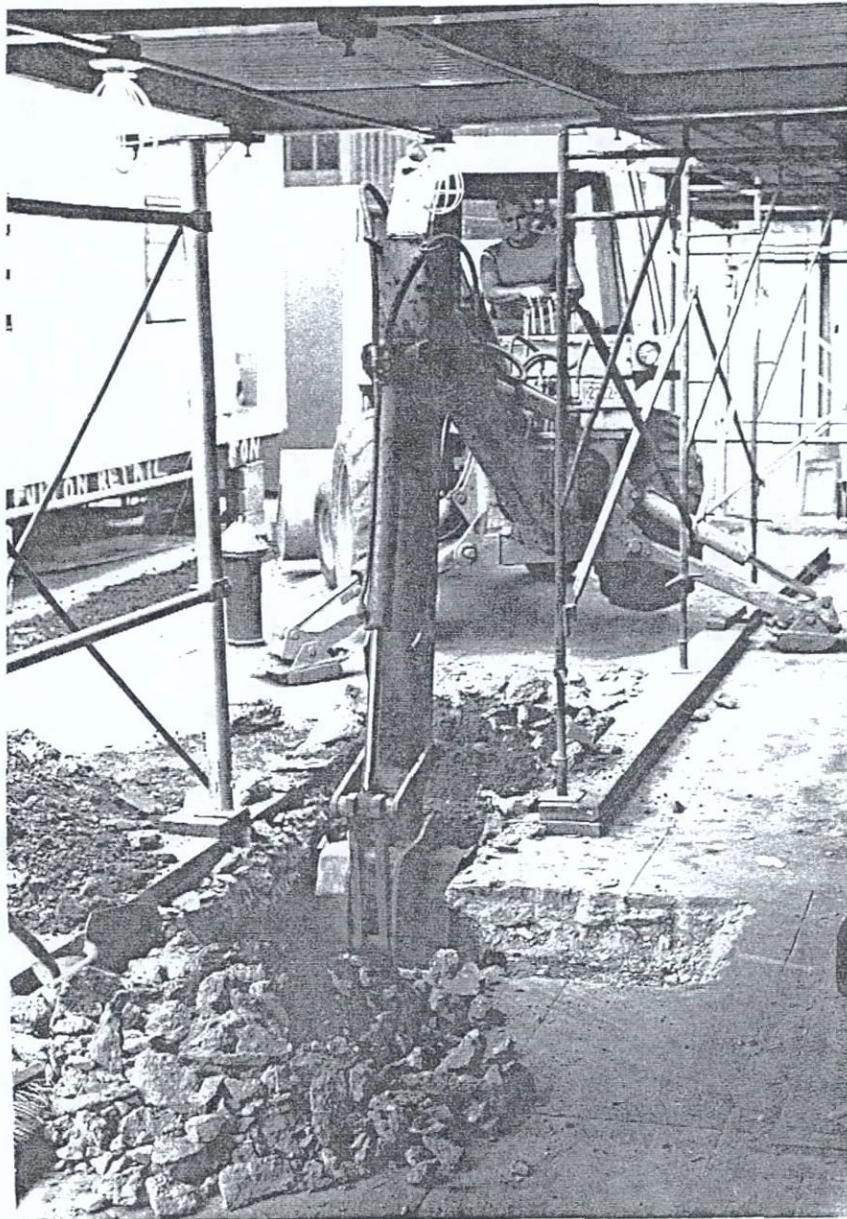
PLATE 15. Backhoes were used for the excavation of the "plumbers' trenches." Here, looking southwest from within the block towards the outside, the creation of relatively short, L-shaped Trench K at the corner of John and Front Streets can be seen in progress (8 Sept. 1982, Roll 251, exp. 33a).

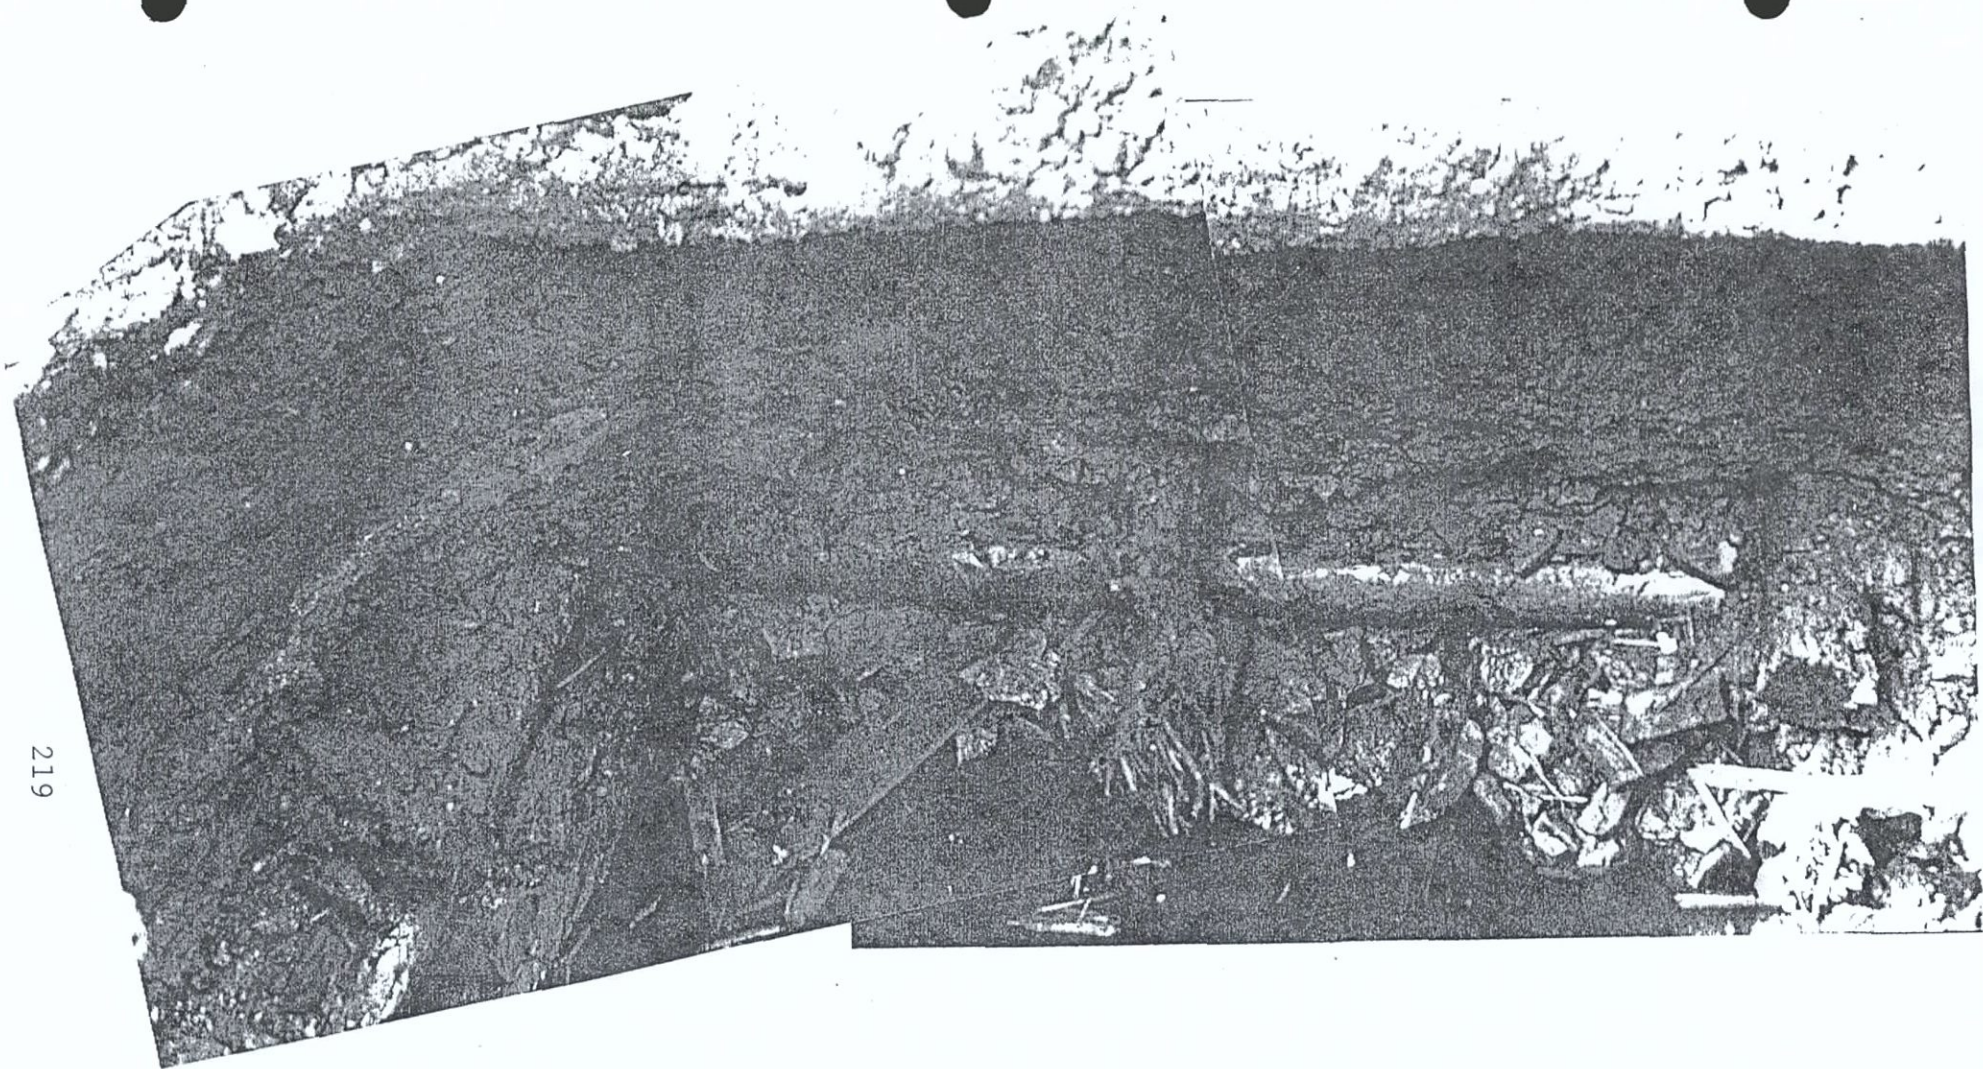
PLATE 16. At the corner of John and South Streets, Trench J exposed some of the wooden cribbing used in the late 18th century landmaking process that created the land upon which the Schermerhorn Row block stands. The interlocked design of this wooden feature is visible in the center of this two-photograph composite (views toward east and northeast, 20 Aug. 1982, Roll 247, exp. 22 and 23).

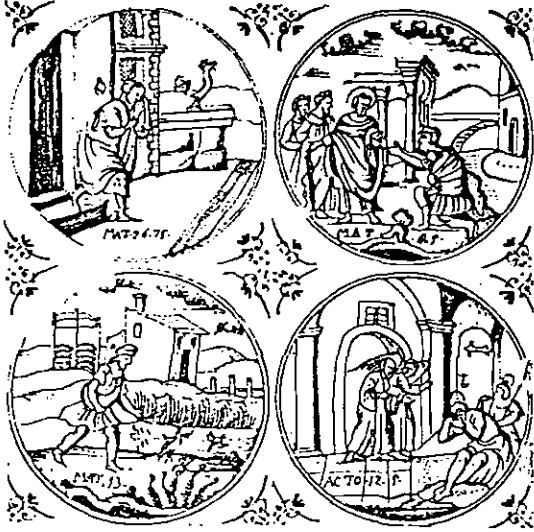
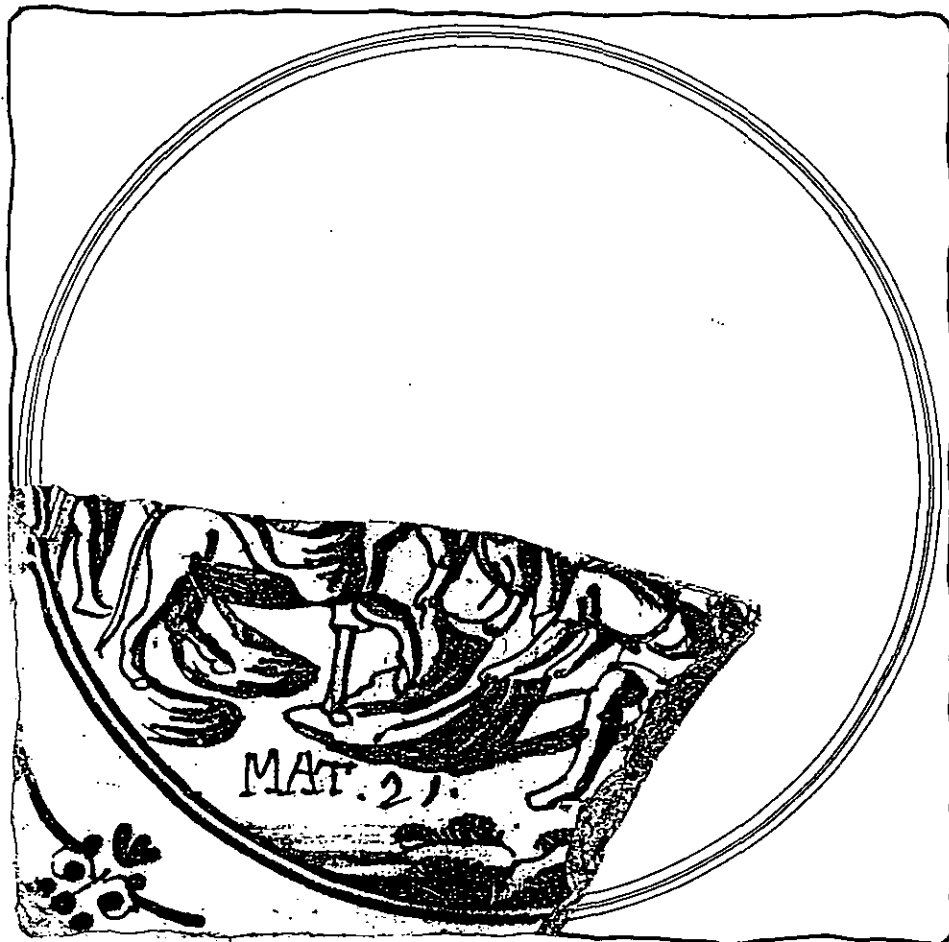
FIGURE 52.

Dutch tile fragment from Lot 65. Blue and white delft. Similar New Testament scenes illustrated in upper left are from Schaap et al. 1984: 78.
