BOARD OF EDUCATION: ROOSEVELT ISLAND SCHOOL SITE PS/IS 217

CEQR No. 88-102M (Revised)

ARCHAEOLOGICAL
ASSESSMENT
REPORT 7/1989

BOARD OF EDUCATION: ROOSEVELT ISLAND
SCHOOL SITE PS/IS 217 (CEQR 88-102M)
ARCHAEOLOGICAL ASSESSMENT REPORT

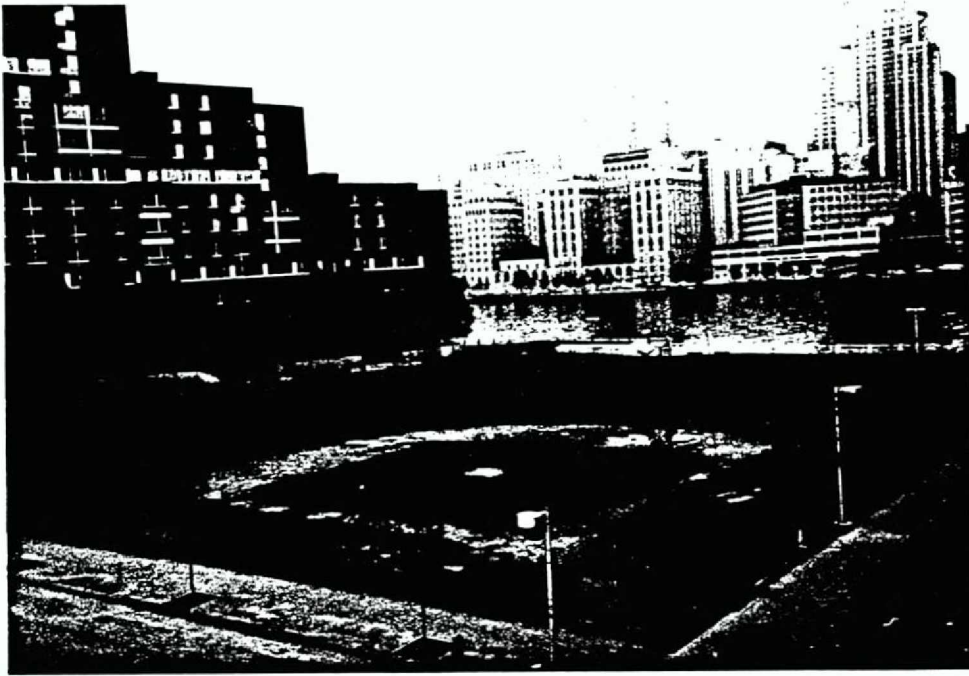
Photo 1: Looking southwest from circular ramp.

In response to the City of New York's City Environmental Quality Review request for a formal documentary study of the proposed Roosevelt Island School Site PS/IS 217, CEQR 88-102M (revised), the archaeological firm of Historical Perspectives, Inc. submits the following report on the potential for archaeological resources to exist on the site. The parcel in question, hereinafter called the Site, is part of Lot 1, Block 1373, Roosevelt Island. (Figure 1) The Site consists of 66,000 square feet and is bounded on the east by Main Street and on the west by the East River promenade. (Figure 2) The parcel is currently a grassy sward which slopes gently down to the East River and contains a baseball diamond in the northeast portion. (Photos 1-4)

No subsurface investigations were conducted. During a site visit (July 1989) a photographic record of current conditions was made (See Photographs 1-4).

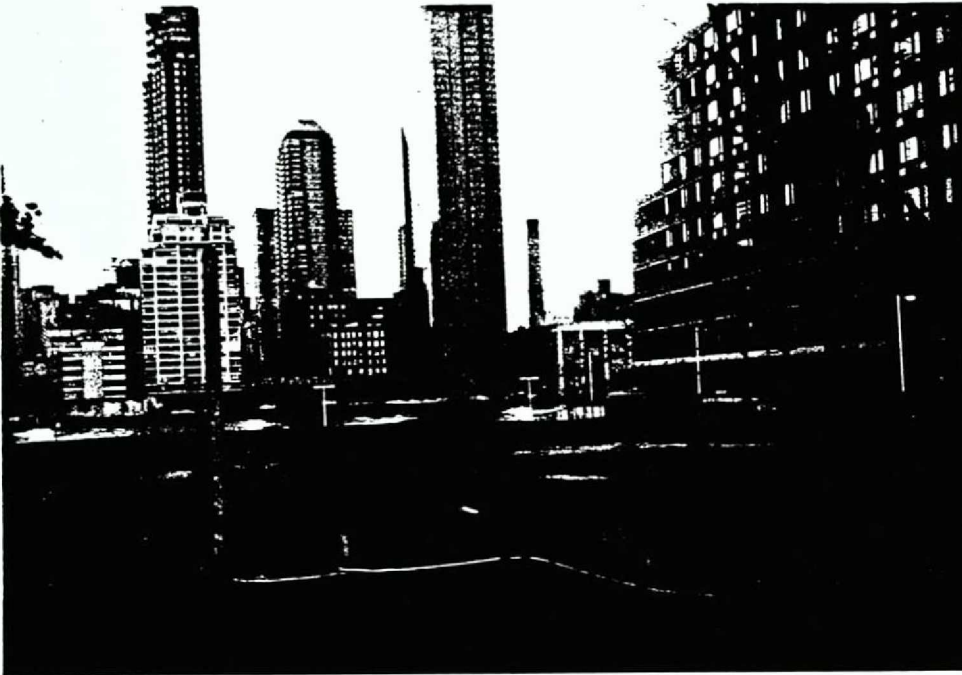
Photo 2: Looking west across the project site from Main Street, the eastern boundary.

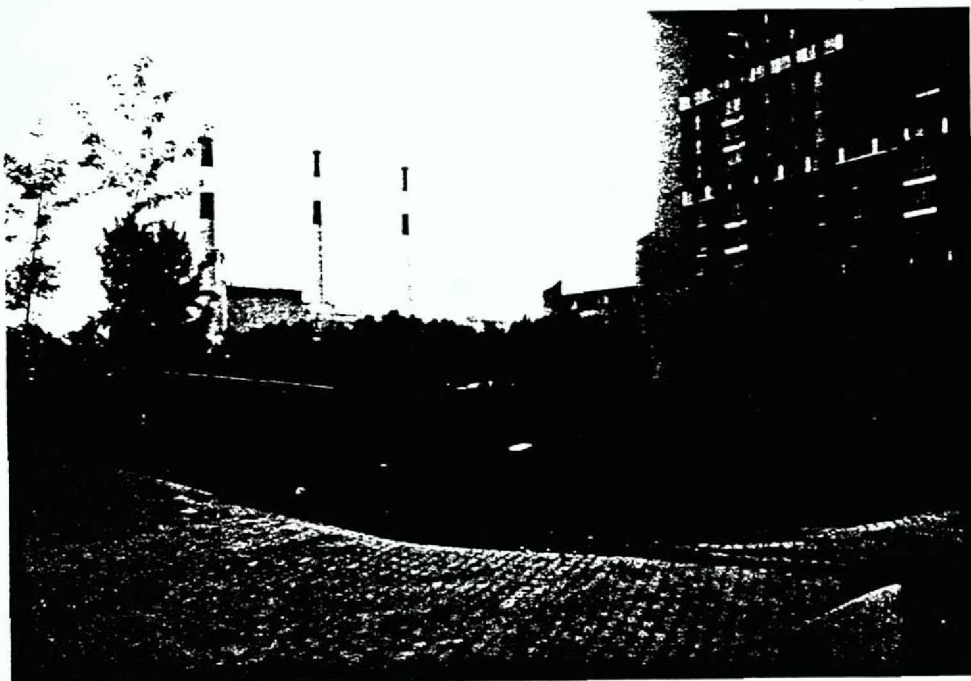
Photo 3: Looking southeast from the East River Promenade.

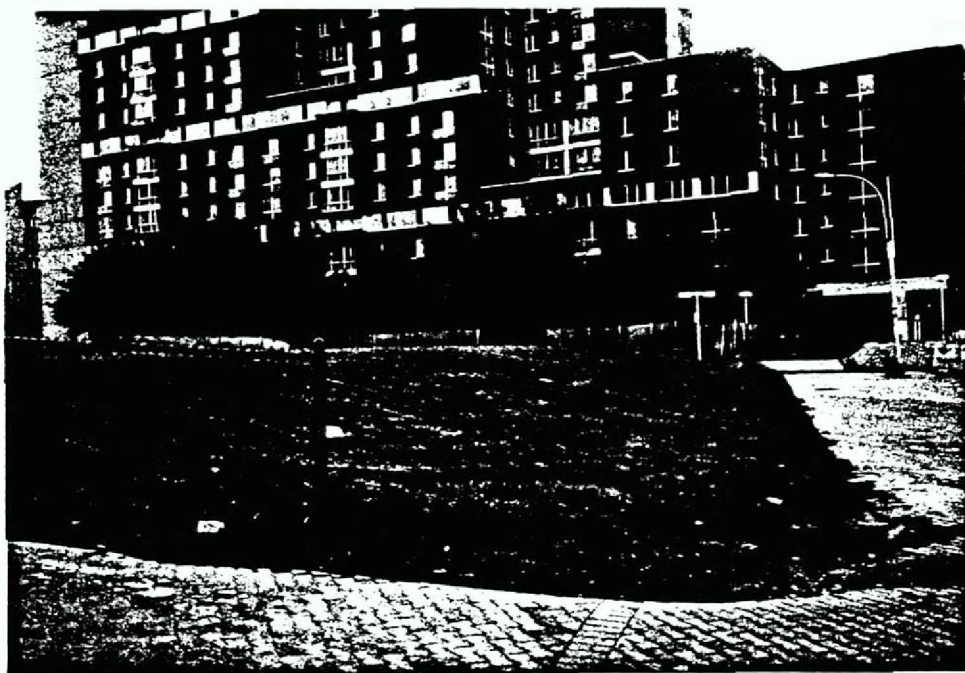
Photo 4: Looking south from the East River Promenade.
Note the slope evident in both photographs.

The present project site topography is a result of its usage in the historical period, during much of which it was roughly equidistant from two New York City charitable/correctional institutions, of which a more detailed discussion will be presented in the Historical Era section of this report. Approximately 350 feet to the north of the Board of Education Site stood the Workhouse, and about 350 feet to the south stood the Almshouse, during whose construction and landscaping of the surrounding grounds in the 19th century, and eventual demolition in the 20th, the ground elevations in the vicinity have increased up to 10 feet (Geismar 1985:17). To examine the third dimension, Dr. Geismar had access to boring data which showed that the Site consists of a deep layer of construction fill (bricks, concrete, wood, cinders, etc.) over a layer of undisturbed glacial till, resting on a foundation of gneiss (Geismar 1985:17, 48 and 52 and see Figure 6). The site is presently a level, grassy baseball diamond, slightly elevated and sloping down toward the East River shore which lies to the west (See Photos 1-4).

Further construction episodes on the Site, also shown on the 1969 map, are the approaches to the Welfare Island Bridge and the West Road, which ran north-south immediately west of the storehouse/garage. The road and bridge were in place in 1956, when they appear on the USGS Topographic map of the area. Today, the road is no longer extant on this section of the island, and the bridge approach is no longer on the Site. The Board of Education Site is presently a play area as shown in Photos 1-4.

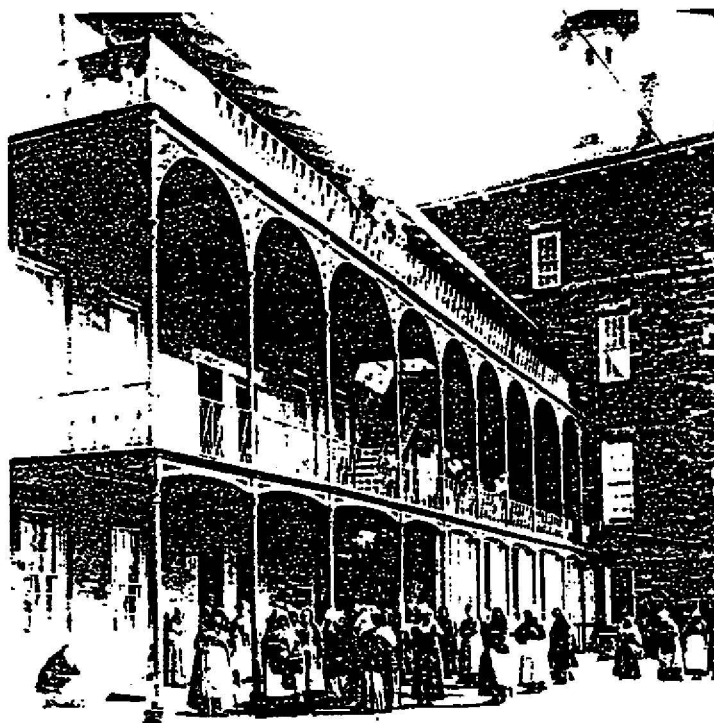
The female almshouse, Blackwell's Island.

Photocopies of an engraving
(Richmond 1872:536) and a
photograph (Barlow 1971:139)
(See Biblio. for reference.)

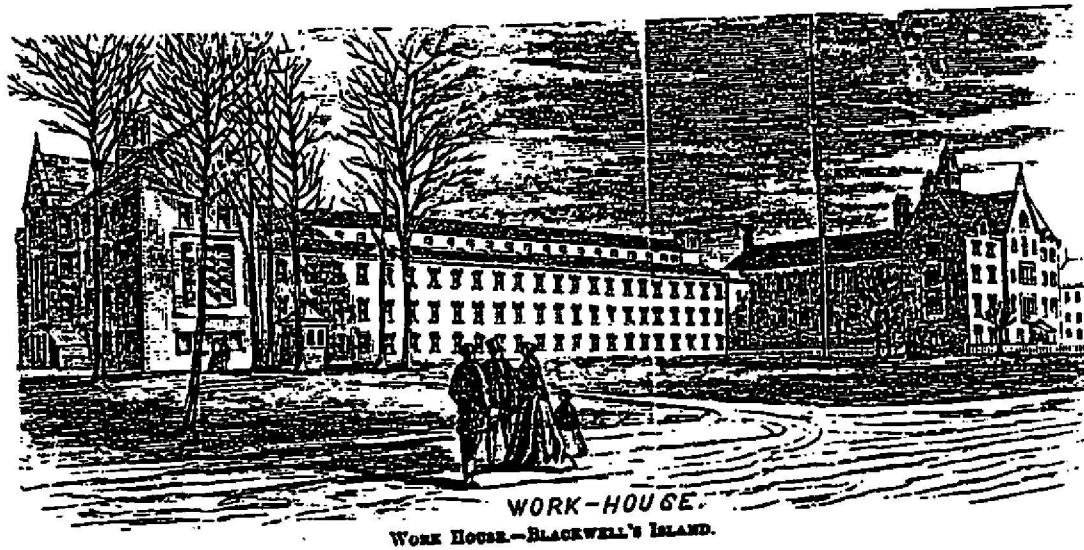
Plate 18. 1871 engraving of the north wing of the Workhouse and part of the central building (compare with much higher central building in Plate 9). Note guardhouse near the crosswing and neat but barren appearance of the grounds (Richmond 1871:opp. p. 535)

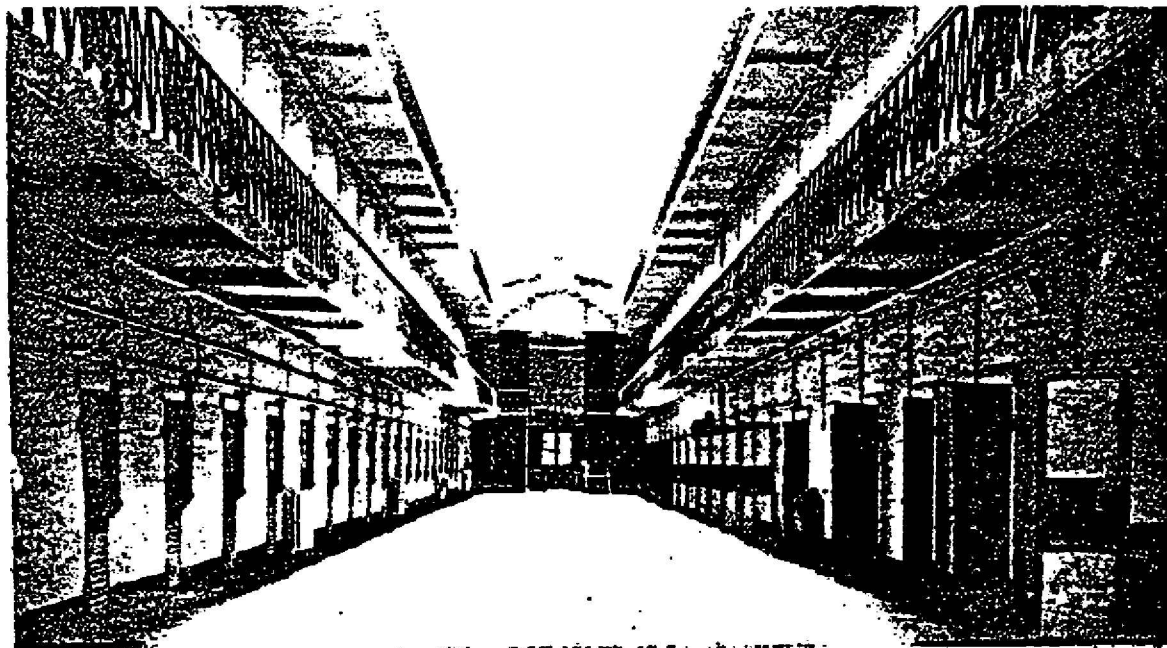
Figure 12

Photocopy of a photograph from I KNEW THEM IN PRISON
by Mary Harris, 1936. Opposite page 48.

The one building about which information could be found was the storehouse. On April 8, 1867 The Workhouse's storehouse burned with the loss of \$30,000 worth of goods. A new stone building was then constructed, which cost \$29,000, and was said to be very neat and attractive, with masonry "unsurpassed by any building in the city" (CPCCAR 1867:455). Not only is the storehouse in the project area of sufficient size to have been this structure, but it is the only stone building in the area, aside from the Workhouse itself. There is no documentation of new buildings added to the project area during the life of the Workhouse. The City Home, whose grounds and Male Almshouse building abut the site very clearly on the 1909 US Coastguard and Geodetic Survey Map, may have also been connected with the outbuildings on and around the Site. Aside from the storehouse, there is no reason to ascribe the property exclusively to either institution (See Figure 8). The storehouse was the only building to survive the demolition of the Workhouse complex, not being removed until after 1969. At that time the stone structure was a garage for the Fire Department. It had been enlarged, then 150 feet long and L-shaped, but it is labelled as having been erected in 1867, so its identity is not in doubt (Welfare Island 1969:Figure A-5). (See Figure 12.)

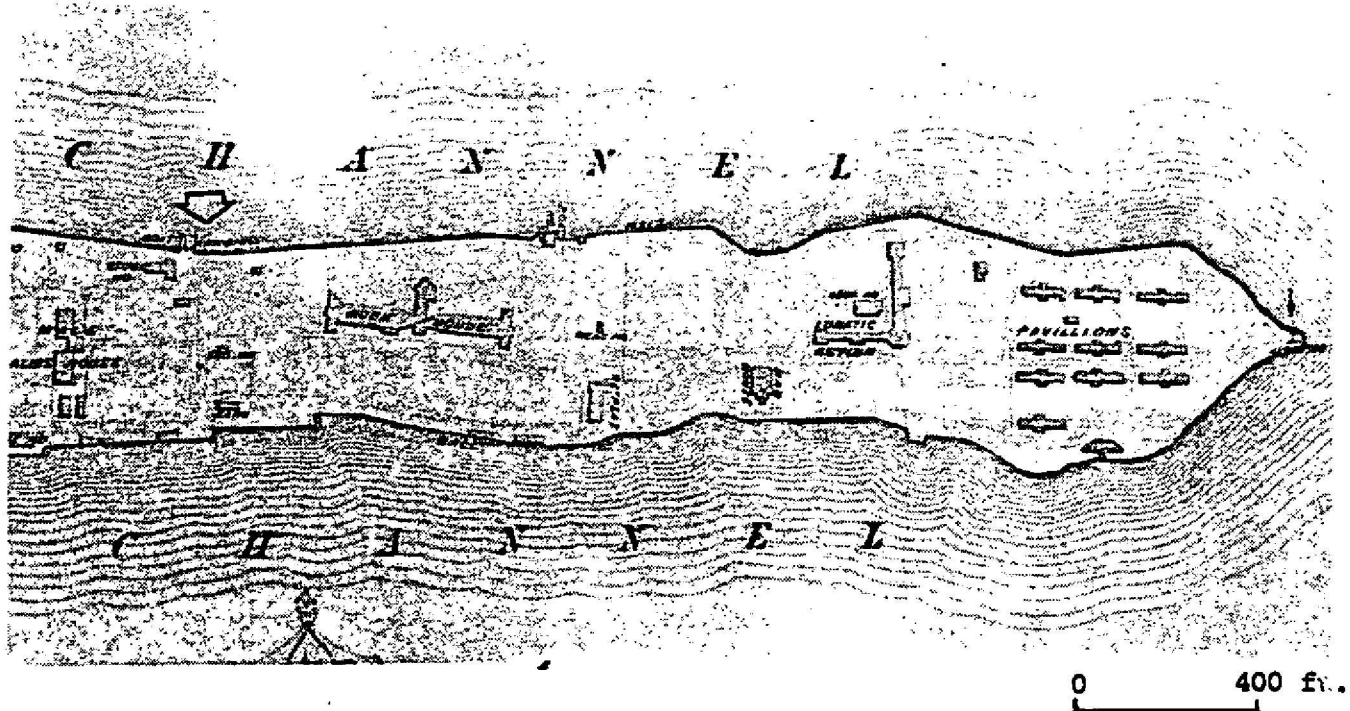
Plate 16. Detail of the north end of Blackwell's Island in 1879. Note lighthouse (arrow) at end of the island. The Workhouse is seen in relation to the Male Almshouse to the south and the Lunatic Asylum to the north (Bromley and Robinson 1879:Plate 41, Map Division of the NYPL)

The building configuration is completely changed on the 1879 Bromley and Robinson Atlas with the possible exception of one tiny structure which is circled on the 1865-74 map (Figure 13). Also, it may be that another of the small buildings (note arrow) was a storehouse because the 1879 Atlas, which shows the project area in detail, depicts a large (110 foot long), new T-shaped stone "storehouse," as well as a wooden structure on the boat landing. (Figure 14) (The New York Public Library's 1879 Atlas is being rebound and is thus unavailable for copying at this writing. The authors viewed the New York Historical Society's volume and made a tracing, copy-machine duplications not being allowed. Therefore, it was necessary to copy the reproduction in Geismar's report. This is not an ideal solution since many details are dim. In particular, the roads which cut through the Site cannot be seen.) Of the other three buildings, the northernmost one may be the same

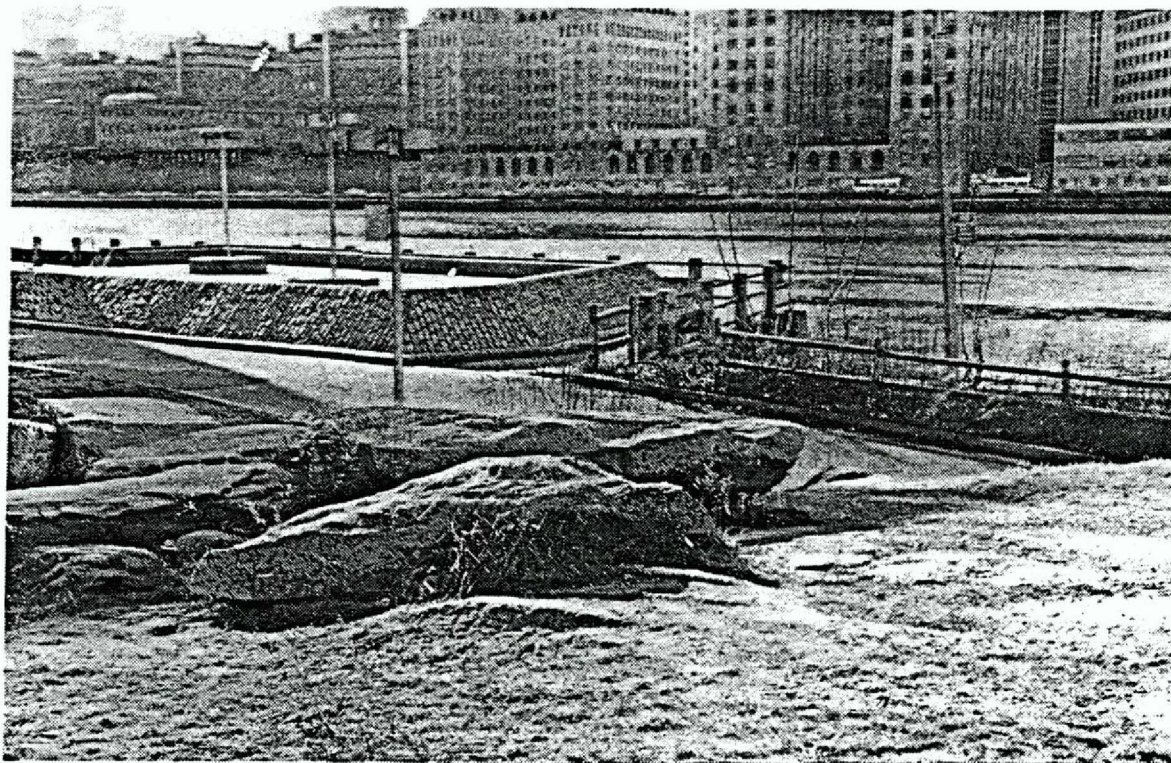
Plate 10. View to southwest from near field and baseball diamond. What appear to be boulders is mainly trashed concrete. New York Hospital in Manhattan is to rear of picture (photo: March, 1985)
