**CASTLE CLINTON
ARCHEOLOGICAL OVERVIEW AND ASSESSMENT
Castle Clinton National Monument
New York, New York**

**William A. Griswold, Ph.D.
Archeology Branch, Northeast Cultural Resources Center
Northeast Region, National Park Service
U.S. Department of the Interior
Lowell, Massachusetts**

December 1999

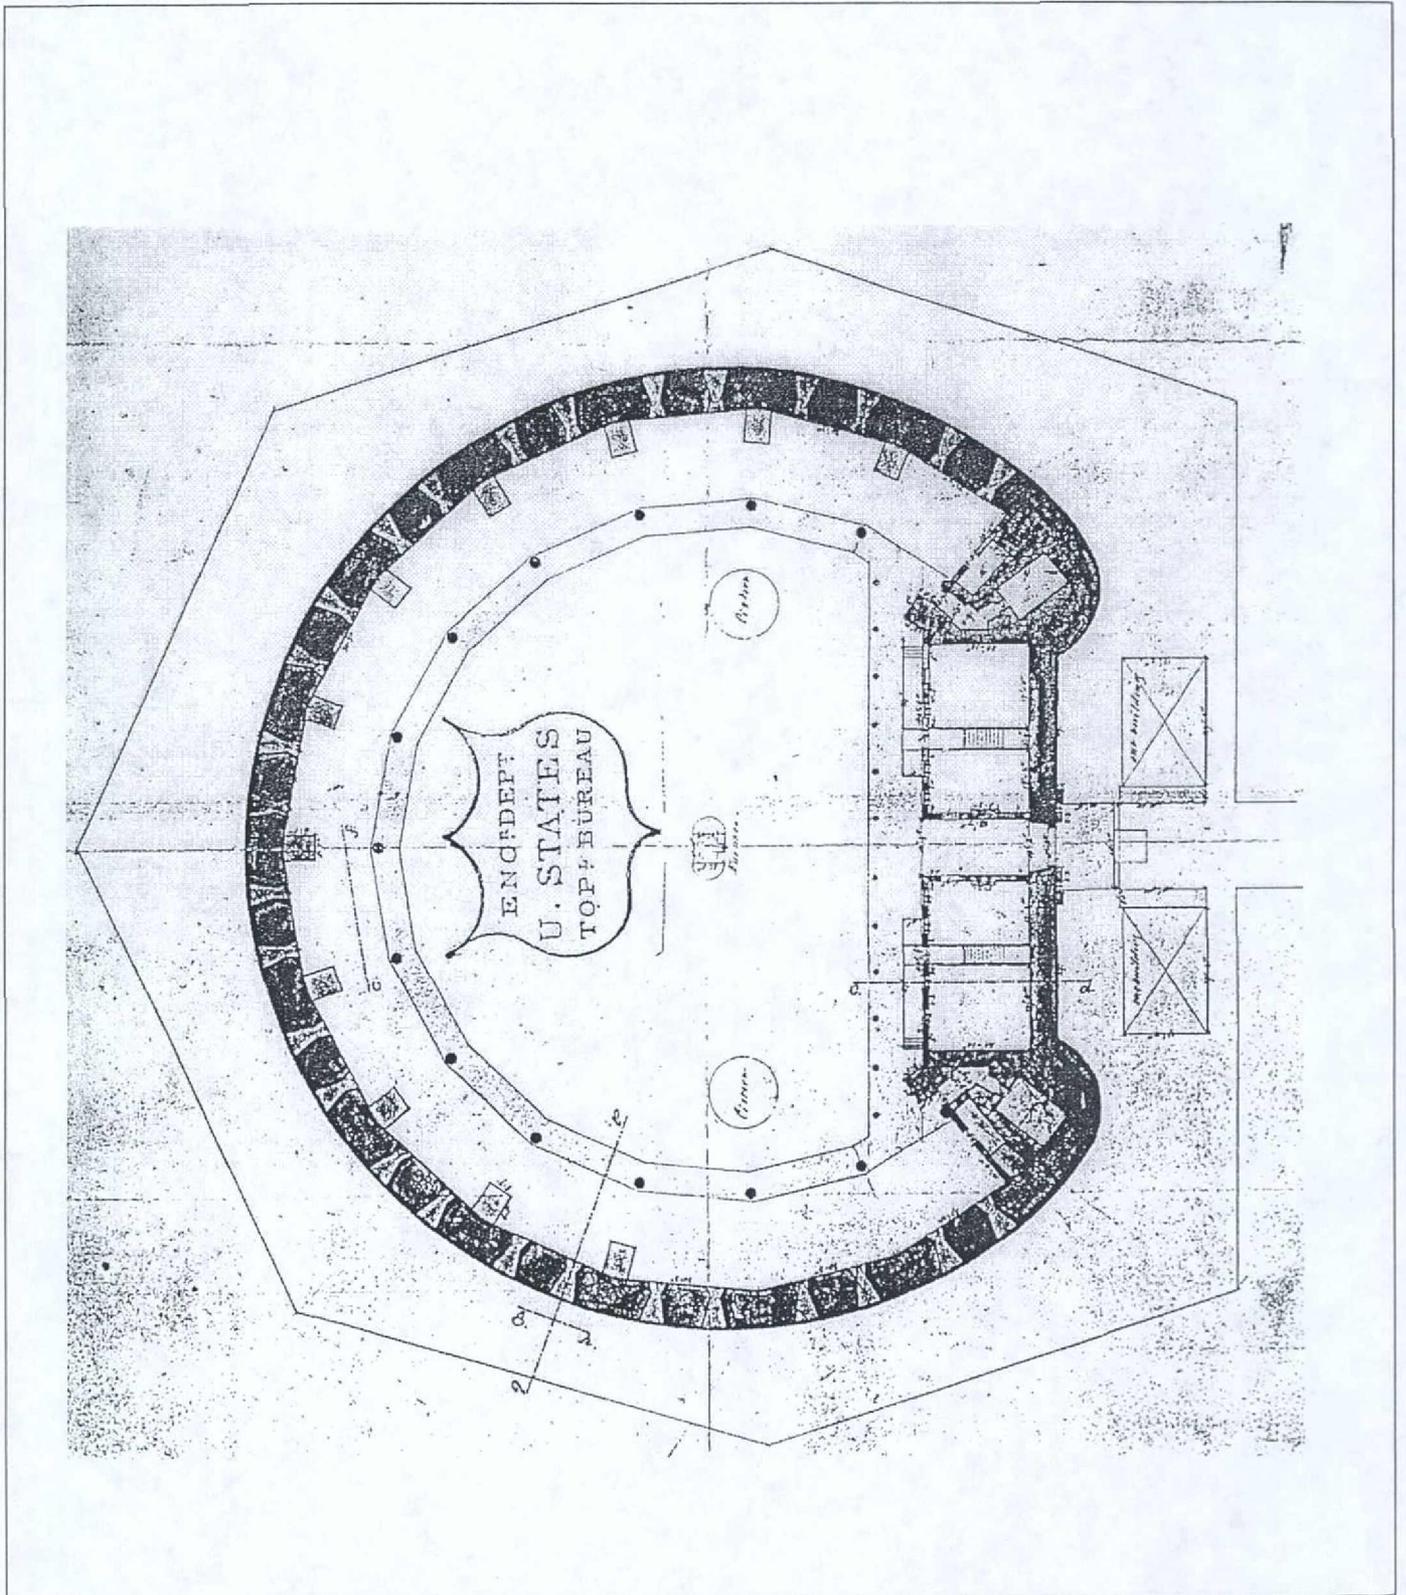
Figure 3.1 Close-up of National Archives drawing (Cartographic and Architectural Room, Drawer 36-32).

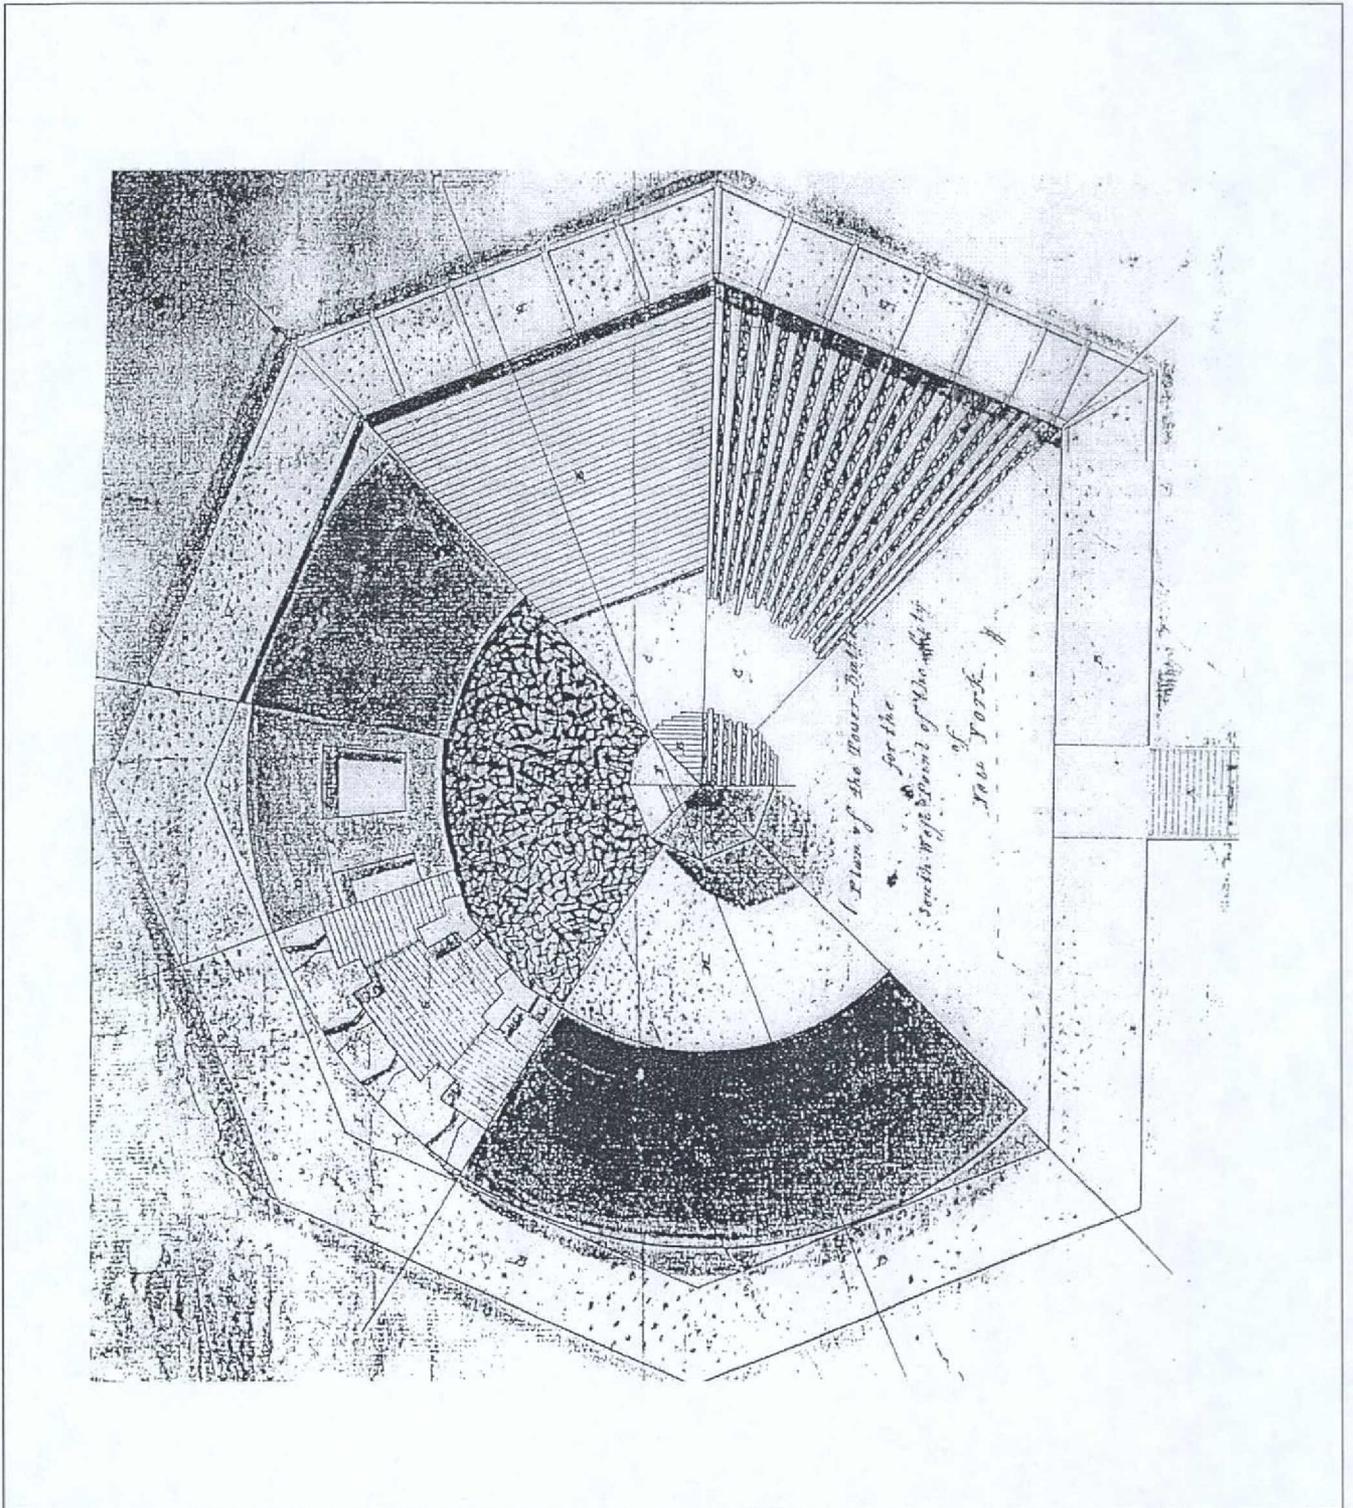
Figure 3.3 Close-up of National Archives drawing (Cartographic and Architecture Room, Drawer 36-14).

Working from a c. 1810 map 36-14, obtained from the National Archives, Hershey located Trench 4, a 5.5-foot long irregular unit. Excavation revealed only rocks, thought to be the rock fill used to build the counterguard. Hershey's computations indicated that the bottom of the trench was well below the low water mark of the c. 1810 drawing. No evidence was found for either the octagonal magazine illustrated on the c. 1810 maps nor for the Hot-Shot oven purportedly built in the same place in 1814. Even the brownstone rocks identified by Cotter were dismissed as being patternless.

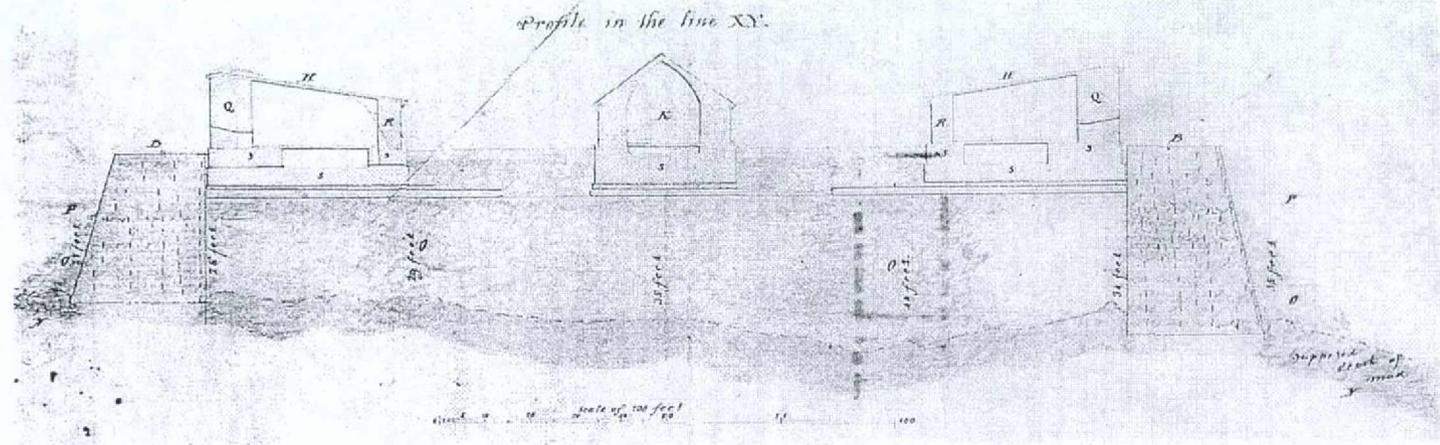
Figure 3.4 Close-up of National Archives drawing (Cartographic and Architecture Room, Drawer 36-14).

Description of the Plan

- A Bridge connecting with the Battery
- B Wharf or Counter-guard, 20 ft wide at top, 30 ft at bottom
- C Road after being filled to low water mark, 20 ft diam.
- D Log pile in ditch with mason work between them - at low water mark
- E Timbers laid over their tops
- F Foundations works upon the floor
- G The plan shows the entrance of the establishment, platform for guns & Piece of the interior wall
- H The surface after being covered with a roof
- I Space between the walls & covering filled with stone & covered at top with gravel
- K Magazine in different state of preparation
- L Stone between the Magazine & Casemate
- M Low, after being spalled

1. The irregularity of the interior was known by means of a plan. 2. The irregularity outside could not be ascertained but by the actual nature of the stone. 3. The lower surface of the plan is a complete one & can only settle in one body. 4. The interior foundation is independent of the wharf & in case of settling will go down by itself & being flooded at low water must therefore settle uniformly. 5. The foundation of the Magazine is also flooded & independent of the other part.

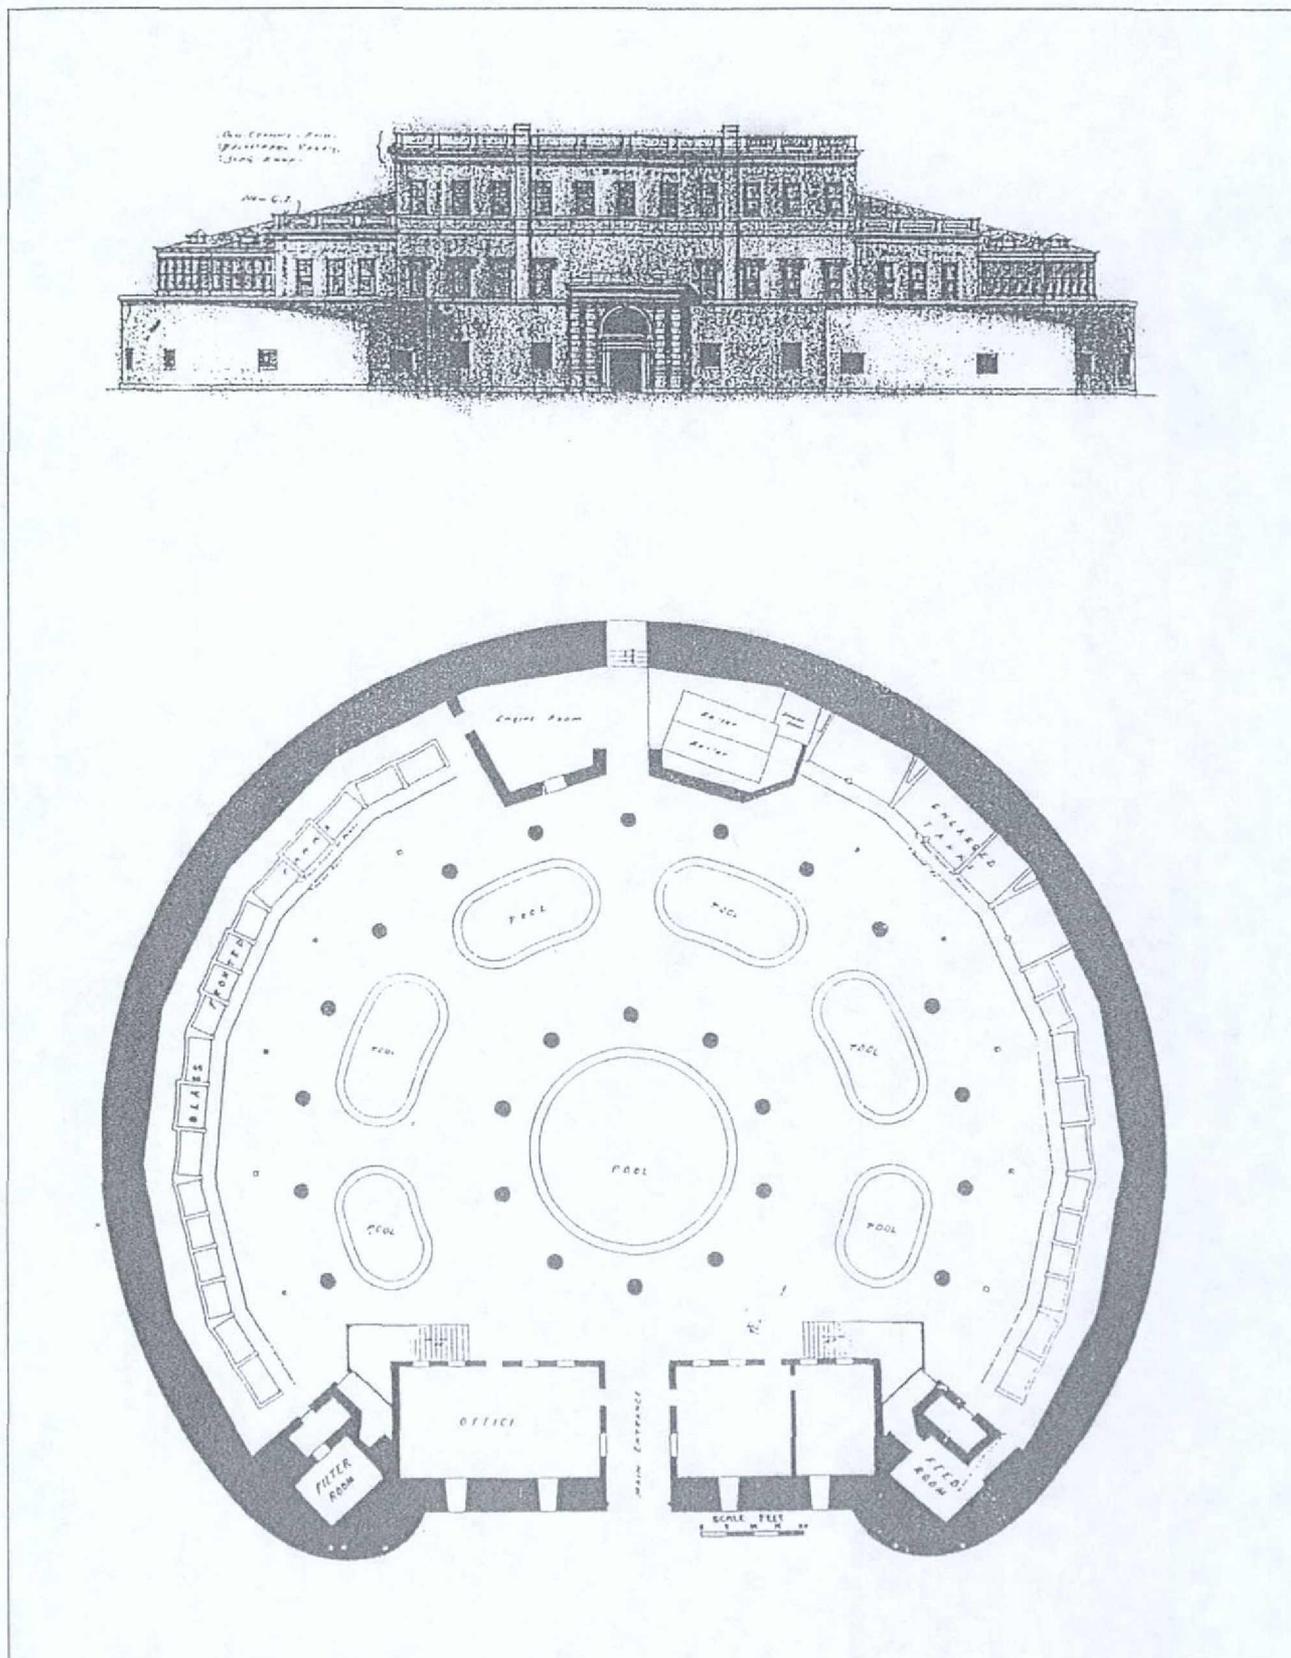
Figure 3.8 Front View and ground floor plan for the Aquarium.

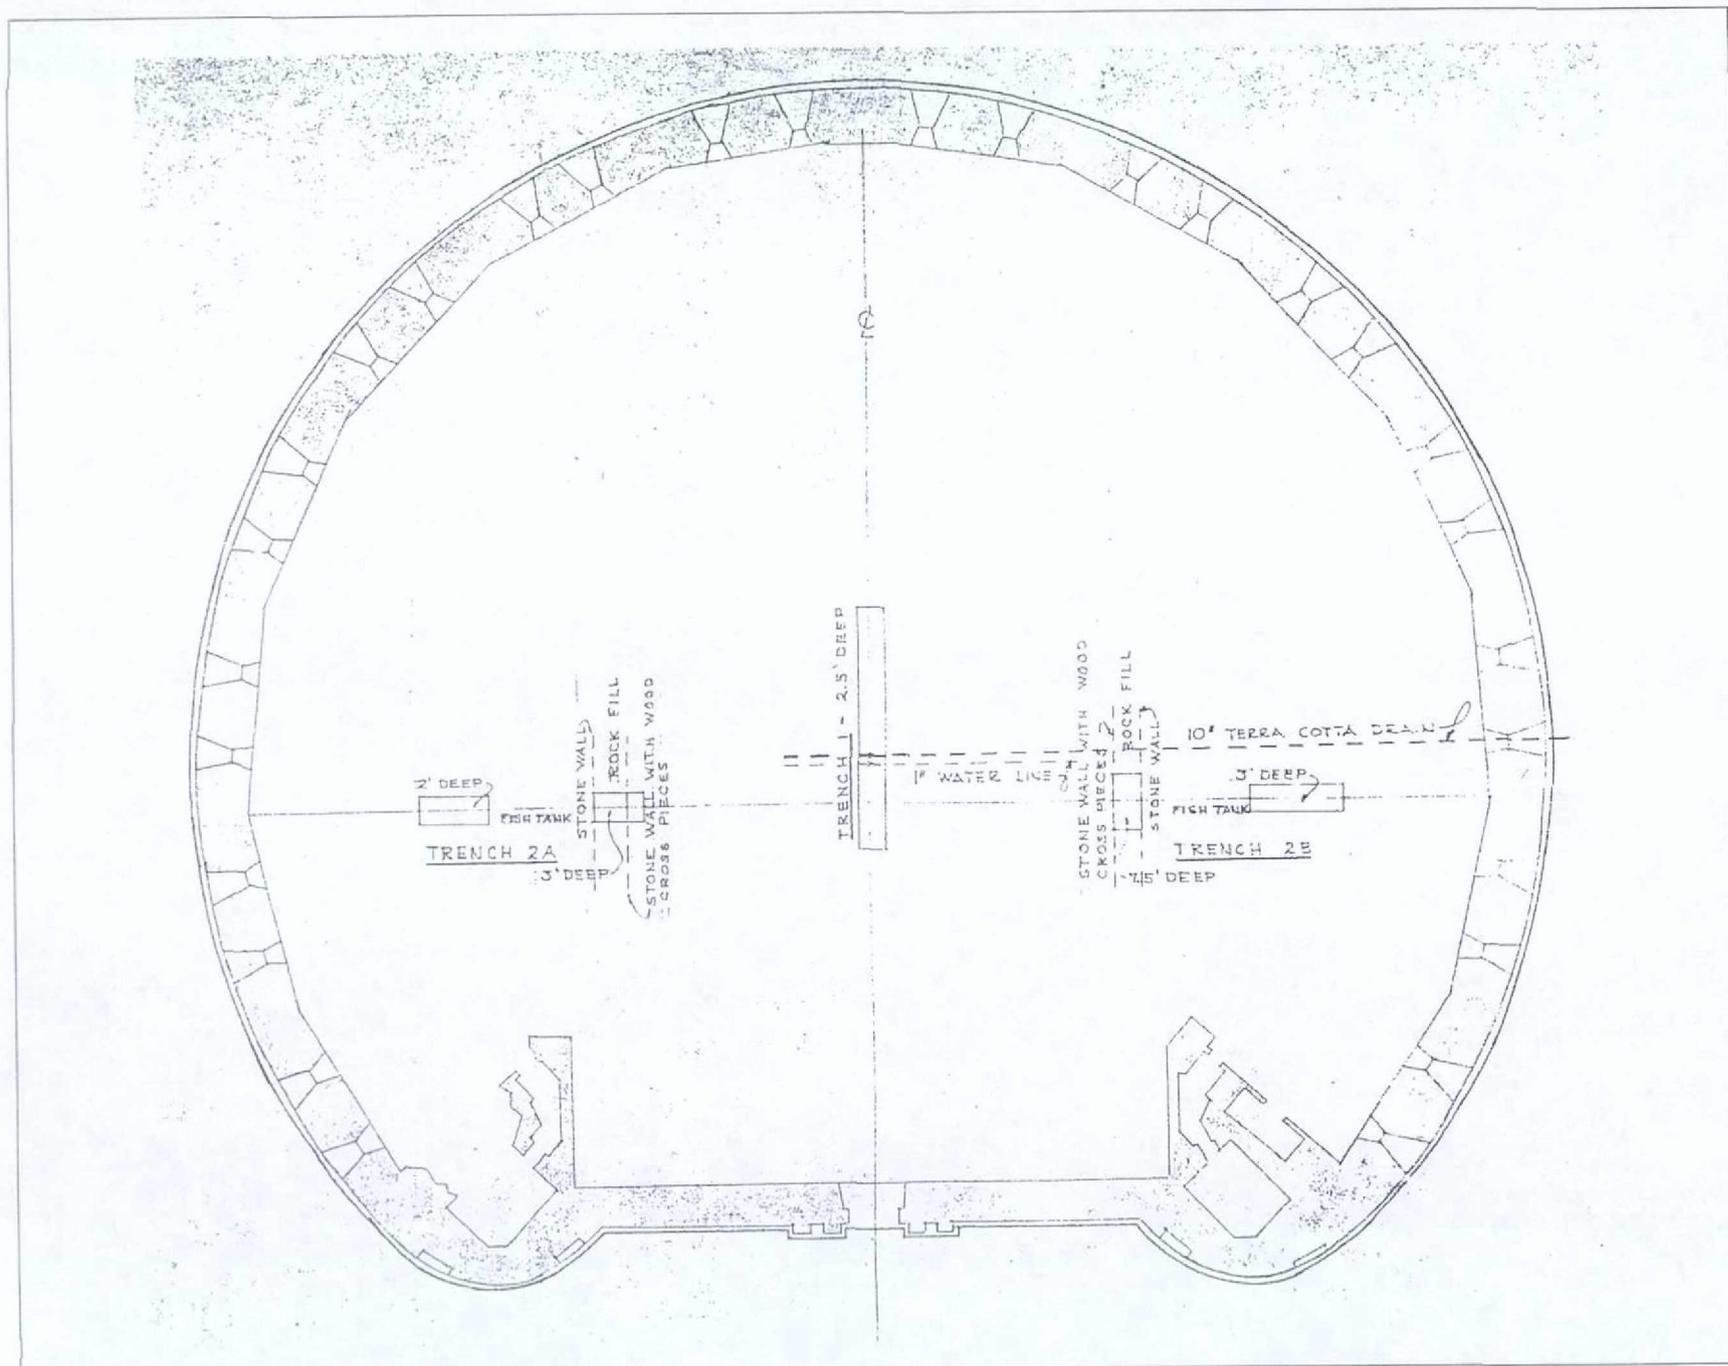
Figure 4.1 Map showing the location of Paul Schumacher's excavations (after Schumacher 1955).

EVALUATION: Schumacher's report provides most of the basics of an informative archeological report. He provides a list of where he excavated and what he found. A map documenting his excavations is also appended which is of large enough scale that the location of his excavations can be pinpointed precisely. Numerous photographs also accompany the report showing the various trenches excavated and several of the features found. Several elements of the report are however disappointing. Schumacher's brevity of description only provides glimpses into what was actually done and found. No profile drawings or plan drawings, other than the large map, are included in the report.

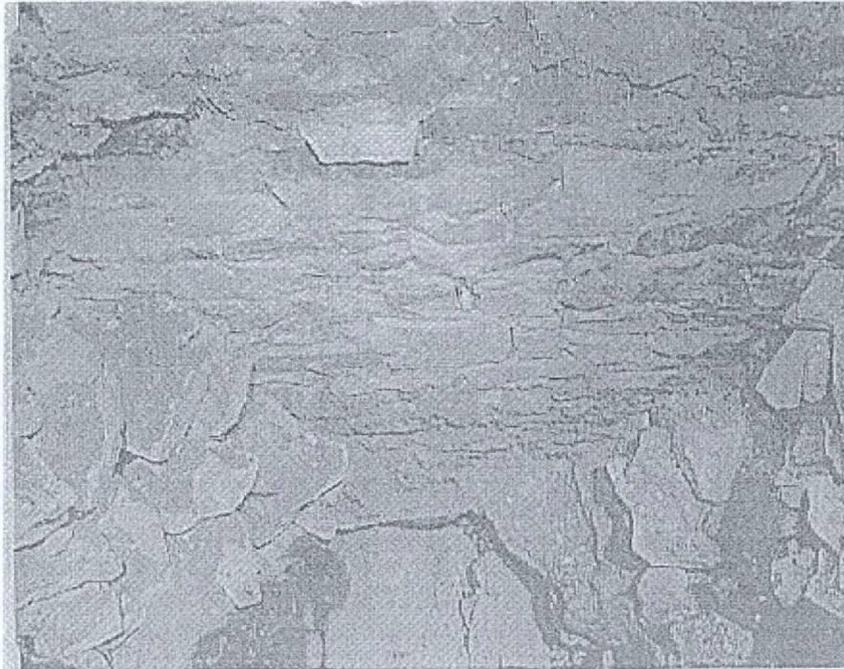
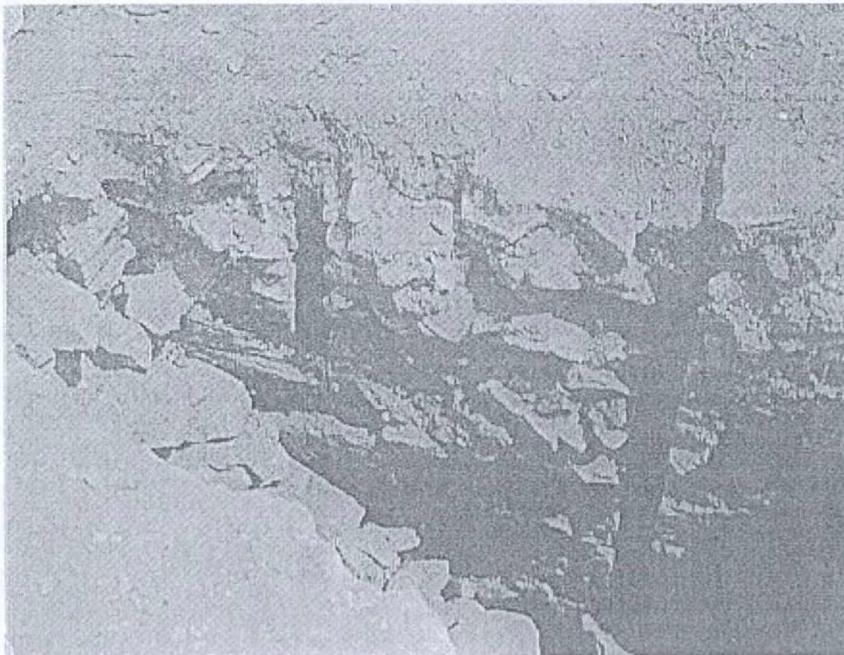
Figure 4.2 Photographs of Paul Schumacher's excavations.

Interior of Trench 2 - North View

Interior of Trench 2 - South View

chosen and is to a large enough scale that the location of the excavations may be precisely identified. The 17 black and white photographs that accompany the report provide very good documentation of the trenches, strata, and features found (Fig. 4.2).

RESULTS: Trench 1 exposed a water pipe, terra cotta drain pipe, and a large amount of rubble. Water was encountered 28-32 inches below the surface. The excavators concluded that the water was due to poor drainage of the old fish tank floors. Schumacher notes that Trench 1 runs through Aquarium Turtle fish tank in the center of the building. Ultimately it was the infiltration of water that led to Trench 1 being abandoned. Portions of some of the Aquarium's fish tanks were found in both Trenches 2A and 2B. The cement of the fish tanks could not be broken without a jackhammer so the excavators dug around them. Two mortar and stone walls were found in Trench 2B. The stone fill between the two walls was removed and the base of the walls was exposed approximately 6 feet 7 inches below the ground surface. Schumacher believed that these walls were footings for the parade ground. Excavation in northern portion of Trench 2B revealed "a solid foundation floor of some sort, probably of Castle Garden or Aquarium Period." Identical stone walls were found in Trench 2A but the working space was narrow and more dangerous and was not attempted.

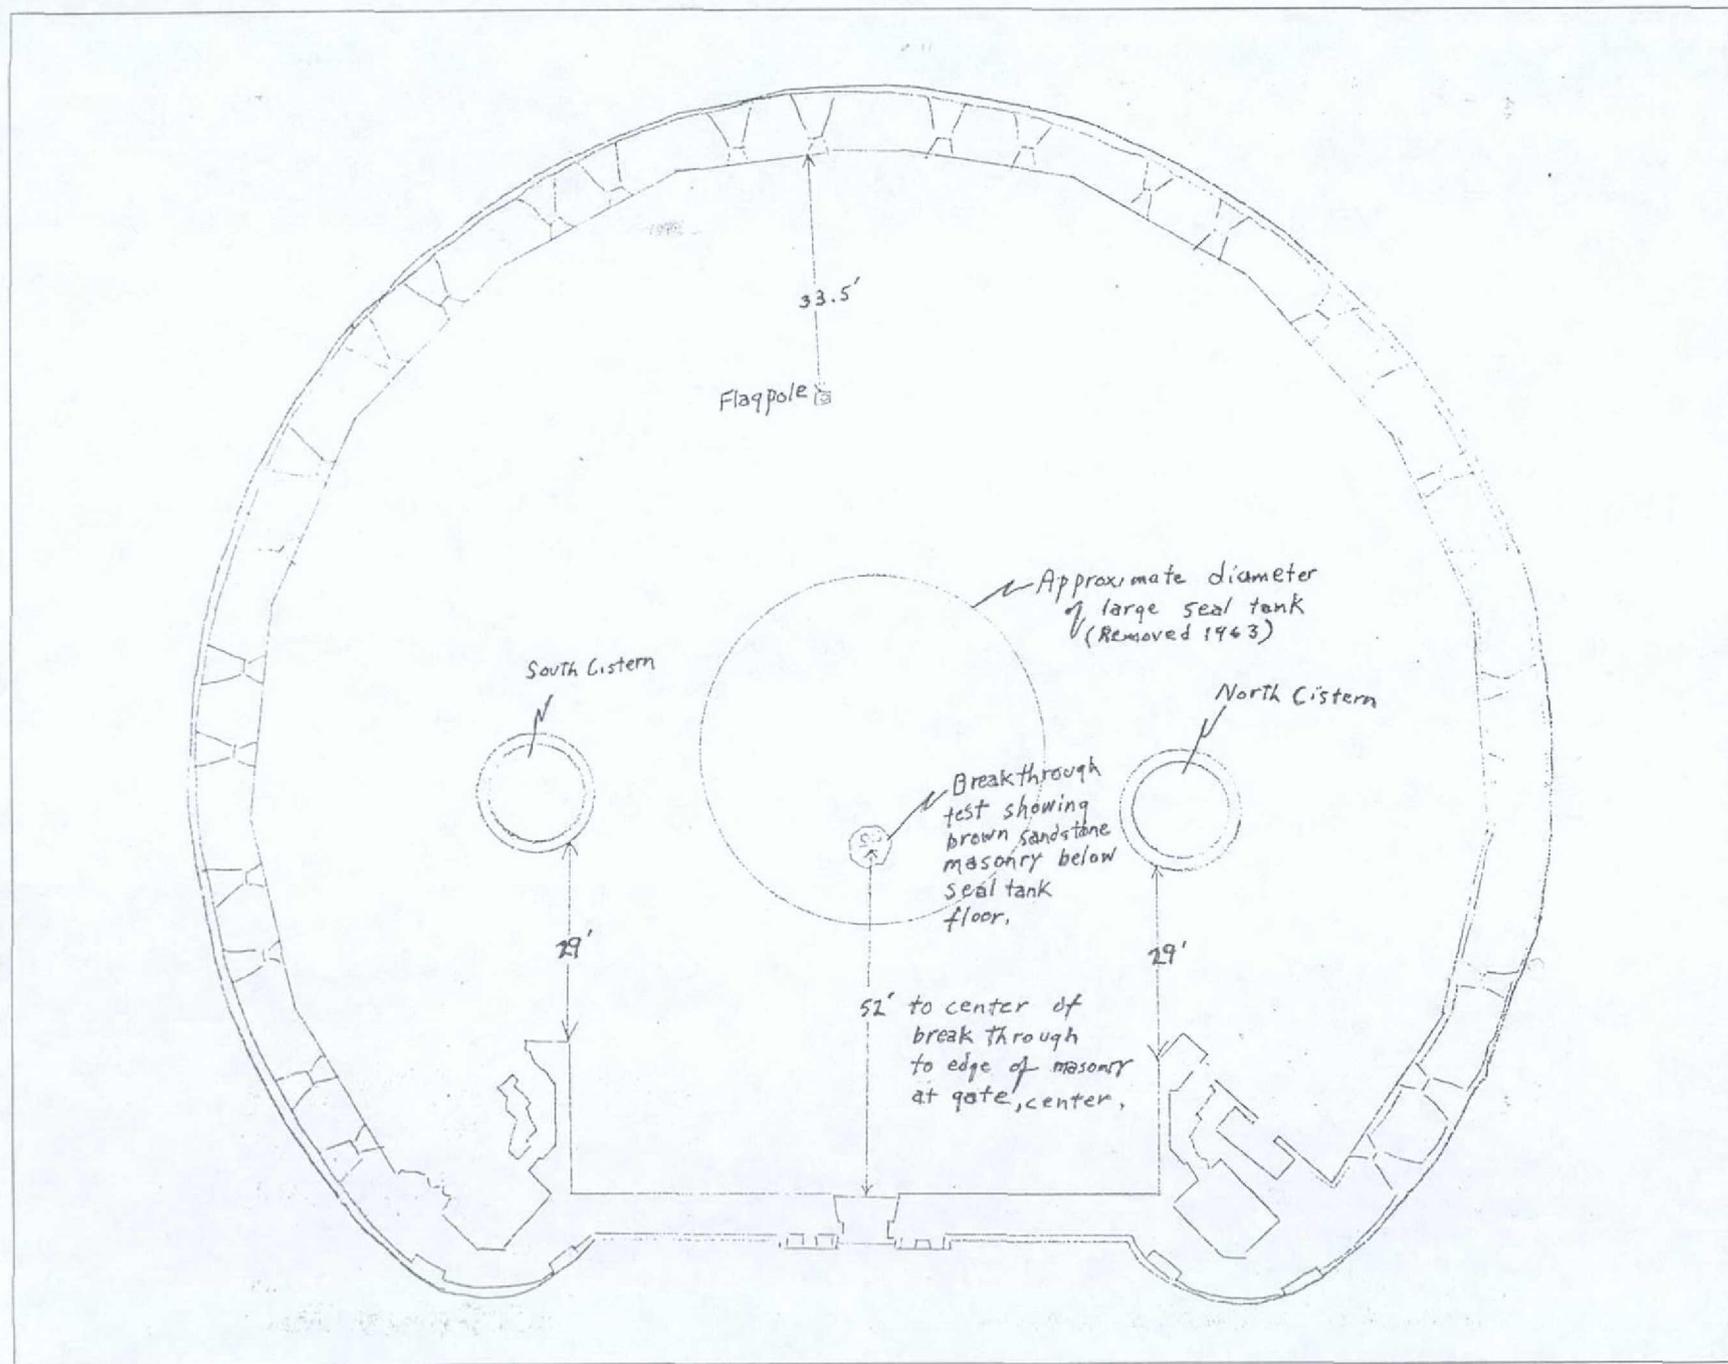
Figure 4-3 Map showing the location of John Cotter's excavations (after Cotter 1962)

METHODS: While not fully developed in his report, the methods of investigation included a combination of hand labor and machine use (Fig. 4.3). The archeological investigations were being conducted in cooperation with architectural explorations around the interior of Castle Clinton. Hired laborers and not archeologists, aside from Cotter, were used for all of the excavations. This method seems relatively appropriate for the conditions. Thick cement slabs from the aquarium tanks overlay the cisterns and the probable location of the hot-shot furnace. These large and thick slabs (1-1 ½') were broken up by jackhammers; rubble fill from the dismantling of the Aquarium was also encountered across the site. Cotter produced a brief report on his results and appended five photographs to his report. Additional comments on methodology were not included.

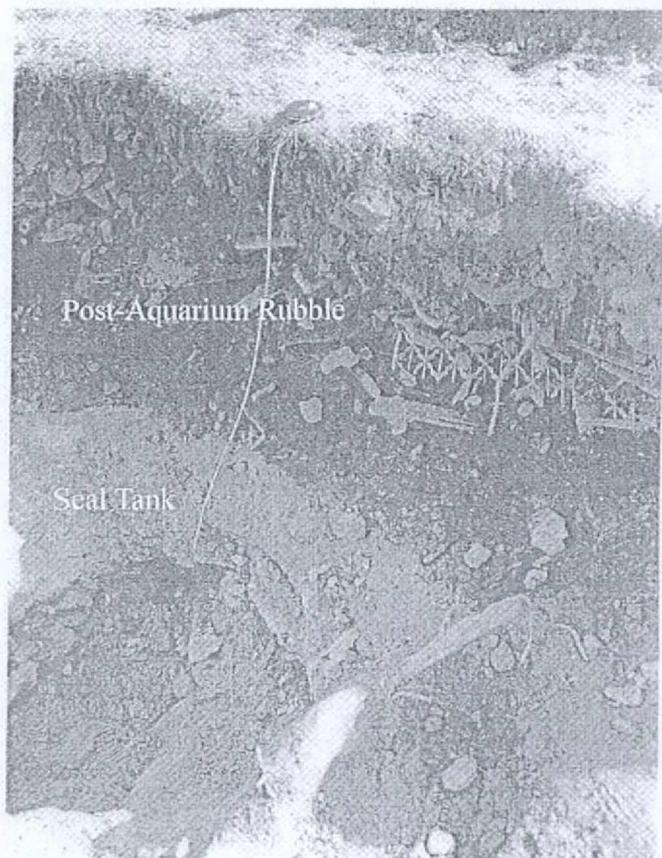
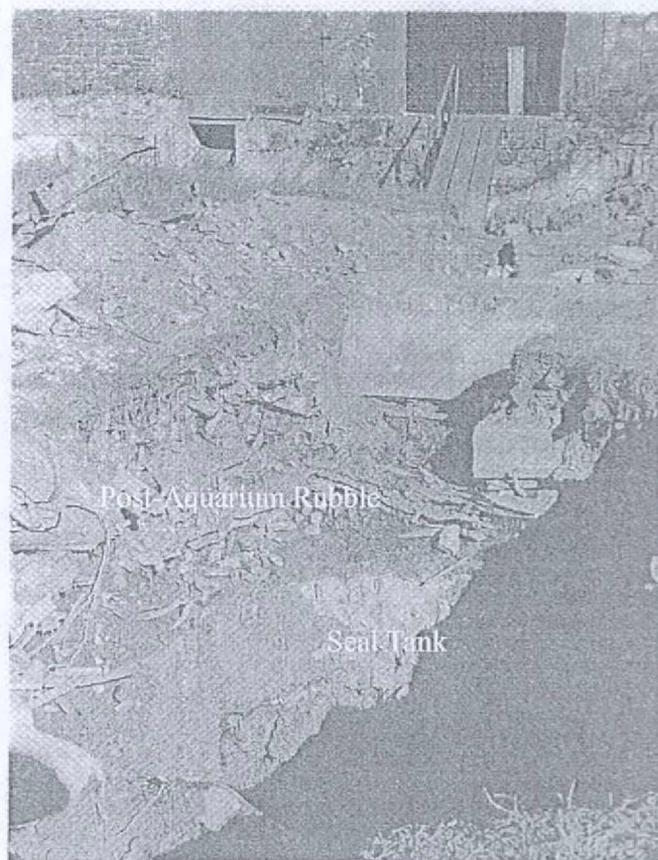
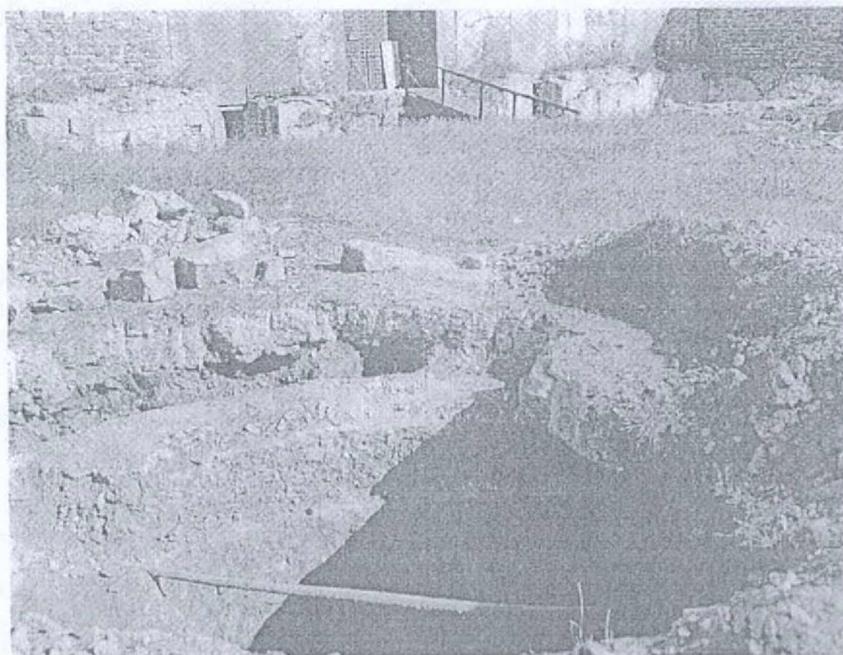
Figure 4.4 Photographs of John Cotter's excavations.

Excavation below the Seal Tank

The North Cistern

After the cement slabs of the Aquarium tanks were jackhammered and broken up, the two cisterns were located. The Aquarium tanks had been built on top of the masonry walls of the cistern. Cotter describes the cisterns as having been filled with sandy earth with some artifacts. Artifacts mentioned include stoneware, earthenware, and bottle fragments. The entire assemblage, according to Cotter, indicates that the cisterns were filled between 1875 and 1911. Exposure of the hot-shot oven proved to be more of a challenge. To even get down to the approximate level of the feature, the workmen had to remove two and a half feet of scrap iron and rubble, and then hammer through one and a half feet of concrete. After much effort a hole of approximately 5 feet in diameter was blasted through the concrete. Portions of sandstone pieces cemented with 18th century type mortar were exposed below the seal tank. Cotter believed that this could be a part of the hot-shot oven, but its identity could not be securely established.

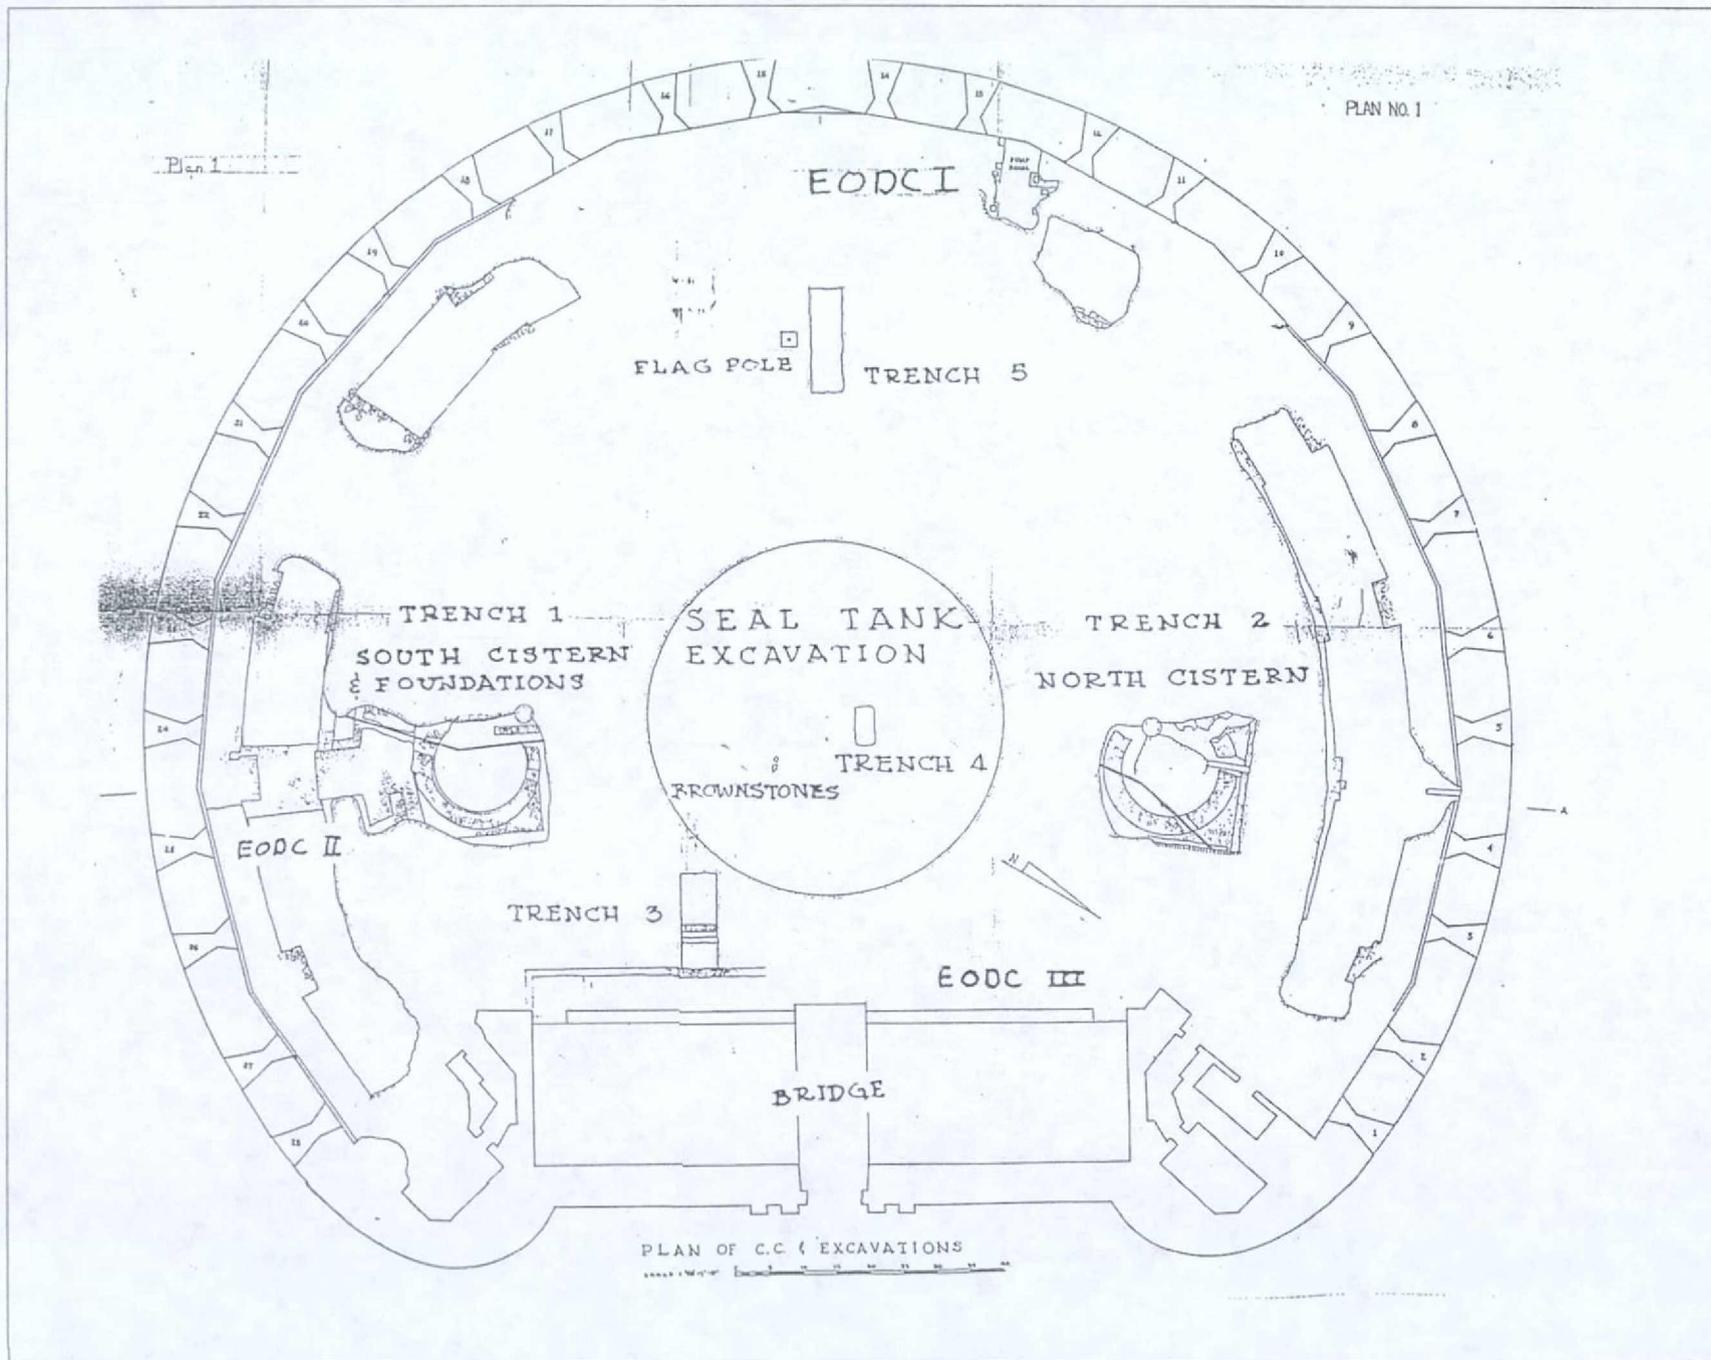
Figure 4.5 Map showing the location of William Hershey's excavations (after Hershey 1963)

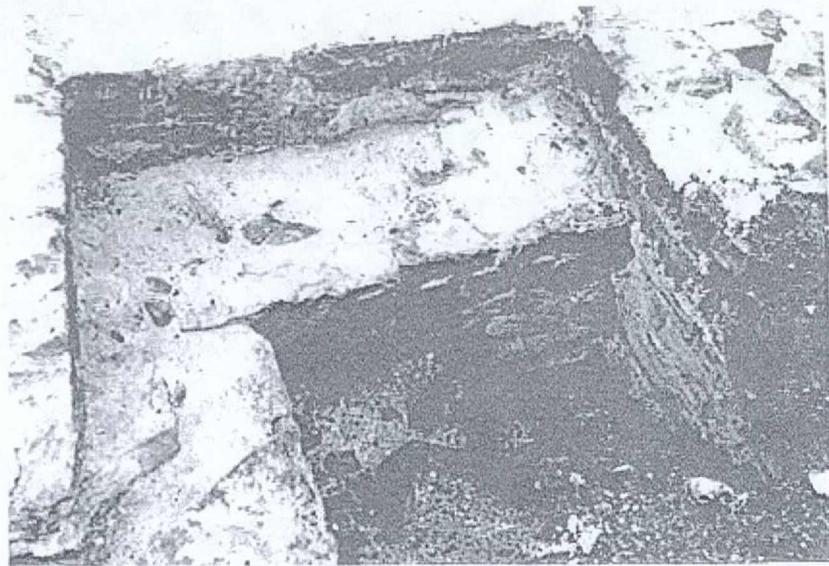
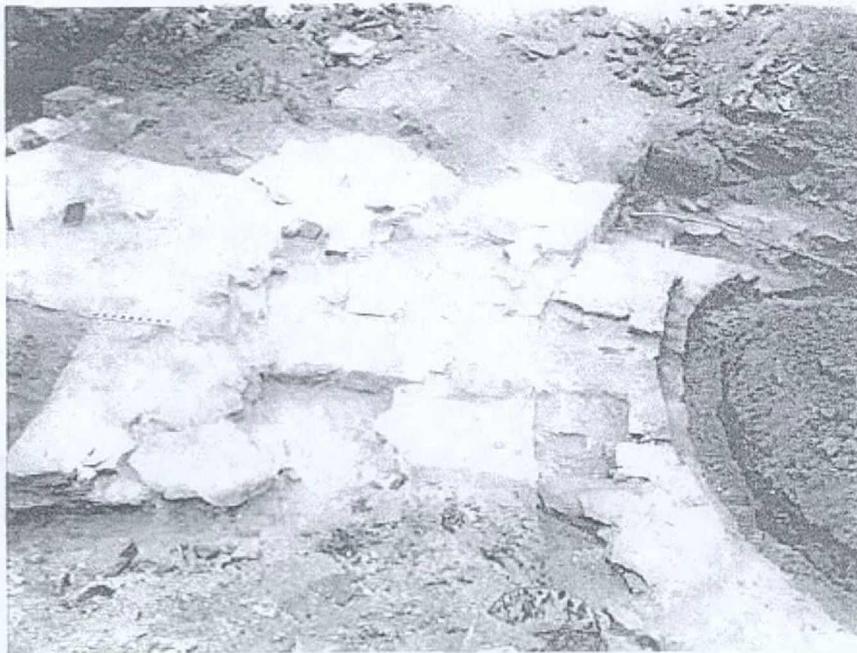
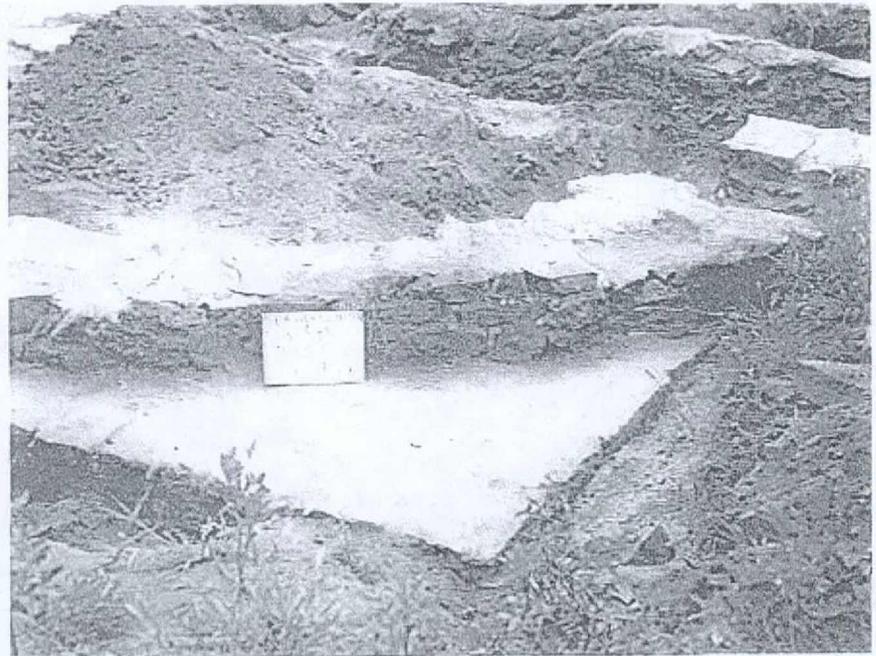
Figure 4.6 Photographs of Hershey's excavations.

EVALUATION: Hershey's report is the most detailed of the three archeological reports. He provides a detailed textual discussion of what he found and includes numerous photographs and illustrative drawings (both plan and section) (Fig. 4.6). At times, however, his discussions, especially concerning the casemate construction, are hard to follow. Labeling the various components on a plan would have aided the discussion.

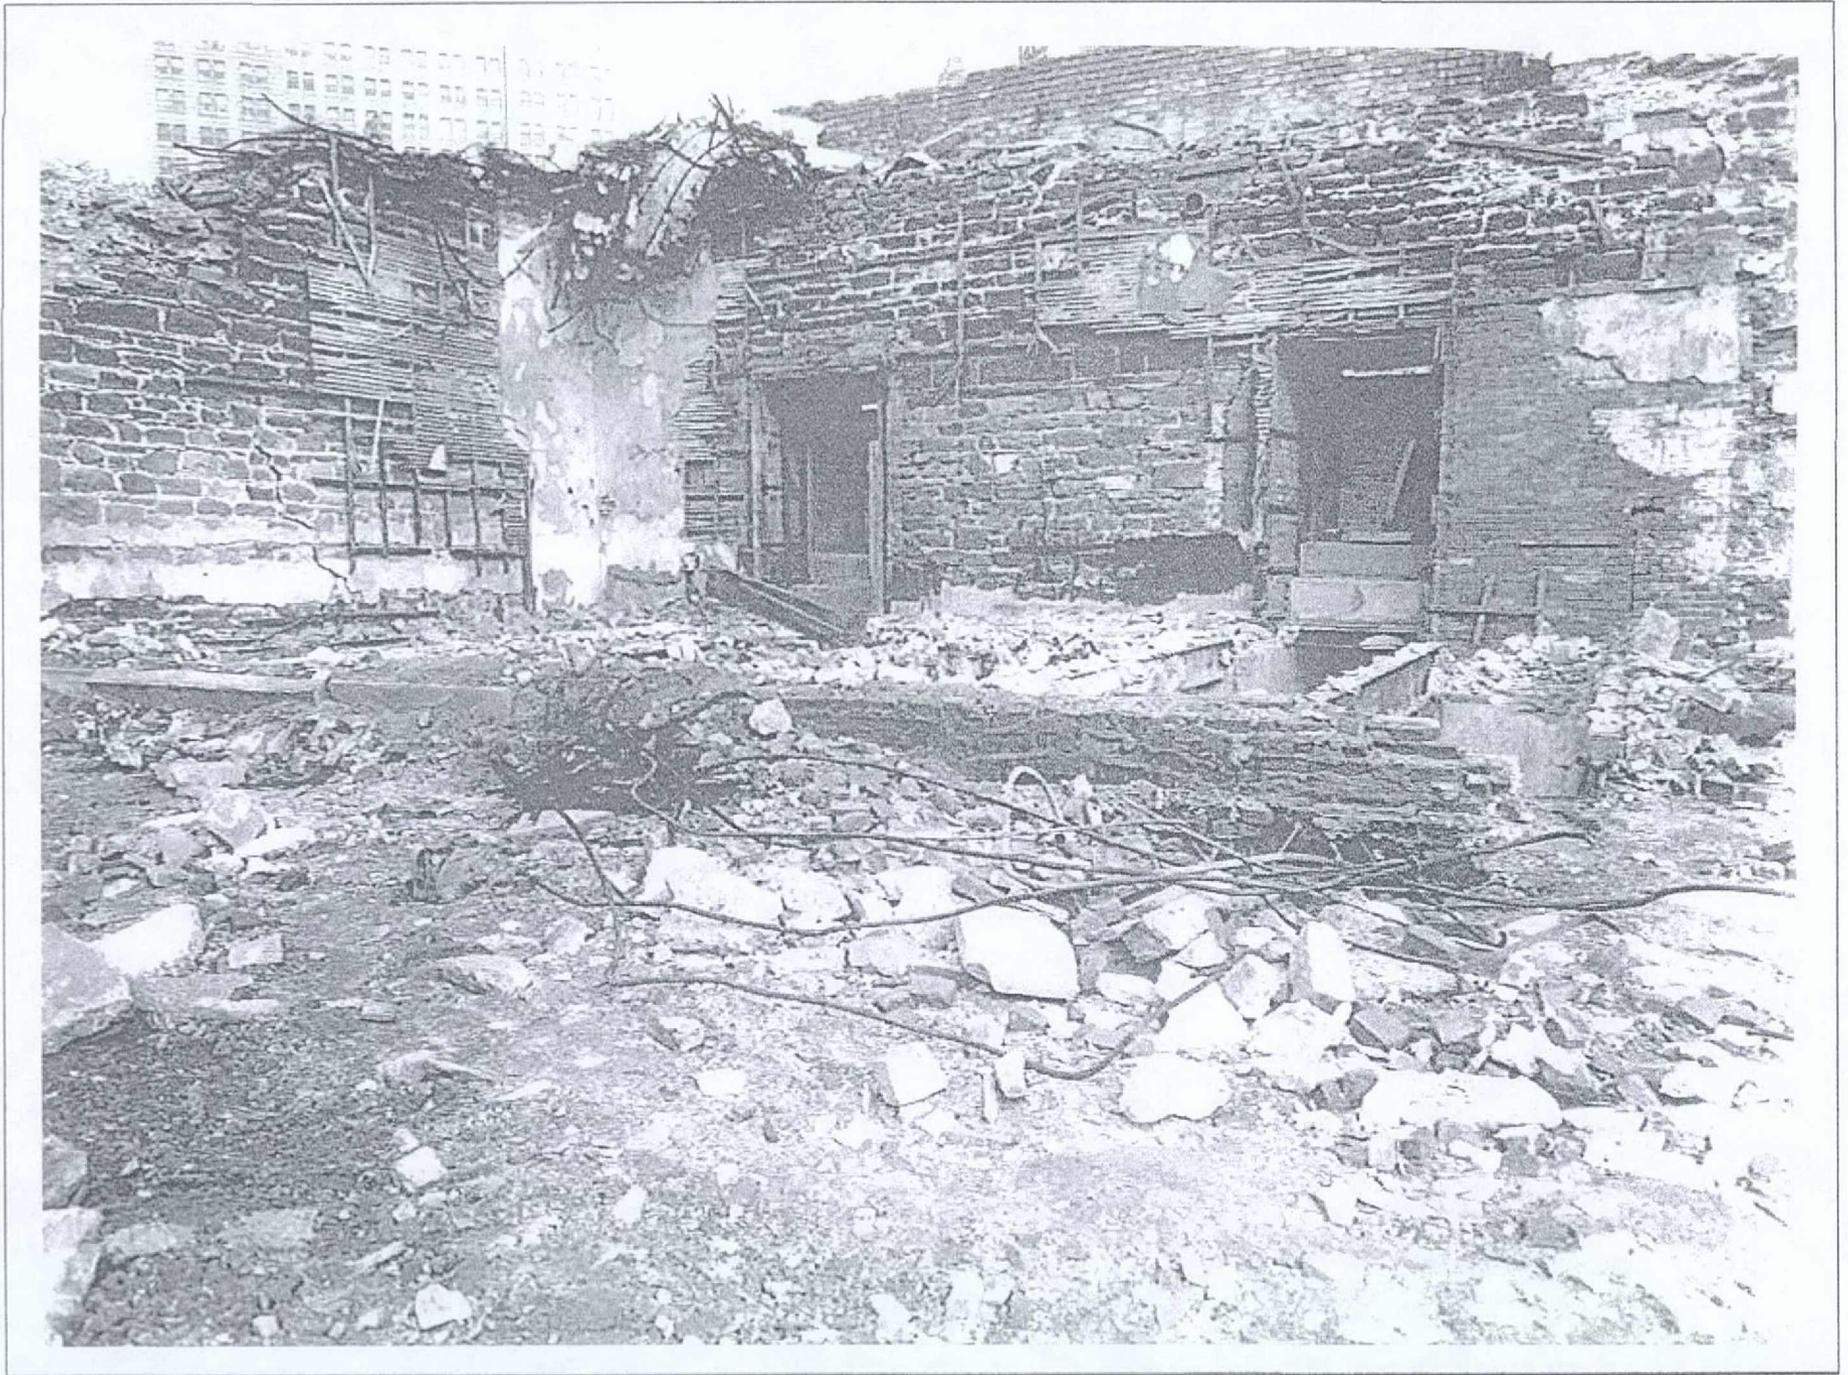
Figure 5.1 Photograph of the interior of Castle Clinton c. 1950s.
