**CASTLE CLINTON
ARCHEOLOGICAL OVERVIEW AND ASSESSMENT
Castle Clinton National Monument
New York, New York**

**William A. Griswold, Ph.D.
Archeology Branch, Northeast Cultural Resources Center
Northeast Region, National Park Service
U.S. Department of the Interior
Lowell, Massachusetts**

December 1999

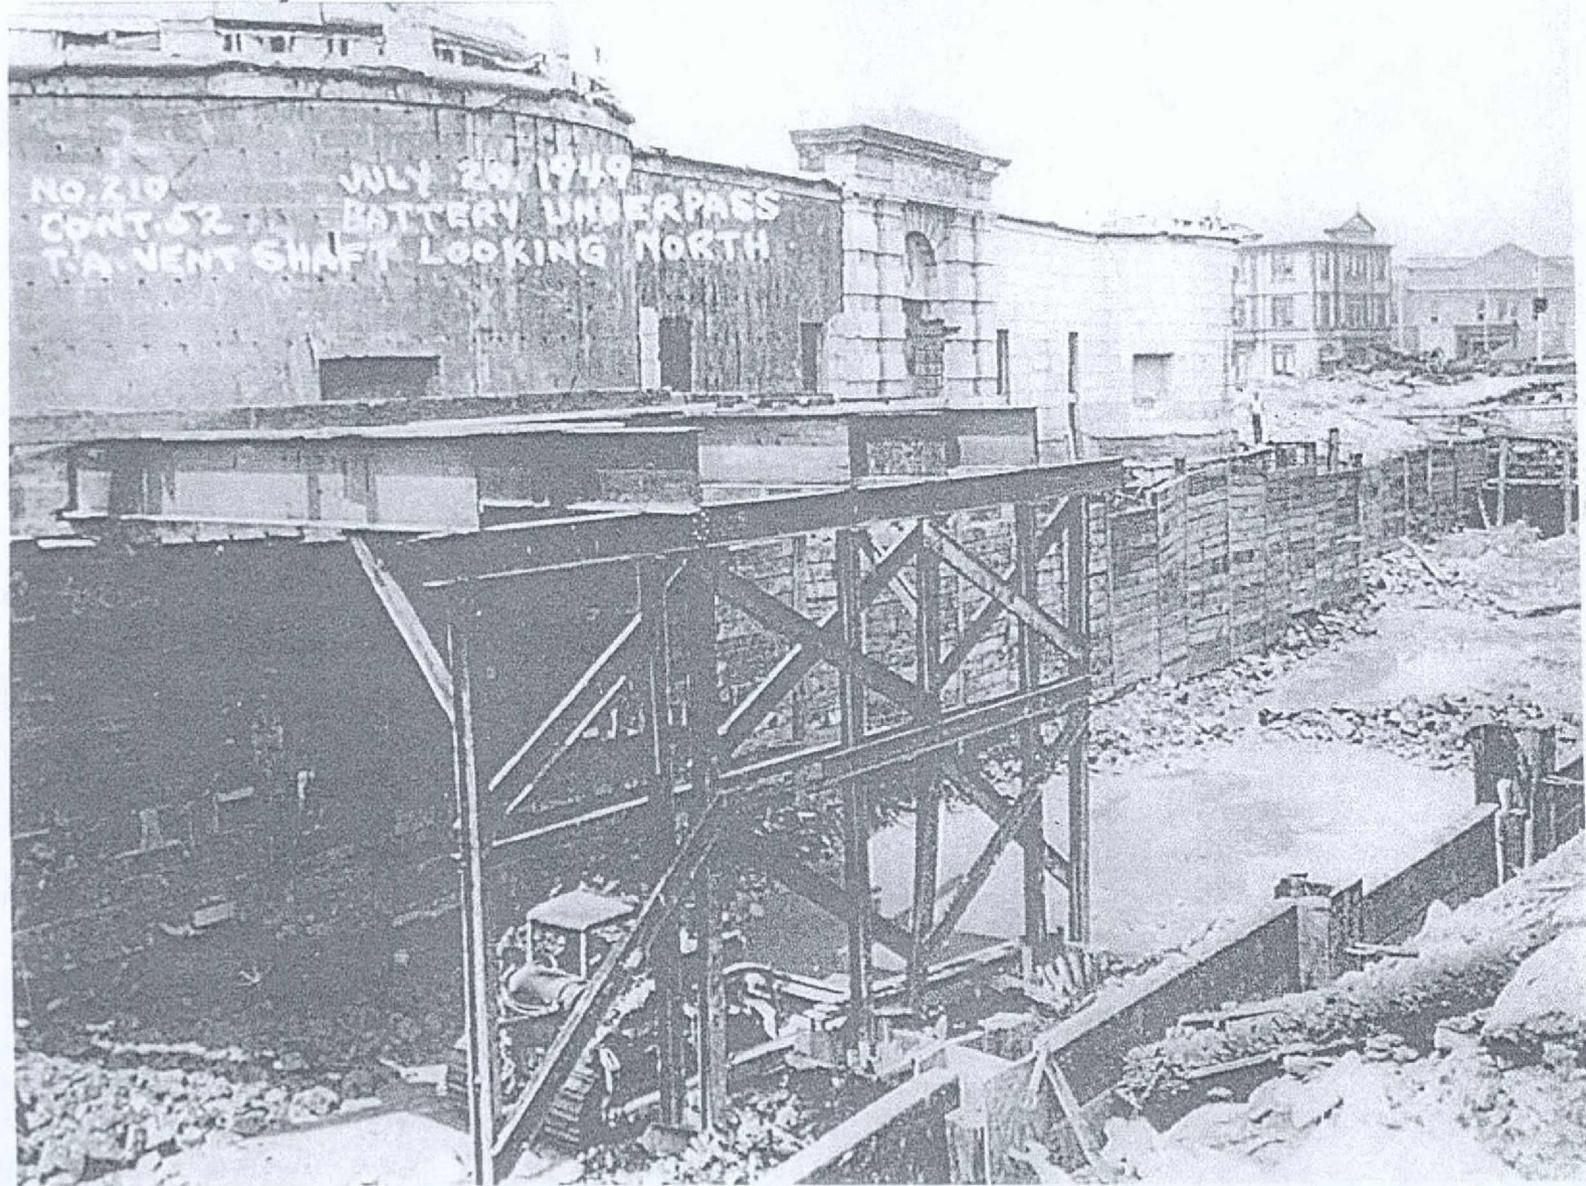
JULY 20, 1949

Figure 5.3 Photograph of the construction of the Battery Park Tunnel.

One of the largest and most damaging construction projects from an archeological perspective was the excavation of the trench for the Battery Park Underpass. This underpass connects the Westside Highway and the FDR Drive and was coordinated by New York City Parks Commissioner Robert Moses back in the 1940's. Photographs in the park archives show an excavation trench approximately 30 feet deep and at least 30 feet wide running in front of the eastern portion of the fortifications (Fig. 5.3). The tunnel, in fact, went underneath a portion of Castle Clinton, which then had to be supported by a steel frame (Fig. 5.3). Another photograph taken a little over a month later shows the excavation of a "test pit" underneath the overhang of the castle. This "test pit", most likely an engineering test pit, shows timbers and stones probably from the construction of the counterguard (Fig.5.4). This indicates that the base of the counterguard was probably never reached and that undisturbed deposits may exist below the lowest level of the underpass.

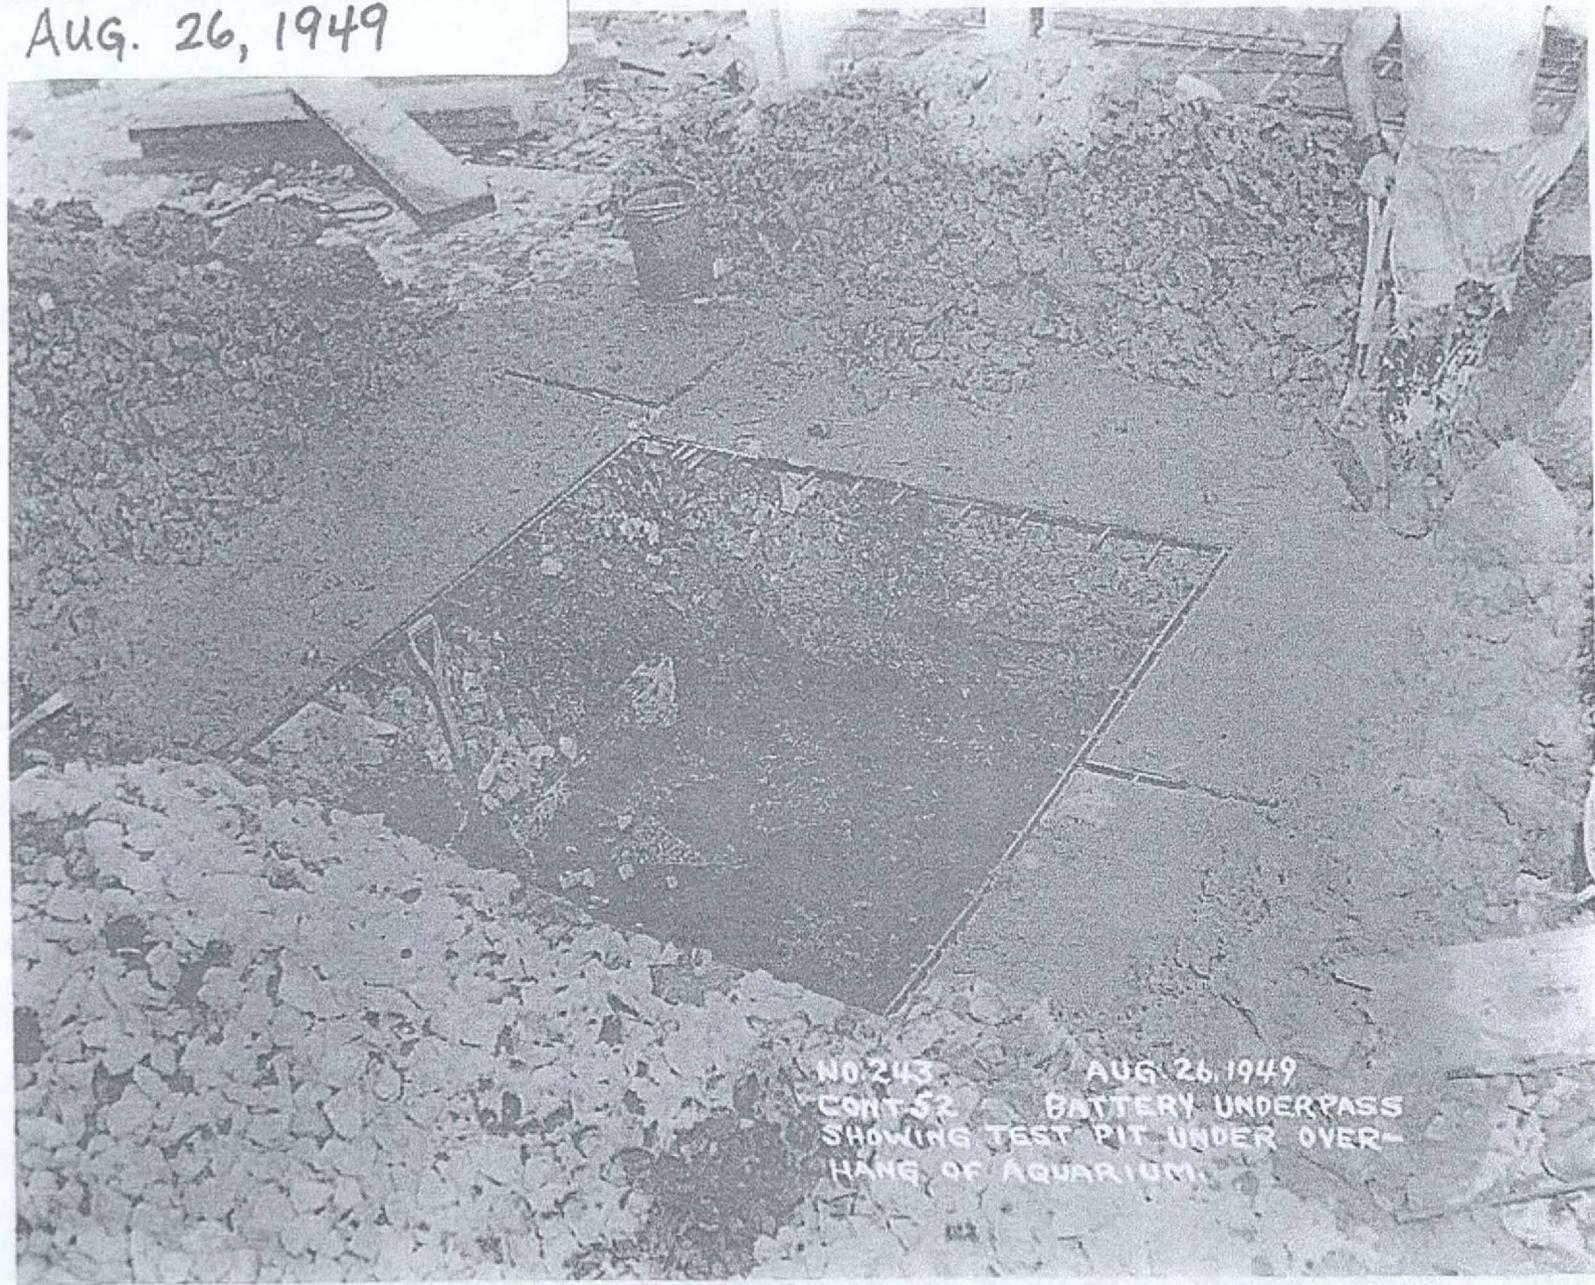
NO. 243 AUG. 26, 1949
CONT. 52 BATTERY UNDERPASS
SHOWING TEST PIT UNDER OVER-
HANG OF AQUARIUM.

Figure 5.4 Photograph of a test pit dug underneath the overhang of Castle Clinton at the bottom of the tunnel.

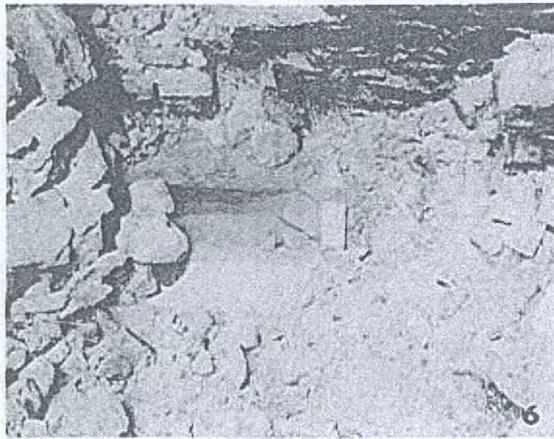
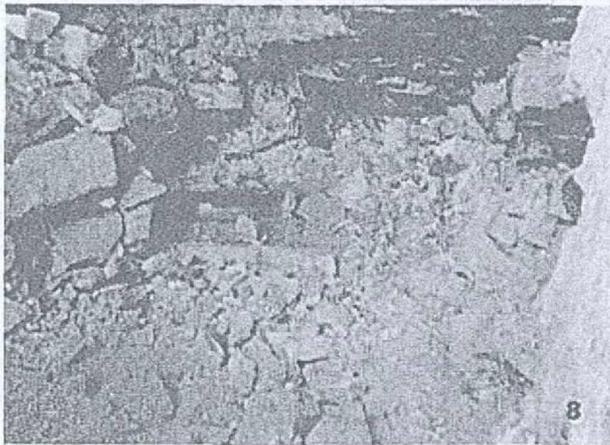
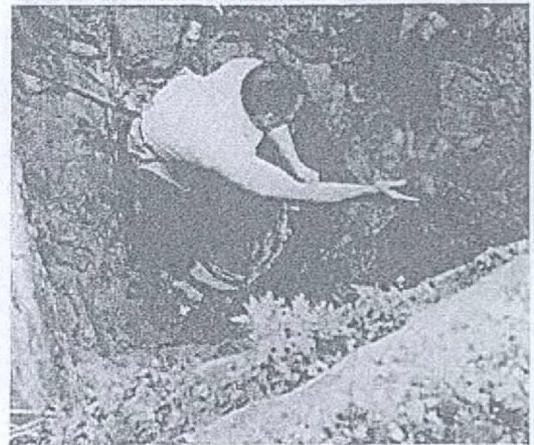
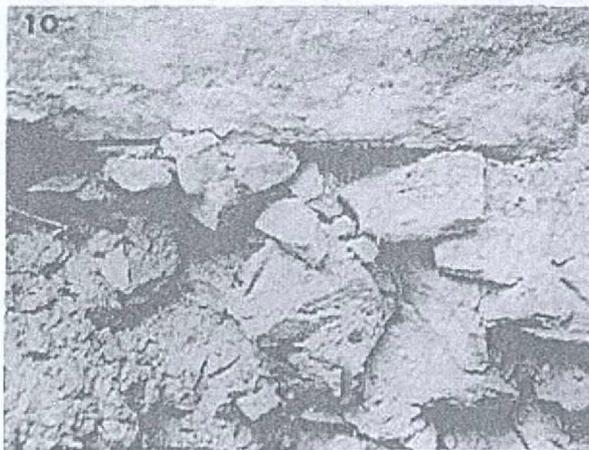
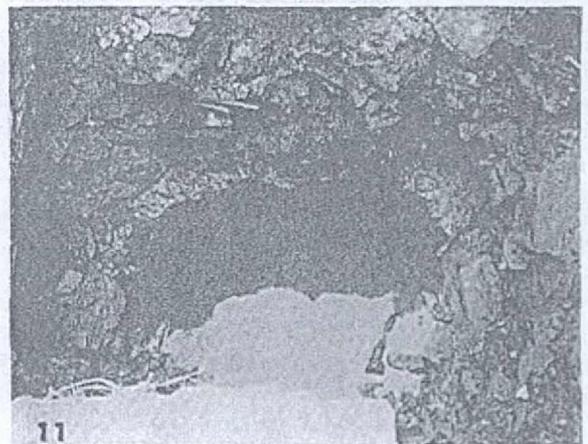
Figure 5.5 Photographs of engineering tests (after Colle 1968).

Another project bearing upon our examination of Castle Clinton concerned subsurface engineering investigations done by the Prepakt Concrete Company. The project was designed to assess the subsurface conditions of the main Battery wall and to test the effectiveness of jet grouting below the wall to stabilize it (Fig. 5.5). Three test pits were excavated (dimensions unknown) to approximately 10 to 13 feet; a fourth was excavated only about 6 feet deep due to caving. Two borings were also drilled to between 25 to 32 feet deep. The Prepakt Concrete company concluded that:

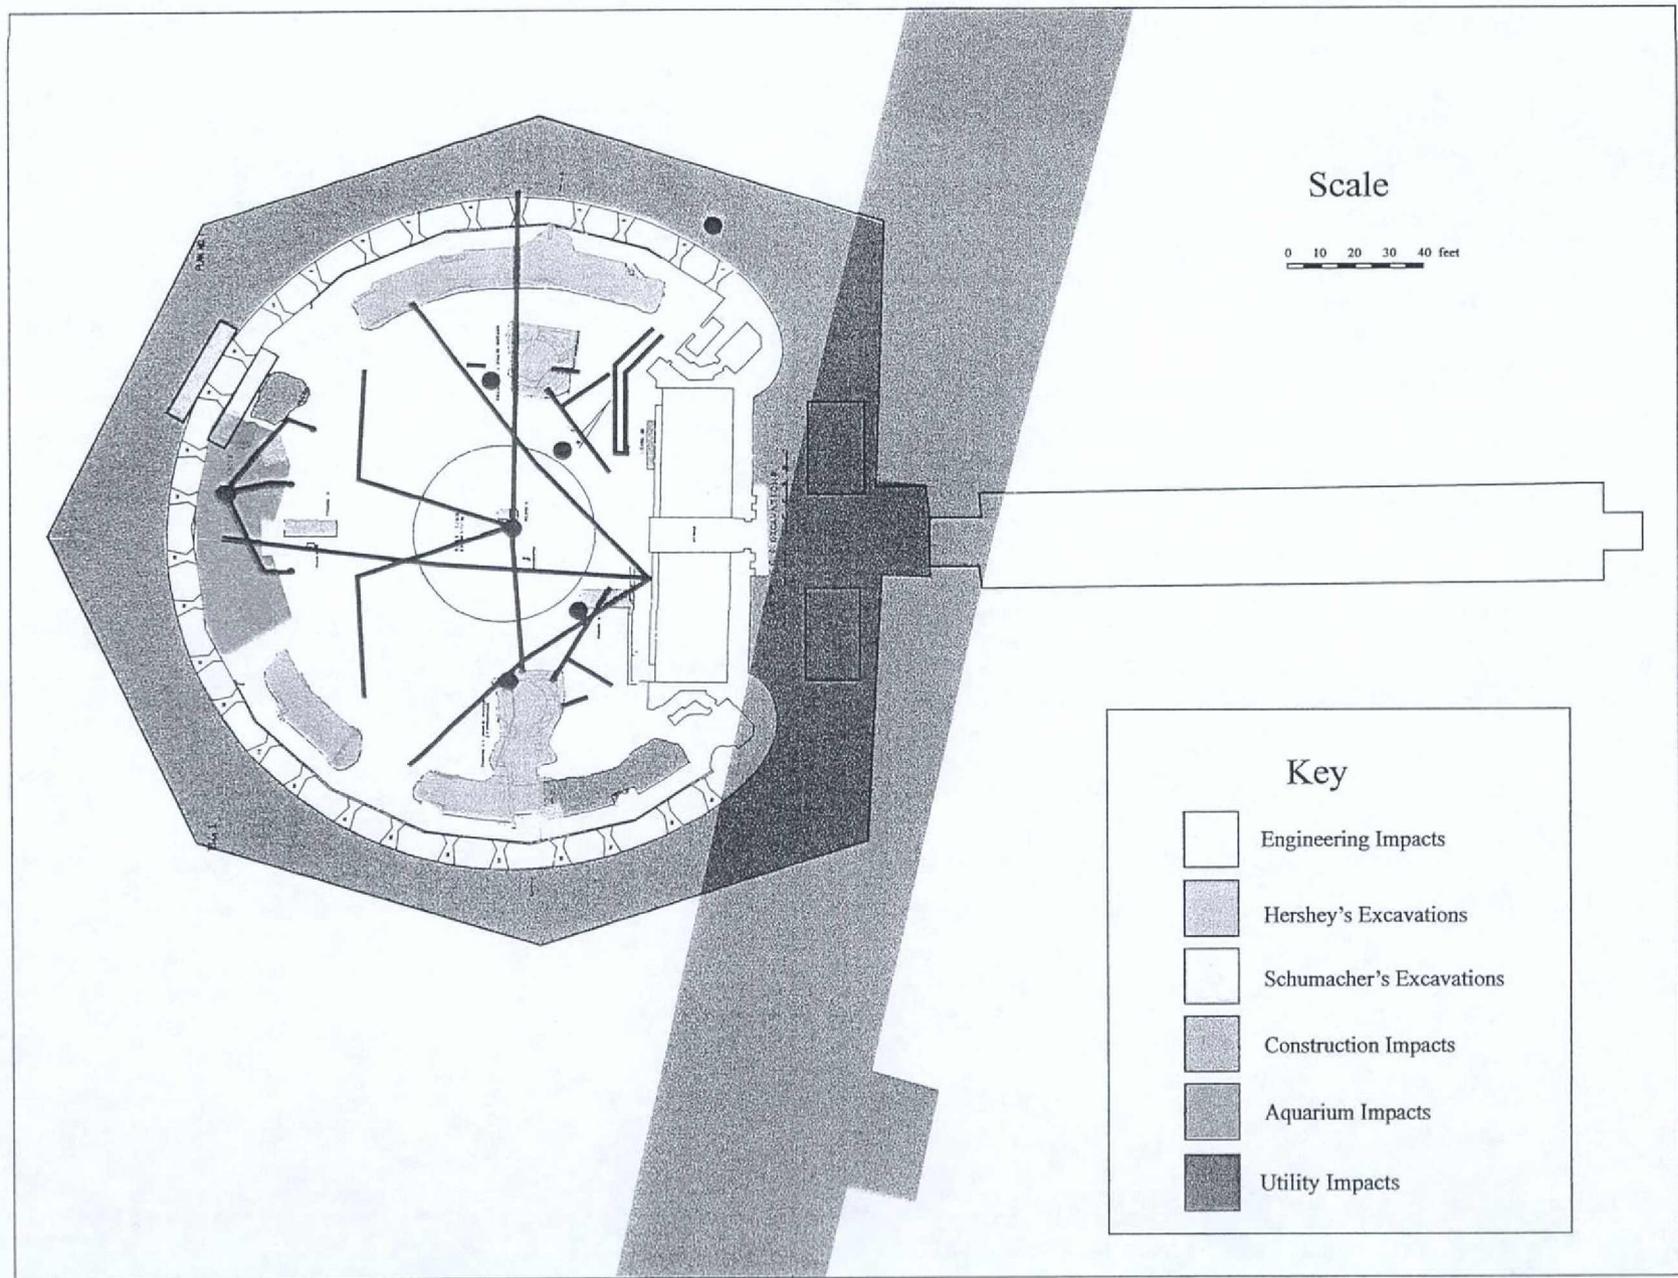
Figure 5.1 Impacts to the archeological deposits at Castle Clinton.

The actual restoration activities in 1973 were, not only damaging from an architectural perspective, but were especially damaging to the archeological deposits. Specific damage to archeological deposits and features will be discussed in the following chapter.

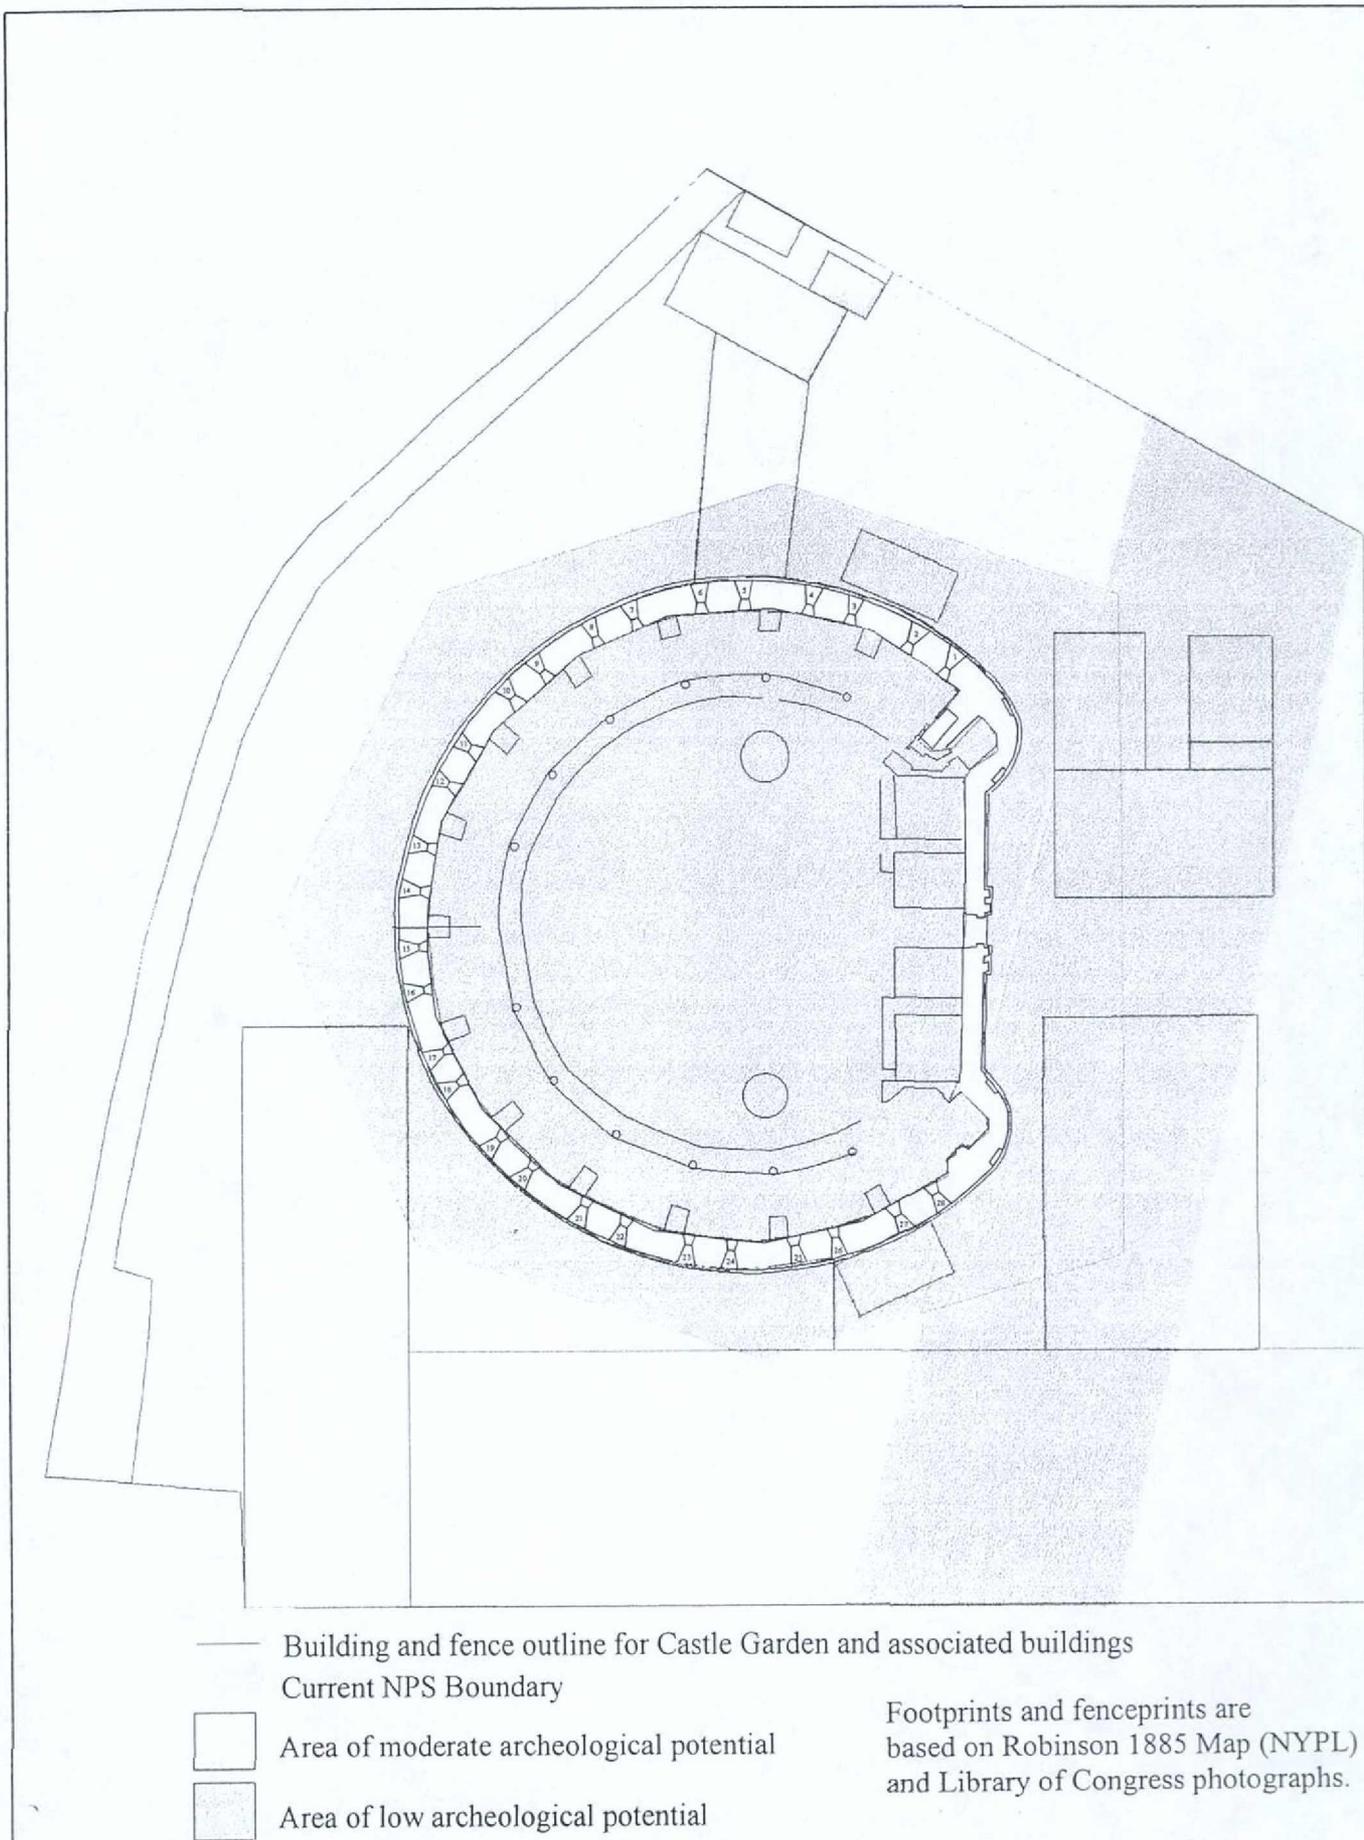
Figure 6.2 Compilation Map of Castle Garden and surrounding buildings.
