**SUB-SURFACE ARCHAEOLOGICAL INVESTIGATION OF THE PARKING AREA
AT POPPENHUSEN INSTITUTE, COLLEGE POINT, QUEENS**

**Poppenhusen Institute
114-04 Fourteenth Road
College Point, New York**

**Eugene J. Boesch Ph.D., R.P.A.
Principal Investigator**

November 8, 2001

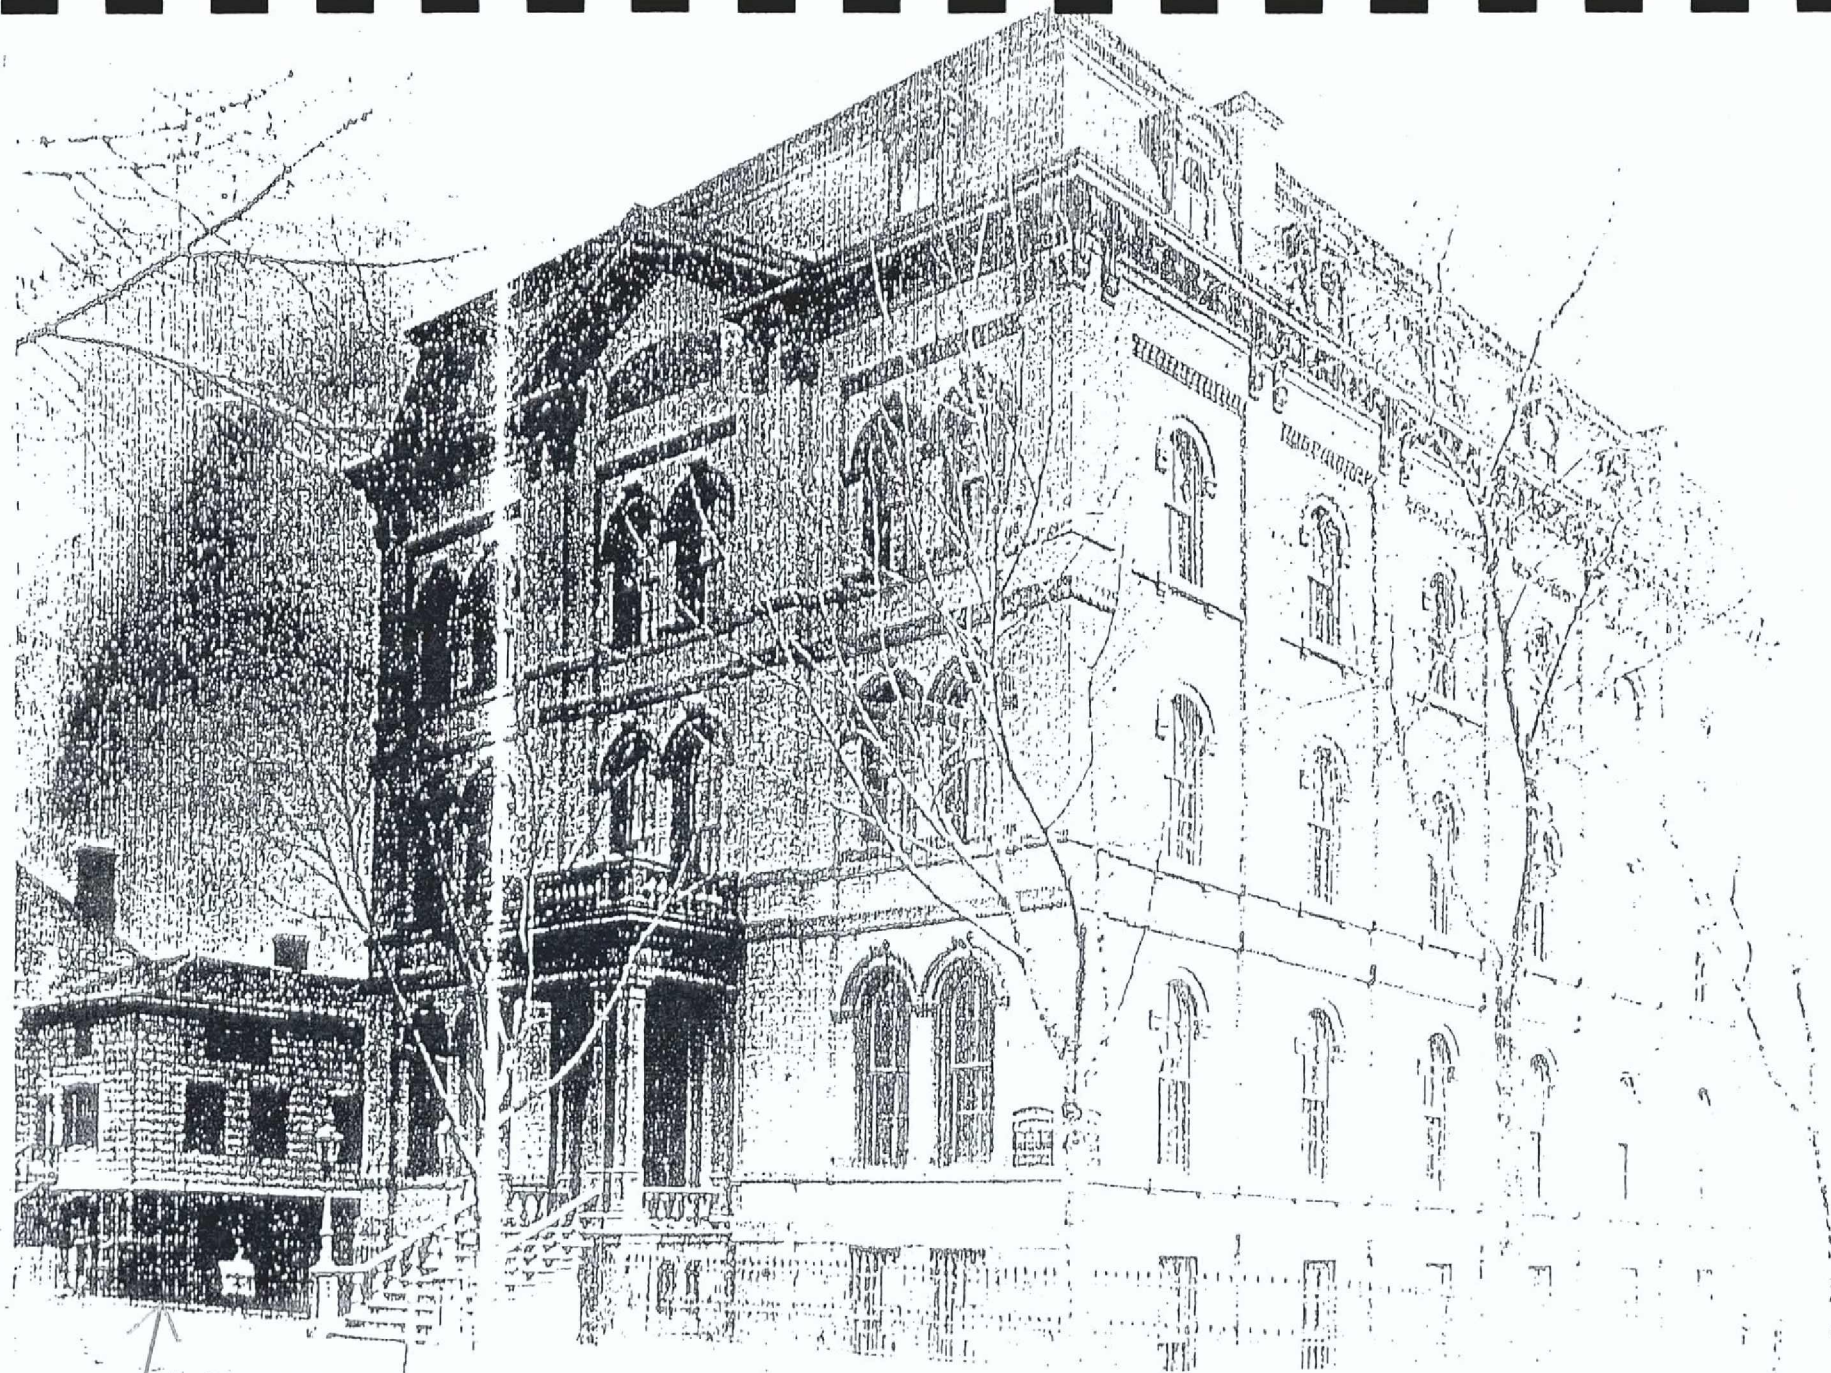
Figure 7
Poppenhusen Institute and Portion of the Barns with the Domestic Residence (Arrow)
Formerly Located in the Study Area - View is to the Southeast

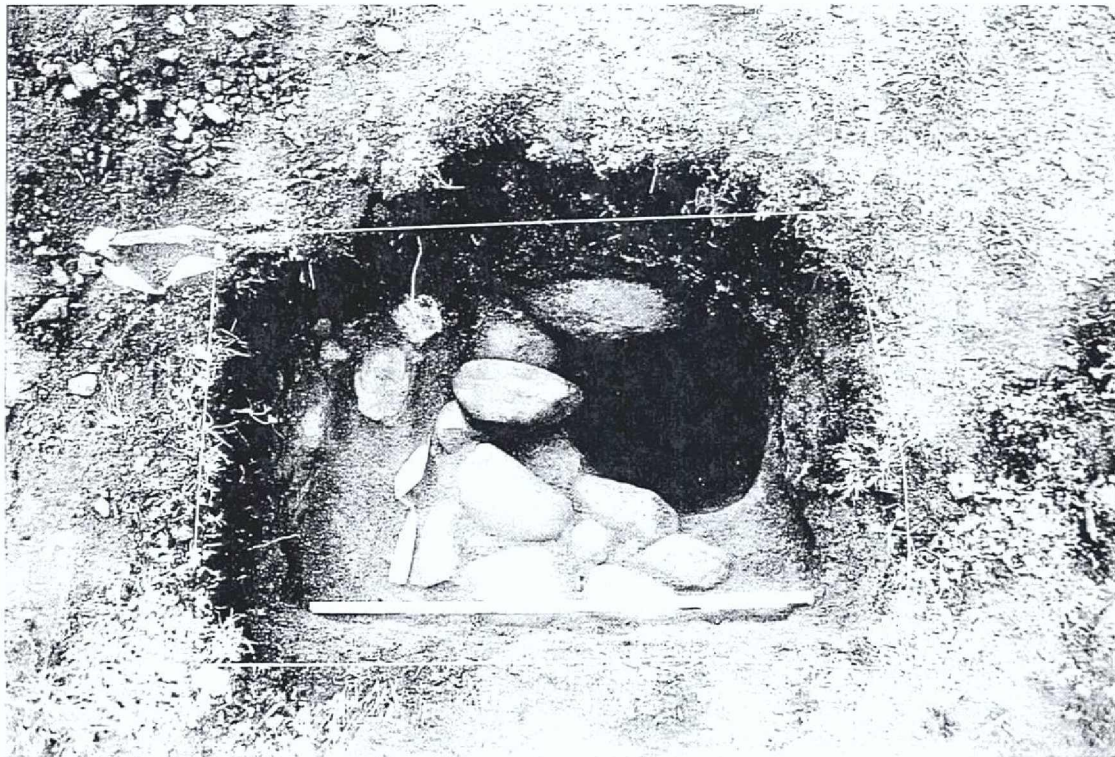
Figure 14
Excavation Unit B

A large cobble layer, seen in shovel test 11 and excavation unit B east of the former location of the "old barns" dwelling at a depth of approximately 12 inches below grade, may represent a former driveway or pathway for that structure. The cobbles were found to be lying on top of the sub-soil. Items of relatively recent manufacture (i.e. plastic, modern bottle glass) were found to be associated with that surface during the testing.

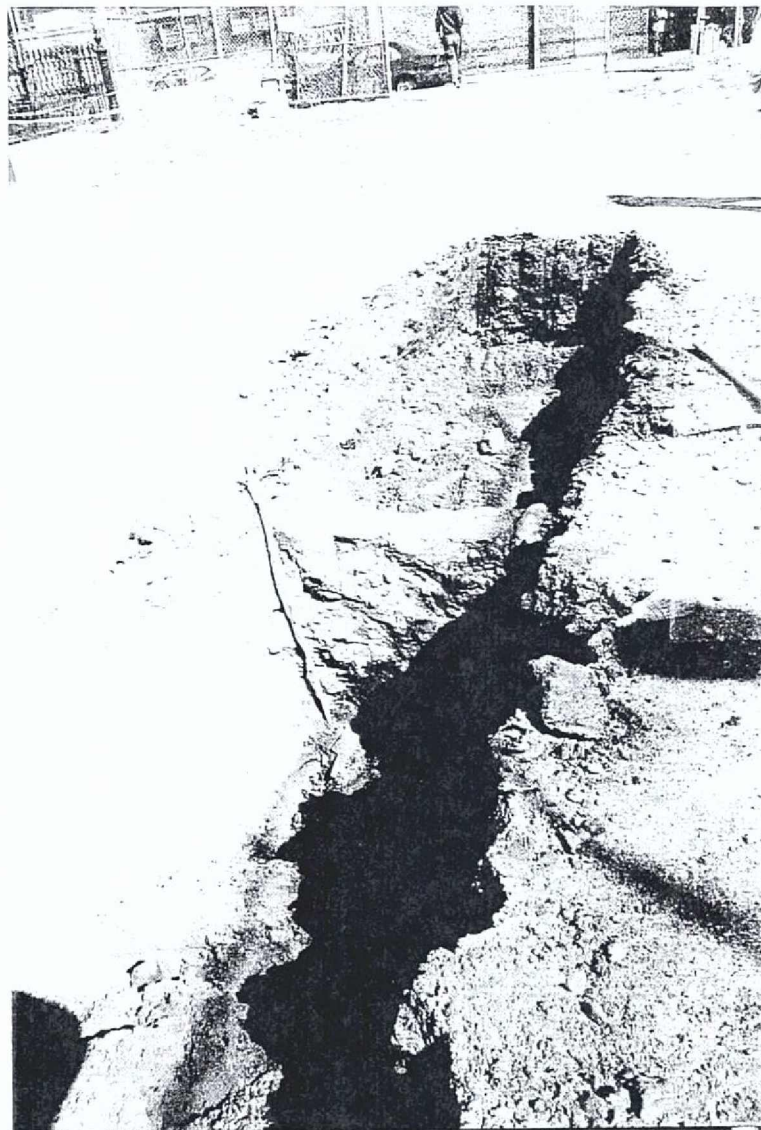
Figure 18
Test Trenches I (Bottom) and II (Top)

Test trench II was placed within the identified foundation of the old barns western ell (Figures 18 and 21). It was approximately 40 feet long and four feet wide. It extended northward from the former rear wall of the residence (Figures 10 - 12). A series of fill layers were encountered in the trench that extended to approximately 47 to 49 inches below modern grade. They consisted sequentially of a 16 inch thick layer of dark brown sandy silt mixed with gray brown sandy silt (Stratum I) followed by layers of: 1) dark gray brown sandy silt (Stratum II), seven to nine inches thick; 2) brown sandy silt mixed with dark brown sandy silt (Stratum III), five to seven inches thick; and 3) tan brown sandy silt (Stratum IV), seven inches thick.
