Archaeological Tests and Artifact Analysis Results from Rufus King Park, Jamaica, Queens, New York.

Joel W. Grossman, PhD. P.I.
Grossman and Associates, Inc.
201 East 16th Street
New York, NY 10003

March 5, 1991

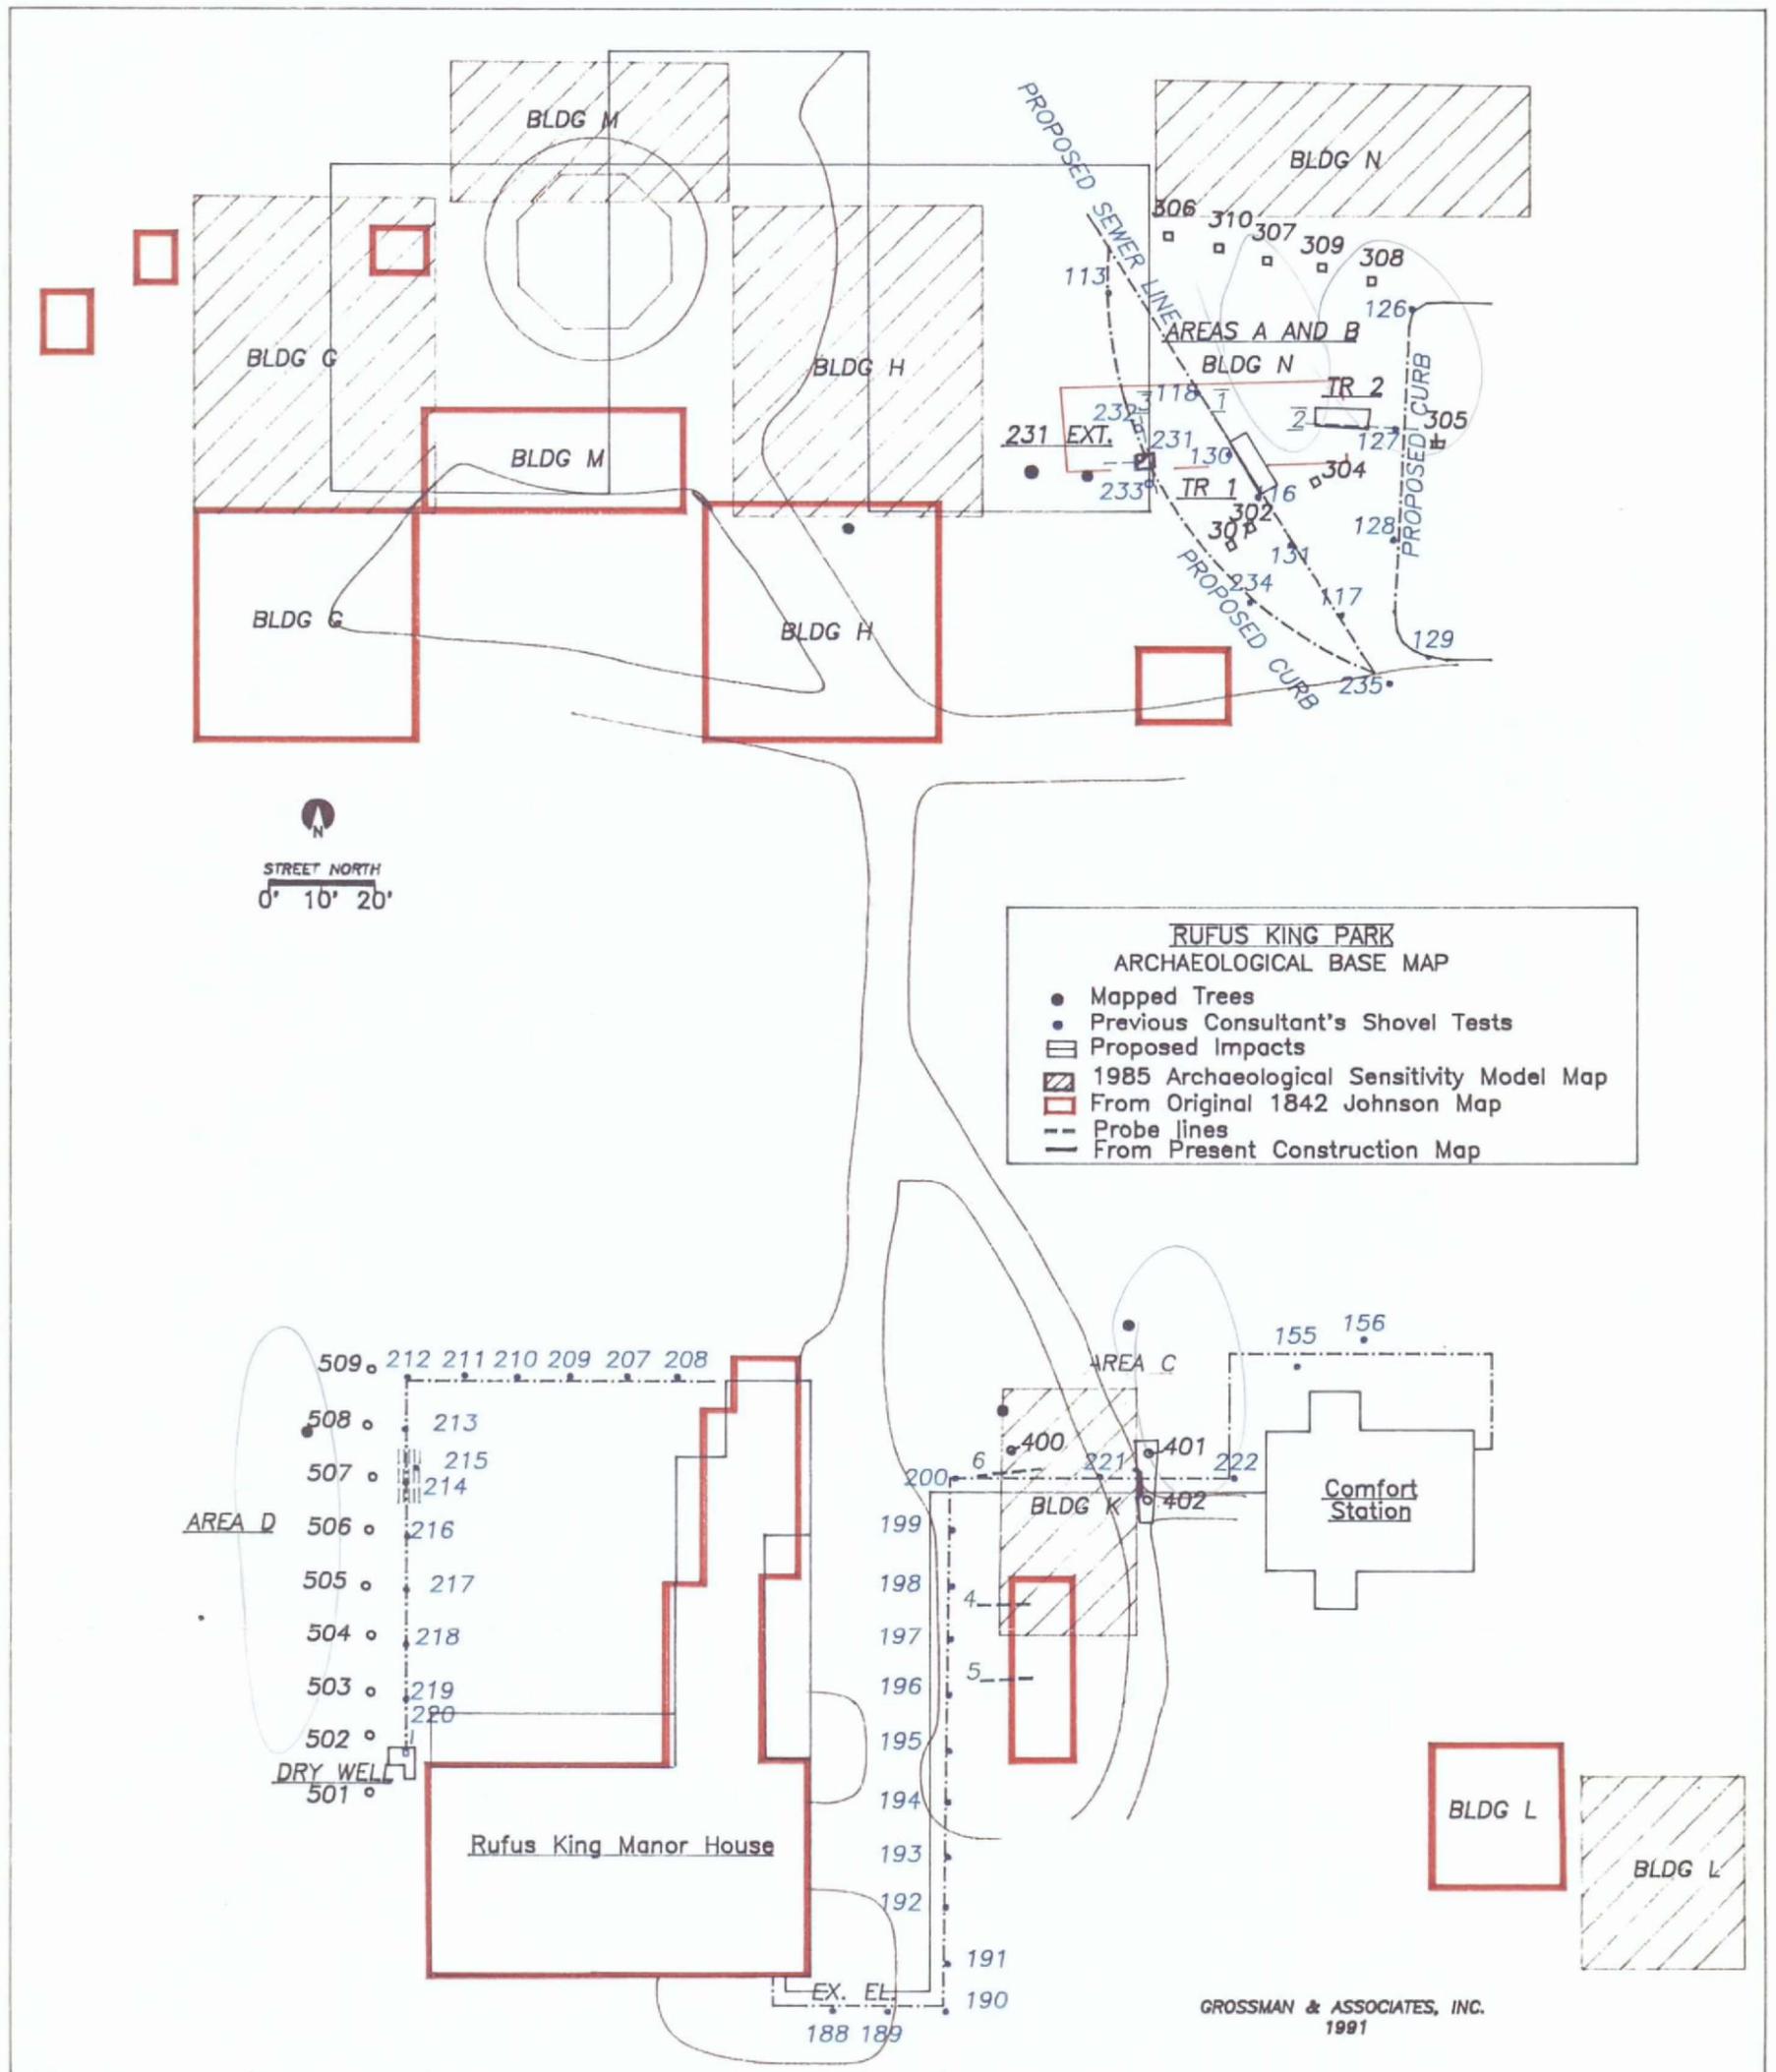
Figure 1: Computer based site map of Rufus King Park showing study areas A,B,C, and D, with subsurface test locations and projections of mid 19th century buildings. Scaled historic map overlays depict the relative positions of current and prior projections of historic structures in relation to the existing Study Areas and standing structures.

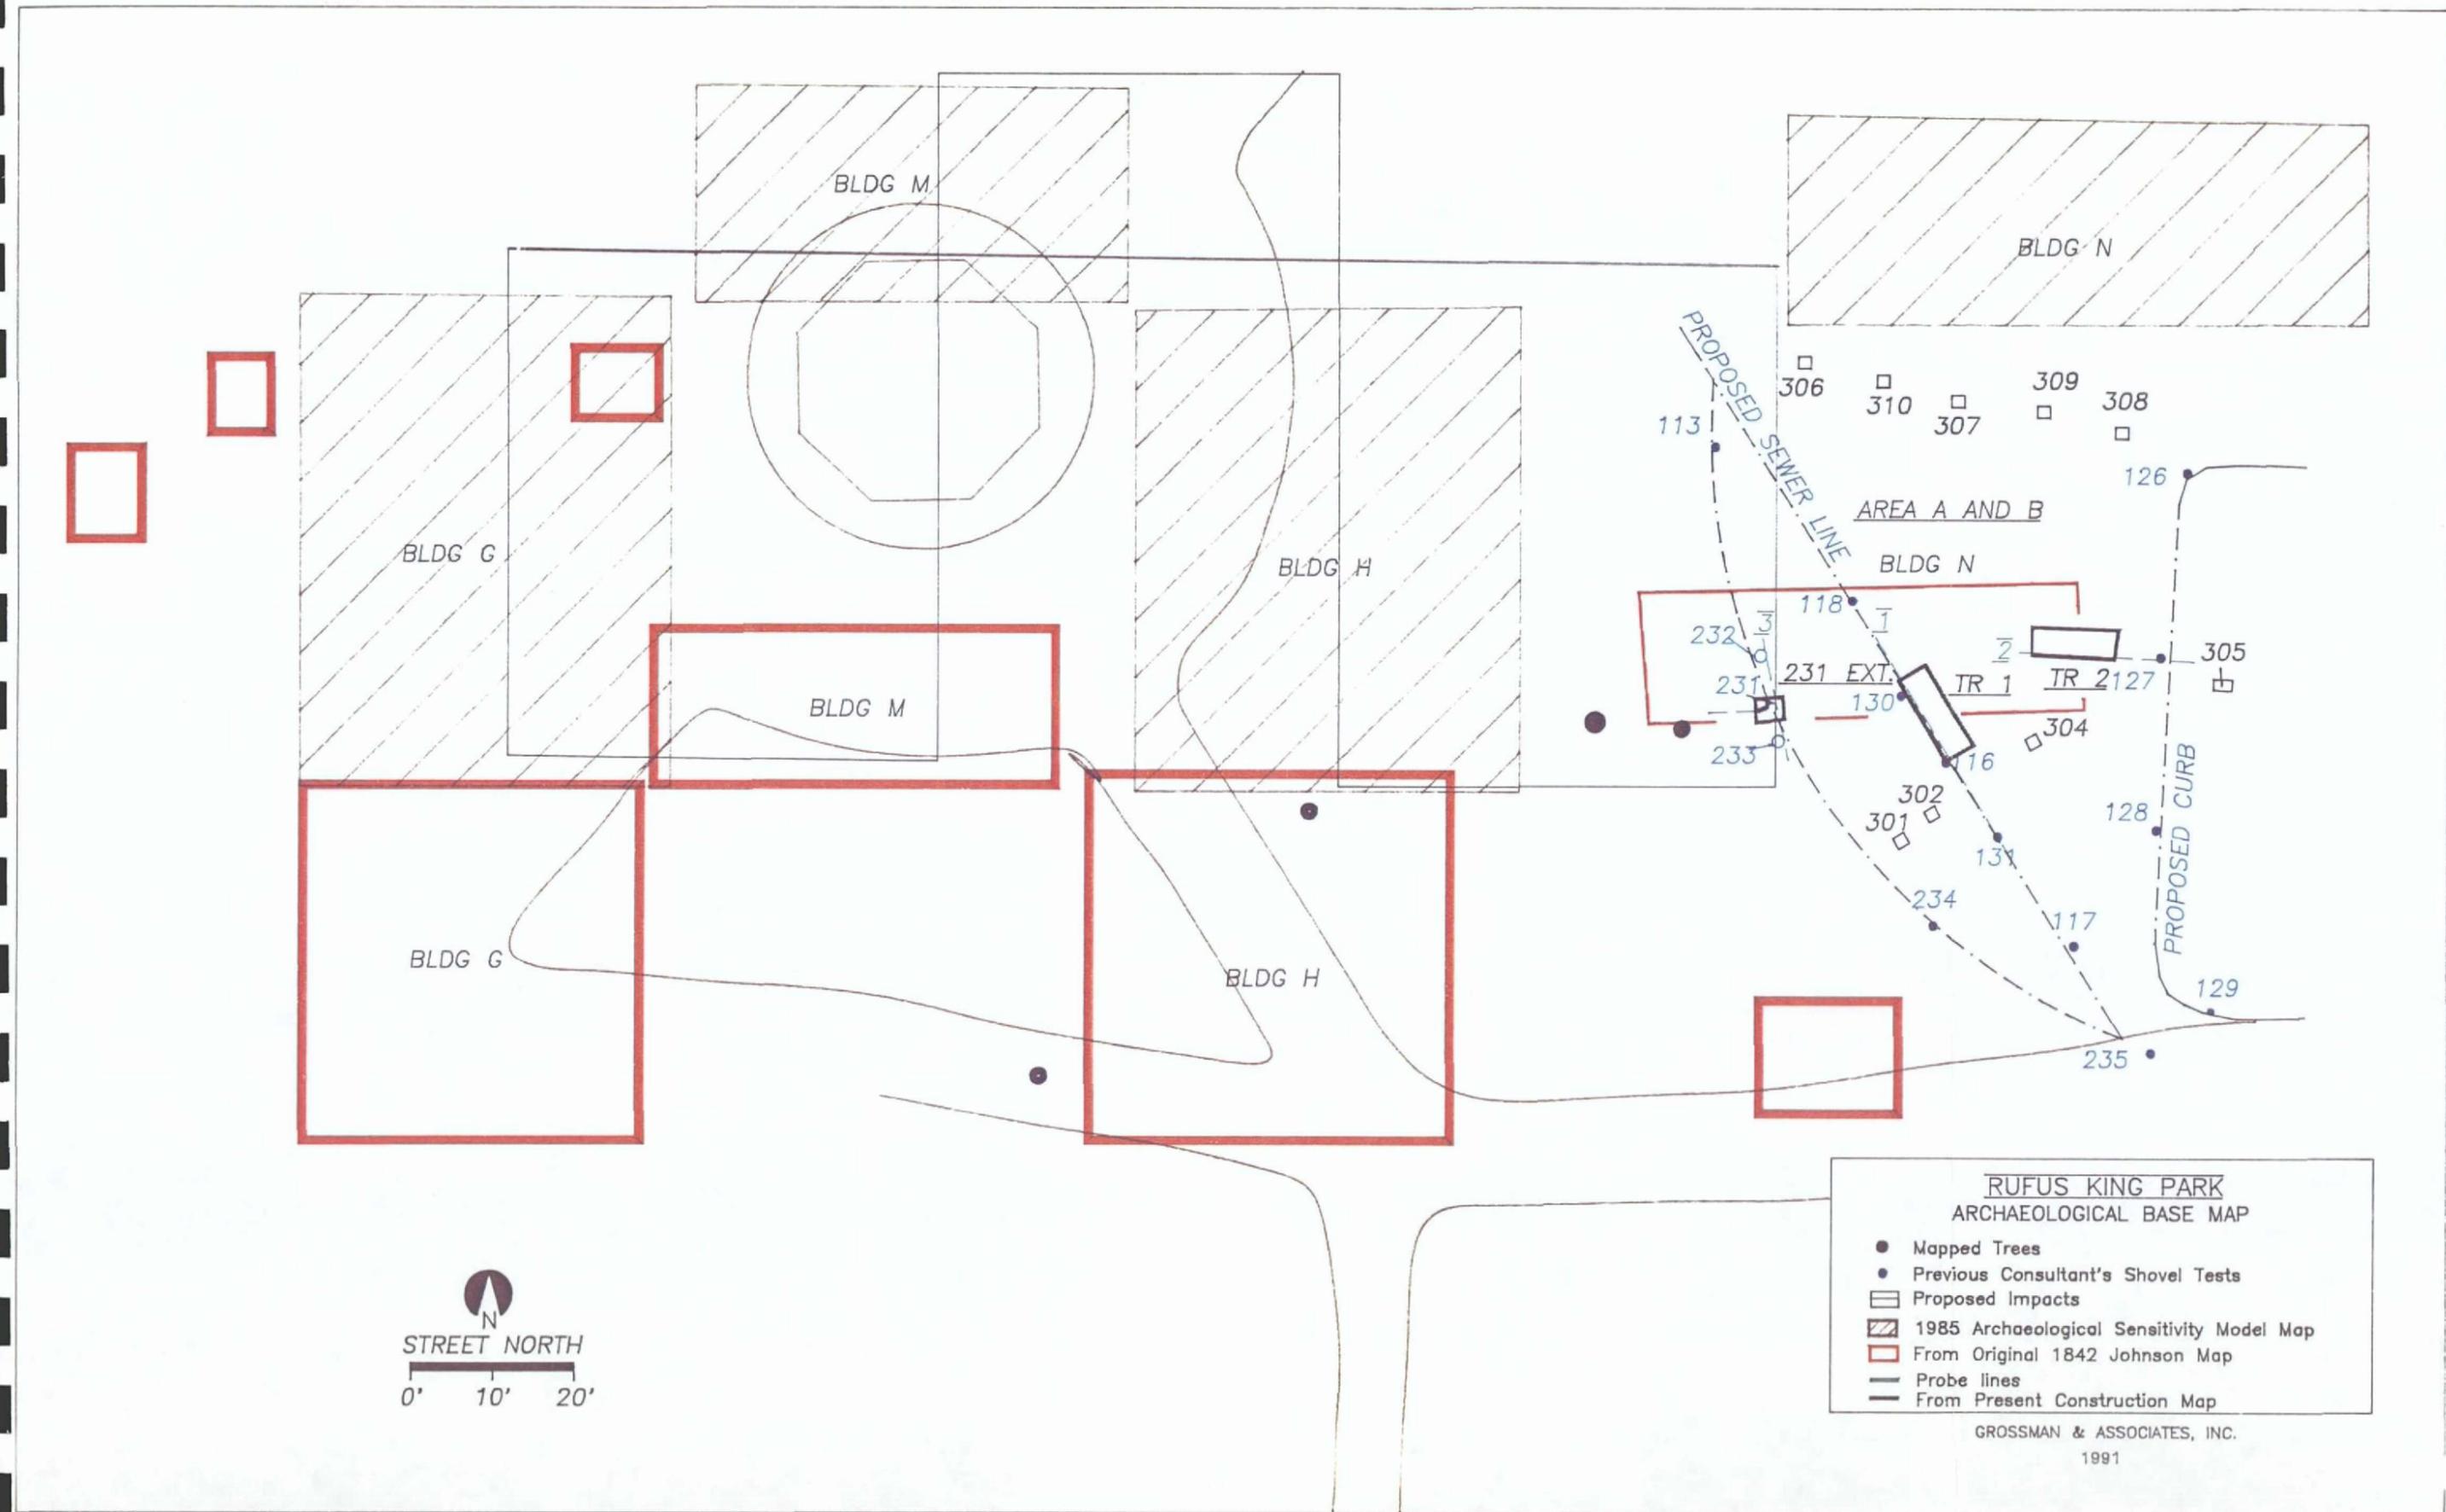
Figure 2:

Detail plan map of Study Areas A and B showing proposed impacts and test locations relative to digitized projections of potential 19th century building locations scaled from original 1842 Johnson map and prior historical reconstructions.

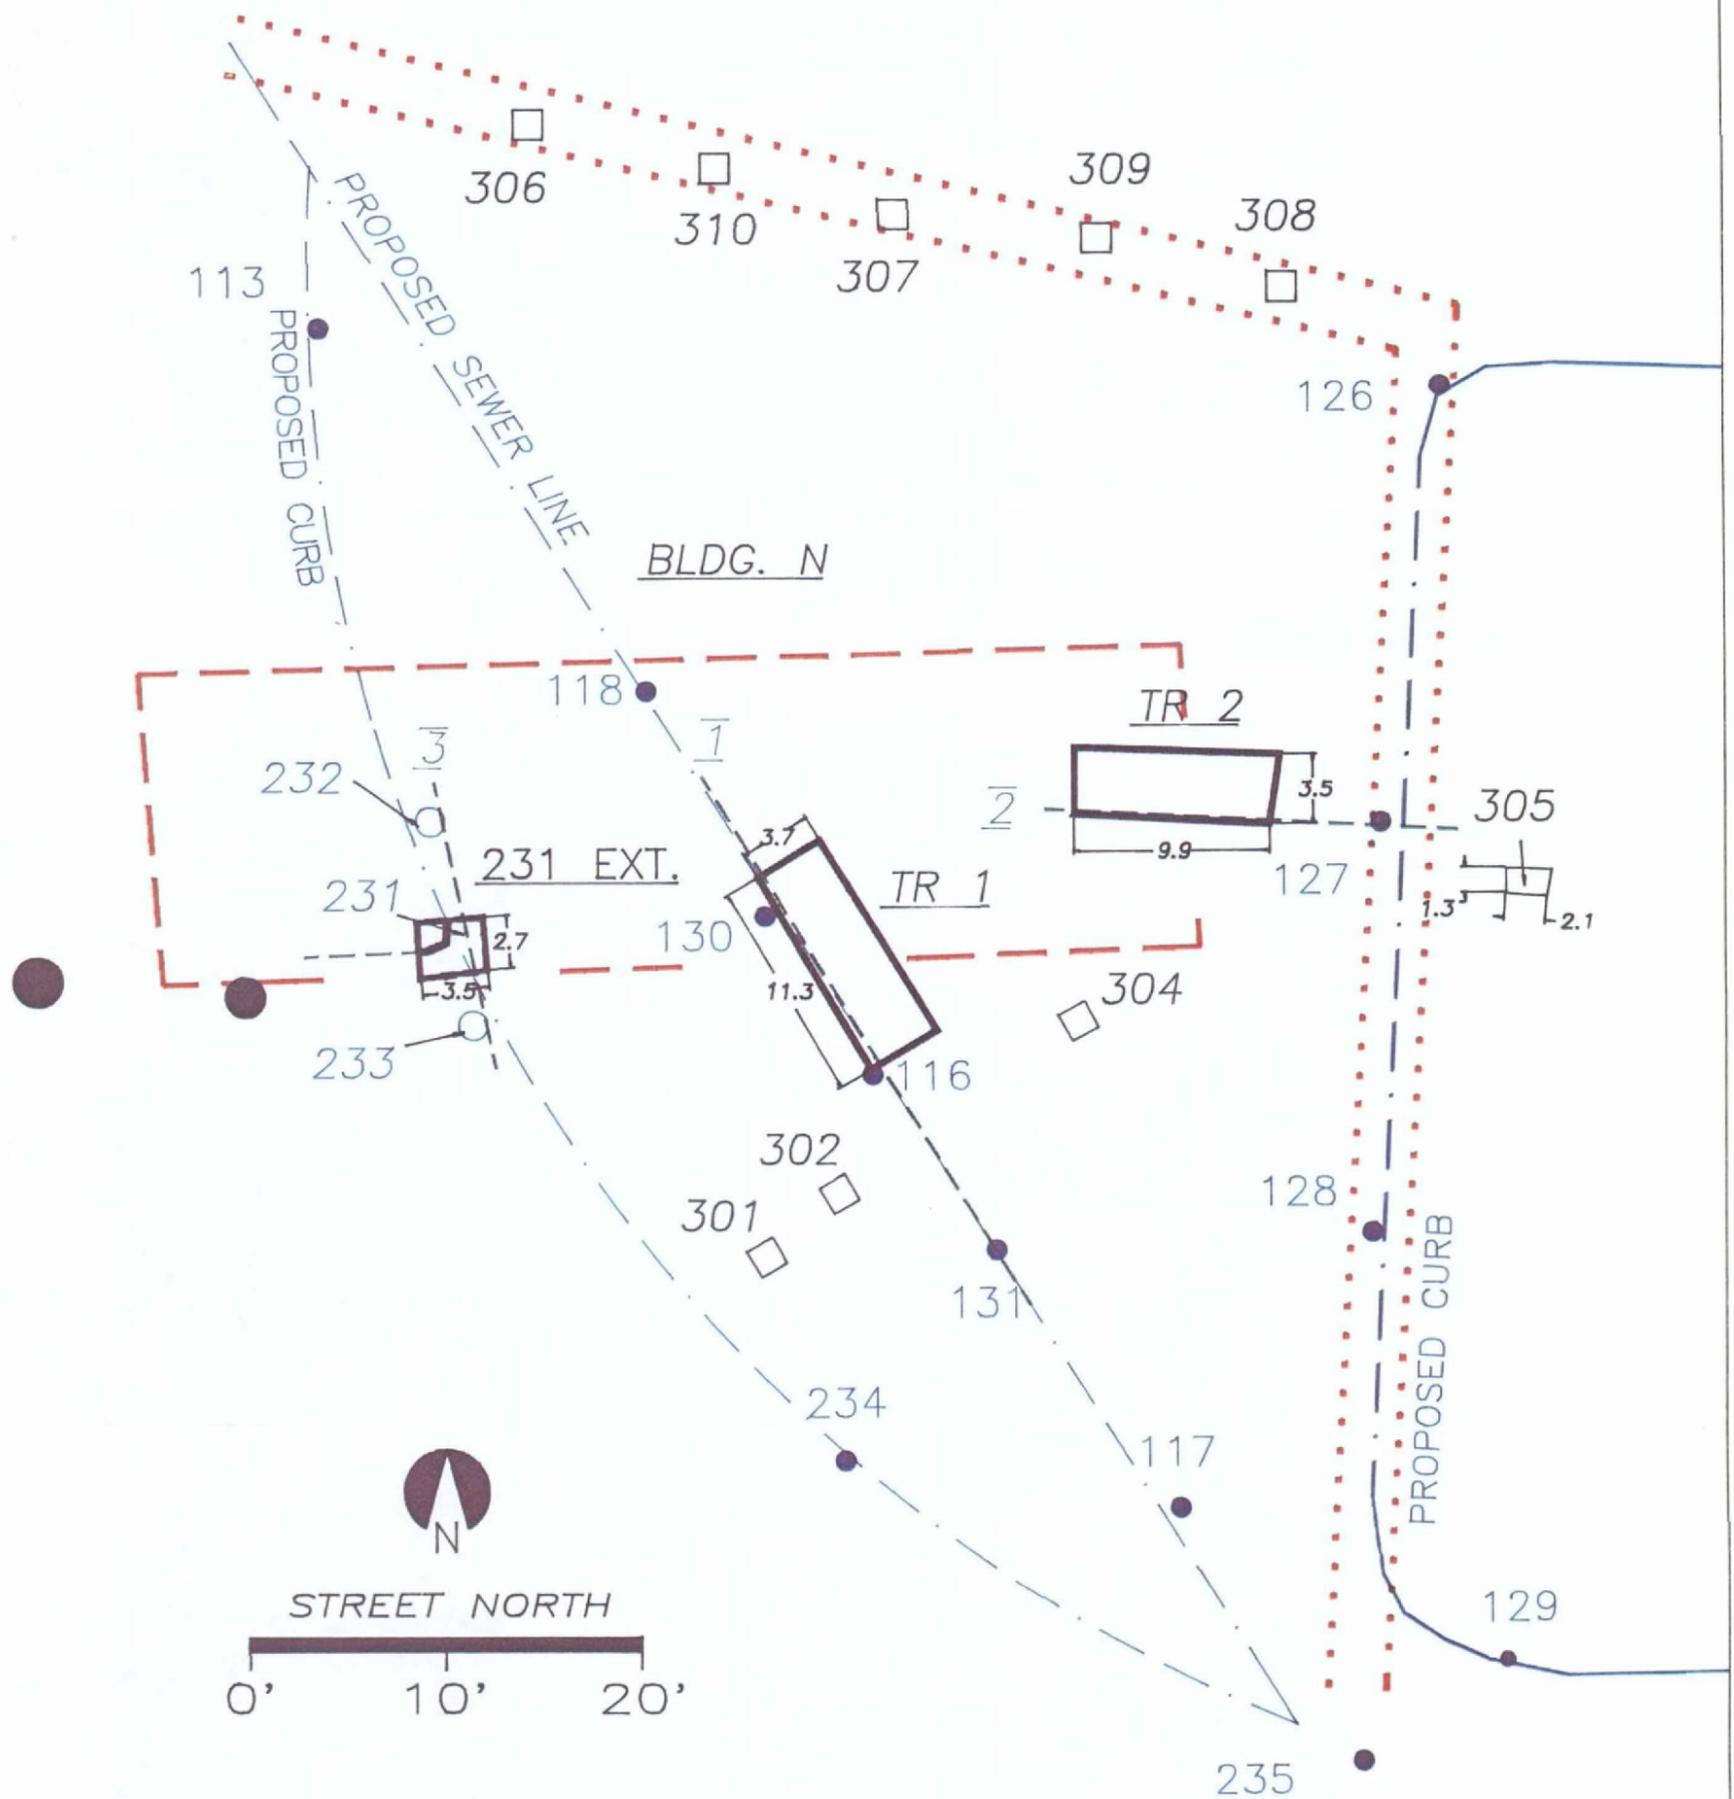
Figure 3: Enlarged scaled map of Rufus King Park showing location of subsurface tests in Areas A and B, and the current and potential alternate route for the proposed sewer line.

sewer line in this portion of the park, and avoiding any impacts on the buried 18th century remains in the vicinity of the newly projected location of Building N (See Figure 3). This new line of shovel tests intersected with the Greenhouse shovel test line numbered 126-129, for which no comparative data was available. Although no significant features or structural remains were encountered, taken as a group, the six shovel tests yielded a small number of predominantly undatable historic artifacts including 28 ceramic specimens, 18 glass, 9 coal, 15 brick, a few small shell fragments, and rusted nails (See Table 1). Only two singular examples of datable artifacts were recovered from the lower (.02) level of shovel tests 308 and 309. Both were post-1780 earthenware sherds.

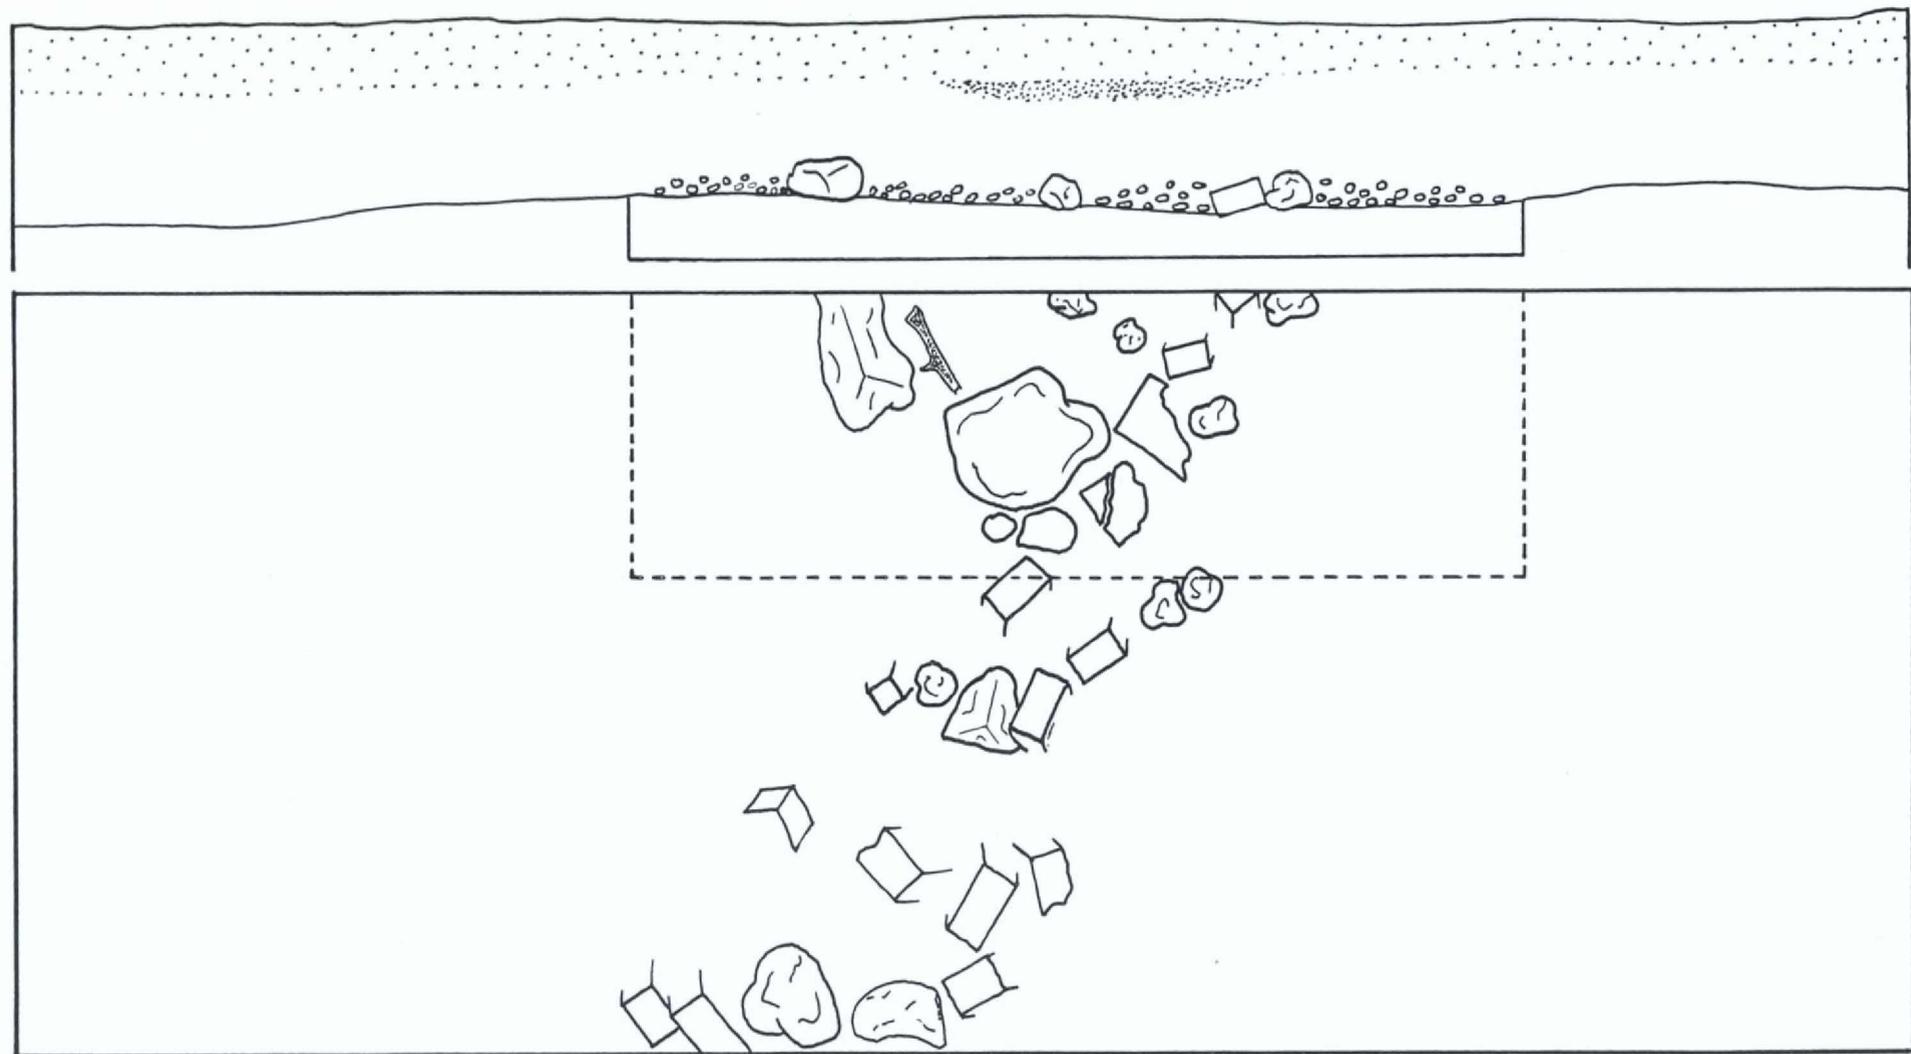
Rufus King Park, Trench No. 1

Figure 4: East wall profile and plan drawing of Trench No. 1.

Once exposed beneath the over burden of the recent organic fill, the surface of the trench was scraped by trowels to expose any possible wall or structural elements associated with Building K. A thin layer of modern structural debris was encountered, but no wall or foundation was identified. The cluster of construction debris consisted of red brick with chunks of mortar and cement which appeared recent in character (See Plate 18). Associated with this rubble was a modern aluminum ginger ale bottle cap, which was crushed and appeared to be stratigraphically associated and contemporary with the rubble beneath the wood chips (See Plate 19 and Plate 35). Two shovel tests, numbered 401 and 402, were excavated through this exposed trench surface and although a large amount of 18th century cultural material was retrieved, no structural wall or foundation elements were encountered (See Plate 16). As itemized below, the contents of each shovel test revealed 20th century artifacts within the first 0.01 or near surface context. However, in all three of the 400 series shovel tests the subsequent .02 context levels yielded only 18th and 19th century artifacts.

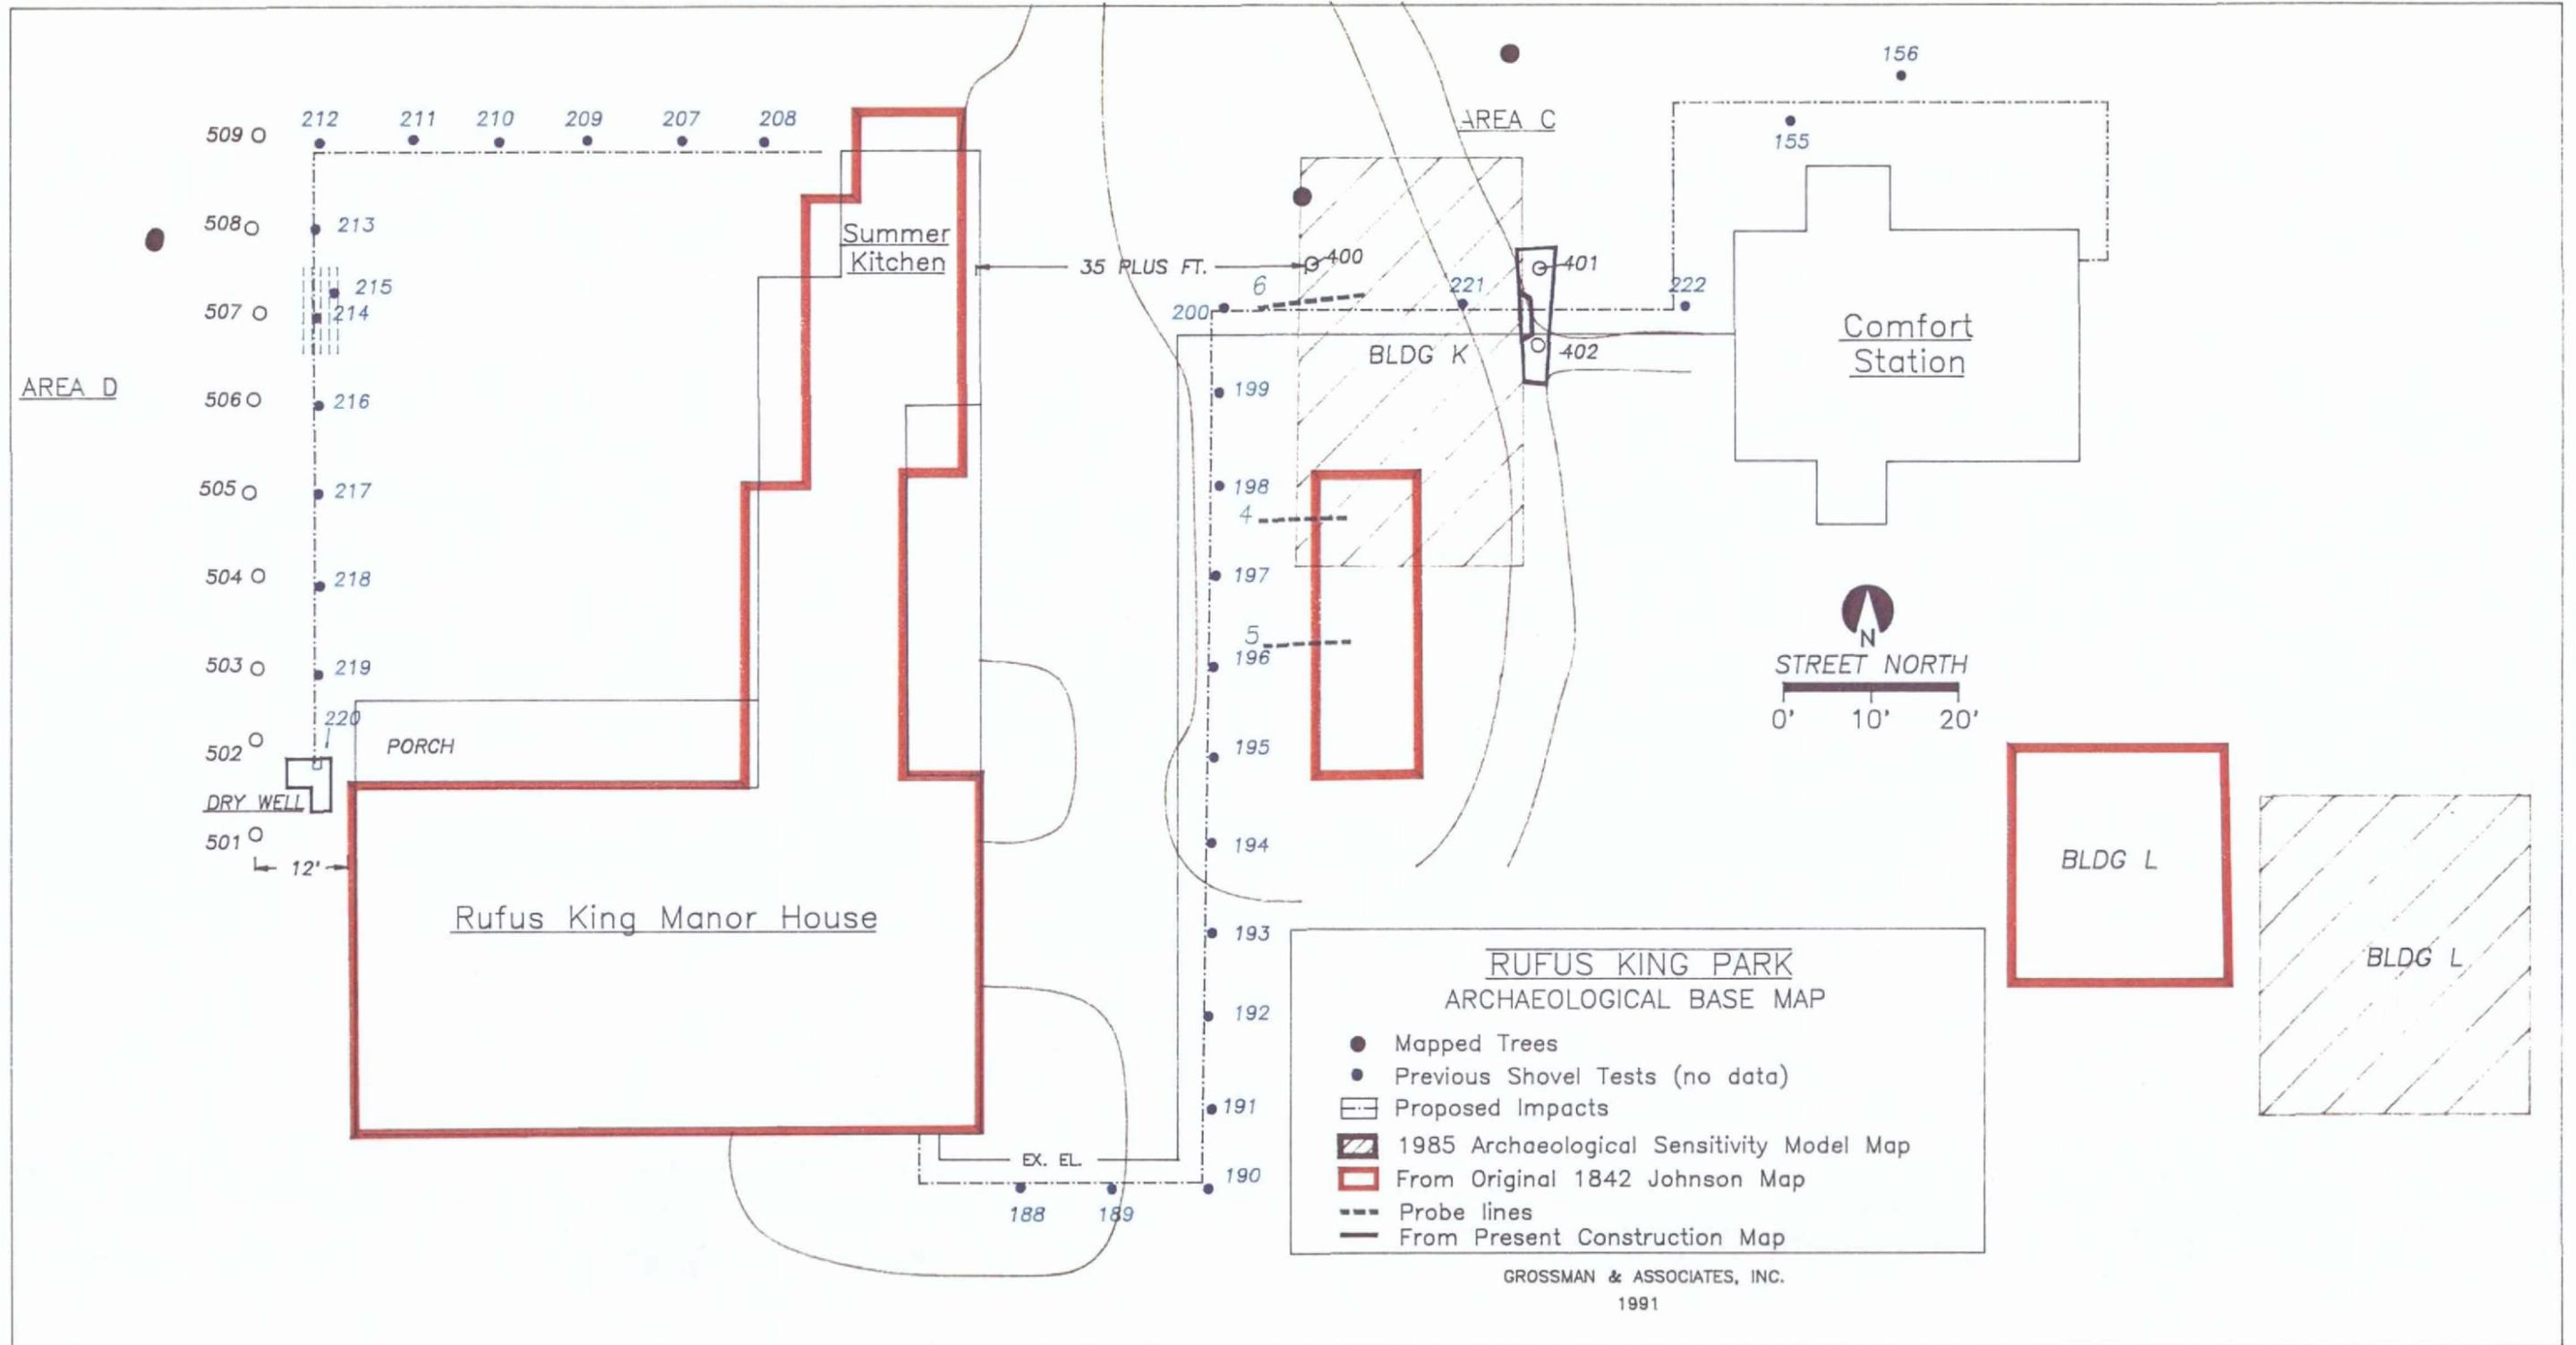
Figure 5:

Computer generated map of the southern half of Rufus King Park showing study areas C and D and scaled projections of 19th century building locations from the prior sensitivity model and original 1842 Johnson map relative to the contemporary Manor House and Comfort Station.

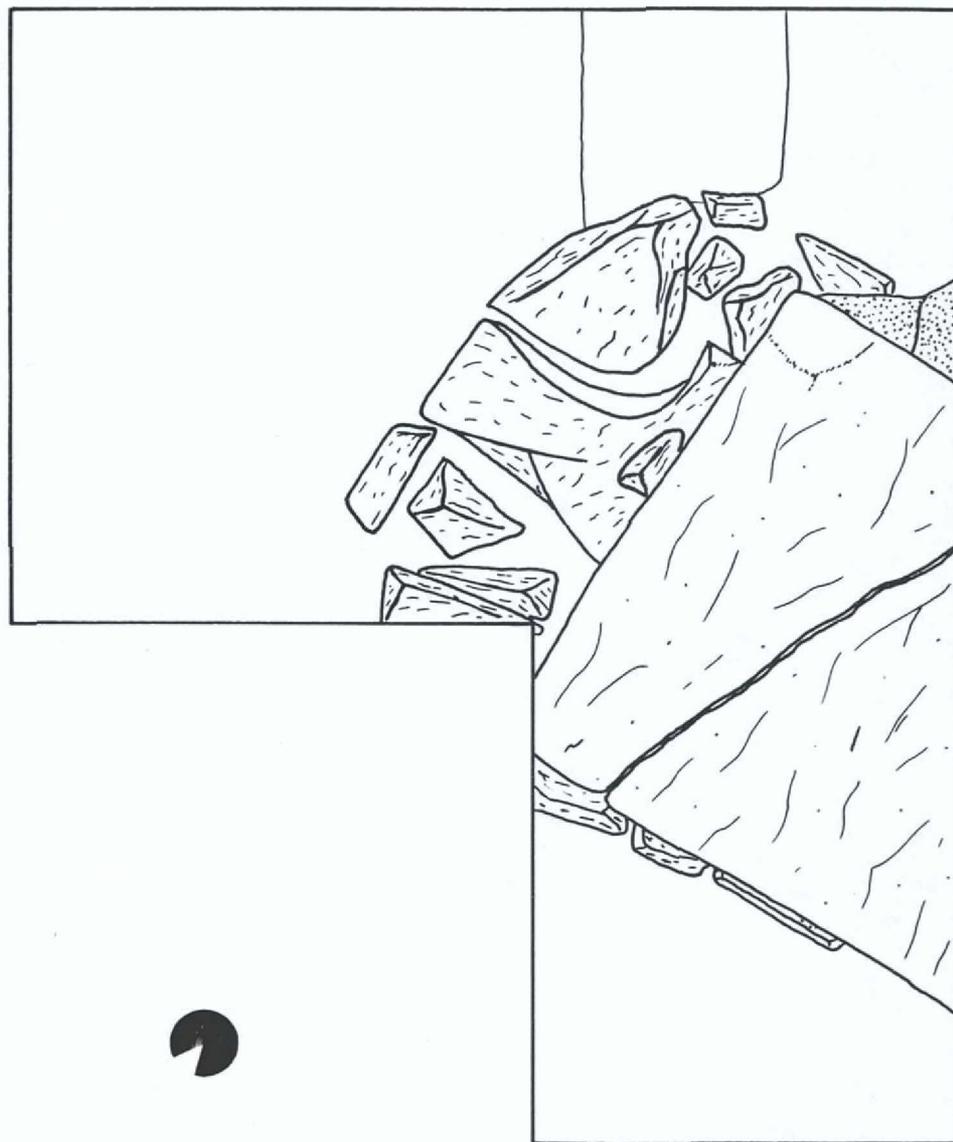
Dry Well

Figure 6: Plan drawing of the possible dry well at the northwest corner of the Manor House in Area D.

Once exposed, this feature proved to represent the well preserved remains of a historic 19th century dry well which appears to have been associated with an early phase of the Manor House construction and occupation. Its function appears to have been as a catchment basin for rain run-off accumulating at the northwest corner of the main house. By trapping the water instead of permitting it to drain next to the house or basement, the dry well served to keep the foundation dry and free of water seepage. While only partially exposed to identify its extent, the feature appears to reflect a high level of structural integrity, extending 5 feet from the house at a ca. 45 degree angle to the west wall of the porch and Manor House. Although the covering slab of stone was not removed, a metal probe inserted through a gap in the rough stone liner showed the feature to be hollow and possibly still functional today. It is highly probable, given its role in controlling rain water and run-off, that the other corners of the Manor House may contain comparable historic features.

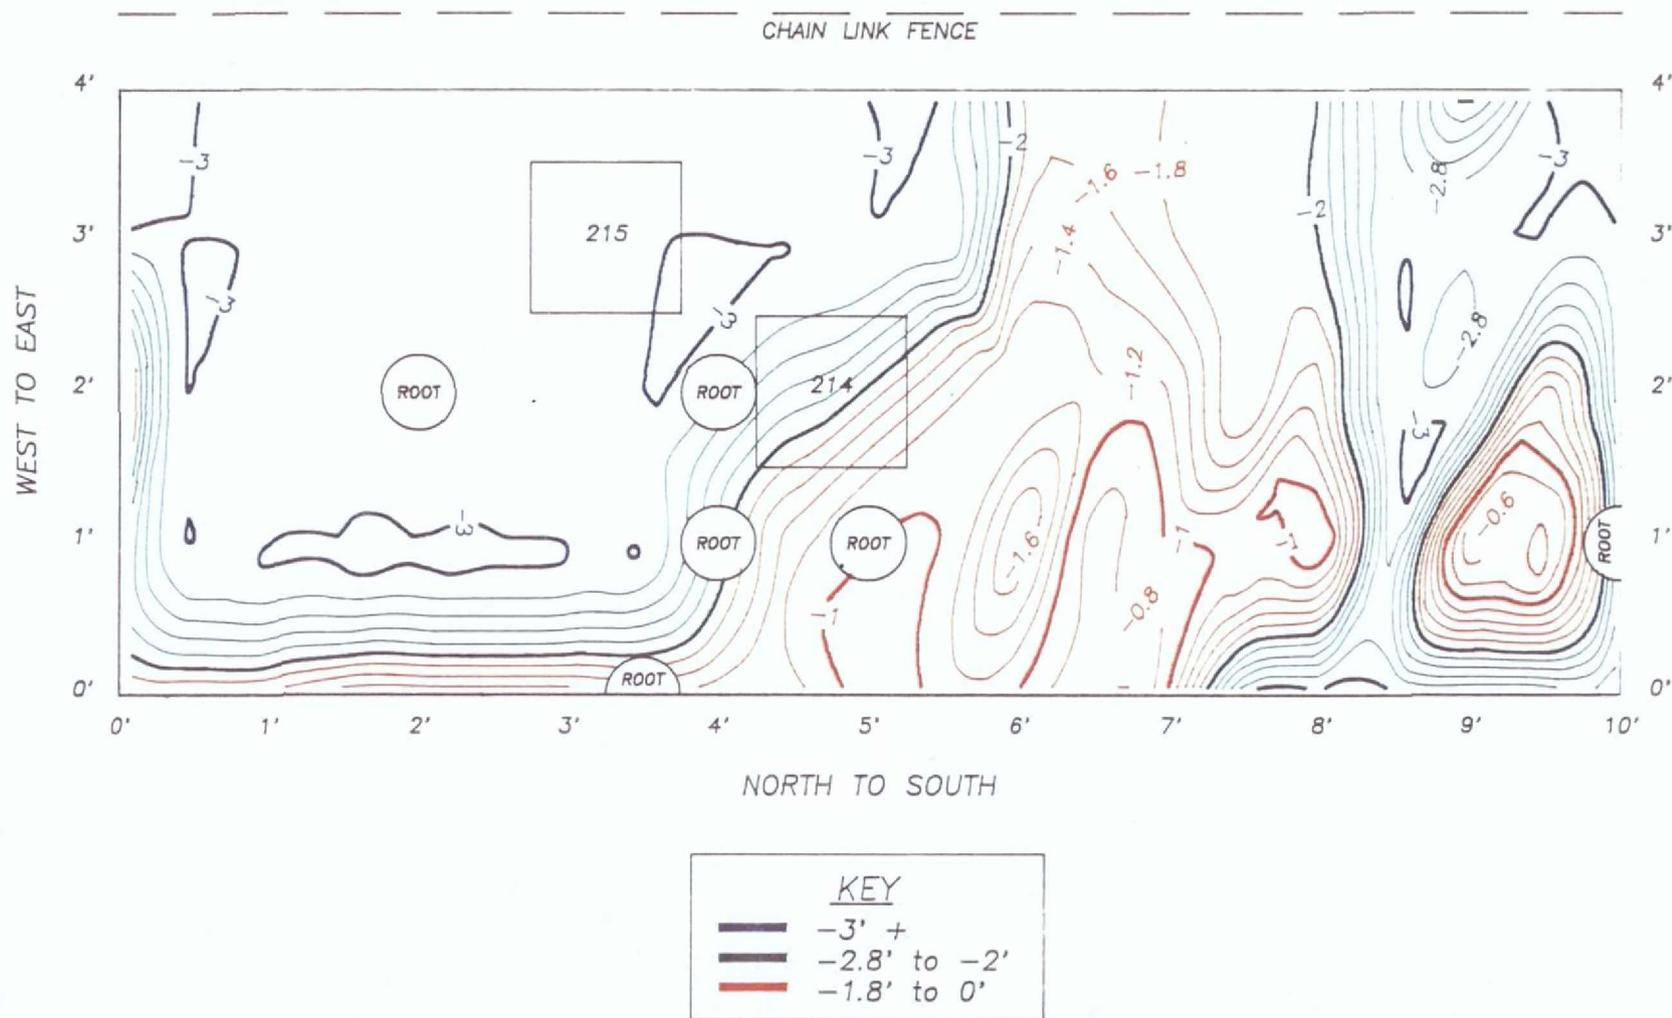
Figure 7:

Computer-generated topographic map of subsurface contours of buried stone and brick "privy" feature elements based on the depth of steel probes recorded at .5' x 1' intervals in the vicinity of the possible privy and to previous shovel tests 214 and 215.

Finally, for Area D on the west side of the manor house, the limited field testing did permit the definition and extent of both the "privy" and "dry well" features in this area. The new alignment of shovel probes defined a safe alternate route to the west of the features, which would constitute a mitigation through avoidance. It should also be noted that the field team encountered an otherwise unmapped steel utility pipe running east-west at a depth of 12 inches below grade in shovel test 502. With the exception of this relatively recent utility pipe, no other features, structural remains, or significant cultural deposits were encountered within the shovel test alignment.

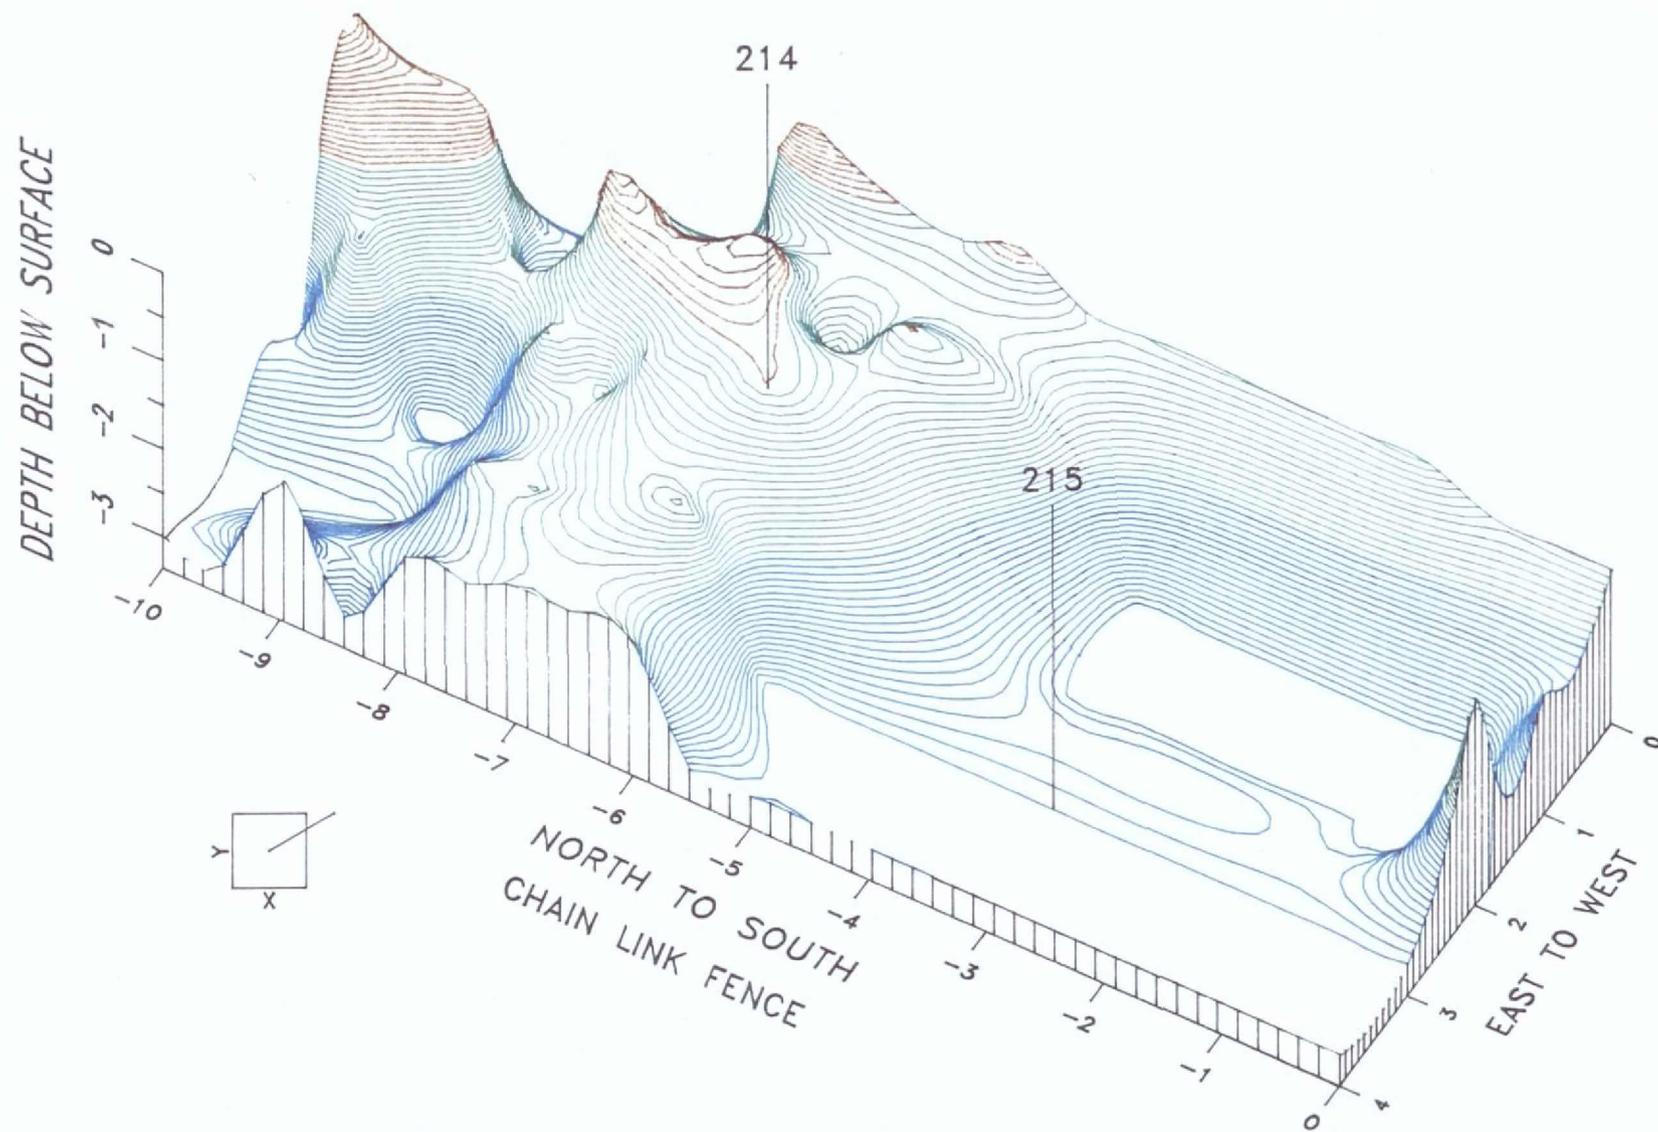
Figure 8:

Computer-generated 3D surface mesh model of subsurface "privy" remains based on the depth of steel probe readings in the vicinity of the prior Greenhouse shovel tests 214 and 215.
