Archaeological Tests and Artifact Analysis Results from Rufus King Park, Jamaica, Queens, New York.

Joel W. Grossman, PhD. P.I.
Grossman and Associates, Inc.
201 East 16th Street
New York, NY 10003

March 5, 1991

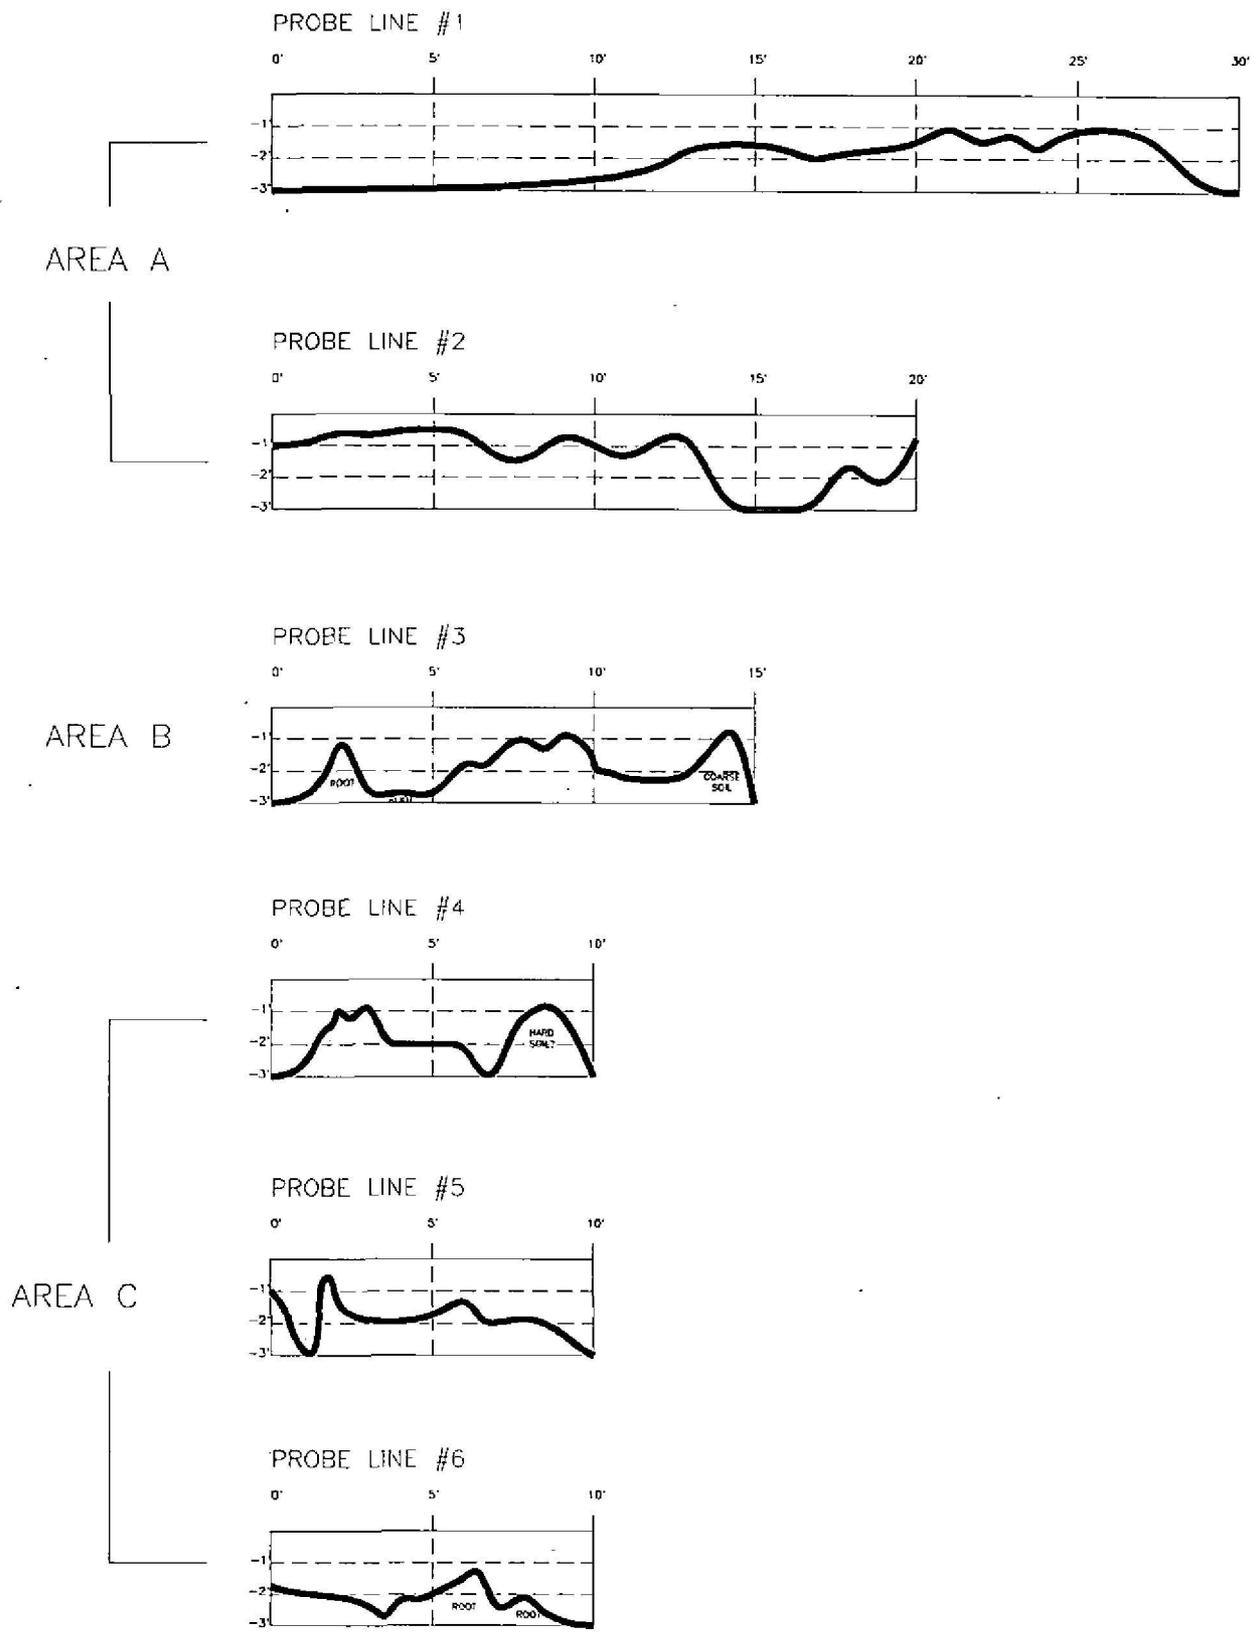
Figure 9: Profile plots of steel probe transect lines across each study area, showing the relative depth of subsurface stone, brick and gravel debris.

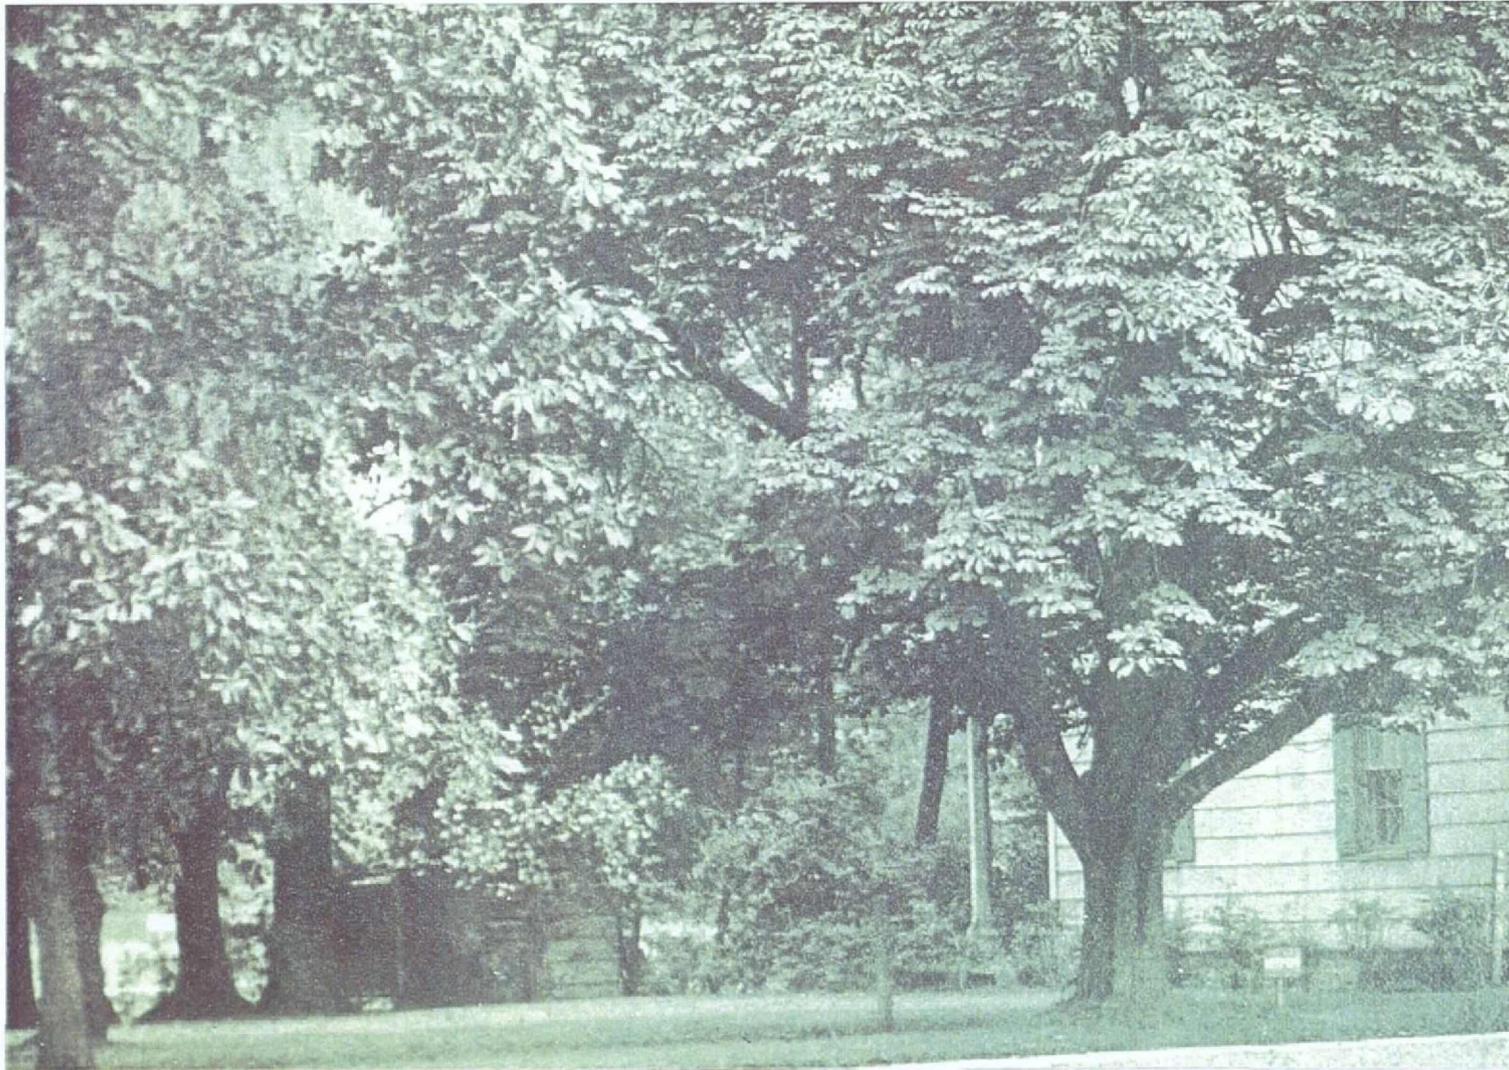
Plate 5: Early 20th Century (possibly 1926; *cf.* Cotz, 1984) photo of the rear yard of the Manor House looking northeast past the west wall of house. Note the presence of an ill defined structure in the vicinity of the privy to the rear between the trees and in line with the west wall of the Manor house.

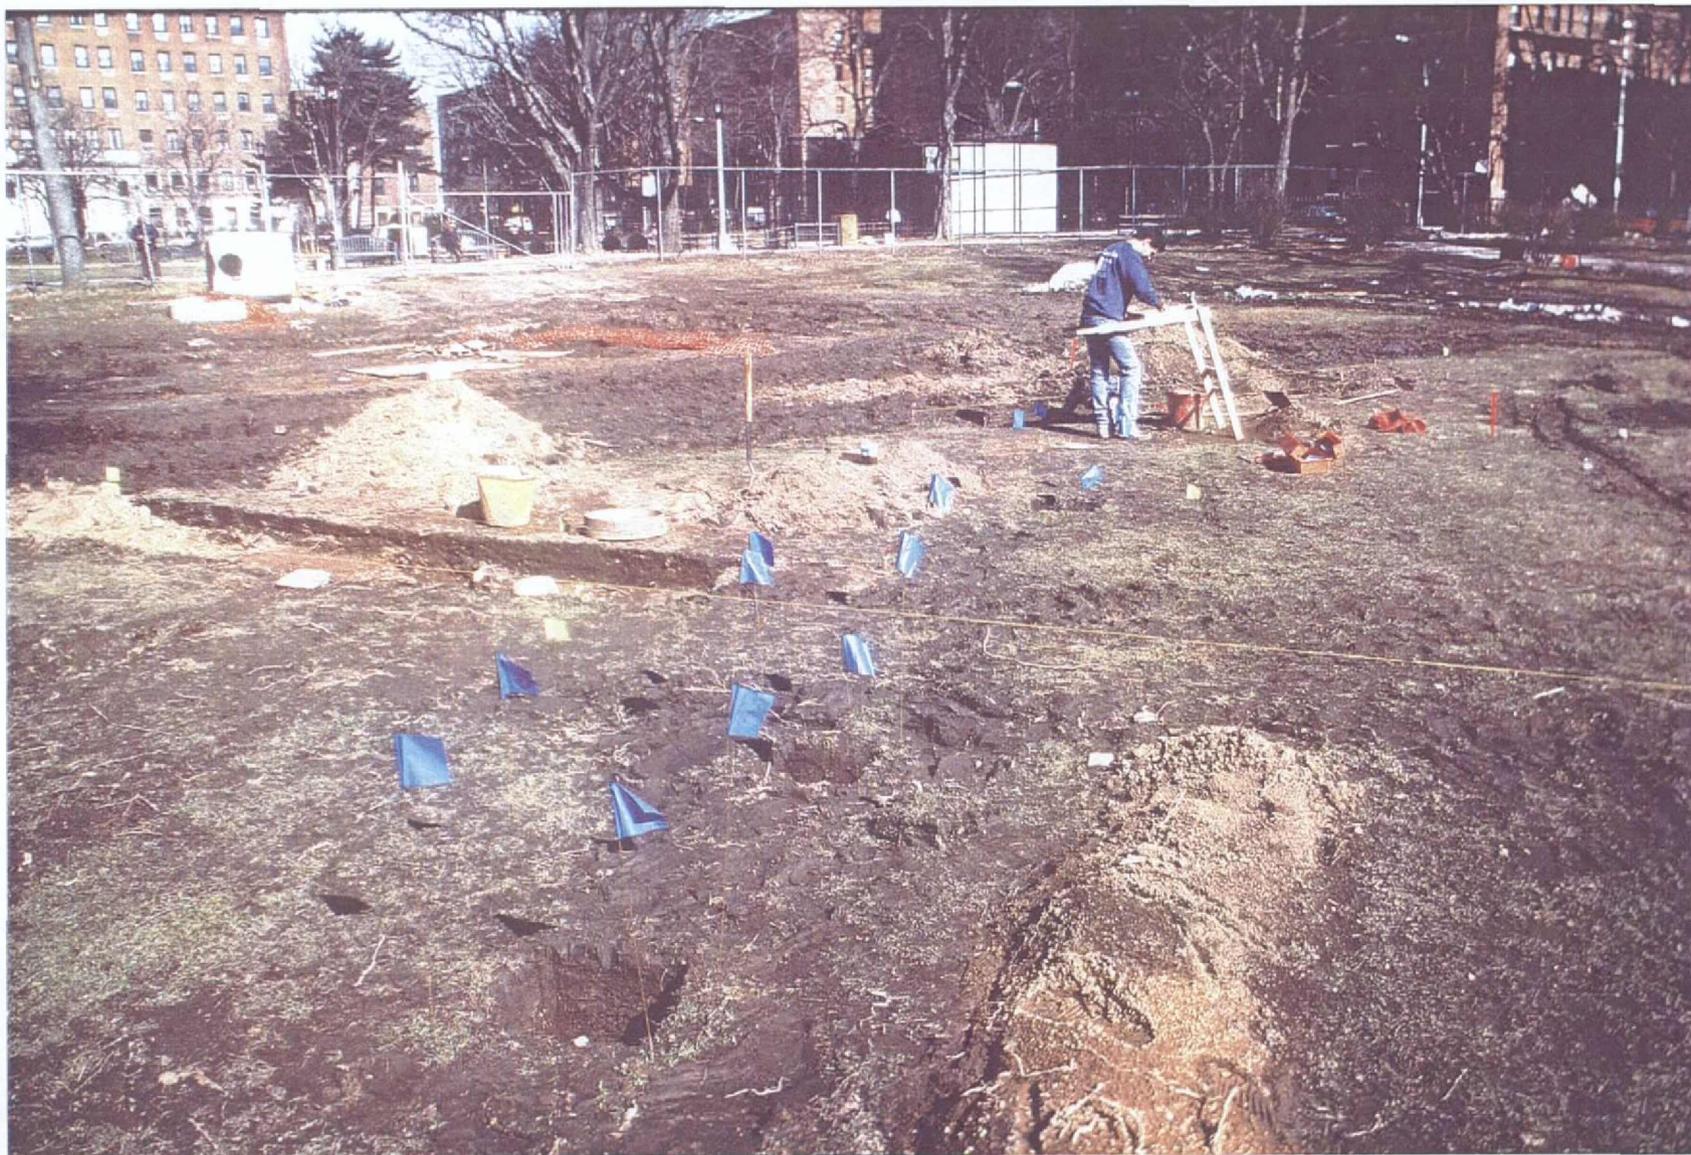
Plate 7: General field view showing location of new shovel tests and shallow test trenches in the vicinity of historic building N. Yellow flags denote the position of previous tests, blue flags denote current, Feb. 1991, test units. Yellow mason's line marks the alignment of the proposed sewer trench as demarcated by the contractor.

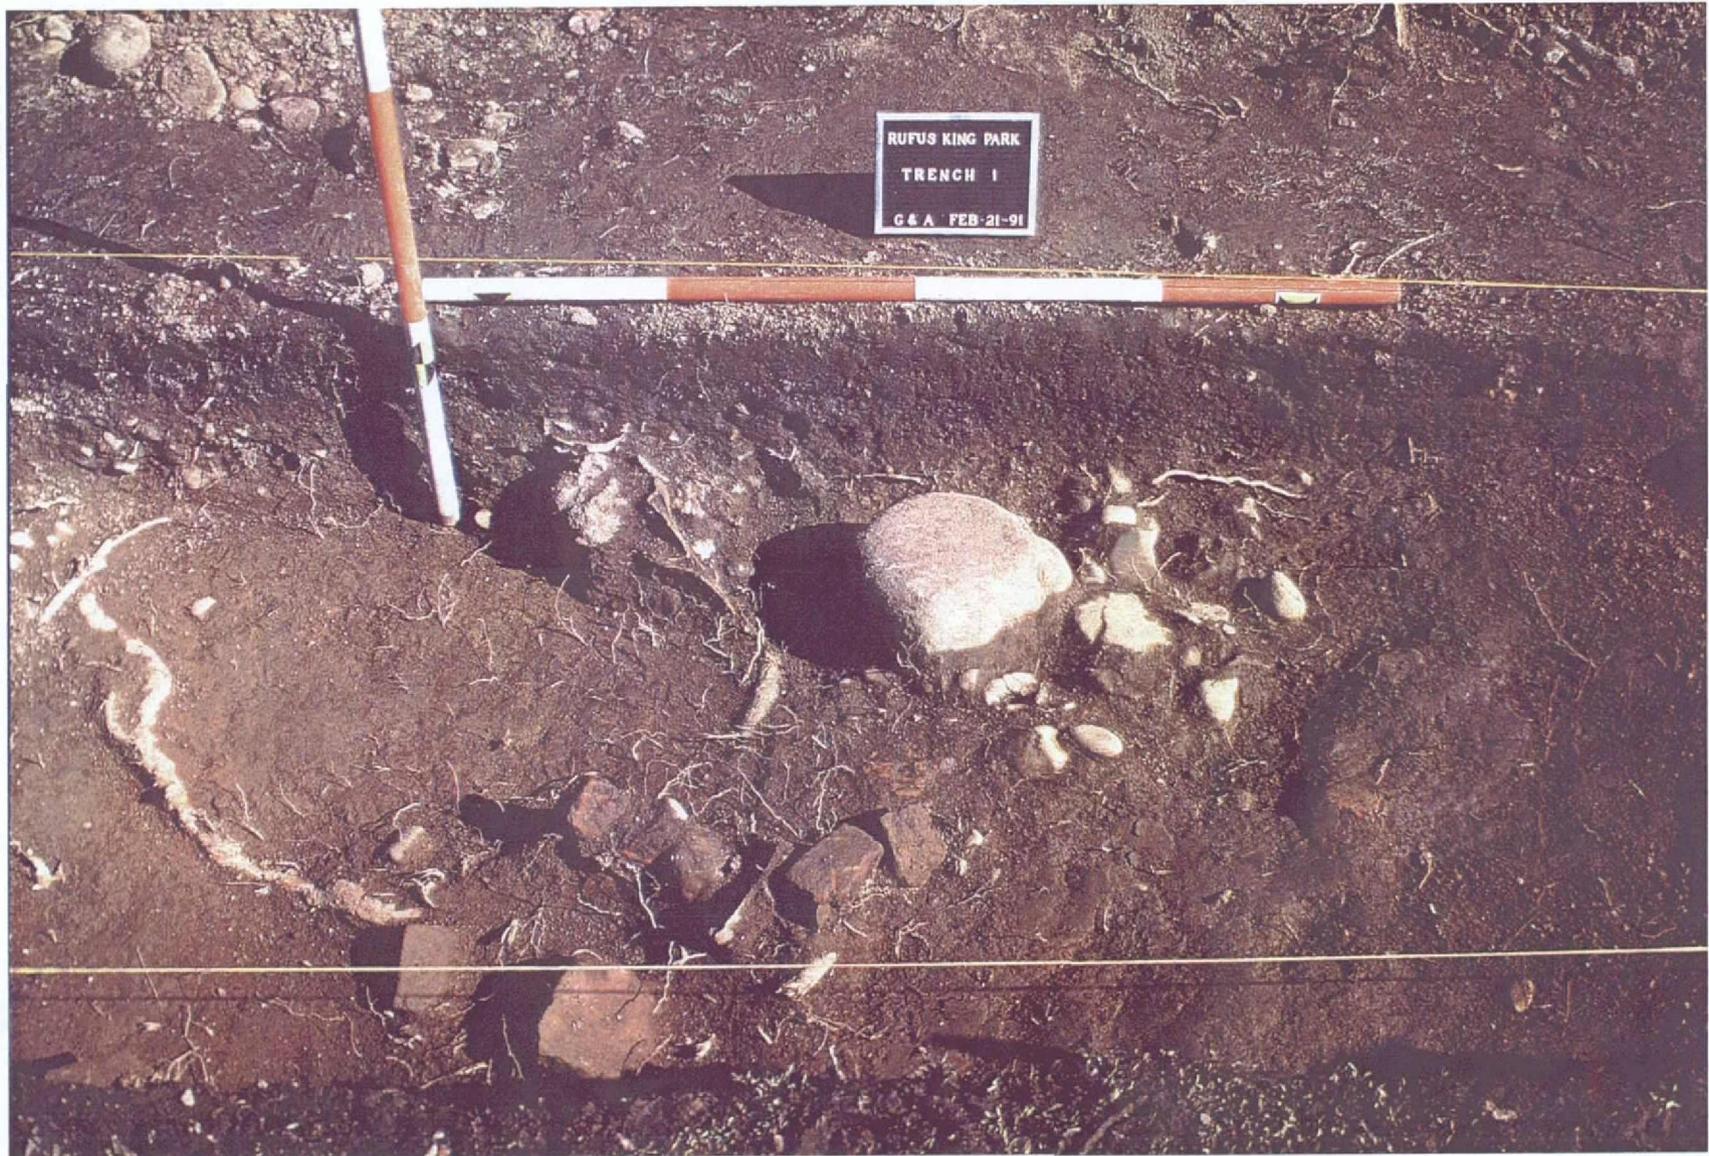
Plate 8: View looking north of early-mid nineteenth century structural debris resting on the original pre-park surface in Trench No. 1, 12 inches below the modern grade.

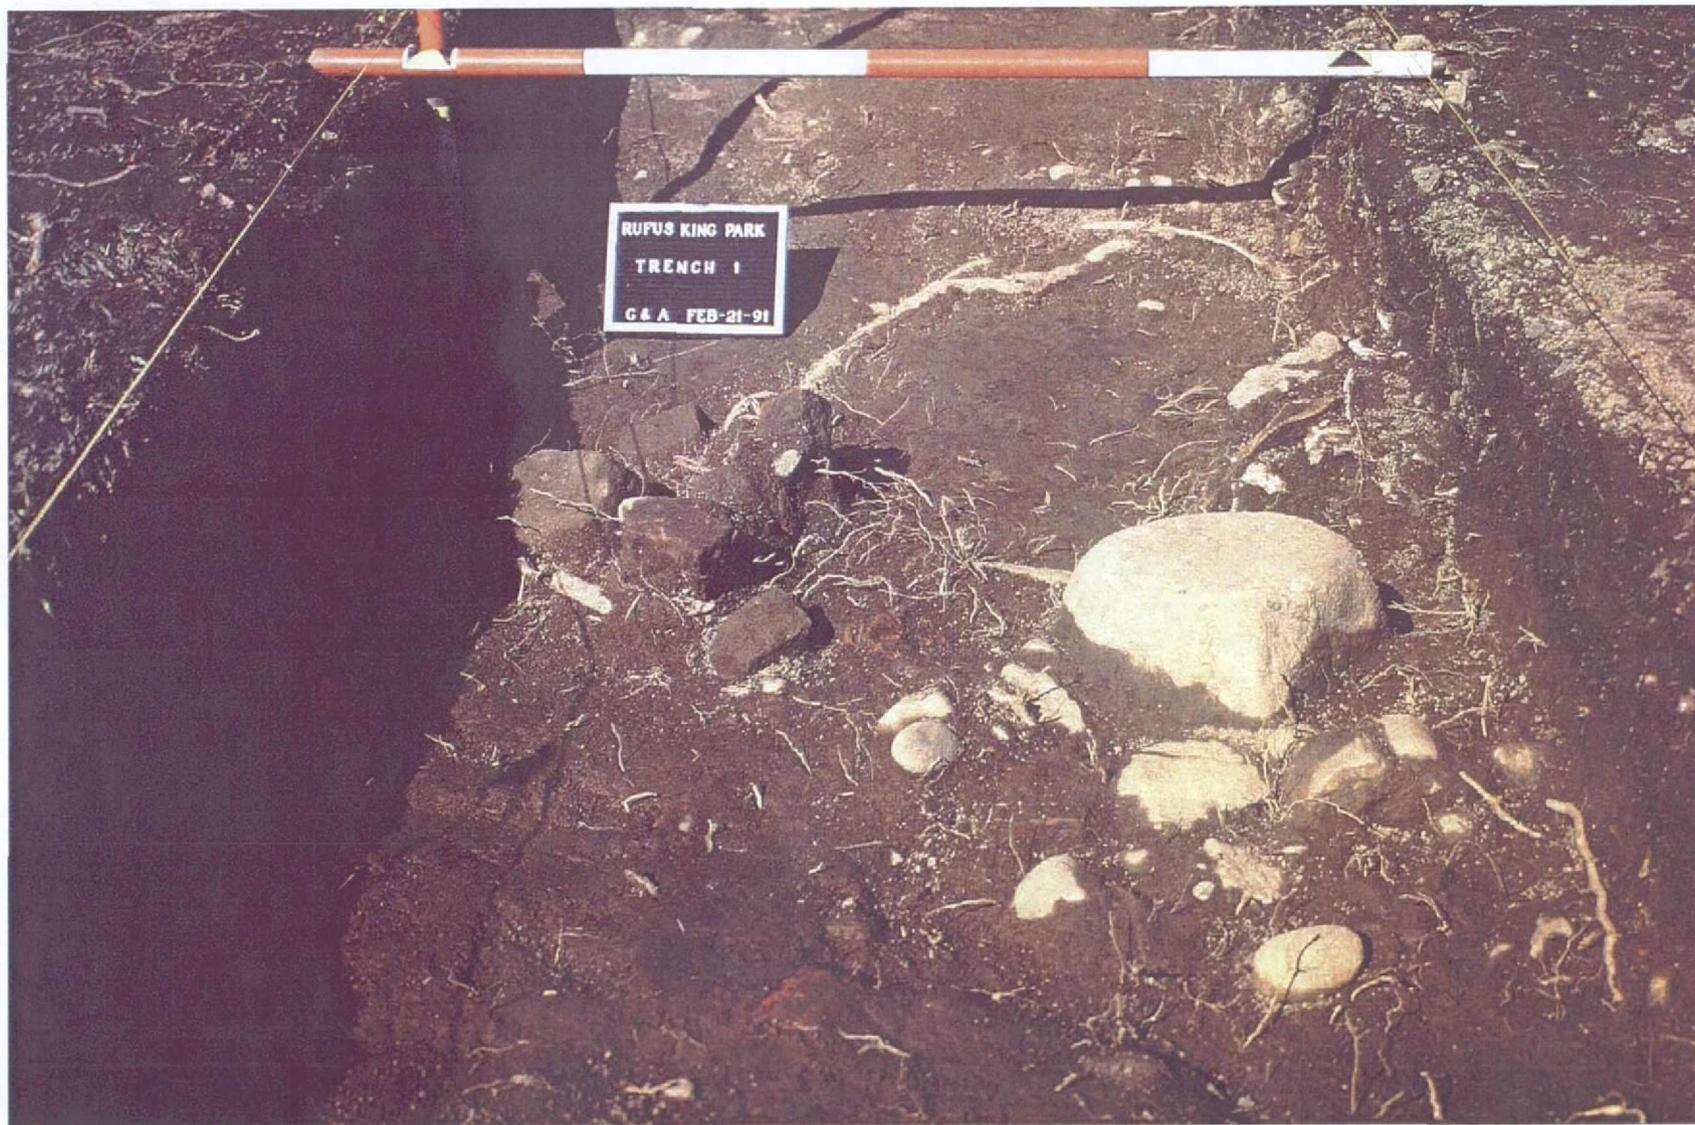
Plate 9: Formal field shot of exposed nineteenth century structural debris looking east in Trench 1 along the proposed sewer trench alignment and within the vicinity of former the Building N location.

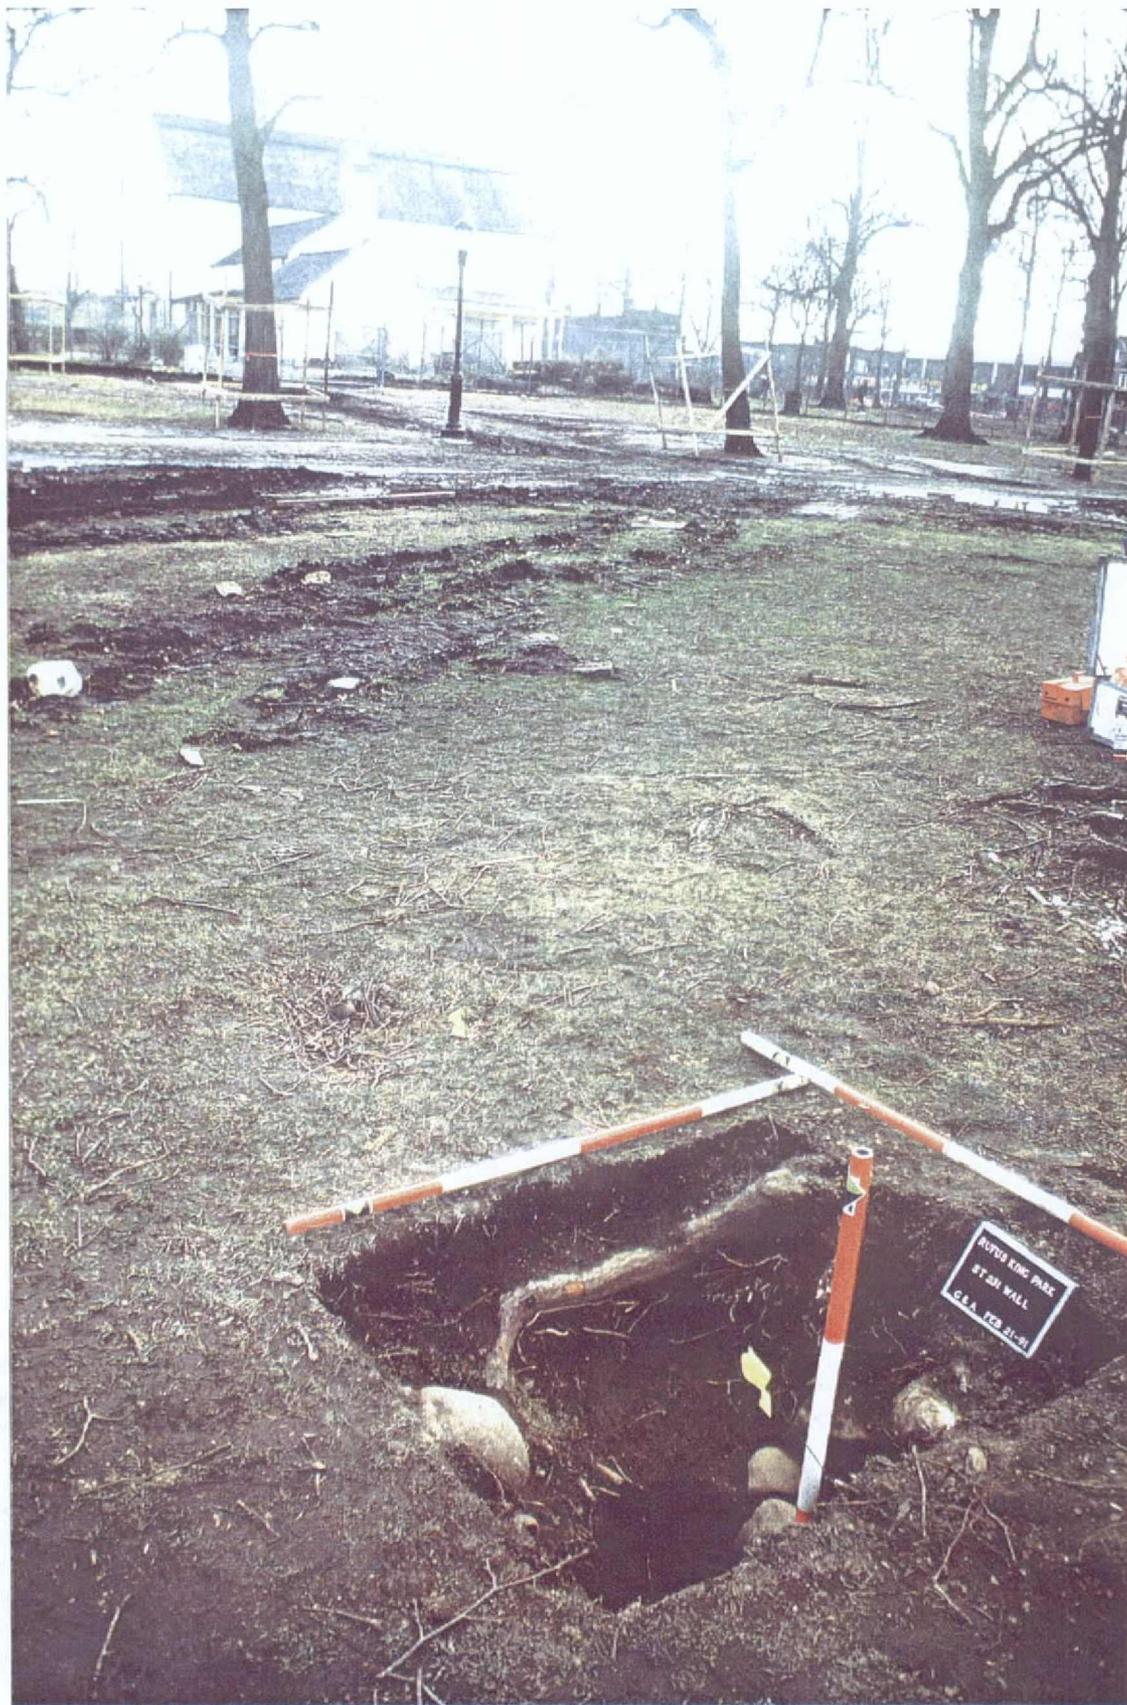
Plate 10: General view looking south of the ST 231 Wall exposure relative to the Manor house to the south of the test unit.

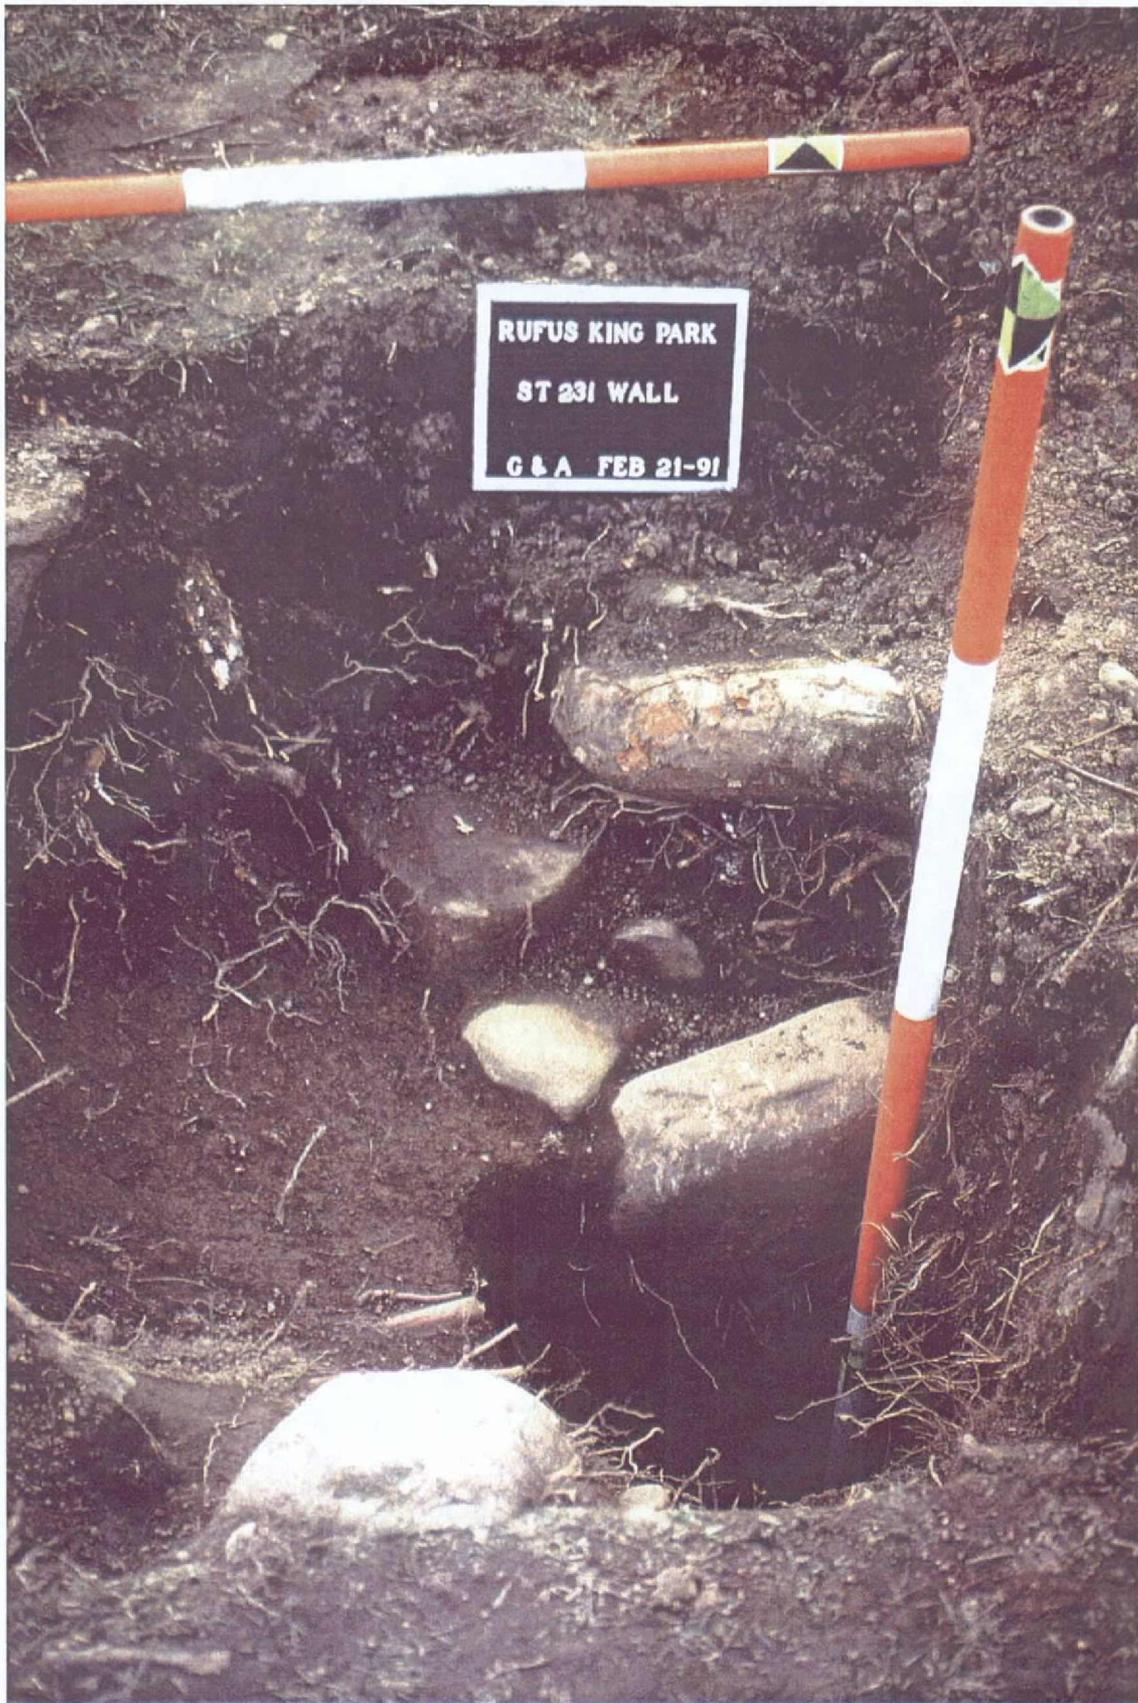
Plate 11: Close-up view of the ST 231 Wall exposure looking west and showing multi-course stone wall corner elements exposed between ca. 6-24 inches below modern grade.

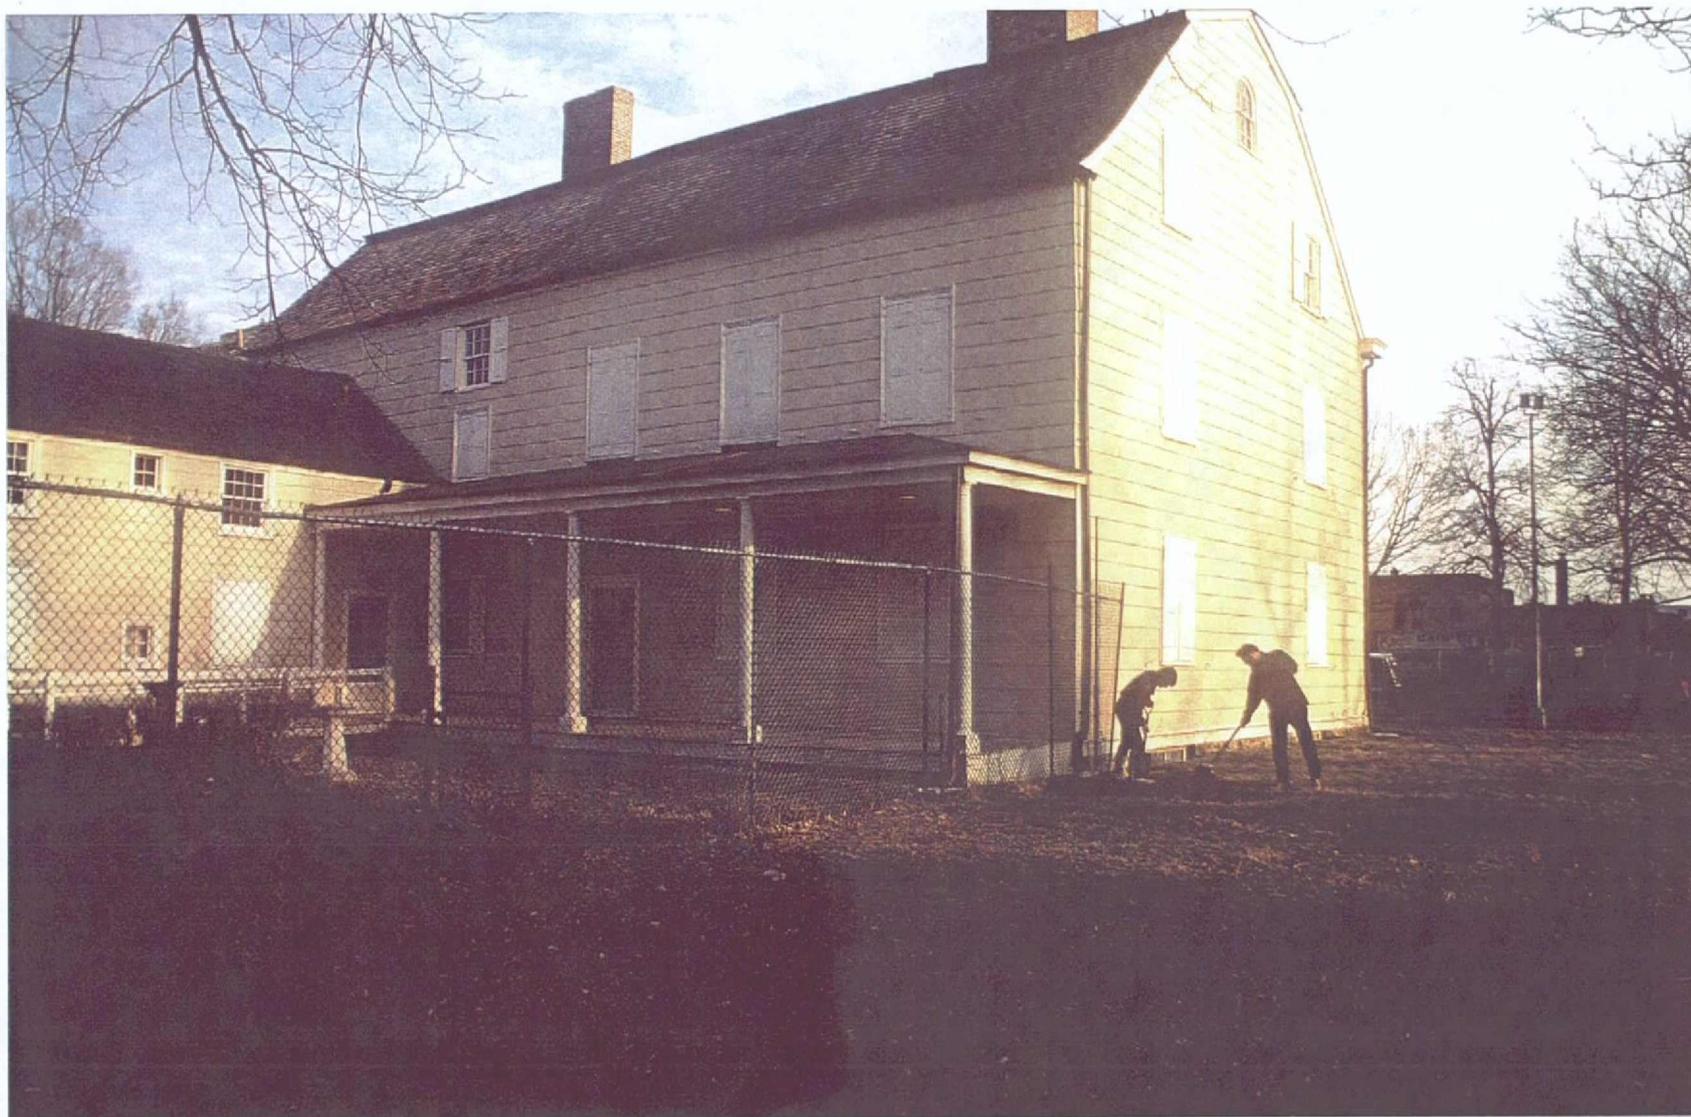
Plate 12: General field photo of the crew working near the exposed dry well at north-west corner of the Manor House.

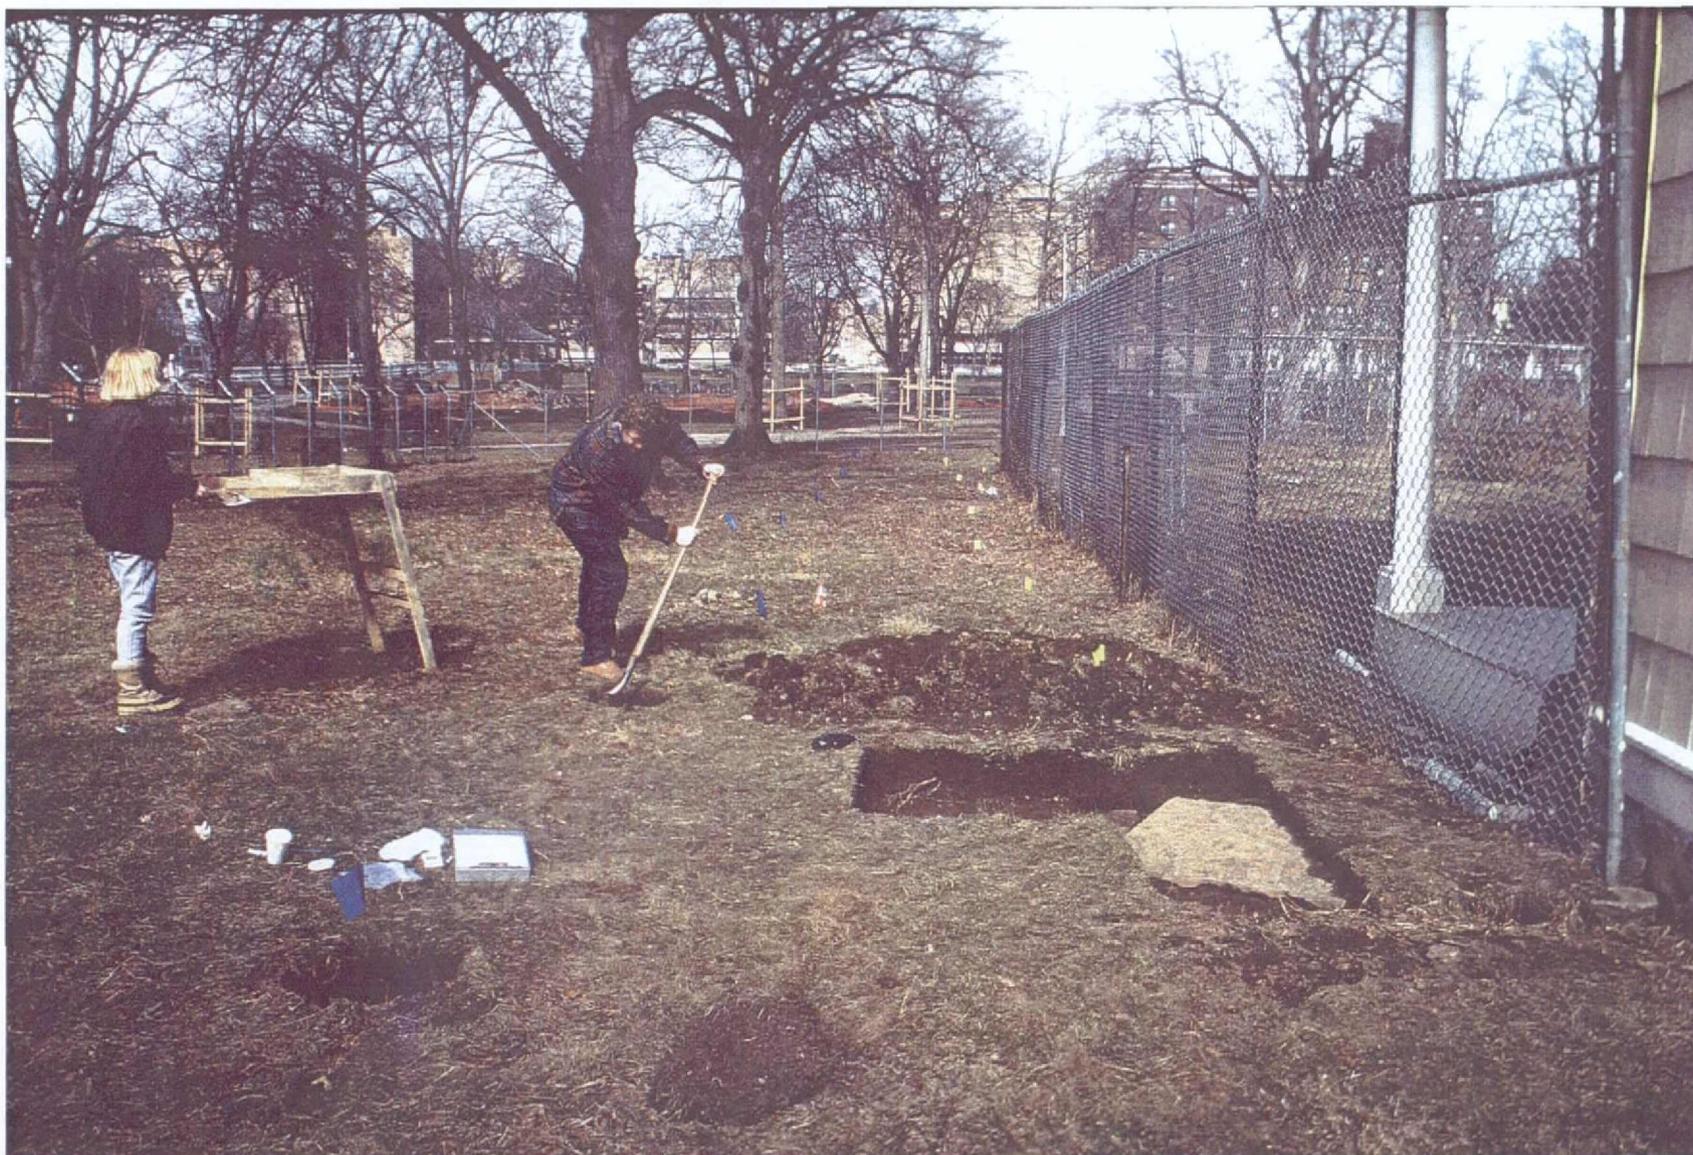
Plate 13: View looking north-west along the rear yard fence behind the Manor house showing the general location of the stone "dry well" at the corner of the house, and former (yellow) and current (blue) marker flags at shovel test locations.

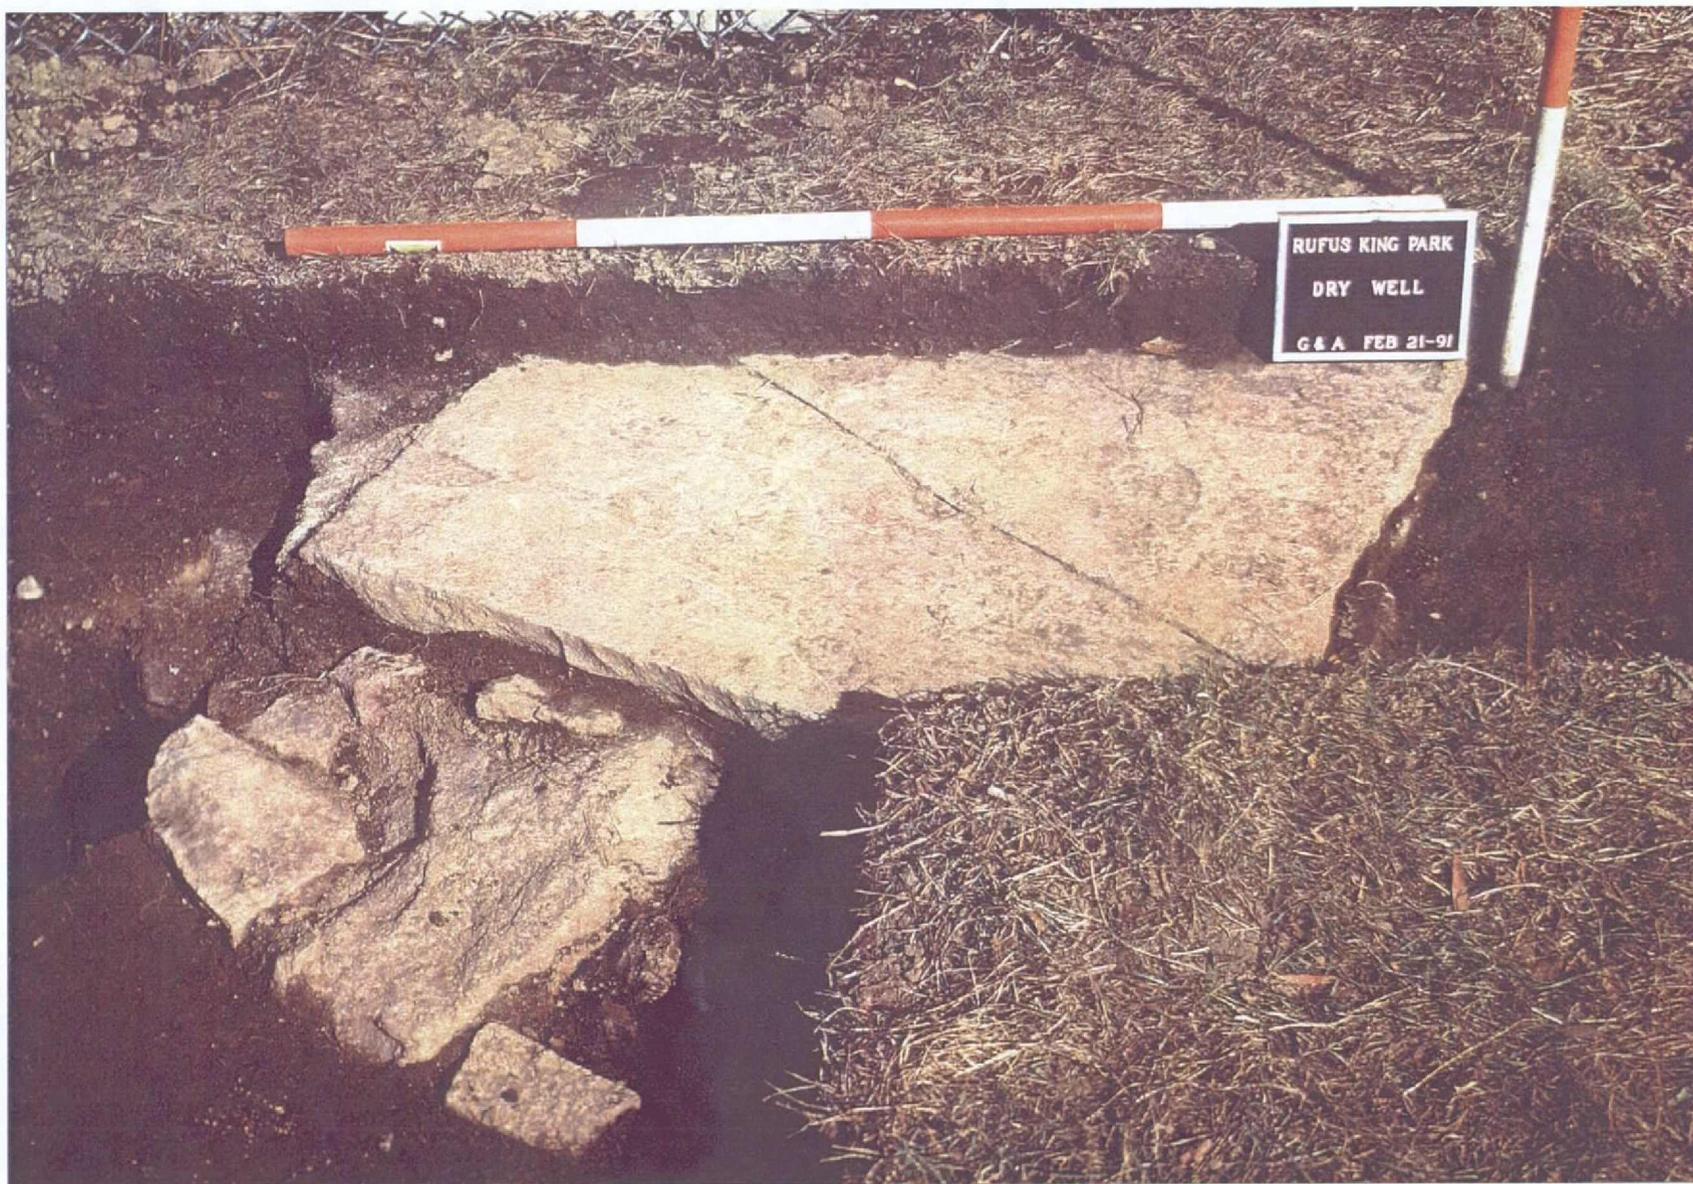
Plate 14: Formal field view of the partially excavated 19th century "dry well" exposed at northwest corner of Manor house.

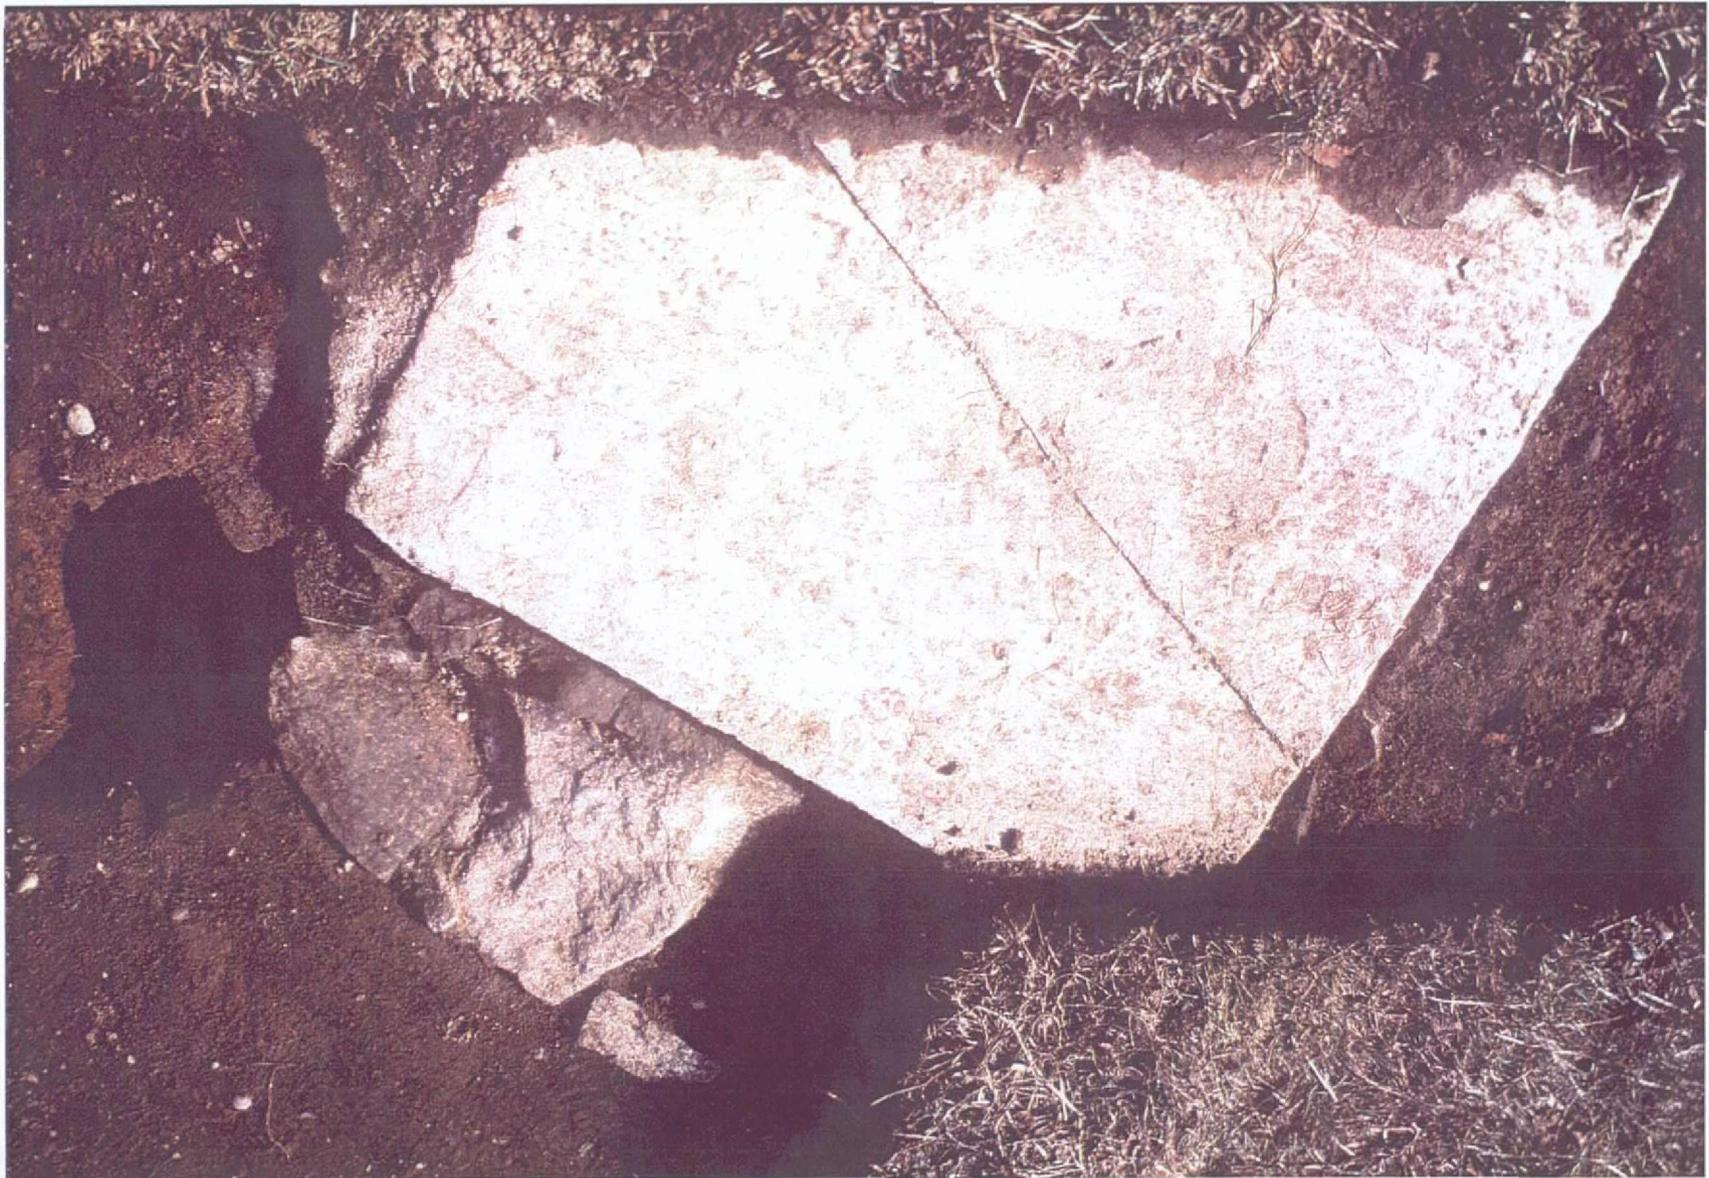
Plate 15: Overhead view of the partially exposed dry well at the corner of the Manor house showing a large stone slab over the rough cut stone liner.
