Archaeological Tests and Artifact Analysis Results from Rufus King Park, Jamaica, Queens, New York.

Joel W. Grossman, PhD. P.I.
Grossman and Associates, Inc.
201 East 16th Street
New York, NY 10003

March 5, 1991

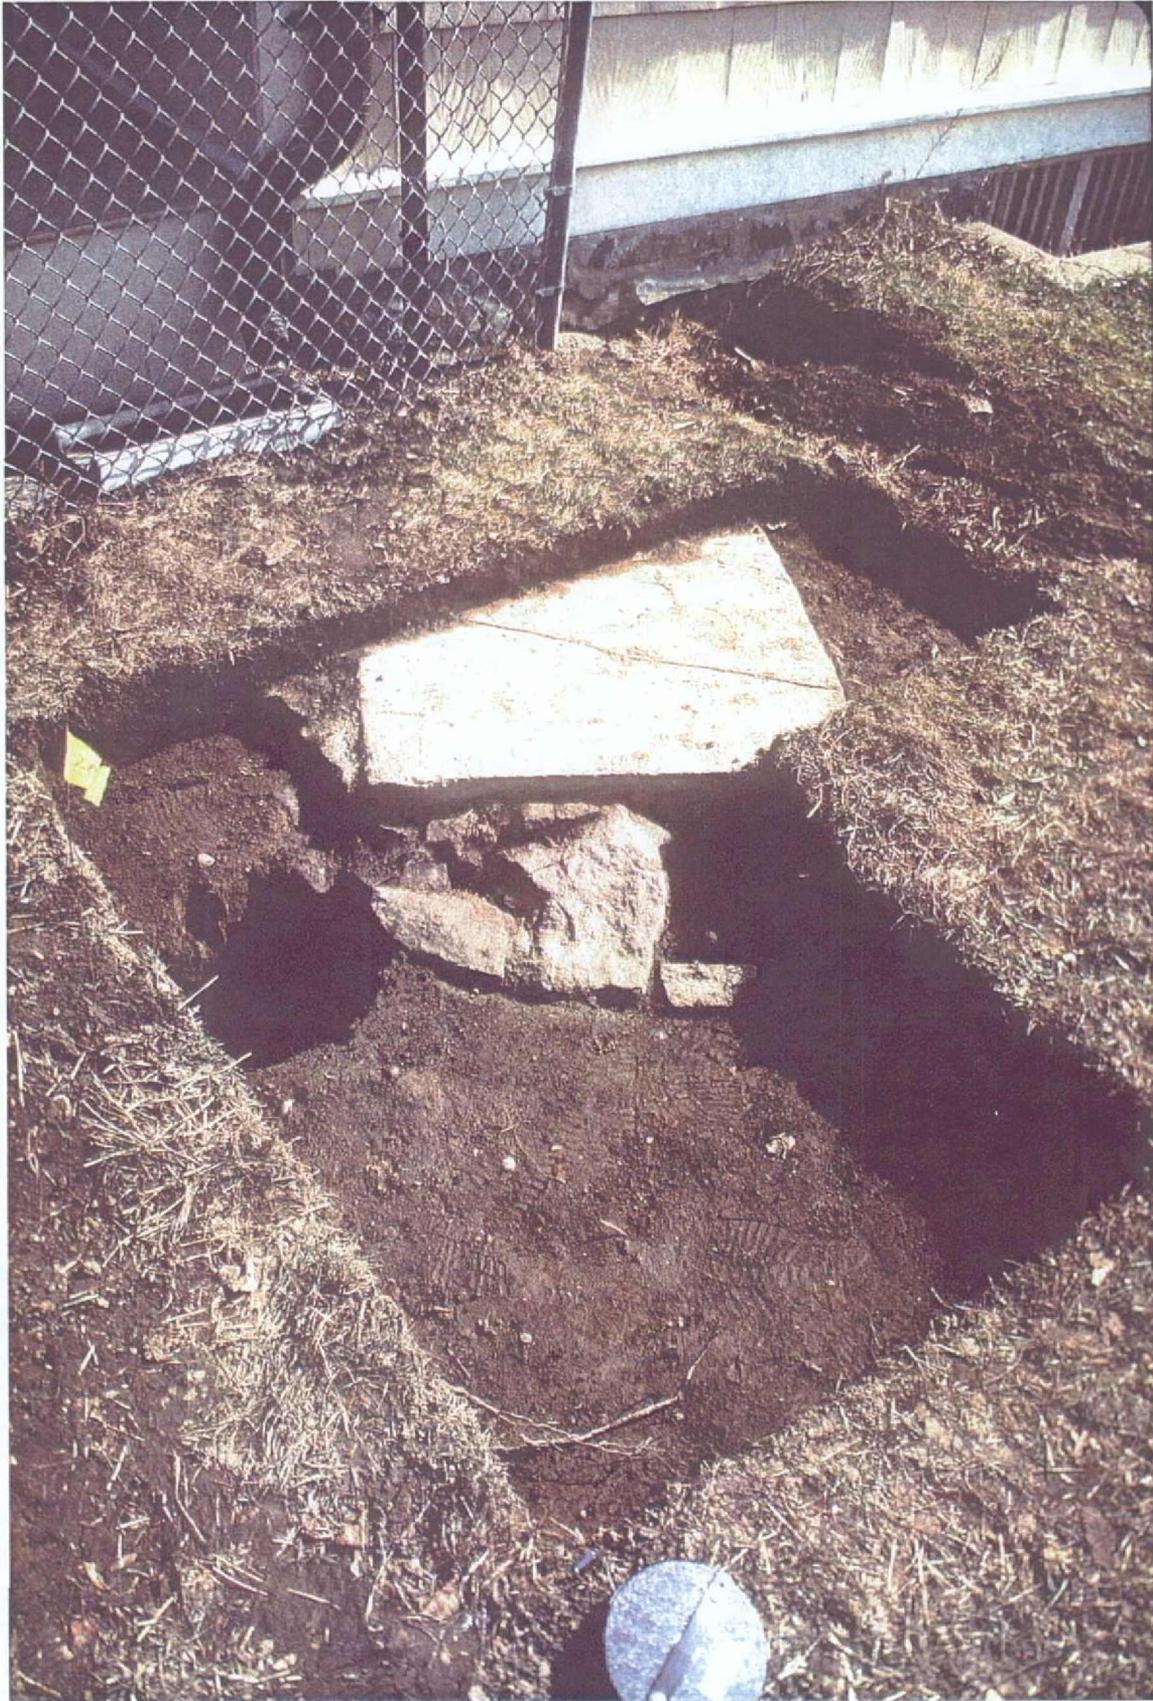
Plate 16: General view looking east of a partially exposed Dry well associated with north-west corner of the Manor house.

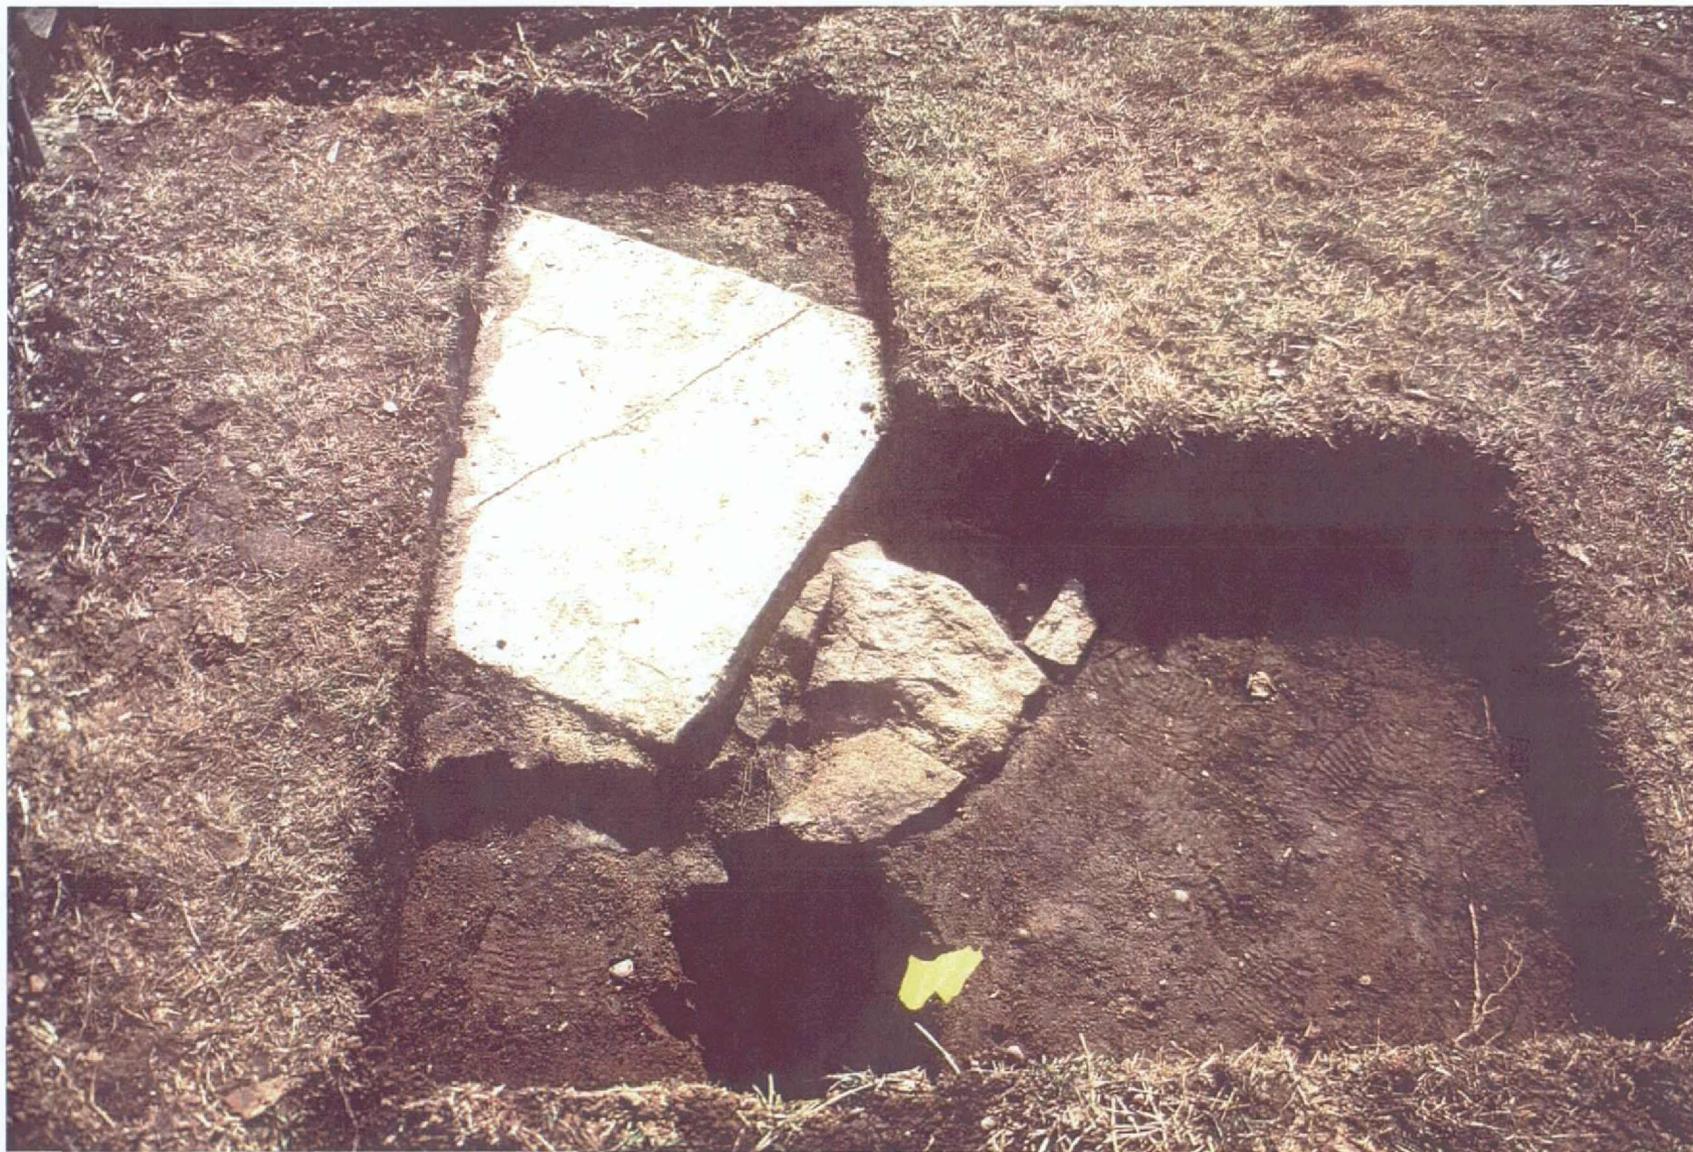
Plate 17: Informal field shot of the partially exposed dry well at north-west corner of the Manor house showing the exposed feature relative to the flagged location of former shovel test unit (No. 220) which made contact with, but did not define, the nature of the feature.

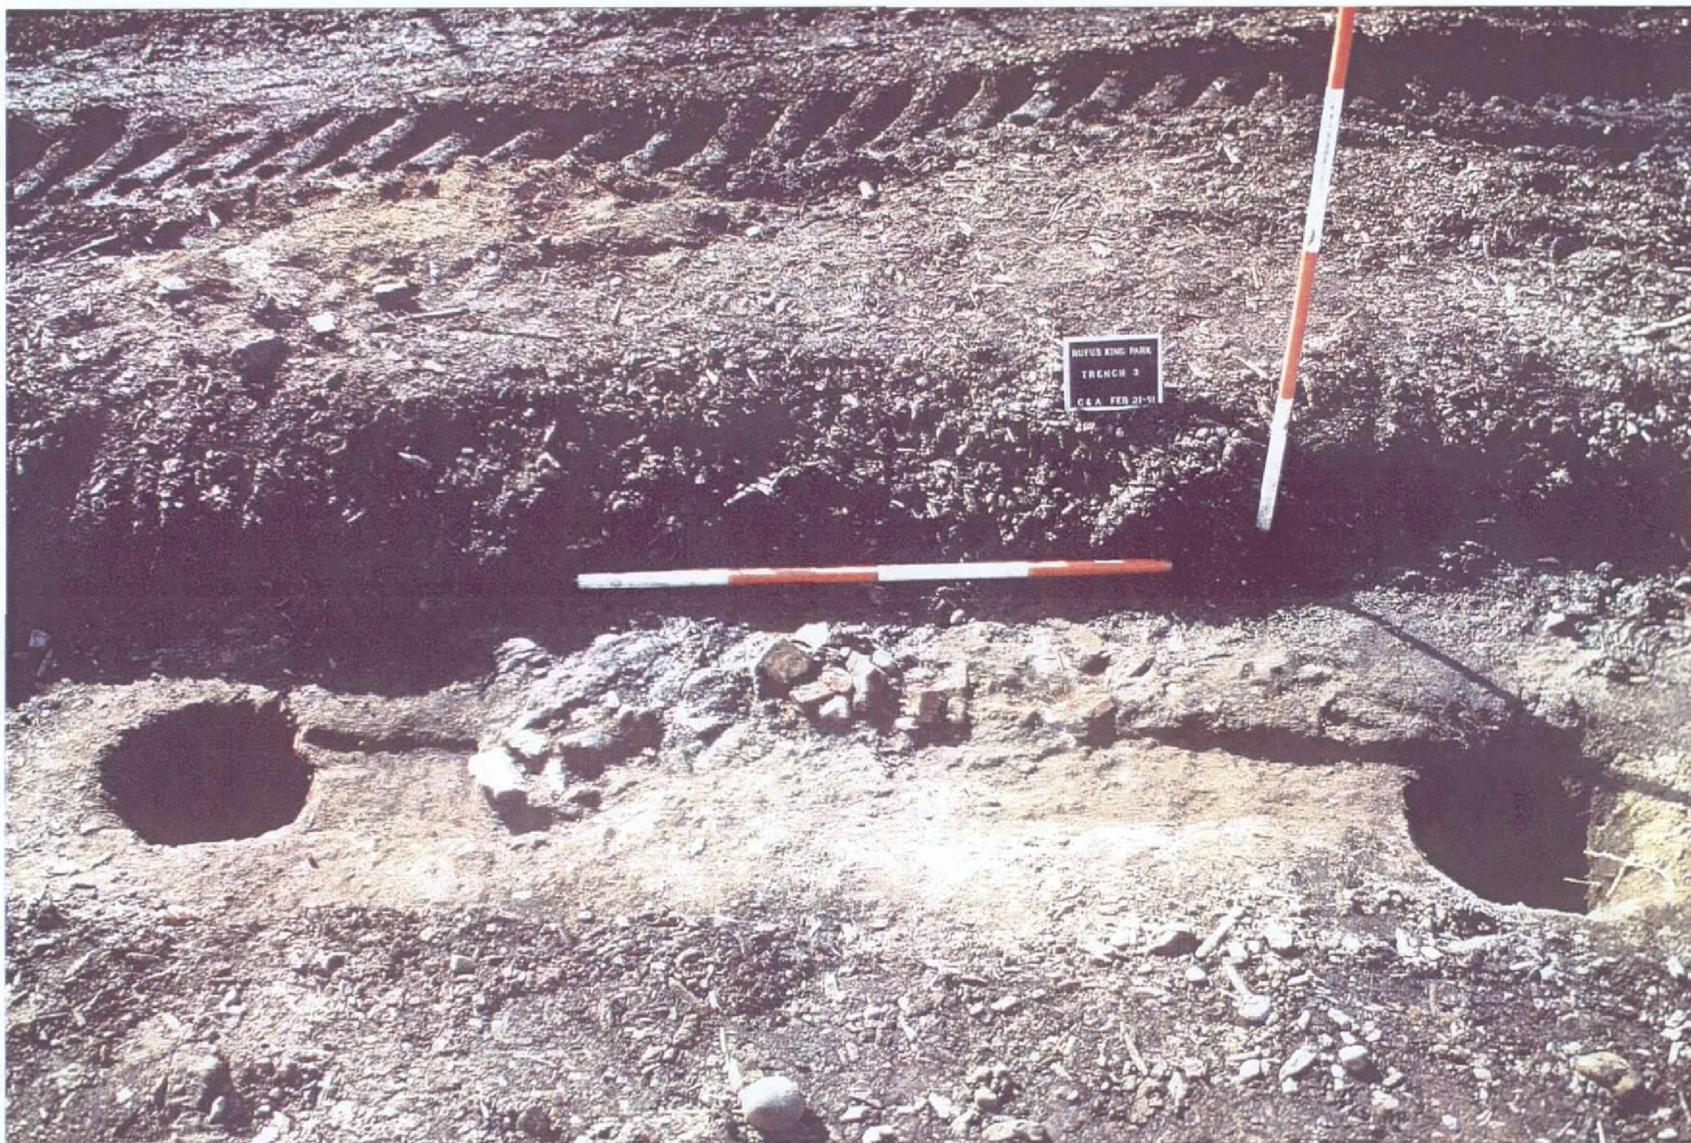
Plate 18: General view looking west of Test Trench No.3 between the Summer kitchen and the modern Comfort Station within the vicinity of the previously suspected location of Structure K. In addition to the revised computer based map analysis indicating that Structure K was actually located to the west and south of the Comfort Station, the Archaeological tests showed the presence of only 20th century debris. Note the presence of LPC mandated shovel tests at either end of the shallow trench.

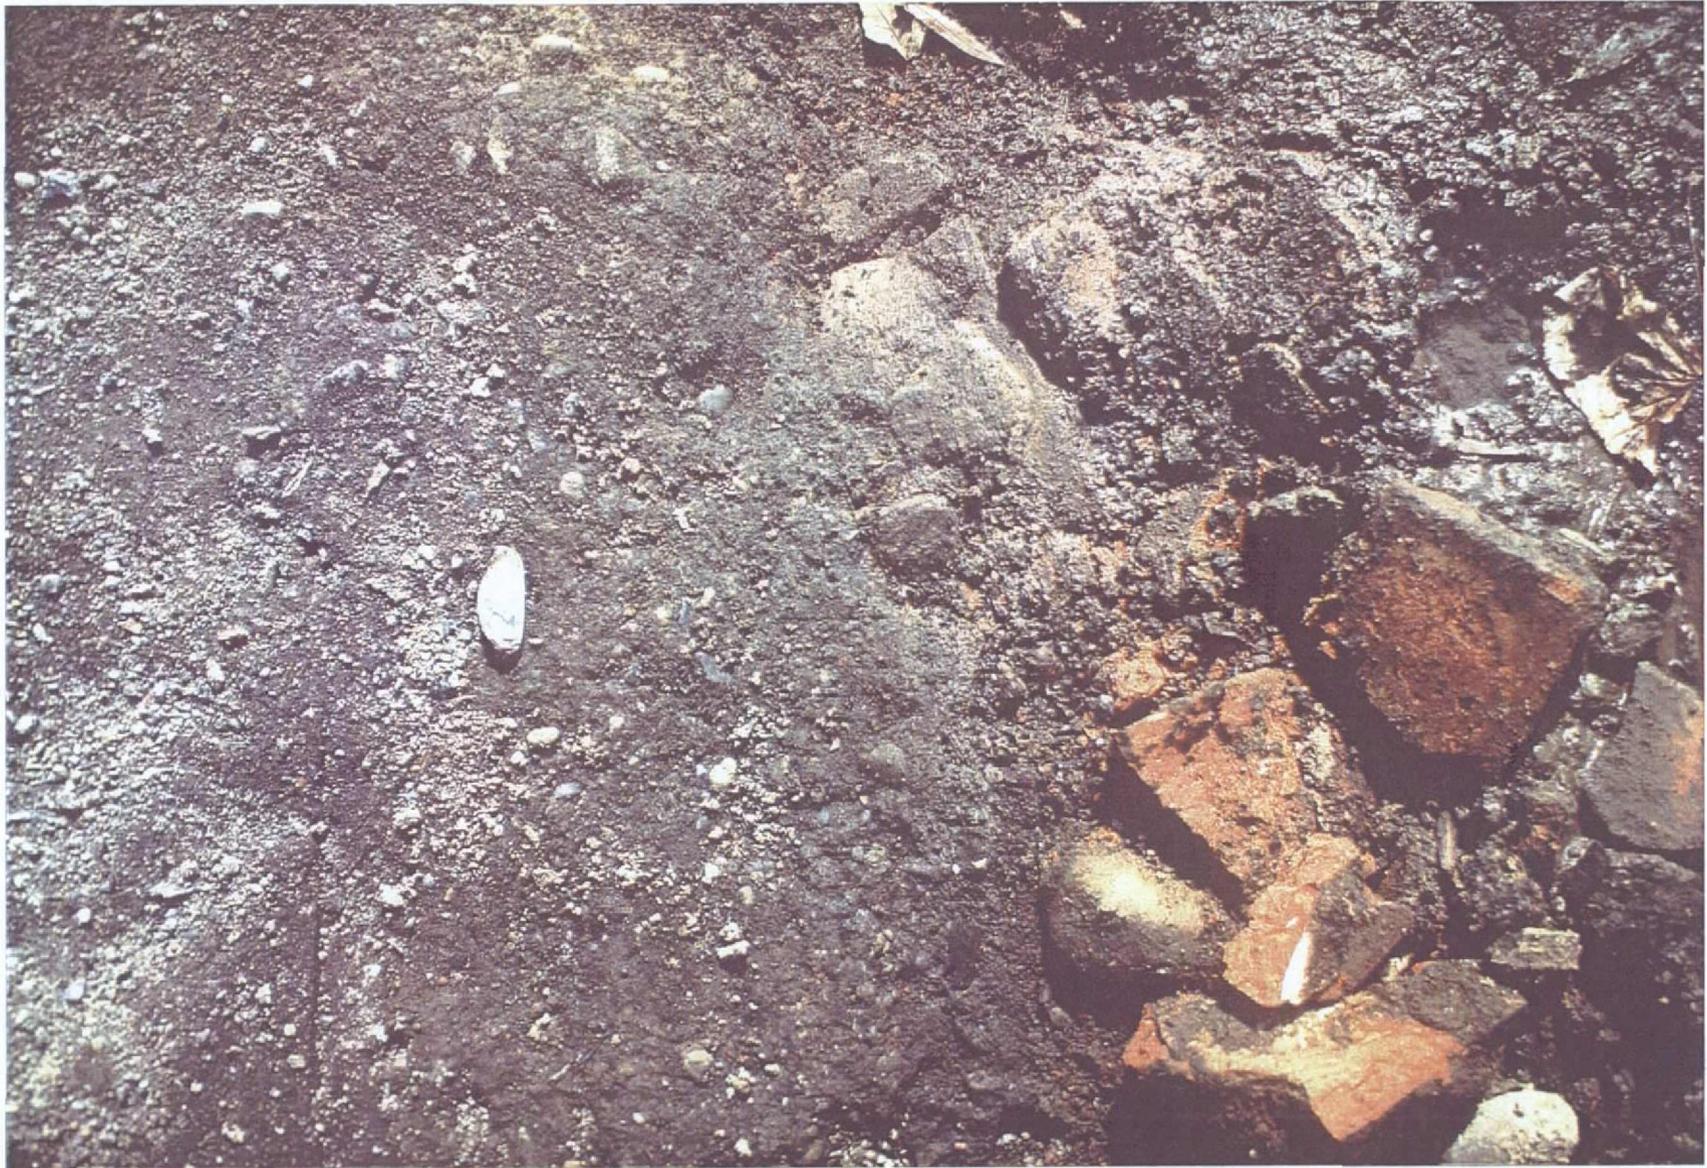
Plate 19: Detail of the exposed surface in Test Trench No. 3 showing 20th century destruction debris found in association with a modern aluminum Seagram's ginger ale bottle cap.

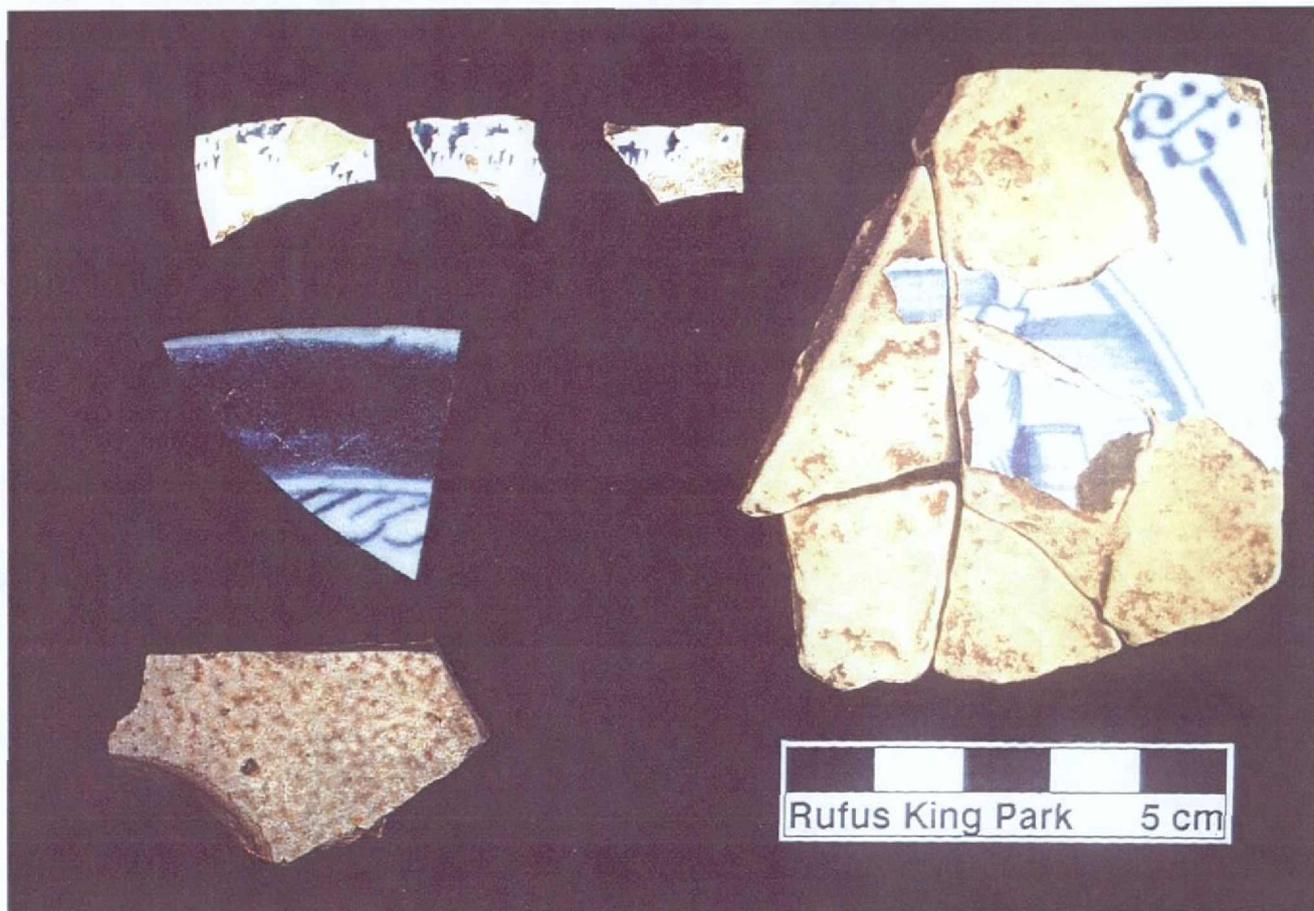
Plate 20:

Mid to Late 18th. Century ceramics recovered from lower level (Cx. 1.02, 5-12 inches below surface) of Trench 1, Area A.

Delft tile fragments with blue and white decoration. Late 18th. Century-Early 19th. Century corner motif (Noël Hume 1976).

In addition to these shovel tests, two trenches, designated trench numbers 1 and 2, were exposed to help identify any additional structure remains which may have been associated with the revised projected location of Building N (See Figure 2). Trench 1 was oriented parallel to the proposed sewer line as laid out by the project contractor and within the revised Building N location (See Figure 3). Trench 2 was laid out to the east, perpendicular to the projected location of the east wall of Building N (See Figure 3). The lateral position of each trench was fixed based on preliminary transects of subsurface probes aimed at identifying the presence of possible structure or wall elements below the surface. The line of probes associated with Trench 1 revealed a cluster of stone or rubble within a limited area which appears to correspond in general with the projected location of one of the walls of Building N (See Figure 3 and Figure 9). After being scraped with the back hoe and manually cleaned, Trench 1 revealed the presence of a well defined alignment of brick and stone structural debris associated with late 18th century artifacts (see below) which included large pieces of saw cut animal bone, oyster and clam shells, historic ceramics (post-1762 creamware and post-1780 pearlware, and a post-1775, delft tile), a post-1788 wine or port glass bottle neck as well as kitchen utensils, including the blade of a dinner knife and a small serving or "shrimp" fork (See Figure 4, Plates 8 and 9, and Plate 20 through Plate 22). Although the function of this early structure has not been documented, the presence

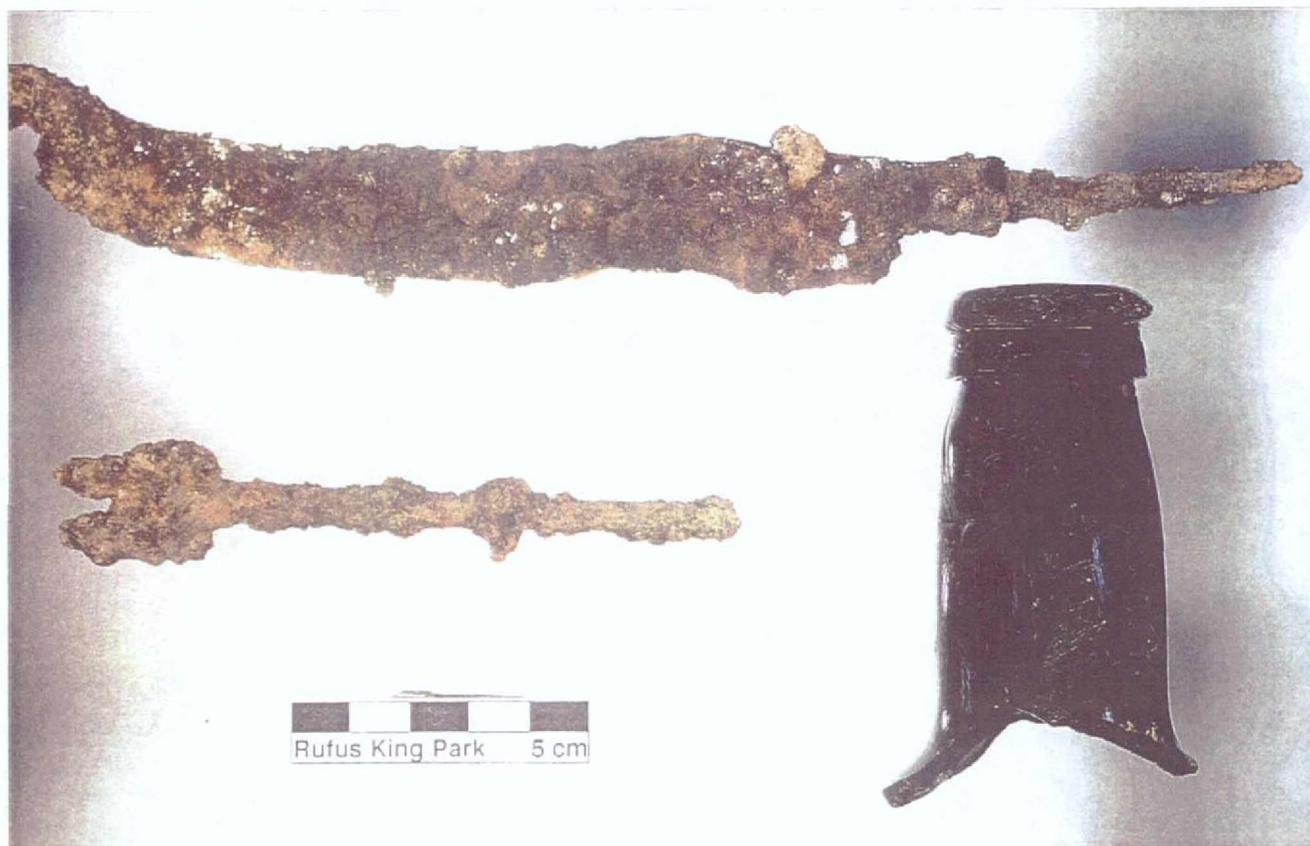
Plate 21:

Historic artifacts from lower level (Cx. 1.02, 5-12 inches below surface) of Trench 1, Area A.

Hand blown dark green wine/liquor bottle neck and lip. Late 18th. Century (Noël Hume 1976).

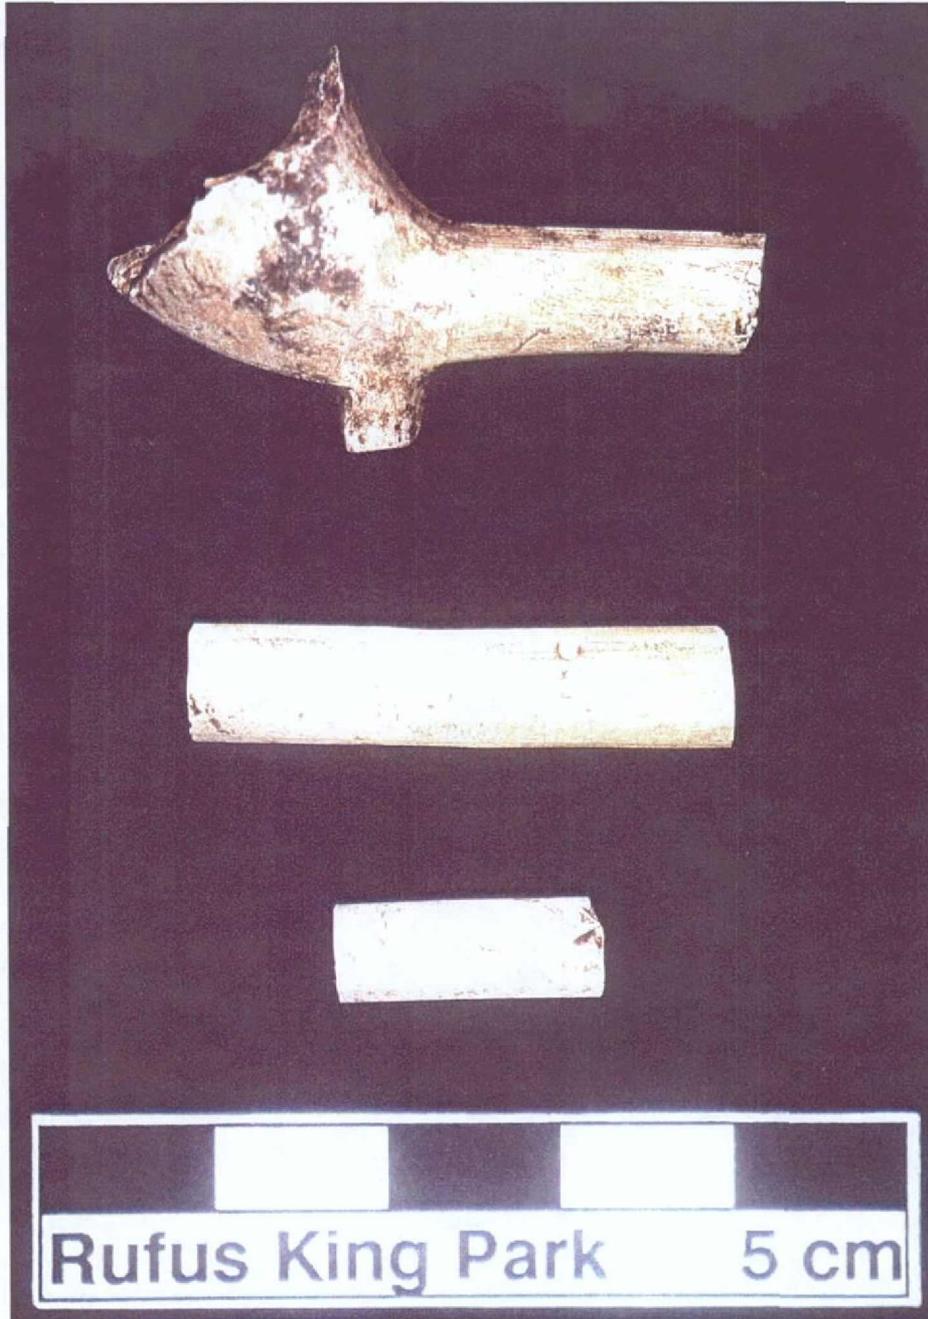
Plate 22: Kaolin pipe bowl and stem fragments recovered from lower level (Cx. 02, 5-12 inches below surface) of Trenches 1 and 2, Area A.
Top: Trench 2: Partial Kaolin Pipe bowl with plain spur and stem.
Bottom: Trench 1: Undecorated Kaolin Pipe stems, no date.

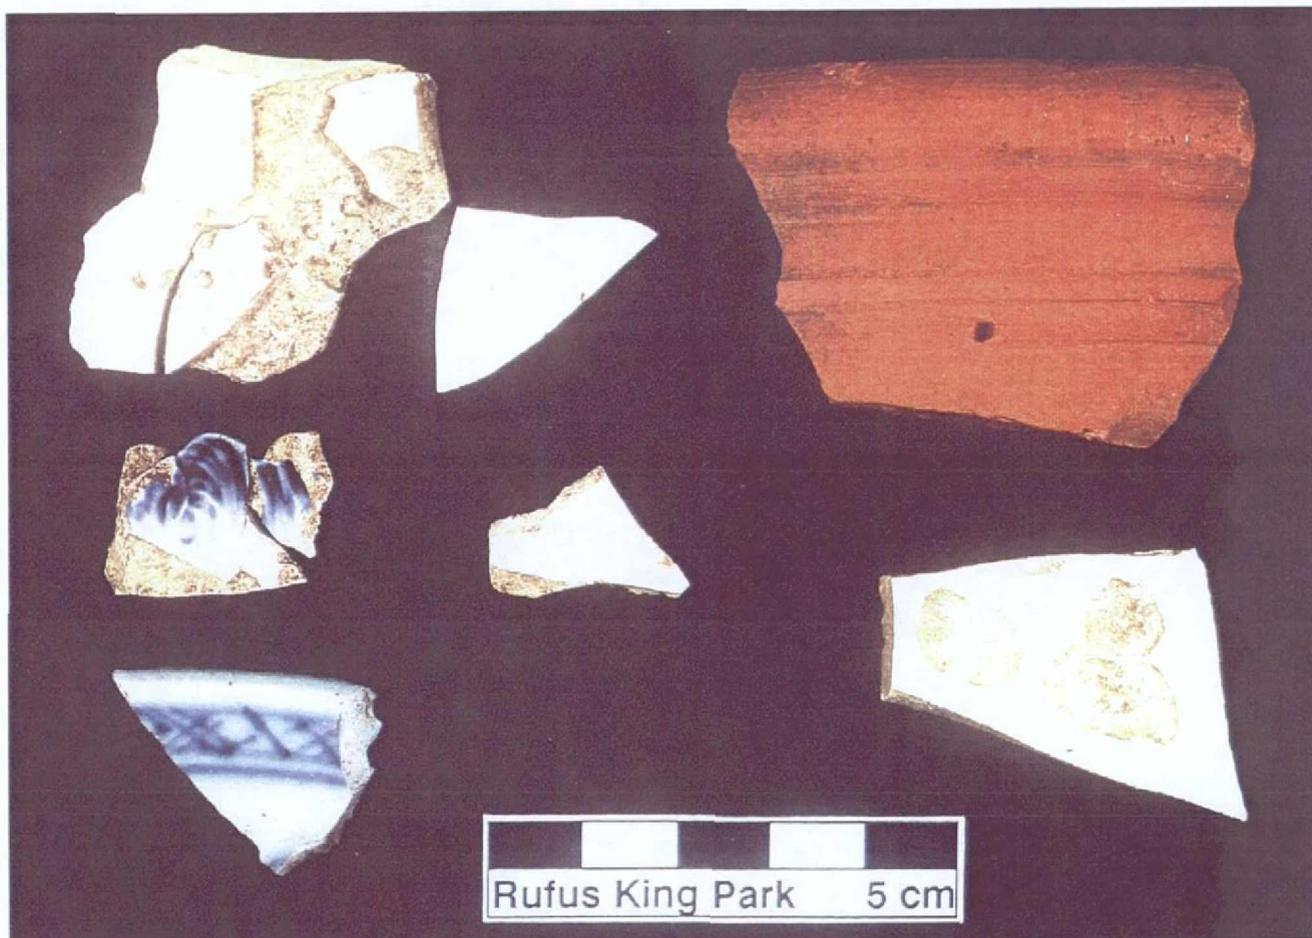
- Plate 23:** Late 18th. Century ceramics recovered from Lower level (Cx. 2.02, 5-12 inches below surface) of Trench 2, Area A.
- Top Left:** Undecorated creamware body sherds. Post-1762 (South 1972; Noël Hume 1976).
- Top Right:** Rim sherd of Unglazed Red Earthenware from large hollowware vessel. No date.
- Mid-Left:** Rim sherds from blue shell-edge decorated pearlware plate. Post-1780 (South 1972; Noël Hume 1976).
- Middle:** Body sherds of undecorated Pearlware. Post-1780 (South 1972; Noël Hume 1976).
- Bottom Left:** Rim sherd of Chinese Export Porcelain plate. Post-1790 (South 1972; Noël Hume 1976).

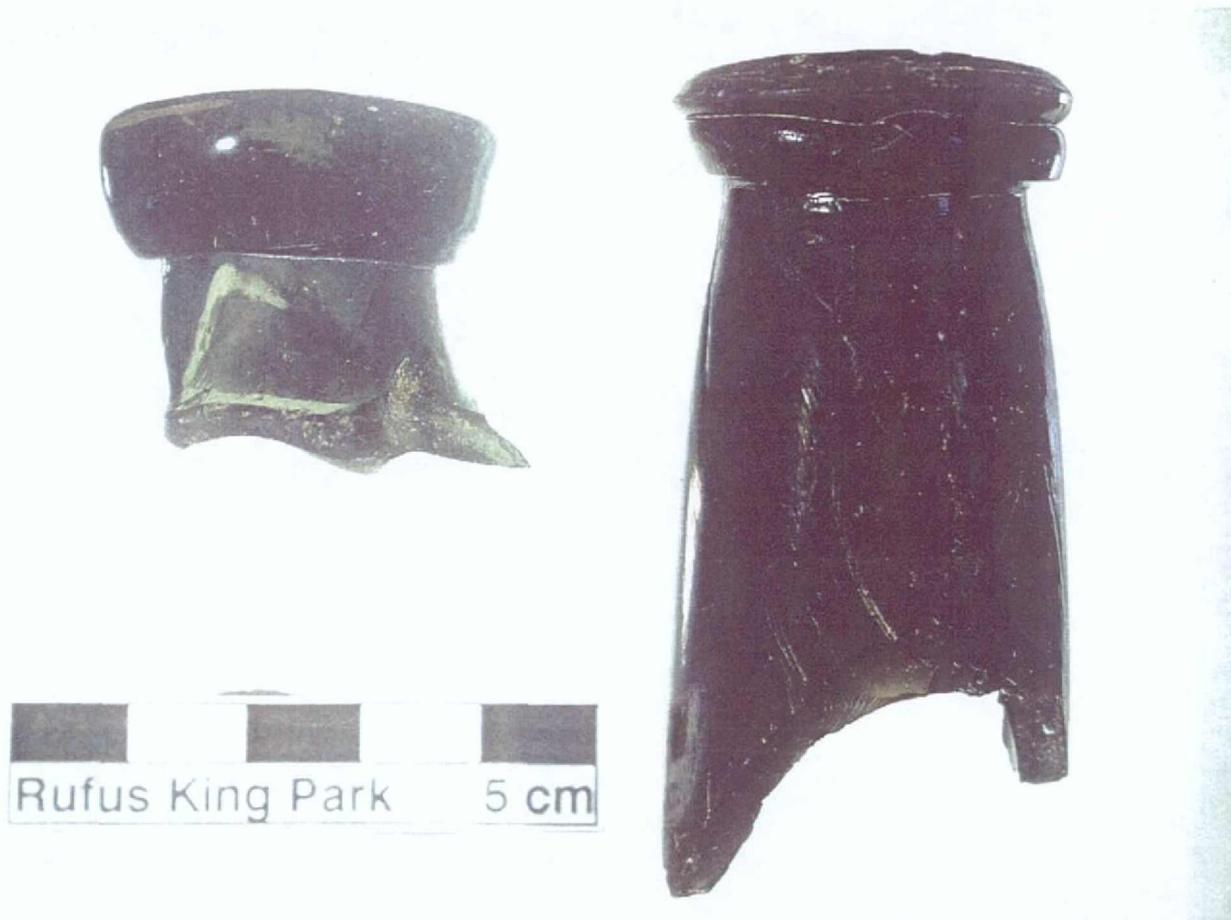
Plate 25:

Two Late 18th. Century hand-blown dark olive green wine/liquor bottle necks and lips, possibly of English or American manufacture, from the lowest level of Trench 2, Cx. 2.02 at a depth of 5-12 inches, in Area A. Probable late 18th century to early 19th century date. Most similar to bottles dated 1788 through 1809 in Noël Hume 1976, p.68.

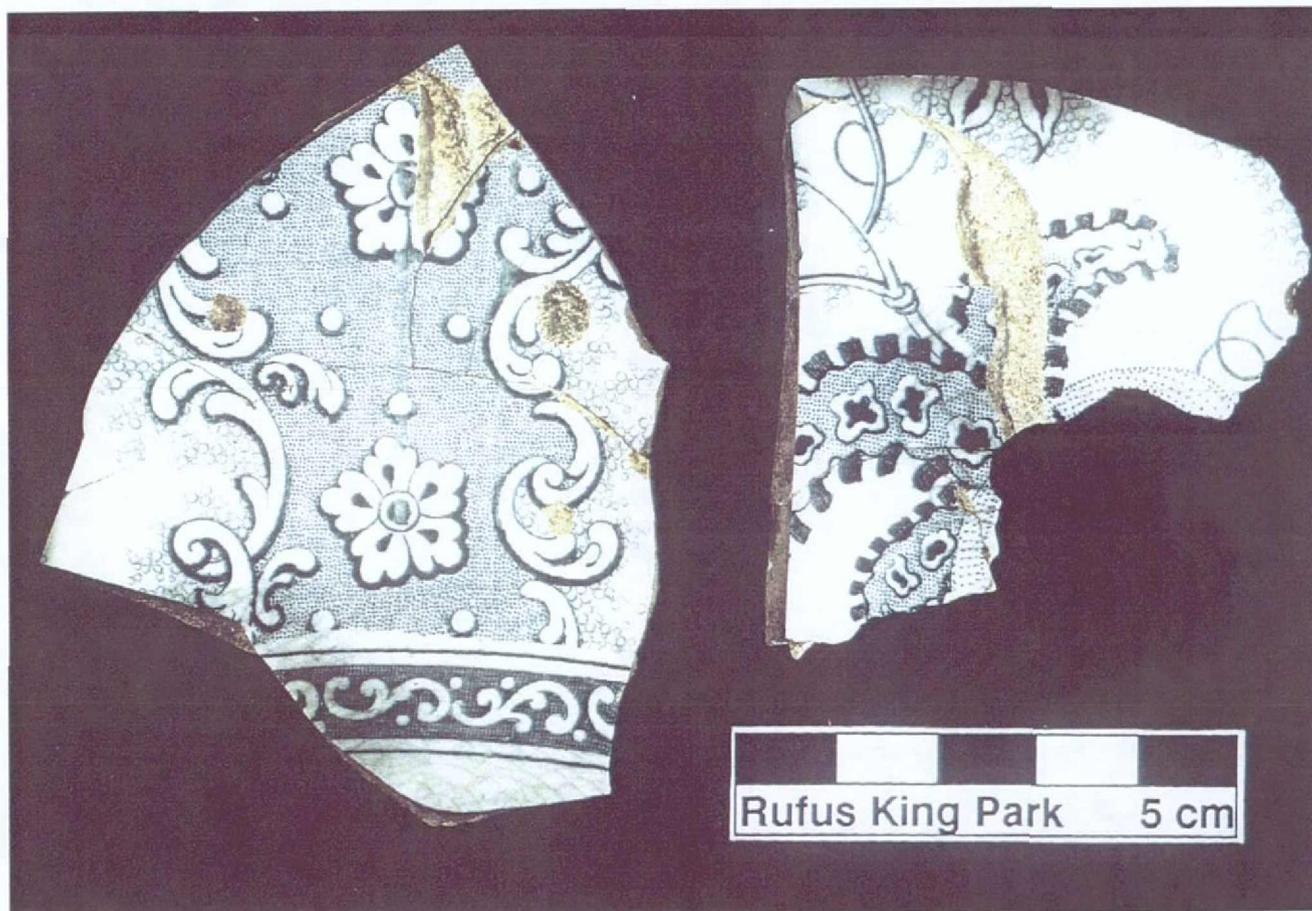
Plate 28:

Mended 19th. Century whiteware ceramic sherds recovered from the second level of Shovel Test 302 (Cx. 302.02) in Area A at a depth of 5-12 inches. Floral green transfer-printed motif on large bowl fragments, post-1850 (Price 1979; Lofstrom et. al. 1976).

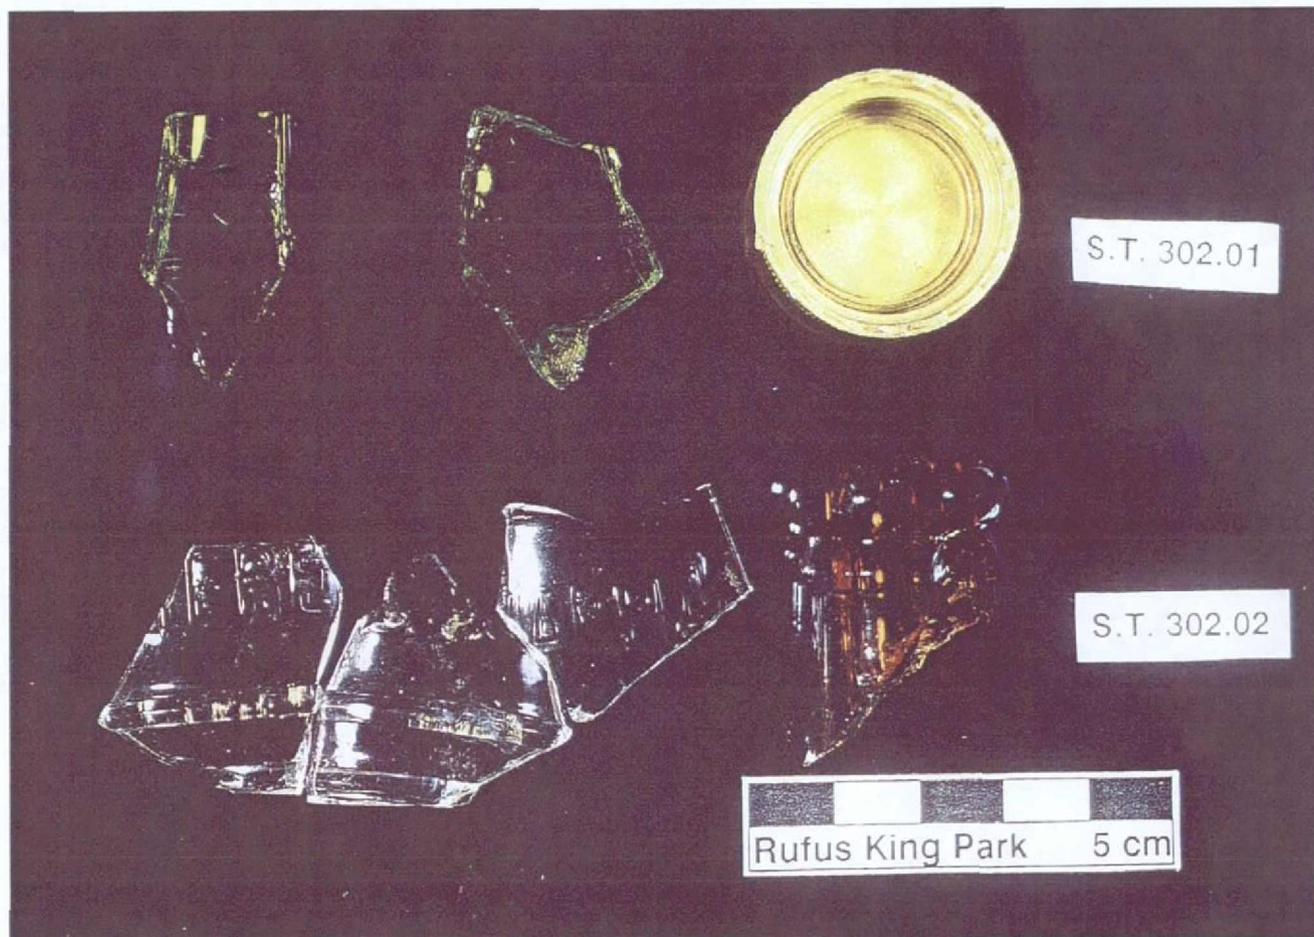
Plate 29:

Historic artifacts recovered from Shovel Test 302, in Area A.

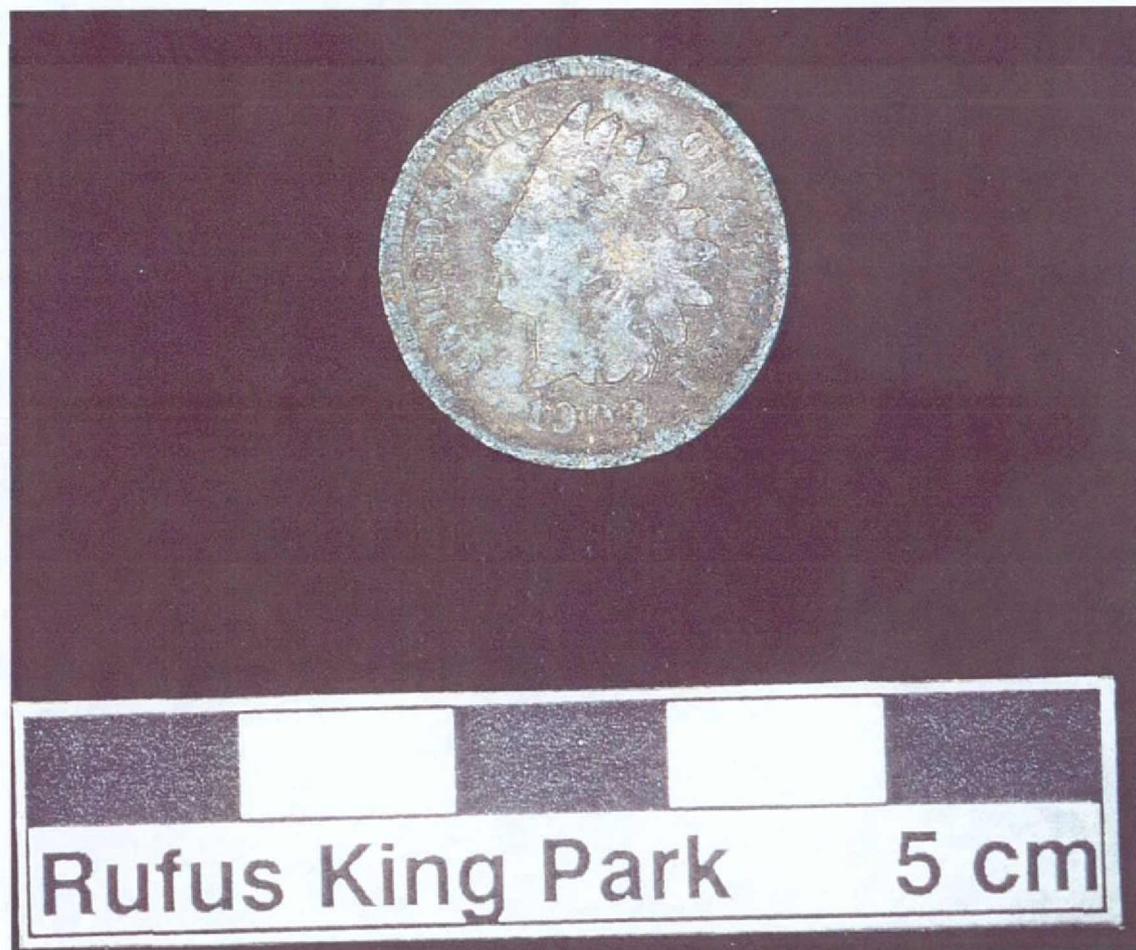
Plate 31: 1903 Indian Head copper penny from Shovel Test 304 (Cx. 304.02) in Area A, at a depth of 5-12 inches.
Obverse: "United States of America" along edge. "1903" below Indian Head.
Reverse: "One Cent" below shield within wreath.

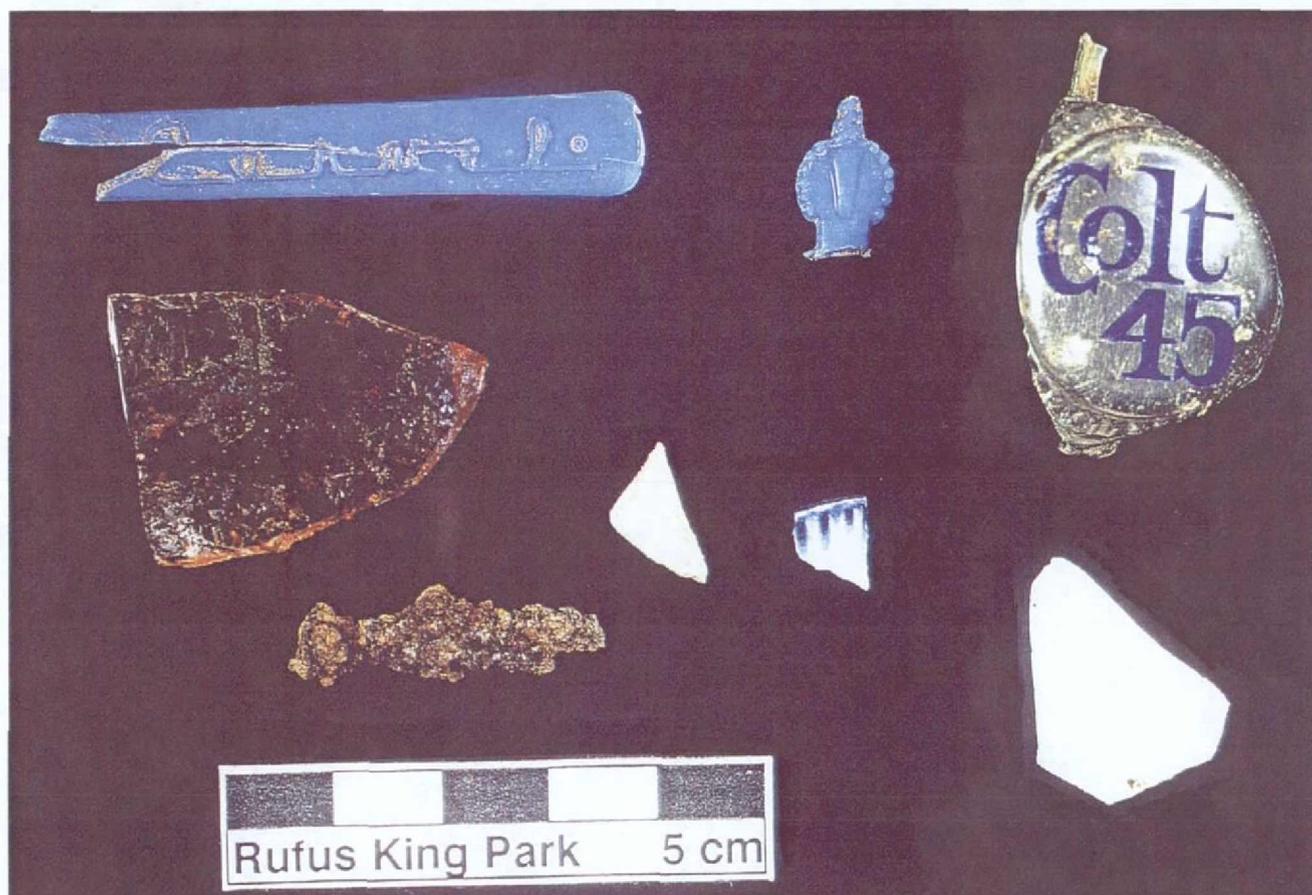
Plate 36:

Top Row:
