**NEW YORK CITY  
DEPARTMENT OF ENVIRONMENTAL PROTECTION  
STORM WATER AND SANITARY DRAINAGE PLAN**

**STAGE 1B  
ARCHAEOLOGICAL TEST EXCAVATIONS  
within  
BMP-2 AND BMP-3, BLUE HERON WATERSHED  
SOUTH RICHMOND, STATEN ISLAND, NEW YORK**

**December 1999**

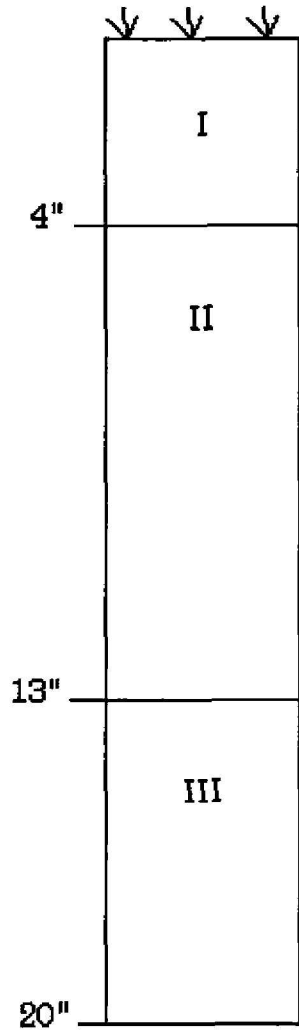
SHOVEL TEST  
NUMBER 5

- I: 10YR 2/1 black, silty loam, humus
- II: 10YR 4/4 dark yellowish brown silty clay
- III: 7.5YR 5/6 strong brown silty clay

Twenty-six (26) shovel test pits were excavated within this project site. In general, three strata of soils were encountered at this site. Stratum I, the upper layer, typically consisted of black silty loam, humus, and roots. This layer varied in thickness from two to six inches but averaged four inches in depth. Stratum II, immediately beneath stratum I, was a dark yellowish brown silty clay of variable thickness. Stratum III was a yellowish brown or strong brown silty clay. Only a few cobbles or fragments of red sandstone were occasionally found within this soil layer. FIGURE 1 presents two representative soil profiles from this site.

5.	I	0-4	Black silty loam, humus, roots; 10YR 2/1	none
	II	4-13	Dk. yellowish brown silty clay, roots; 10YR 4/4	ceramic frag.
	III	13-20	Strong brown silty clay; 7.5YR 5/6	none

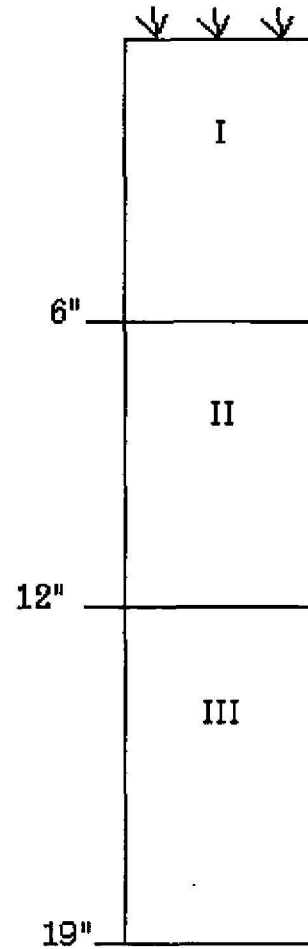
SHOVEL TEST  
NUMBER 23

- I: 10YR 3/3 dark brown silty loam, wet
- II: 10YR 4/4 dark yellowish brown sandy silty clay
- III: 10YR 6/2 and 7/8 mottled light brownish gray and yellow silty clay, water.

The test excavations revealed wet or moist soils or a high water table in several locations. Wet soils and water were encountered in STPs 3, 20, 22, 23, and 24. Disturbed soils were observed within two shovel tests: STP number 19 was an eighteen inch thick deposit of mixed clayish soils. A buried "A" soil horizon was found in STP 20. Overall, the entire site seems to have a clay base. Water drains southerly through this area and wetland conditions prevail at the southern end.

23.	I	0-6	Dk. brown silty loam, wet; 10YR 3/3	none
	II	6-12	Dk. yellowish brown sandy silty clay, roots; 10YR 4/4	none
	III	12-19	Mottled lt. brownish gray and yellow silty clay, water; 10YR 6/2, 7/8	none

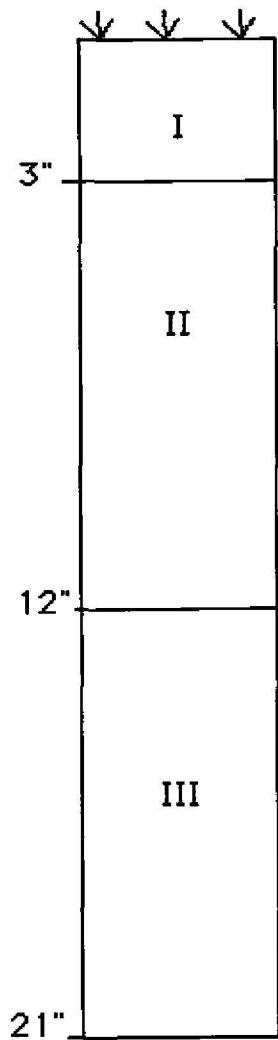
SHOVEL TEST  
NUMBER 7

- I: 10YR 2/1 black silty loam, humus, roots
- II: 7.5YR 4/6 strong brown sandy silt
- III: 7.5YR 5/6 strong brown sandy silt

Twenty-eight shovel test pits were excavated within BMP-3. Twenty-four tests were excavated along three transects on the north side of Koch Pond. Three strata of soils were encountered at this site. Stratum I, the upper soil layer, was black silty loam, humus, and contained numerous roots. This soil layer was three to four inches in depth. Stratum II, directly beneath I, was a strong brown or dark brown sandy silt that occasionally contained small pebbles. This layer varied in thickness from four to fifteen inches but averaged nearly nine inches. Stratum III was strong brown sandy silt or sandy silty clay that occasionally contained pebbles and cobbles. In general strata II and III were similar in terms of texture and content but differed slightly in color. Figure 2 presents two representative soil profiles from this site.

7.	I	0-3	Black silty loam, humus, roots; 10YR 2/1	none
	II	3-12	Strong brown sandy silt; 7.5YR 4/6	none
	III	12-21	Strong brown sandy silt; 7.5YR 5/6	none

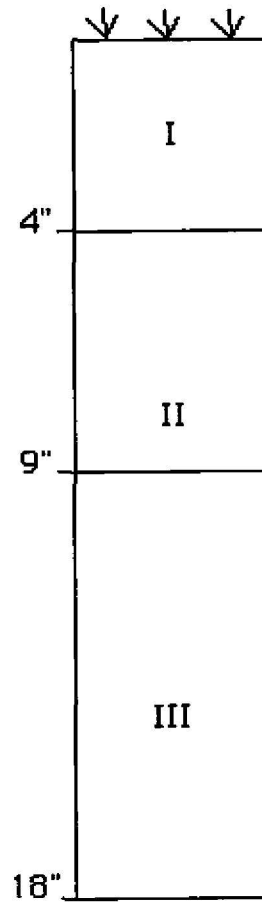
SHOVEL TEST  
NUMBER 20

- I: 10YR 2/2 black sandy silty loam, humus, roots
- II: 7.5YR 4/4 dark brown sandy silty clay, two cobbles
- III: 7.5YR 5/6 strong brown sandy silty clay, pebbles

20.	I	0-4	Black sandy silty loam, humus, roots; 10YR 2/1	none
	II	4-9	Dk. brown sandy silty clay, two cobbles; 7.5YR 4/4	none
	III	9-18	Strong brown sandy silty clay, pebbles; 7.5YR 5/6	none
