**PHASE IB/II ARCHEOLOGICAL INVESTIGATIONS  
OF THE BRICKTOWN CENTRE AT CHARLESTON  
STATEN ISLAND, NEW YORK**

**John Milner Associates**

2000

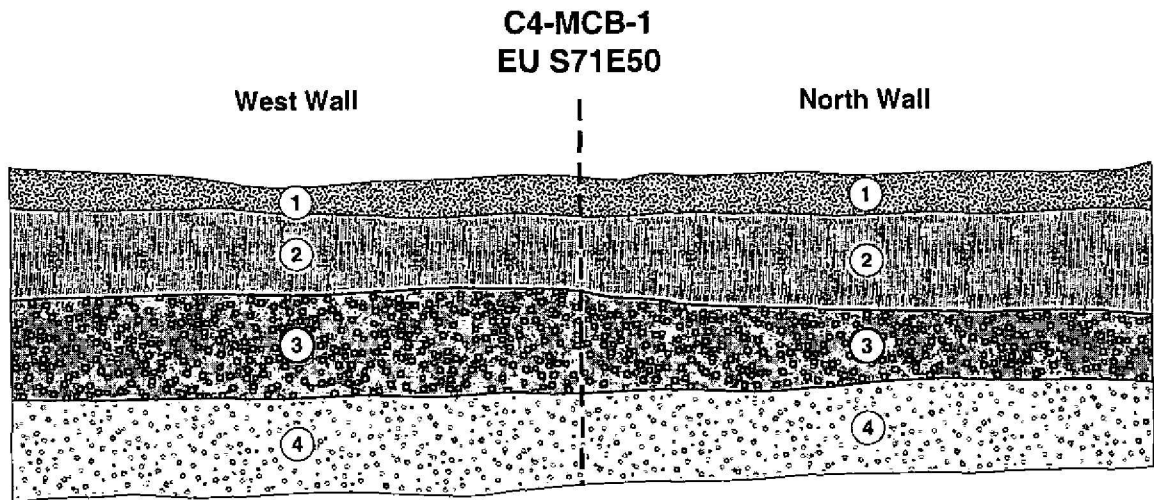
- 1 10YR 3/1 very dark gray sandy silt loam
- 2 10YR 4/4 dark yellowish brown sandy silt with clay traces
- 3 7.5YR 4/6 strong brown sandy clay with pebbles
- 4 5YR 4/6 yellowish red sandy clay with pebbles

Figure 30. Stratigraphic profiles of Excavation Unit (EU) S71/E50 (ASL C4-MCB-1).

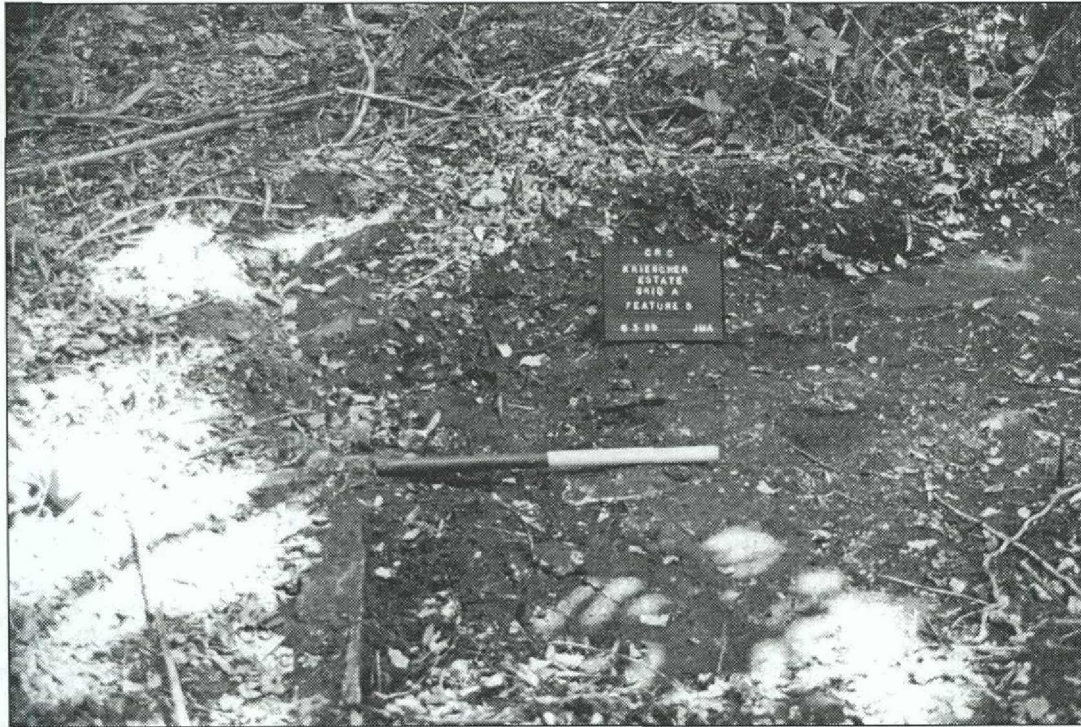
**Feature A5.** Feature A5 is likely the remains of a small outbuilding or garage (Plate 8). The feature consists of a concrete floor, approximately 10 feet from north to south and six feet from east to west. One-brick thick foundation walls run along both the north and south edge of the concrete floor. An STU (N100/E100) was placed just north of this feature, and contained architectural materials such as mortar, oxidized sheet metal, and a cut nail.

Plate 8. Kreischer Estate, Feature A5. Concrete floor of a small outbuilding or garage.

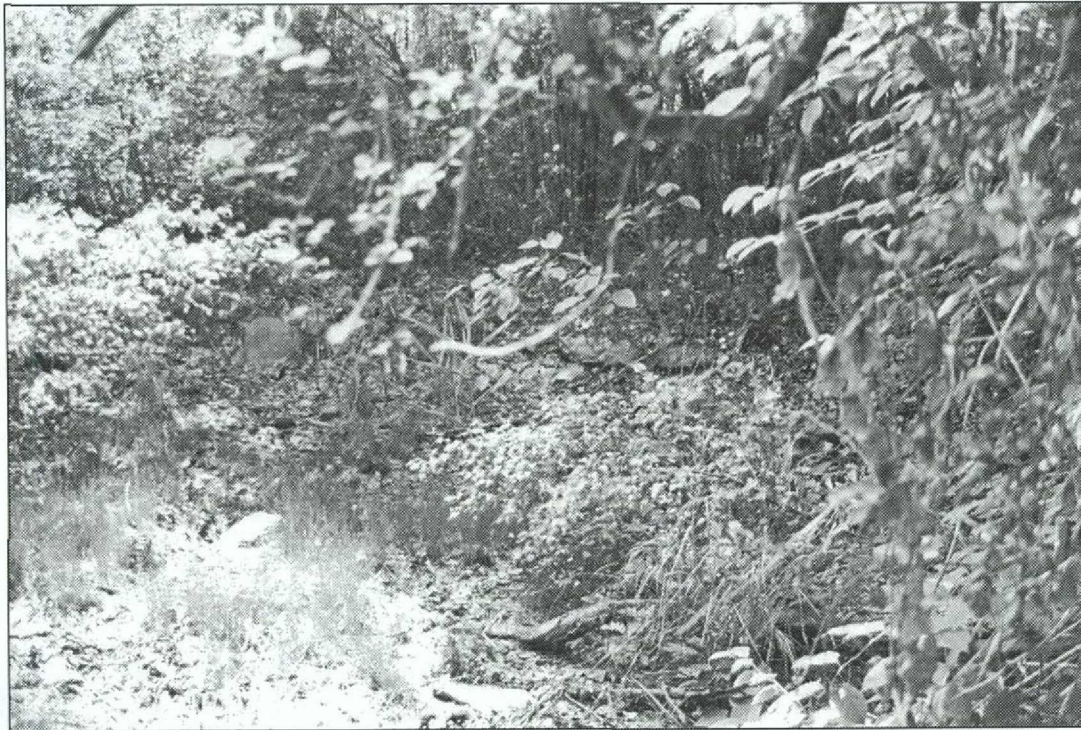
Plate 9. Kreischer Estate, Feature A7. Sections of a dry-laid stone wall were observable lining the perimeter of the drained pond.

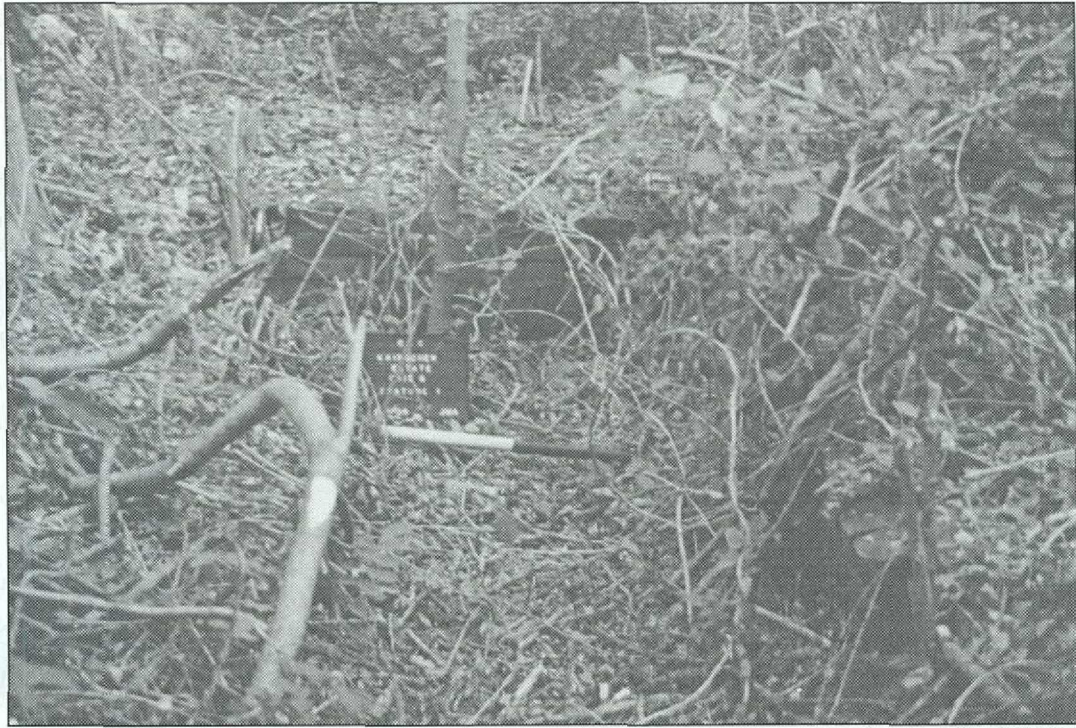
**Feature B1.** Feature B1 is a 30-foot long brick-lined trough, approximately four feet wide, connected to a small outbuilding foundation (Plate 10). The trough runs roughly southwest into a brick building foundation, approximately 30 feet east-west by 10 feet north-south. Glass bottle fragments (10) dating to the late nineteenth and early twentieth century littered the western area of the brick building foundation. These surface finds indicate that Feature B1, like Features A2 and A3 in Area A (above), was used as a dump for household debris around the time the site was abandoned.

Plate 10. Kreischer Estate, Feature B1. Brick-lined trough feature.

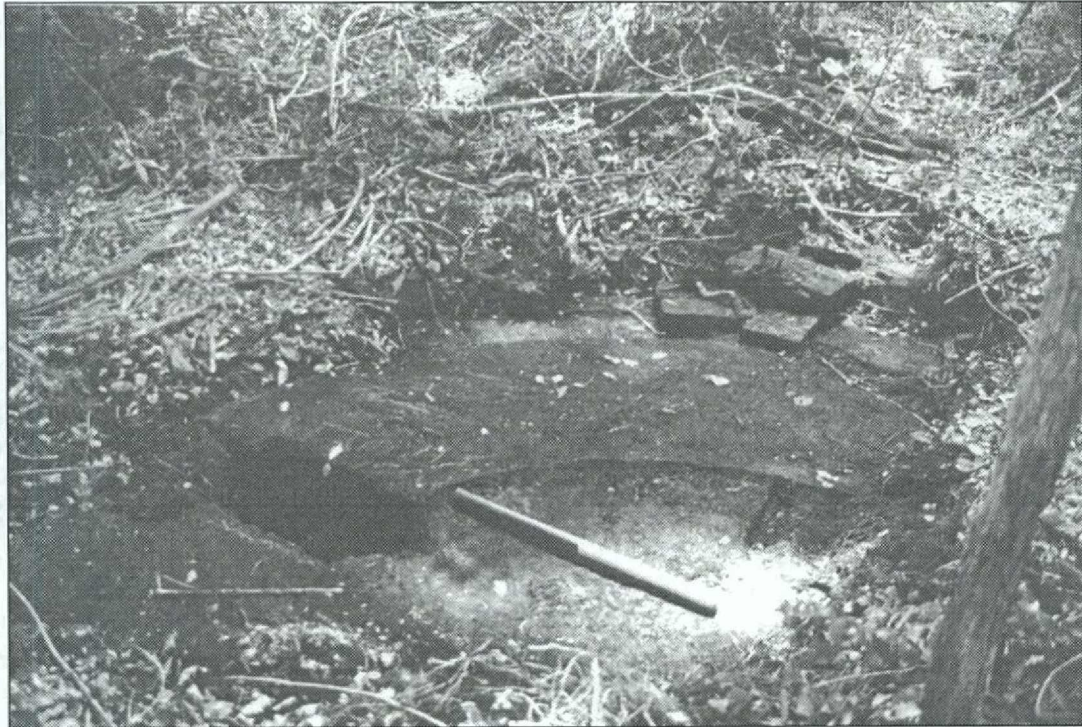
Perspectives 1996: Figure 19) behind but close to the house. Feature B5 is probably the foundation of this tower. A round structure is also depicted east of the "Fairview" main house (Area C - Feature C2, see below) on the Robinson 1898 map of the area, although the function of this structure is not indicated. This round structure is not indicated on the 1913 map (Topographic Survey 1913) depicting the survey area, suggesting that this feature was no longer used and was possibly demolished by 1913.

Plate 12. Kreischer Estate, Feature B5. Circular brick platform, probably the foundation of a water tower.

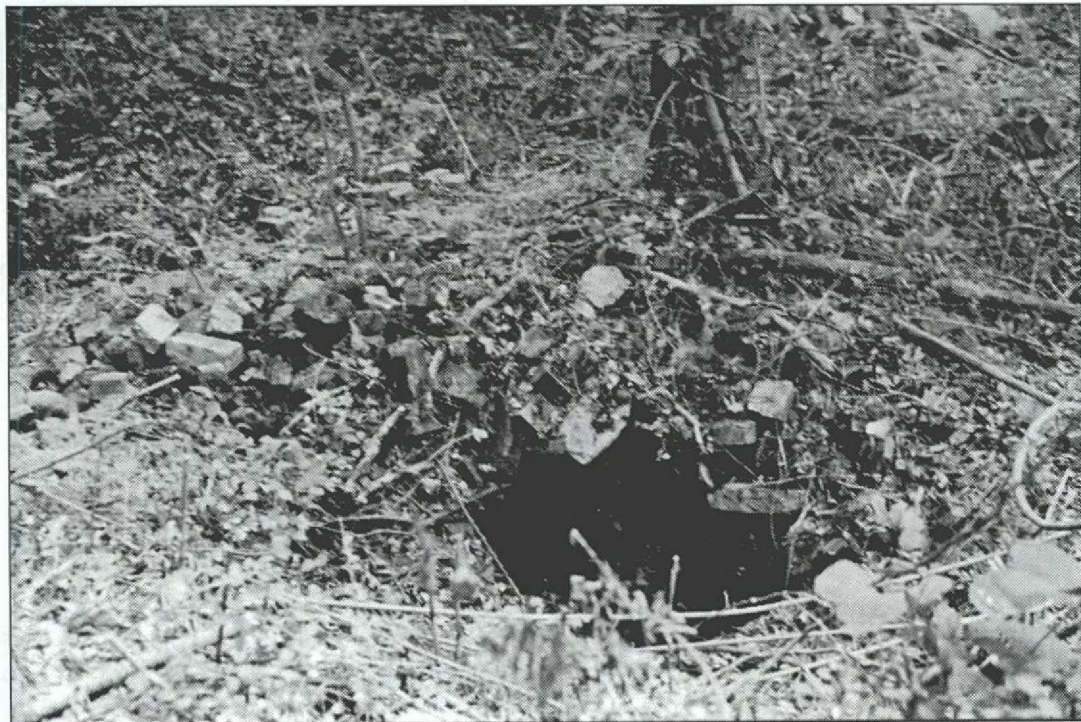
**Feature C1.** Feature C1 is a cellar hole measuring approximately 25 feet east-west and 20 feet north-south (Plate 13), located about 45 feet north of the main dwelling house foundation (Feature C2). This structure is depicted on the 1913 map (Topographic Survey 1913) as a one-story brick structure located on the north side of the driveway opposite the main house. The building also appears on the 1898 map of the area (Robinson 1898). This smaller foundation, in immediate proximity to the foundation of the Kreisler mansion, may represent servants quarters or a guesthouse.

Plate 13. Kreischer Estate, Feature C1. Detail of the corner of the secondary dwelling foundation.

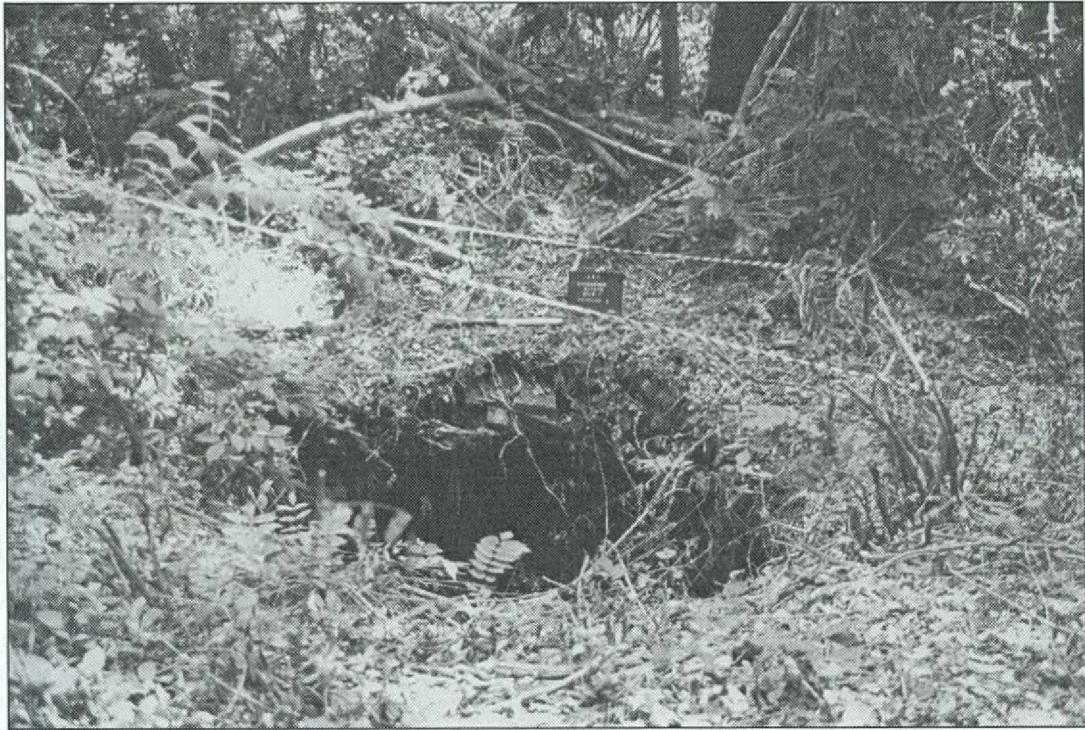
**Feature C3.** Feature C3 is a circular brick-lined shaft or vault feature (Plate 14) adjacent to the southeast corner of the main house foundation (Feature C2). The feature is approximately eight feet in diameter and at least seven feet deep. Observable contents within the feature's interior included architectural debris such as brick, stone, and mortar. Given the potential hazards posed by the feature's depth and fragile brick lining, the fill within the feature was not tested for artifacts. Although the feature appears to be a cistern, its actual function remains unknown. Machine-aided excavation would be required to document the feature's fill and further investigate its function.

Plate 14. Kreischer Estate, Feature C3. Brick-lined vault feature adjacent to the Kreischer mansion main house foundation.
