REPORT ON PHASES 1B and 2/3  
ARCHAEOLOGICAL TESTING AND EXCAVATIONS  
OF THE MILL POND SEWER PROJECT  
LOCATED ALONG PARTS OF OLD MILL ROAD,  
ARTHUR KILL ROAD, AND PARTS OF  
HISTORIC RICHMOND TOWN (Blocks 2278, 2290 and 4444),  
BOROUGH OF STATEN ISLAND  
NEW YORK

Contract No. SER 20099

Submitted by: Linda Stone, MA, RPA  
249 East 48th Street, #2B  
New York, New York 10017

May 23, 2003

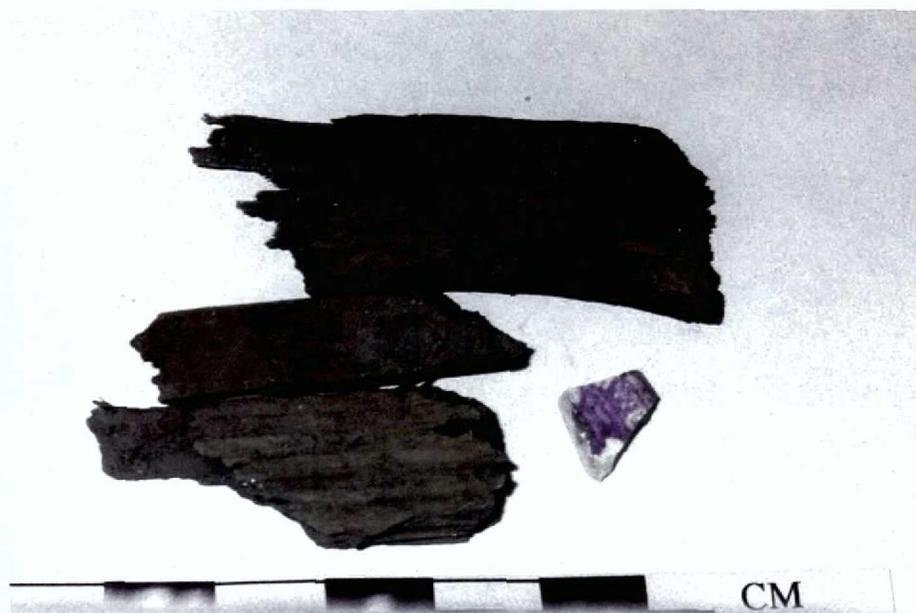
Plate 1 Artifacts recovered from the surface of the early Arthur Kill Road (Context 45), cut wood and blue transfer print sherd.

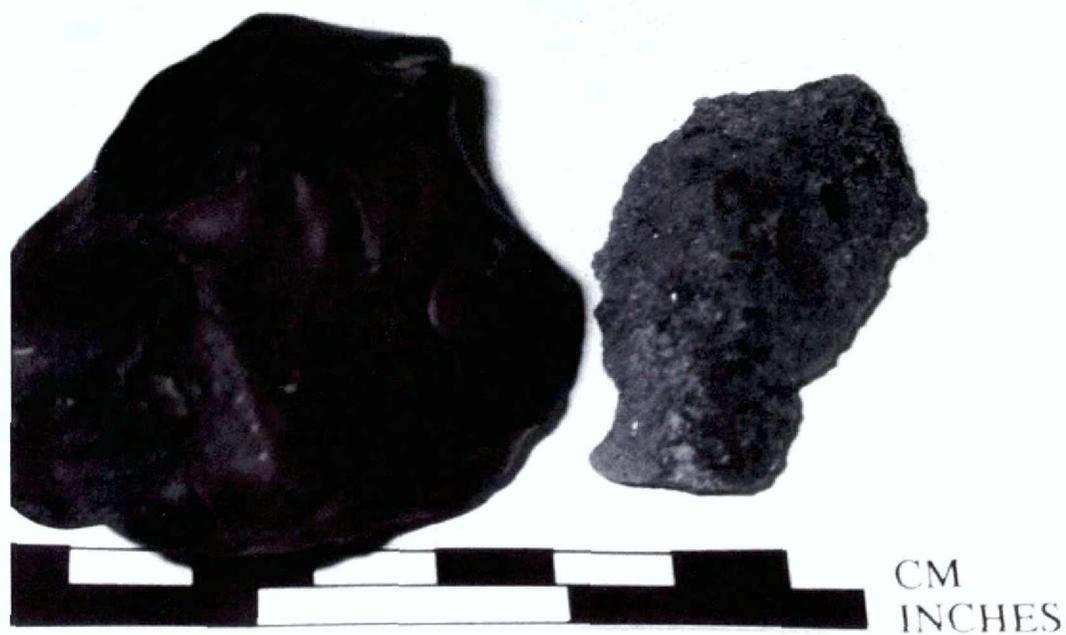
Plate 2 Possible Pre-contact Period artifacts recovered from around the foundation of the former Hennessy House (Contexts 40 & 42)

Very few artifacts were found in and among the foundation stones of the Hennessey House. Some shell, a small amount of coal and a small amount of burned wood were noted but not retained. A piece of redware was retained from the elliptical storm sewer archaeological excavations. The burned stratum (Context #41) contained several diagnostic artifacts. The *tpq* comes from a piece of molded glass which could have been manufactured any time after 1867. This context also contained a smoking pipe bowl and stem, redware and whiteware. The most surprising find from this archaeological work was a pre-contact period worked stone piece, possibly a scraper (Plate 2).

period artifact (Plate 2), although more dubious than the one recovered from Context # 40, as well as ceramic and glass sherds. The *tpq* comes from a piece of glass which could have been made any time after 1890. Context # 44 represents the soil between the foundation stones and contained two artifacts; a small piece of aluminum, possibly from a specialized type of cap, and a sherd of white granite.

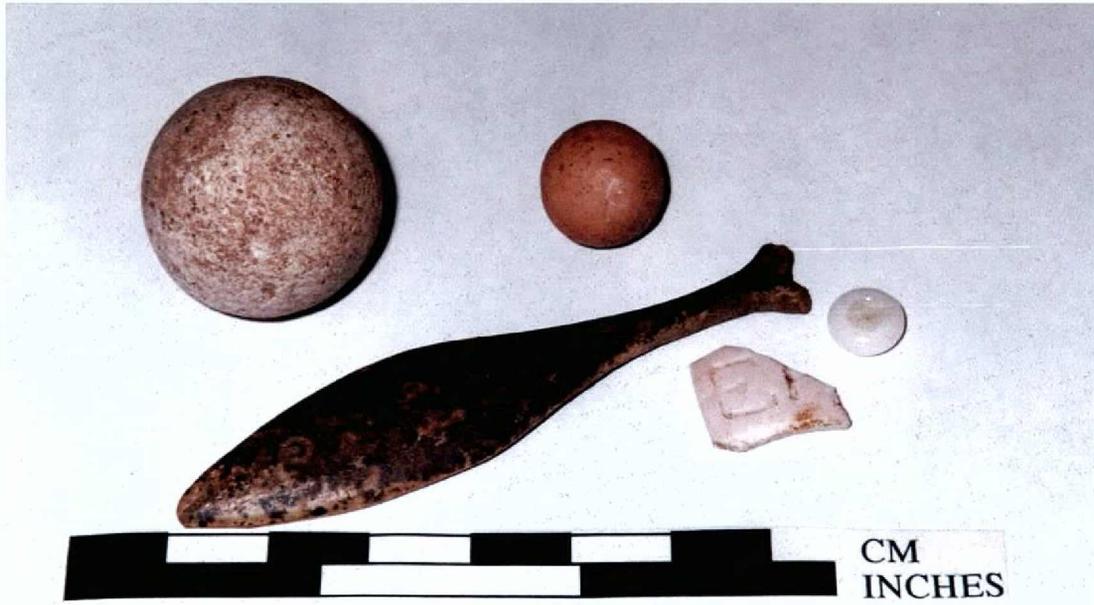
Plate 3 Sample of small finds from various contexts (clockwise from fish Contexts 8, 13, 1, 3, & 3)

Underneath the second level of foundation stones at the eastern end of the excavation, was a carved fish made of bone or ivory/tooth/tusk (Context #8) (Plate 3). It was initially thought it may be a lure, however there was no hole for a hook or line. The piece is intricately carved with eyes and gills on each side. The only other artifact retained from this context was a diagnostic piece of glass which could have been manufactured any time from the eighteenth century until the present time.

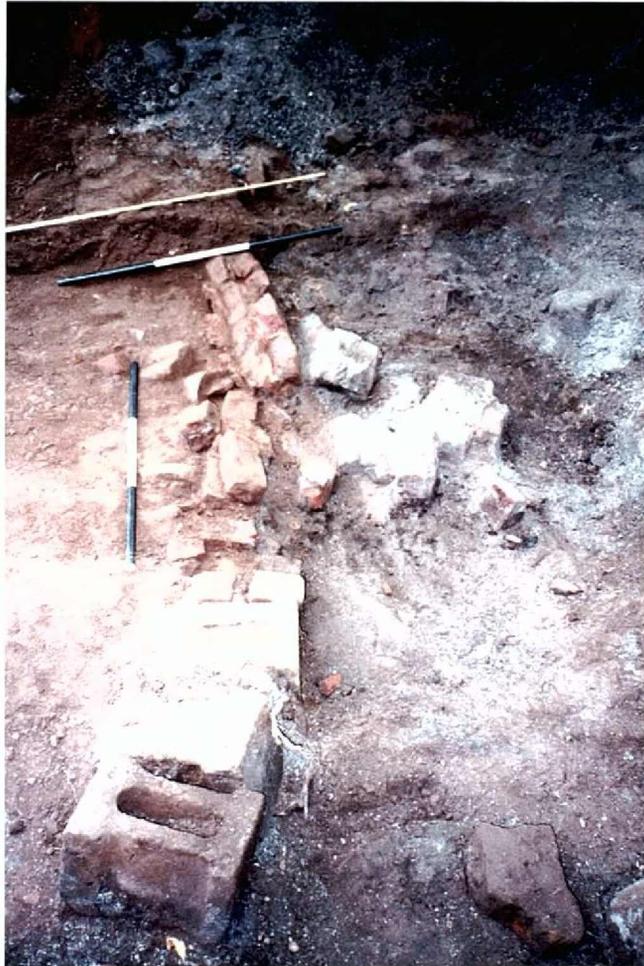
Plate 4 Brick and cinderblock foundation remains of Area D shed.

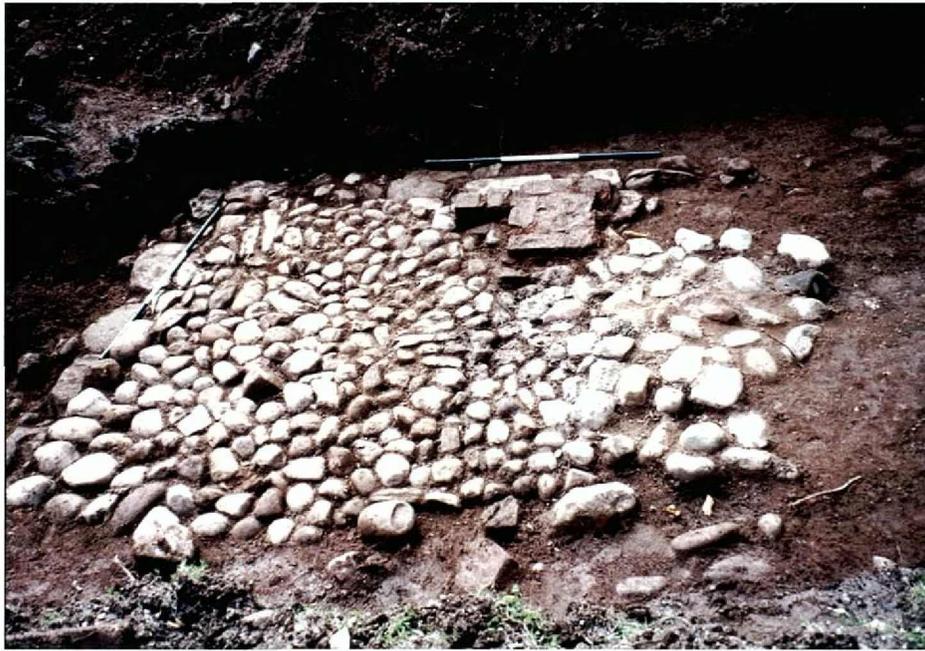
Plate 5 Cobble surface and brick footing from Areas D-F, the Tinsmith Shop and shed(s), facing south.

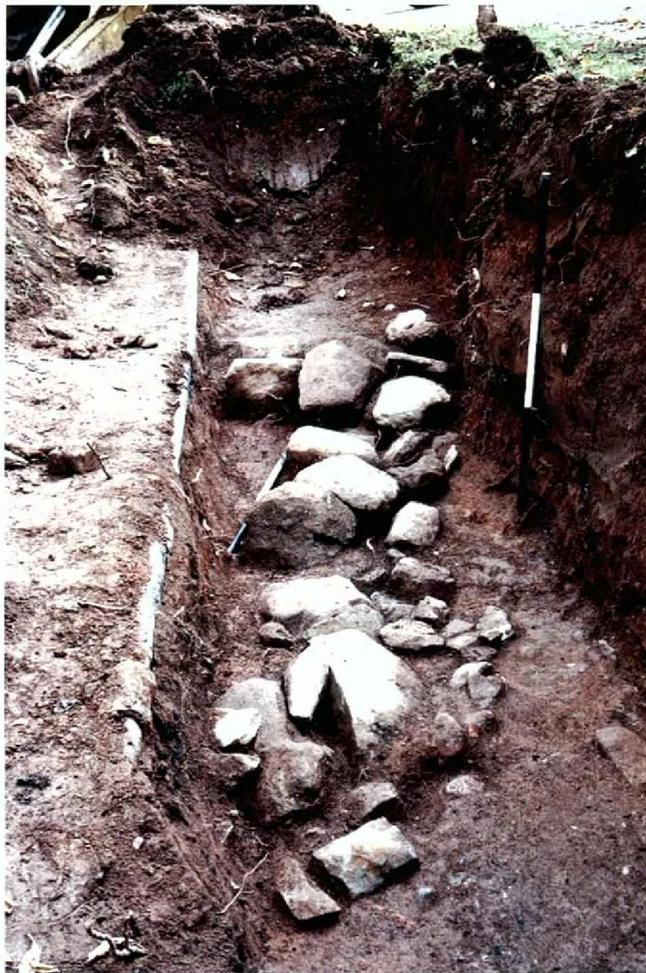
Plate 6 Foundation remains of previously unknown structure in Area J/K, facing east.

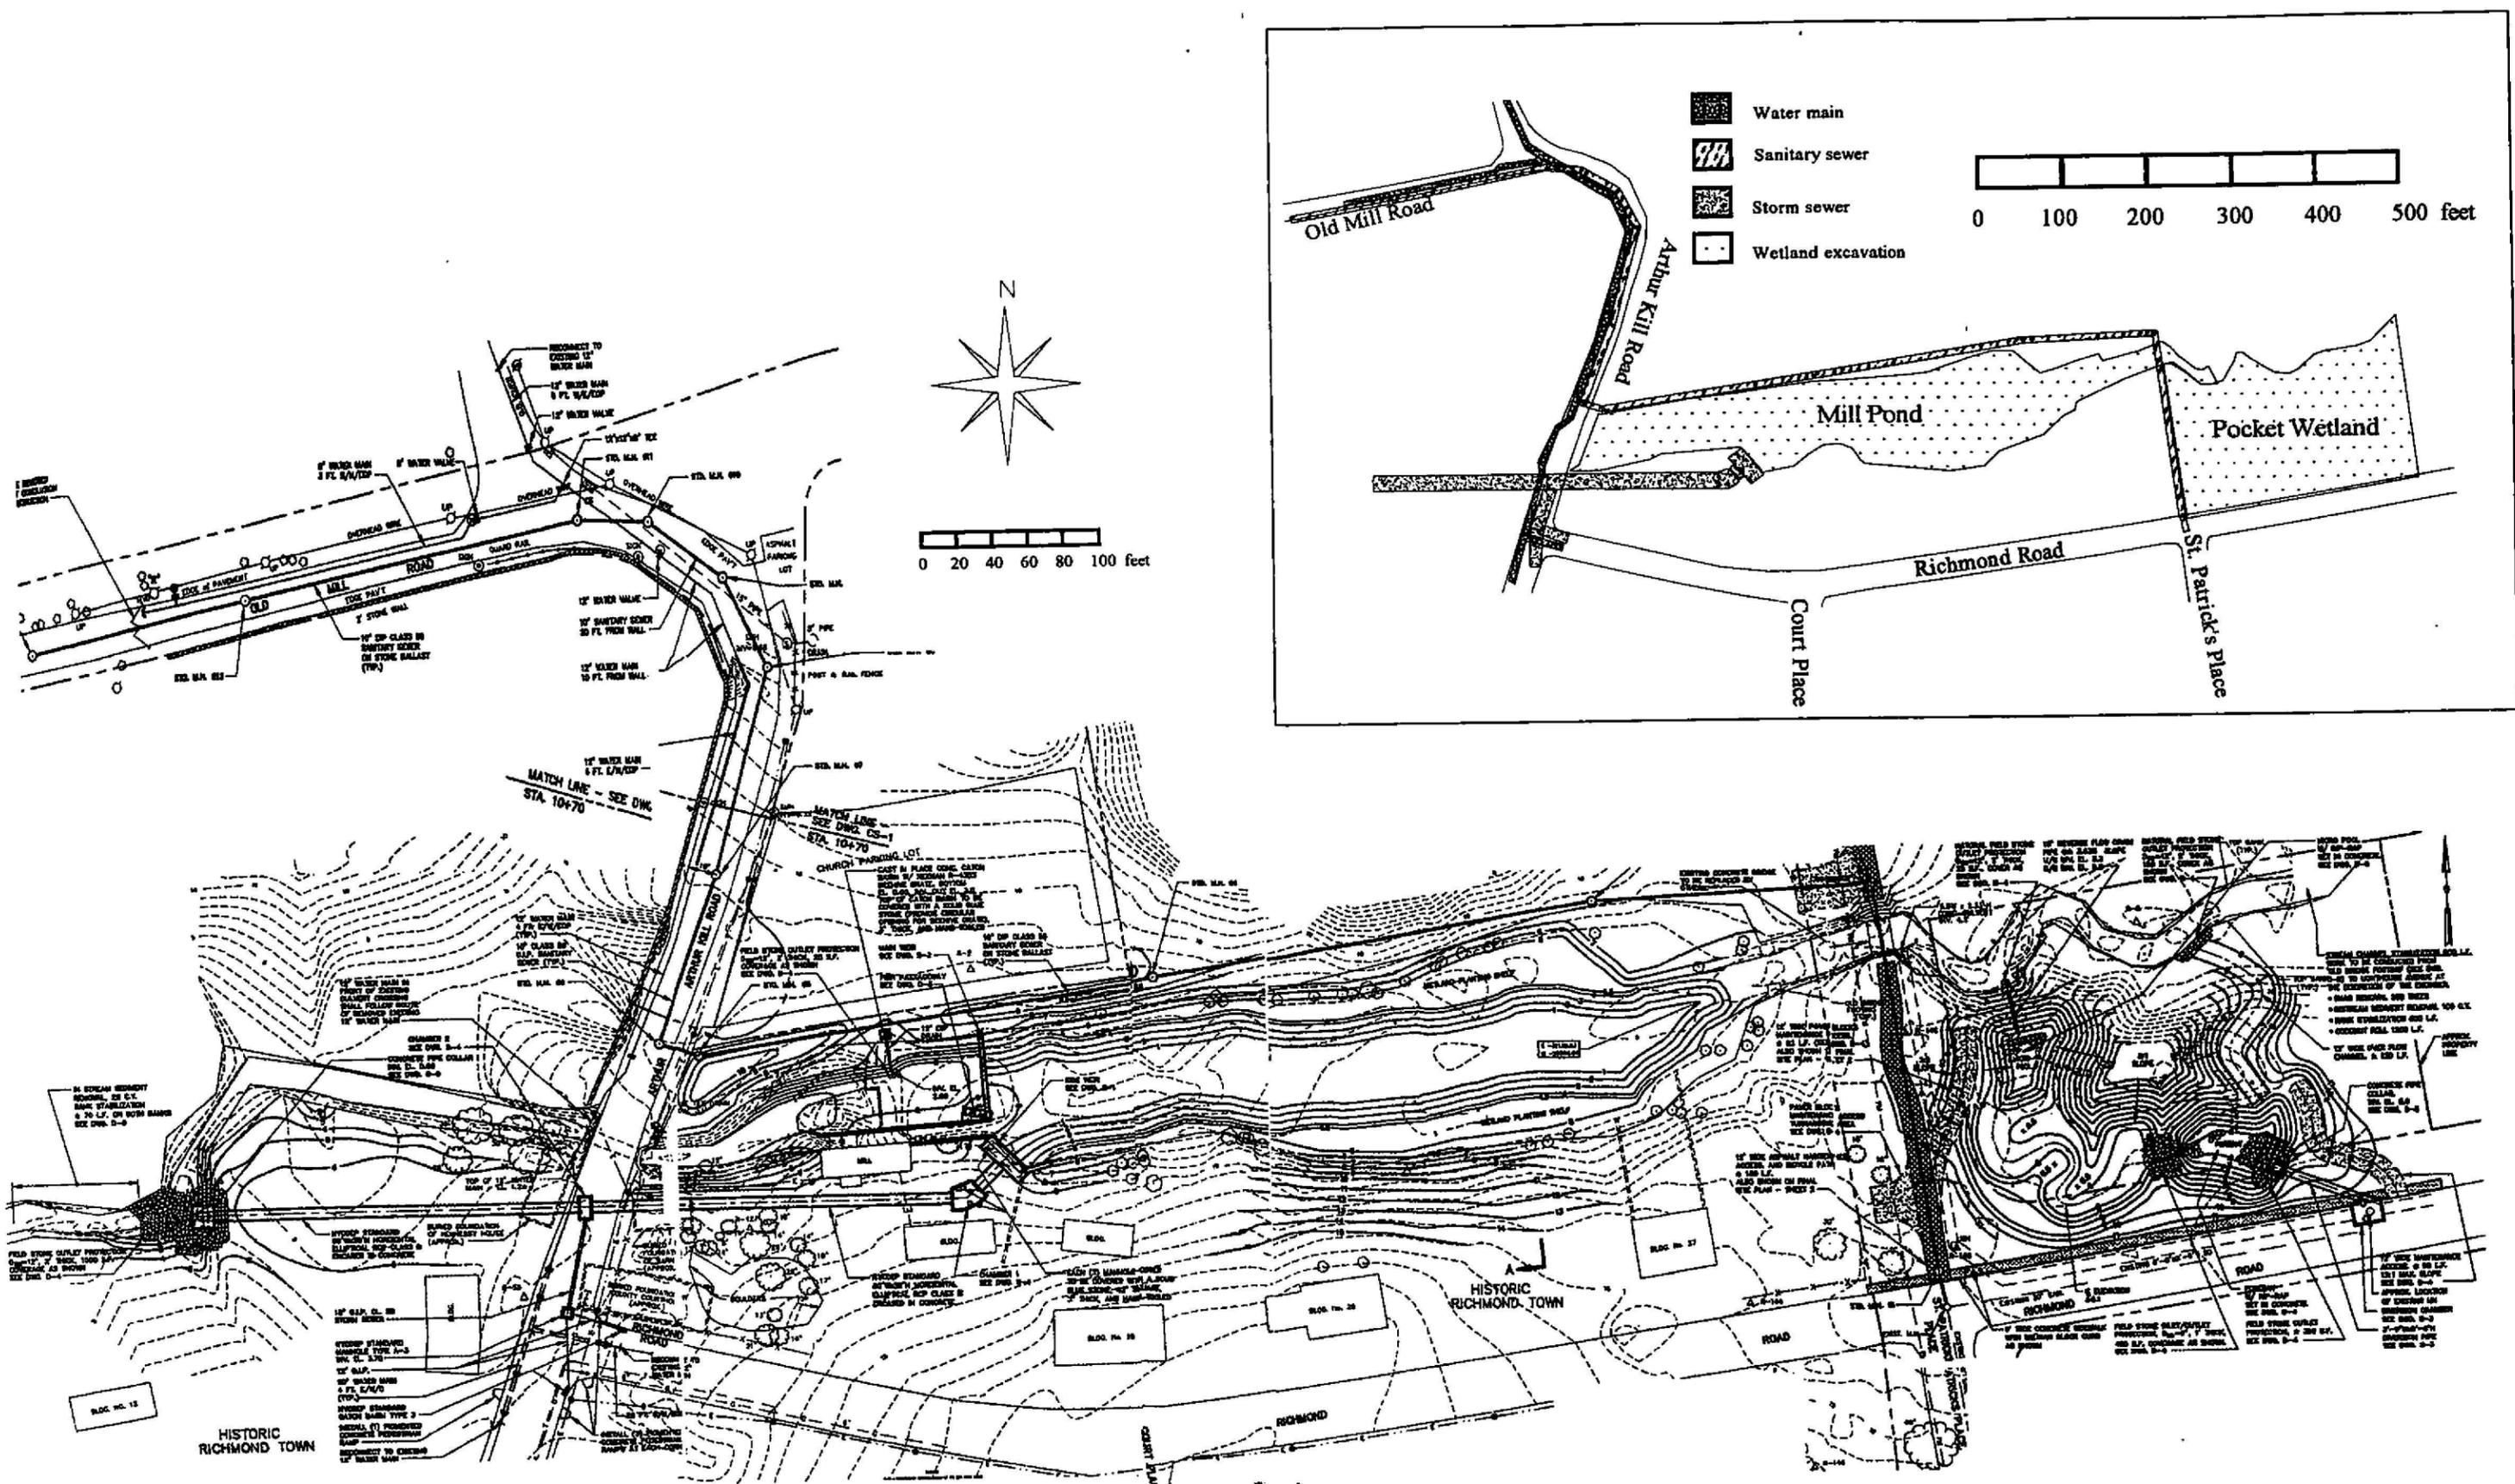
Figure 1 Hazen & Sawyer site plan showing the footprint on planned impacts from the Mill Pond project.

The project contains four types of impacts; water main replacement, new sanitary sewer, new storm sewer, and wetlands reconstruction in the vicinity of Mill Pond (see Figure 1). The water main will go along the center of Old Mill Road, beginning at a point near the start of the stone wall surrounding the St. Andrew's Church cemetery, to Arthur Kill Road and south down Arthur Kill Road, about five feet from the western curb, to Richmond Road. It will reconnect with existing 12 inch water mains on both Arthur Kill and Richmond Roads. The trench for this impact will be three to four feet wide and up to six feet deep. Its total length will be about 950 feet. The water main replacement trench will be excavated to the depth of the existing water main.

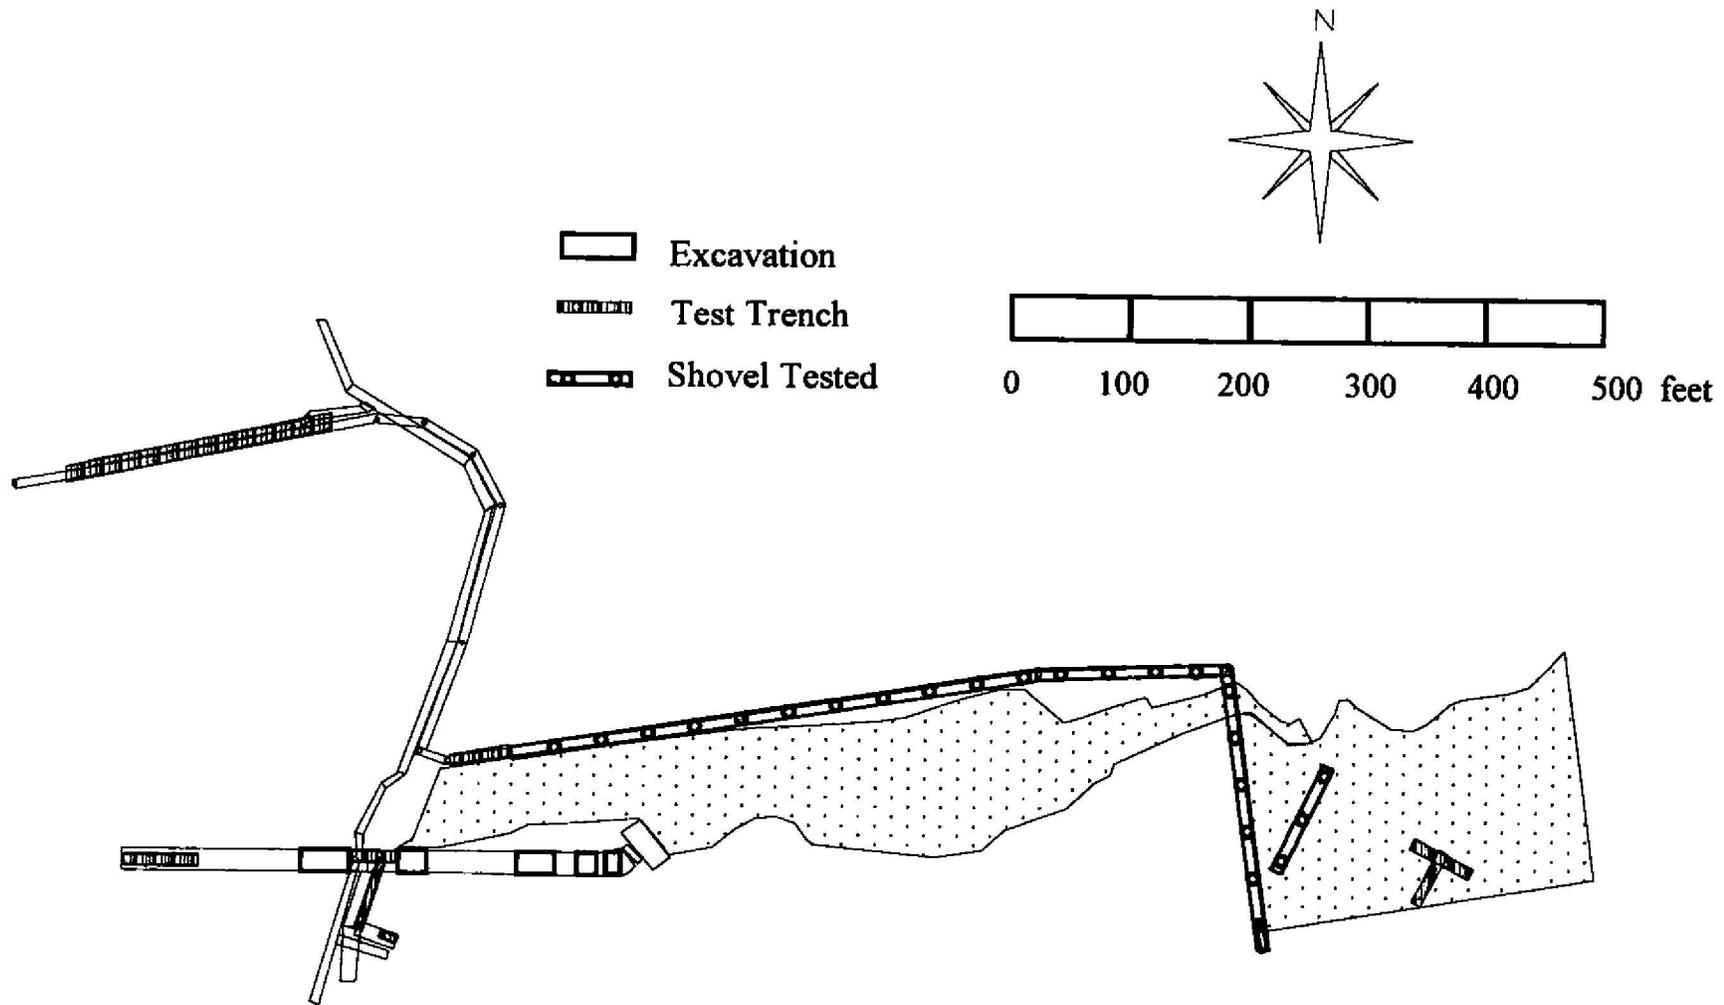
Figure 2 Field methods used during this phase of the Mill Pond project.

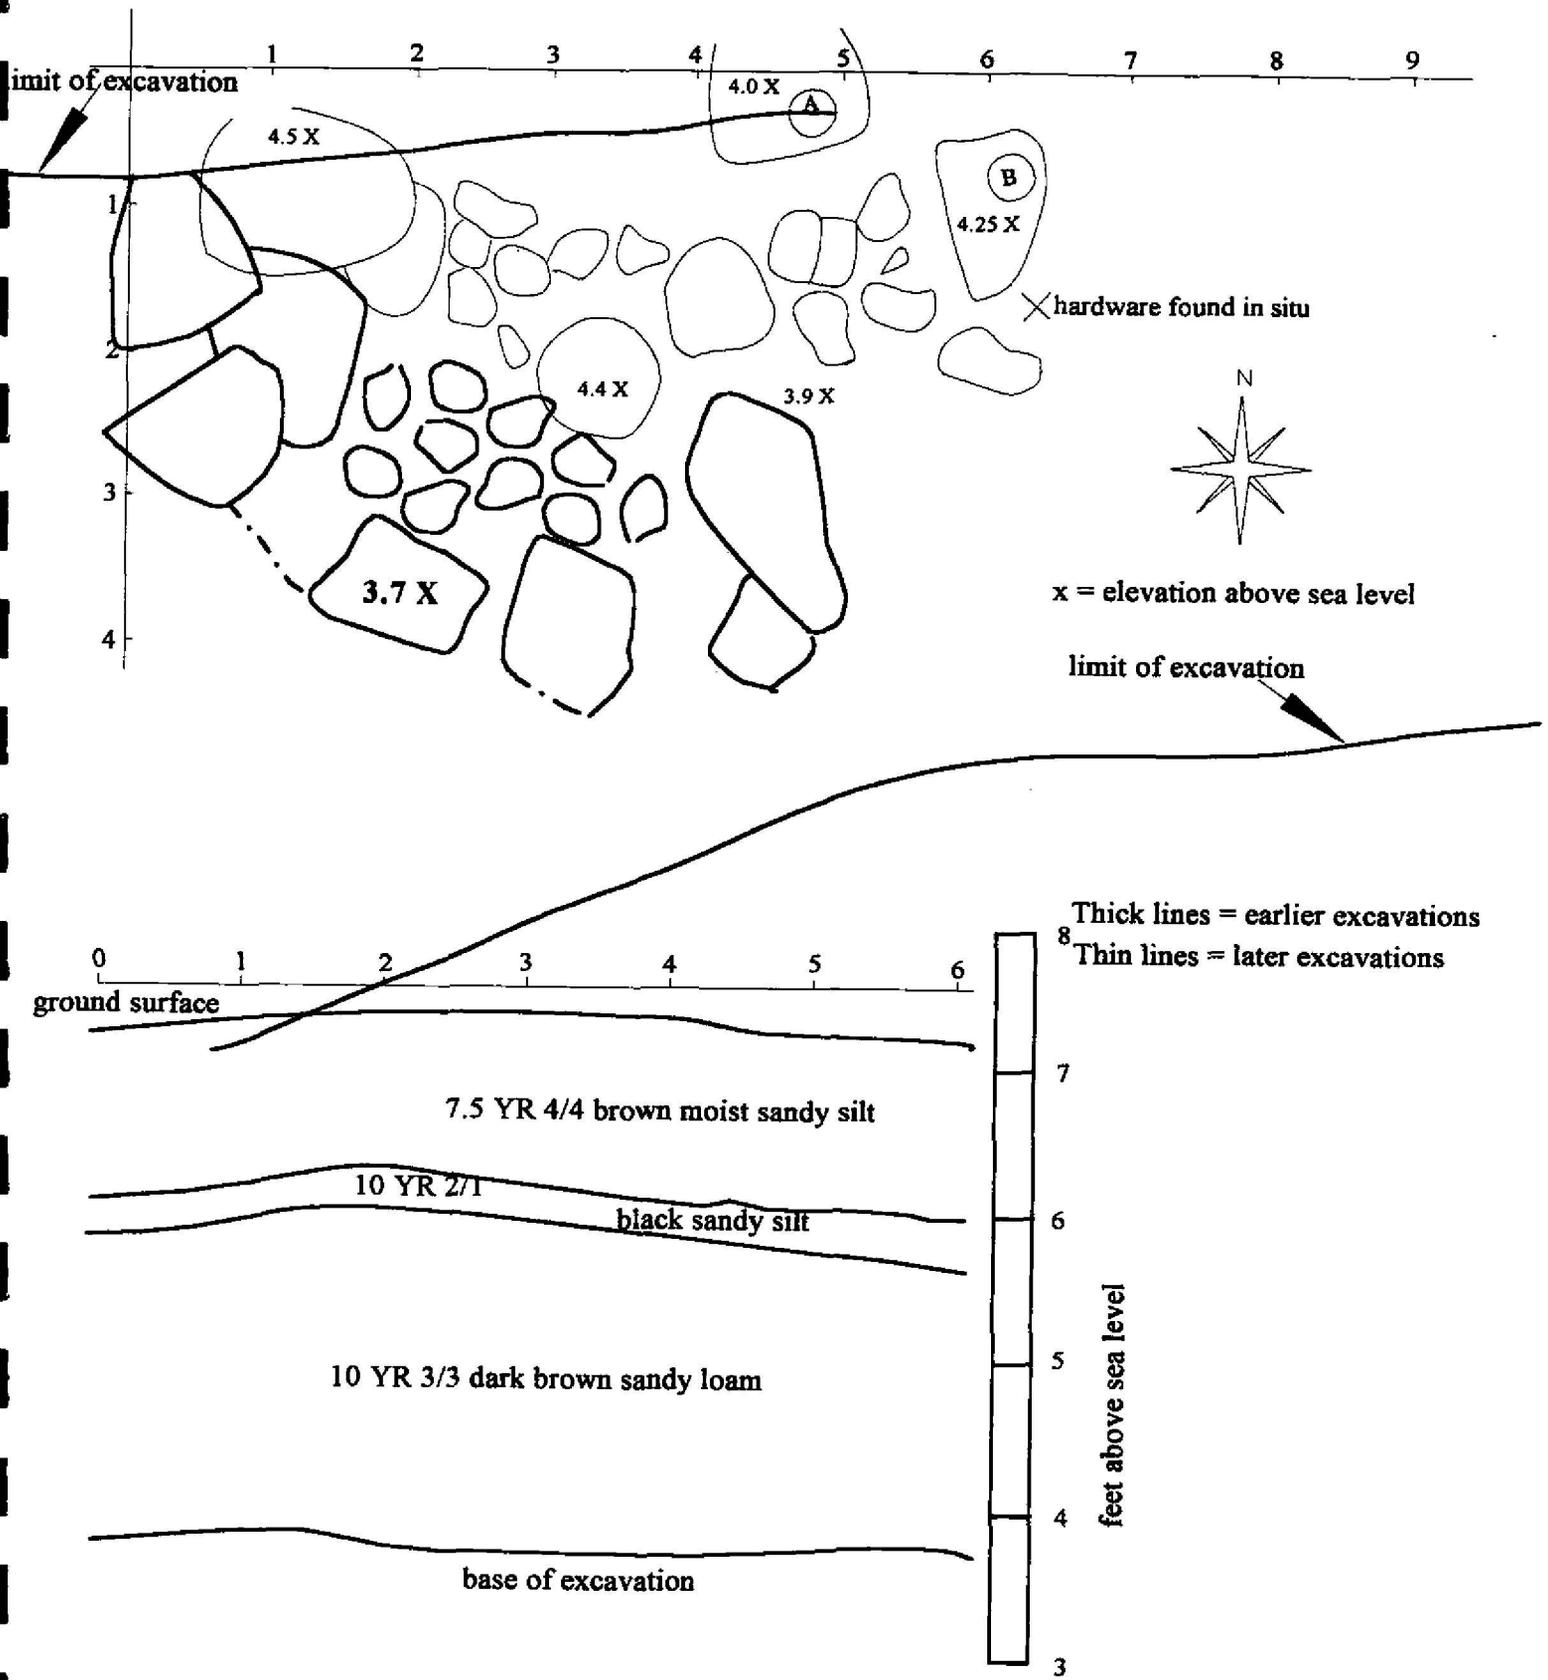
Figure 4 Plan views and south profile of excavations at the location of the former Carriage Factory/Wagon shed.

equipment going back and forth for two months. No builder's trench was identified and soils were not screened. Upon excavation of the larger stones, labeled A and B on Figure 4, additional stones were found about one foot down, roughly the diameter of the exposed stones. These were below the water table. As excavations extended eastward to determine the extent of this stone feature, a pipe trench was found, thus truncating the feature. Since test excavations further east did not reveal any remains of this structure, it was presumed it either ended there, at the point shown on Figures 4 and 4A, or was truncated at its eastern limit by the pipe. The backhoe removed the rest of the large stones and they were found in about two layers, to about one to one and a half below the plan view. These were underlain with natural soil deposits.

Diagnostic artifacts recovered from adjacent to the foundation stones include ceramics and glass (see Appendix D – Context # 38). The *tpq* comes from part of a machine made, soda type bottle glass sherd. This could have been made any time from the late-nineteenth century through the present time. A large piece of unidentified corroded hardware was documented *in situ*, retained and is shown on Figure 4.

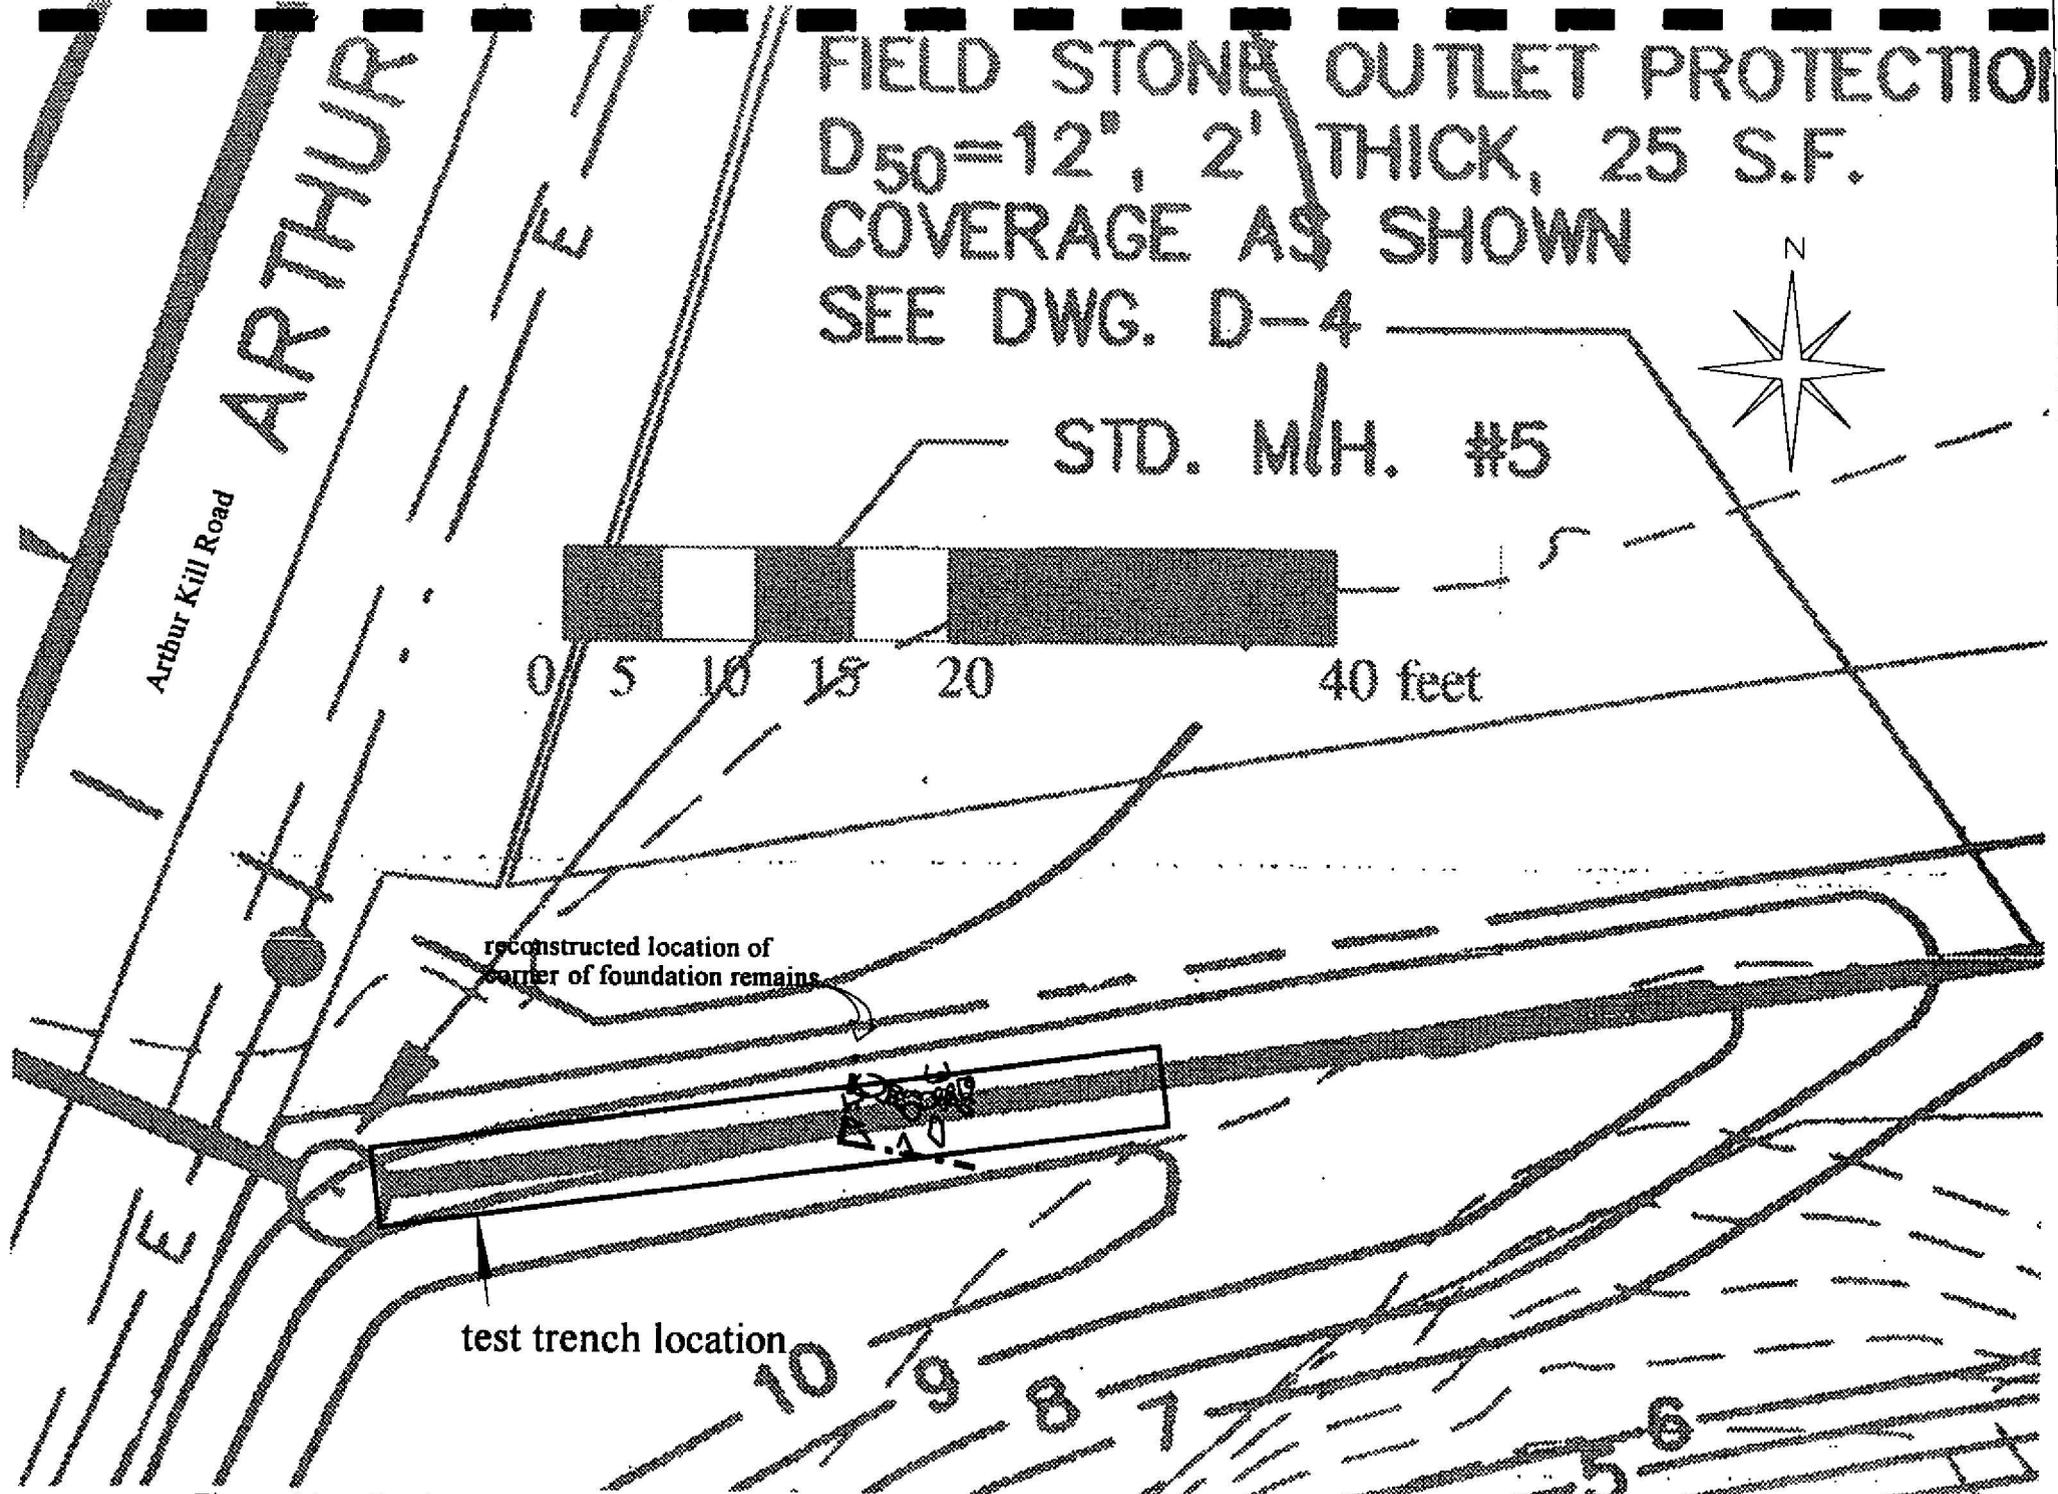
Figure 4A Carriage Factory/Wagon Shed plan views superimposed on the site survey.

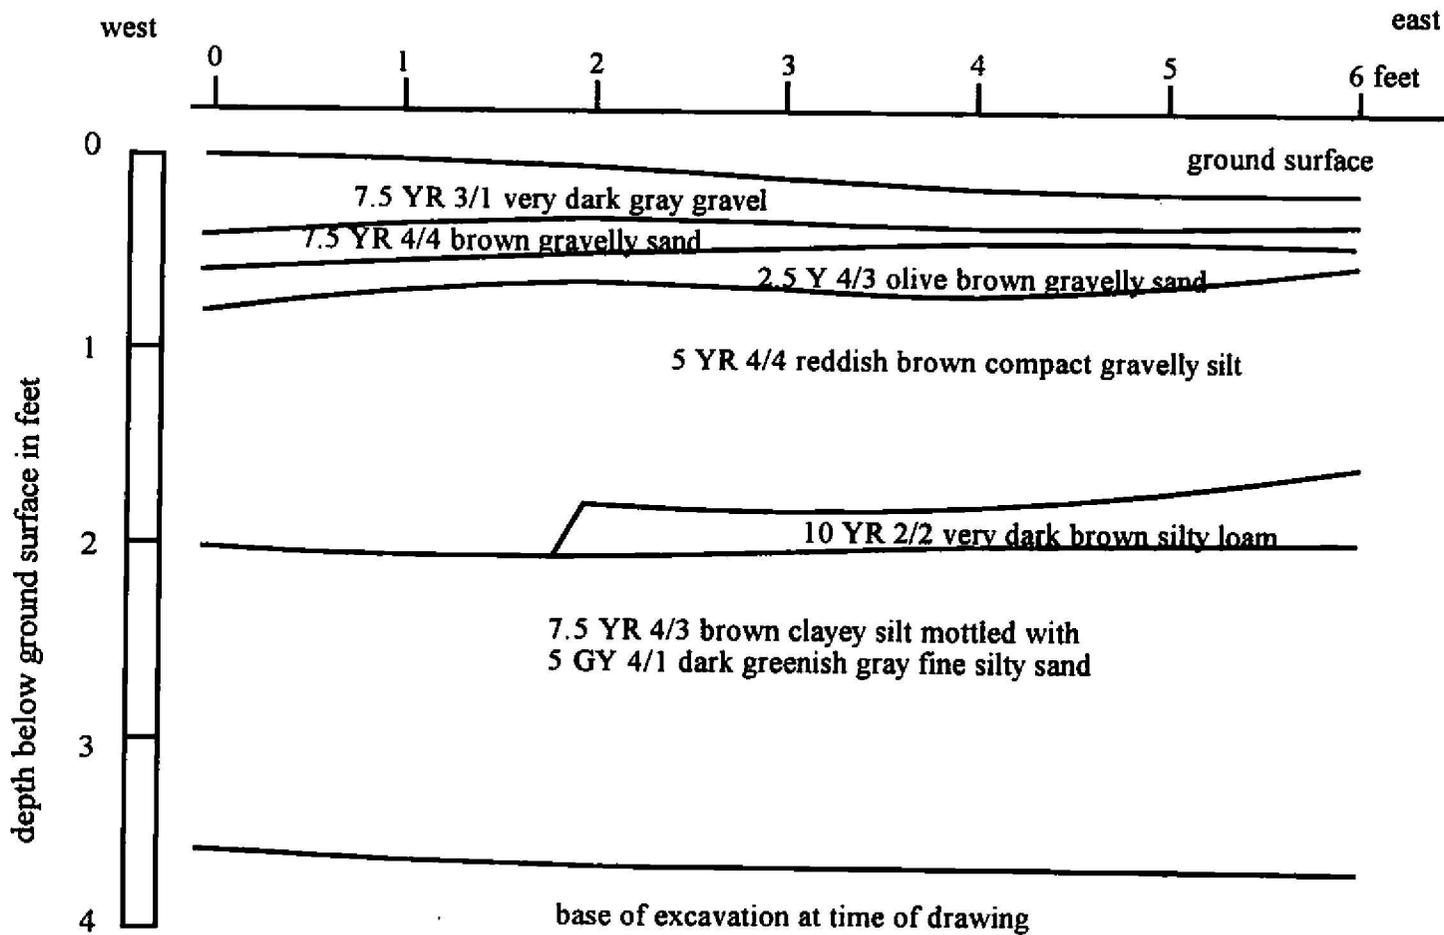
Figure 6 North profile of Test Trench D, pocket wetlands.

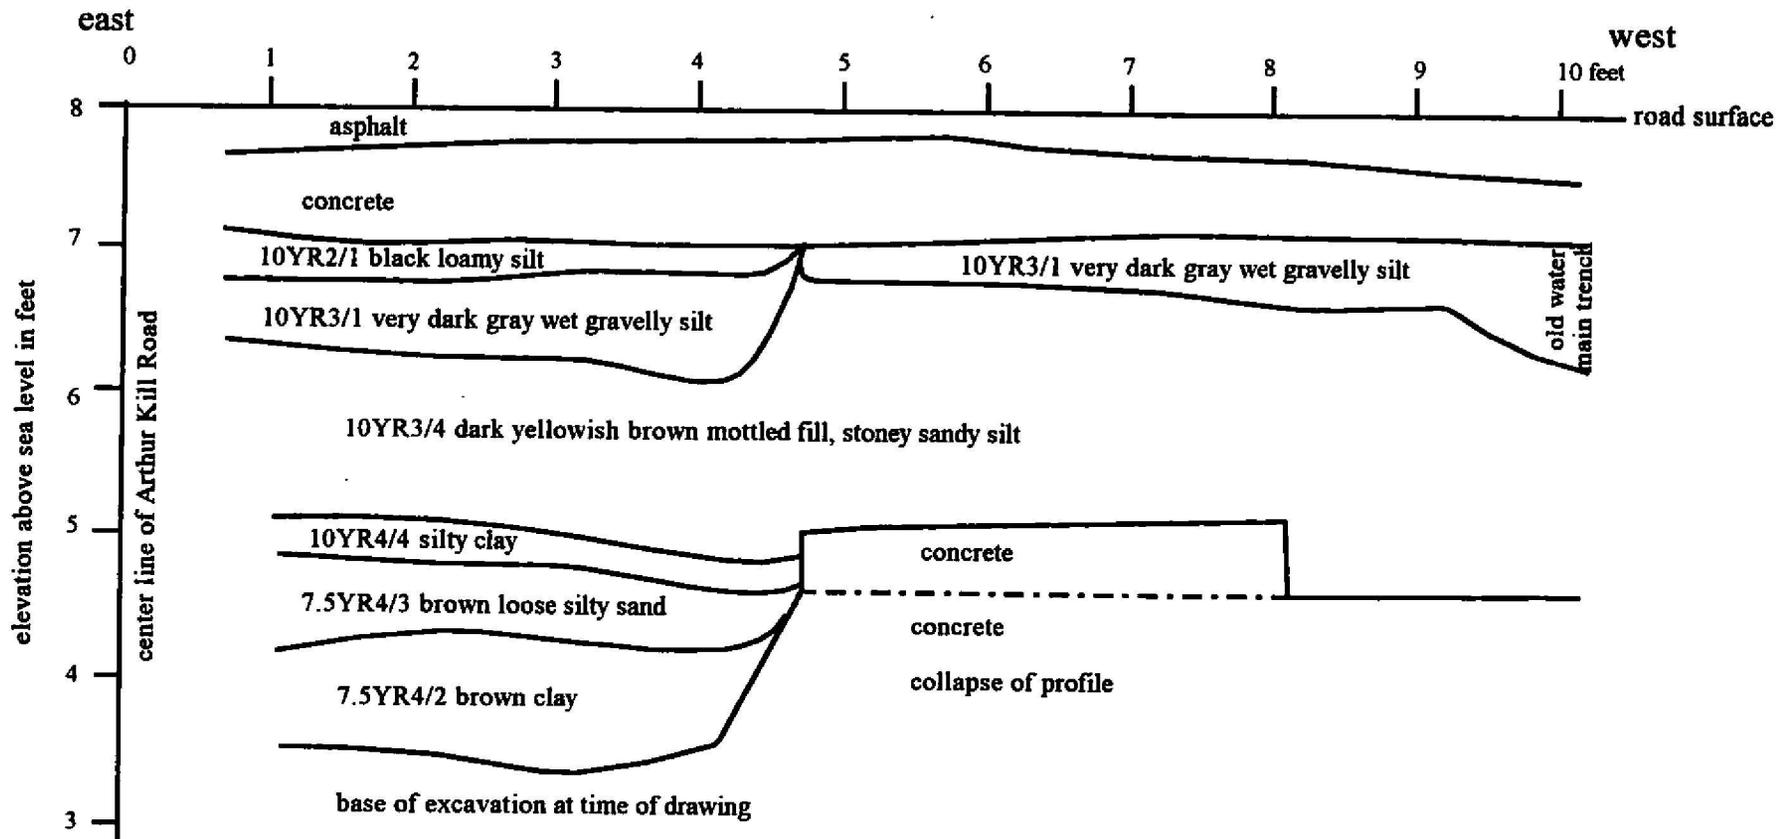
Figure 8 South profile of the upper levels of the test trench within the west lane of Arthur Kill Road.

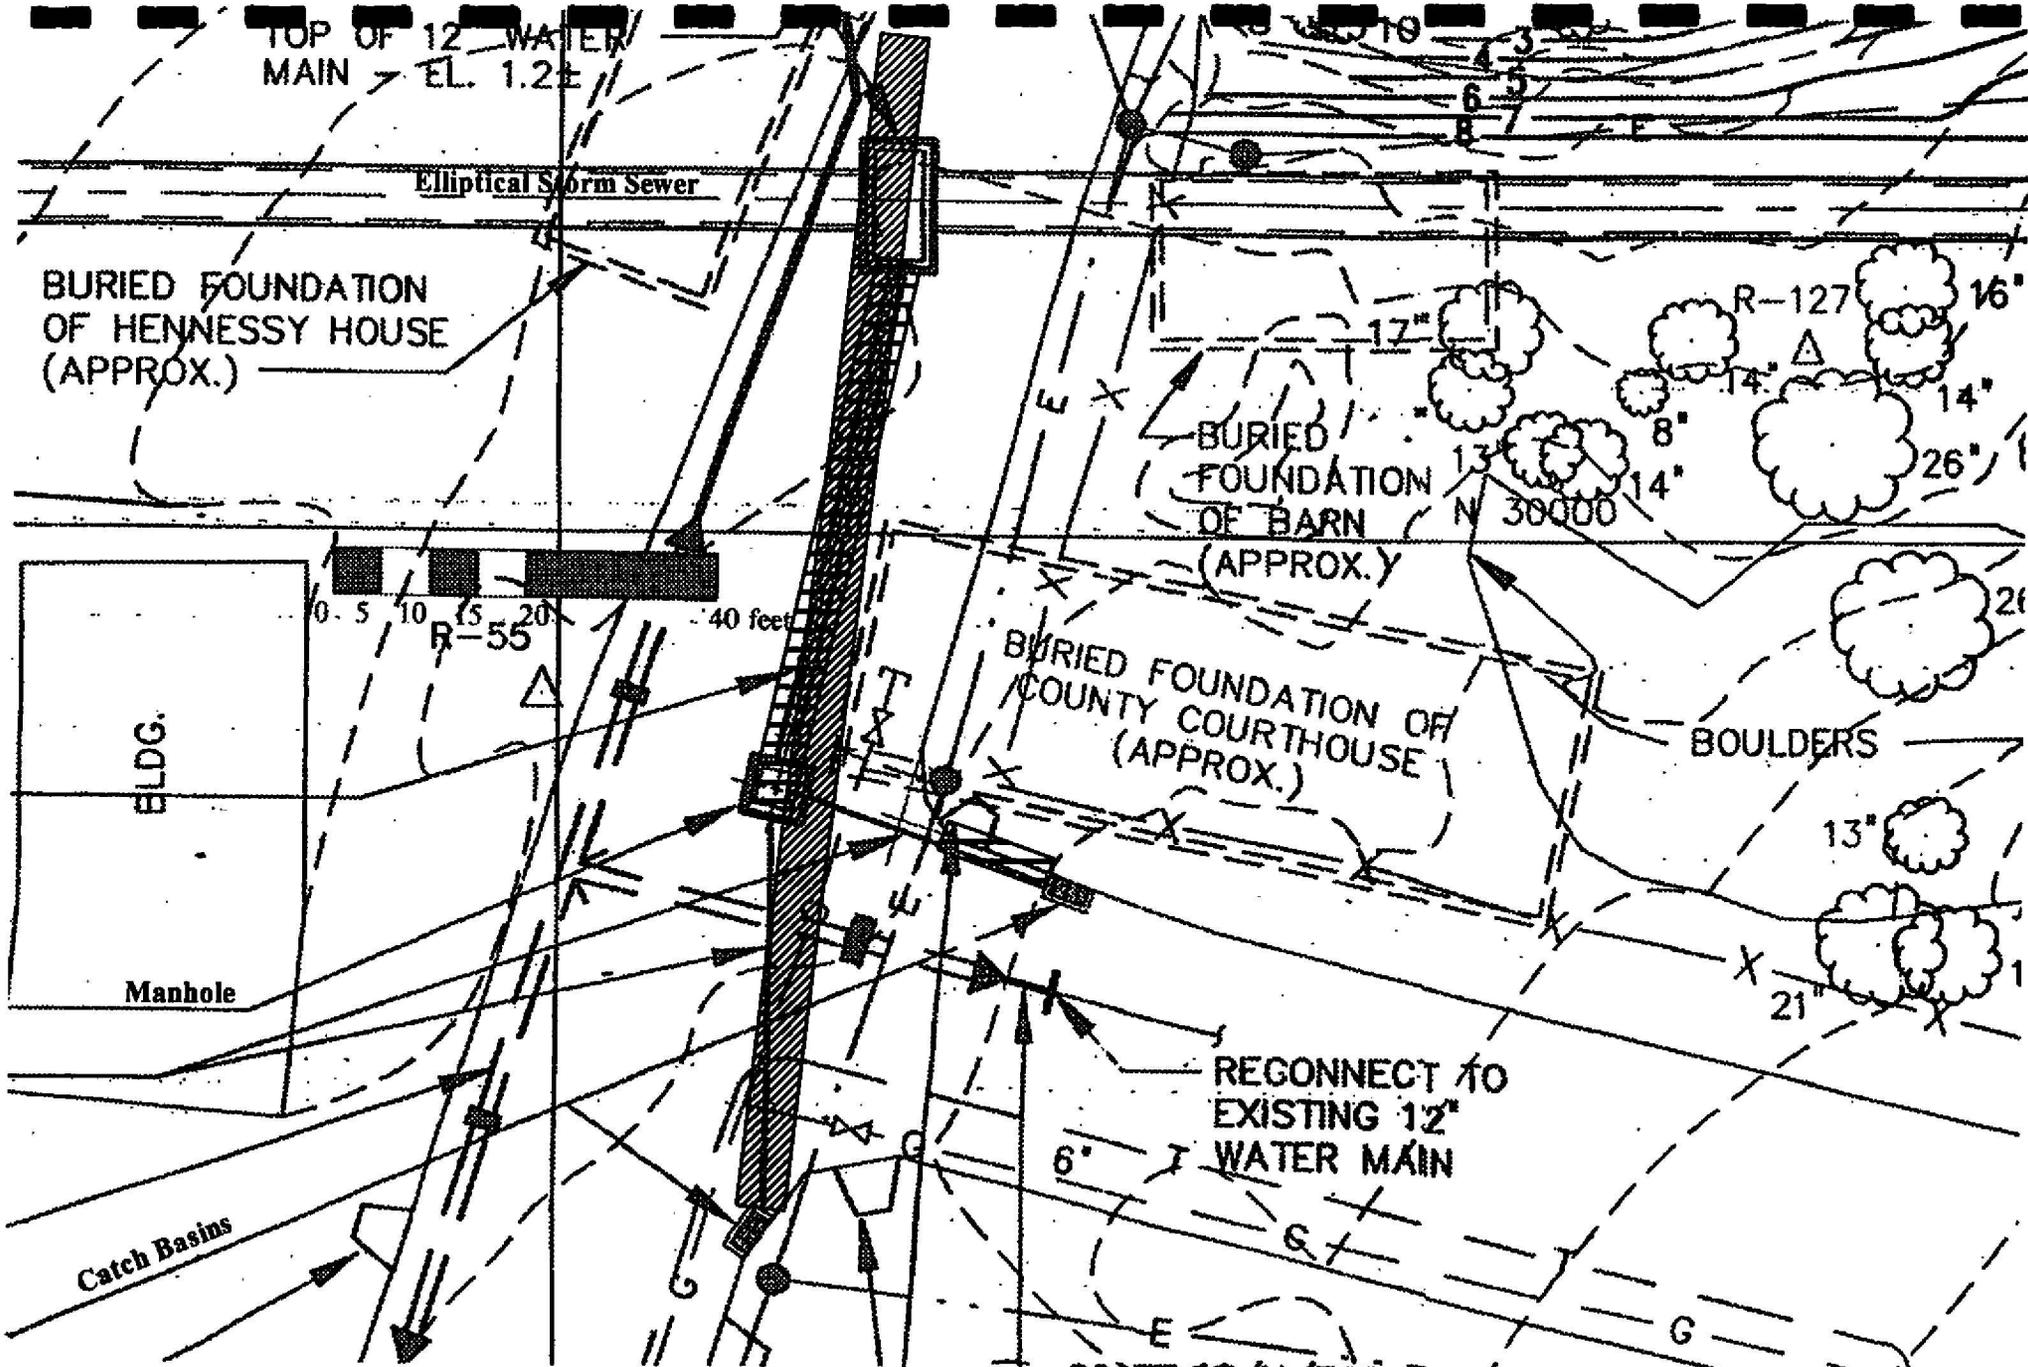
Figure 9 Storm sewer connector trenches with reconstruction of culvert location shown on section of the site plan.

The feature was determined to be a defunct culvert which likely once connected the existing manhole at the intersection of Arthur Kill and Richmond Roads to the creek. The concrete was jack hammered and found to contain wire mesh for reinforcing on the top. The sides of the culvert were substantial, about a foot thick. The culvert itself was about three feet wide and its bottom was about 4.6 feet below the roadway near the northern end of the trench, about 4.3 feet halfway to the intersection. The base of the concrete at that point was 5.1 feet below the roadway. Figure 9 depicts the area of the storm sewer connectors and shows a reconstruction of the extent of the culvert.
