REPORT ON PHASES 1B and 2/3  
ARCHAEOLOGICAL TESTING AND EXCAVATIONS  
OF THE MILL POND SEWER PROJECT  
LOCATED ALONG PARTS OF OLD MILL ROAD,  
ARTHUR KILL ROAD, AND PARTS OF  
HISTORIC RICHMOND TOWN (Blocks 2278, 2290 and 4444),  
BOROUGH OF STATEN ISLAND  
NEW YORK

Contract No. SER 20099

Submitted by: Linda Stone, MA, RPA  
249 East 48th Street, #2B  
New York, New York 10017

May 23, 2003

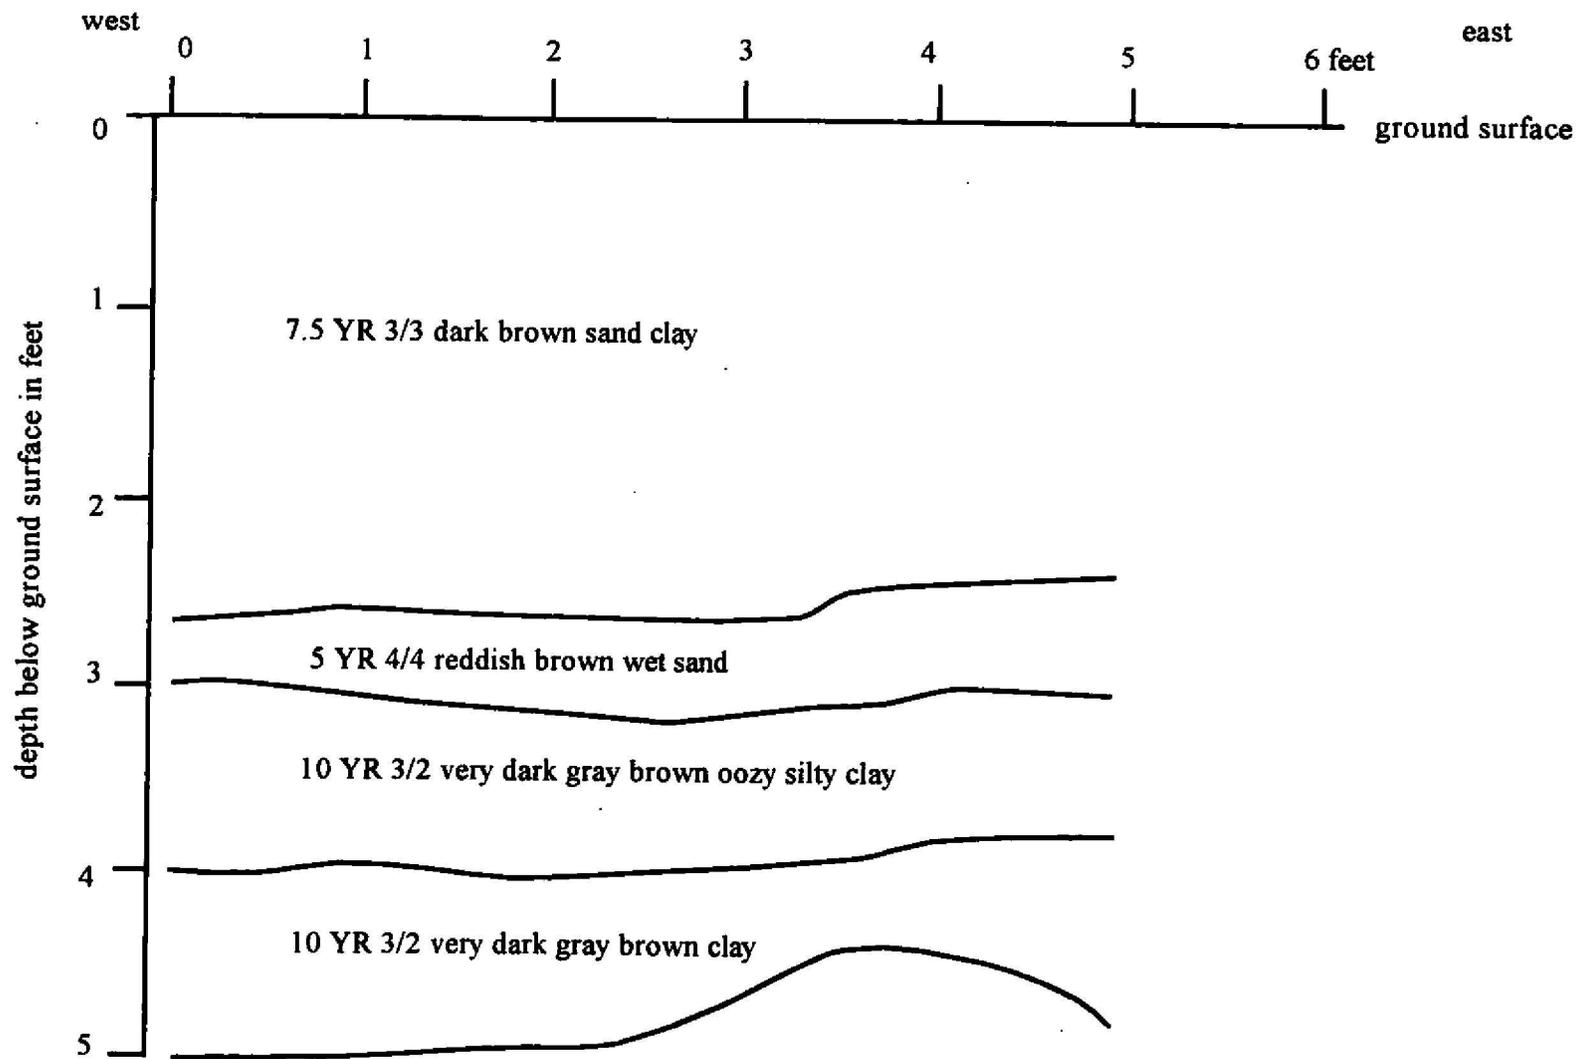
Figure 10 North profile of upper levels of elliptical storm sewer test trench near Richmond Creek.

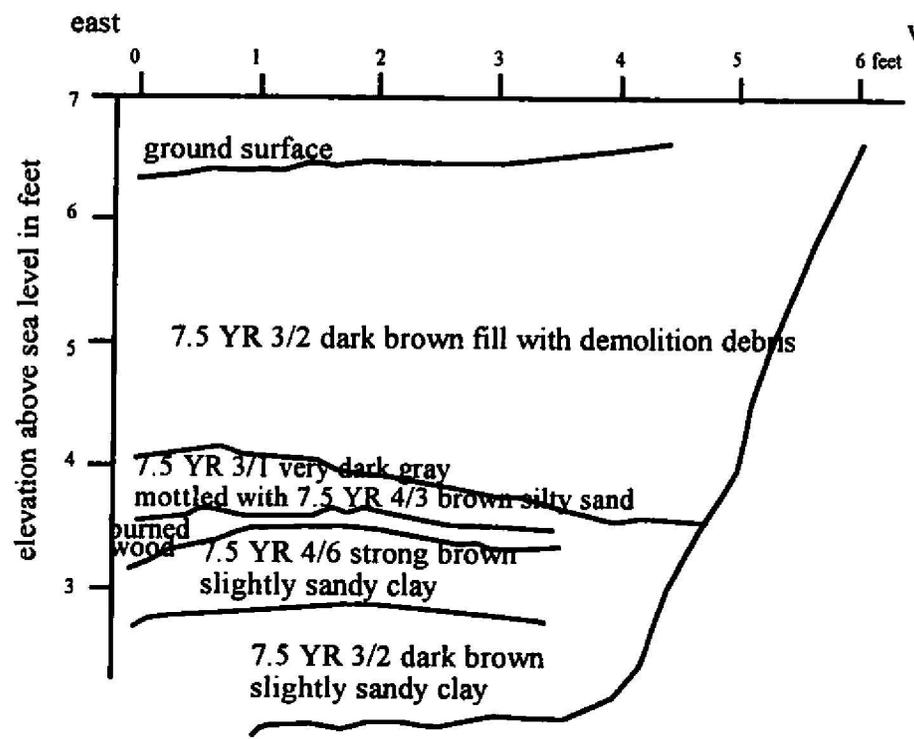
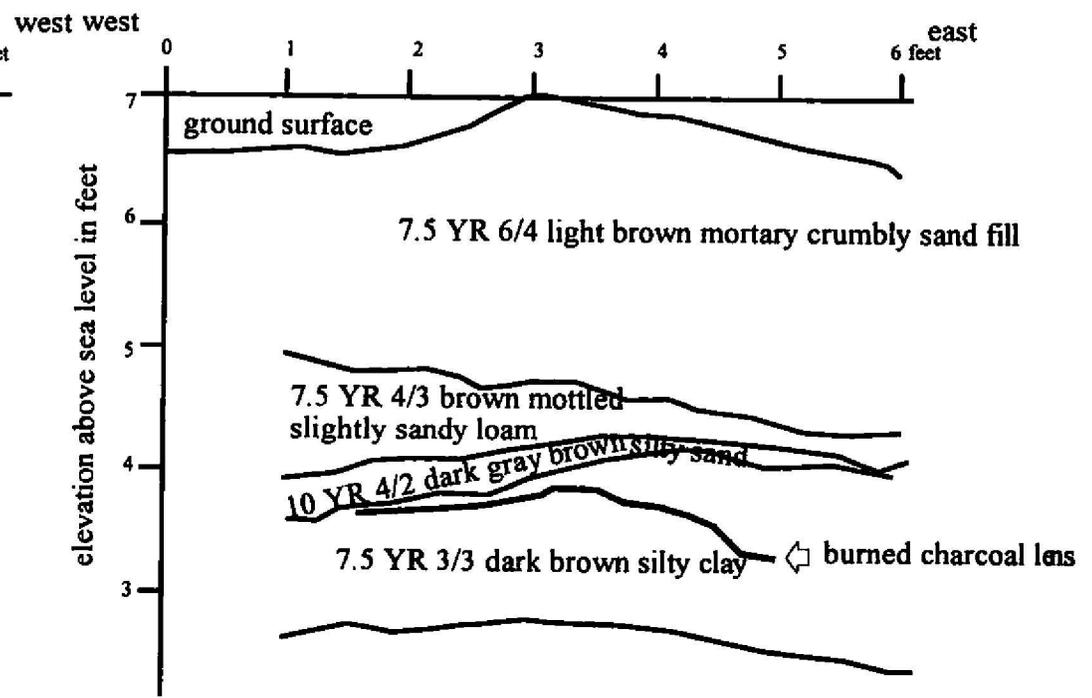
Figure 11 North and south profiles of the upper levels of Area A excavations west of Arthur Kill Road.

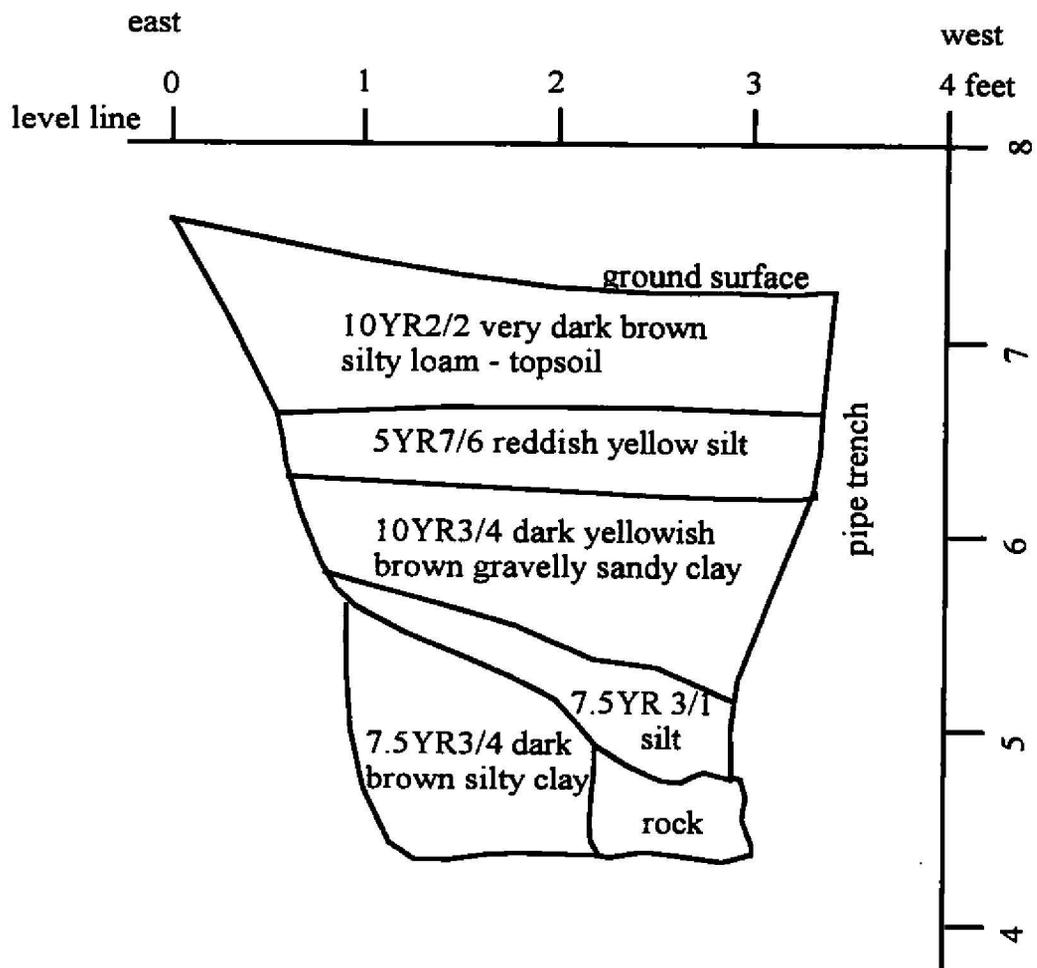
Figure 12 South Profile of soils above the remains of the Hennessy House.

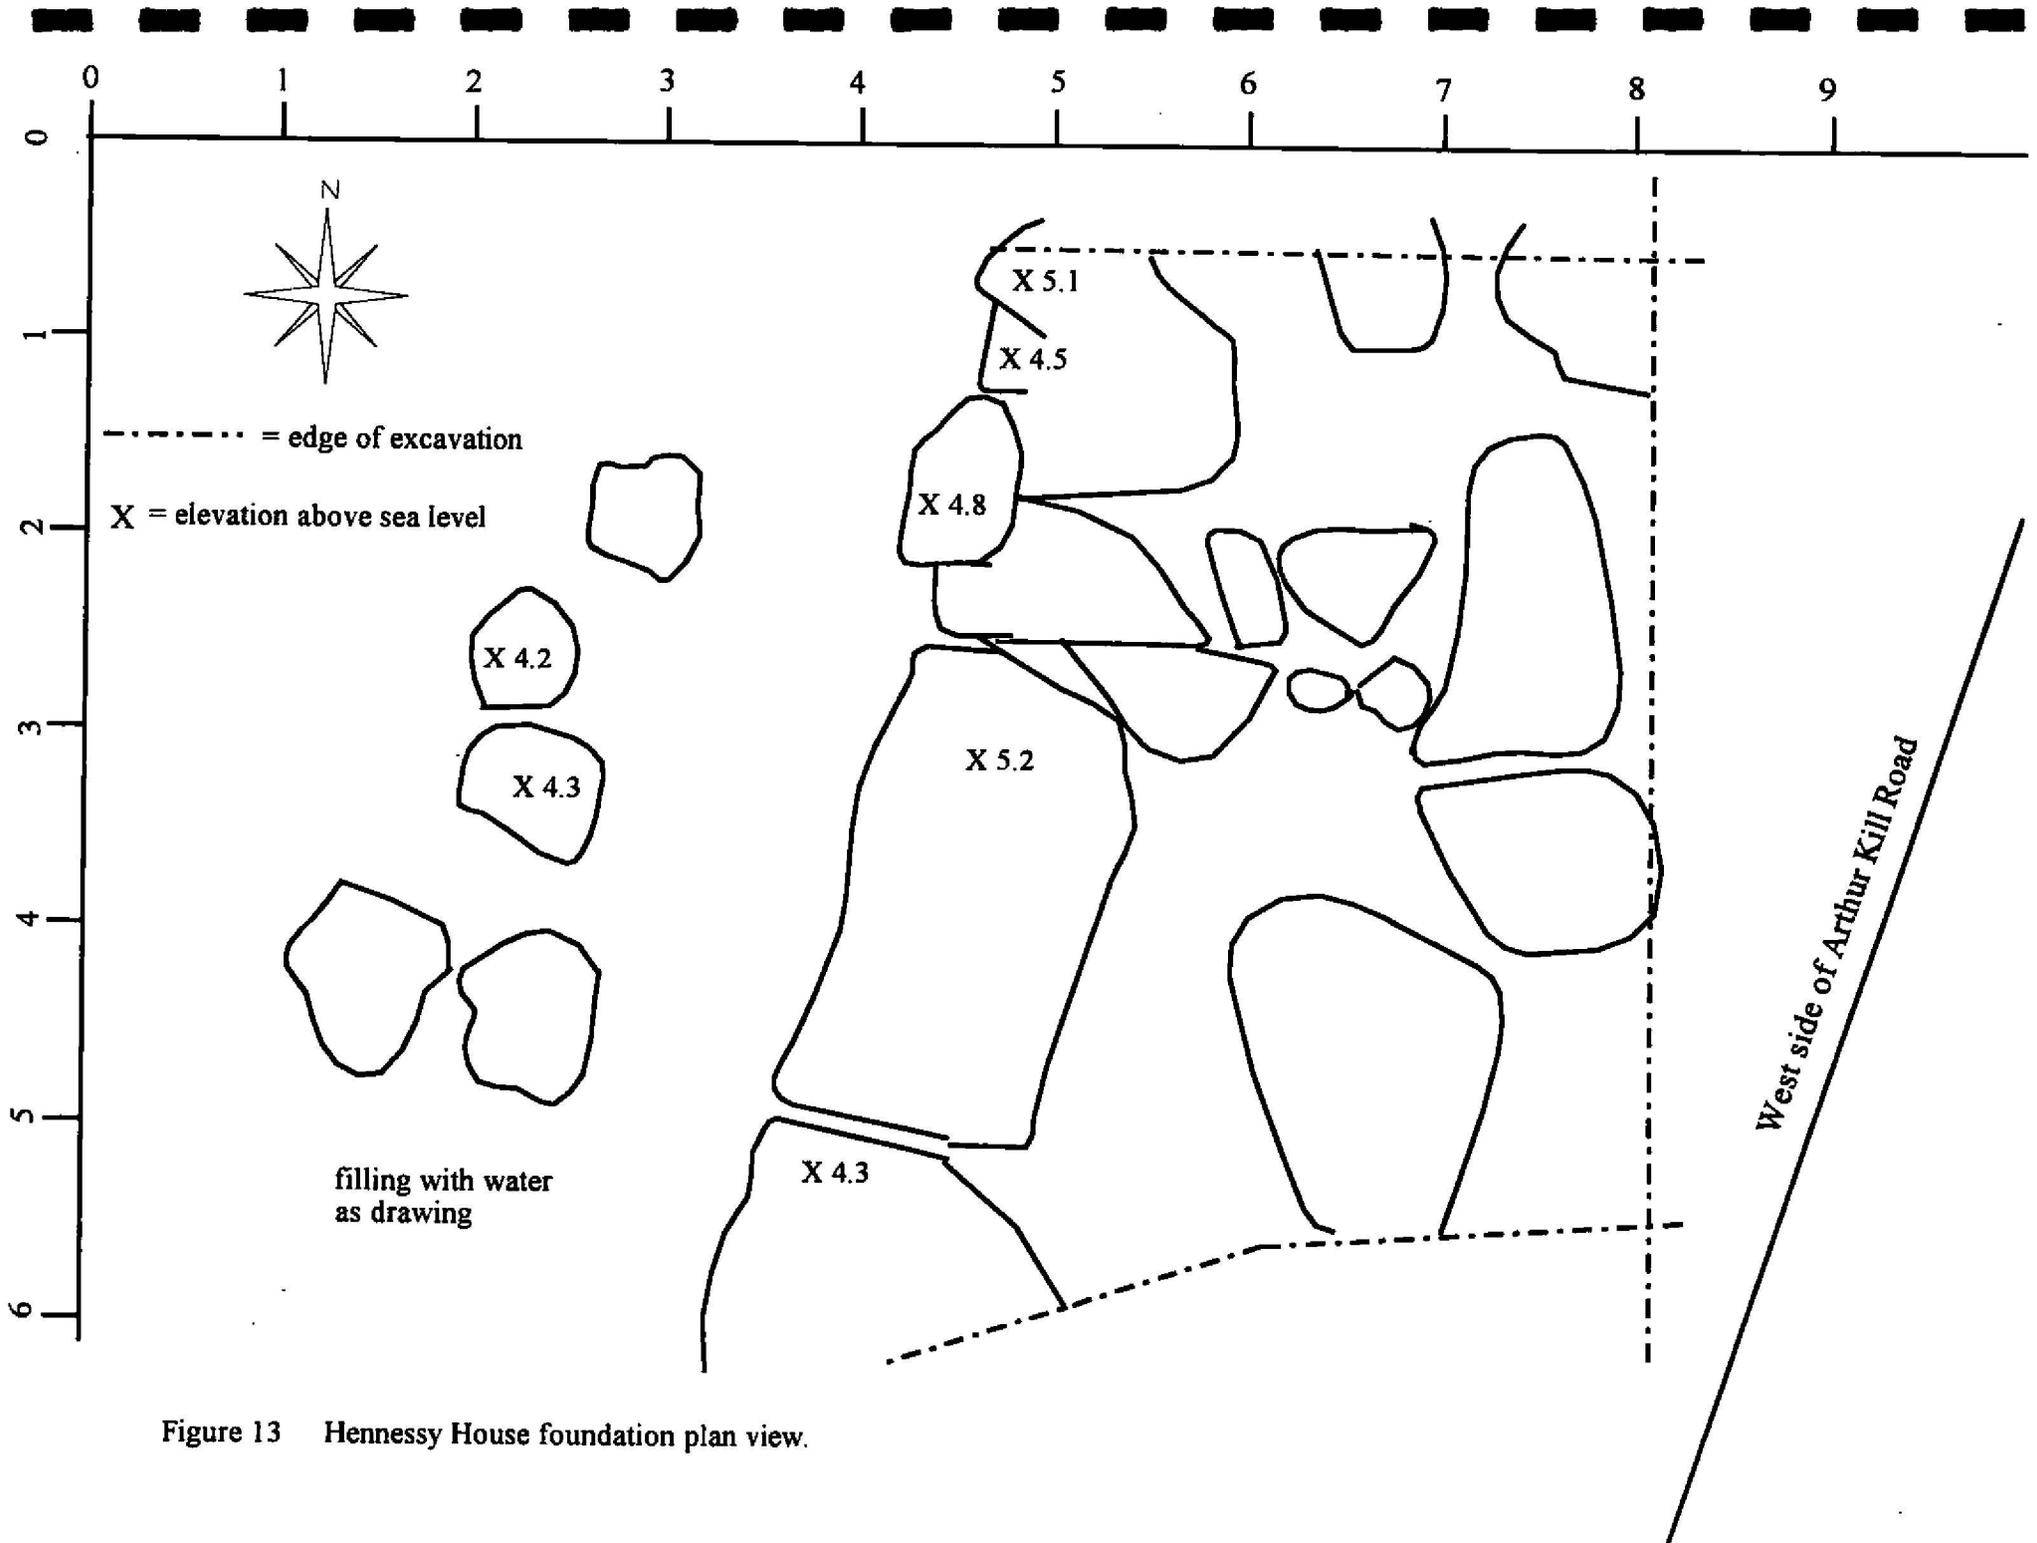
Figure 13 Hennessy House foundation plan view.

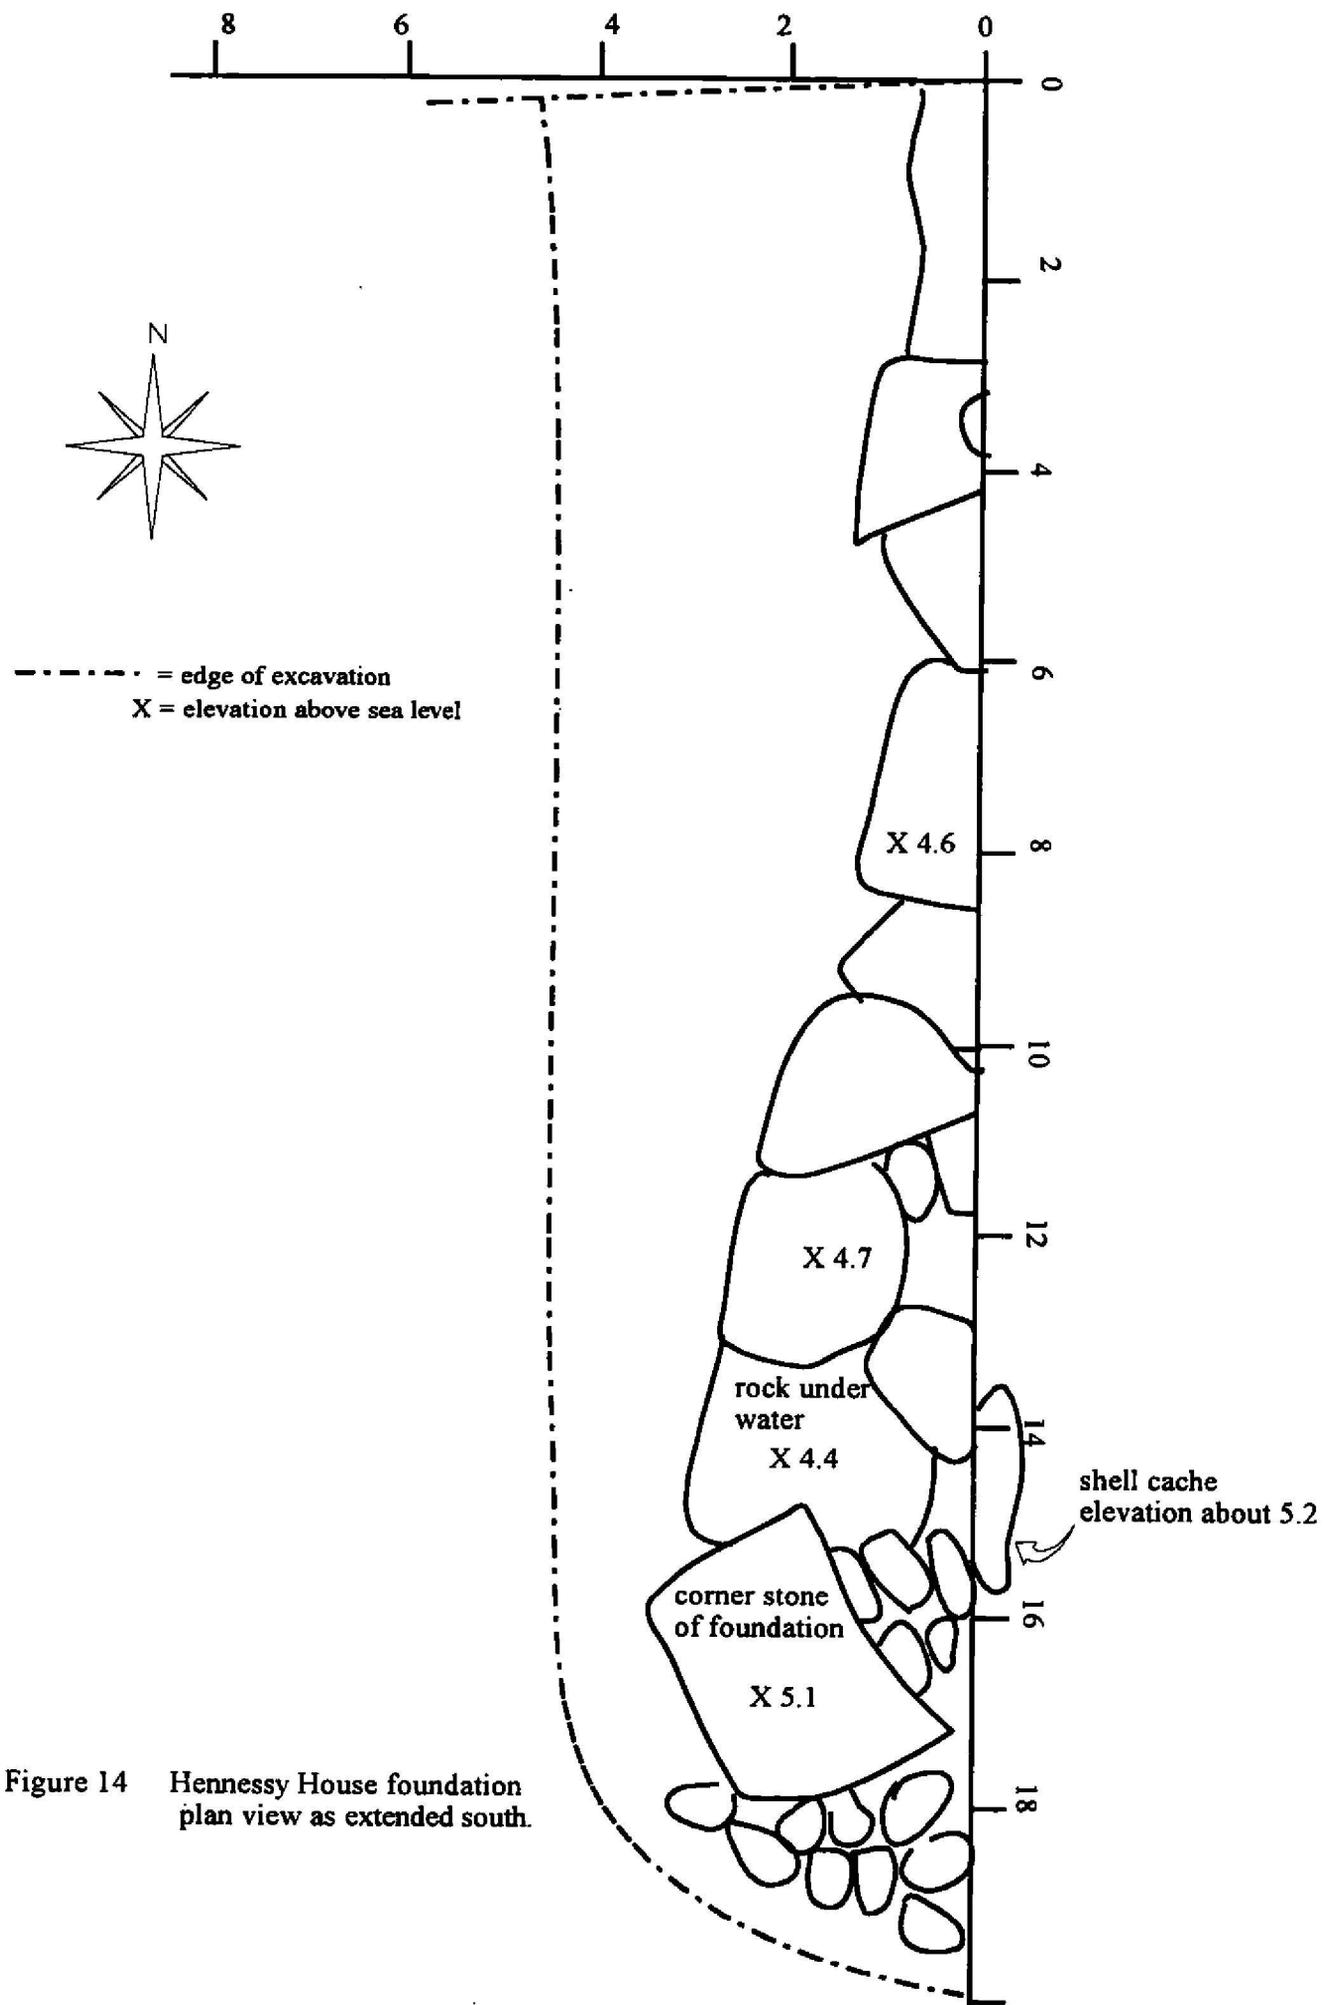
Figure 14 Hennessy House foundation plan view as extended south.

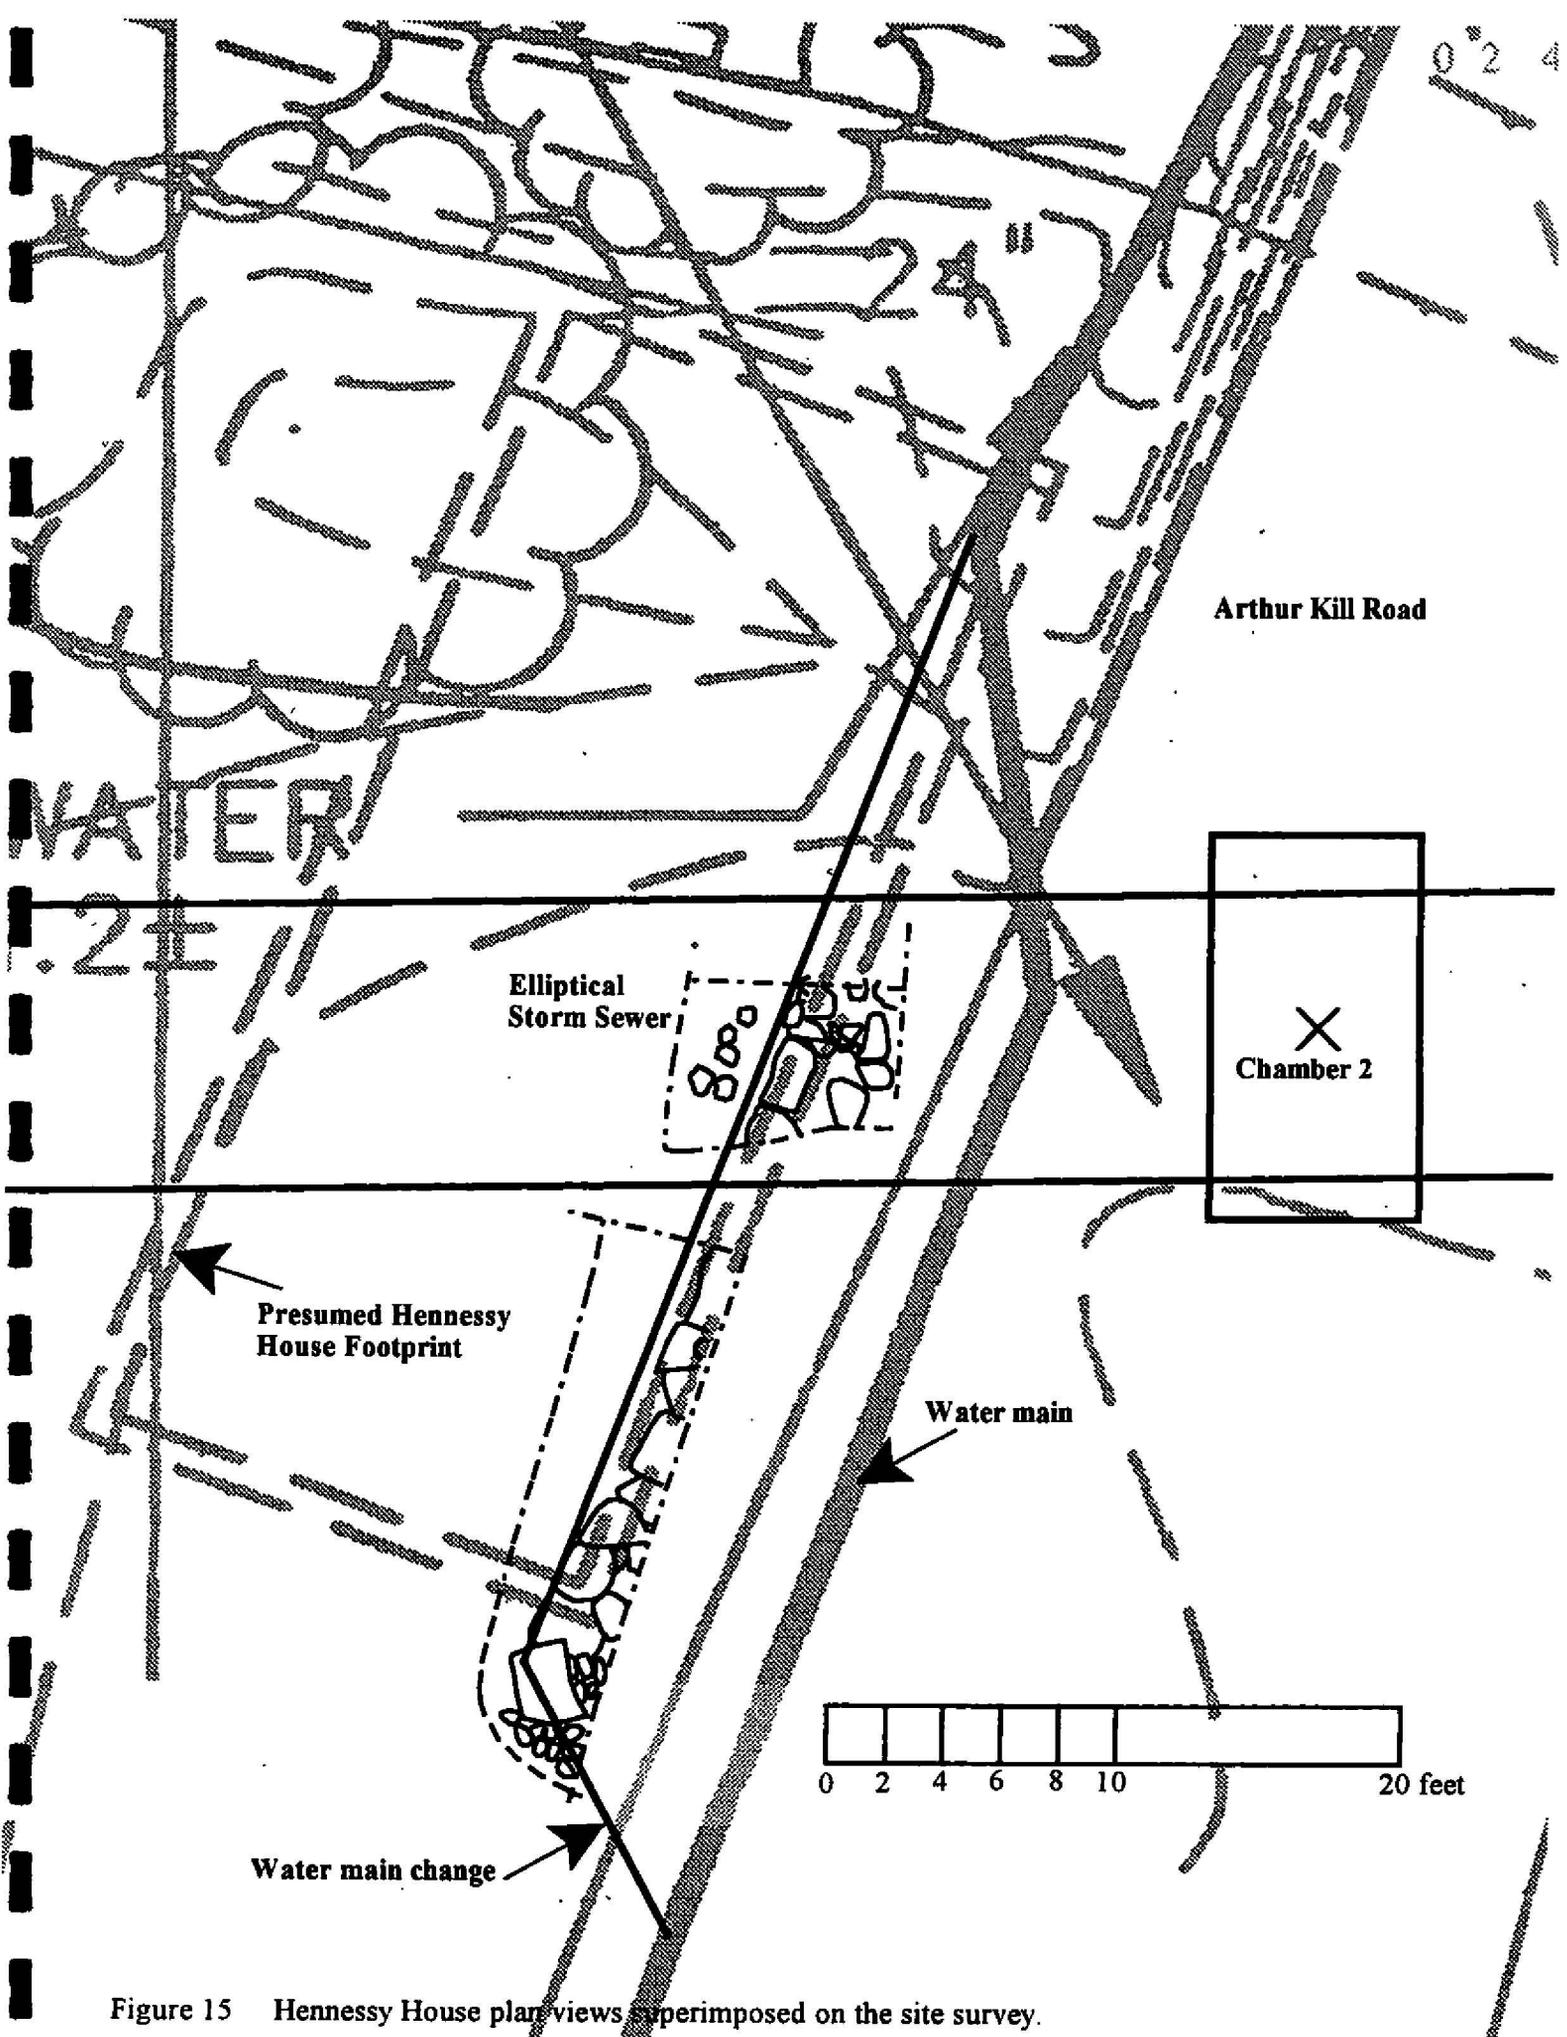
Figure 15 Hennessy House plan views superimposed on the site survey.

The Hennessy House stood on the site from 1861 through 1899 when it burned down. Remains of a dry-laid stone foundation were documented as was a burned stratum which could represent the fire. Figure 15 shows the plan views of the Hennessy House foundations superimposed over the site survey. Once again, note the survey is off slightly. The existing water main cuts west at a point further south within the elliptical storm sewer trench than depicted and the angle at which it turns is 45 degrees, sharper than drawn on the survey. The entire water main replacement north of the elliptical storm sewer trench is an in-kind replacement, not causing any disturbance to potential archaeological resources. Additionally, the archaeological remains of the foundation of the Hennessy House were actually found slightly south of where the foundation footprint is drawn on the survey, although the eastern wall does align.

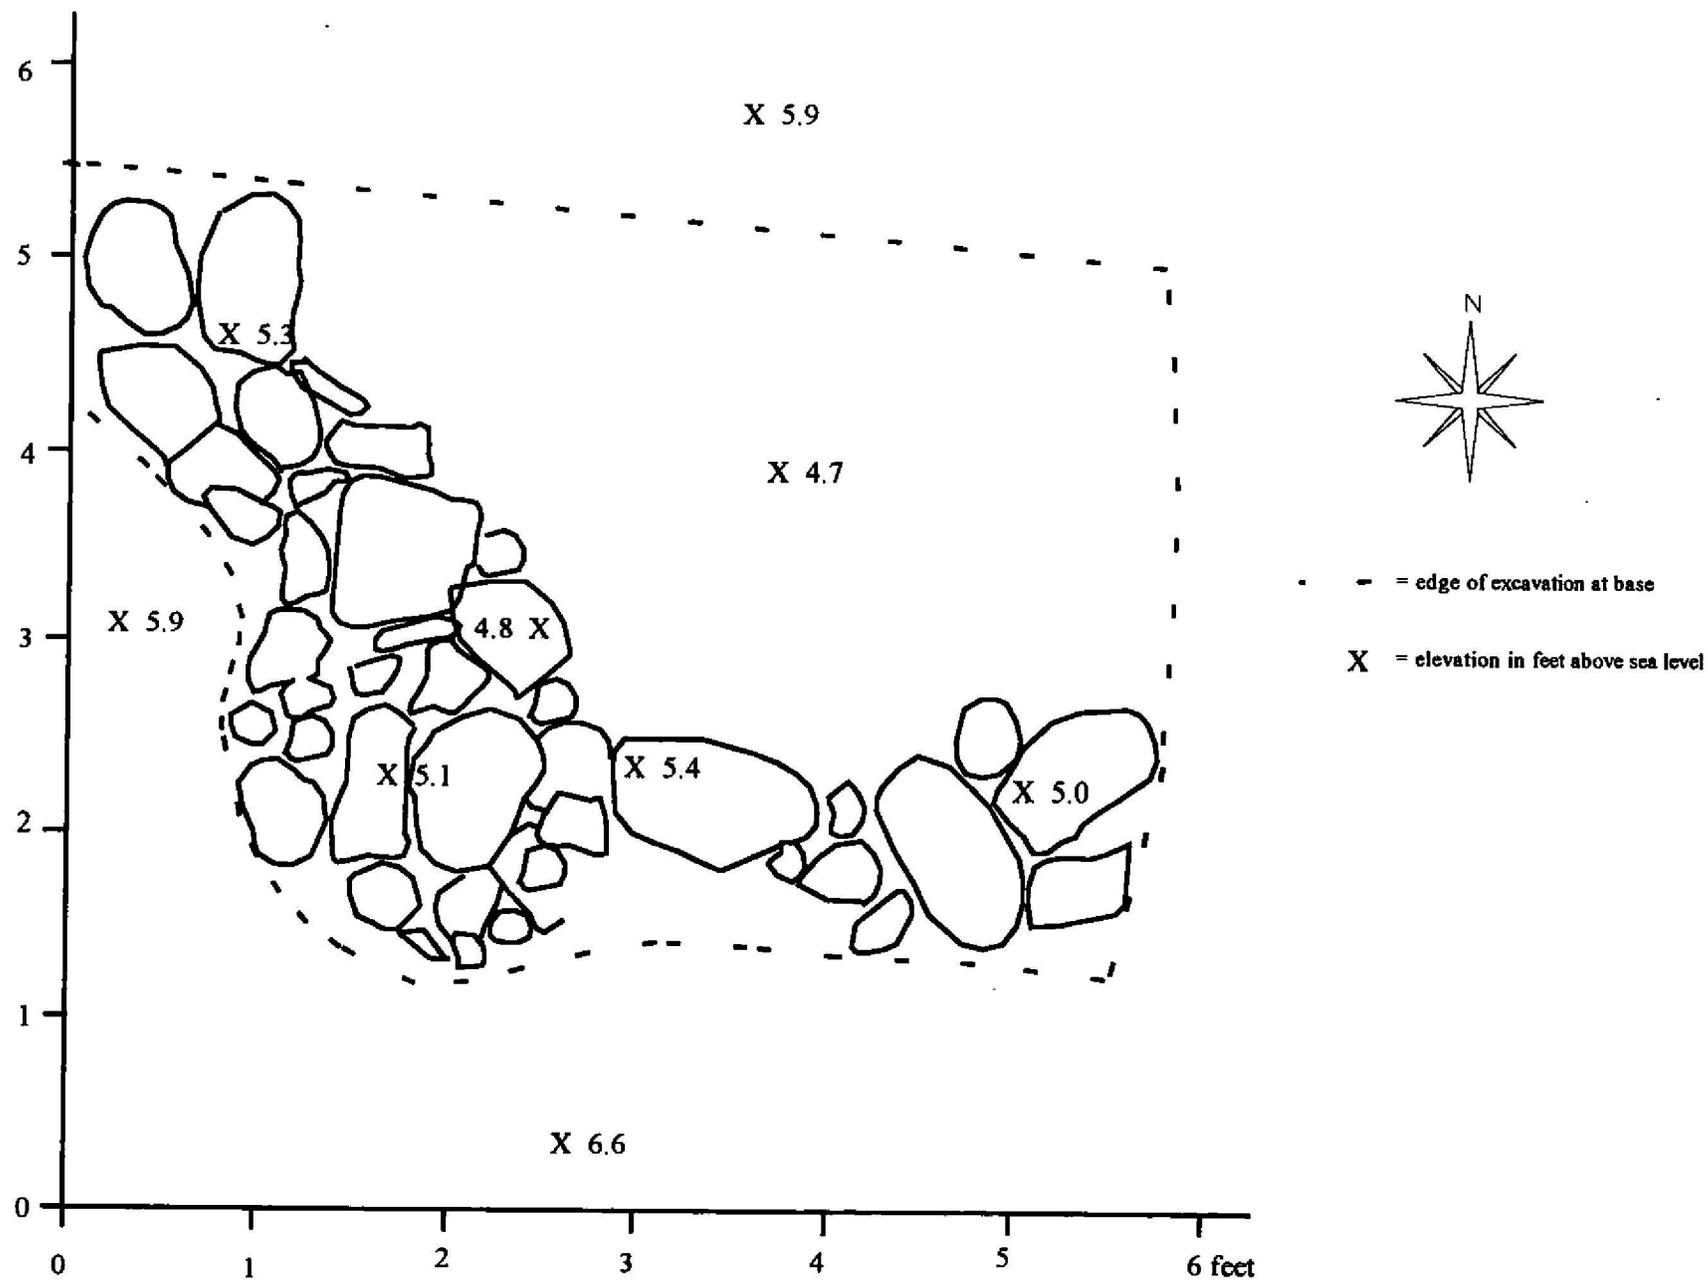
Figure 16 Plan view of Area B/C, remains of the stone foundation of the Johnson Barn.

The first part of the work was done in a seven foot square excavation pit, three feet short of impact width because of the previously excavated three foot wide test trench dug in 1999. It revealed remains of a dry-laid stone foundation buried only about 1.5 feet below the ground surface, just below the topsoil. Most of the foundation stones were about a foot in diameter on the longest dimension. Some smaller chinking stones as well as pieces of brick were also observed. The foundation stones as they were revealed are depicted on Figure 16. The northern section of the excavations in Figure 16 were not headed at quite

ninety degrees in that direction and did not seem as clear as the line of foundation stones in the east/west direction. It was hypothesized this could represent part of the demolition of the foundation. Excavations were expanded toward the west and south to see if the east/west line of foundation stones continued. Since it did, this added credence to the theory the stones to the north were tumbled in that direction.

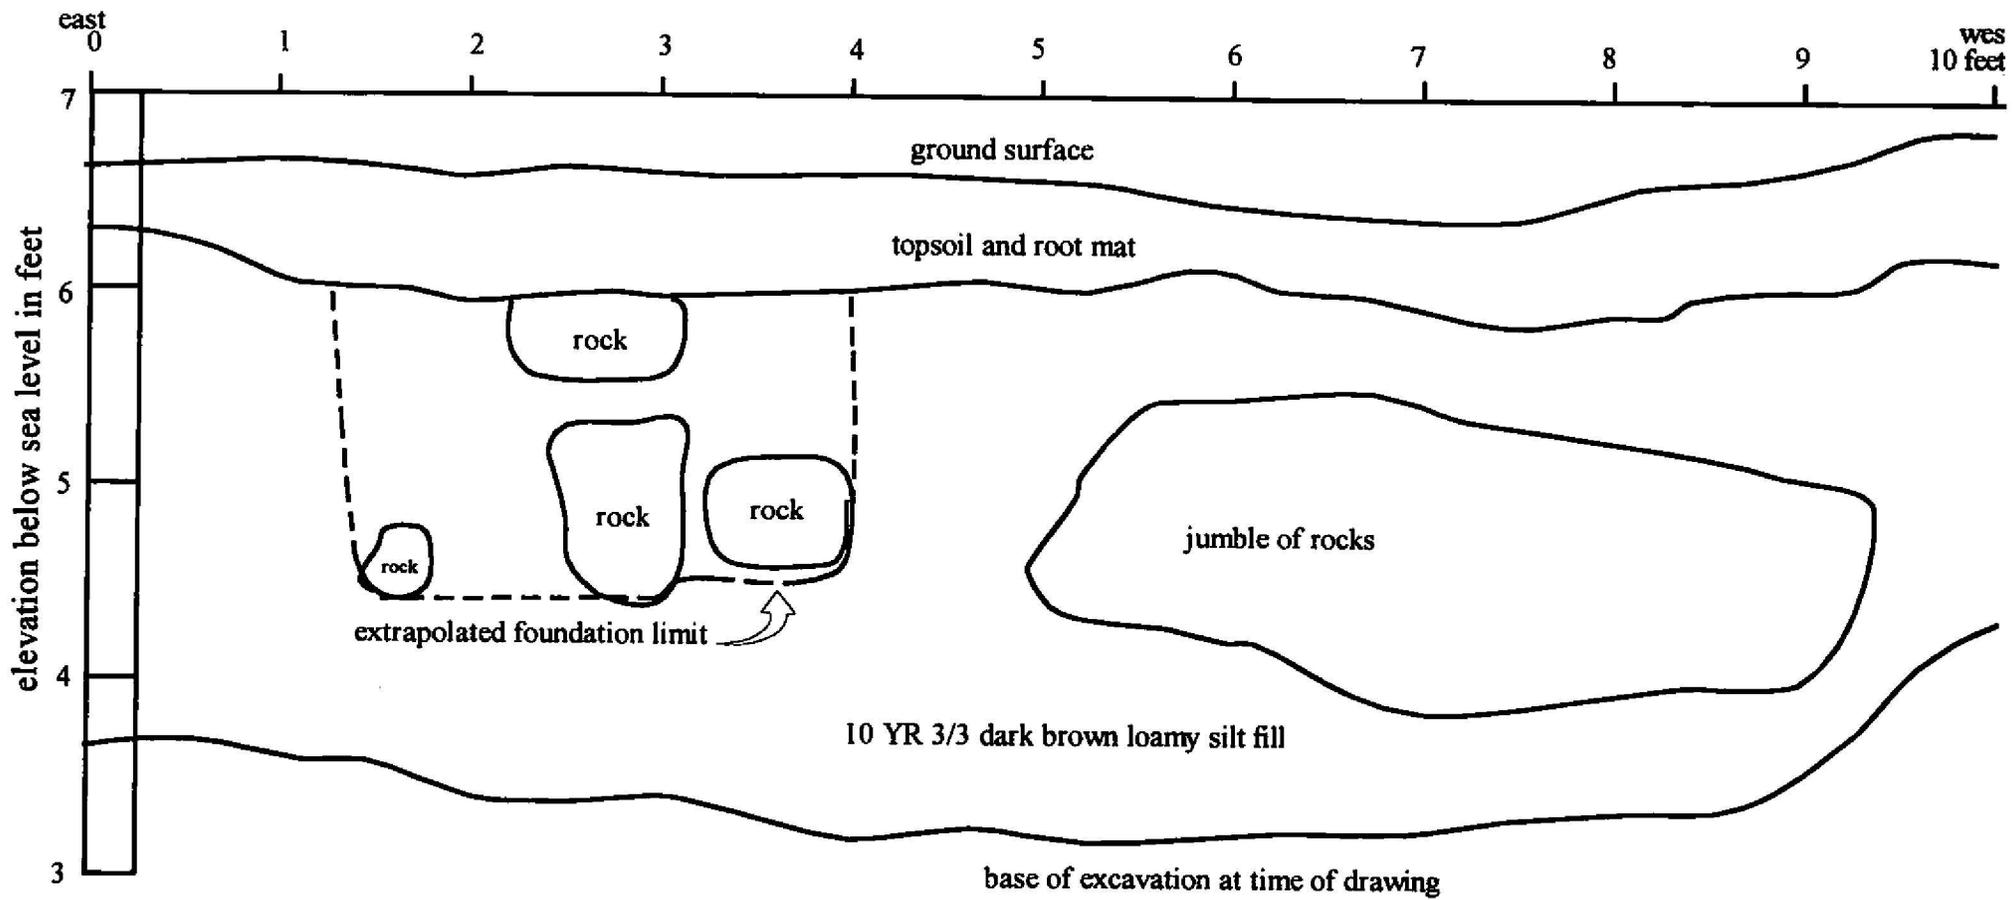
Figure 17 South profile of Area B/C, the Johnson Barn.

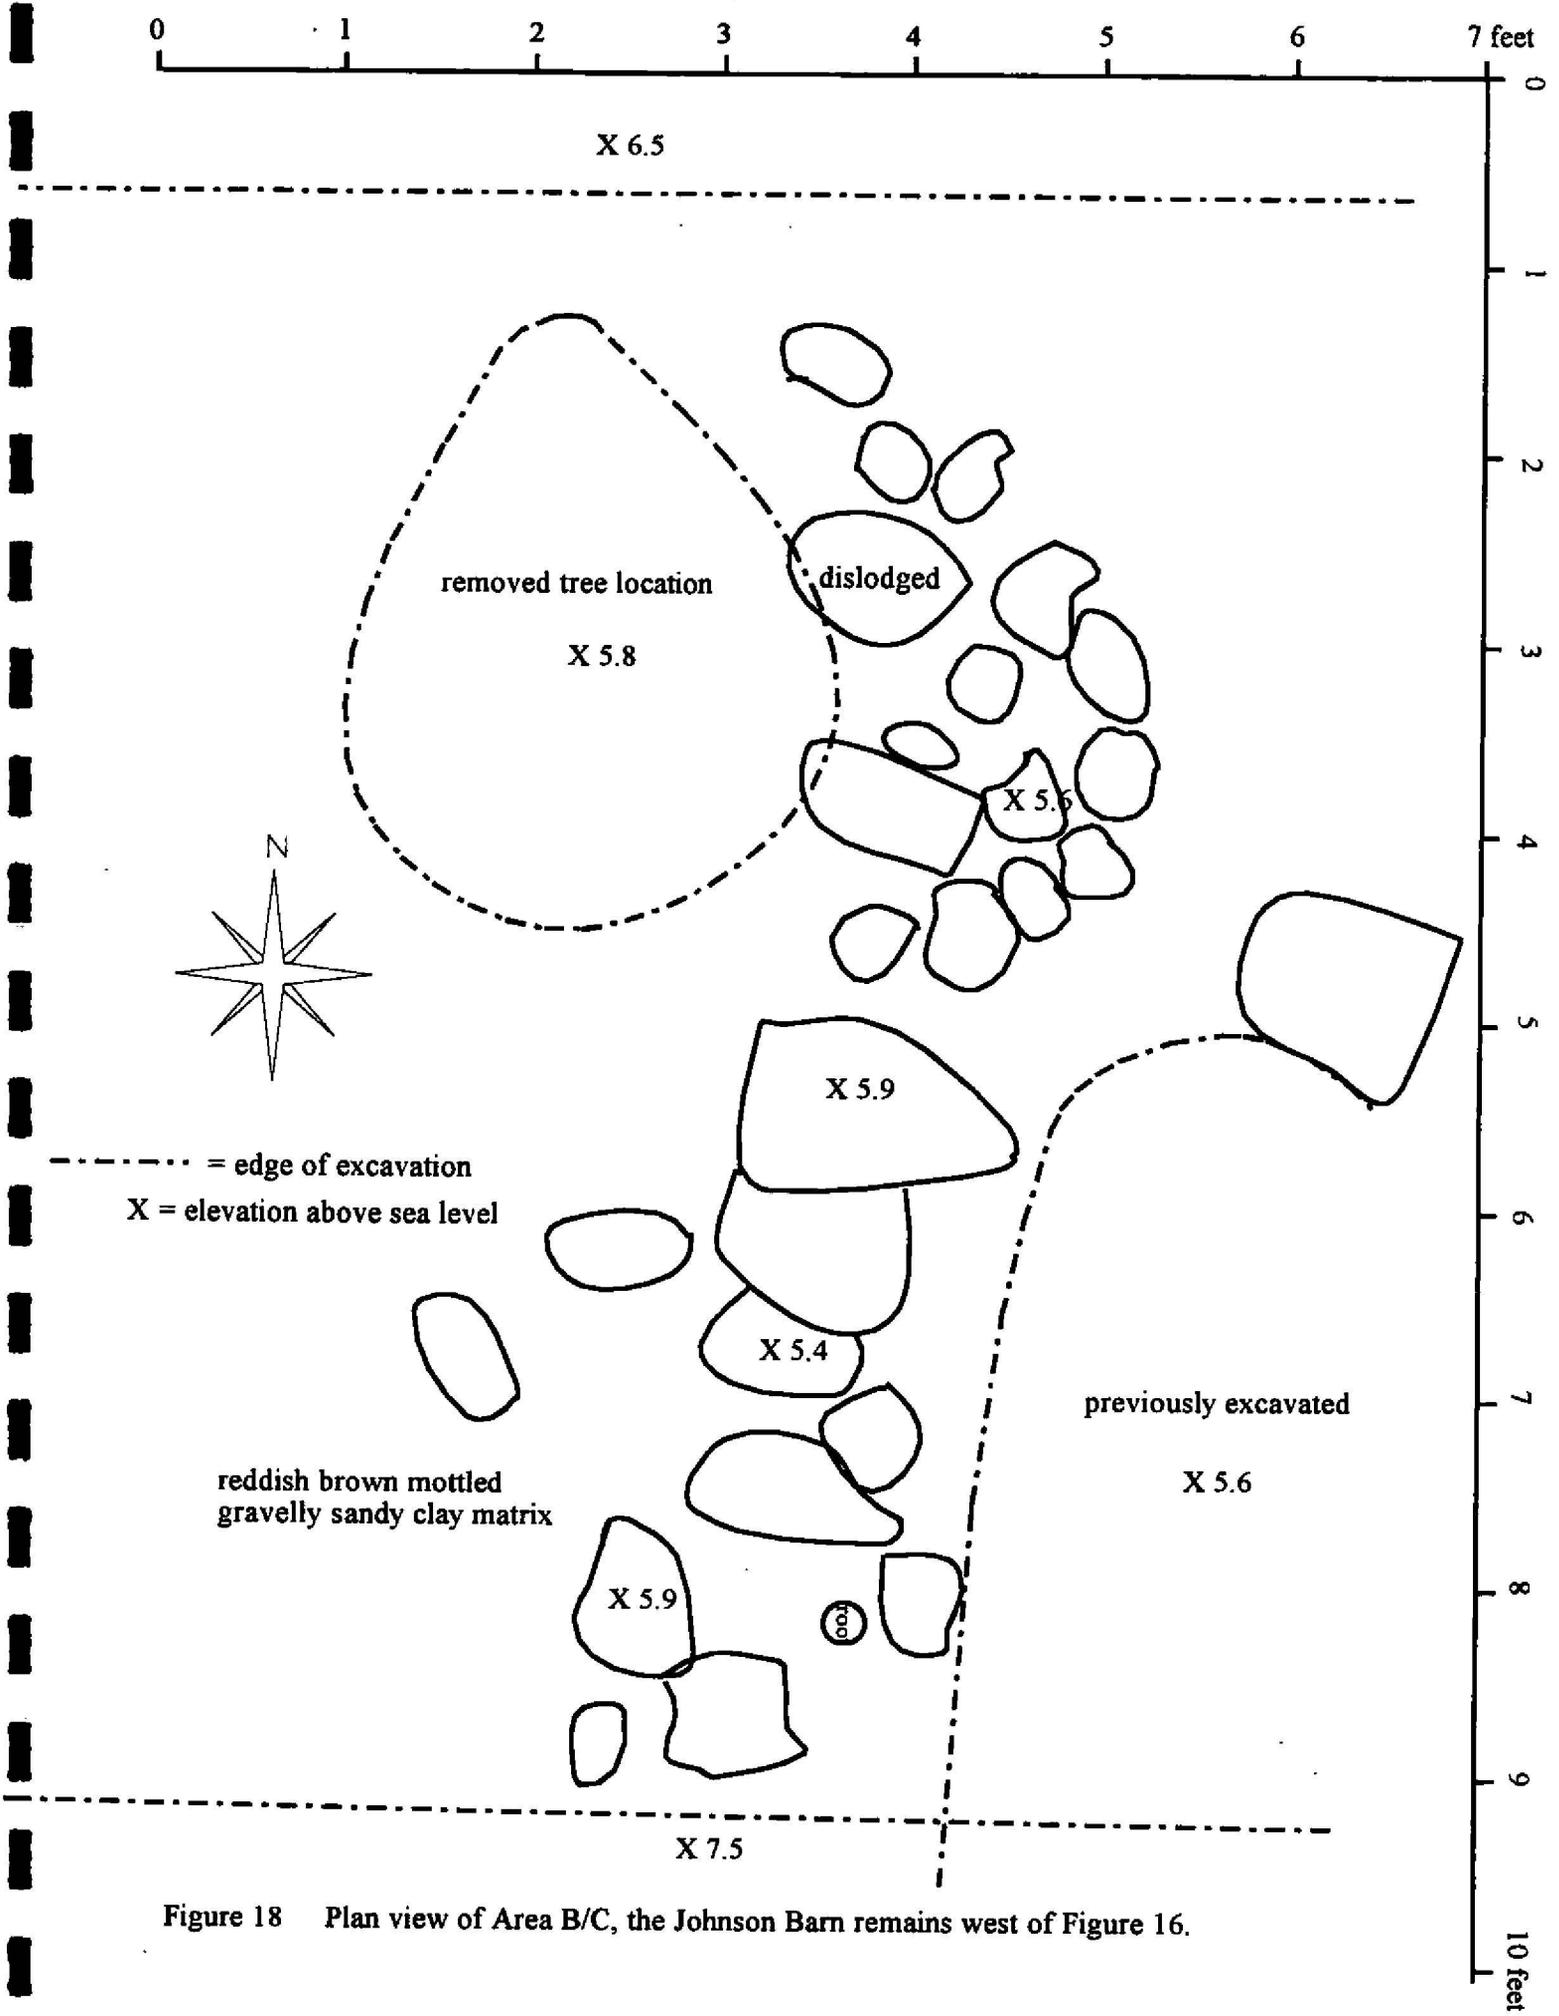
Figure 18 Plan view of Area B/C, the Johnson Barn remains west of Figure 16.

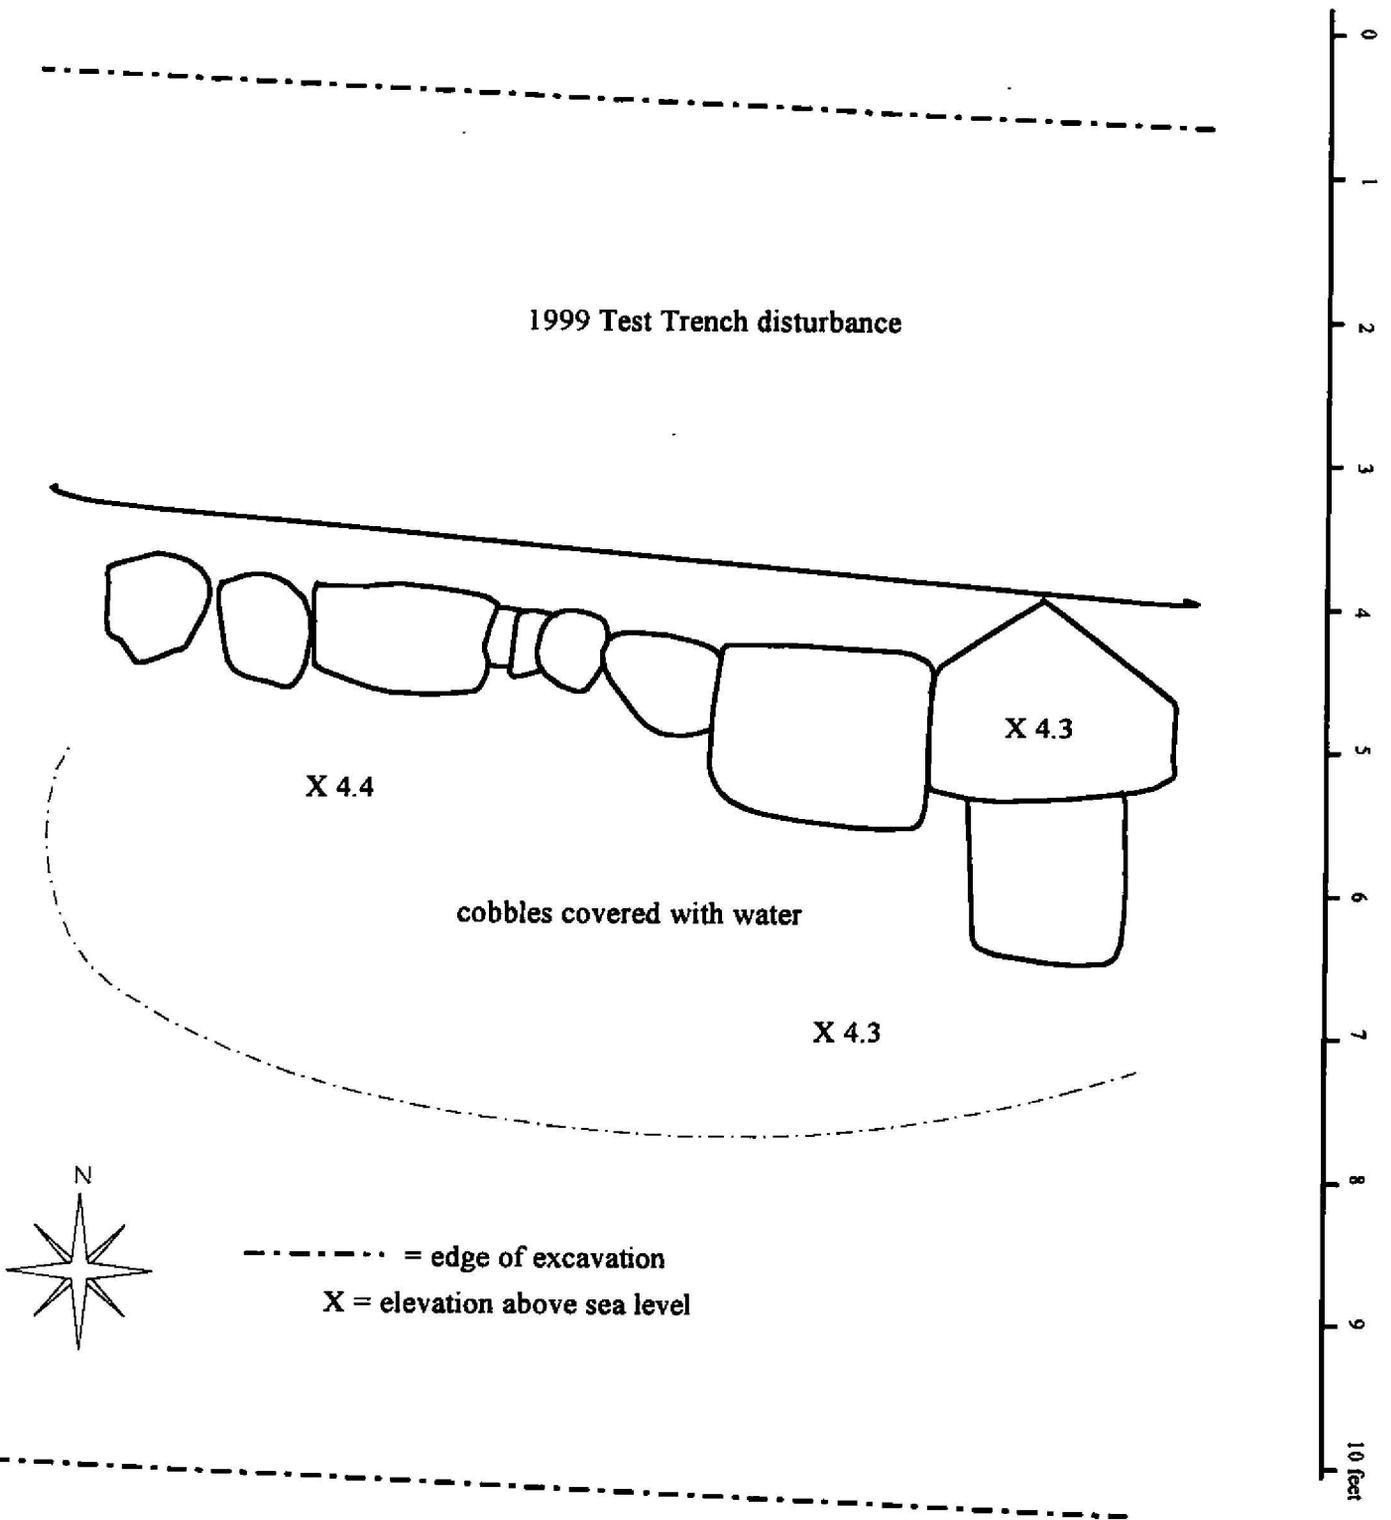
Figure 19 Plan view of Area B/C, Johnson Barn under Figure 18
