REPORT ON PHASES 1B and 2/3  
ARCHAEOLOGICAL TESTING AND EXCAVATIONS  
OF THE MILL POND SEWER PROJECT  
LOCATED ALONG PARTS OF OLD MILL ROAD,  
ARTHUR KILL ROAD, AND PARTS OF  
HISTORIC RICHMOND TOWN (Blocks 2278, 2290 and 4444),  
BOROUGH OF STATEN ISLAND  
NEW YORK

Contract No. SER 20099

Submitted by: Linda Stone, MA, RPA  
249 East 48th Street, #2B  
New York, New York 10017

May 23, 2003

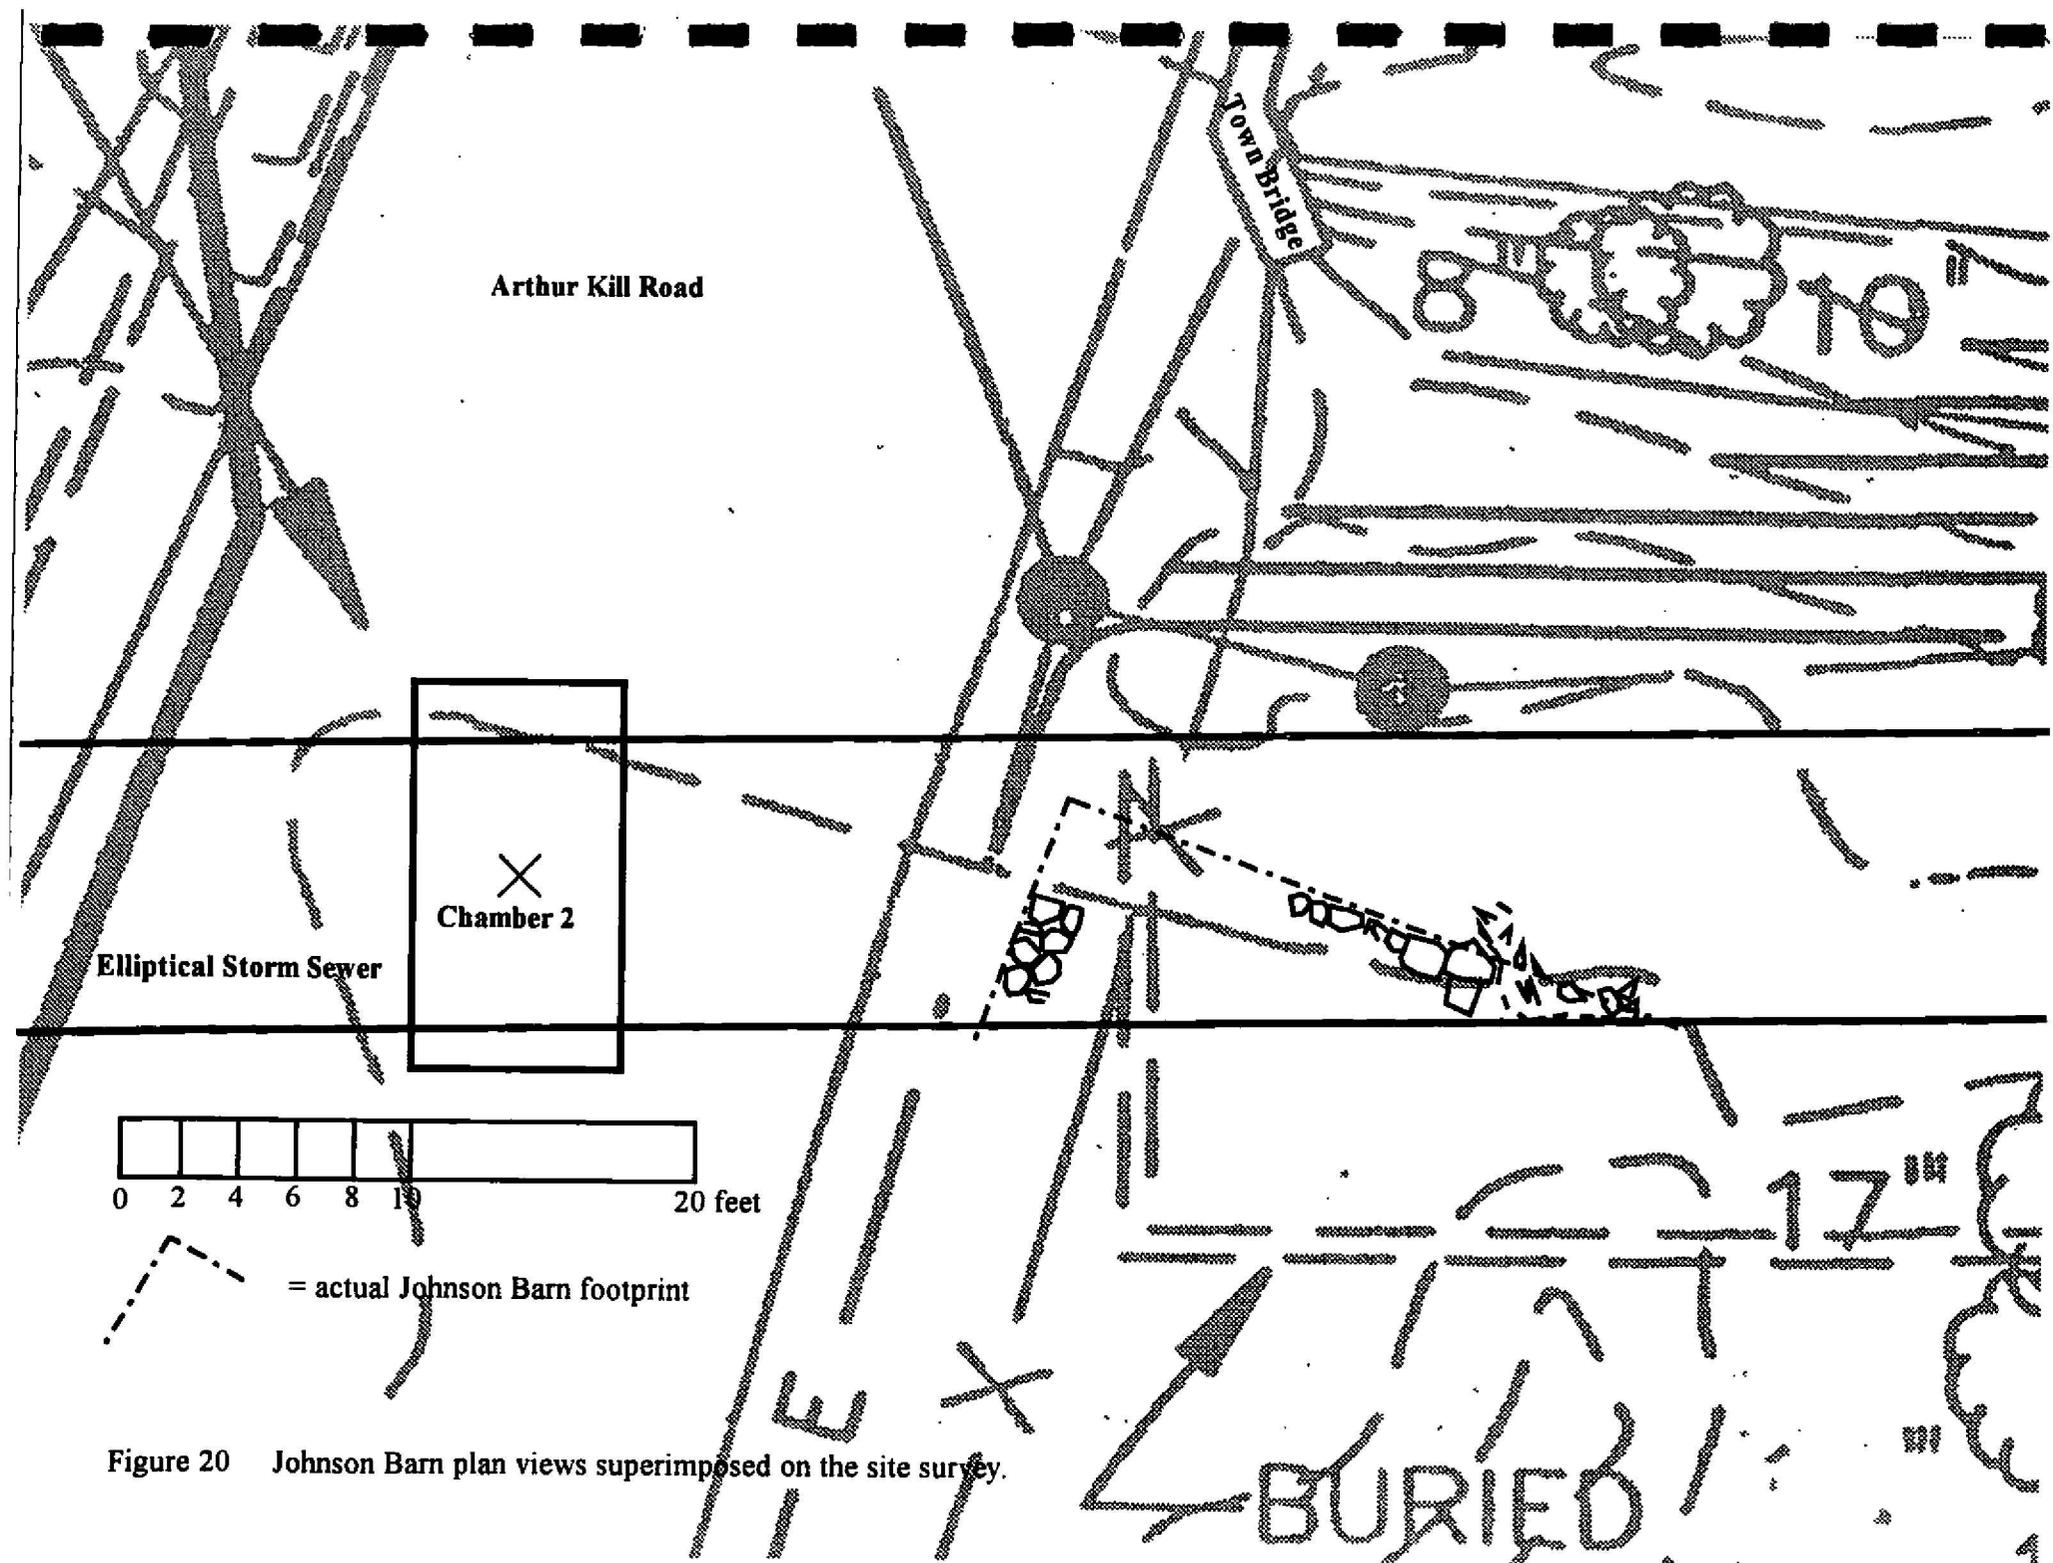
Figure 20 Johnson Barn plan views superimposed on the site survey.

Two parts of a previously identified stone foundation wall were exposed and documented to be the remains of the Johnson Barn which had been destroyed by fire in 1895 (Stone 2002: 19). The reason, it is now known, is two sections of stone wall were identified in a trench oriented in the same direction the barn is oriented on the site survey, but not spaced as far apart as would be expected, is because the survey is incorrect. The historic maps as well as actual archaeological remains show the barn was parallel to Arthur Kill Road (Stone 2002: Fig.12). It was about four feet west of the current curb. The excavations did not reveal the entire dimension of the barn in either direction because it was askew to the orientation of the planned elliptical sewer. Figure 20 depicts the archaeological findings on the site survey. The outline of the previously presumed location of the barn is a gray dashed line with an arrow and the word "buried" pointed at it. The actual footprint is extrapolated and shown within the elliptical storm sewer in black.

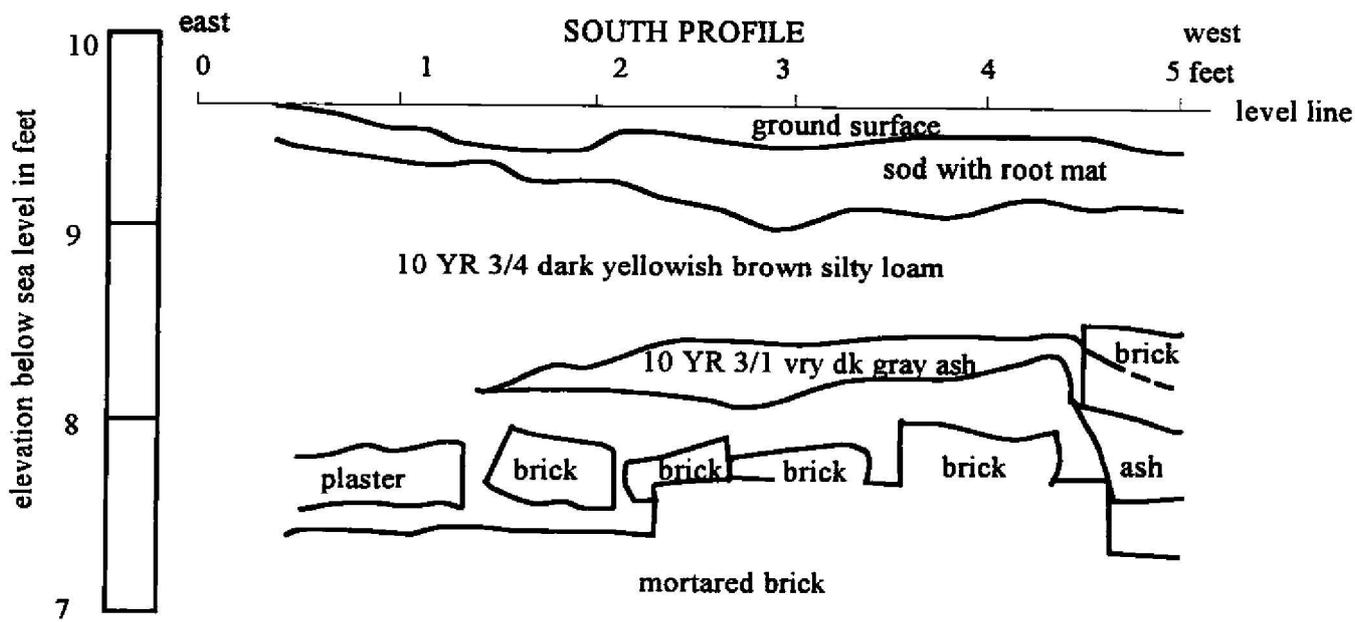
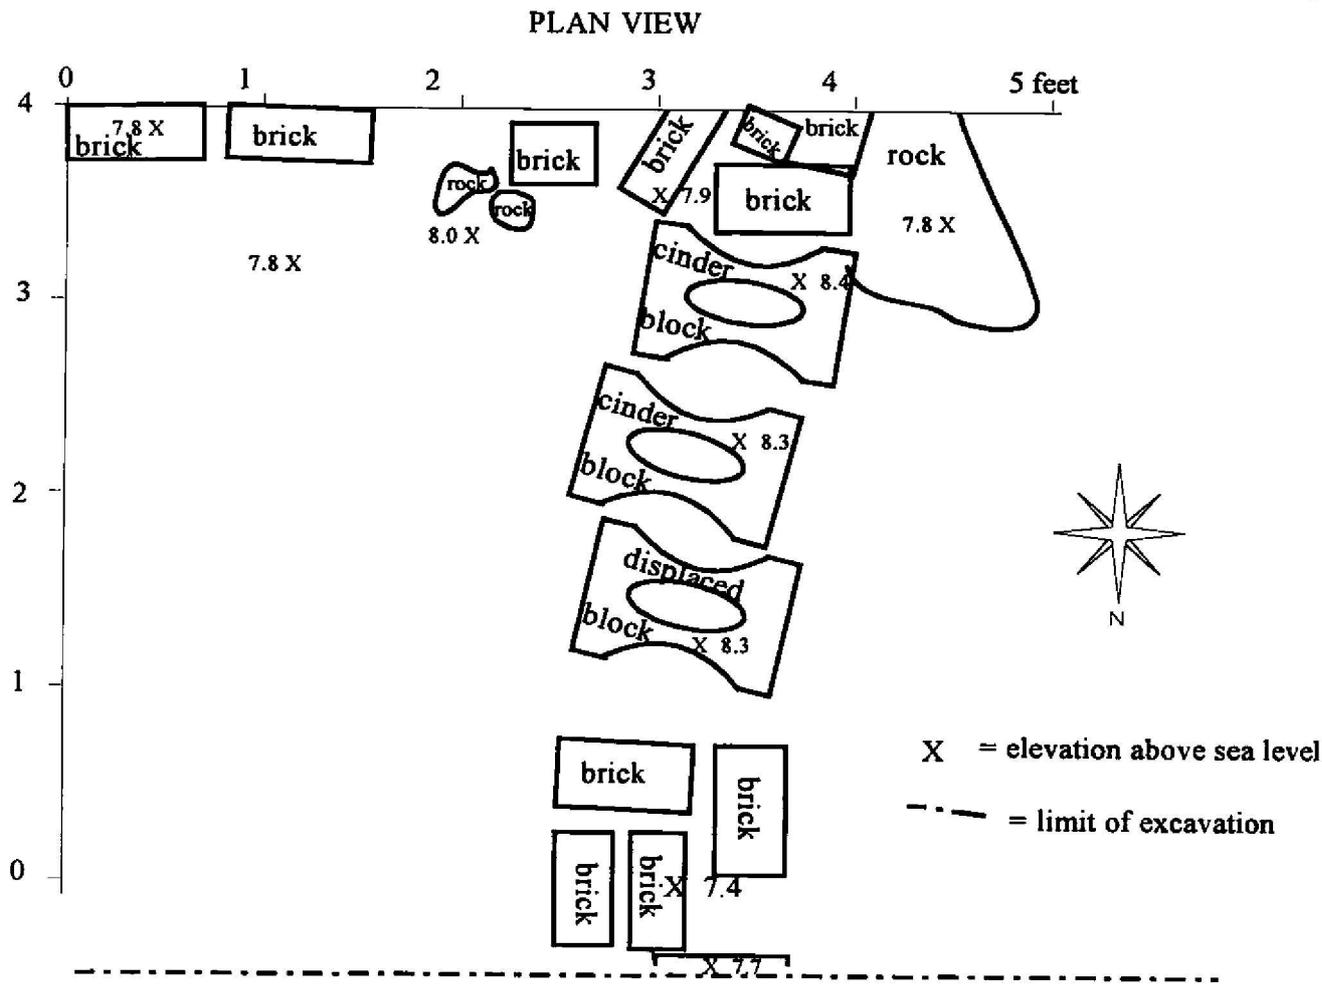
Figure 21 South profile and plan view of Area D, tinsmith shop/shed prior to expanding southward.

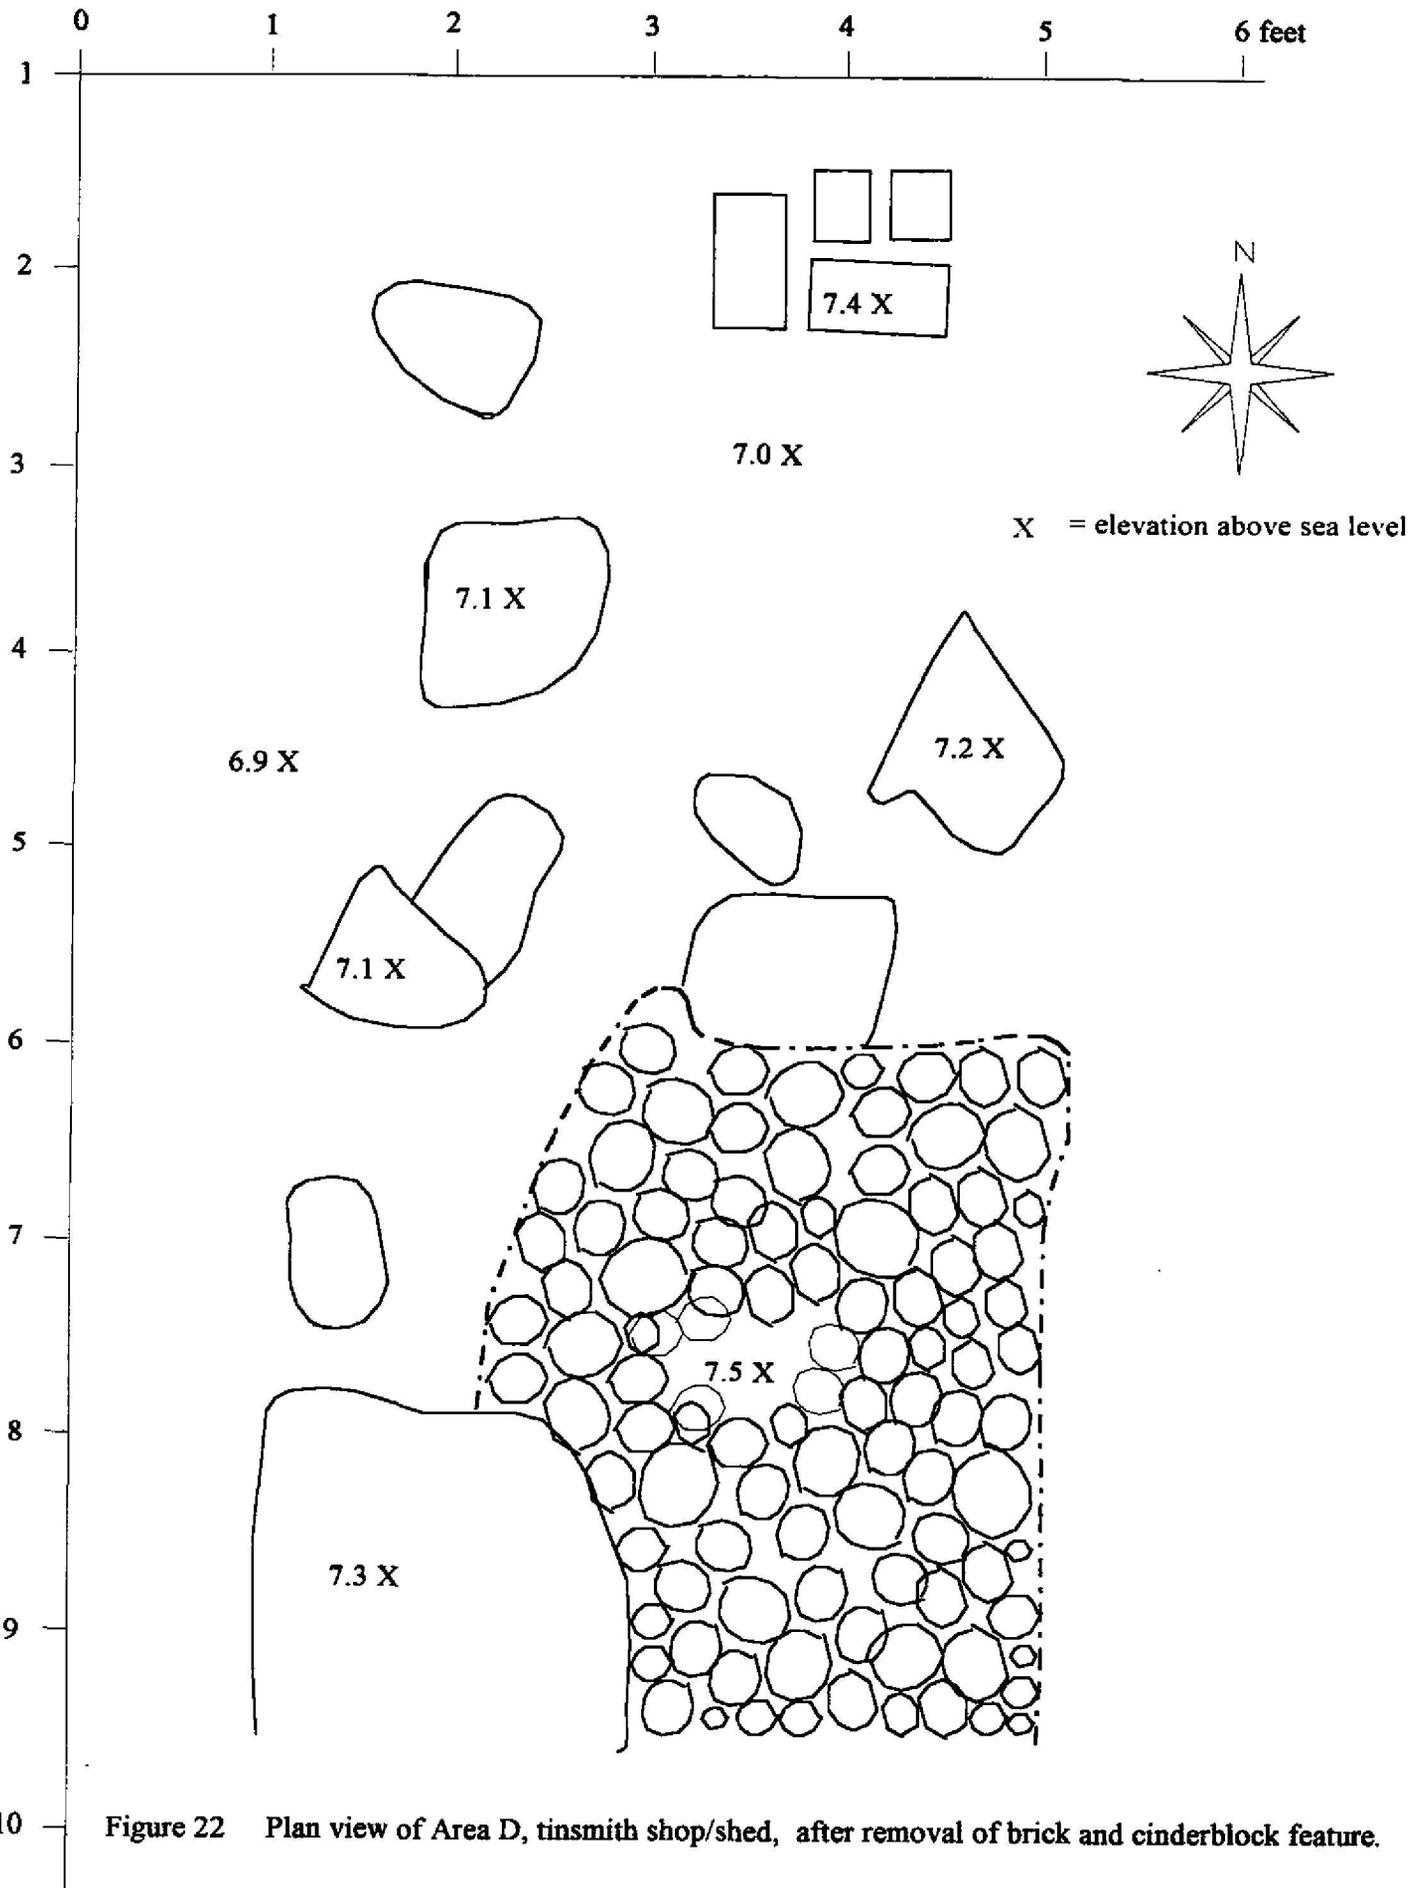
Figure 22 Plan view of Area D, tinsmith shop/shed, after removal of brick and cinderblock feature.

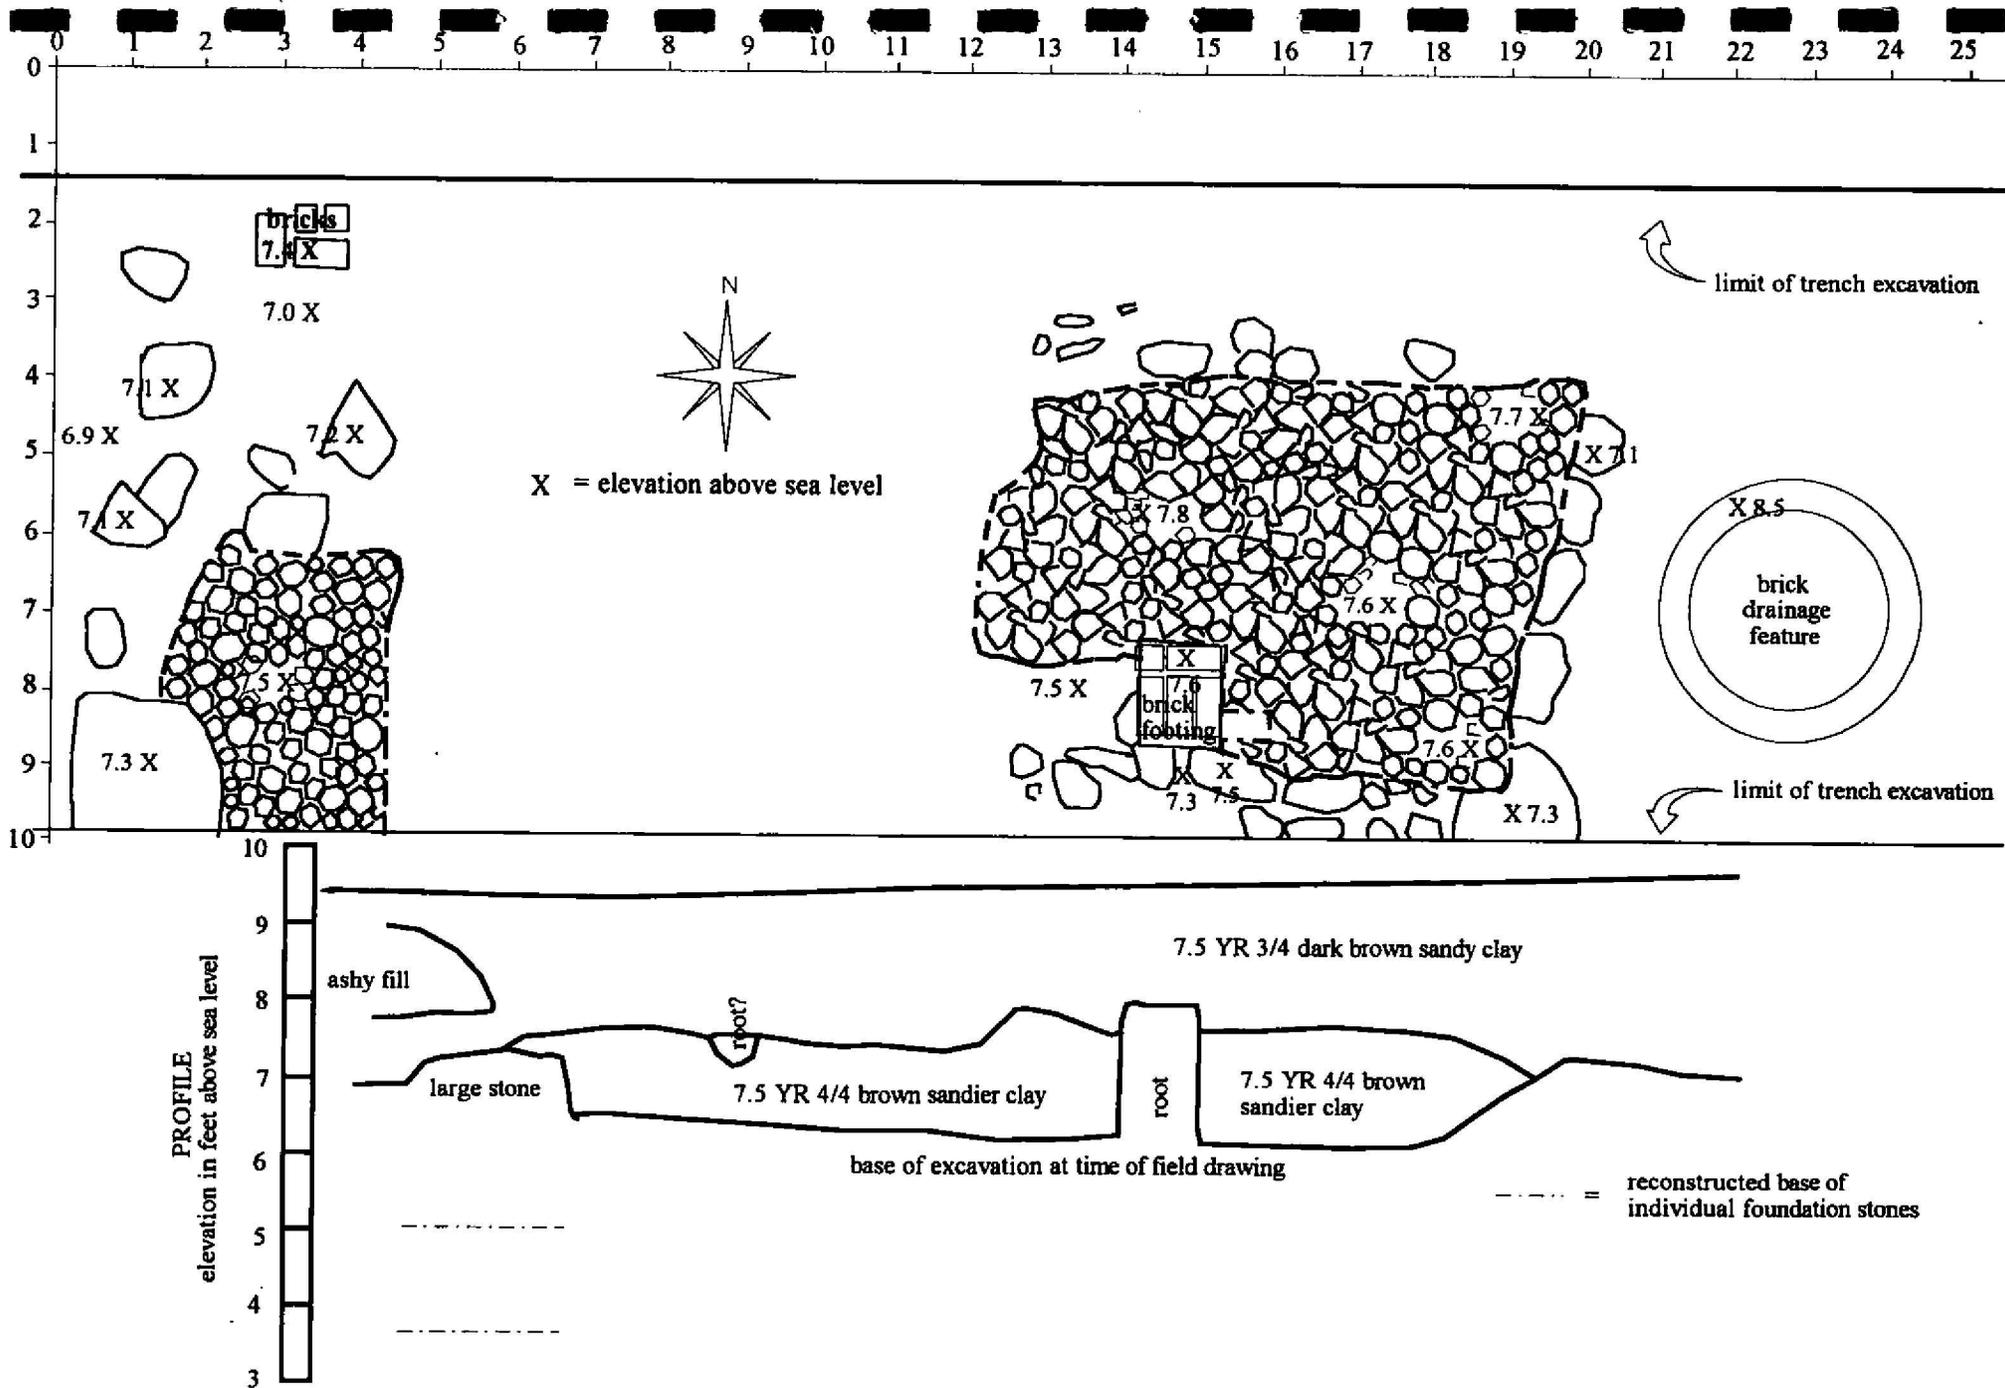
Figure 23 Tinsmith shop/shed profile and plan view, showing cobble surface, brick footings and also a brick drainage feature.

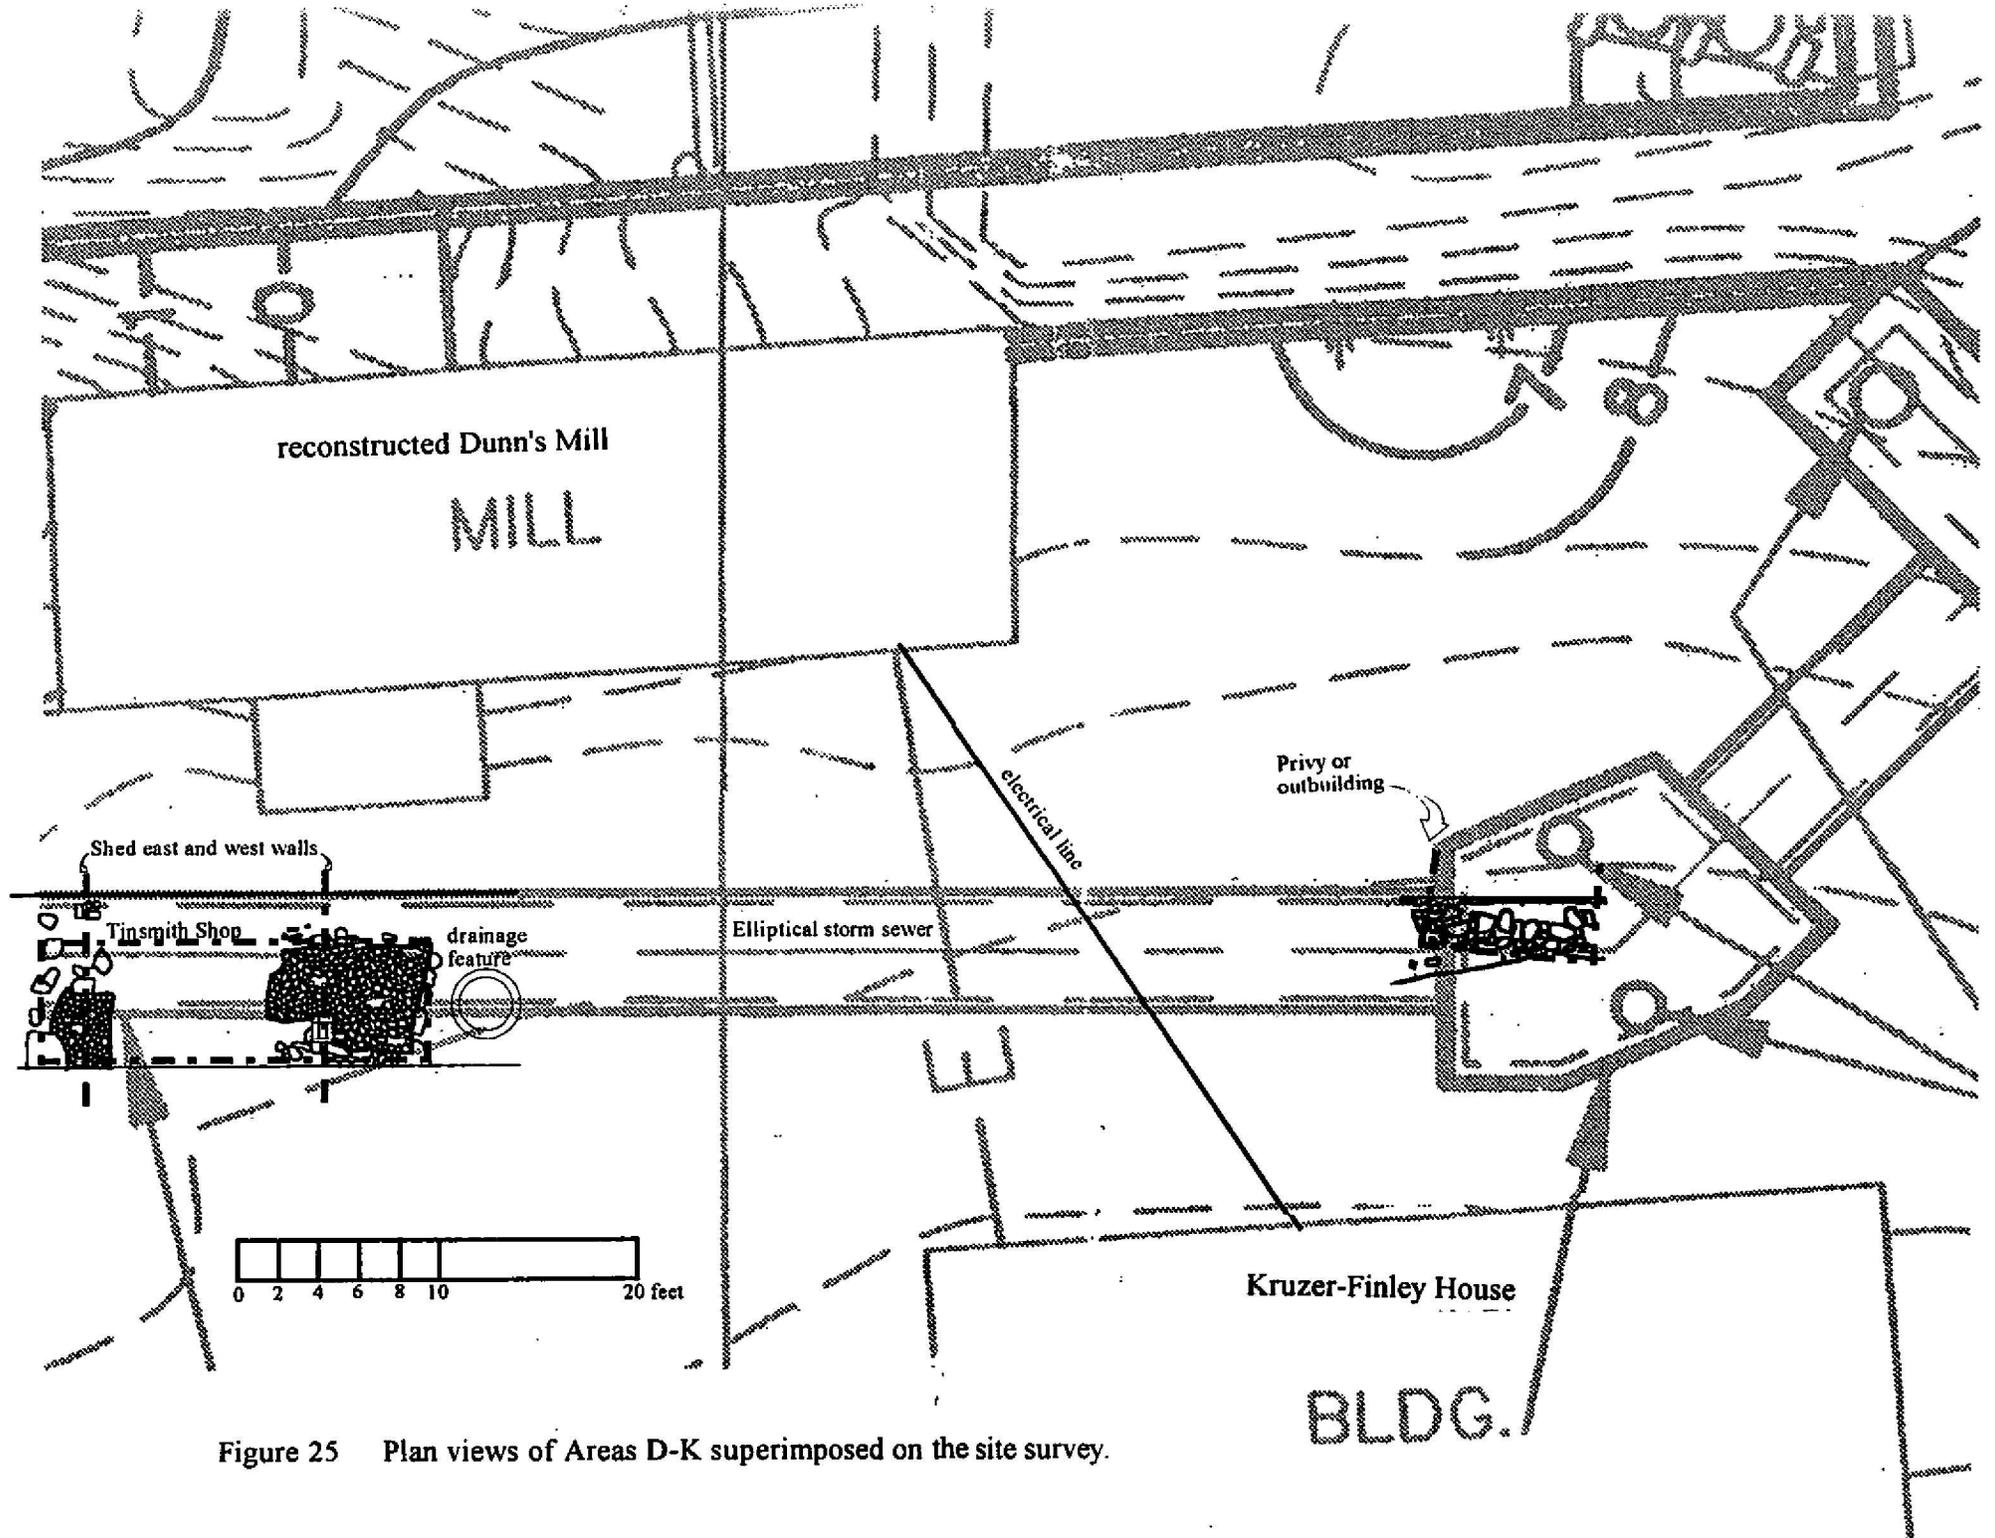
Figure 25 Plan views of Areas D-K superimposed on the site survey.
