Archeological Investigations on Block 457, Lot 1 (Formerly 4 East First Street) Proposed Extra Place Apartments New York, New York

John Milner Associates, Inc.
Croton-on-Hudson, New York

June 2004

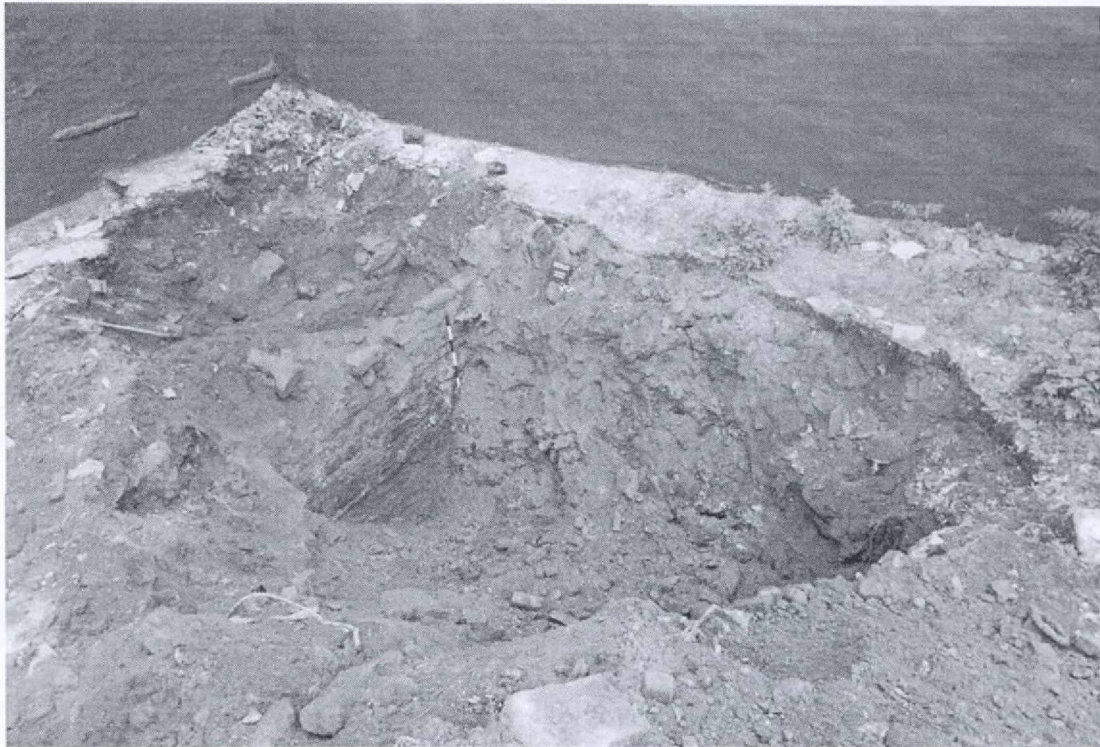
Plate 1. The rear (northern) foundation wall of 4 East First Street documented within Archeological Test Trench 1; view to the northeast.

The rear (north) wall of 4 East First Street was documented within Trench 1 (Plates 1 and 2). The wall is constructed of mortared brownstone and is located 15 feet south of the rear lot line (Figure 8). The top of the wall was encountered at 1.5 feet bgs, and the wall extended to a depth of 8 feet bgs. The interior of the structural foundation (south of the wall) included two strata of demolition rubble. Stratum II was reddish brown sandy loam fill with brick rubble and demolition debris that extended between 1-foot and 8 feet bgs. Stratum II represents debris from the demolition of the former structure at 4 East First Street. The underlying fill deposit (Stratum III) was dark gray sandy loam with ash, cinders, and structural-timber debris. This deposit extended from 4.5 to 8 feet bgs and represented a mound in the center of the foundation (Figure 8). A similar deposit of dark gray fill was documented along the northern side of the foundation wall.

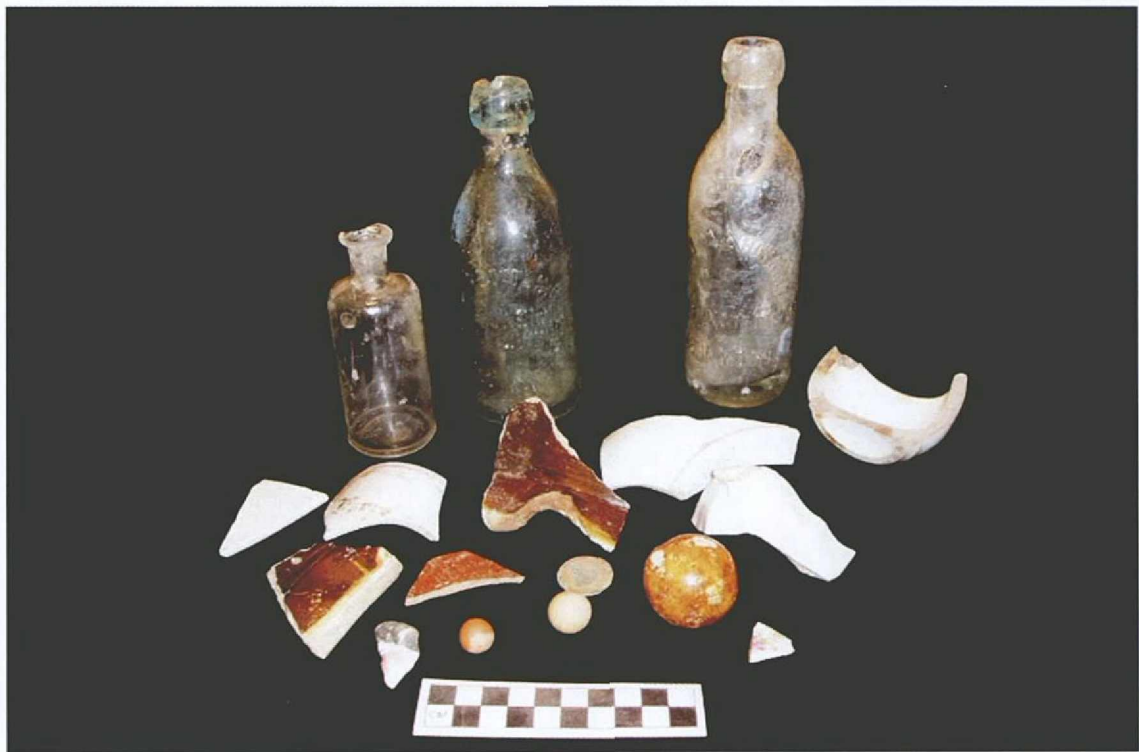
Plate 4. Artifacts recovered from the overburden and upper fill deposit (Stratum 1A) within Feature 1.

The feature fill included two distinct depositional units (Figure 8). JMA investigated a mottled deposit of gray, grayish brown, and black loam with ash, cinders, and plaster (Stratum 1A) that overlay and slumped into the uppermost portions of the disarticulated vault. This deposit extended between 1 foot and 4.75 feet bgs. Stratum 1A included a low-density assemblage of nineteenth-century domestic debris (Plate 4). Materials recovered from Stratum 1A are listed in Table 1. The lower half of the vault (between 4 feet and 7 feet bgs) was filled with brown sandy loam with brownstone cobbles and brick fragments (Stratum 1B). No artifacts were observed within this fill deposit during the archeological testing.

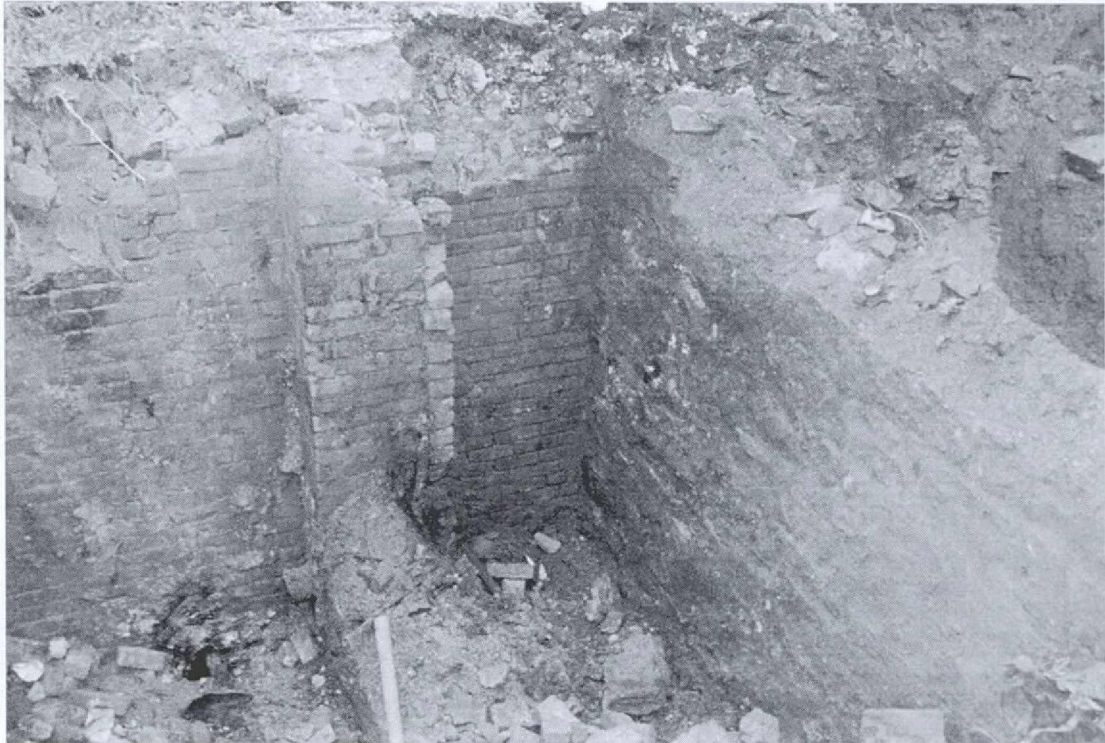
Plate 5. The rear (eastern) foundation wall of 309 Bowery documented within Archeological Test Trench 2; view to the north.

The rear (eastern) foundation wall of the former structure at 309 Bowery was documented in the western portion of the trench (Figure 9; Plate 5). Soils observed west of the wall (within the 309 Bowery foundation interior) included reddish brown brick rubble (Stratum II) and dark gray sandy loam fill (Stratum III). No additional archeological features were observed within the rear yard of Lot 55 during the excavation of Trench 2.
