Construction of Coenties Slip

Report on the Log Water Main Discovery and Monitoring

(October 22-26, 2004)

Prepared for New York City Parks and Recreation
Through Trocom Construction Corporation, Inc.
Prepared by Joan H. Geismar, Ph.D. LLC
March 2005

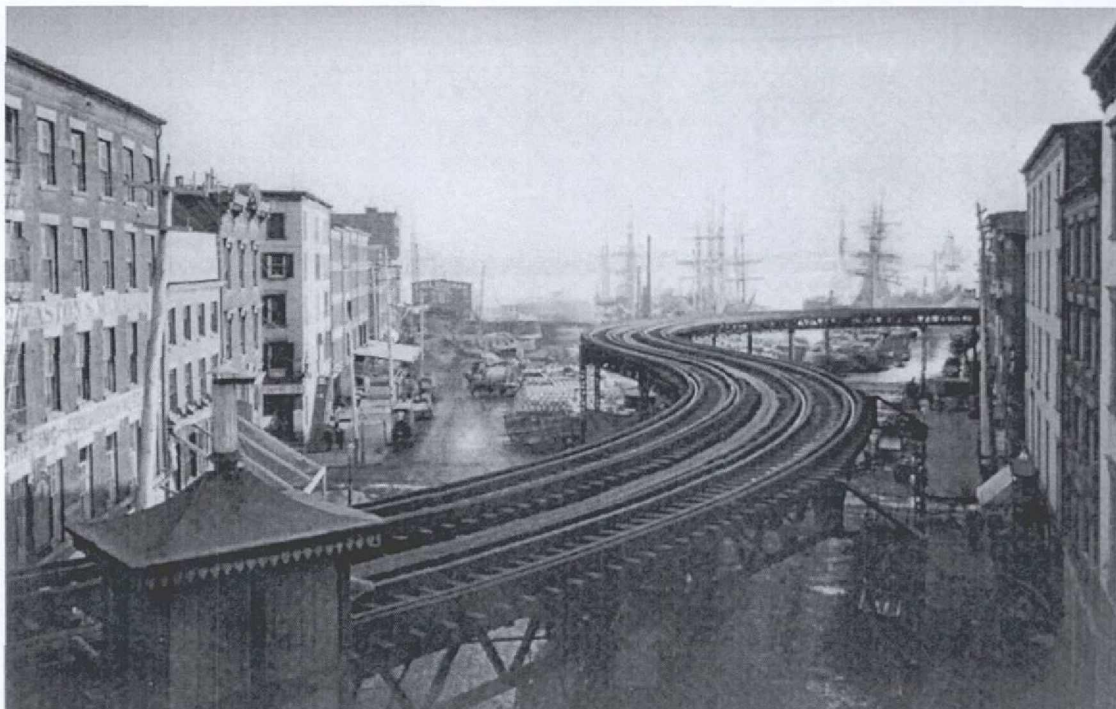
3 Coenties Slip looking east from Pearl Street in 1879, shortly after the elevated IRT was constructed. The park site is on the right side of the "S" curve of the "El." (Black 1973)

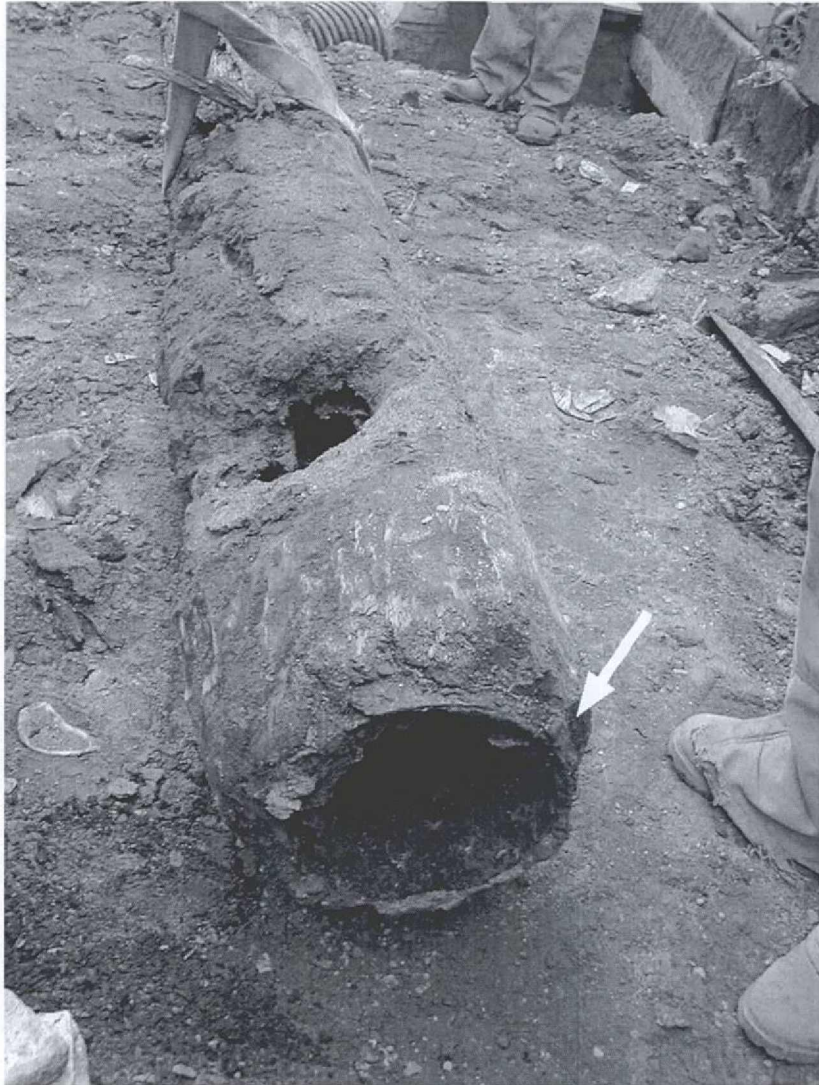
The log pipe, which proved to be the female end of a water main segment, still retained the metal ring, albeit heavily corroded, that once stabilized its joint when it was one of many sections of what comprised an early-19th century water main (Figure 5). The park's construction protocol was for an archaeologist to be in attendance only when excavations reached depths of 4 feet or more, that is, the depth at which a landfill structure might be an issue. However, no archaeologist was on site when the excavation inadvertently extended below 4 feet and encountered the log pipe. During the site visit, after the bored-out log was identified, Douglas Greeley, Deputy Commissioner of the Bureau of Water and Sewer Operations of the Department of Environmental Protection (DEP), was notified and agreed to have the pipe fragment picked up by DEP personnel and transported, as it turned out, temporarily to an agency facility.

5 Large fragment of log water main after removal. The remnants of a corroded metal band (arrow) that stabilized its joint is still evident. (Geismar 10/22/04)

Quick action on the part of several agencies, among them Parks, DEP, and the New York City Landmarks Preservation Commission, resulted in the removal on October 27 of the two whole log mains and the smaller segment from the DEP facility to a conservation lab in New Jersey (Cultural Preservation & Restoration) where they were immediately stabilized pending a cohesive plan for their preservation. Field measurements had indicated that each intact pipe was about 13.5 feet long, 1 foot in diameter and with bore holes about 8 inches in diameter at the untapered end of the logs; the pipe segment first seen on October 22 was just about 10 feet long. These measurements were later refined in preparation for conservation when they were found to be 13.5 feet, 13 feet, and 9 feet 10 inches long with diameters ranging from 8 to 10 inches at the two tapered ends and 13, 11.5, and 9 inches at the open ends. Bore holes ranged from 5 inches at

the tapered (male) end to 9 inches at the unaltered (female) end in the two intact segments. All were identified as yellow pine.¹³ After exploring the alternatives, it was decided that the most practical method of preservation for the pipes was the introduction of polyethylene glycol (PEG) followed by freeze drying. Initially, the log mains were submerged in fresh water to clean and prepare them for conservation, a program that will take at least ten months to complete.

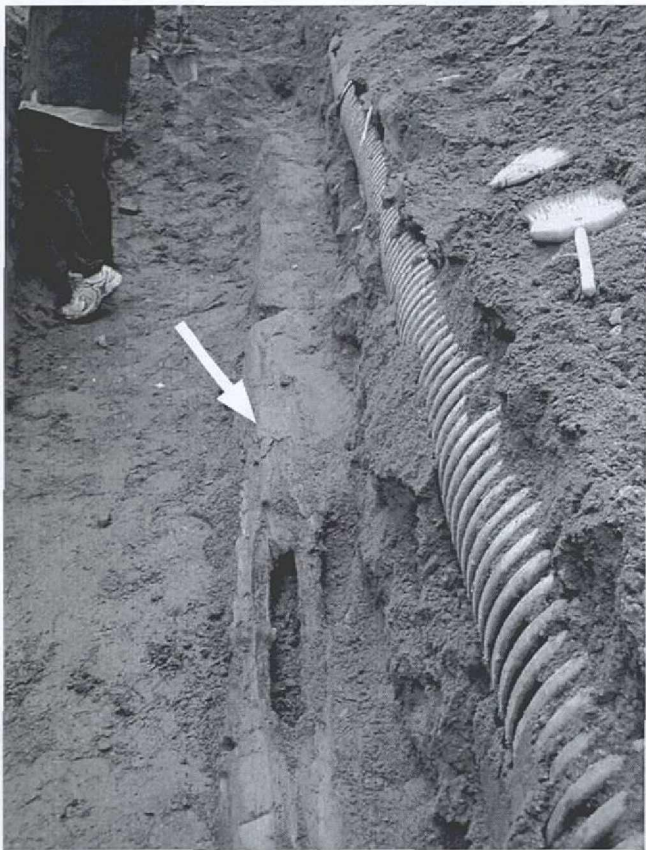
Subsequent hand and backhoe excavation during the October 22 visit revealed that additional log pipe remained *in situ* east of the electric service pit, and that its depth was about 4.8 feet below the curb east of the pit, but less than 4 feet below site grade. Moreover, it exposed an intact joint of two additional log segments, a unique remnant of what may be considered New York City's earliest infrastructure. The partially exposed pipe and joint were photographed (Figures 6 to 8) and it was expected they would be reburied and remain where they were found since it was feared that removal might damage the somewhat fragile looking pipe. However, on October 26, it was learned that the pipes had been removed, apparently without causing any noticeable damage (Figure 9).

6 Log water main (arrow) partially exposed at the Coenties Slip construction site. A newly installed utility pipe is to the right. View is looking east. (Geismar 10/22/04)

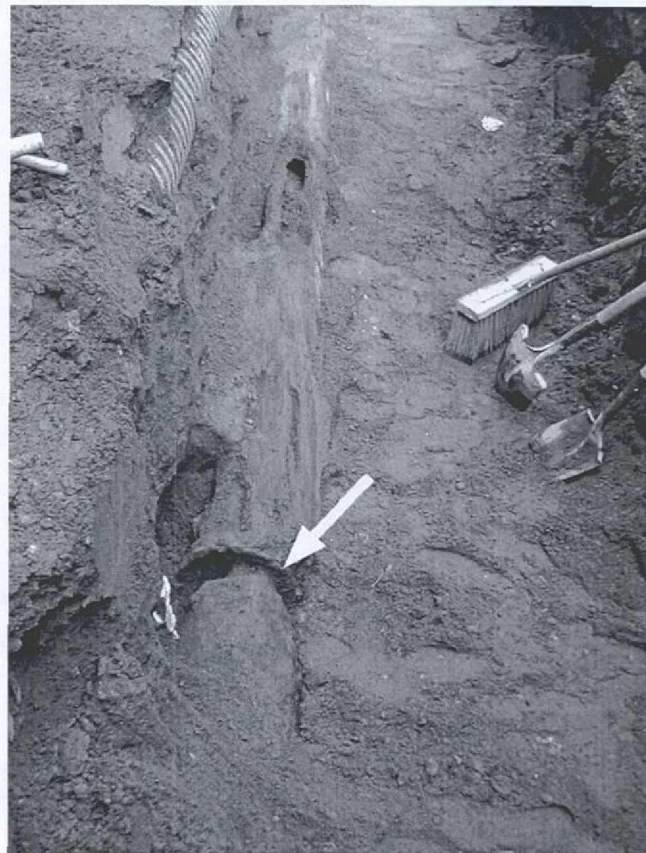
The intact water main segments removed from Coenties Slip are an exceptional example of the hollowed-out log pipes initially used by the Manhattan Company to distribute water to lower Manhattan. The fact that they were unscathed by subsequent introduction of the city’s infrastructure and the elevated train line that once crossed the site is almost miraculous. Moreover, the depth of the logs, at about 4 feet below the current surface, but undoubtedly as much as 3 feet shallower under original street elevations, is one of the few examples of the actual depth of these mains. The joint between the two logs, documented in field photos (see Figures 7 and 8), constitutes a unique find.

7 Intact joint (arrow) of partially exposed log water main *in situ*. Each segment is more than 13 feet long. (Geismar 10/22/04)

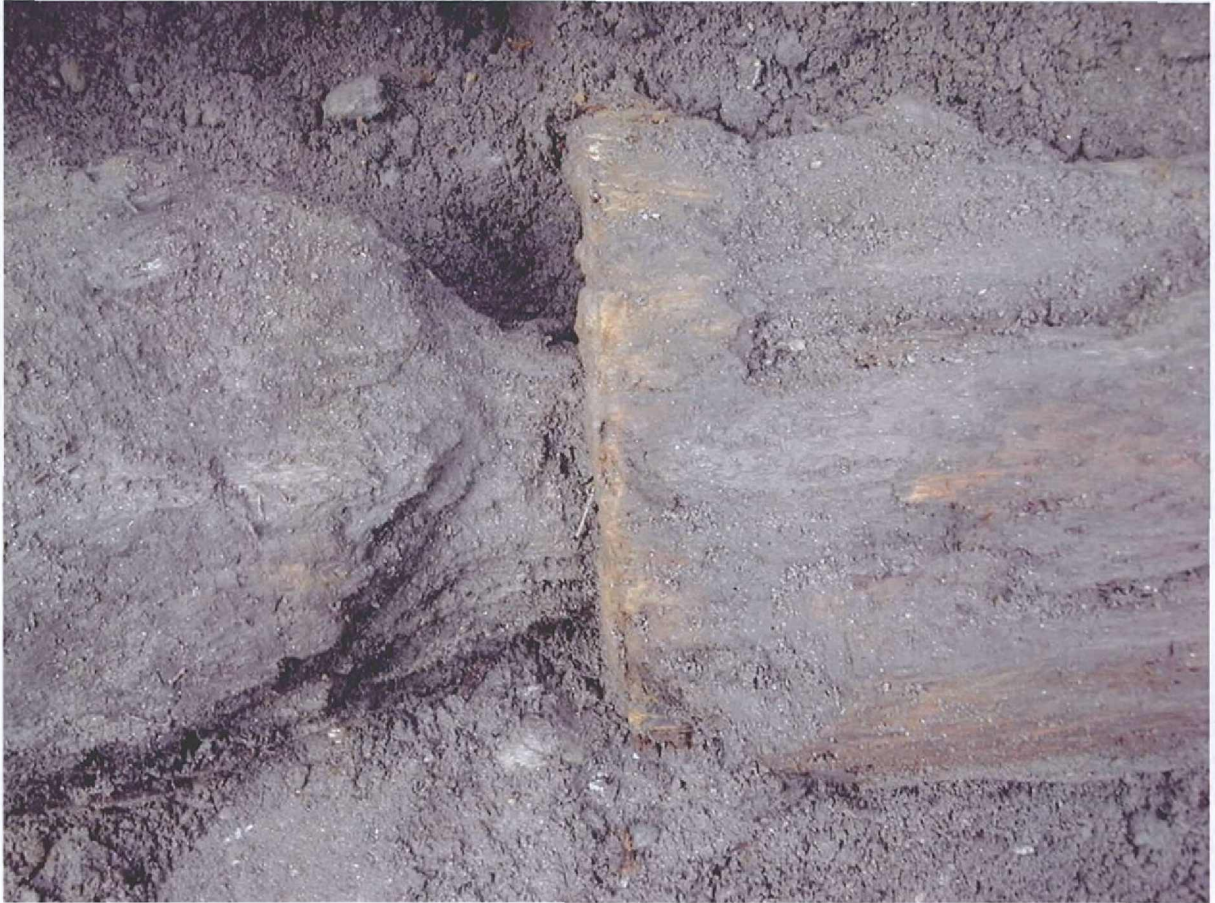
8 Detail of the exposed log water main joint, with the male (left) and female (right) components *in situ* and intact. (Geismar 10/22/04)

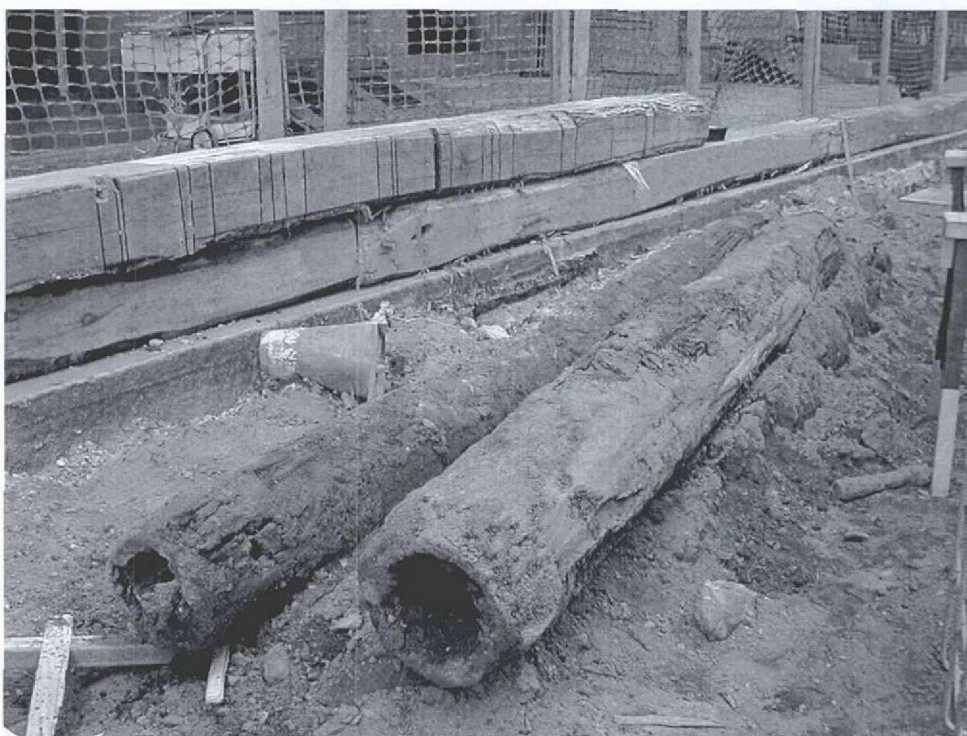
9 Two log water main components after being removed from the ground. Only the female ends are shown. (Geismar 10/26/04)

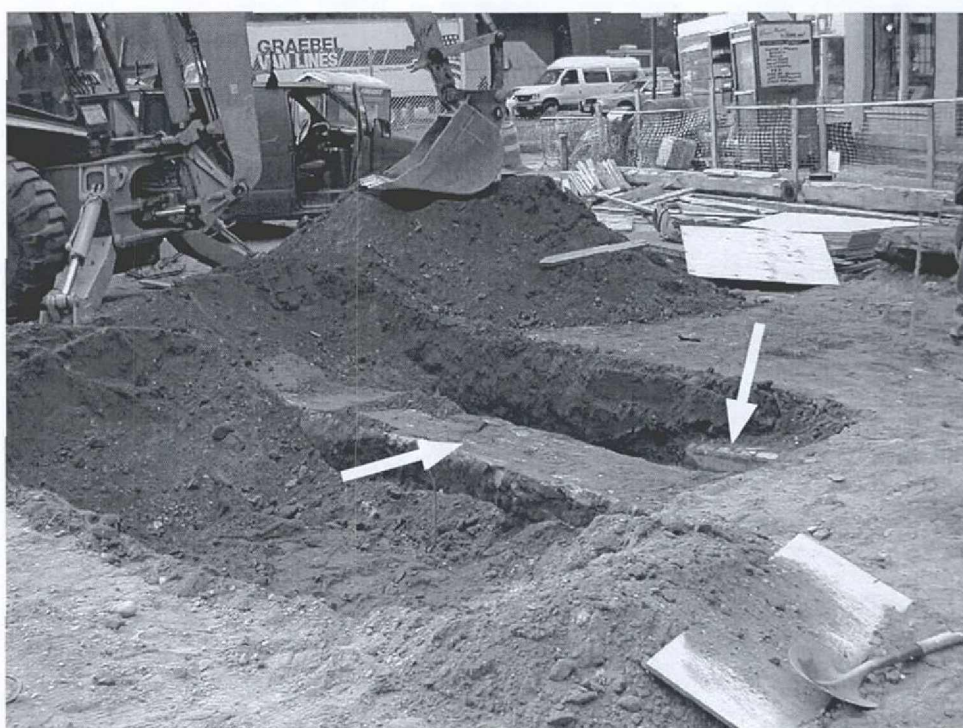
Also on October 26, at Parks' request, excavation of a shallow pit at the site of a planned steel and glass art sculpture was monitored to ensure that its installation would not impact any additional archaeological features or resources. The pit, approximately 10 by 11 feet and 2 feet deep (about 4.5 feet below the south curb, or approximately at the same depth as the water pipes), was located north of the log water main. Excavation revealed fill material that included ash and fragments of oyster shell and brick. It also exposed utilities that indicated this part of the park site had been disturbed in the past. Among the exposed utilities were two ducts, one identified as an Empire City Subway duct, located in the southern half of the pit, the other a shallow electrical duct in its southwest corner (Figure 10). Excavation did not encounter any archaeological features or resources. Figure 11 offers a location plan for the monitored excavation in the vicinity of the sculpture base and for the log pipes. A composite photo taken on February 24, 2005, shows the park construction virtually complete with the exception of its final major detail, the steel and glass art sculpture (Figure 12).

10 A shallow pit excavated where a statue base was to be installed revealed a subway duct (left arrow) and an electric line (right arrow), but no archaeological resources. (Geismar 10/26/04)

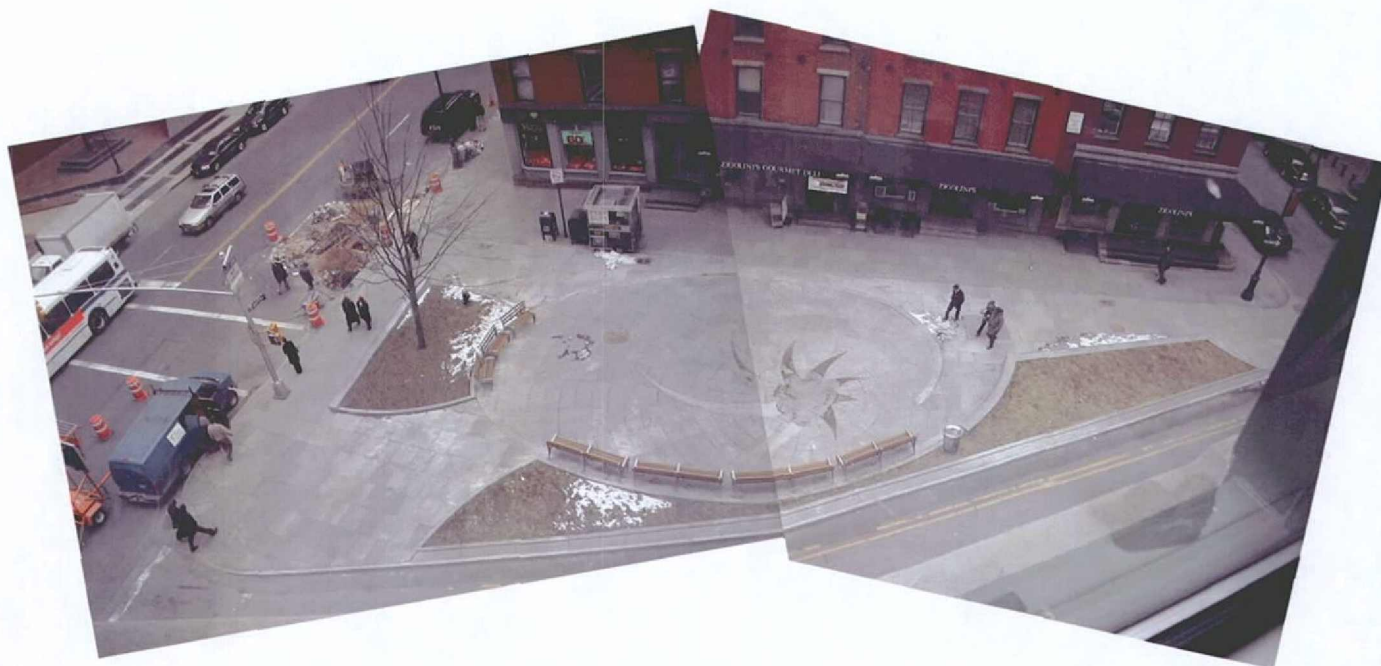
12 Composite view of Coenties Slip showing park near completion in February 2005. View is from a 5th floor window on the north side of the slip. The three figures on the right side of the photo are crossing the electric service box where the first log pipe was first discovered. (Geismar 2/24/05)
