REPORT ON
ARCHAEOLOGICAL MONITORING
DURING STABILIZATION EXCAVATIONS
IN AND AROUND BUILDING 298
ON GOVERNORS ISLAND
NEW YORK, NEW YORK

Prepared for: Bedford Construction Corp.
221 Industrial Loop
Staten Island, New York 10309

Submitted by: Linda Stone, MA, RPA
249 East 48th Street, #12B
New York, New York 10017

July 26, 2005

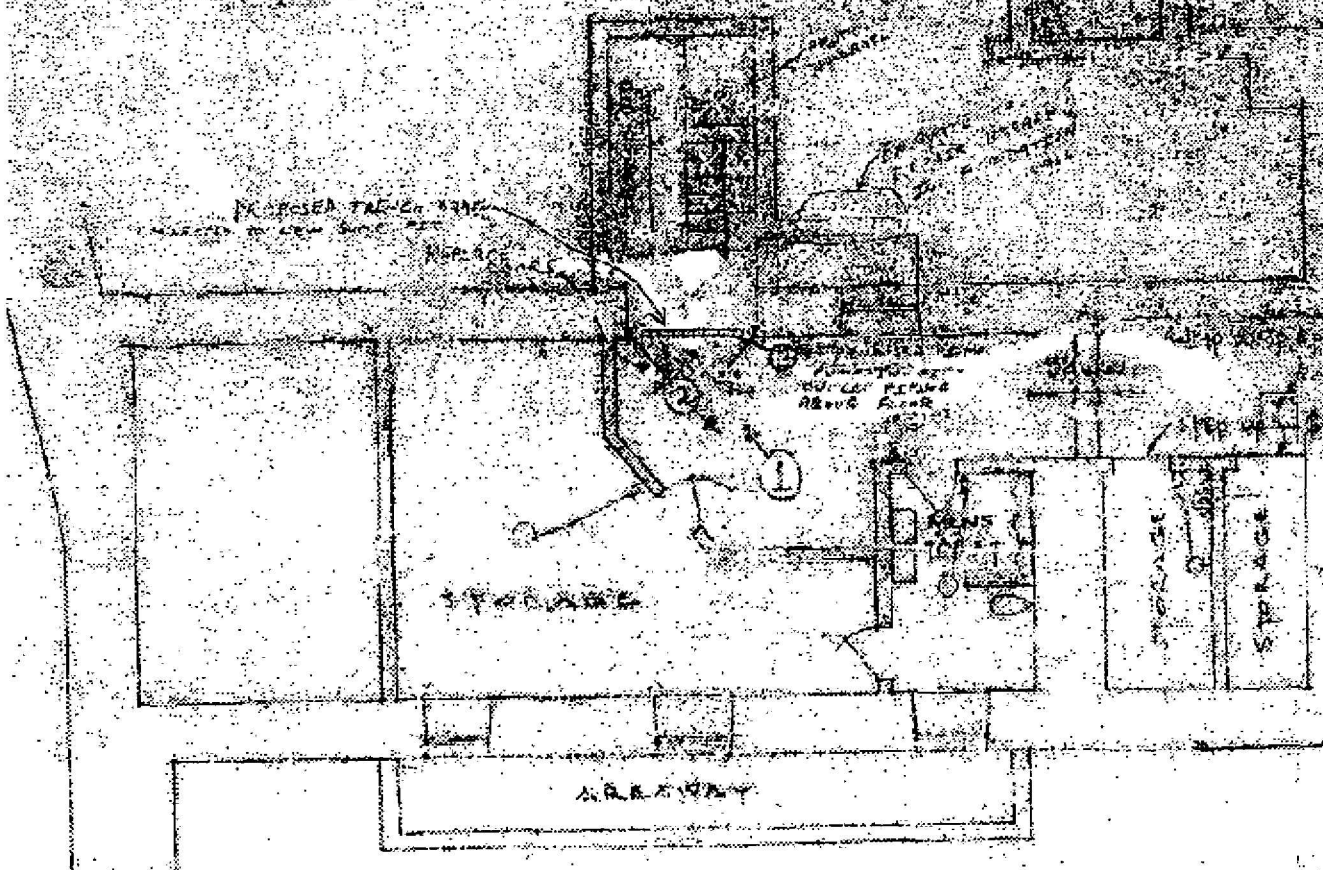
BASEMENT WORK LIMITS

Photo ① SHOWS LOCATION OF WASTE
ENCLOSURE PHOTO WAS TAKEN
