# Fulton Street Transit Center (FSTC)

Archaeological Assessment of Foundation Walls at Maiden Lane and Broadway

## Letter Report

June 1, 2005

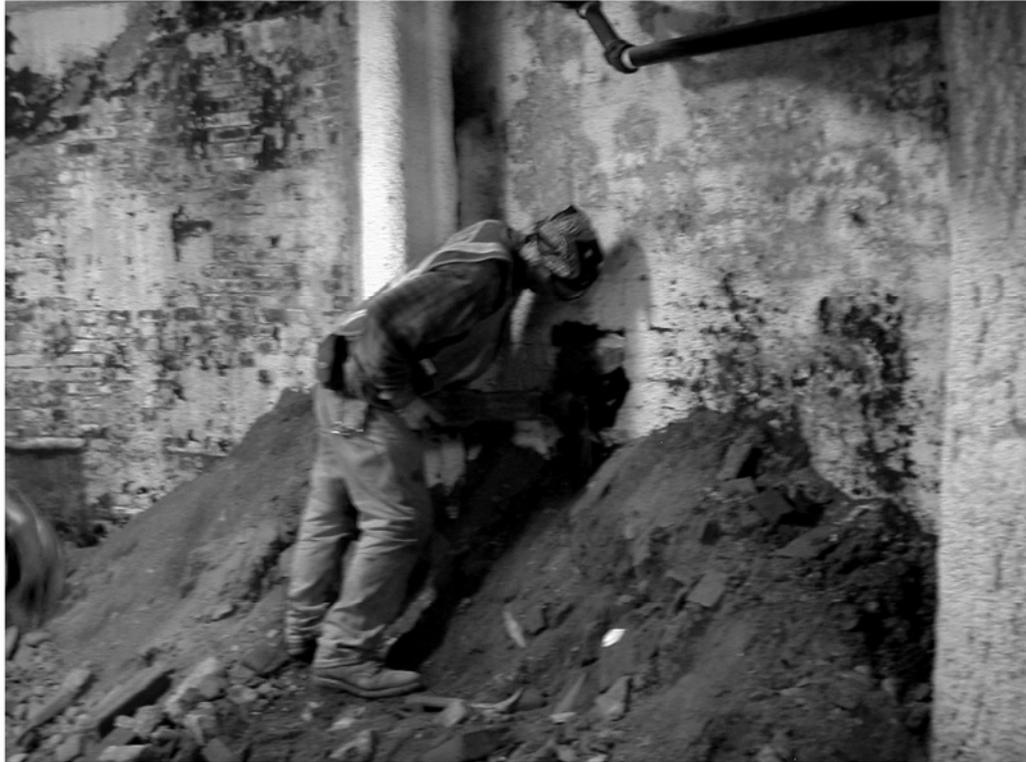
**3** Construction worker attempting to determine the thickness of the basement wall of 170 Broadway. The attempt was ultimately abandoned when it became apparent that the wall was more than a brick facing to the wall exposed on the south side of the Maiden Lane utility trench. (Geismar 5/9/05)

At my request, a construction worker hand excavated a pit adjacent to the north wall (see Figure 9c) to determine its depth and, if possible, to examine the nature of the floor at the bottom of the two stone walls. A visit was made to the basement of 170 Broadway, the adjacent building, to explore its relationship to the walls uncovered in the street. The basement proved to be very deep (at least 14 feet below street grade), and an attempt to penetrate its north wall, which paralleled

the trench, was abandoned when five contiguous bricks, laboriously removed, failed to locate the other side (Figure 3).

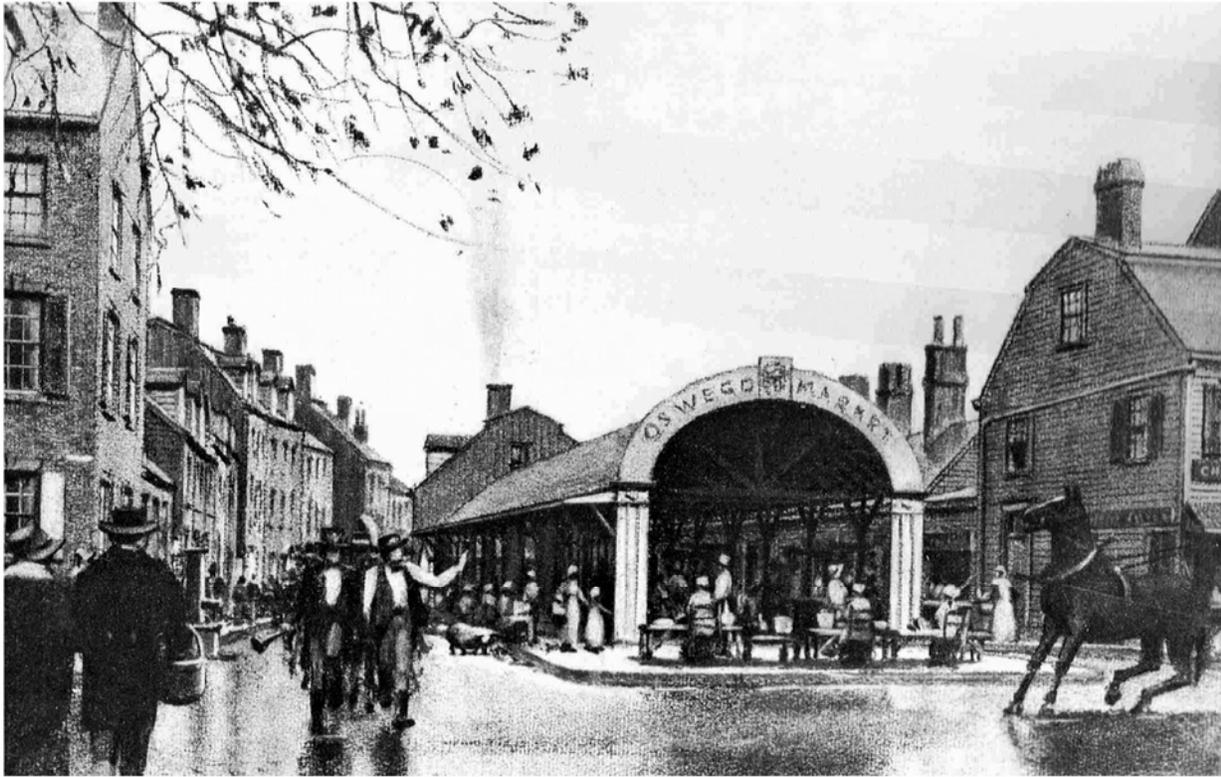
**5** Rendering of the Oswego Market in 1811, the year it was closed and demolished (Dunshee 1952:95). The source of the information used in the illustration is unidentified and its accuracy therefore unconfirmed. The view is looking east down Maiden Lane from Broadway. The trench in this study would be located to the right of the market.

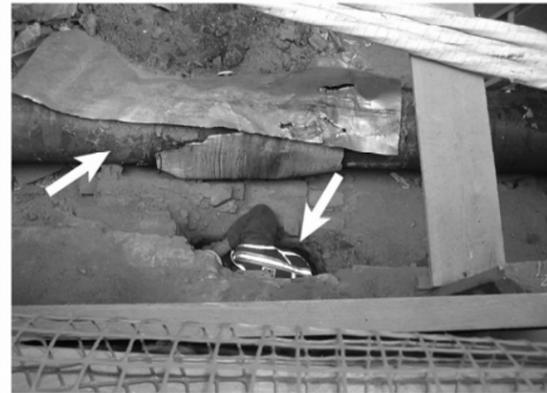
**e.** Excavator in the pit under excavation next to north wall (right arrow). A partially exposed steam pipe (left arrow) that runs down the center of the trench is next to the pit. The view is looking down from above the trench. (Geismar 5/9/05)

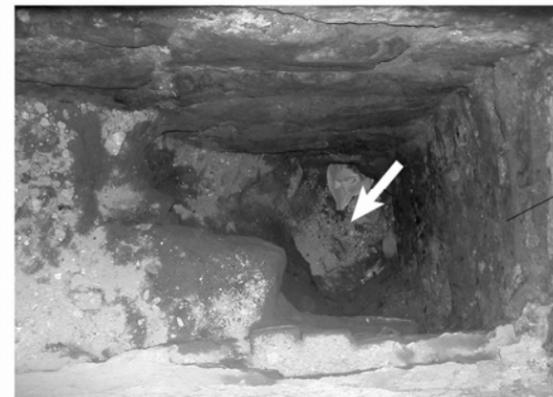
**f.** Pit (5 feet deep) next to the north wall after excavation. A dirt floor with cobbles (arrow) has been exposed. (Spritzer 5/10/05)

Excavation of the 5-foot deep pit on the north side of the utility trench reached the bottom of the stone wall at 12 to 13 feet below the current street level (the actual street grade was difficult to determine). Based on previous Lower Manhattan research, as recently as the 1930s, the street could have been as much as 2.5 feet lower than it is today.<sup>11</sup> The aforementioned line of "soldier" bricks below the curb in the south wall of the trench, now under 3 feet of fill but possibly closer to the surface originally, tends to support this assumption (see Figures 9g and 14).

At the bottom of the north wall, the "floor" between the two stone walls proved to be dirt with inclusions of scattered cobbles. Figure 9a shows a plan of the trench in relation to Maiden Lane and its north and south sidewalks; Figure 9b offers a schematic profile of the arched brick and stone

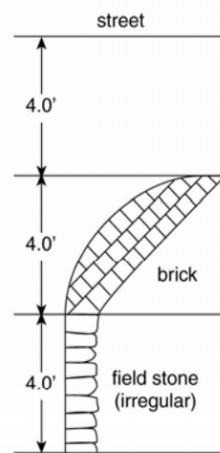
**b.** Projected profile (schematic) of north wall and arched brick remnant.

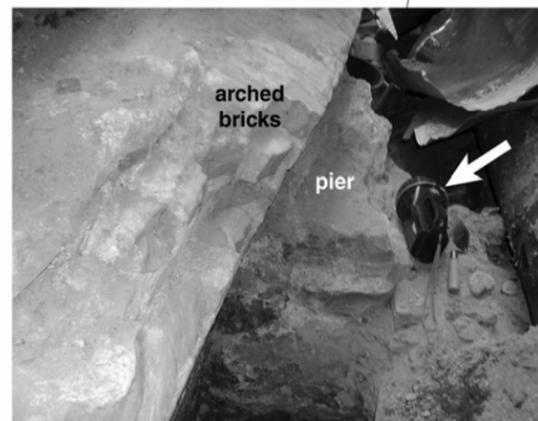
**c.** Arched brick remnant (left) with fragment of brick pier faced with mortar or cement seen from above (view is east). A flashlight lies on the broken pier (arrow). Remnants of the covering removed from the steam pipe that runs down center of the trench are in the upper right corner. (Geismar 5/10/05)

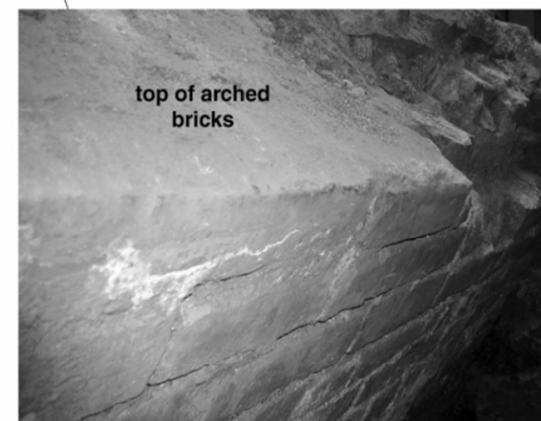
**d.** Detail of flat face of arched brick construction found above the stone wall exposed on the north side of the trench. (Spritzer 5/10/05)

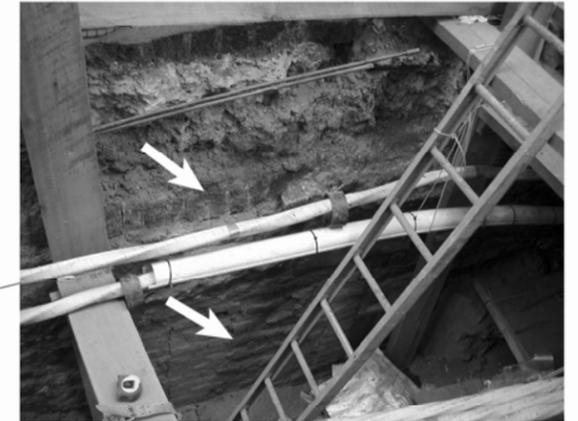
**g.** View of south wall from above. "Soldier" bricks (upper arrow) under fill are visible above encased live wires. A brick inset, apparently a sealed-off access, in the stone wall (lower arrow), is visible below the wires. (Geismar 5/10/05)

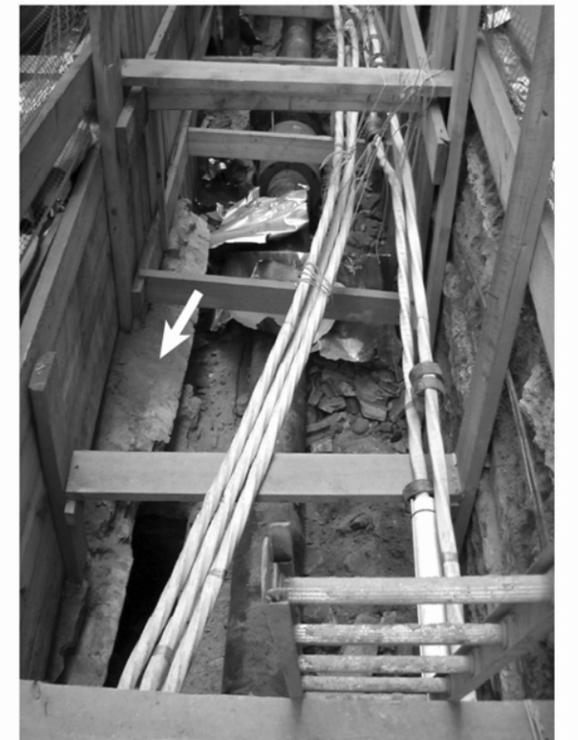
**h.** View of utility trench looking east from above. Note remnants of arched brick construction (arrow) above the north stone wall (not visible). (Geismar 5/10/05)

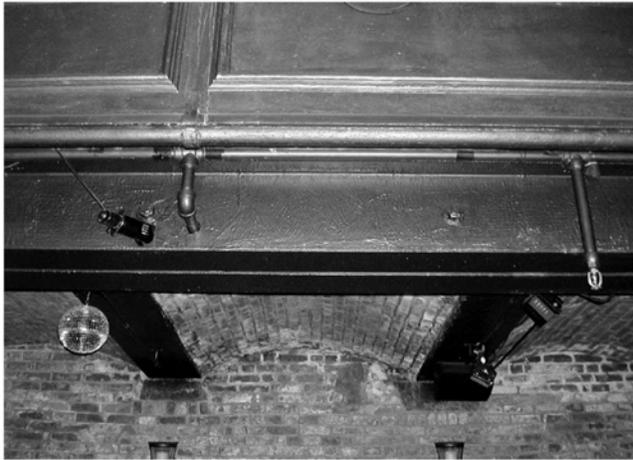
**10** Brick street vault, an extension of the basement in the City Hall Restaurant on Duane Street. The vault's arch, which runs perpendicular to a brick street wall, is shored by iron beams. The long steel beam seen in the upper foreground replaced cast-iron columns that originally supported the structure. (Geismar 5/19/05).

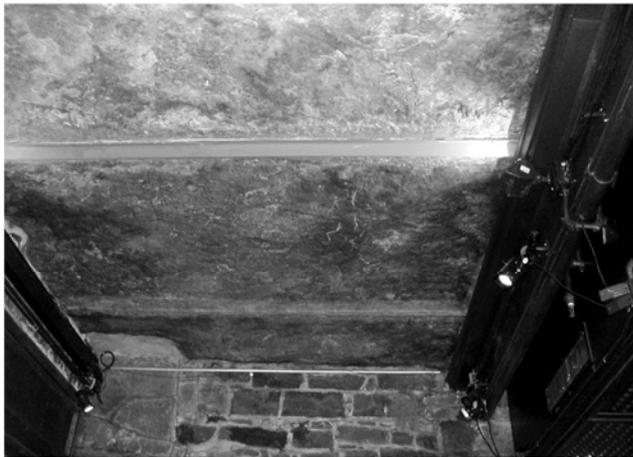
**11** Underside of the sidewalk exposed adjacent to the brick street vault seen in Figure 10. Here, too, steel beams were introduced to support the vault. Note the mortared stones of the end wall of the vault. (Geismar 5/19/05)

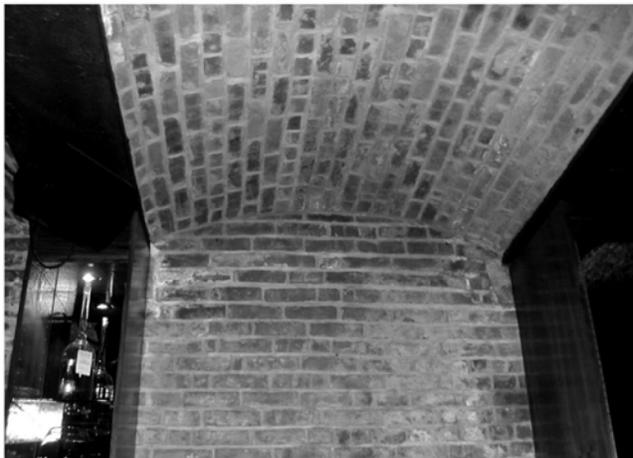
**12** Long view of the brick arch of the street vault now incorporated into the bar of the City Hall Restaurant on Duane Street. View is looking toward the brick street wall. Elements of the restaurant's downstairs bar are to the left. (Geismar 5/19/05)
