REPORT ON
ARCHAEOLOGICAL MONITORING
DURING FENCE POST EXCAVATIONS
ON THE EAST SIDE OF PROSPECT CEMETERY
ALONG 159TH STREET
IN JAMAICA, QUEENS, NEW YORK

September 20, 2005

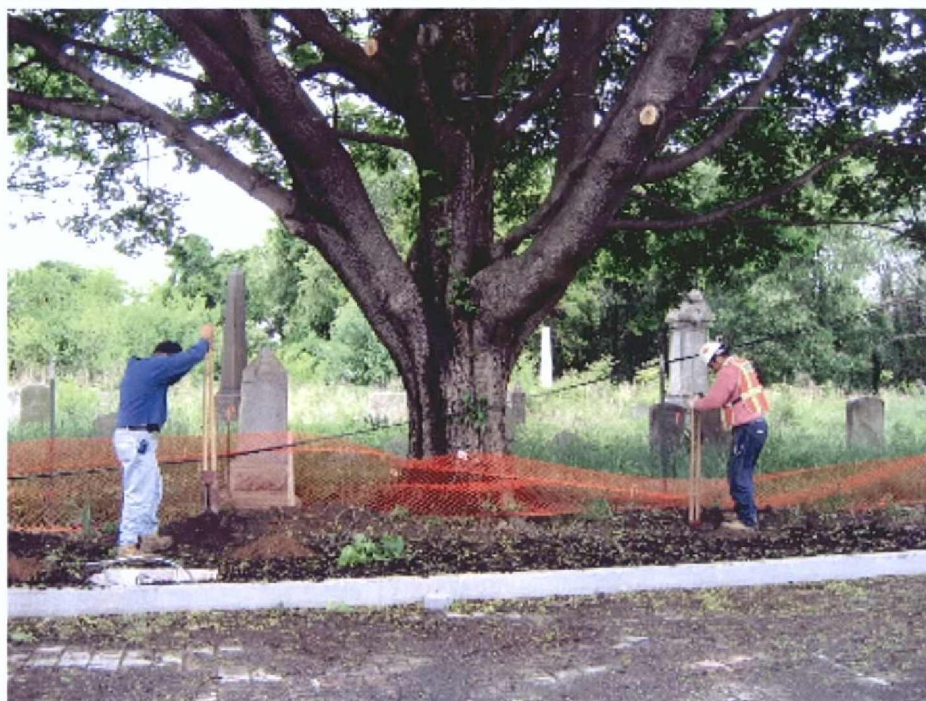
Contractor excavations of Post Holes 13 and 16 at Prospect Cemetery along 159th Street facing west.

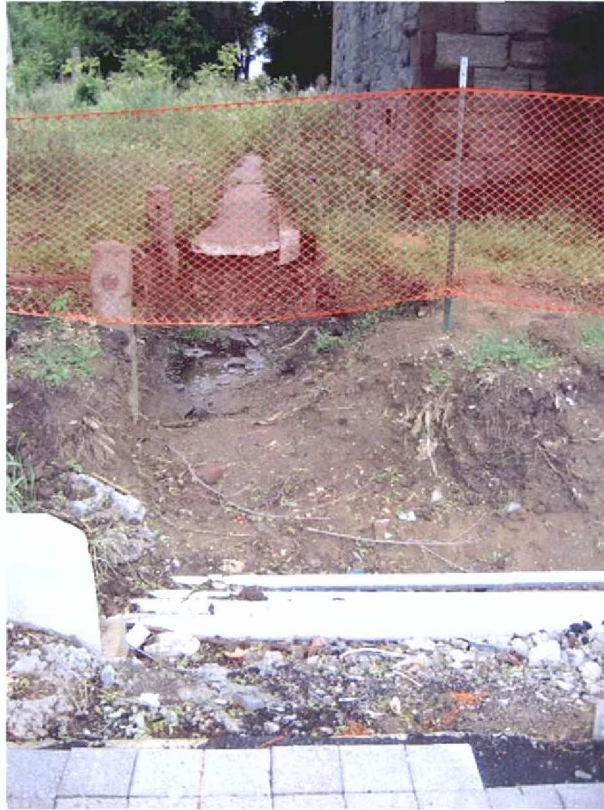
Photo 1 View of site conditions at start of monitoring on the south side of the chapel.

Upon arrival to commence monitoring, a walkover immediately revealed that excavations for the curb to the south of the chapel had been completed prior. Photo 1 shows the conditions at that time. The rain washed edges of the trench can be seen through the plastic mesh safety fence in the photo. The trench base and profiles were examined to determine if any bones were visible, indicating disturbed burials. None were seen.

Several PVC pipes are seen in the foreground of Photo 1. A wider view of the excavations for these pipes is seen in Photo 2. The pipe trench is relatively shallow, less than one foot below ground surface, and to the east of the line of the new fence, partially within the area of bluestone excavations. The pipes were installed as part of the wider road improvements for 159th Street and were not part of the fence project. However, the areas disturbed by the pipe trench were also examined for evidence of human remains and none were found.
