**New York City
Department of Environmental Protection
South Richmond Drainage
Storm Water and Sanitary Drainage Plan**

South Shore Golf Course Drainage Area

**Phase 1B Archaeological Field
Testing of BMP-SG-1 Pond Street
Staten Island, New York**

**Author:
James Cox, M.A.**

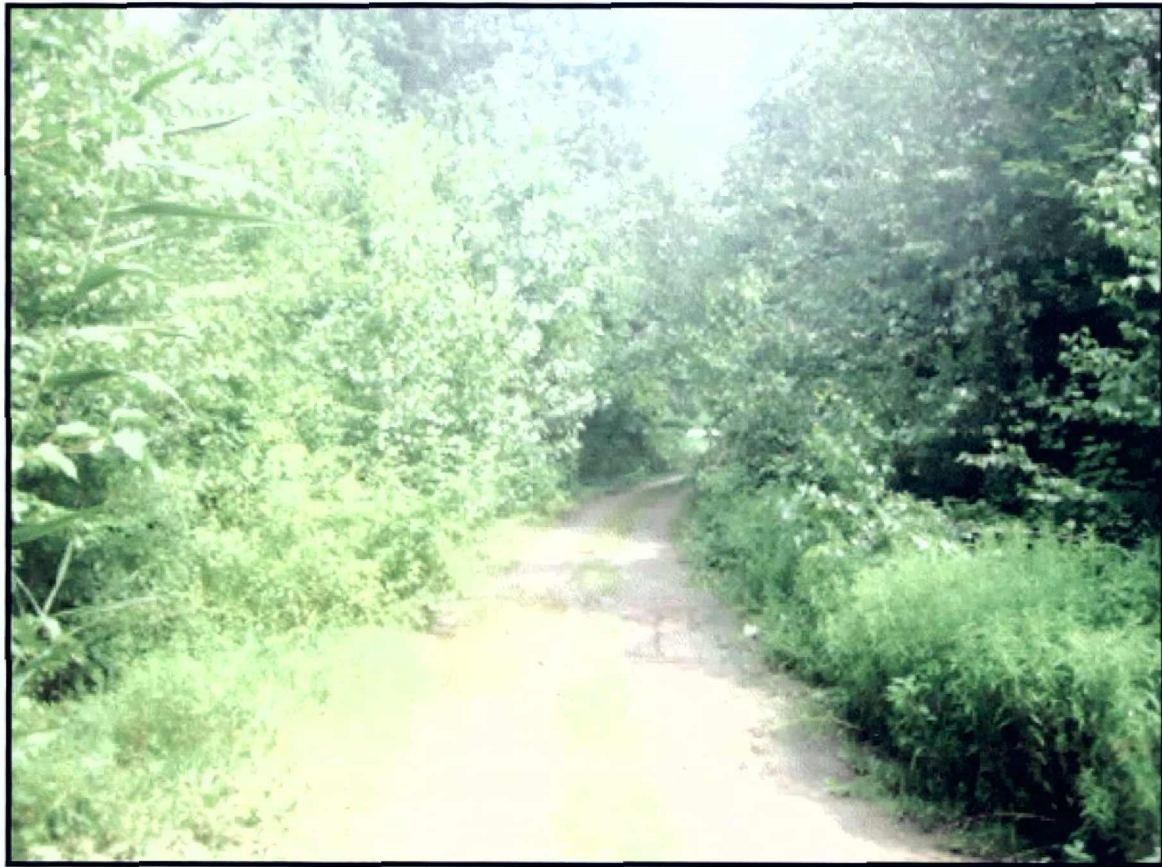
Plate 1. Southeastern Boundary of Project Area Looking Northeast, Dirt Road, July 18, 2005. Photographer: James Cox.

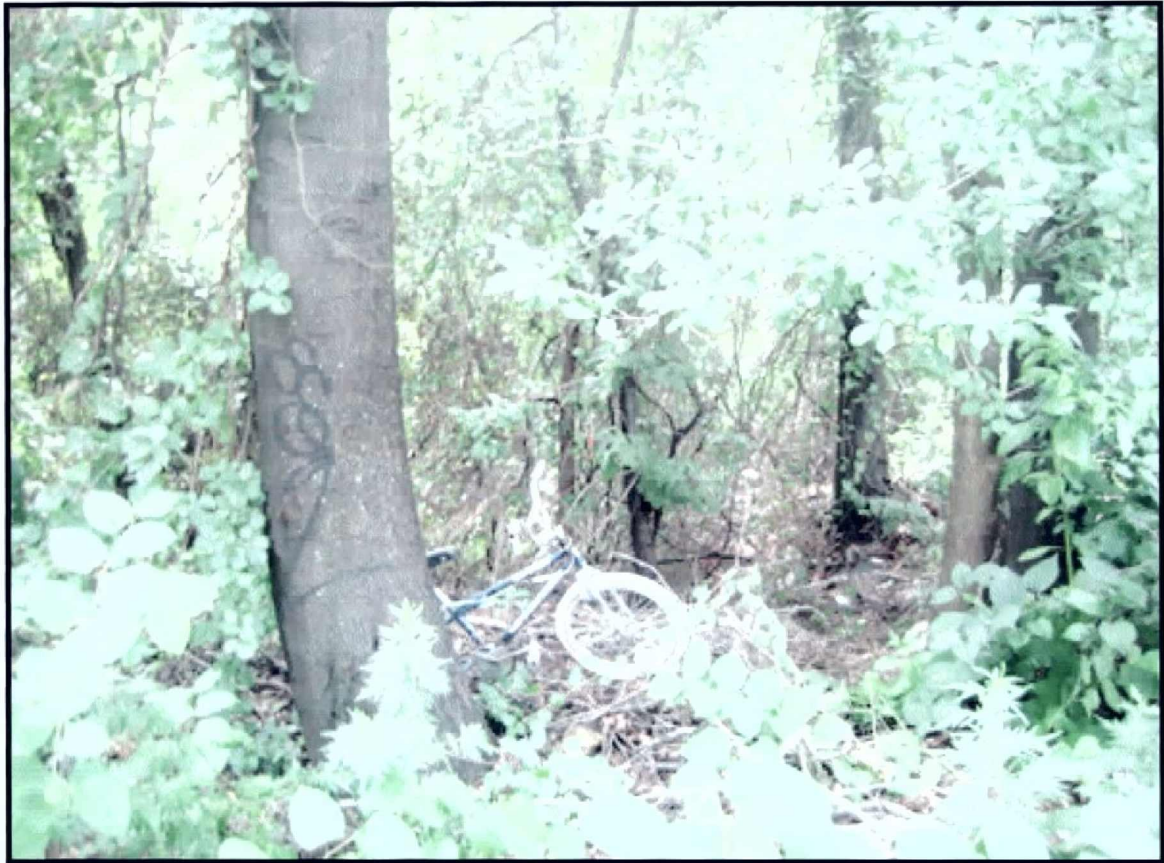
Plate 2. Southwestern Boundary of Project Area, July 18, 2005. Photographer: James Cox.

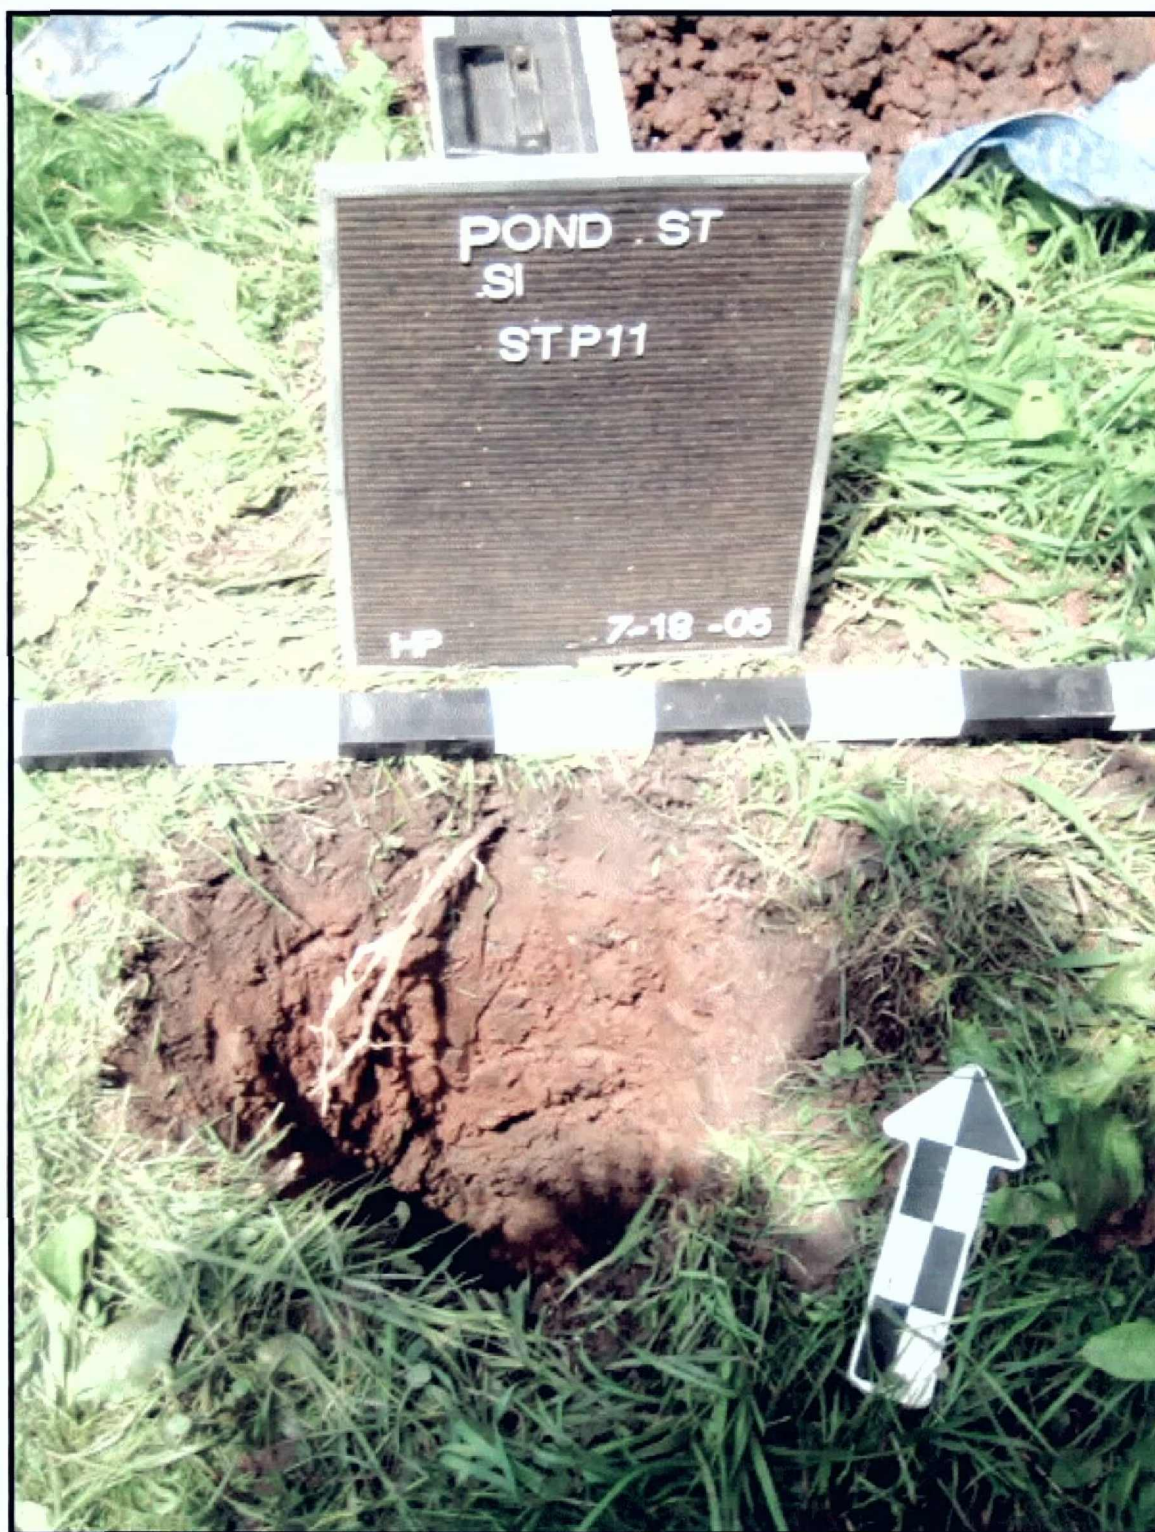
The southern portion of the project area was extremely wet (STPs 5-8). A portion of the northern section of the project area appeared to be composed of fill (STP 9-13) with some historic artifacts coming from buried horizons representing dumping episodes. STP 11 yielded historic materials from a buried yard deposit overlaid by 47 centimeters of fill. The yard deposit from STP 11 (Plate 3) produced non-diagnostic historic materials. STP 12 did not appear to contain a buried A Horizon, but was instead composed of fill (0-12 cm) overlaying two layers of historic yard deposits/dumping episodes (Layer 2, 20-23 cm; Layer 3, 23-44 cm). These dumping episodes/cultural processes are still evident today from the amount of loose modern trash scattered across the site. The historic dumping episodes are likely the result of similar actions. Area residents appear to have utilized the project area as an informal dump for the past several years and can be used as an analog for historic period processes.

Plate 3. Shovel Test Pit 11 looking north. Photographer: James Cox.

Historic artifacts were gathered from STPs 3, 10, 11, 12 and 14; modern trash was found in STPs 1, 5 and 10 (Table 1 and 2). STP 3 contained historic materials found in the second horizon. STP 10 Level 1 contained a plastic wrapper mixed in with historic whiteware (1820-1900) and yellowware (1820-1900) ceramics and other materials. STP 10 Level 1 likely represents modern deposition because of the presence of the plastic wrapper and is therefore not an intact historic horizon. STPs 11 and 12 yielded historic 19th century artifacts from buried yard deposits/horizons (STP 11 and 12). STPs 11 and 12 likely represent historic late-19th to early-20th century dumping episodes similar to those evident today. STP 14 Level 2 yielded one piece of undecorated curved glass.
