**STAGE 1B  
ARCHAEOLOGICAL  
FIELD SURVEY**

**32-40 BOND STREET  
MANHATTAN, NEW YORK**

**Historical Perspectives, Inc.  
P.O. Box 3037  
Westport, CT 06880**

**November 2005**

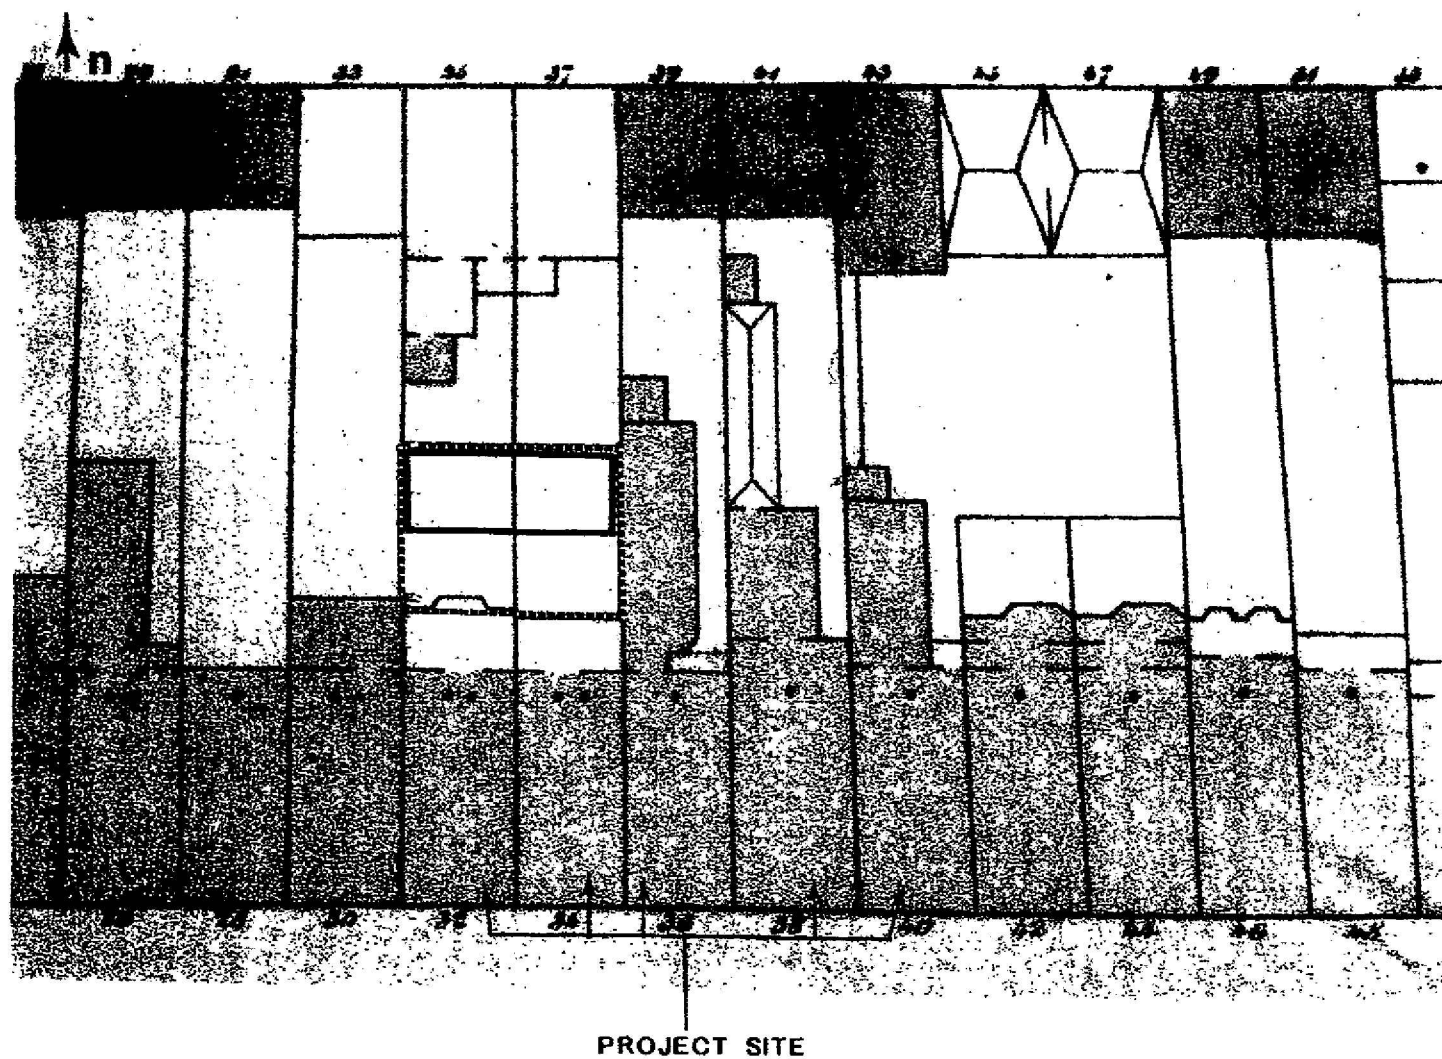
**Figure 2. Archaeological Sensitivity.**

----- Area of Archaeological Sensitivity (from Perris, 1857)

—— Location of Proposed 50 x 20 foot Test Trench

The Stage 1A Archaeological Assessment identified a section of the project site as sensitive for historical resources (HPI 2003; see Figure 2). A visual inspection found that majority of the ground surface within the project site was covered by asphalt.

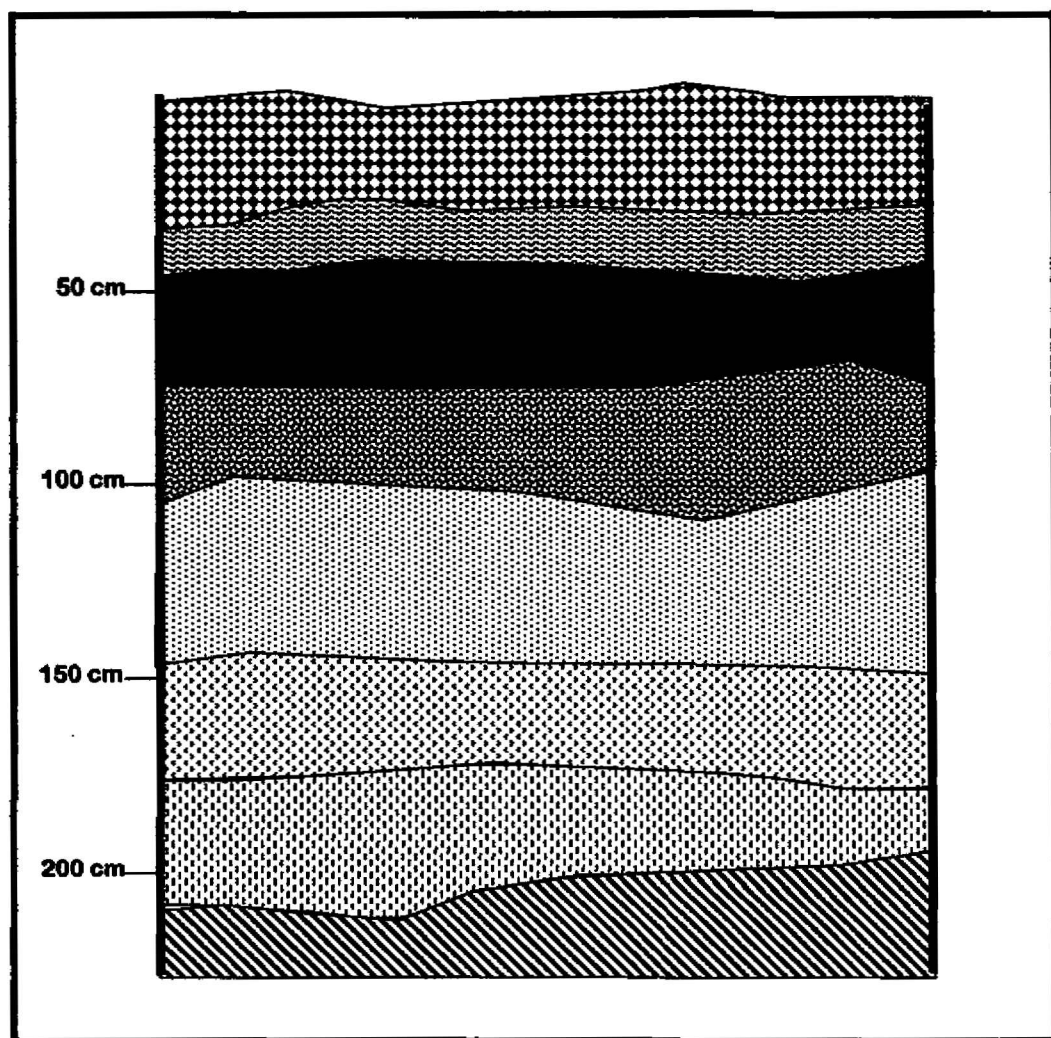
Figure 4. Soil Profile of Trench A.

Excavation revealed seven distinct soil layers in this location (Figure 4; Photograph C). Four of these layers were associated with various fill episodes. The fill encountered appeared to be associated with the twentieth century demolition episodes that took place in the project site and possible filling activities that took place to create a level surface for the asphalt parking layer.

Level	Depths	Description
1	0-35 cm	Sand and gravel fill with modern trash
2	35-45 cm	Dark gray fill and gravel with demolition debris (concrete, iron pipes)
3	45-76 cm	Dense layer of bricks and concrete debris
4	76-100 cm	Dark brown to black coarse sand/ash fill mixed with architectural debris, modern bottles (coke), electrical wire, asphalt, tar roofing fragments, safety glass
5	100-150 cm	Dark grayish brown (10YR 3/2) to brown (10YR 4/3) silty sand (Buried A Horizon).
6	150-180 cm	Mottled yellowish brown (10YR 4/6) coarse sand subsoil
7	180-201 cm	Brown (10YR 3/4) moist fine sand subsoil

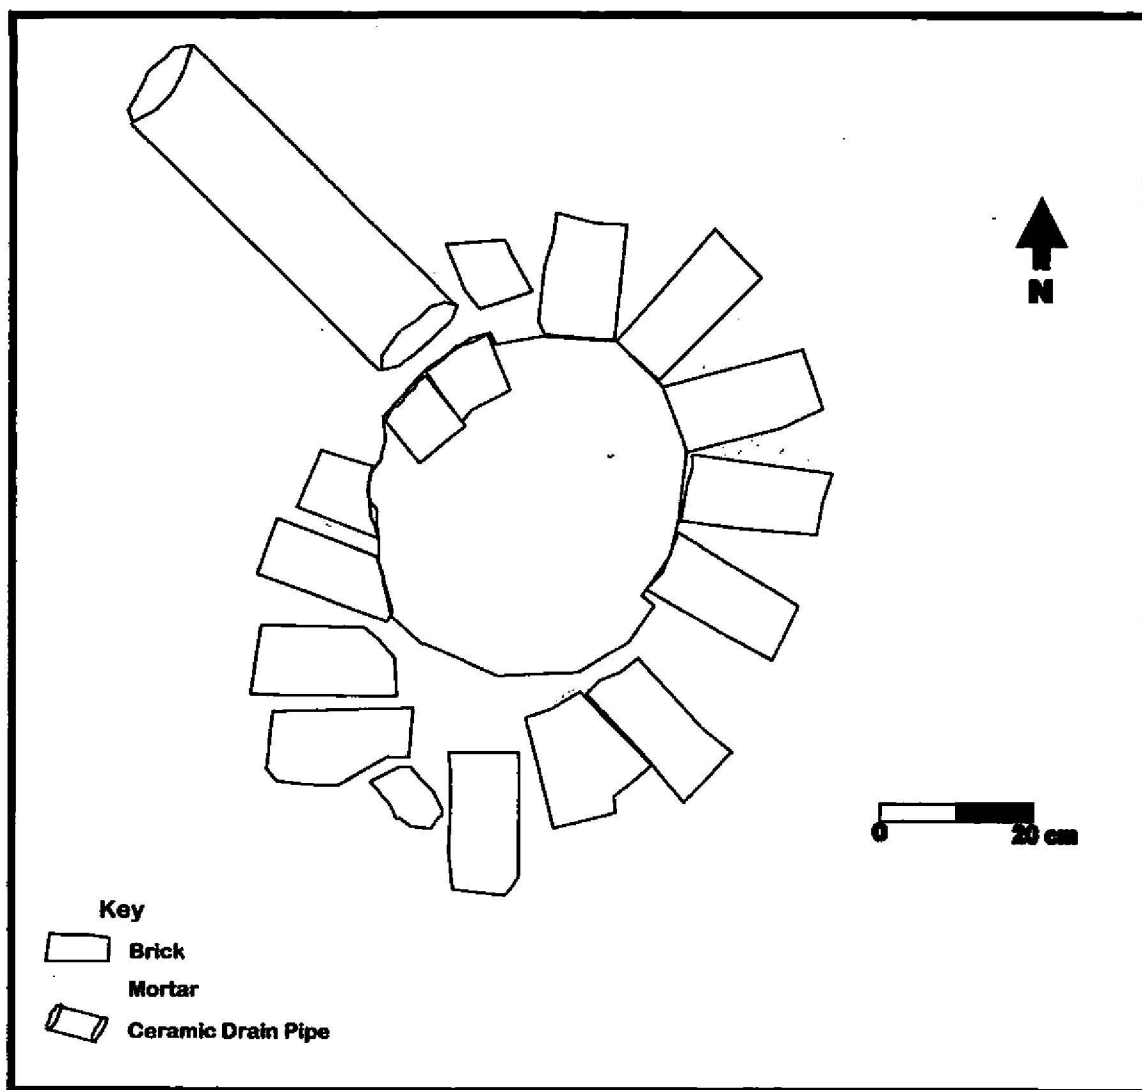
Figure 5. Plan of the top of the Brick Dry Well at 32 Bond Street.

After clearing the remaining portion of the center of the back lot within the trench, the top of a brick water-management feature was exposed. A small metal plate that was moved when the area was cleared during machine excavation may have covered the surface of the feature. The top of the shaft was approximately 18" wide and had a ceramic drain pipe leading into the opening (Figure 5, Photograph E). The three-inch pipe was located on the surface of the buried "A horizon." Excavation exposed a brick bottle-shaped shaft feature (see Figures 5 and 6; Photographs E-G).

The southern side of the feature was carefully removed to enable excavation of the interior. Only the bottom of the feature was filled. The interior was bisected and all soils screened. Only a small number of artifacts were recovered, the majority dating from the late nineteenth through early twentieth centuries (see Appendix). Most of the artifacts were small in size (many less than .25" x .25"), indicating that they may have entered into the feature through the drainage pipe or through a small opening at the surface. Earlier artifacts in the interior assemblage number less than 15 (e.g., four pipe bowl fragments, eight cream-colored ceramic sherds). Numerous bricks spalls, unidentified metal and ceramic drainage pipe fragments were also noted). The artifacts likely fell into the feature through the narrow top. The interior was not mortared and there was no floor present at the base. No pipes were found intersecting with the feature below-ground. It is likely that the late nineteenth century feature was used for drainage in the rear yard.

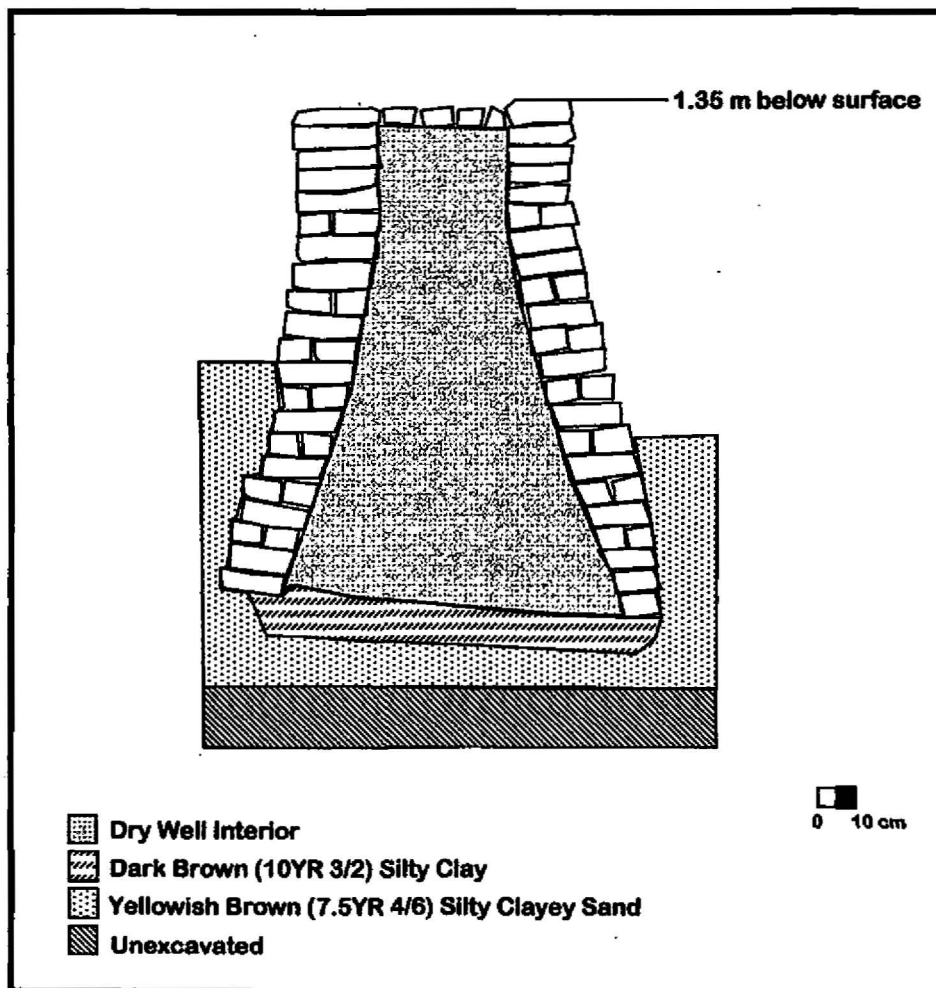
Figure 6. 32 Bond Street, Trench A, Section of Brick Dry Well.

The feature was not filled when it had outlived its purpose. Instead, it appears that the entire yard was filled when the building was razed and the top of the feature was covered. The dry well was encountered at a depth of 1.35 meters beneath the surface and the base of the feature extended to a depth of 2.8 meters. In order to excavate to the base of the feature the trench was canted and benches were created for stability. Excavation was halted approximately 60 cm below the feature (Photograph G).

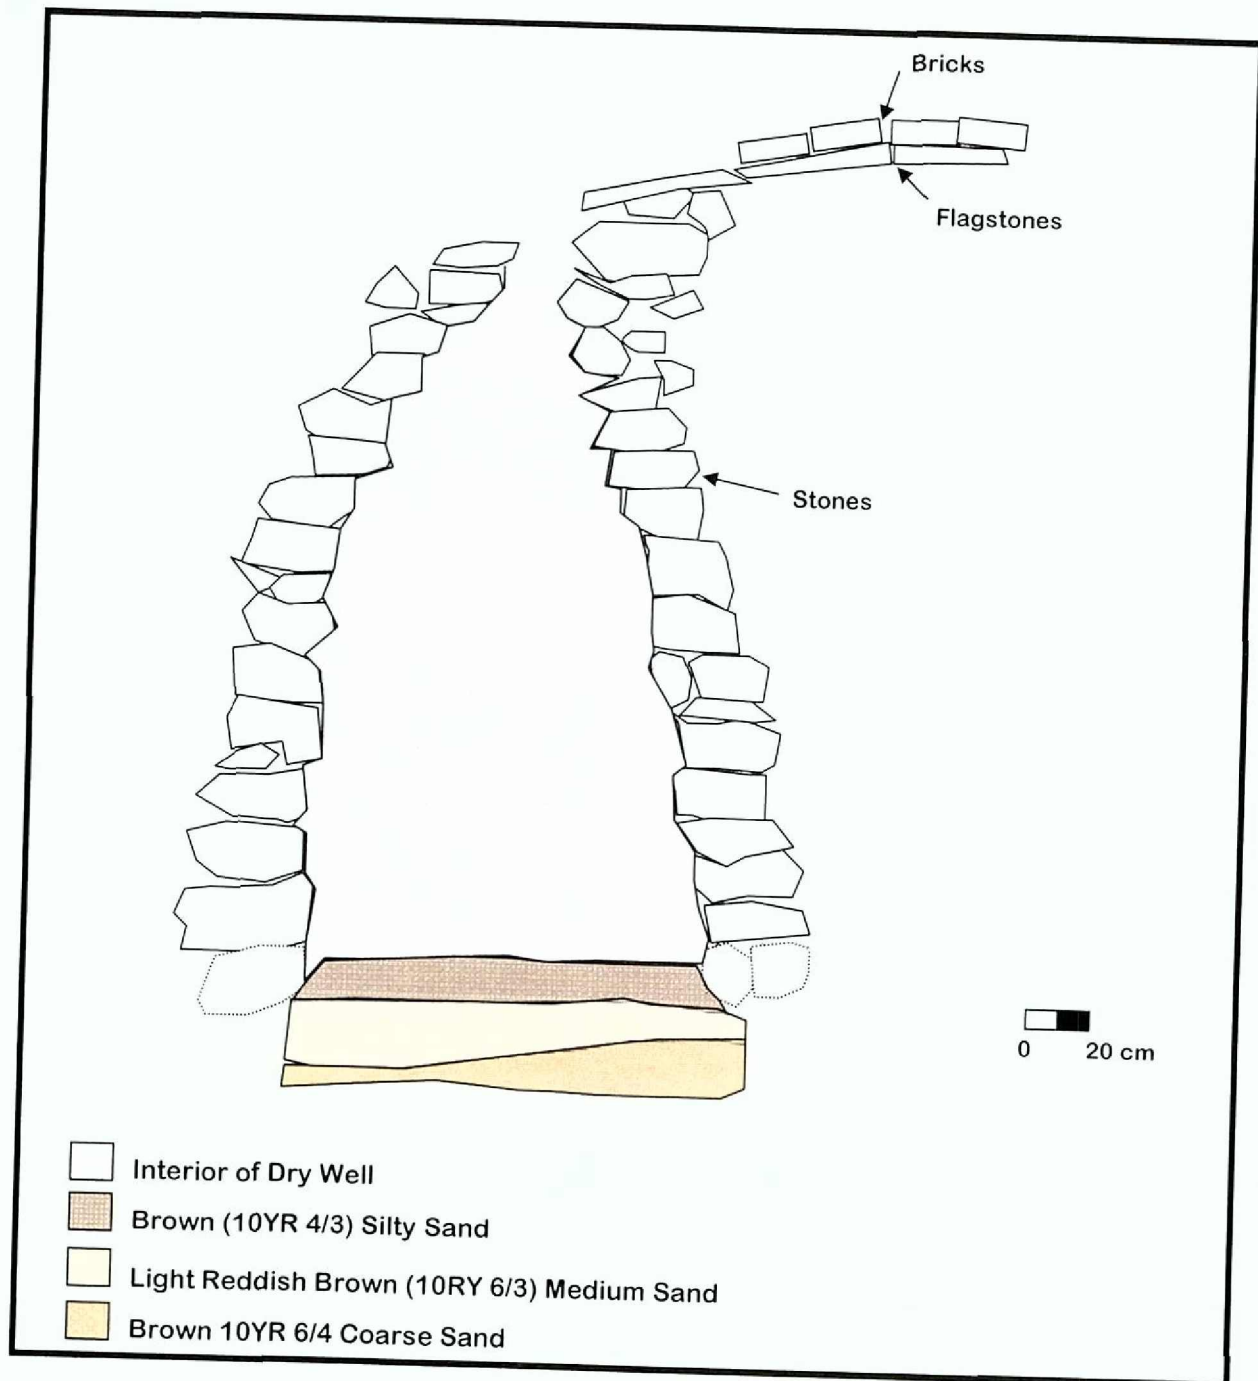
Figure 7. 34 Bond Street, Section of Stone Dry Well.

The drainage pad was made up of an inclined flagstone base with brick side walls directing the water down into the stone dry well (see Figure 7). Excavators carefully removed the flagstones and bricks and the thin layer of soil below the drainage pad. No artifacts were recovered from beneath the drainage pad. Subsoil was encountered approximately 15-20 cm beneath the flagstones.

The top of the stone shaft feature was approximately 50 cm (just over 19 inches) wide (see Photographs K and L). Excavation exposed a stone bottle-shaped shaft feature. The southern side of the feature was carefully removed to enable excavation of the interior. Similar to the brick drainage feature in the adjacent lot, a void was present near the top of the feature and levels of soil fill were found near the base. The interior was bisected and all soils screened. Four distinct soil layers were encountered within the feature. Less than 75 artifacts, dating from the late nineteenth through the early twentieth centuries, were recovered (35 were small fragments of mammal bone). As with the drainage feature found in the adjacent lot, the artifacts recovered from the interior were small in size. In addition, a number of architectural fragments were noted (e.g., brick spalls, unidentified metal, sewer pipe, and concrete). The interior was not mortared and there was no floor to

the feature. It is likely that this feature was also used for drainage in the rear yard of this lot. The top of the feature was encountered approximately 1.62 meters from the surface and the base extended to a depth of 3.32 meters (see Figure 7; Photograph L). The sidewalls were canted and benches were established for support and stability during the excavation of this feature.

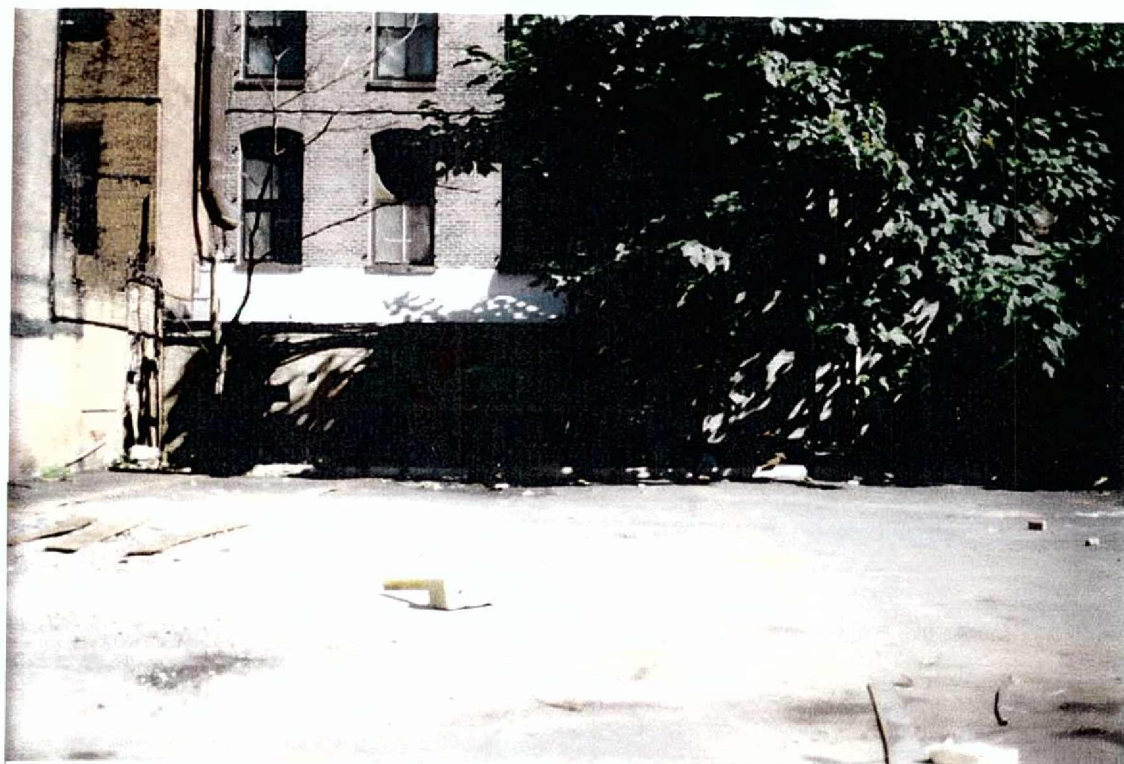
Photograph A. Photograph of the location of Test Trench A Prior to Excavation.

The proposed development of 32-40 Bond Street (Block 530, Lot 48; see Figure 1) necessitated the completion of Stage 1A and Stage 1B archaeological surveys. The project Block (530) is bounded to the north by Great Jones Street, to the east by Bowery, to the south by Bond Street, and to the west by Lafayette Street. Modern Lot 48 is comprised of five historic lots on the south side of the block fronting onto Bond Street (formerly 32-40 Bond Street). At present, the project site is a paved parking lot (Photographs A-B).

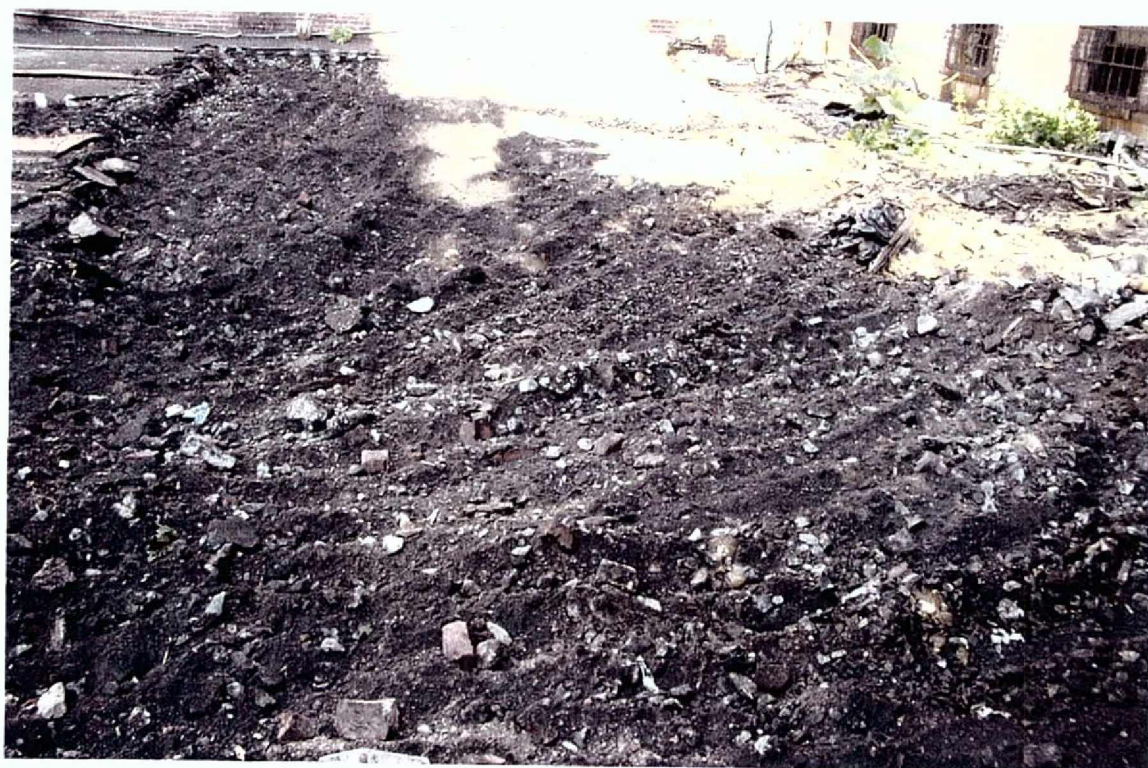
Photograph B. View of the 32-40 Bond Street Project Site, facing west.

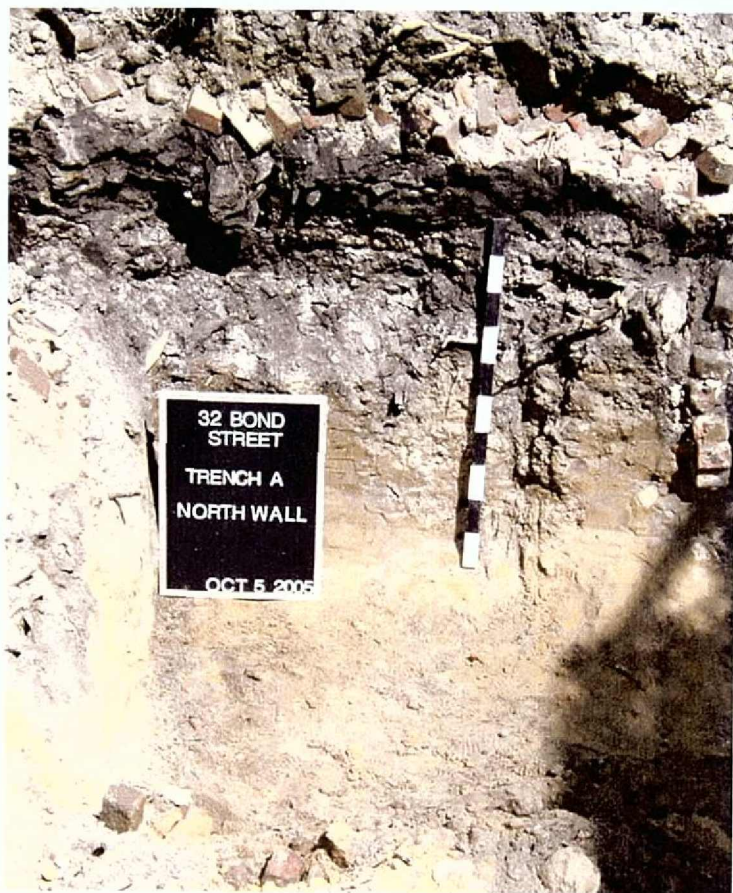
Photograph C. North Wall of Trench A, 32 Bond Street.

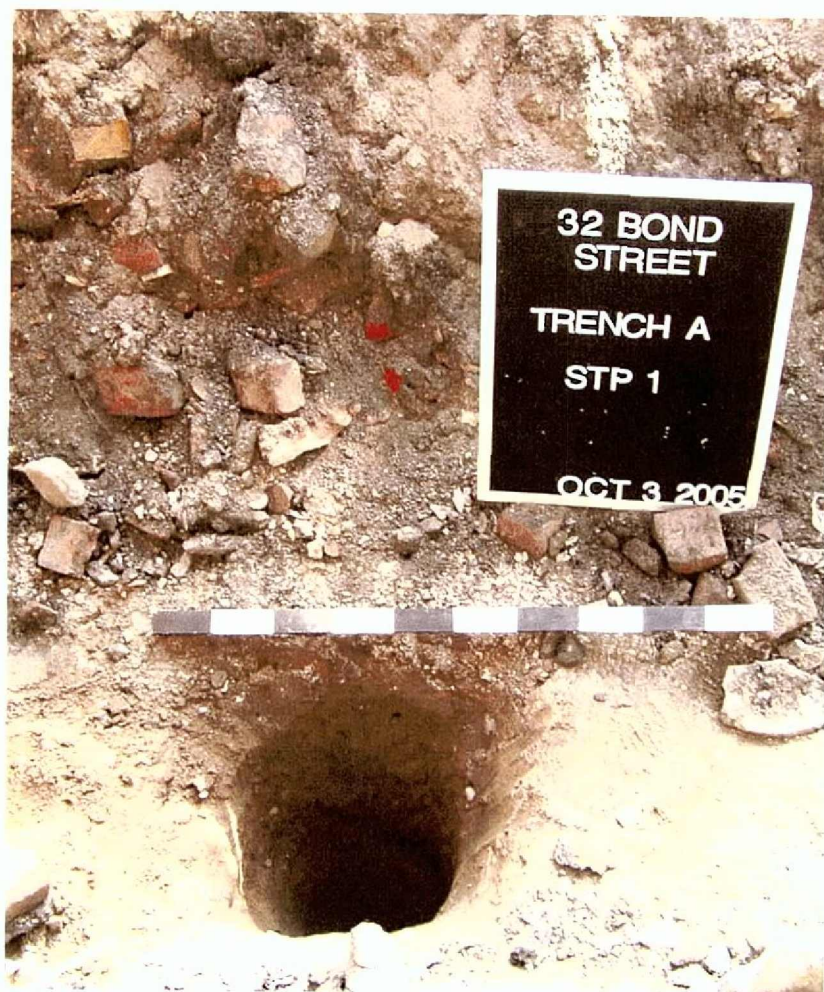
The former yard surface was exposed in a very limited area (approximately 3 x 2.5 meters/10 x 8 feet). In one location an ash deposit was observed at the interface with the buried A-horizon, just north of the former basement foundation. Ash deposits are often identified with nineteenth century features, as it was typical to use this type of prevalent “trash” to fill and/or cover abandoned shafts. STP 1 was placed in this location to determine the depth of the ash and the potential presence of any features (see Figure 3). Excavation revealed that the ash was only a thin lens at the interface between the fill and the buried “A horizon.” The buried ground surface was identified as a brown (10YR 3/2-10YR 4/3) silty sand that contained a mixture of historic artifacts, typical for yard scatter. No significant numbers of diagnostic or datable materials were recovered. Instead, the assemblage mostly included very small fragments of undecorated whiteware, window glass, corroded and unidentified nails, and small pieces of machine made bottles (see Appendix). Excavation was halted when subsoil was encountered about 1.5 m below the present surface (Photograph D).

Photograph D. 32 Bond Street, Trench A, Shovel Test Pit 1.

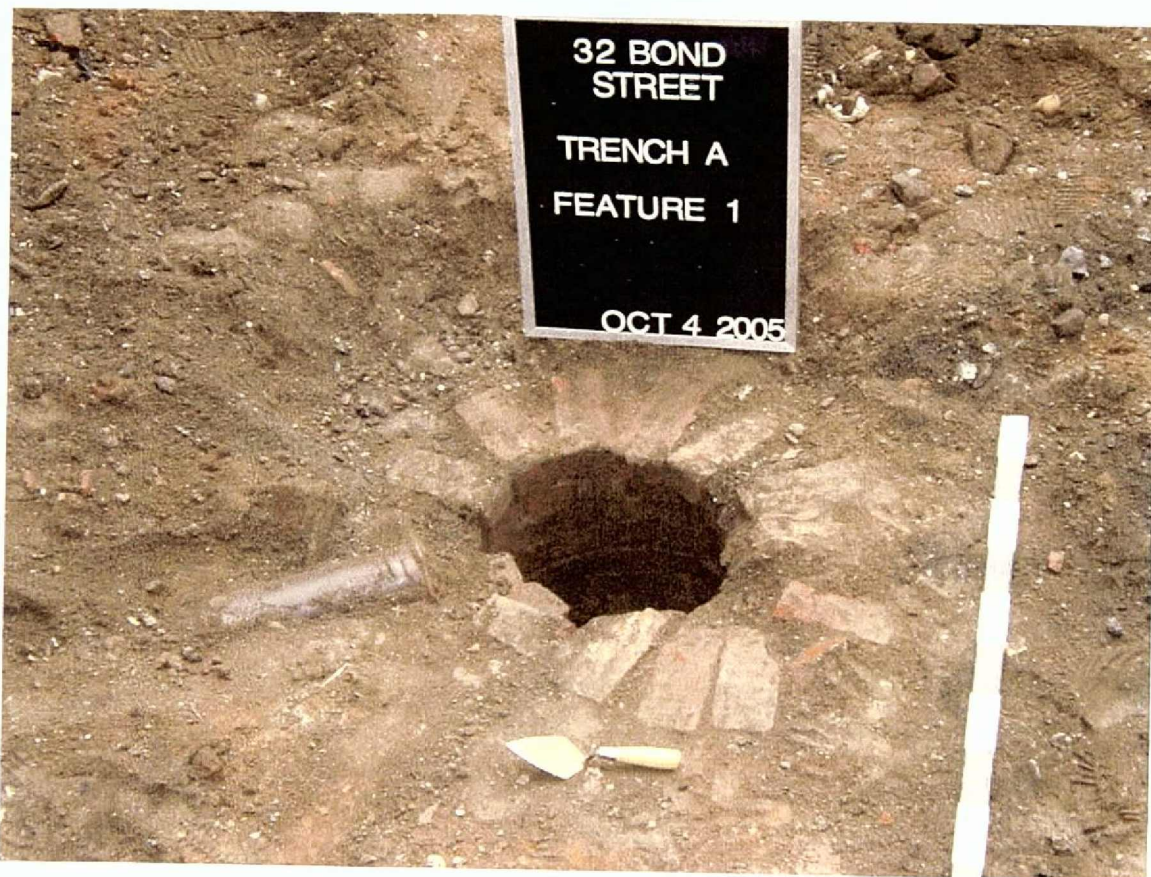
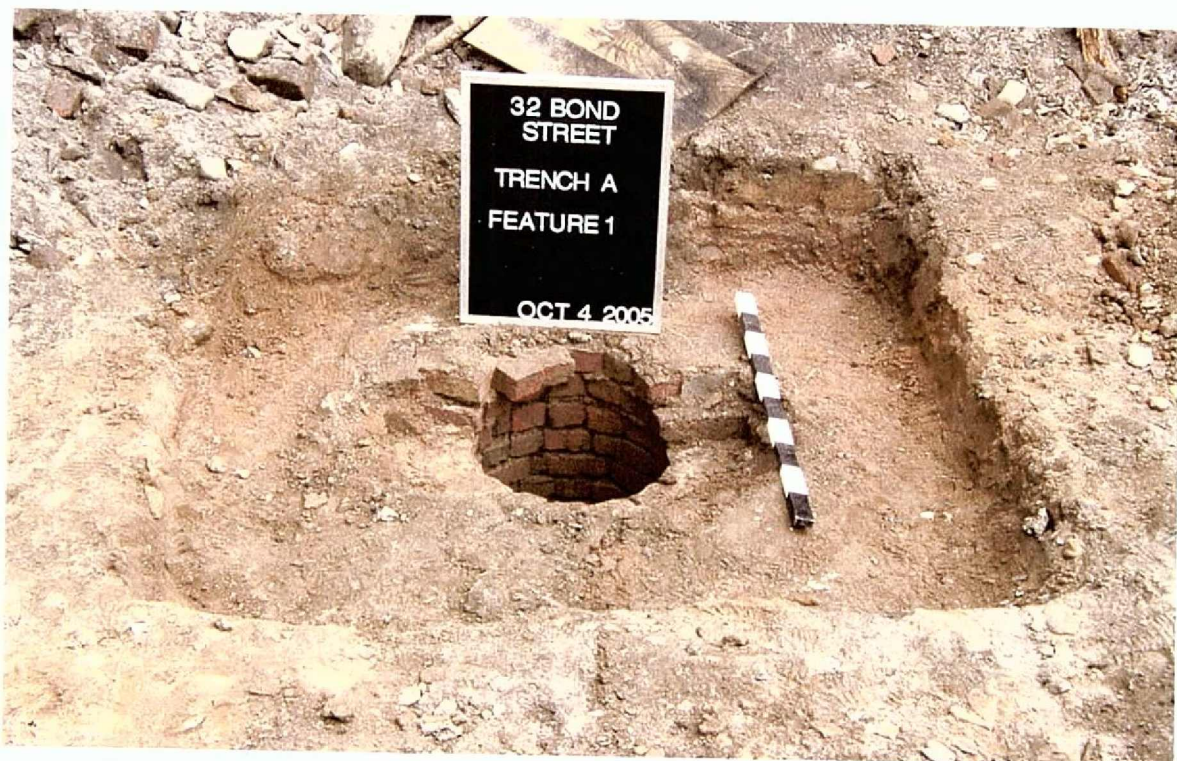
Photograph E. 32 Bond Street, Trench A, Brick Dry Well.

Photograph F. 32 Bond Street, Trench A, Brick Dry Well.

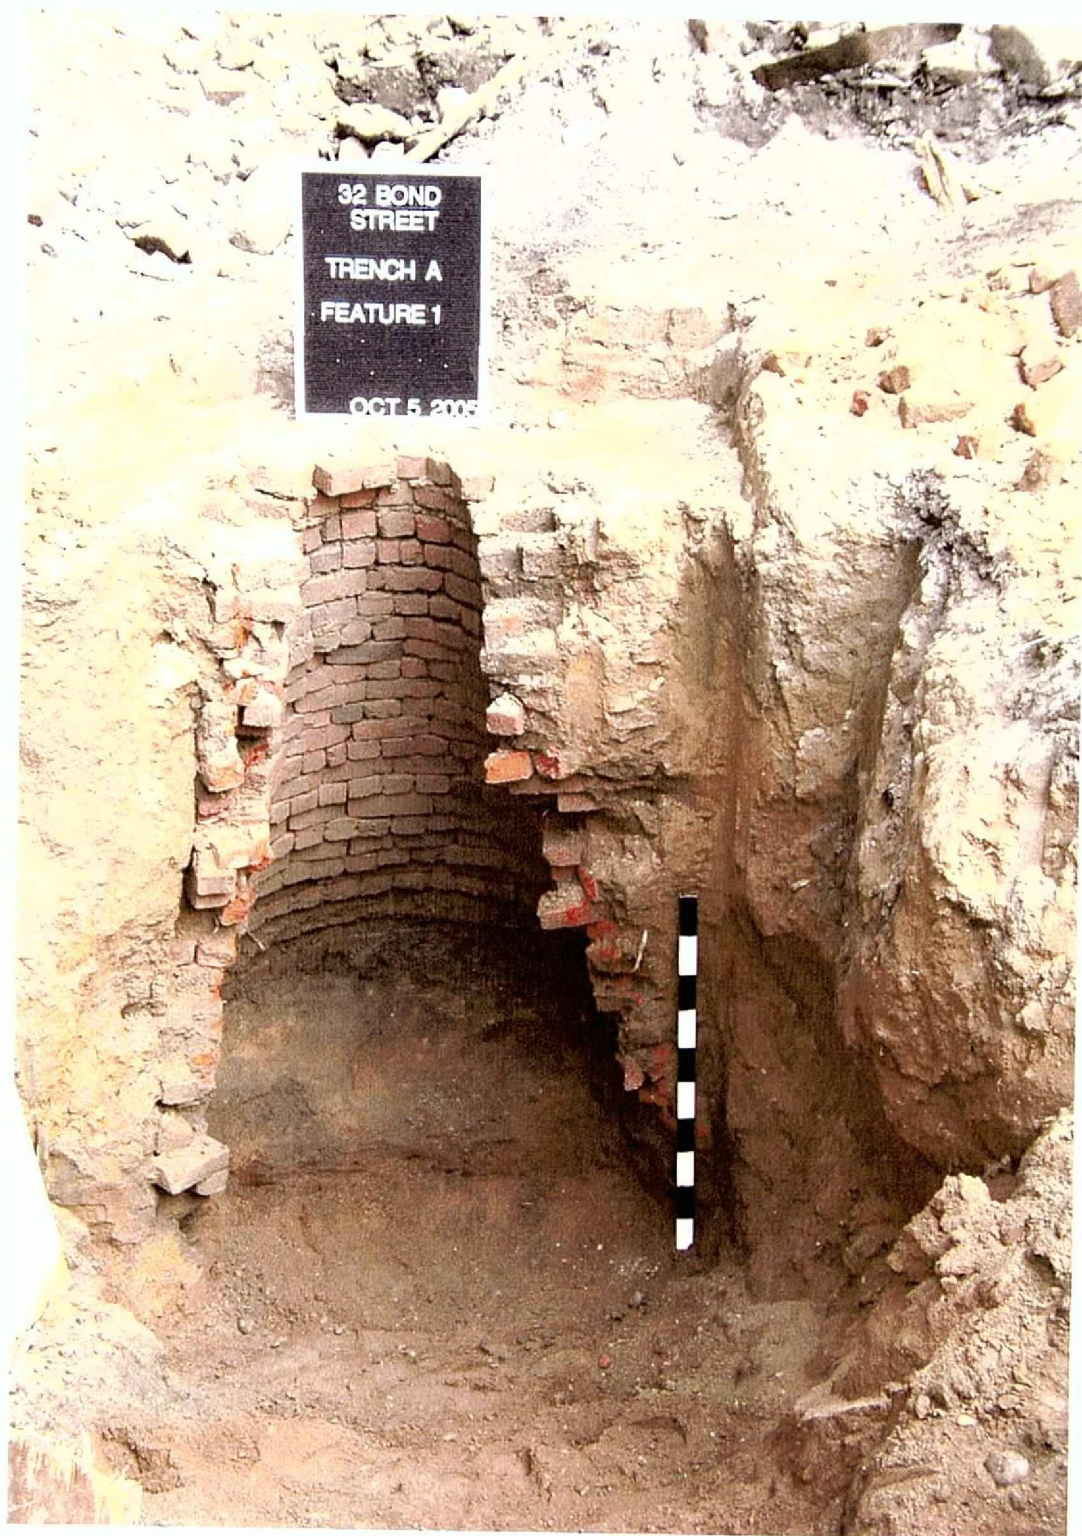
Photograph G. 32 Bond Street, Trench A, Brick Dry Well, Final.

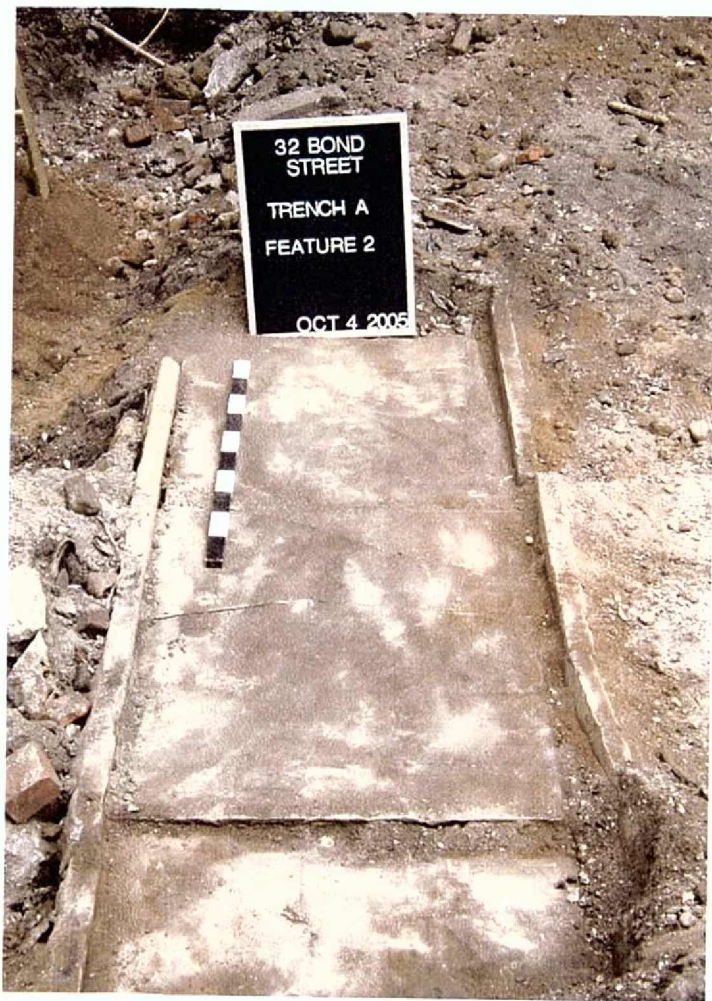
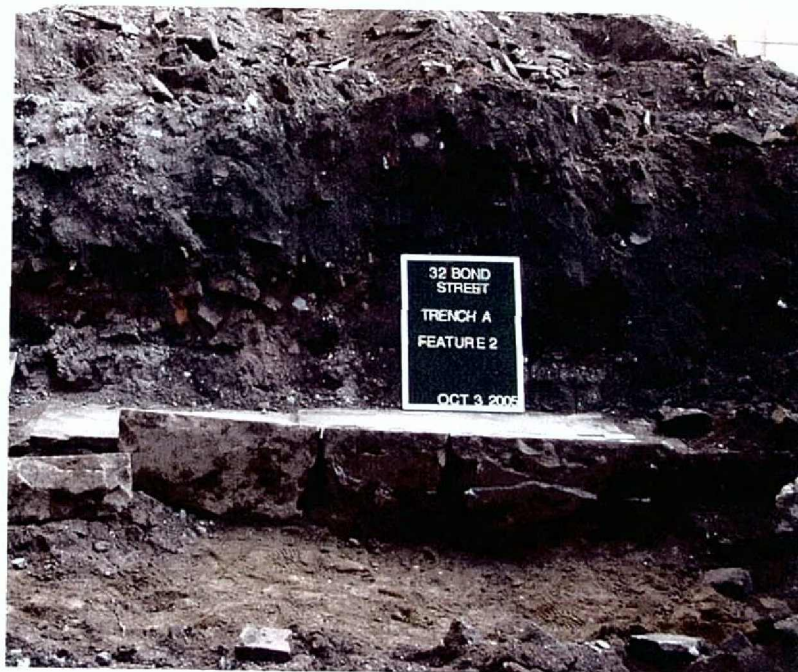
Approximately 60 centimeters from the eastern edge of the former back lot, Feature 2, a flagstone path (running N-S), was encountered at a depth of about 40 centimeters below the surface (Photograph H). The installation of the path had disturbed the buried "A" layer. The fill above the pathway contained a variety of twentieth-century architectural debris as well as fragments of modern bottles, plastic fragments, roof shingles, and several large fragments of modern plumbing fixtures. The flagstones were lifted and no artifacts were recovered from the soils beneath them. During testing, it was discovered that each of the flagstone pathways had thick stone sidewalls that were raised approximately 10 cm above the surface of the paths that they bordered (Photograph I).

Photograph H. 32 Bond Street, Trench A, Flagstone Path.

Photograph I. 32 Bond Street, Trench A, Flagstone Path.

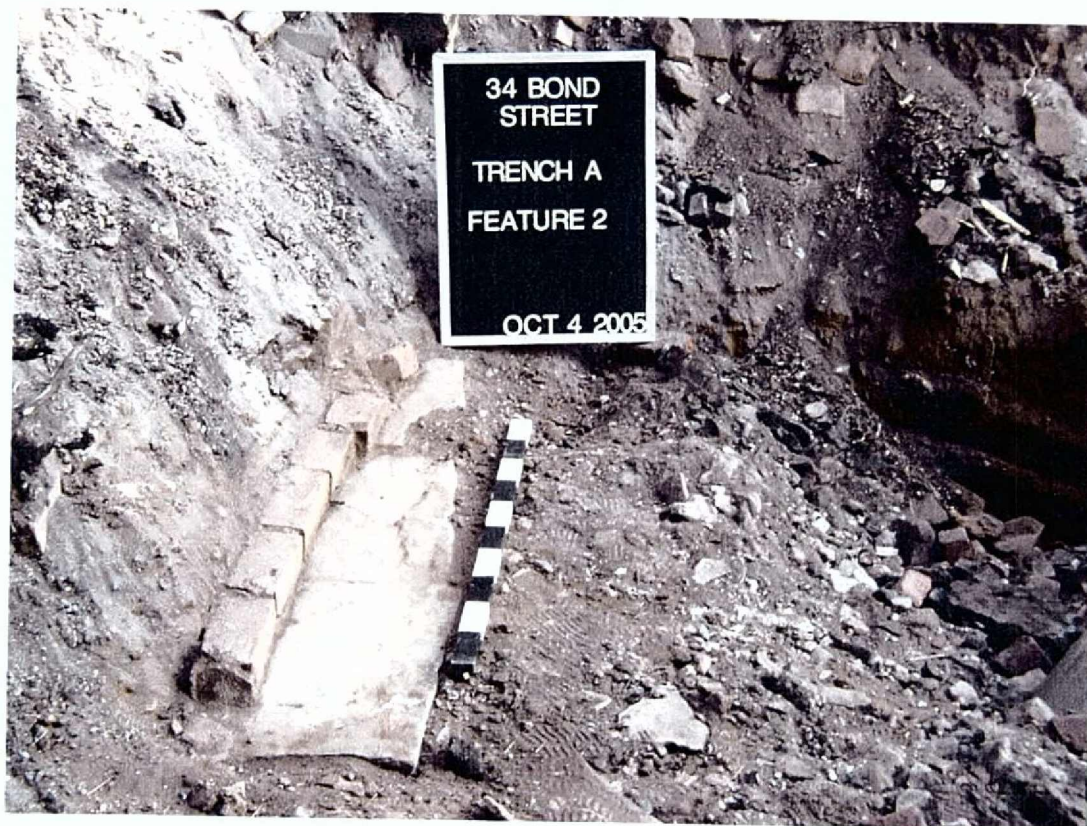
Traces of a brick and cinder block foundation were present at the edges of the concrete floor. Four distinct soil layers were found above the concrete floor and four strata were found beneath it. The machine excavator removed the floor and found that throughout the majority of the rear lot only a thin layer of fill/architectural debris was present above subsoil. At the northern end of the trench, approximately three feet from the lot line, two features were encountered (Photographs J-L).

Photograph J. 34 Bond Street, Trench A, Drain.

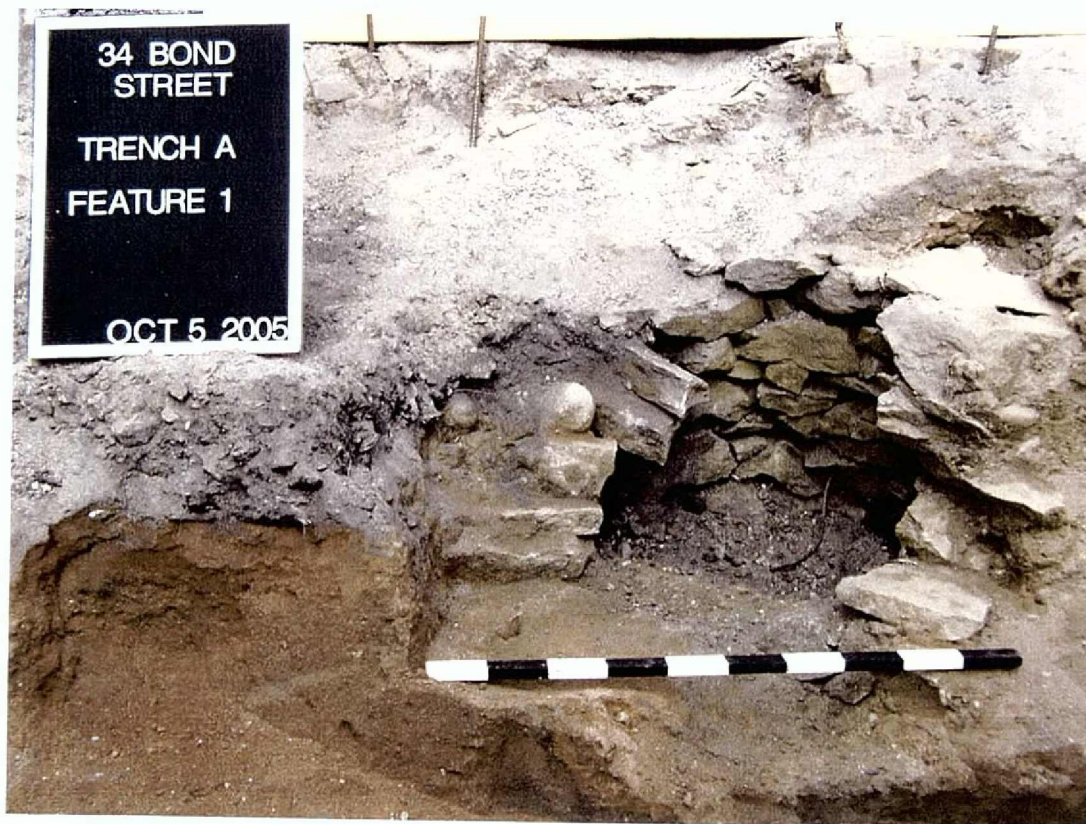
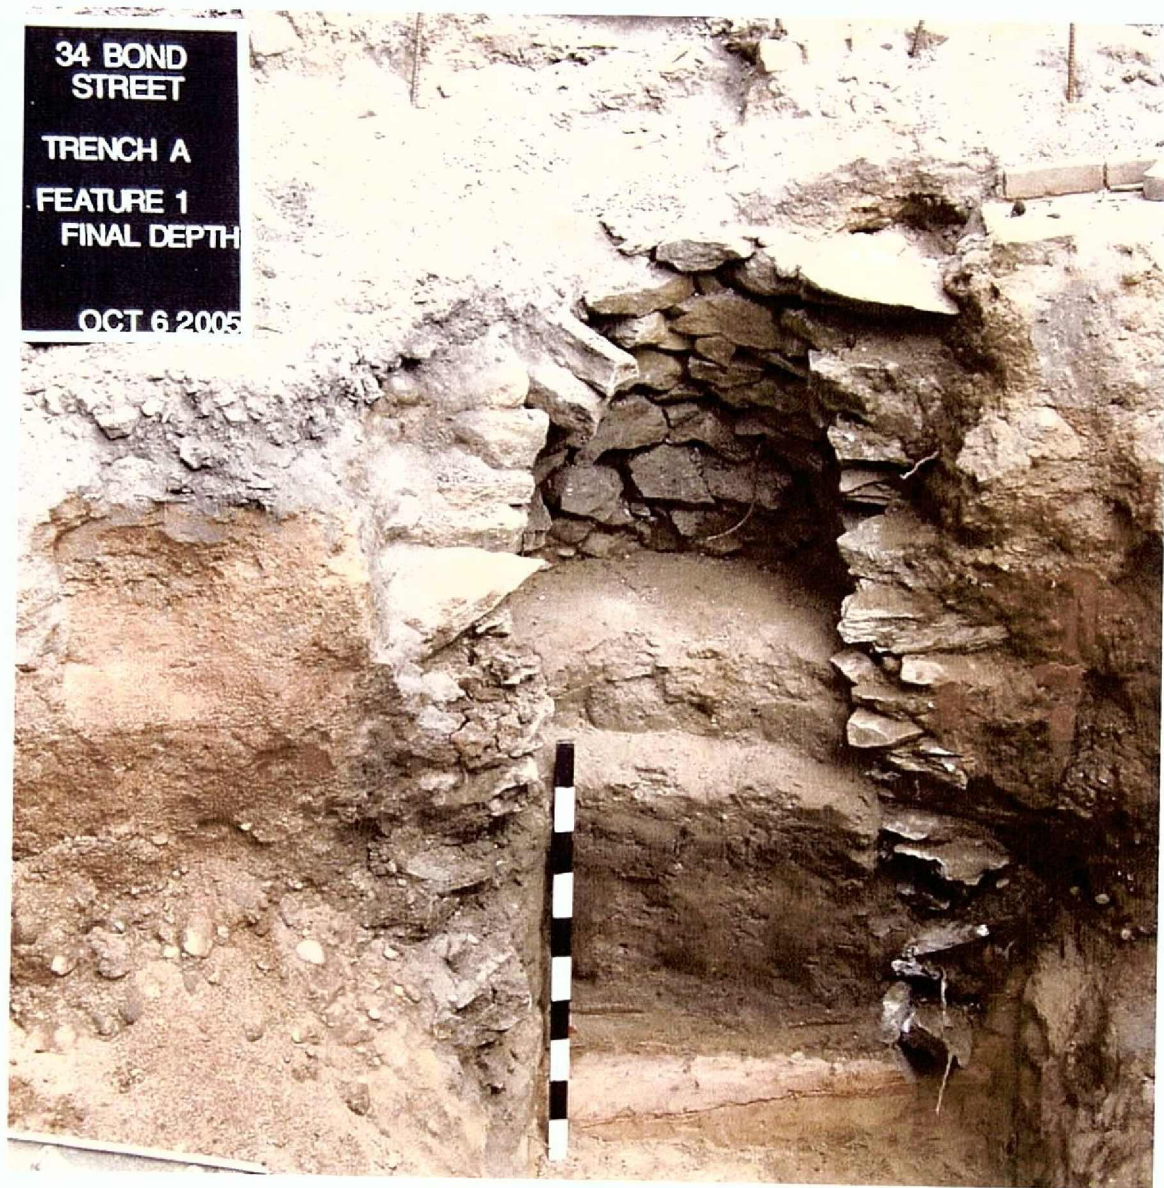
Photograph K. 34 Bond Street, Trench A, Stone Dry Well.

Photograph L. 34 Bond Street, Trench A, Stone Dry Well, Final.

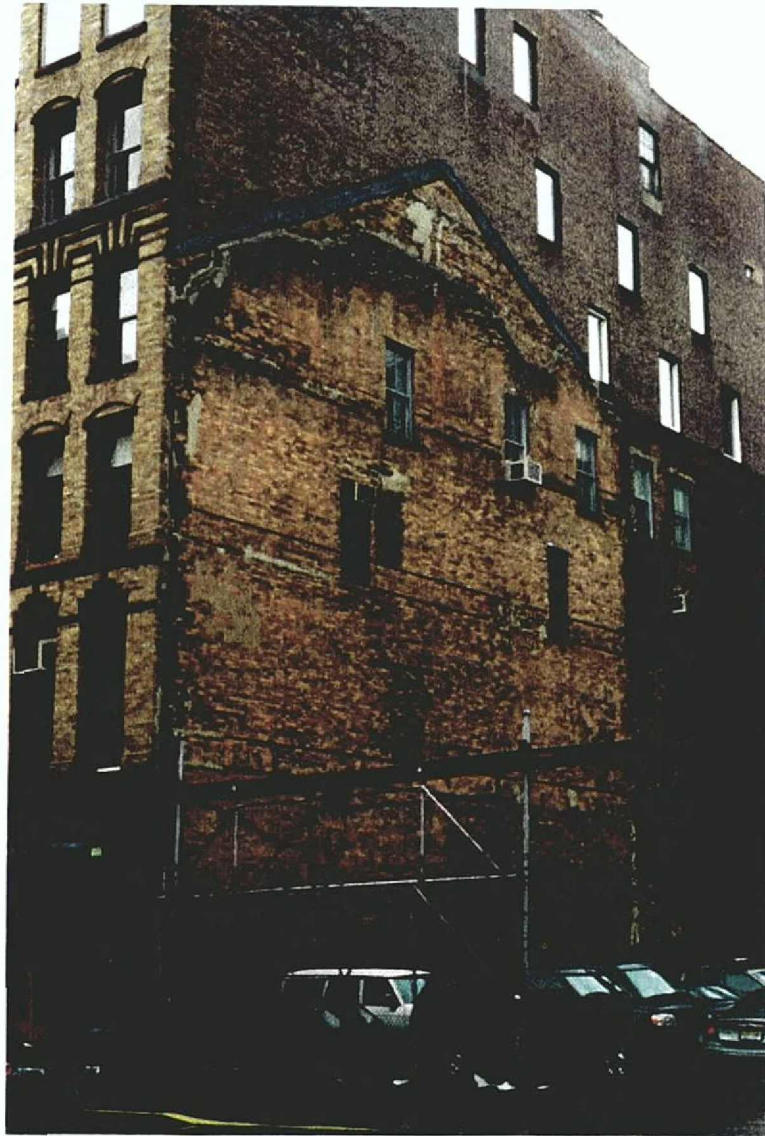
The dry wells found at 32 and 34 Bond Street represent the more complex types of these features. Although constructed of different materials, both of the features revealed during testing are similar in design. The shadow of the roofline for the former residence at 32

Photograph M. Roofline of the Former 32 Bond Street Residence.
